PHASE II INVESTIGATION REPORT

AREA A: PARCEL A10
TRADEPOINT ATLANTIC
SPARROWS POINT, MARYLAND

ARM Project No. 150298M-5

Revision 1 – July 8, 2019

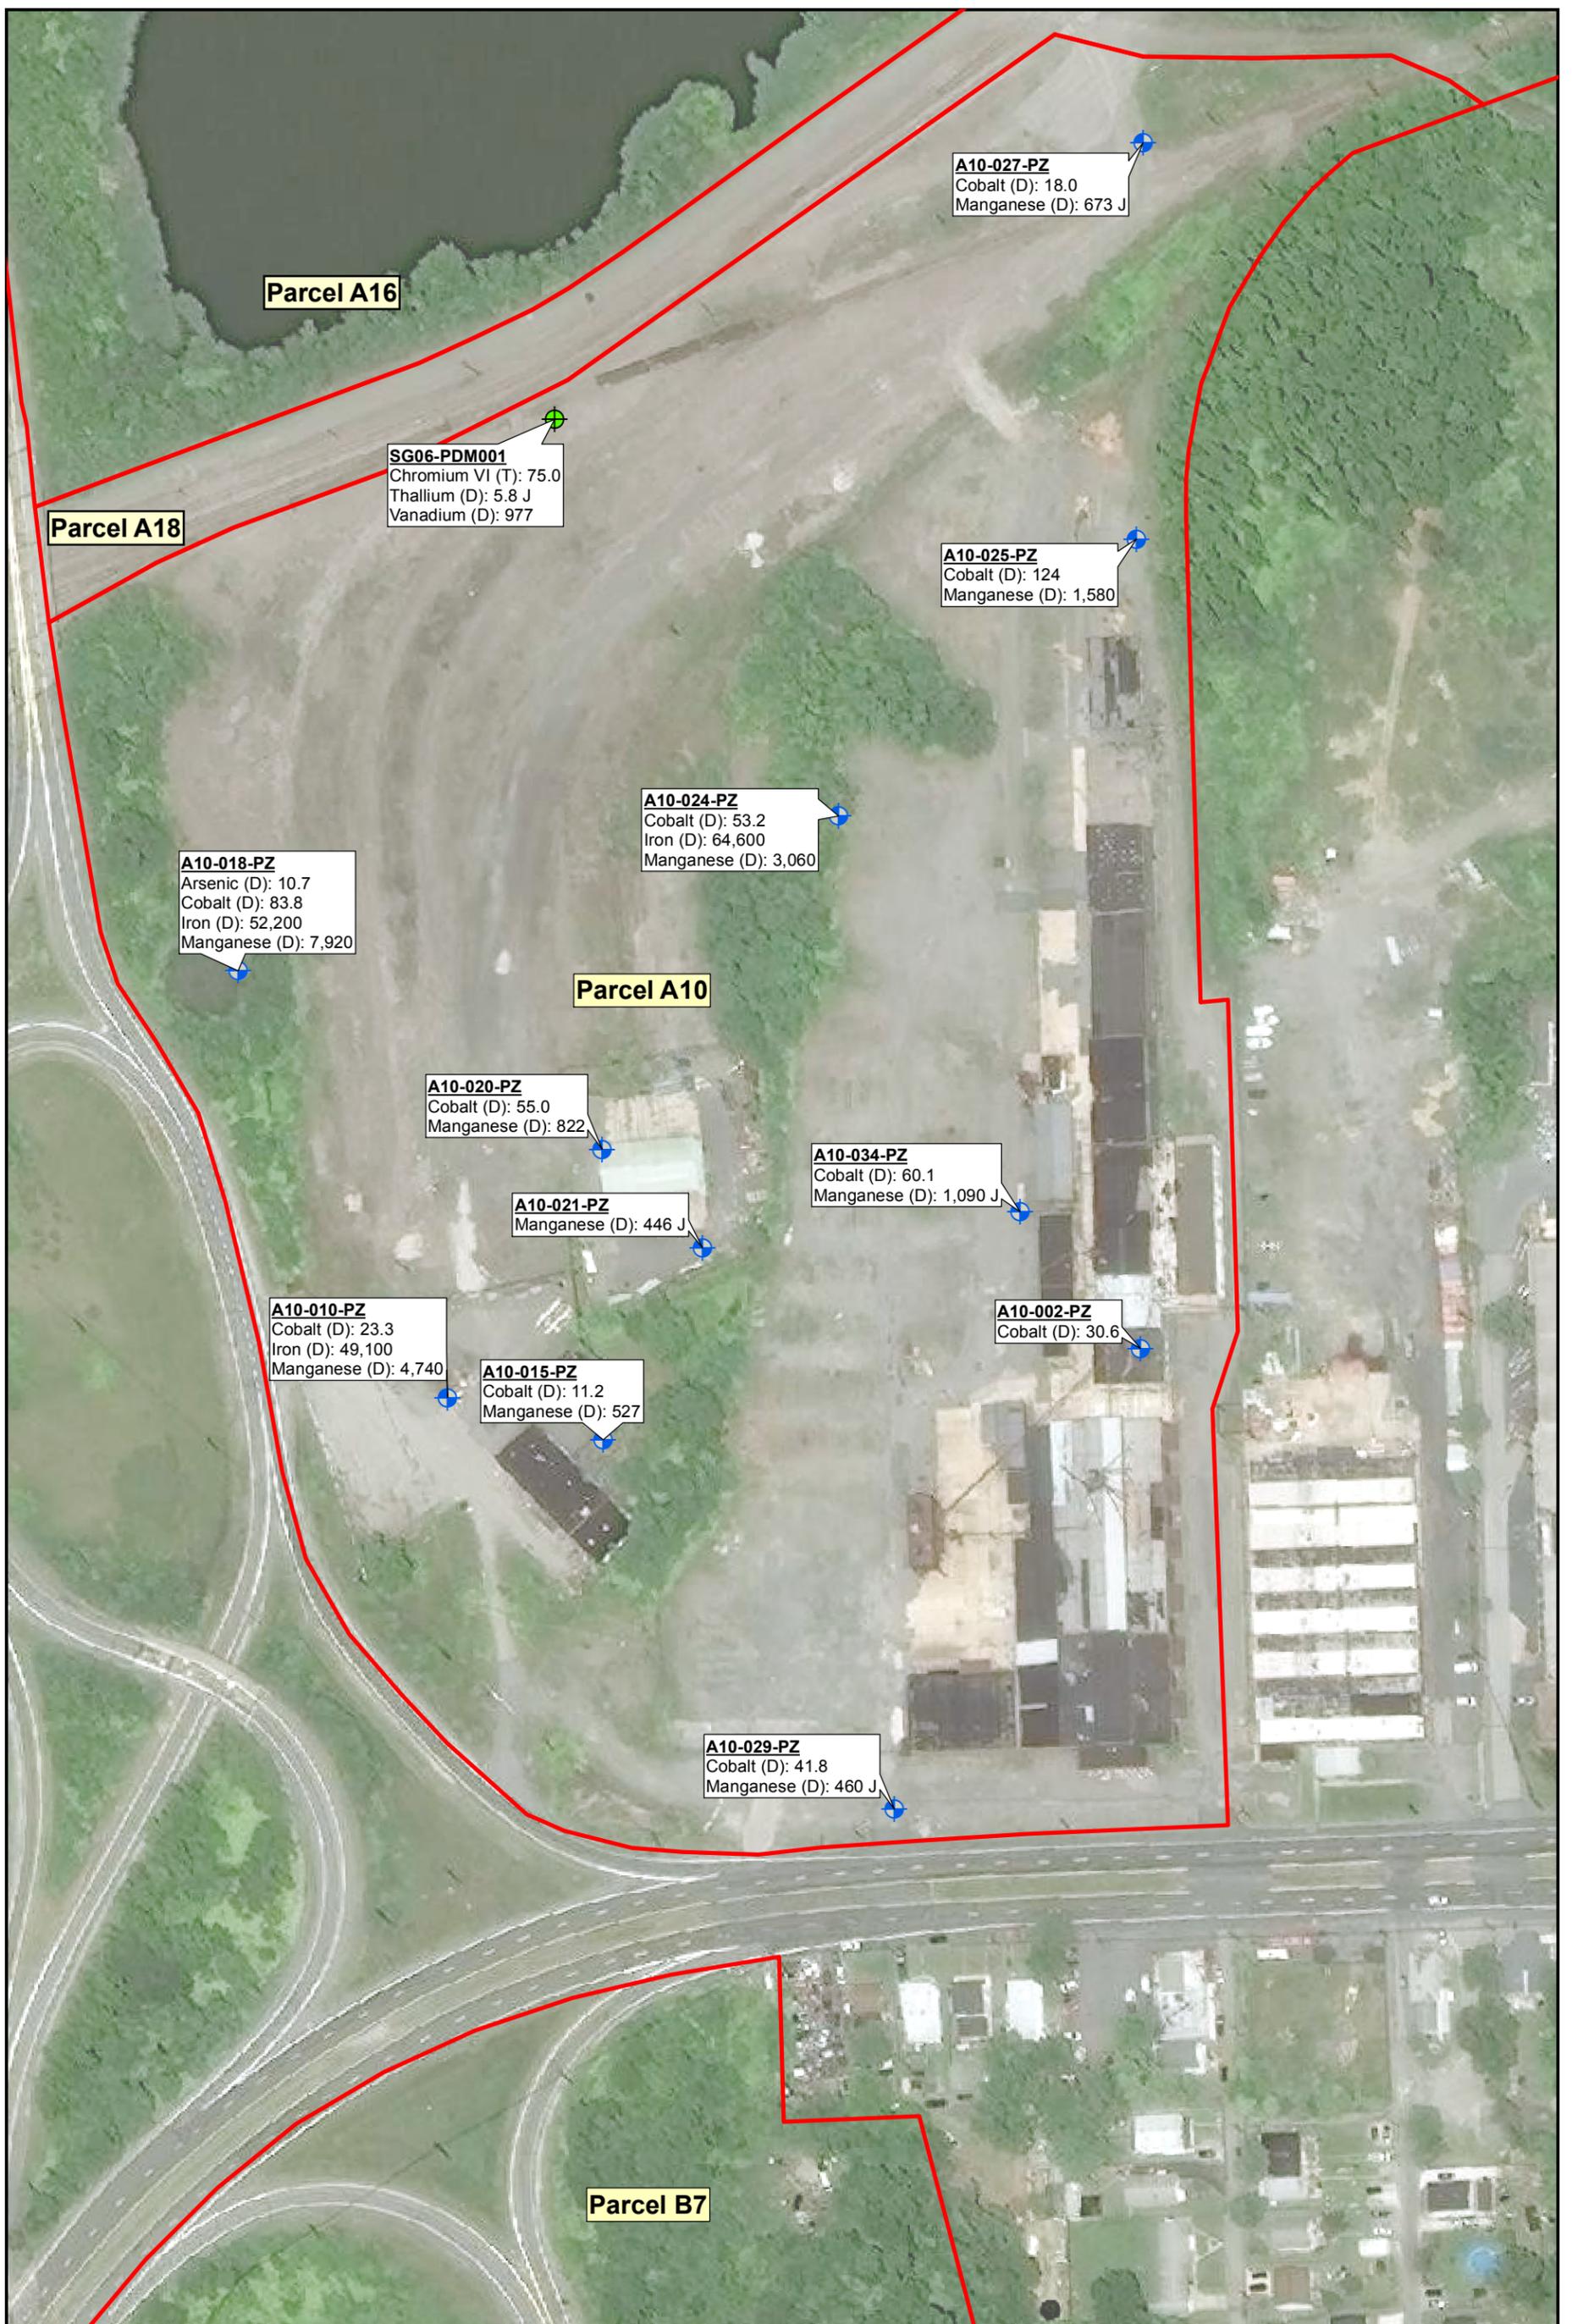
**Figure
GW-4**

- Piezometer (T) = Total (D) = Dissolved
- Permanent Well
- Parcel Boundary

**Parcel A10 Piezometers
Phase II Inorganic Exceedances (ug/L)**
April 4, 2018

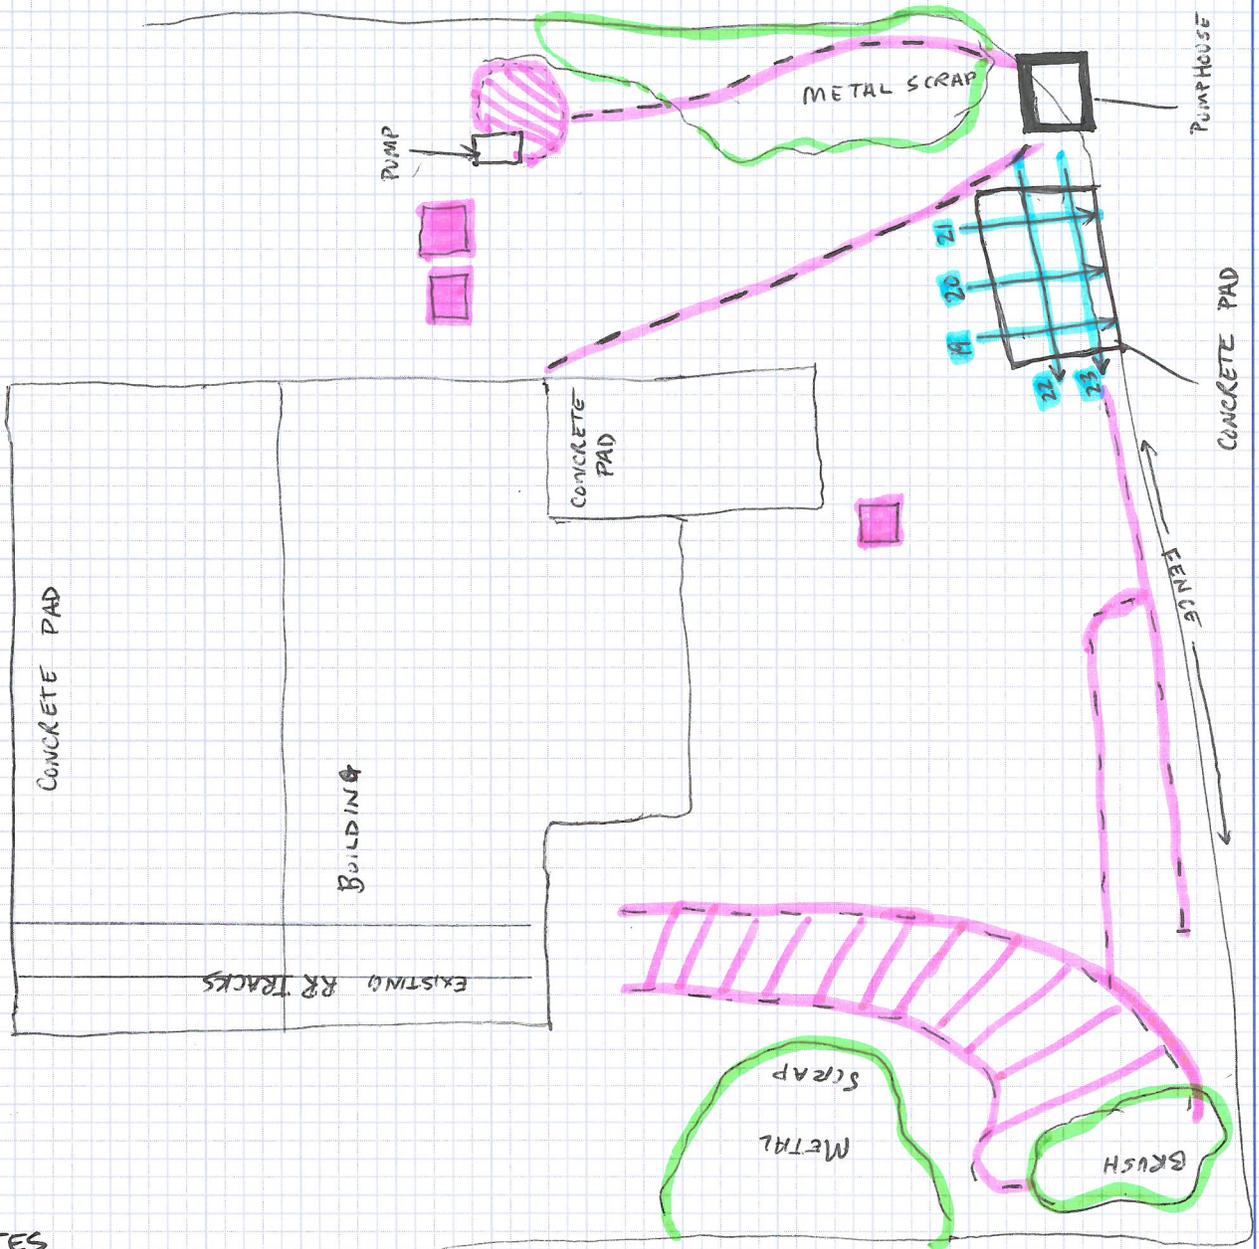
The geophysics investigation was conducted in the area to the south of the repair shop on June 22, 2016. This investigation utilized EM61 metal detectors, utility and pipe locators, and ground penetrating radar (GPR) to screen the pad and surrounding open ground. Although a few metallic anomalies were noted and marked on the ground, there was no evidence of a UST below the concrete pad or in the surrounding open areas. The field notes obtained during the geophysics investigation are provided in **Appendix D**. Since the UST was not located, there were no changes to the proposed investigation plan.

- METALLIC ANOMALIES
- GPR TRANSECTS
- METAL INTERFERENCE BRUSH
