PHASE II INVESTIGATION REPORT

AREA B: PARCEL B17
TRADEPOINT ATLANTIC
SPARROWS POINT, MARYLAND

ARM Project No. 150300M-22

Revision 1 – August 7, 2019

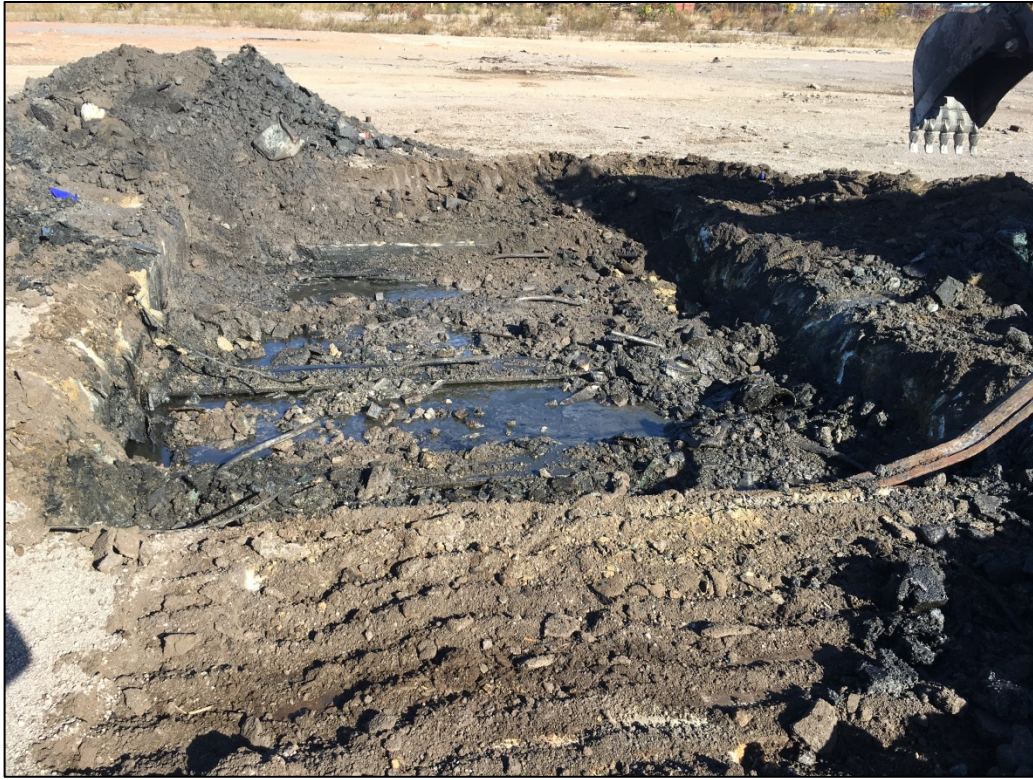
Photo 1: View of test pit at B17-007-SB, facing north, prior to clearing and cleaning. NAPL can be observed on the water.

- B17-007-SB: This location targeted the Machine Shop No. 2 Stained Ground (Possible Oily Pits/Sumps). The boring had visible low to medium viscous black product in the soil core from 1.8 to 3 feet bgs which was noted on the boring log. A moderate odor was also detected accompanying the product. A shallow soil sample (B17-007-SB-1) was collected from the 0 to 1 foot bgs interval. Oil & Grease (detected at 347 mg/kg) was identified in the sample well below the PAL. An intermediate soil sample was not collected due to shallow refusal at 3 feet bgs. Due to the observed NAPL and based on the sampling plan target, a test pit was completed in the vicinity of B17-007-SB. During test pitting, a subgrade structure containing NAPL-impacted material was identified. All impacted debris, soil, and aqueous material was removed from the subgrade structure, and the

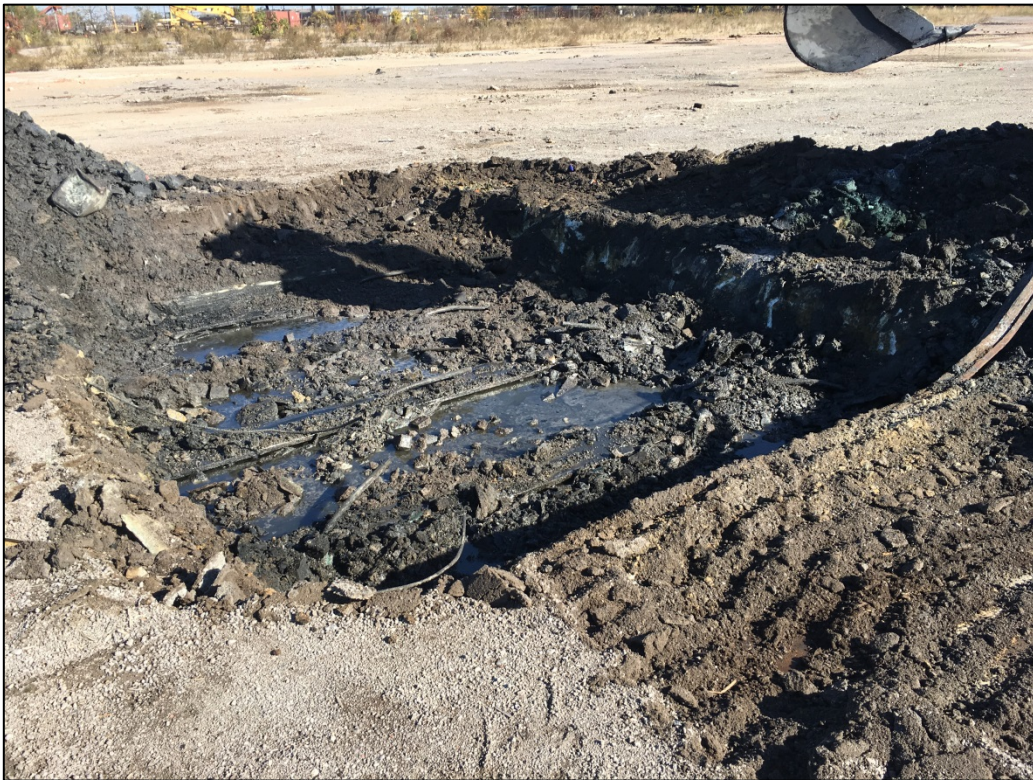
Photo 2: View of test pit at B17-007-SB prior to clearing and cleaning.

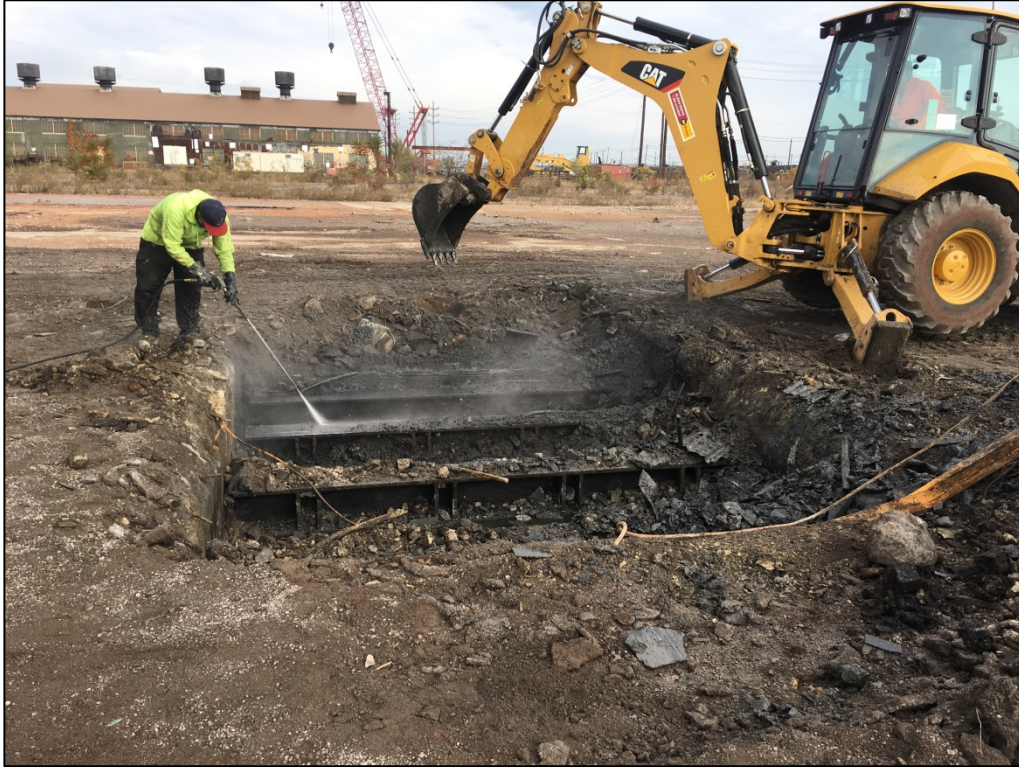
Photo 3: View of the ACE Environmental crew cleaning pit at B17-007-SB and the ENRC crew using the backhoe to remove the impacted material.

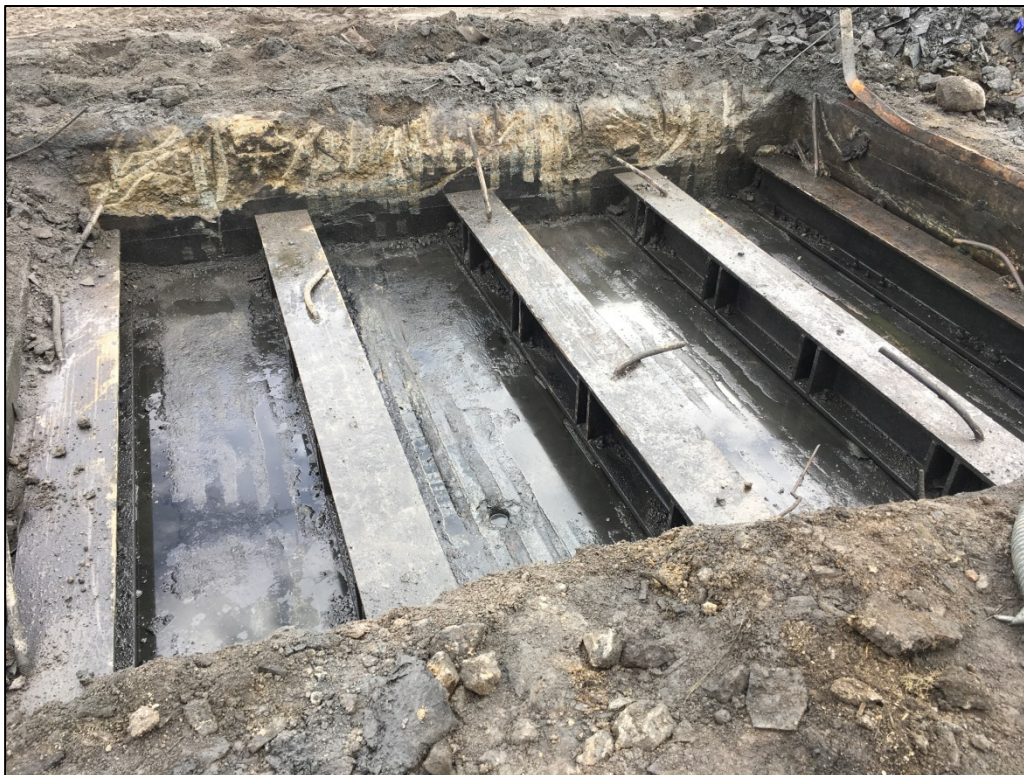
Photo 4: View of the cleaned concrete box facing east. Please note the circle along the concrete floor between the I-beams; this was the Geoprobe attempt to complete B17-007-SB.

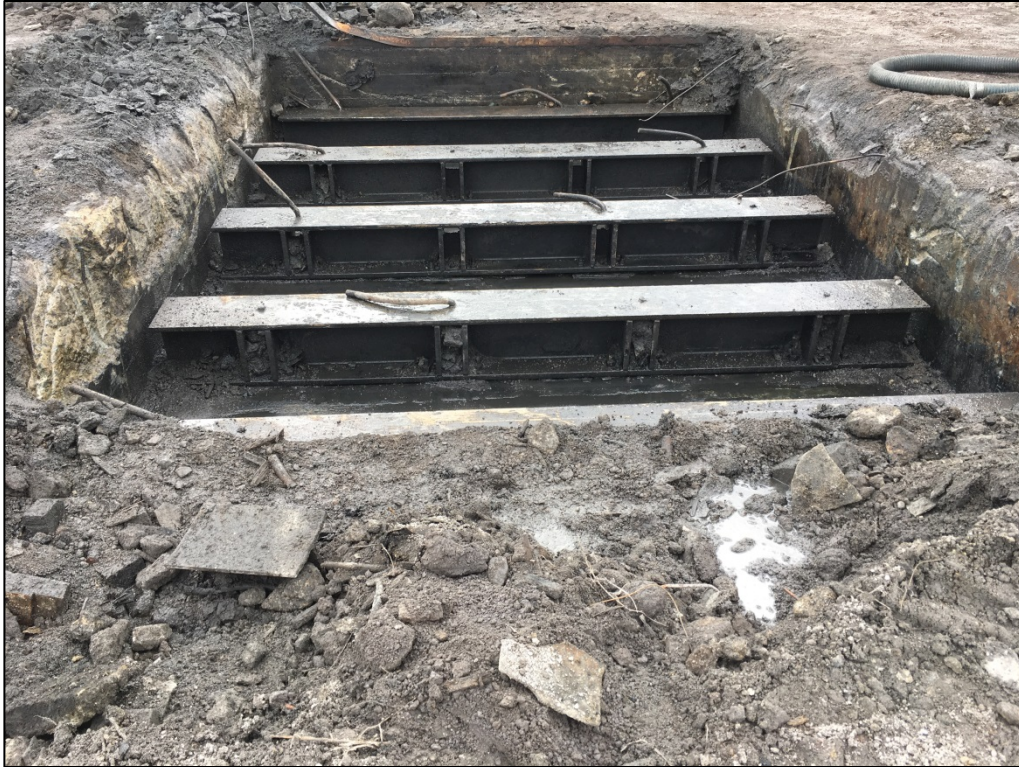
Photo 5: View of the cleaned concrete box facing south.

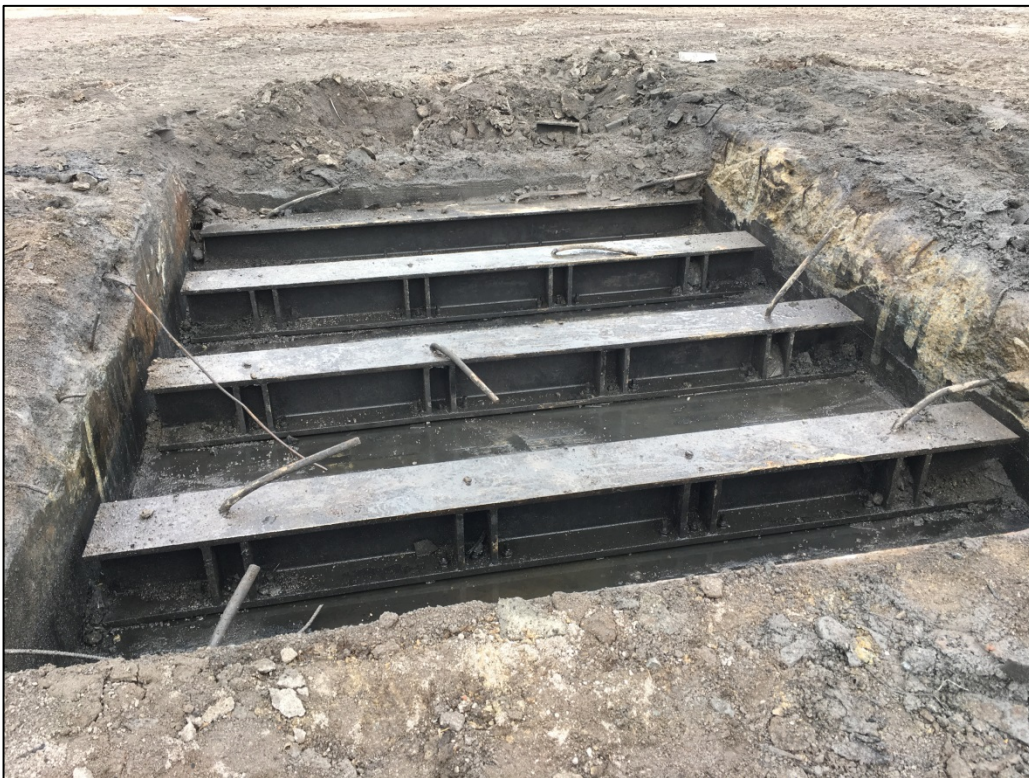
Photo 6: View of the cleaned concrete box facing north.

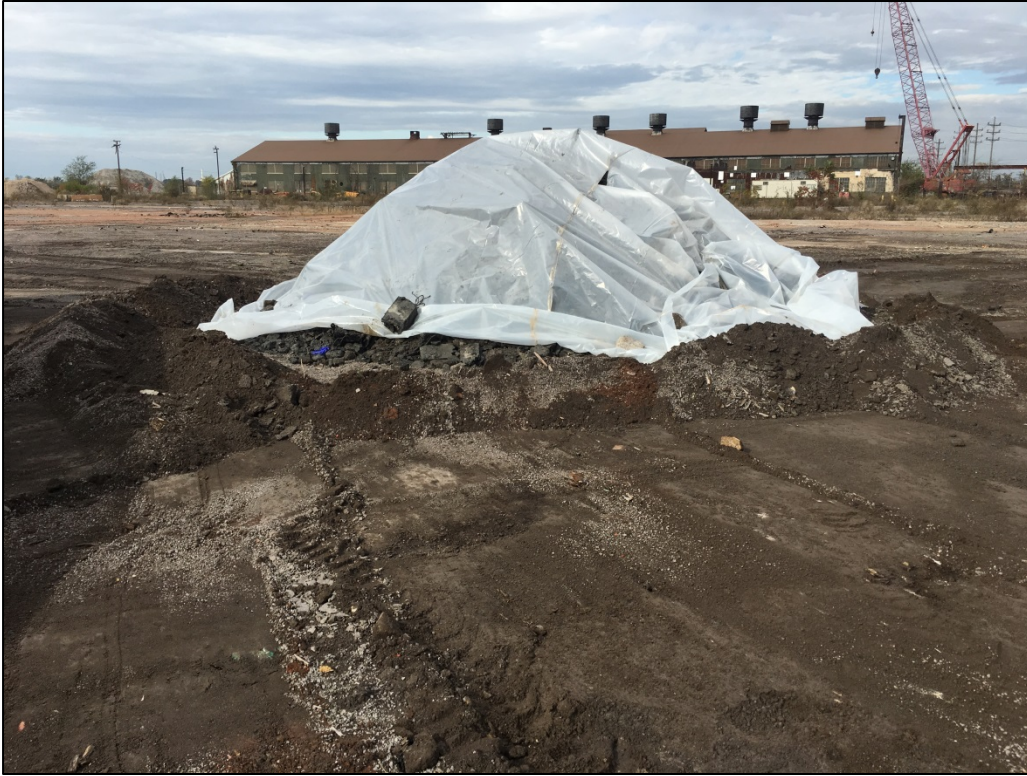
Photo 7: View of covered material removed from test pit at B17-007-SB facing north. A gravel filter berm was temporarily set up around the stockpile to prevent run-on and runoff of stormwater.

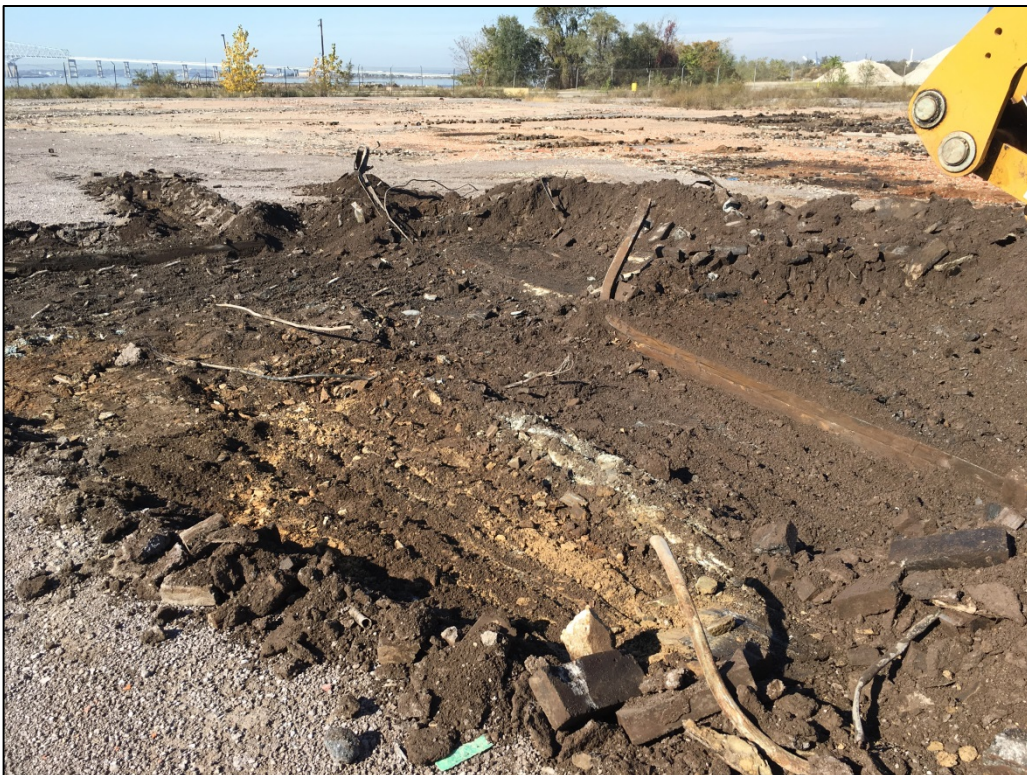
Photo 8: View of shallow test pit at B17-021-SB facing northwest. Reinforced concrete and large diameter rebar encountered during test pit activities. Little to no petroleum impacts observed.

The boring was successfully completed to 10 feet bgs with groundwater observed at 9.5 feet bgs. Due to the elevated analytical detection and based on the sampling plan target, a test pit was completed in the vicinity of B17-021-SB. During test pitting, little to no petroleum impacts were observed, and no subgrade structures/pits were encountered. The test pitting was documented in a photograph log (**Appendix E**). A temporary NAPL screening piezometer was not installed at B17-021-SB based on the field observations during the test pitting.

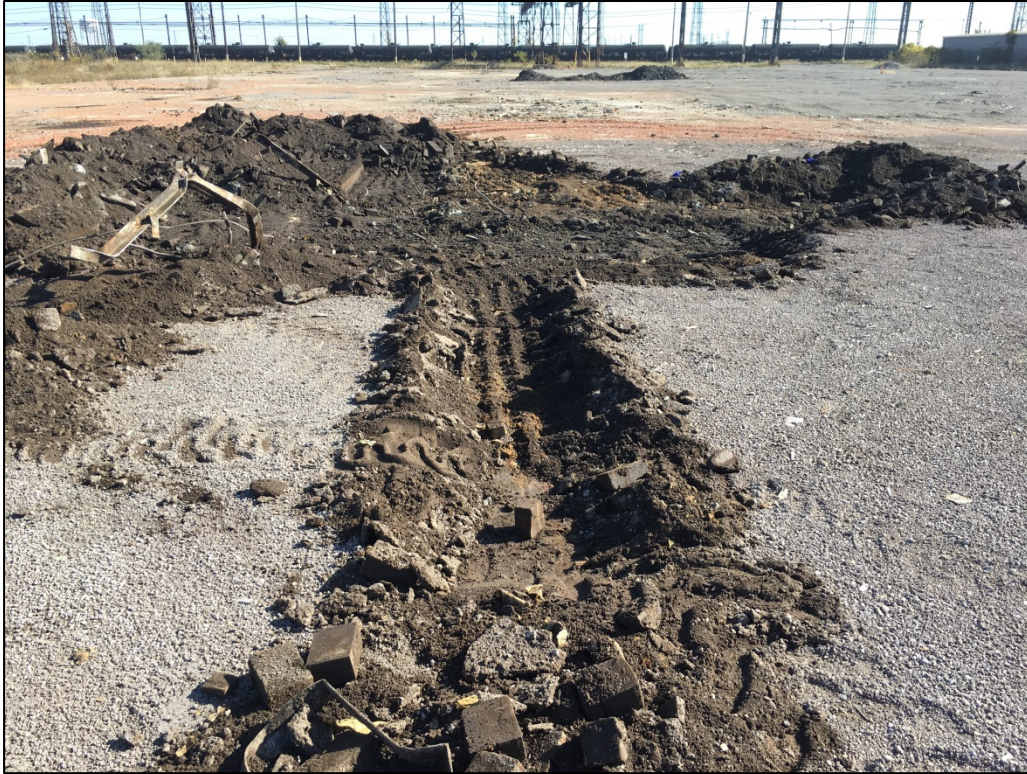
Photo 9: View of shallow test pit at B17-021-SB facing east. Reinforced concrete and large diameter rebar encountered during test pit activities. Little to no petroleum impacts observed.
