PHASE II INVESTIGATION REPORT

AREA B: PARCEL B20
TRADEPOINT ATLANTIC
SPARROWS POINT, MARYLAND

Revision 0 – January 14, 2021

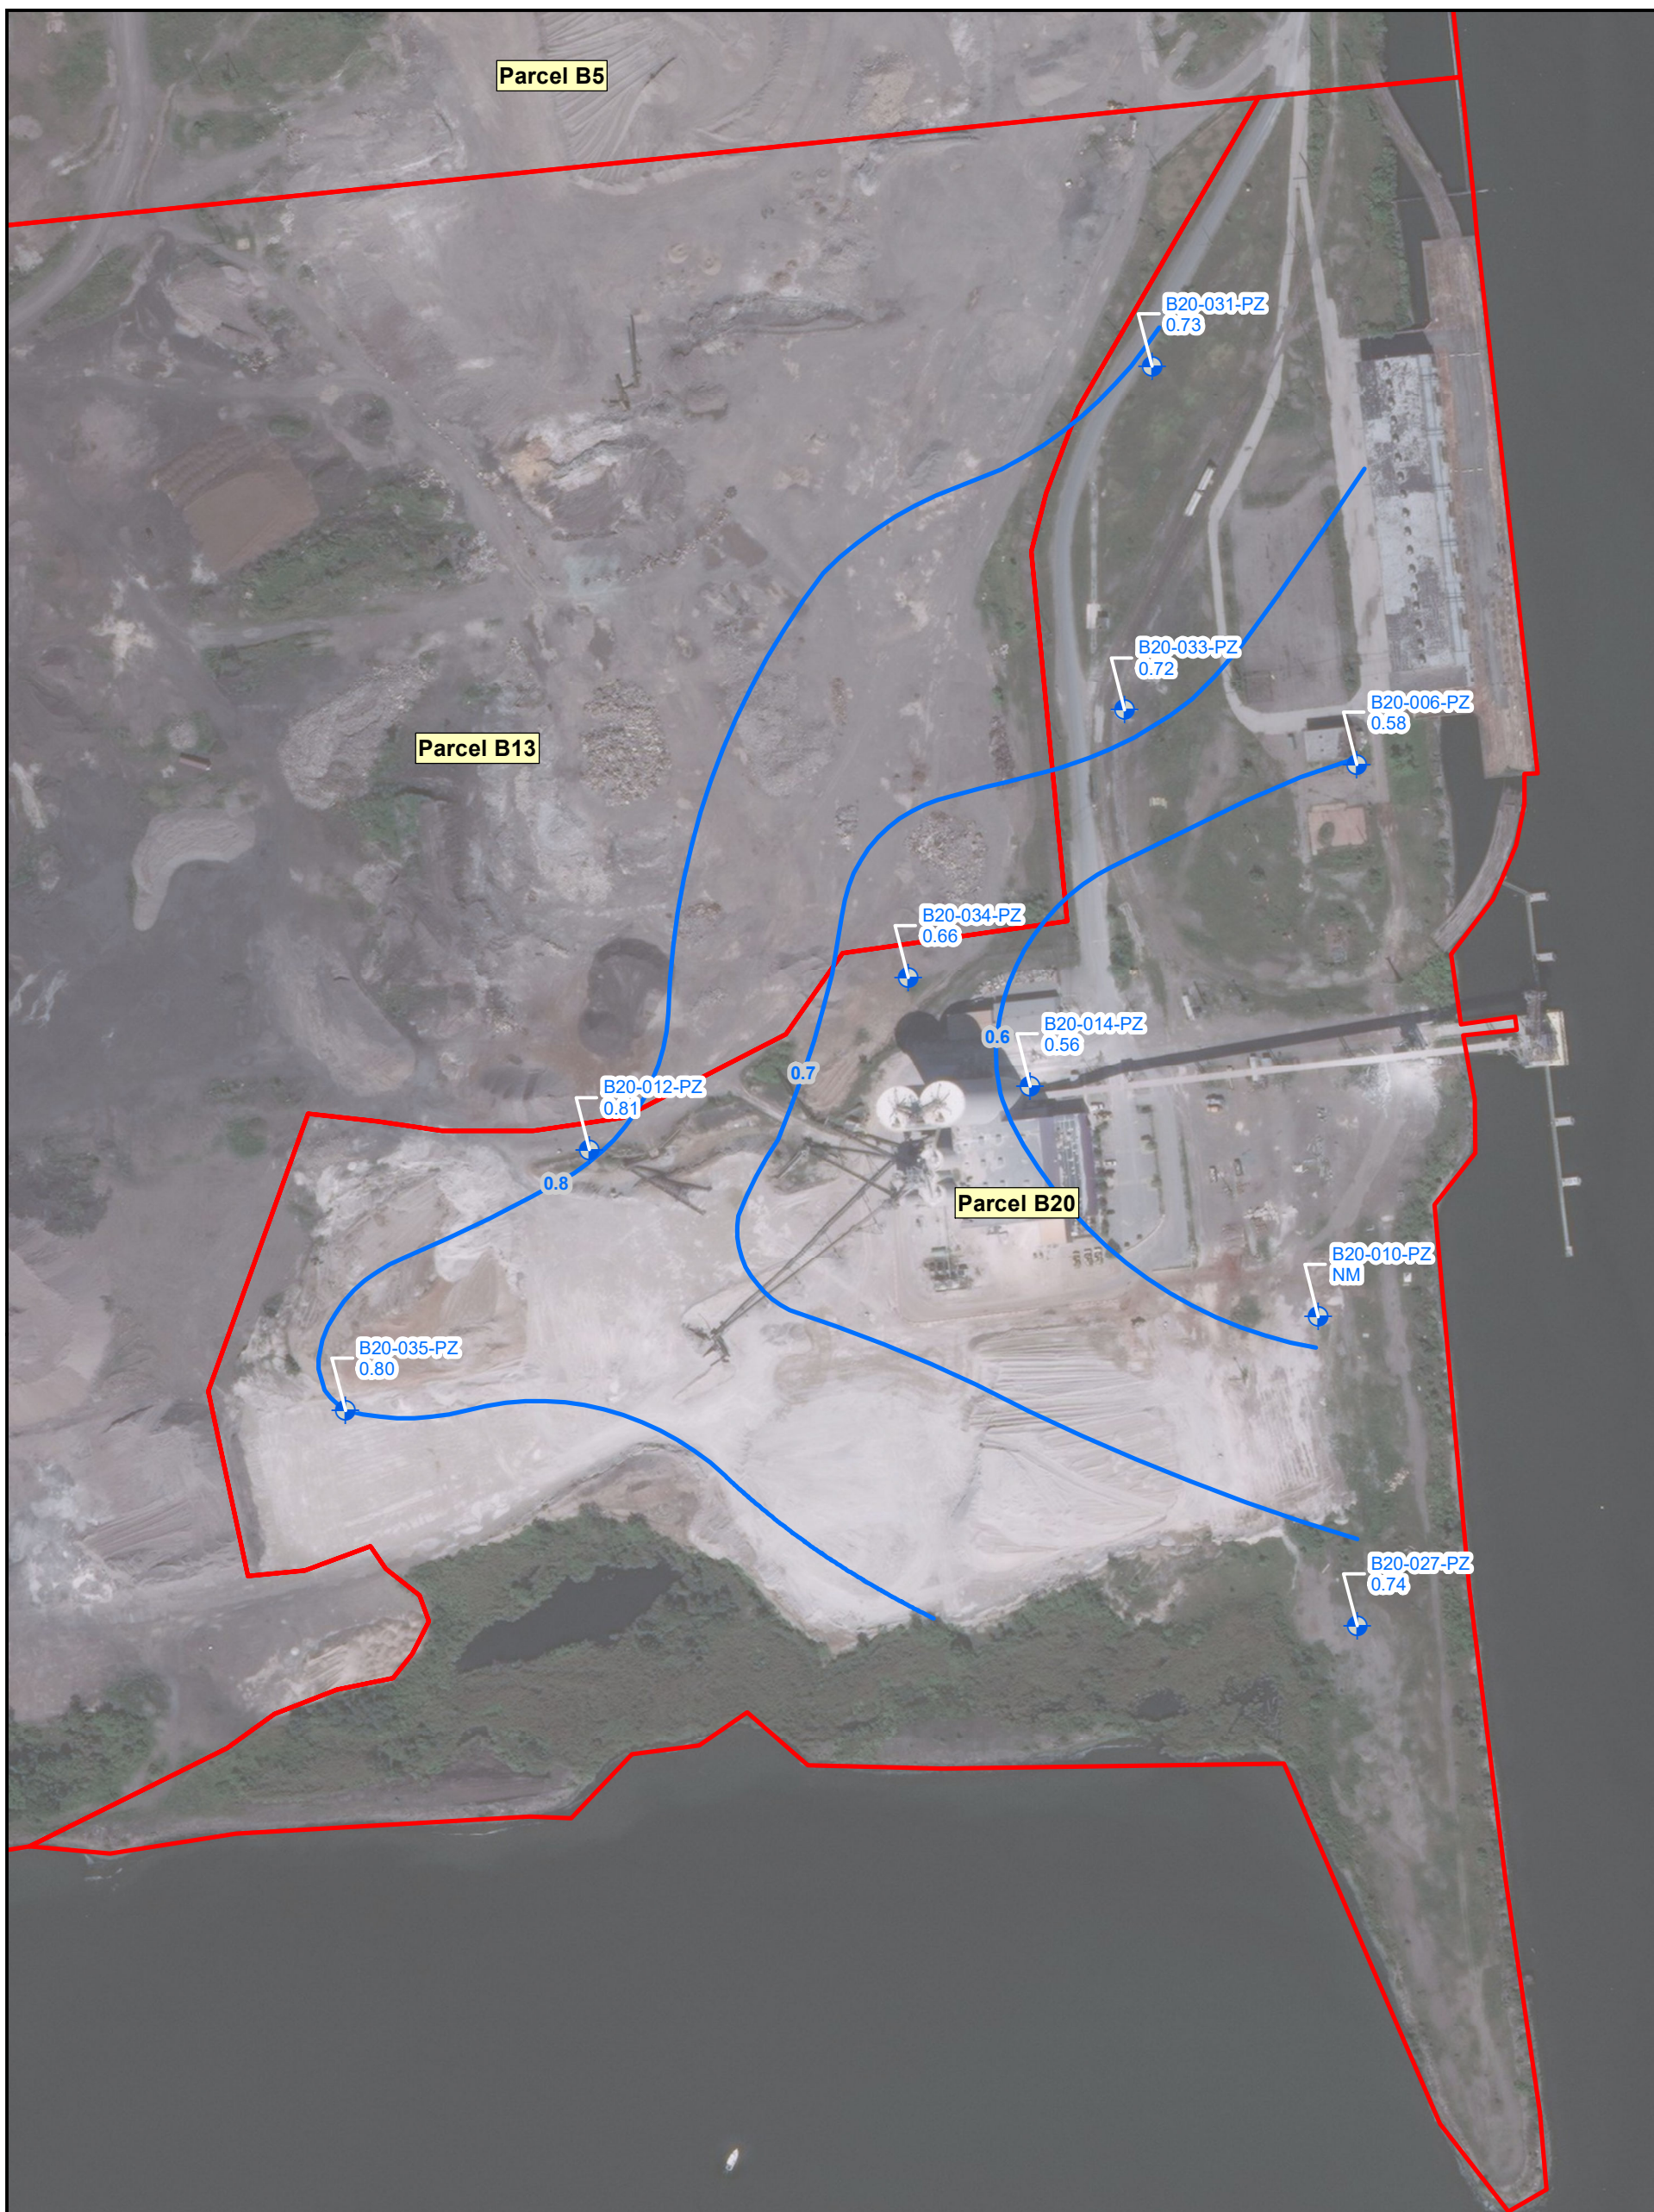
Water Level Measurements
Recorded October 27, 2020

Parcel B20 Groundwater Samples
Potentiometric Surface Map
Revised 11/2021

The piezometers were surveyed by a Maryland-licensed surveyor, and the supporting documentation from the survey is included in **Appendix C**. A synoptic round of groundwater level measurements was completed on October 27, 2020. Surveyed top of casing (TOC) elevations for all applicable locations can be found in **Table 1**, along with the depth to water (DTW) measurements from this date. B20-010-PZ was excluded from the survey and synoptic gauging event because of damage to the piezometer. Based on the recorded field measurements, a groundwater potentiometric surface map was constructed for the shallow hydrogeologic zone. The localized potentiometric map for shallow groundwater has been included on **Figure 3**. The elevation contours indicate that groundwater generally flows from west to east across the Site; however, it should be noted that the groundwater elevation gradient is very shallow. All of the computed groundwater elevations are between 0 and 1 foot amsl.

Nine shallow temporary groundwater piezometers (B20-006-PZ, B20-010-PZ, B20-012-PZ, B20-014-PZ, B20-027-PZ, B20-031-PZ, B20-033-PZ, B20-034-PZ, and B20-035-PZ) were included in the parcel-specific sampling plan to characterize groundwater below Parcel B20 and to support the definition of the groundwater potentiometric surface. A piezometer was originally specified to be installed at B20-028-PZ; however, this location could not be installed due to equipment refusal and B20-027-PZ was installed as a replacement location. The locations where shallow groundwater samples were collected are provided on **Figure 3**.

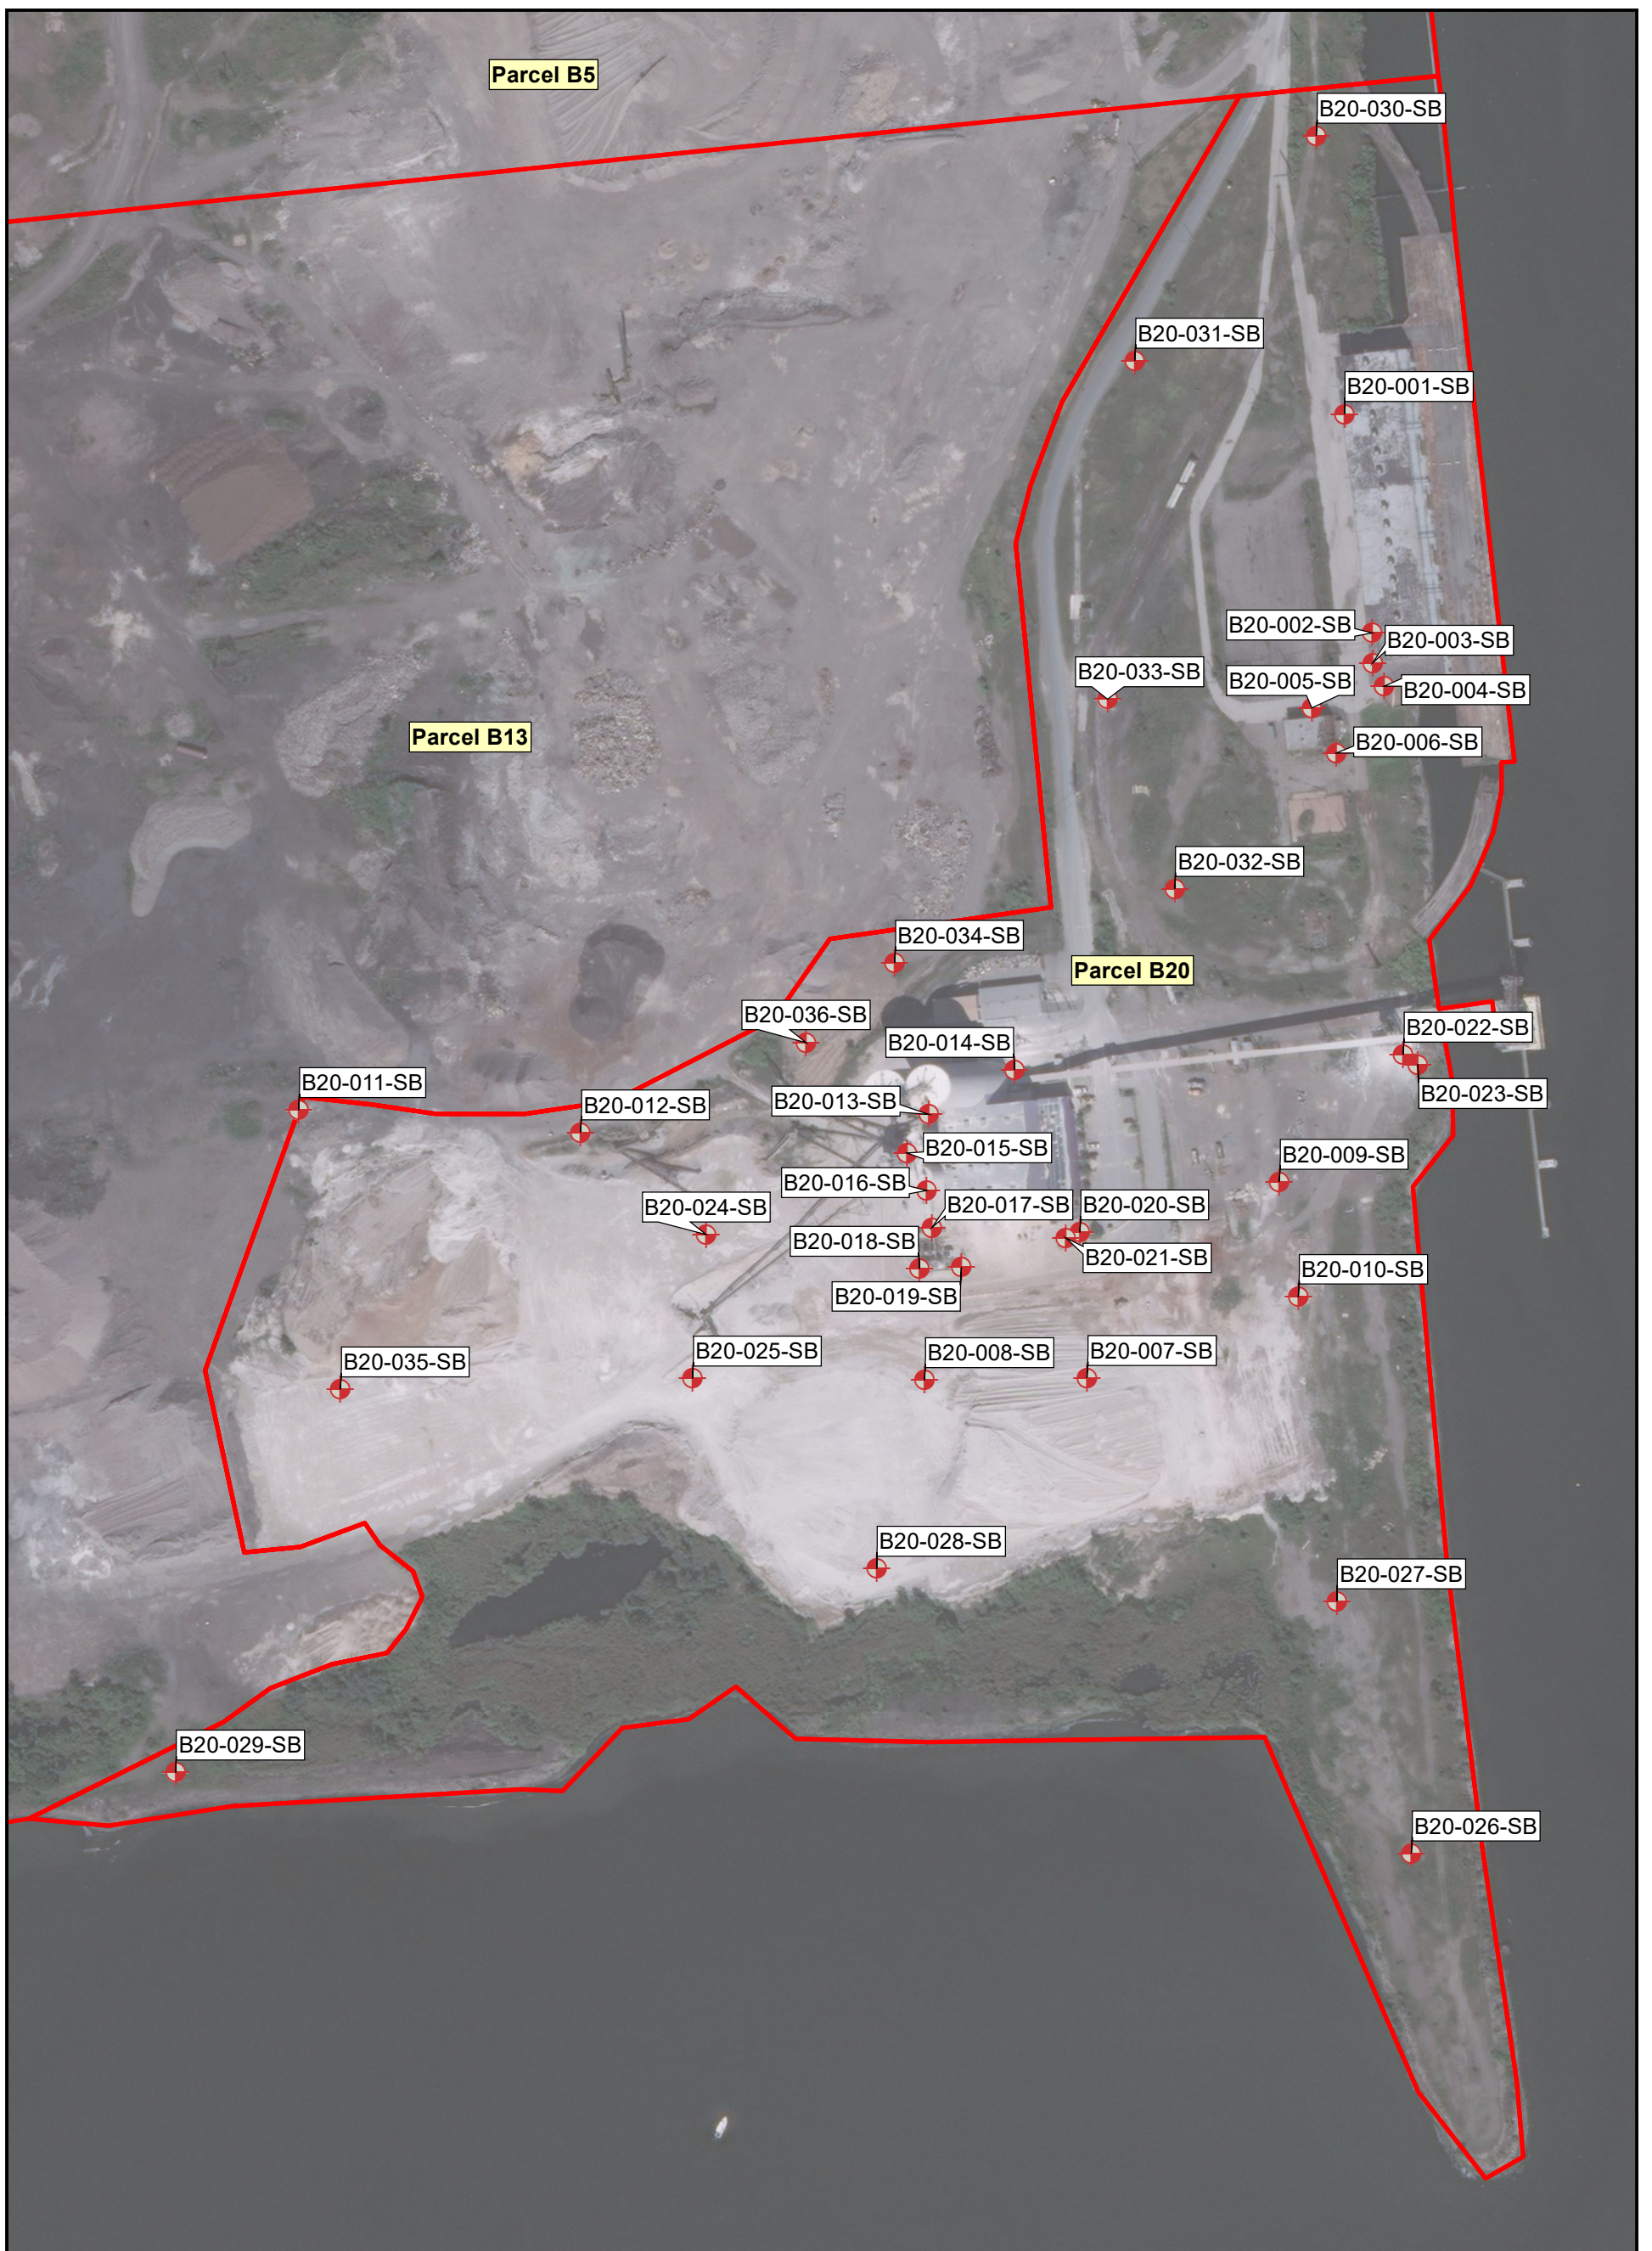
Figure
4

Parcel B20 Soil Samples
Aerial View
January 7, 2021

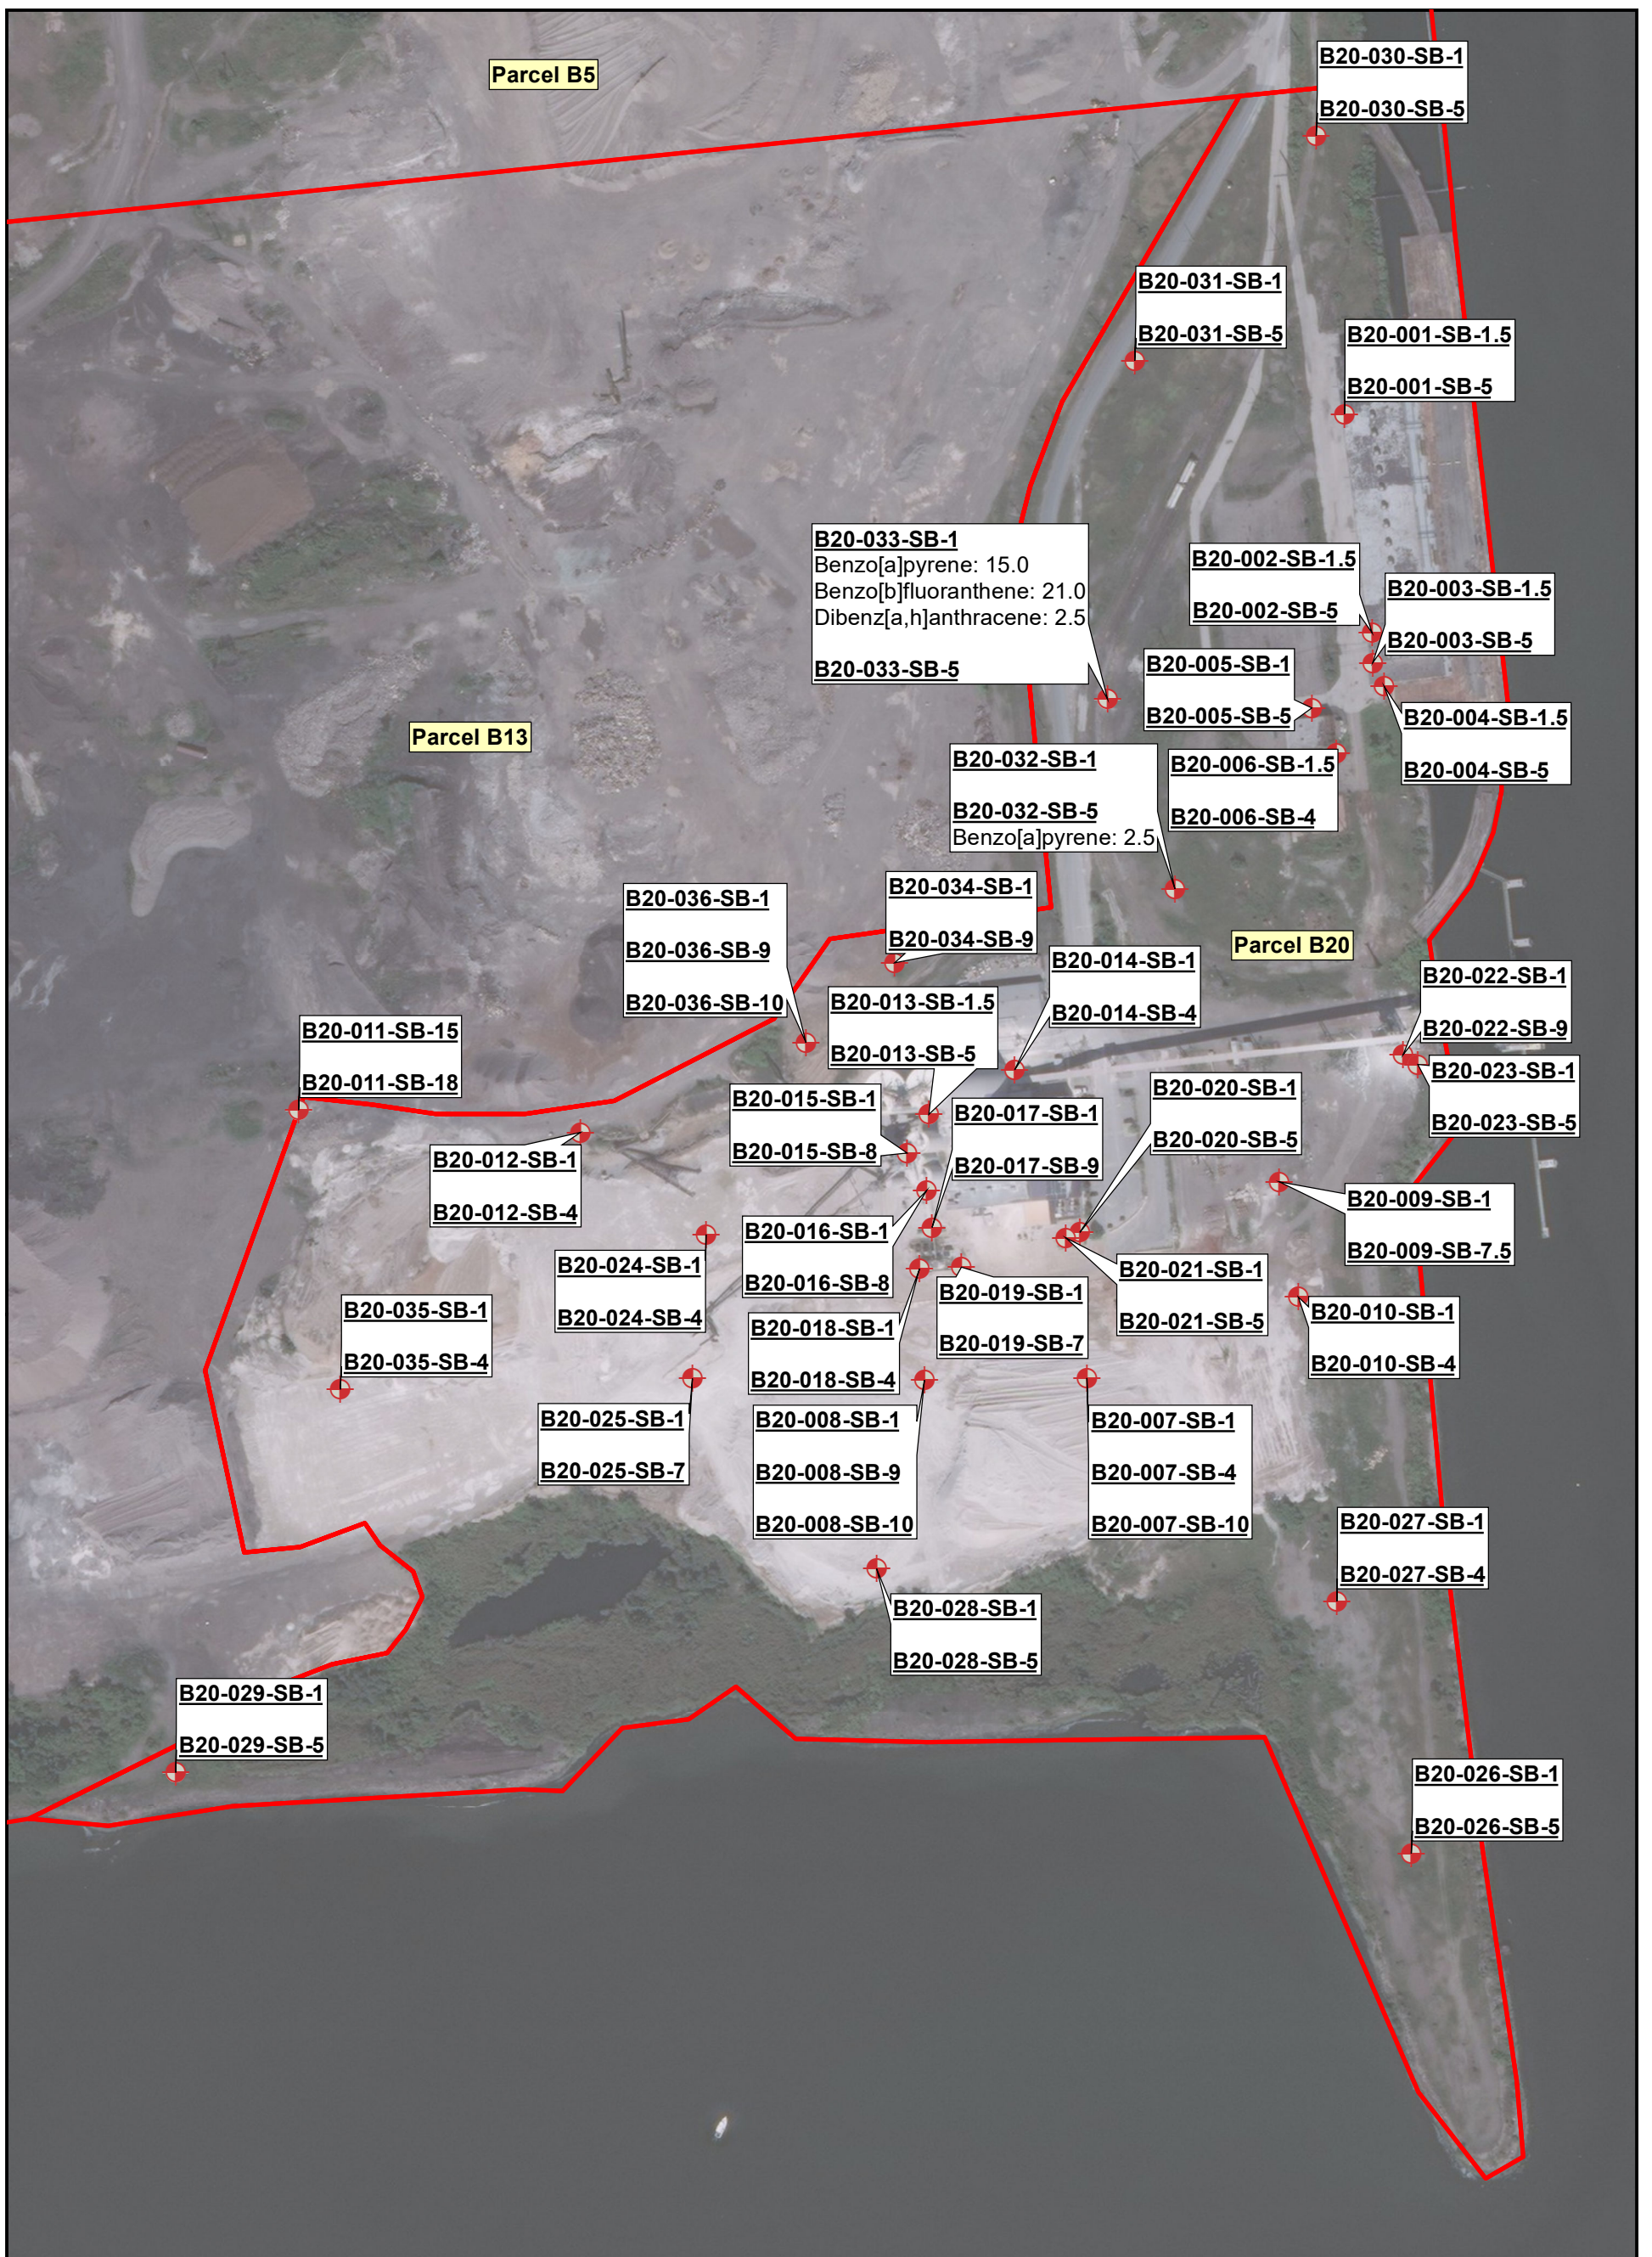
Parcel B20 Soil Samples
SVOC PAL Exceedances (mg/kg)

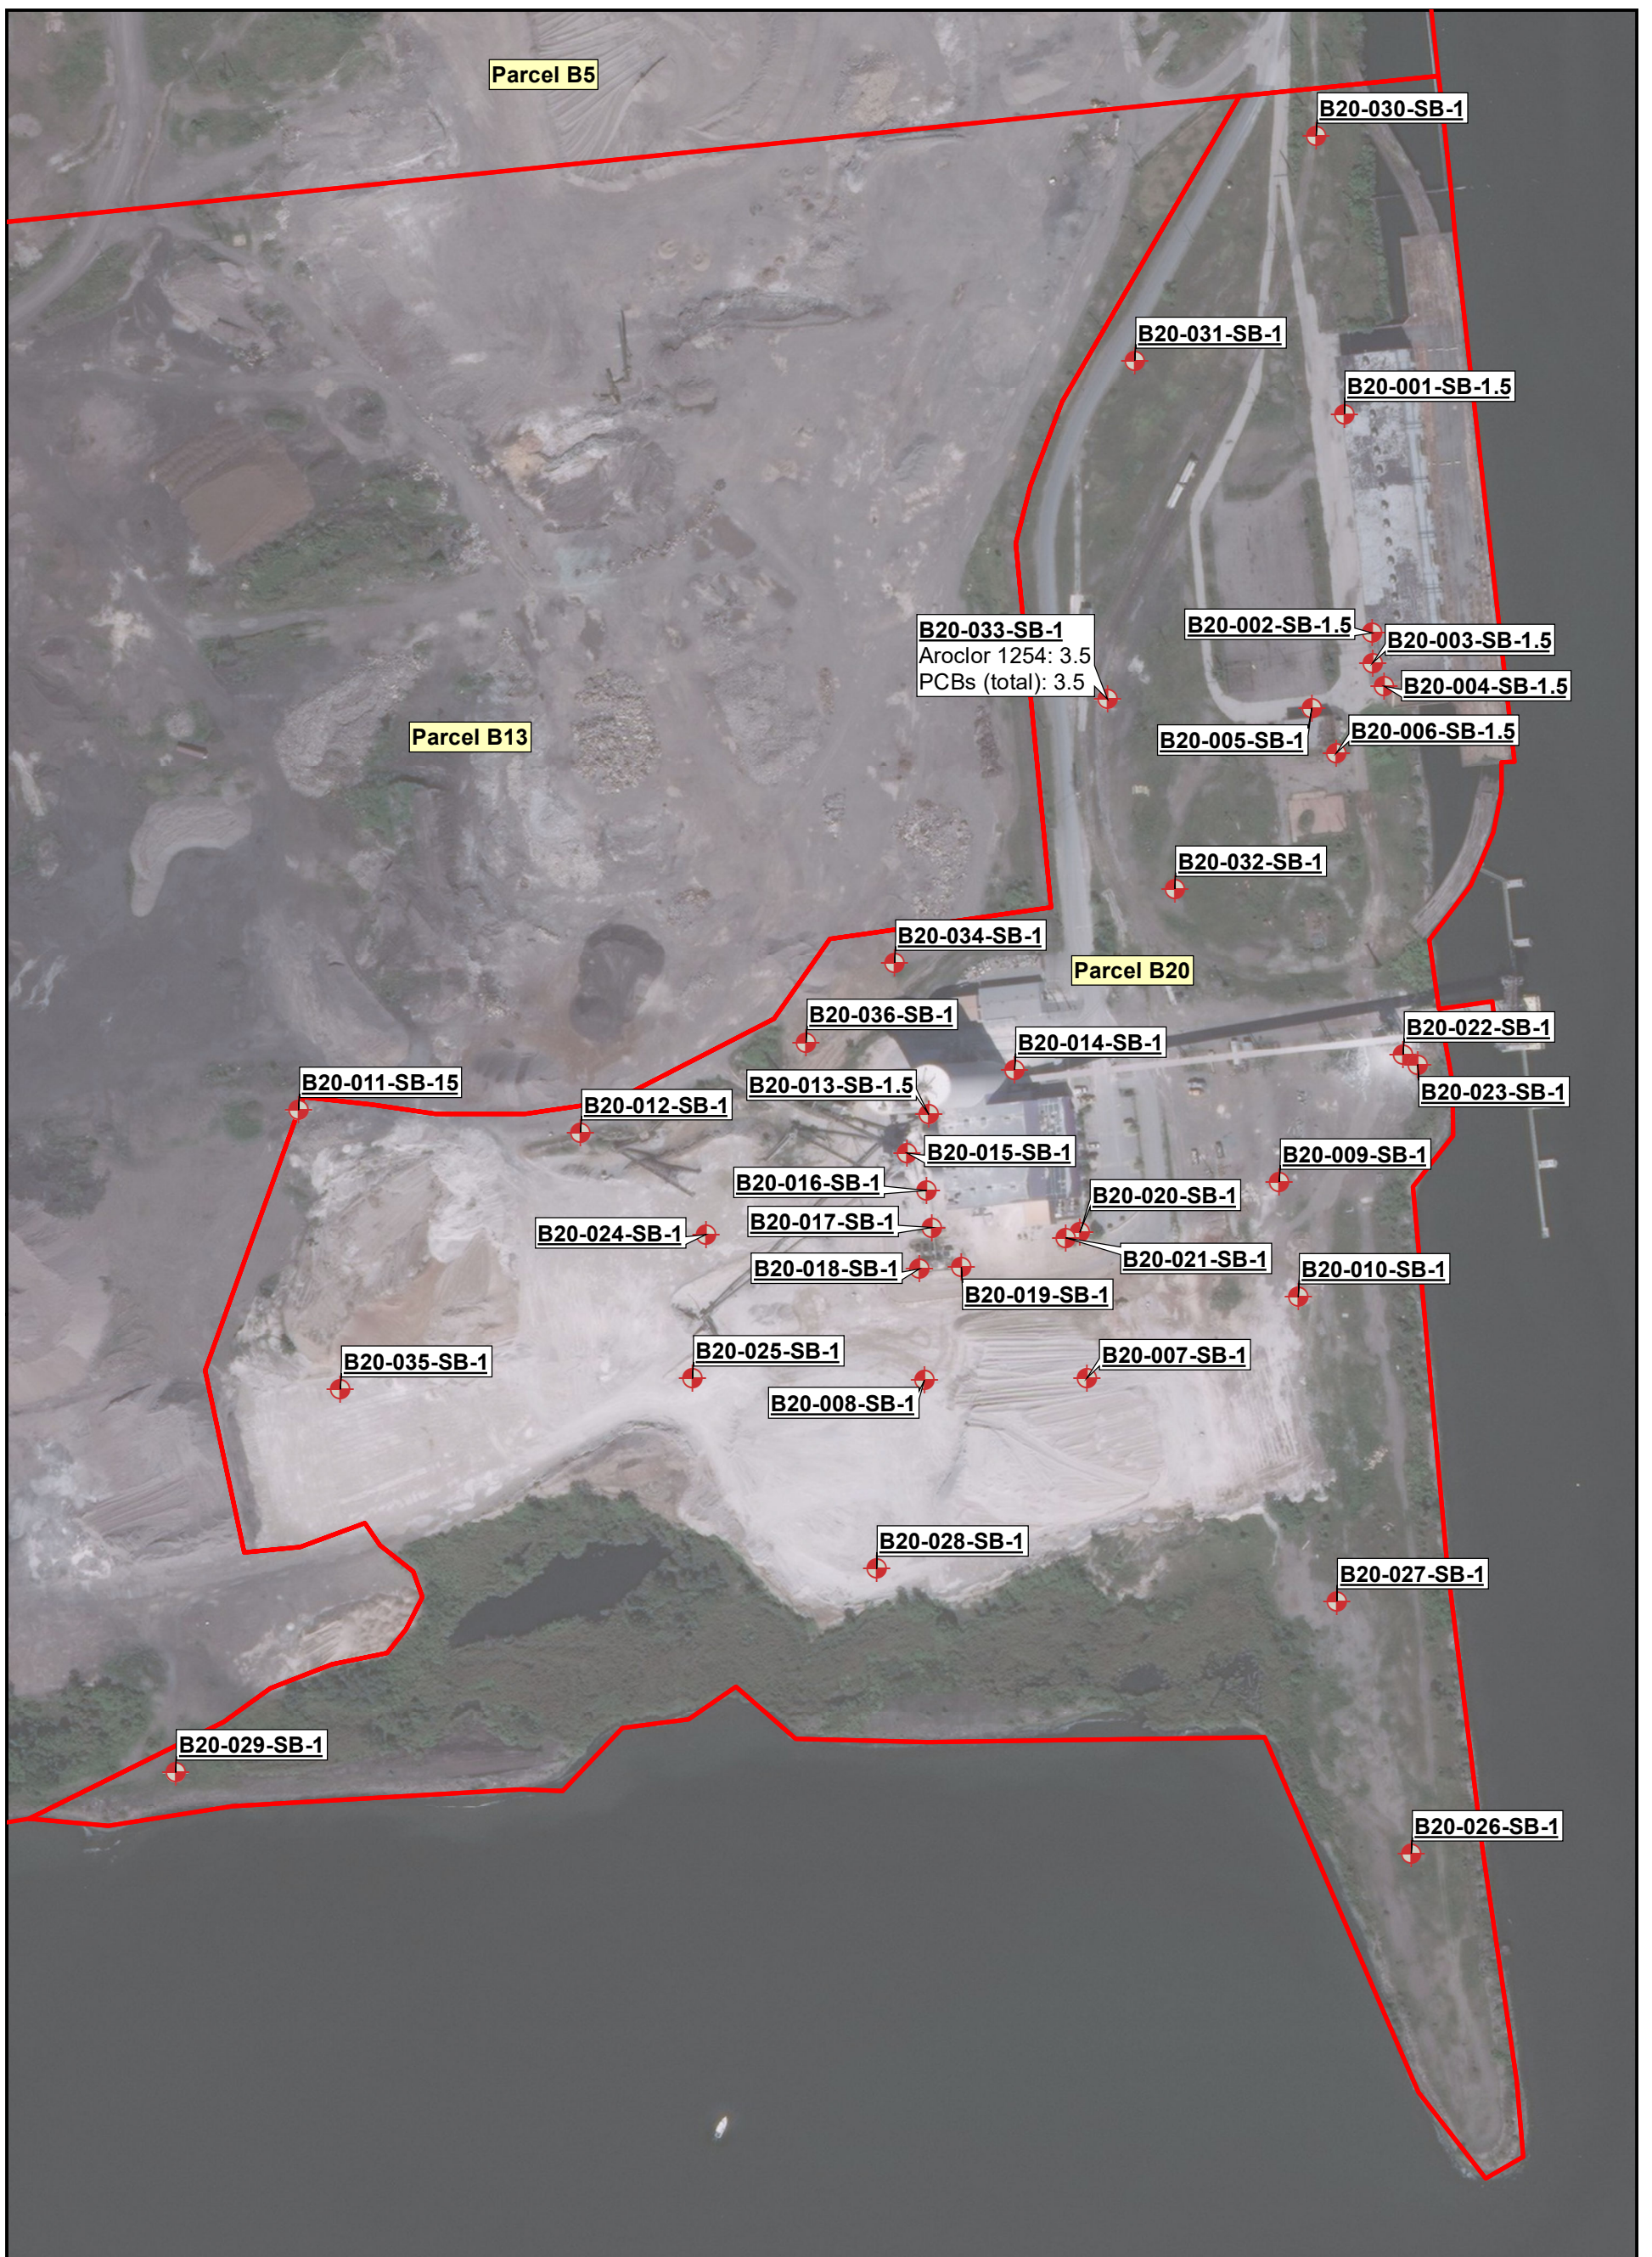
Figure
7

Parcel B20 Soil Samples
 PCB PAL Exceedances (mg/kg)
 Revision 202F

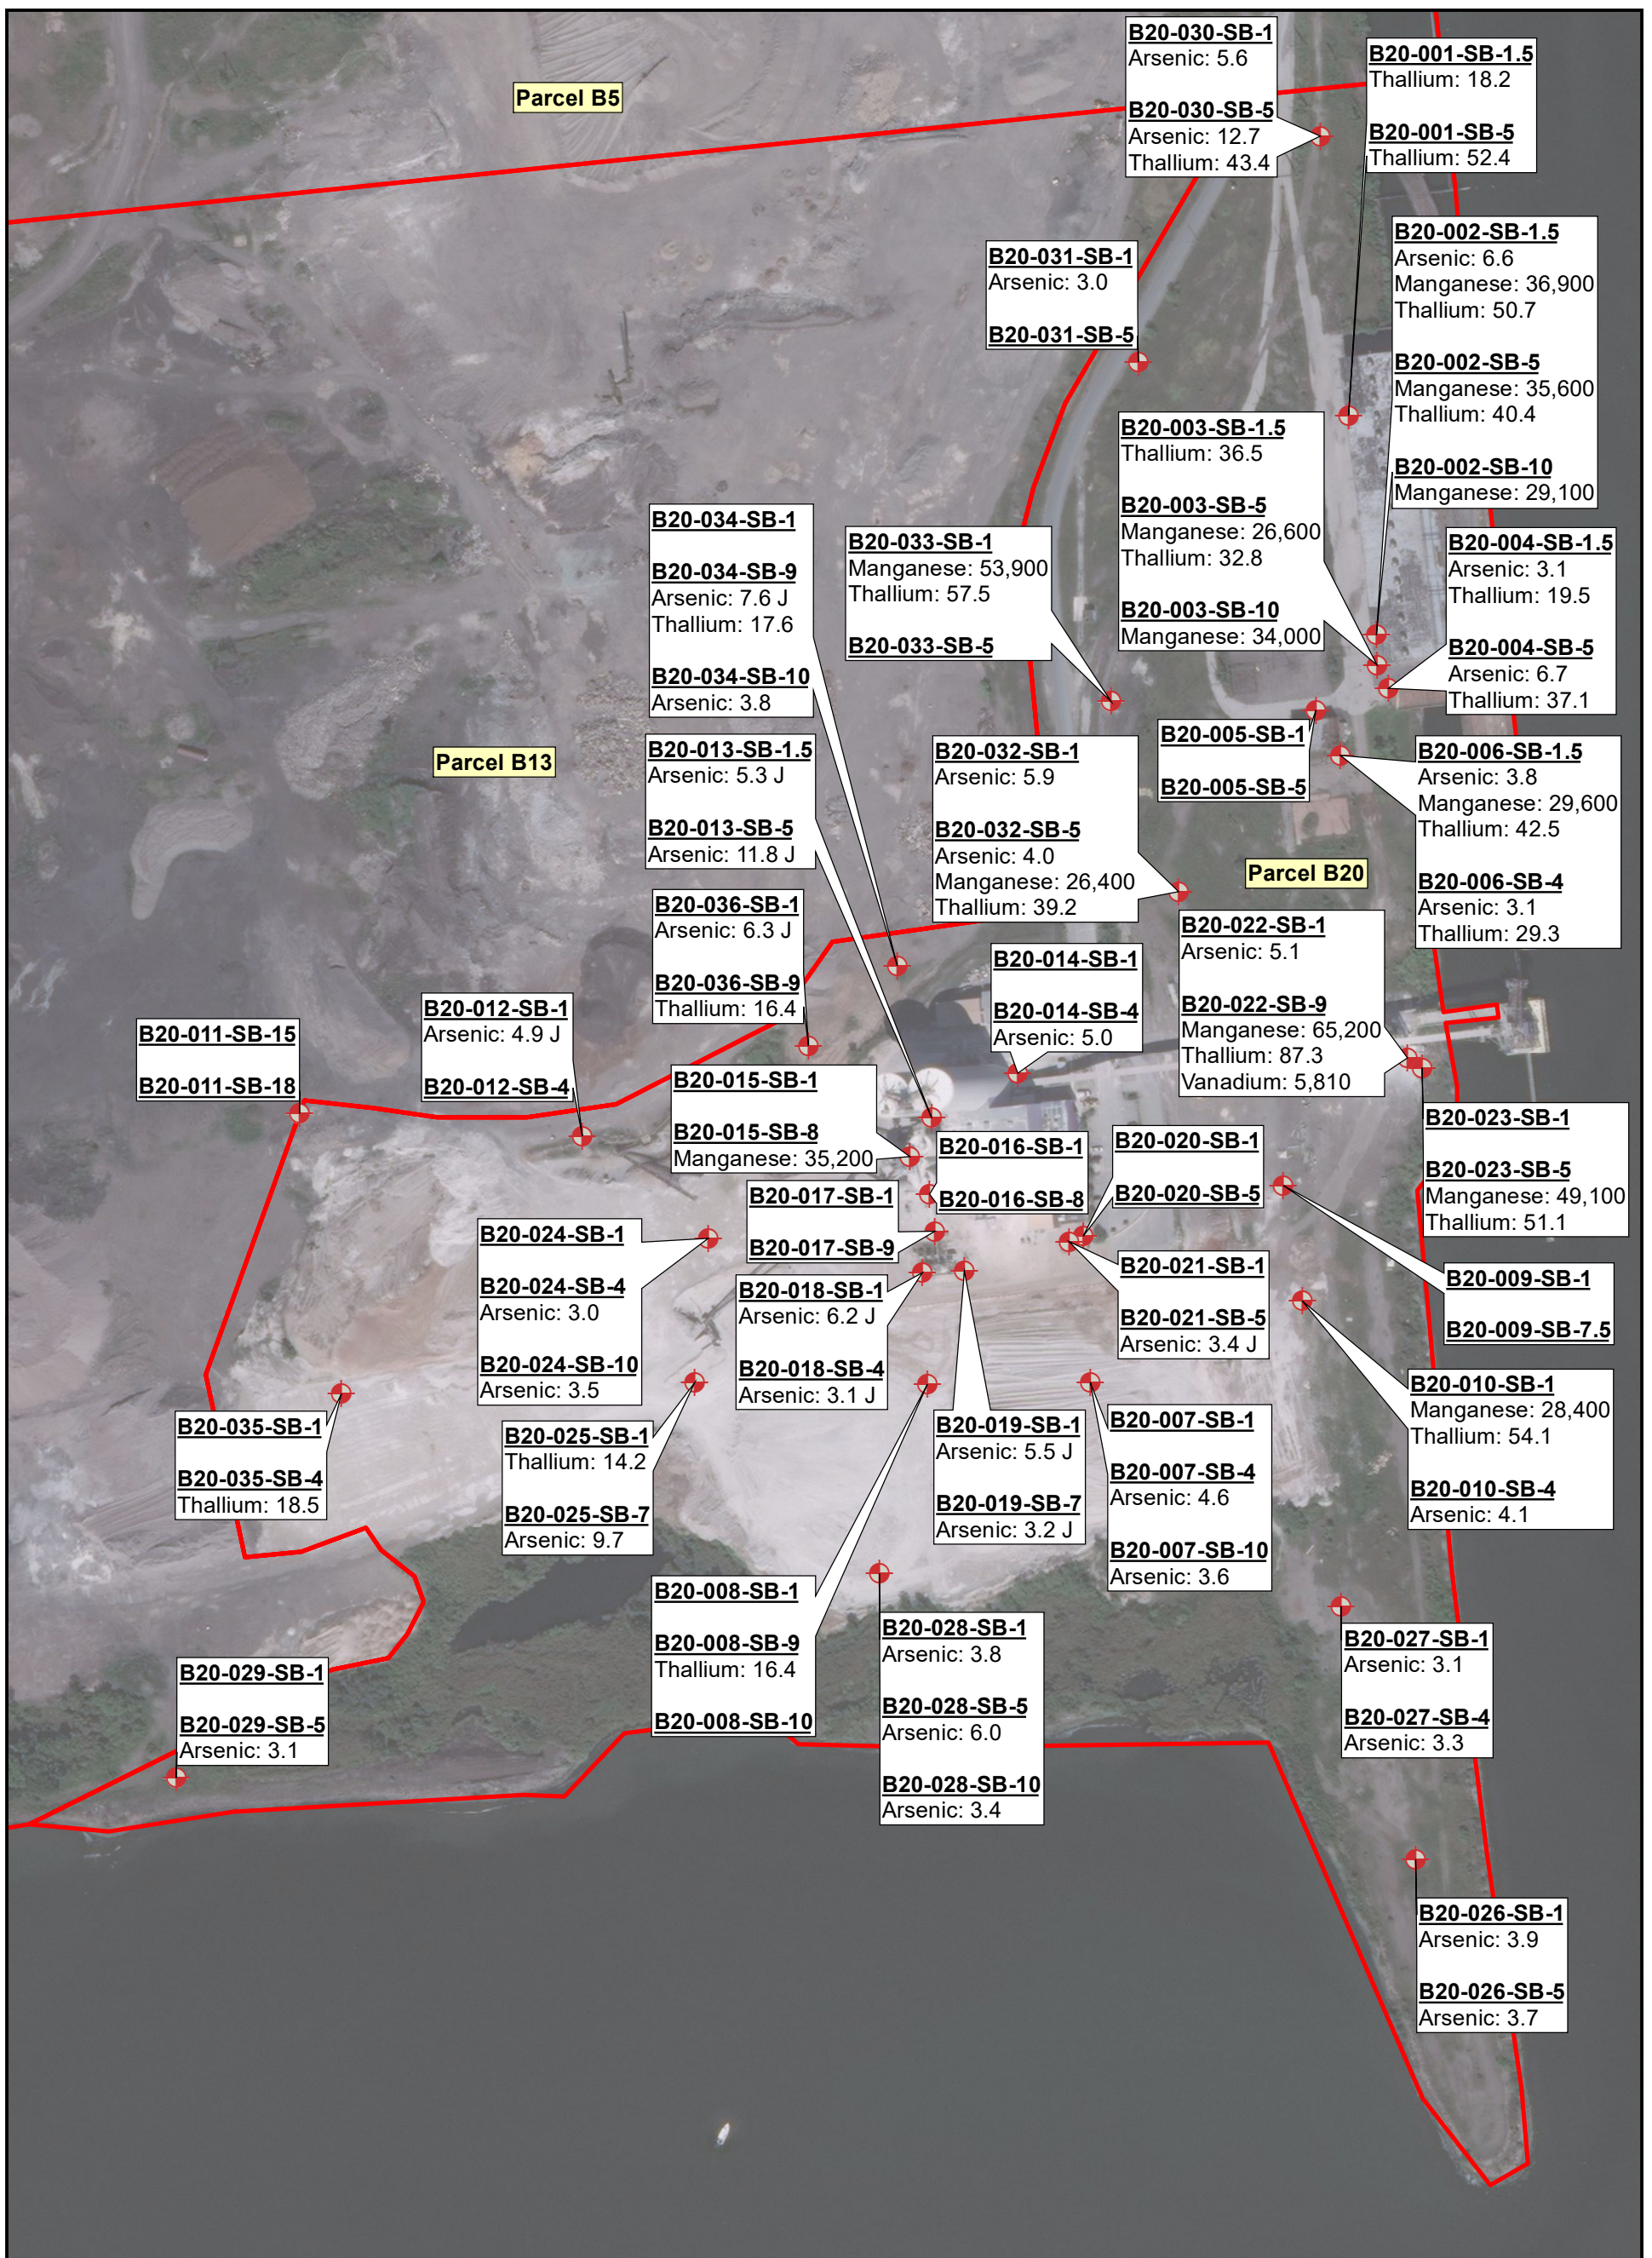
Figure
9

Parcel B20 Soil Samples
Inorganic PAL Exceedances (mg/kg)
 January 7, 2021

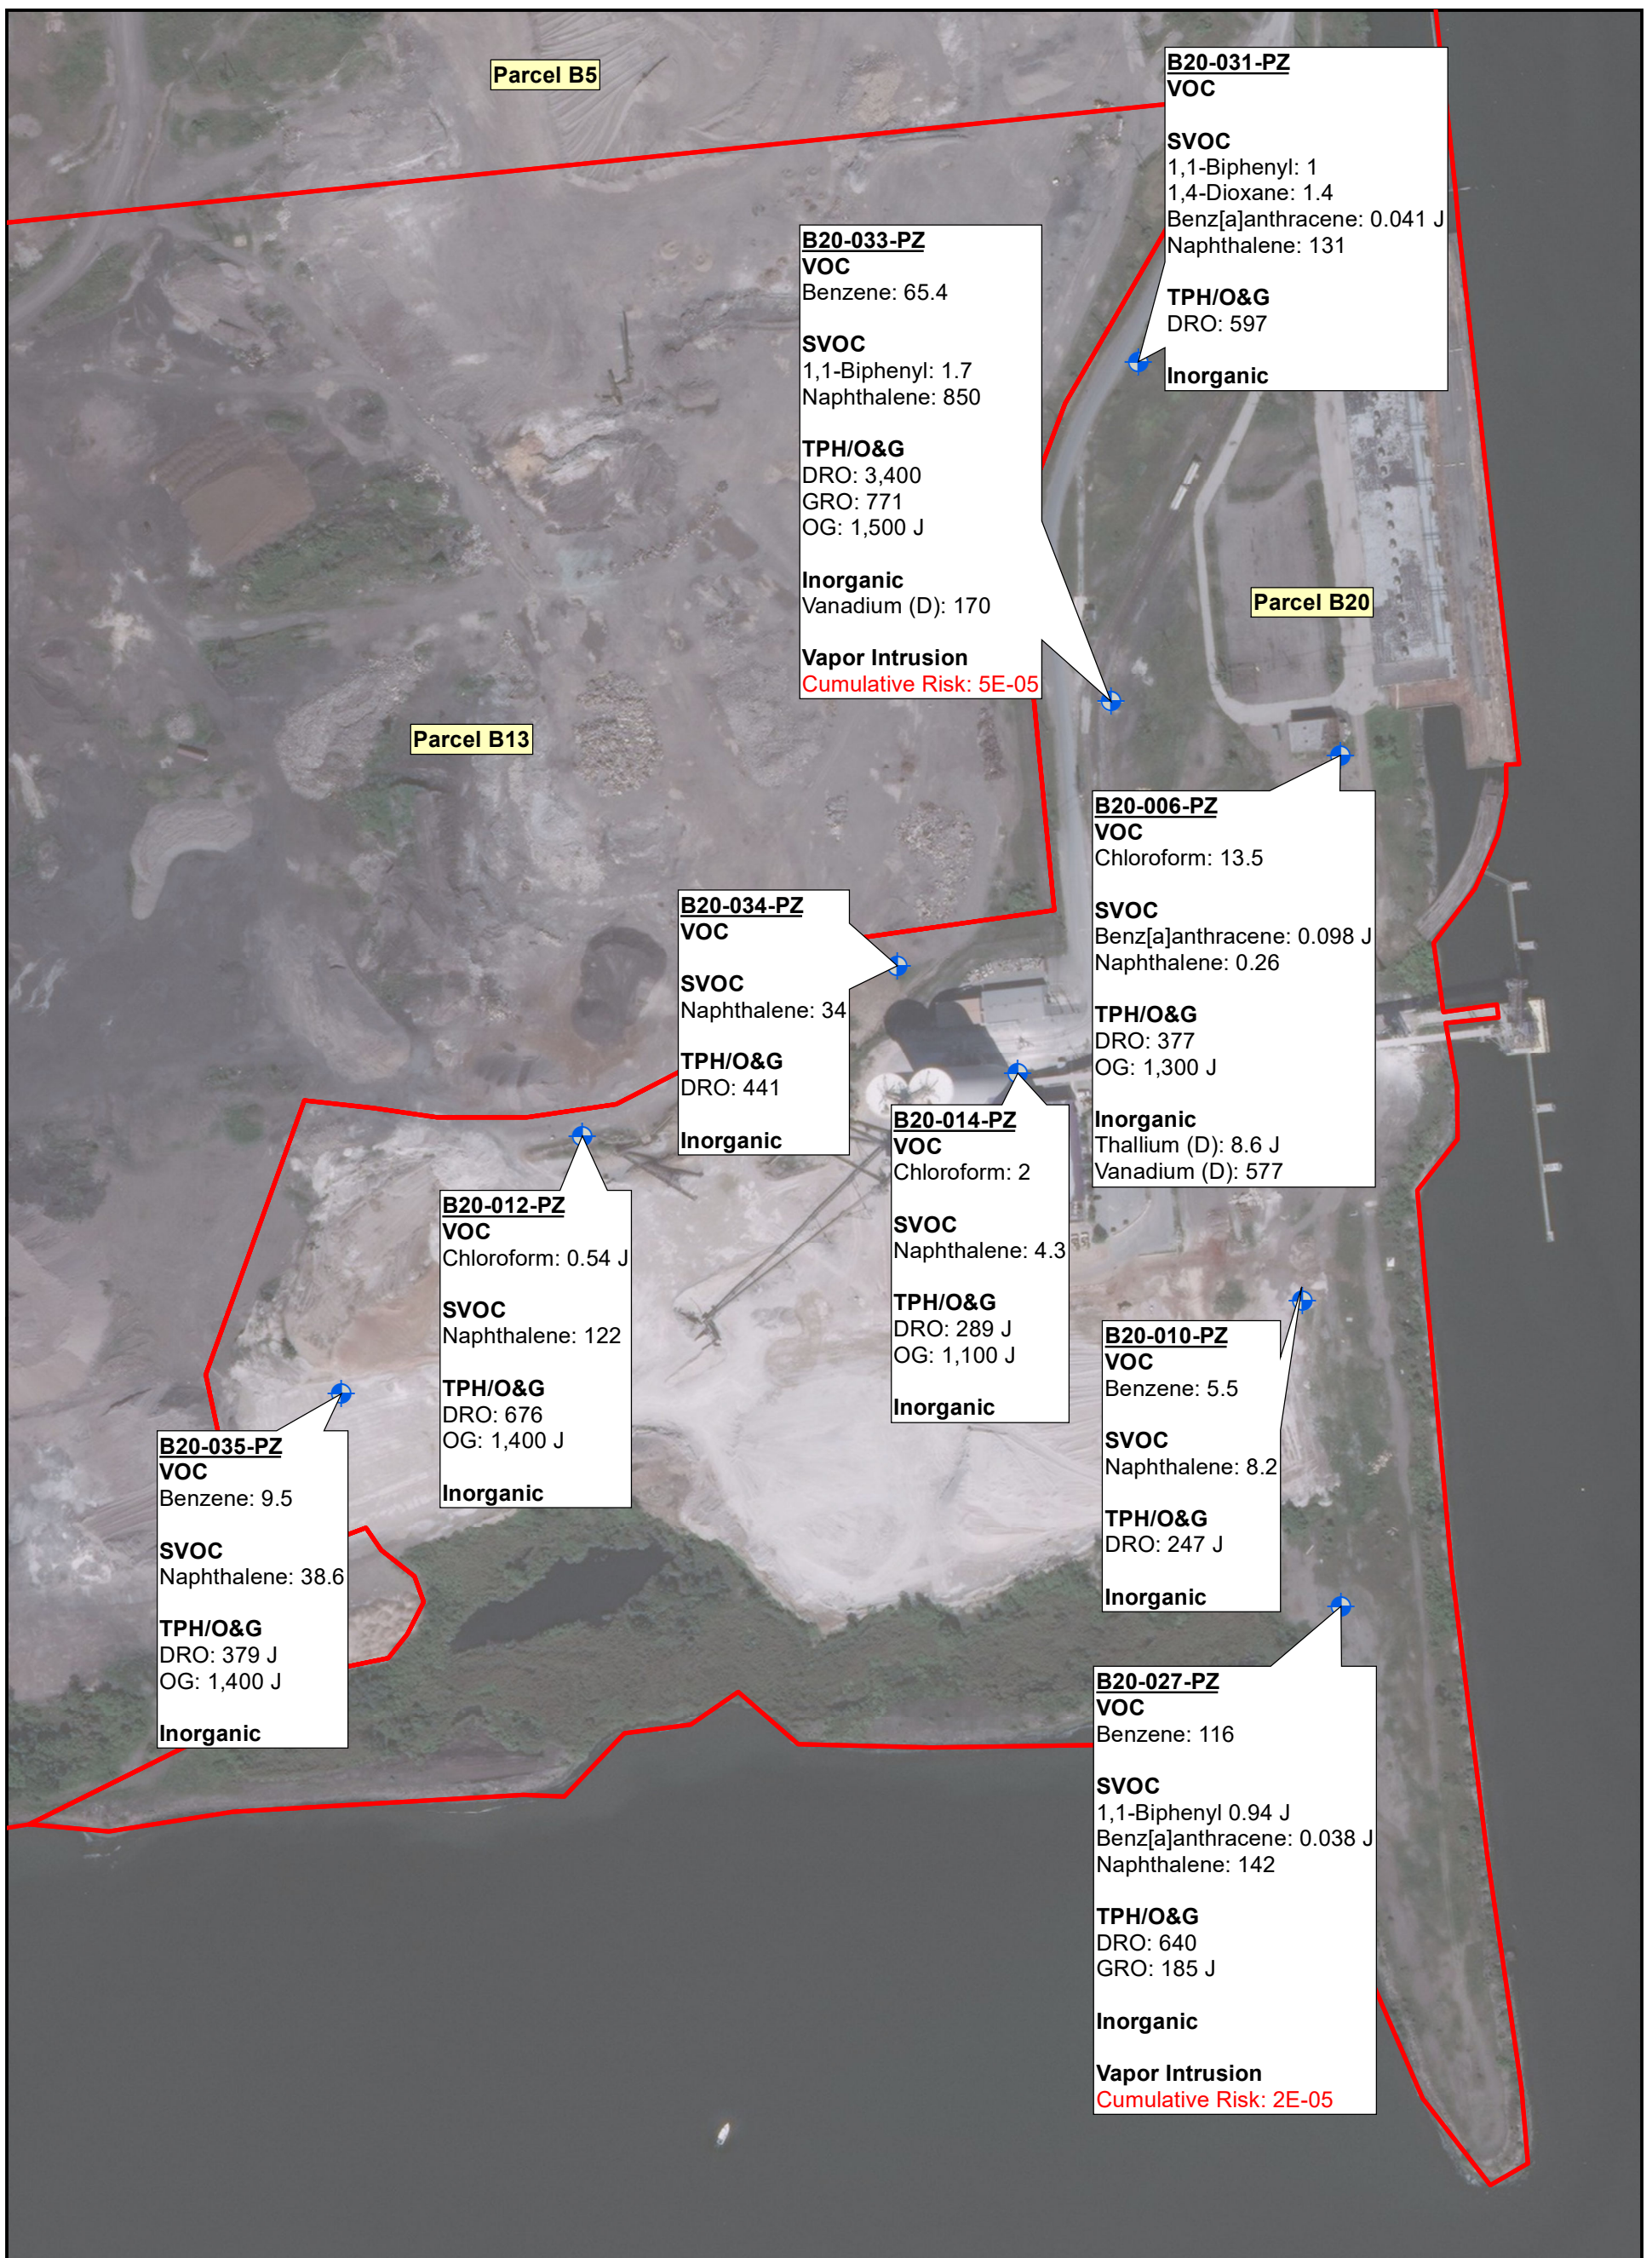
B20-035-PZ
VOC
 Benzene: 9.5

SVOC
 Naphthalene: 38.6

- If an enclosed structure is proposed for construction in the vicinity of B20-027-PZ or B20-033-PZ further assessment or mitigation is recommended to address the potential VI risks resulting from elevated benzene and naphthalene. The selection of appropriate response measures, based on the specific development plan for the parcel, should be addressed in a project-specific Response and Development Work Plan.
