PHASE II INVESTIGATION REPORT

AREA B: PARCEL B23
TRADEPOINT ATLANTIC
SPARROWS POINT, MARYLAND

Revision 0 – December 20, 2019

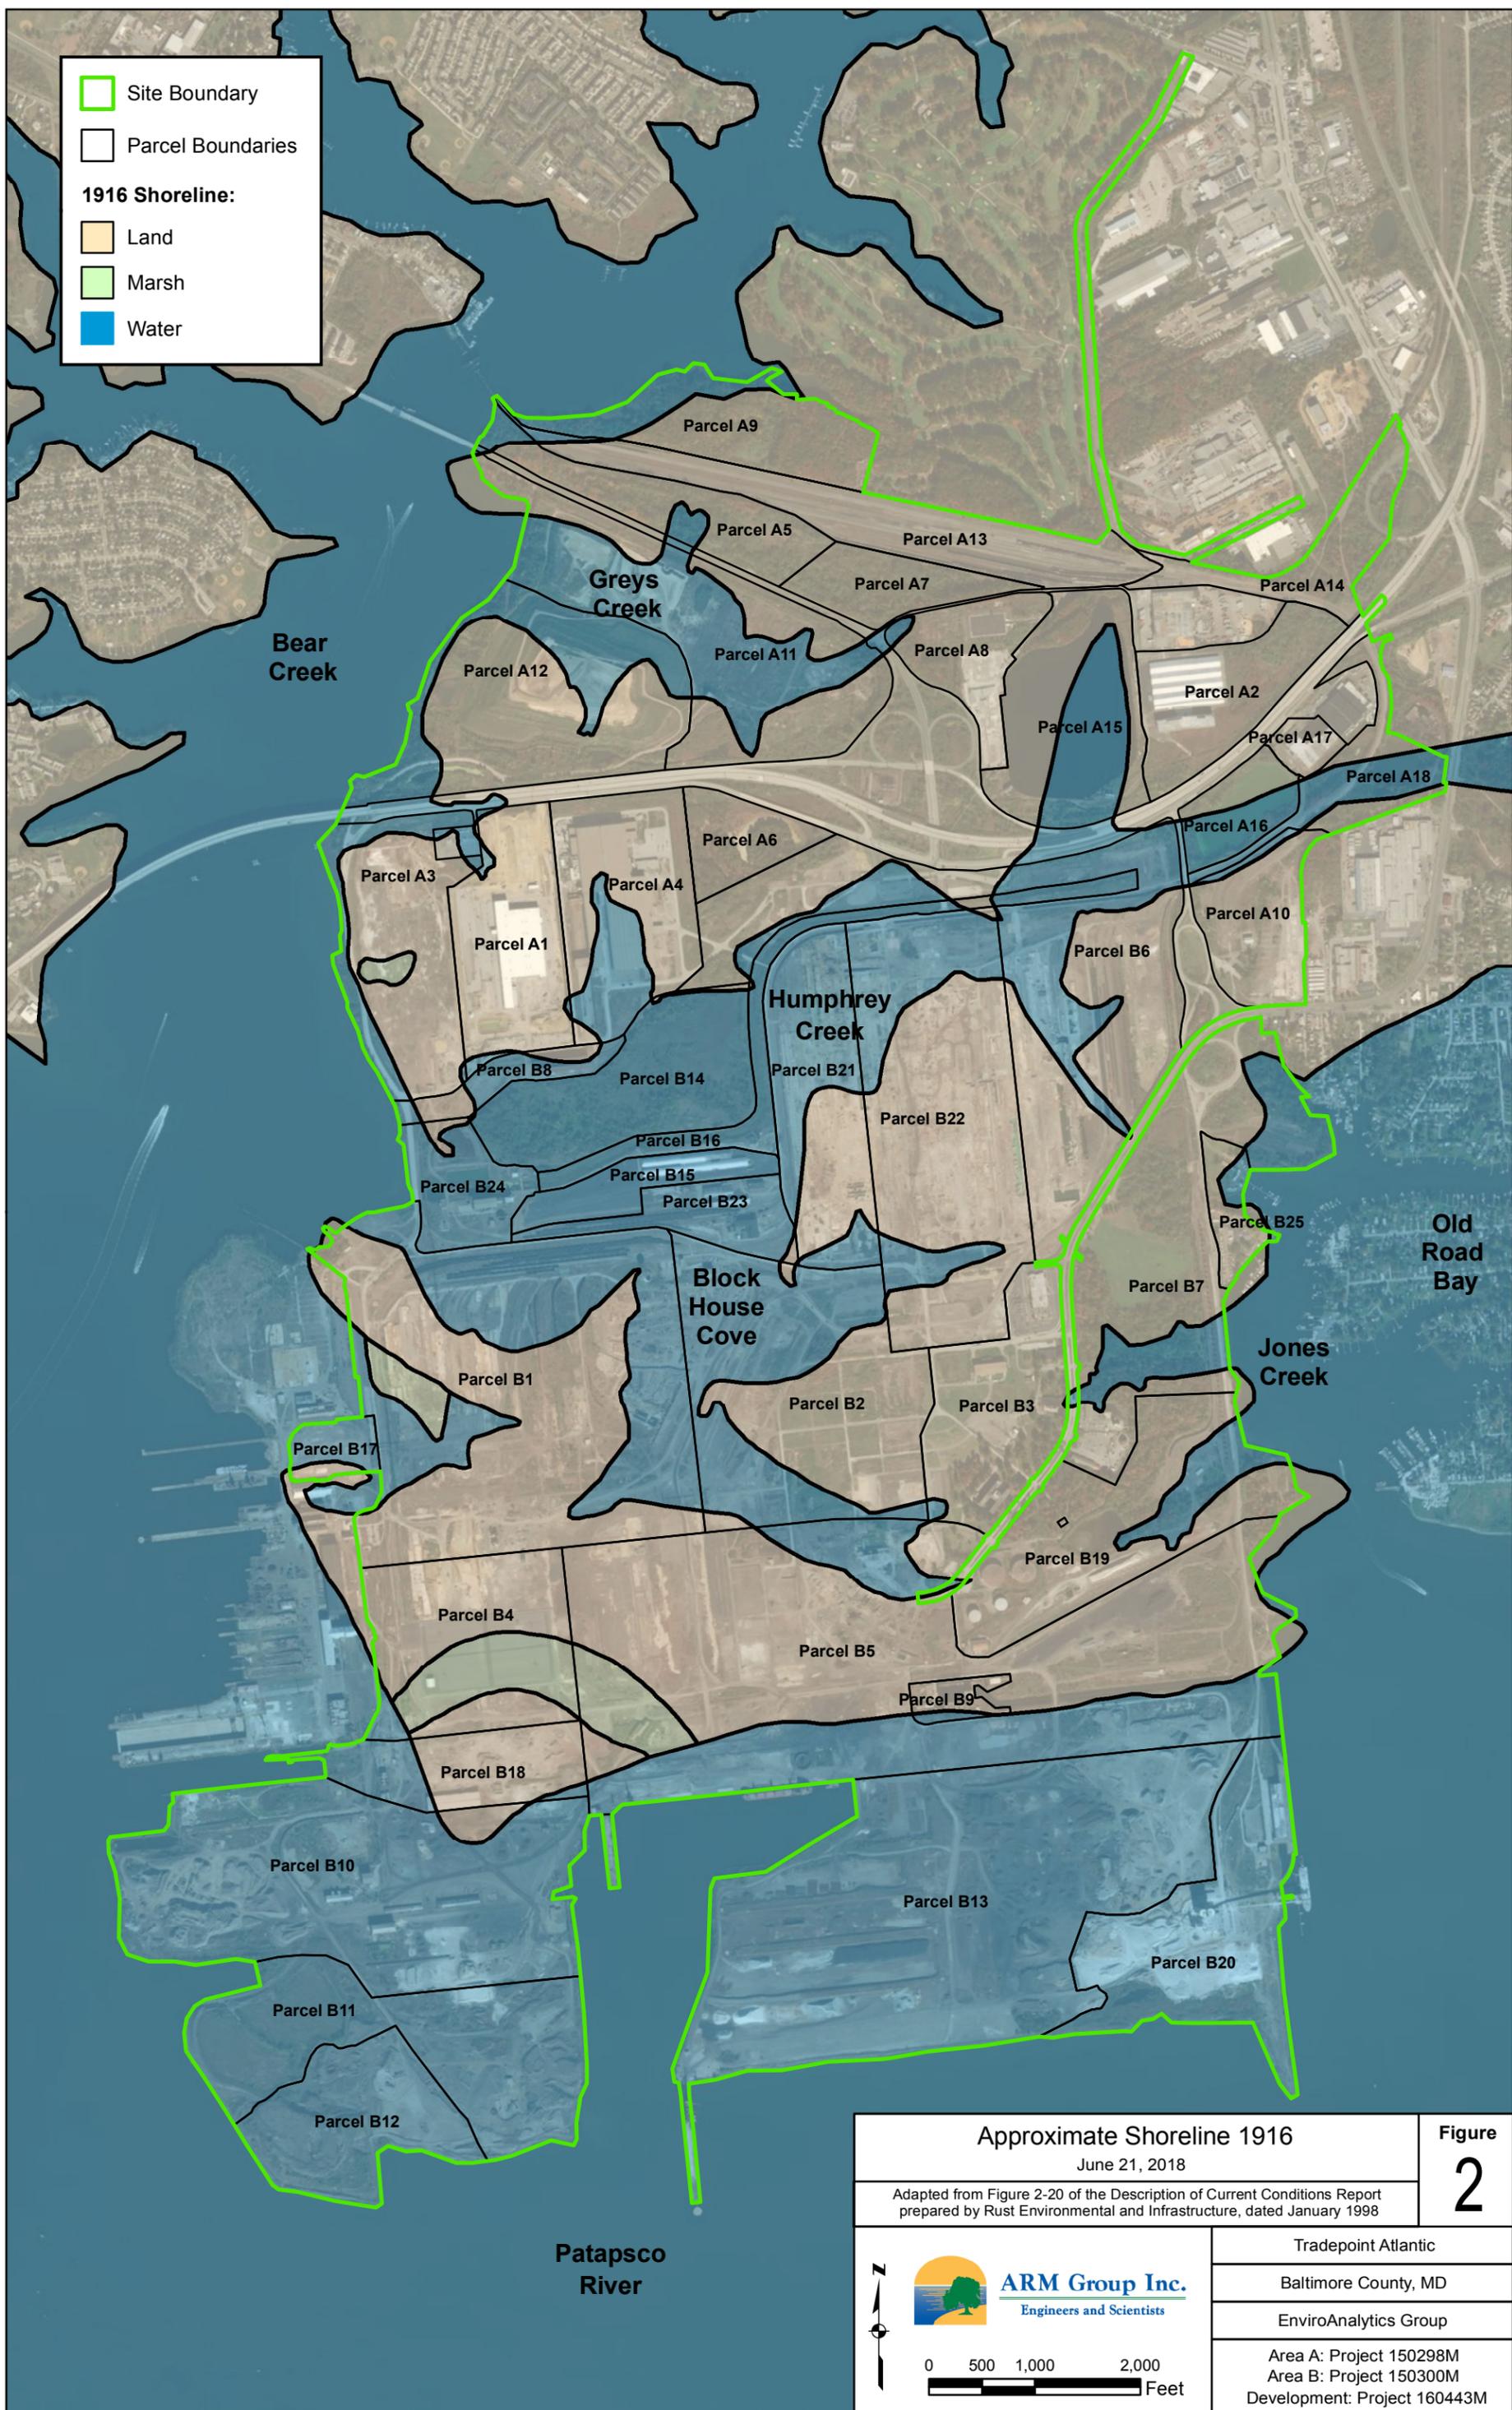
2

Groundcover at the Site is comprised of approximately 3% natural soils and 97% slag based on the approximate shoreline of the Sparrows Point Peninsula in 1916, as shown on **Figure 2** (adapted from Figure 2-20 in the Description of Current Conditions (DCC) Report prepared by Rust Environment and Infrastructure, dated January 1998).
