PHASE II INVESTIGATION REPORT

AREA B: PARCEL B24
TRADEPOINT ATLANTIC
SPARROWS POINT, MARYLAND

ARM GROUP LLC
9175 Guilford Road
Suite 310
Columbia, Maryland 21046
ARM Project No. 20010224

Revision 0 – September 25, 2020

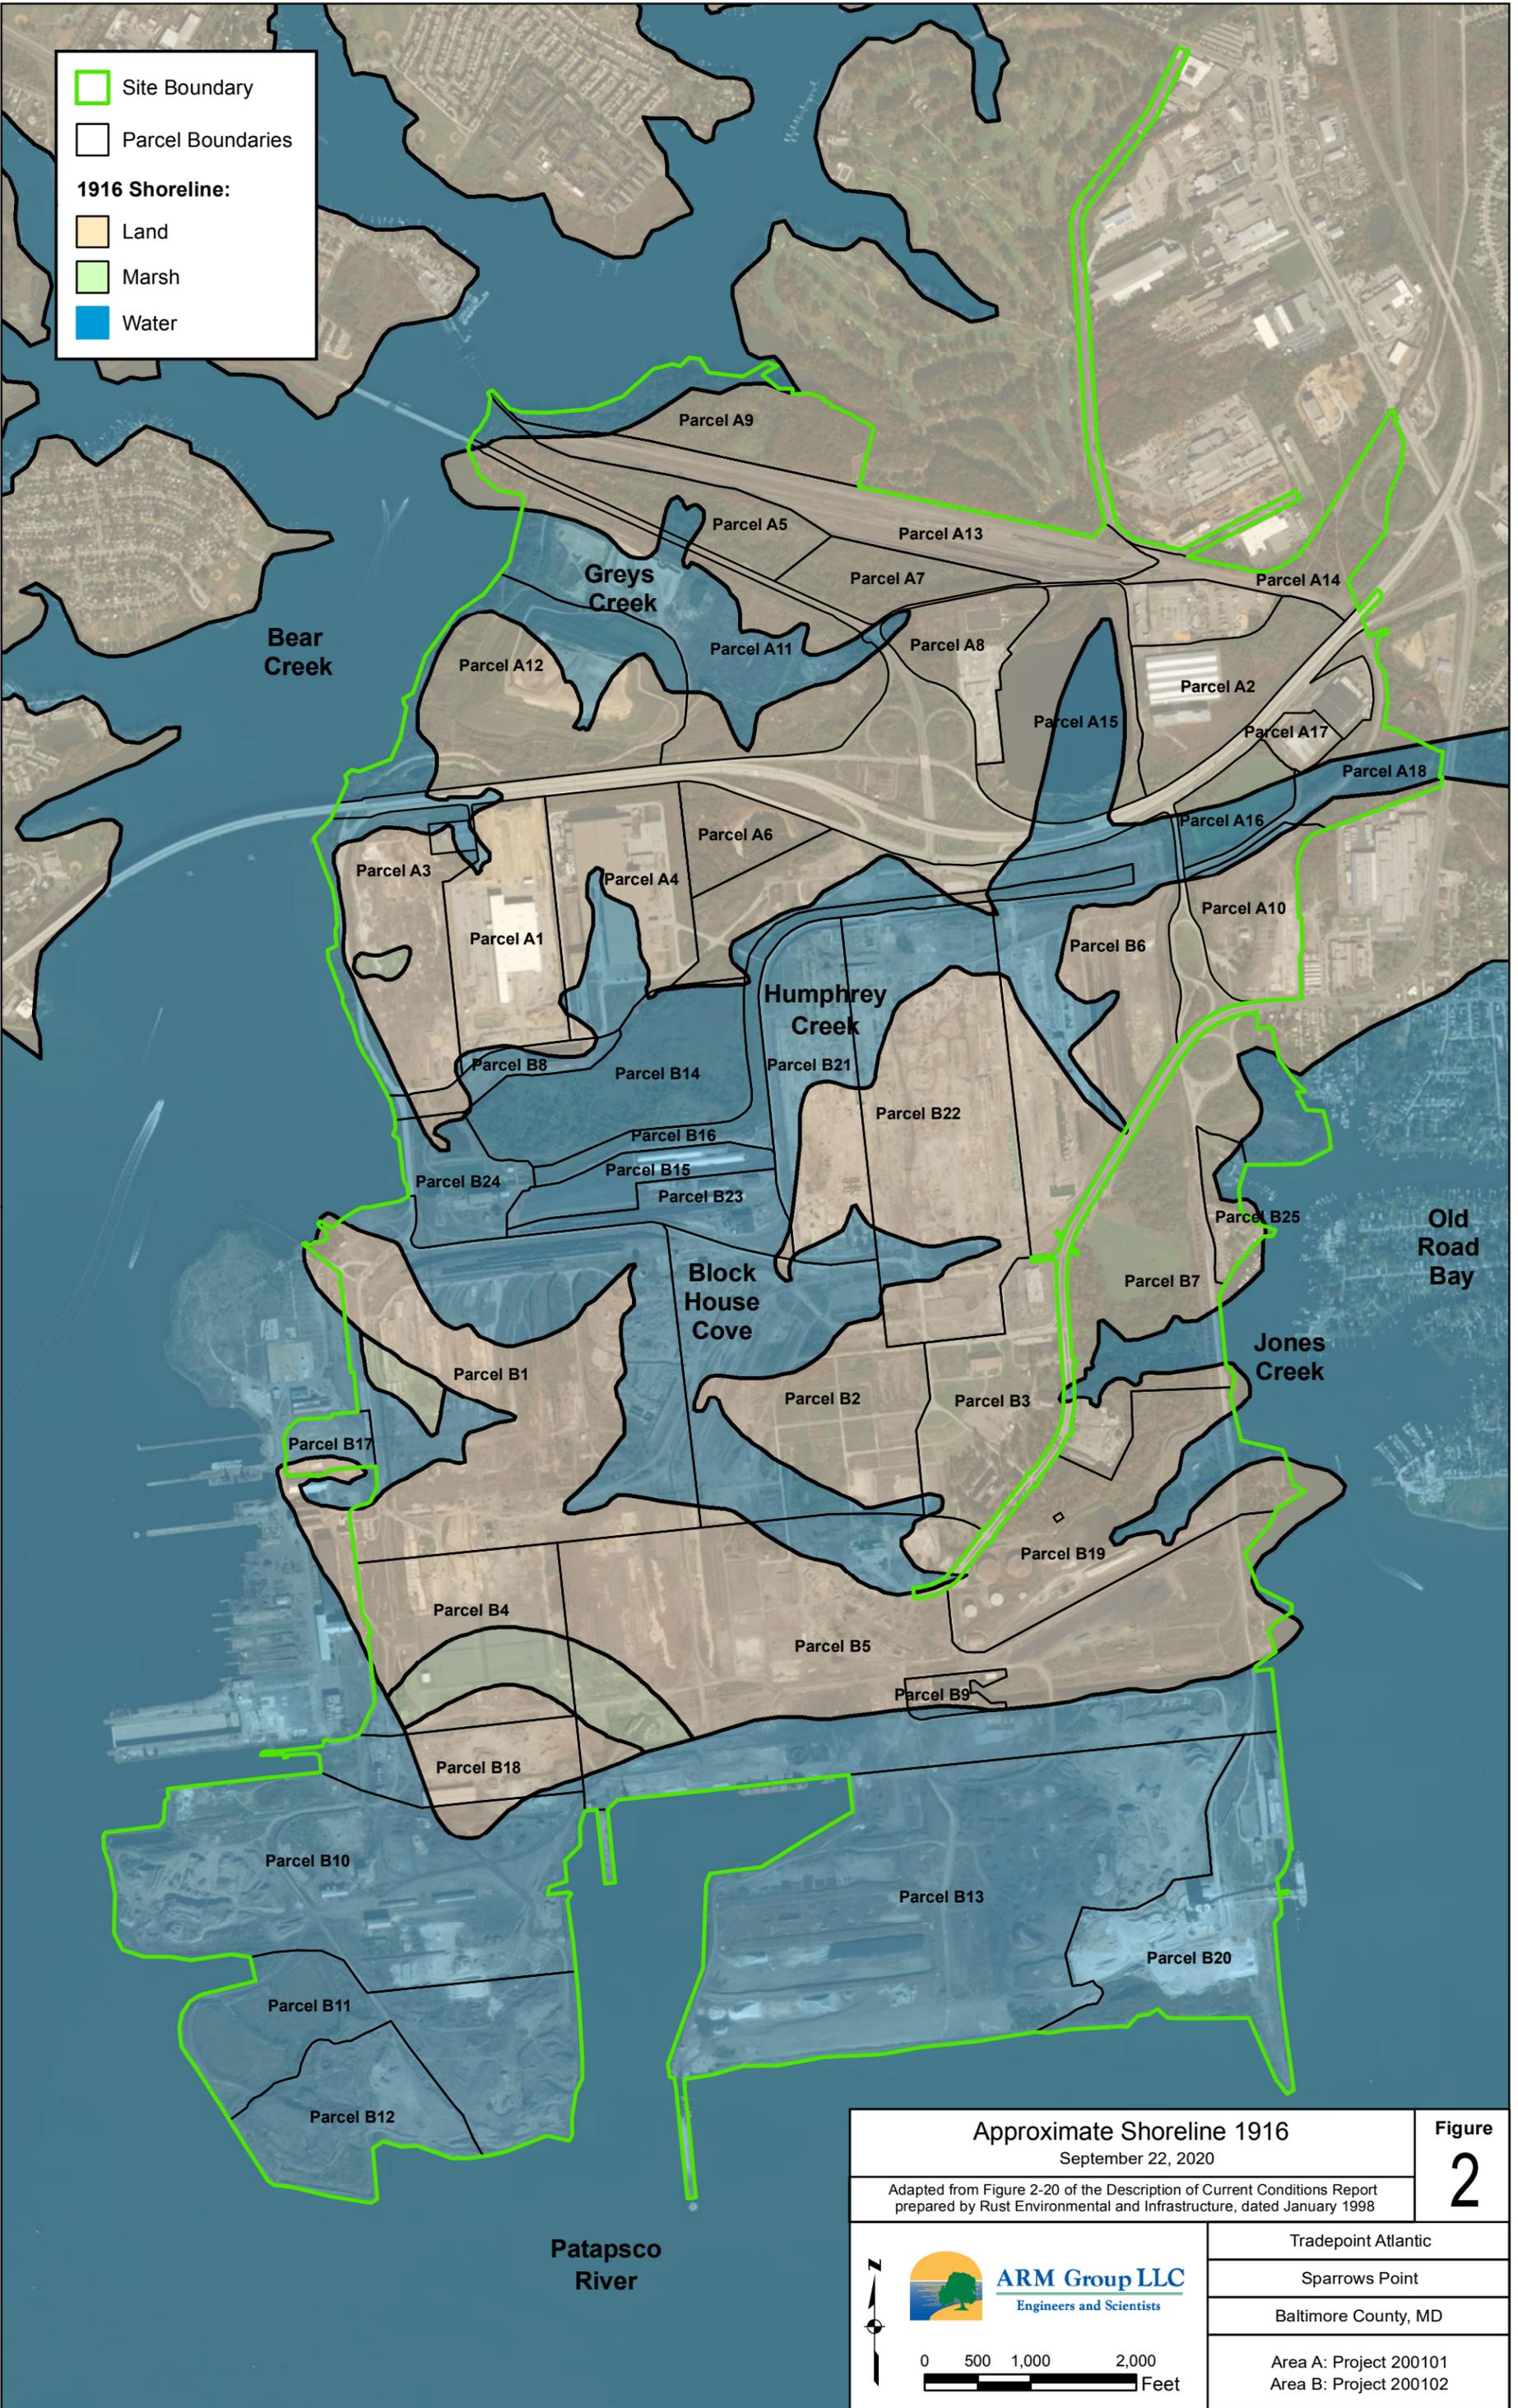
Approximate Shoreline 1916 September 22, 2020		Figure 2
Adapted from Figure 2-20 of the Description of Current Conditions Report prepared by Rust Environmental and Infrastructure, dated January 1998		
	Tradepoint Atlantic	
	Sparrows Point	
	Baltimore County, MD	
Area A: Project 200101 Area B: Project 200102

Groundcover at the Site is comprised of approximately 5% natural soils and 95% non-native fill materials (i.e., slag) based on the approximate shoreline of the Sparrows Point Peninsula in 1916, as shown on **Figure 2** (adapted from Figure 2-20 in the Description of Current Conditions (DCC) Report prepared by Rust Environment and Infrastructure dated January 1998).

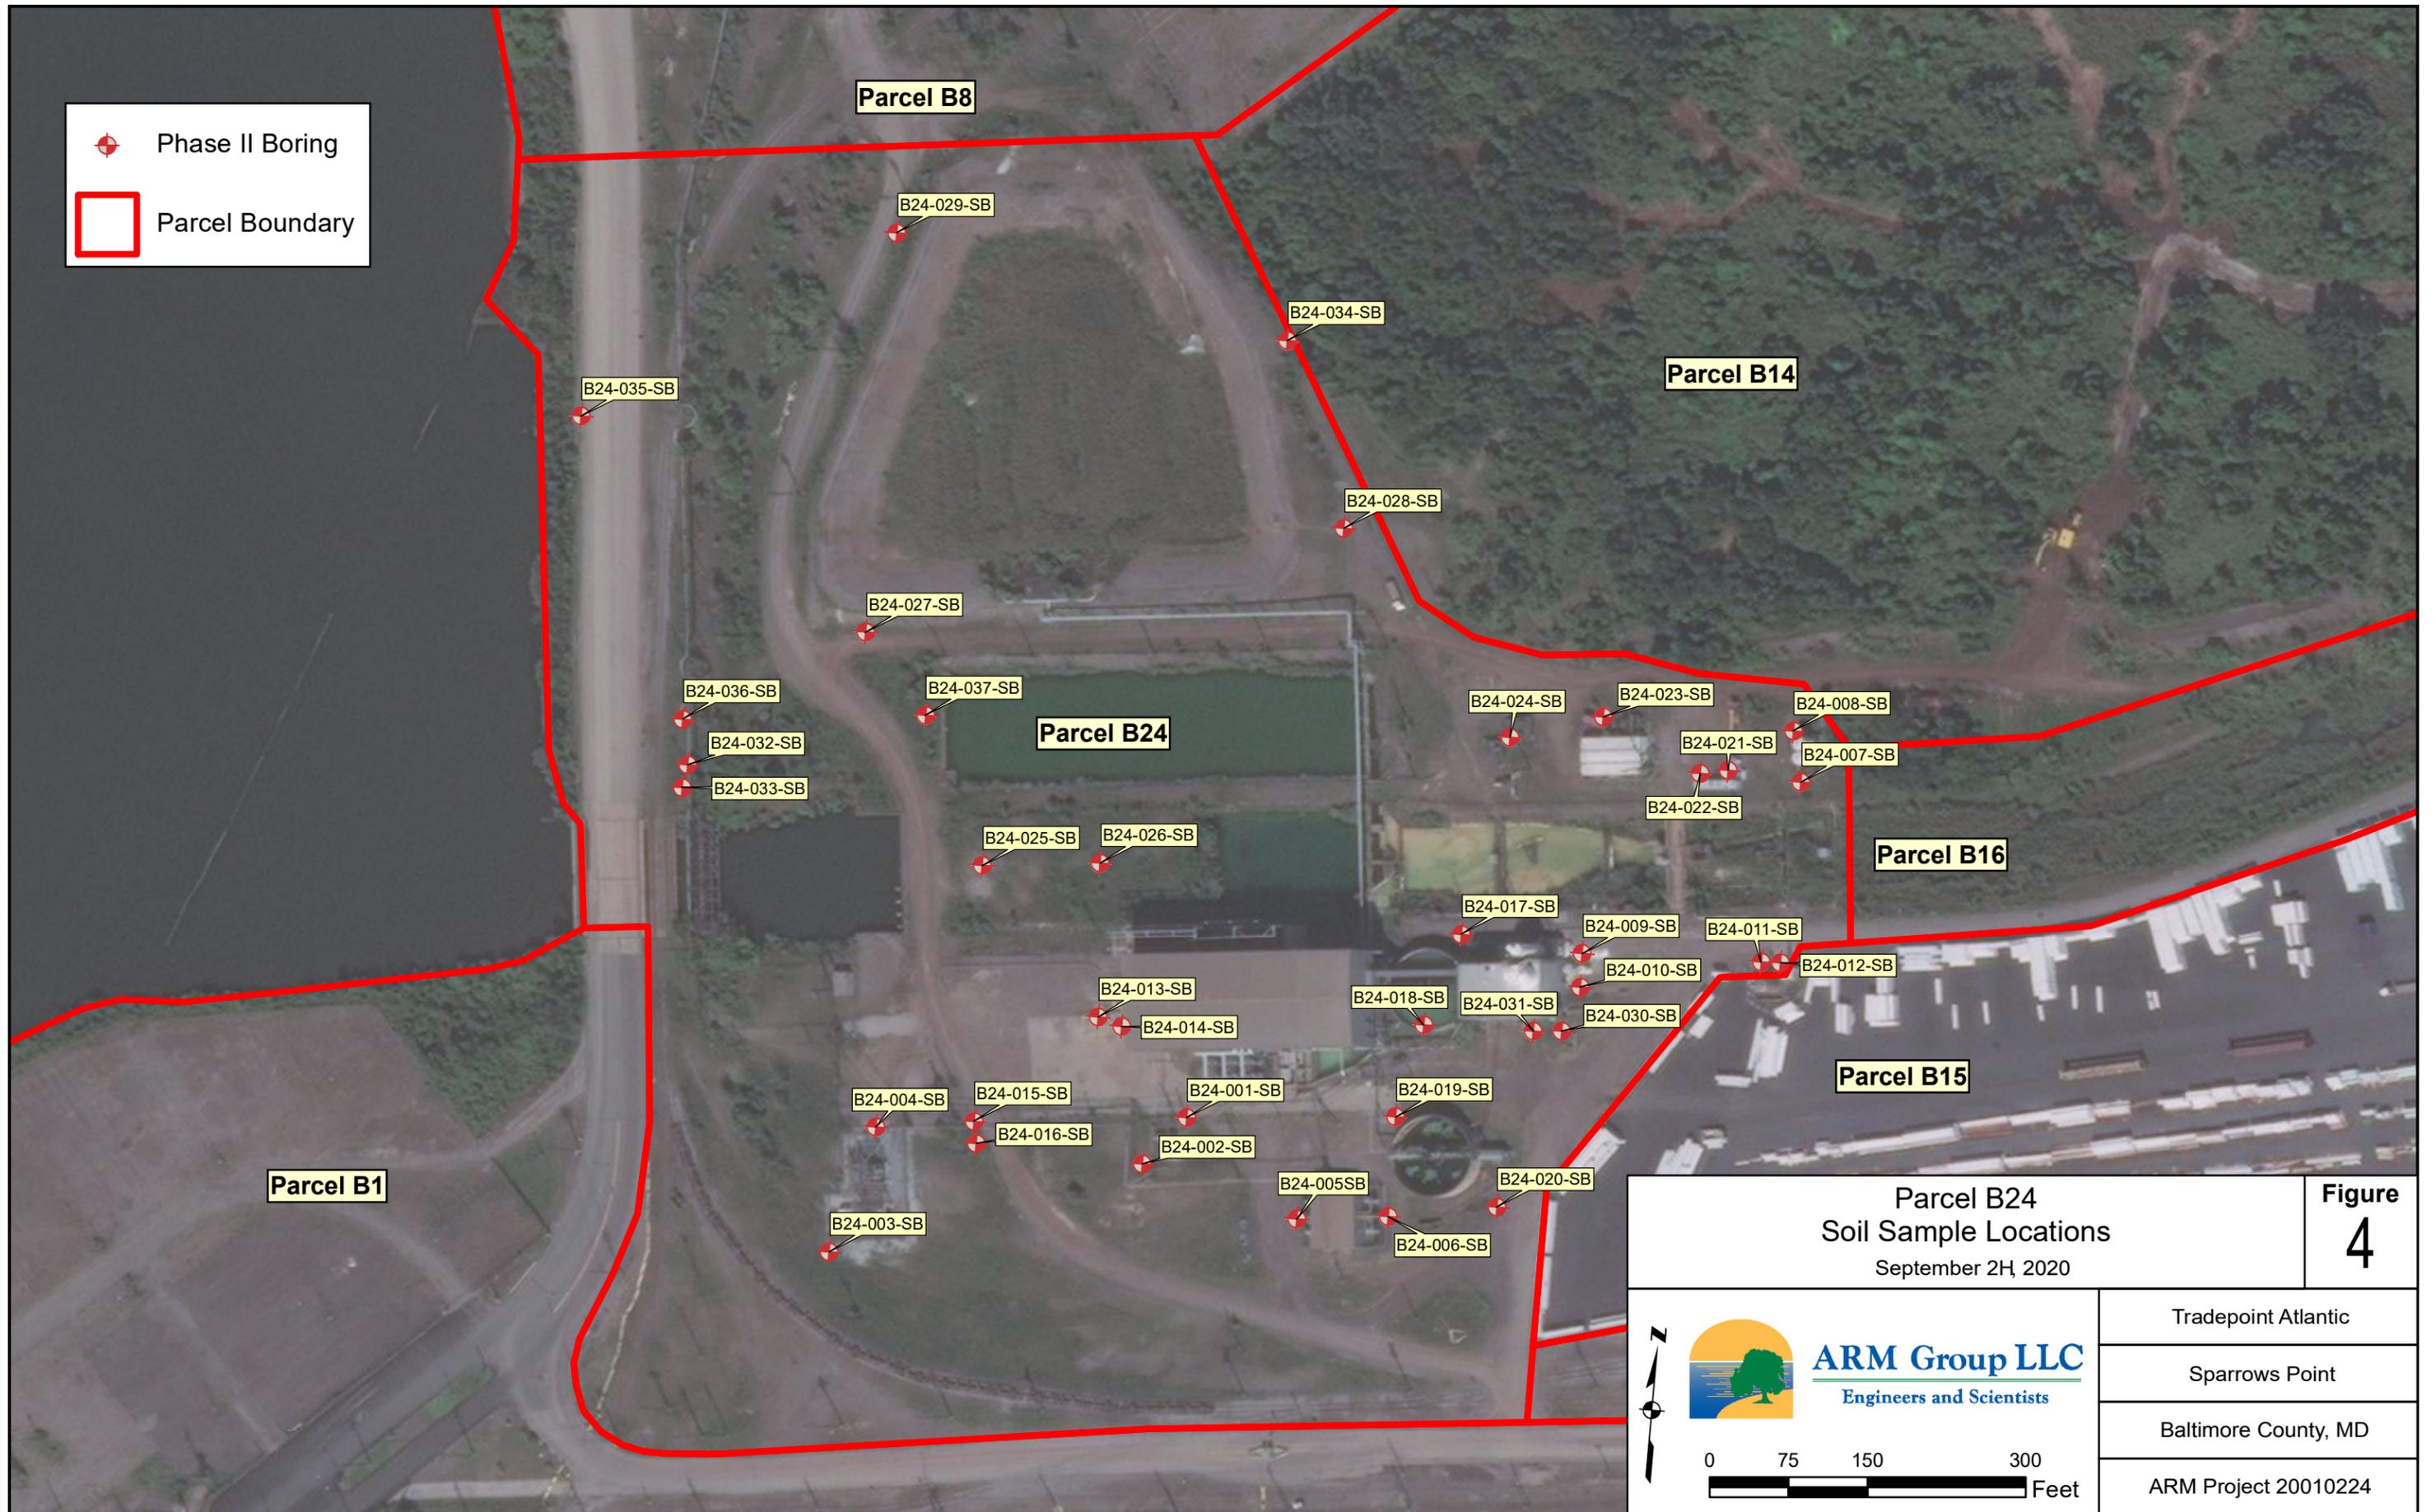
Figure 3

Static groundwater elevation measurements were obtained from each piezometer. Surveyed top of casing (TOC) and ground surface elevations for all piezometers can be found in **Table 1**, along with the static depth to water (DTW) measurements. The groundwater elevations calculated from the survey data and gauging measurements are shown on **Table 1** and **Figure 3**. Based on the gauging measurements and resulting groundwater contours, the water table appears to be relatively flat. Bear Creek is the presumed discharge location for regional groundwater.

Additionally, two existing shallow wells (TM02-PZM009 and TM03-PZM004) upgradient from the TMC were added to the sampling plan at the request of the CBF and BWB. These wells are also shown on **Figure 3**.

Six temporary groundwater sample collection points (piezometers) were installed in the shallow hydrogeologic zone to investigate groundwater below Parcel B24. The Parcel B24 Work Plan had originally proposed only five piezometers; however, an additional sample location (B24-036-PZ) was added at the request of the MDE. Additionally, two existing shallow groundwater monitoring wells (TM02-PZM009 and TM03-PZM004) upgradient from the TMC were added to the sampling plan at the request of the CBF and BWB. The eight groundwater sampling locations are displayed on **Figure 3**.

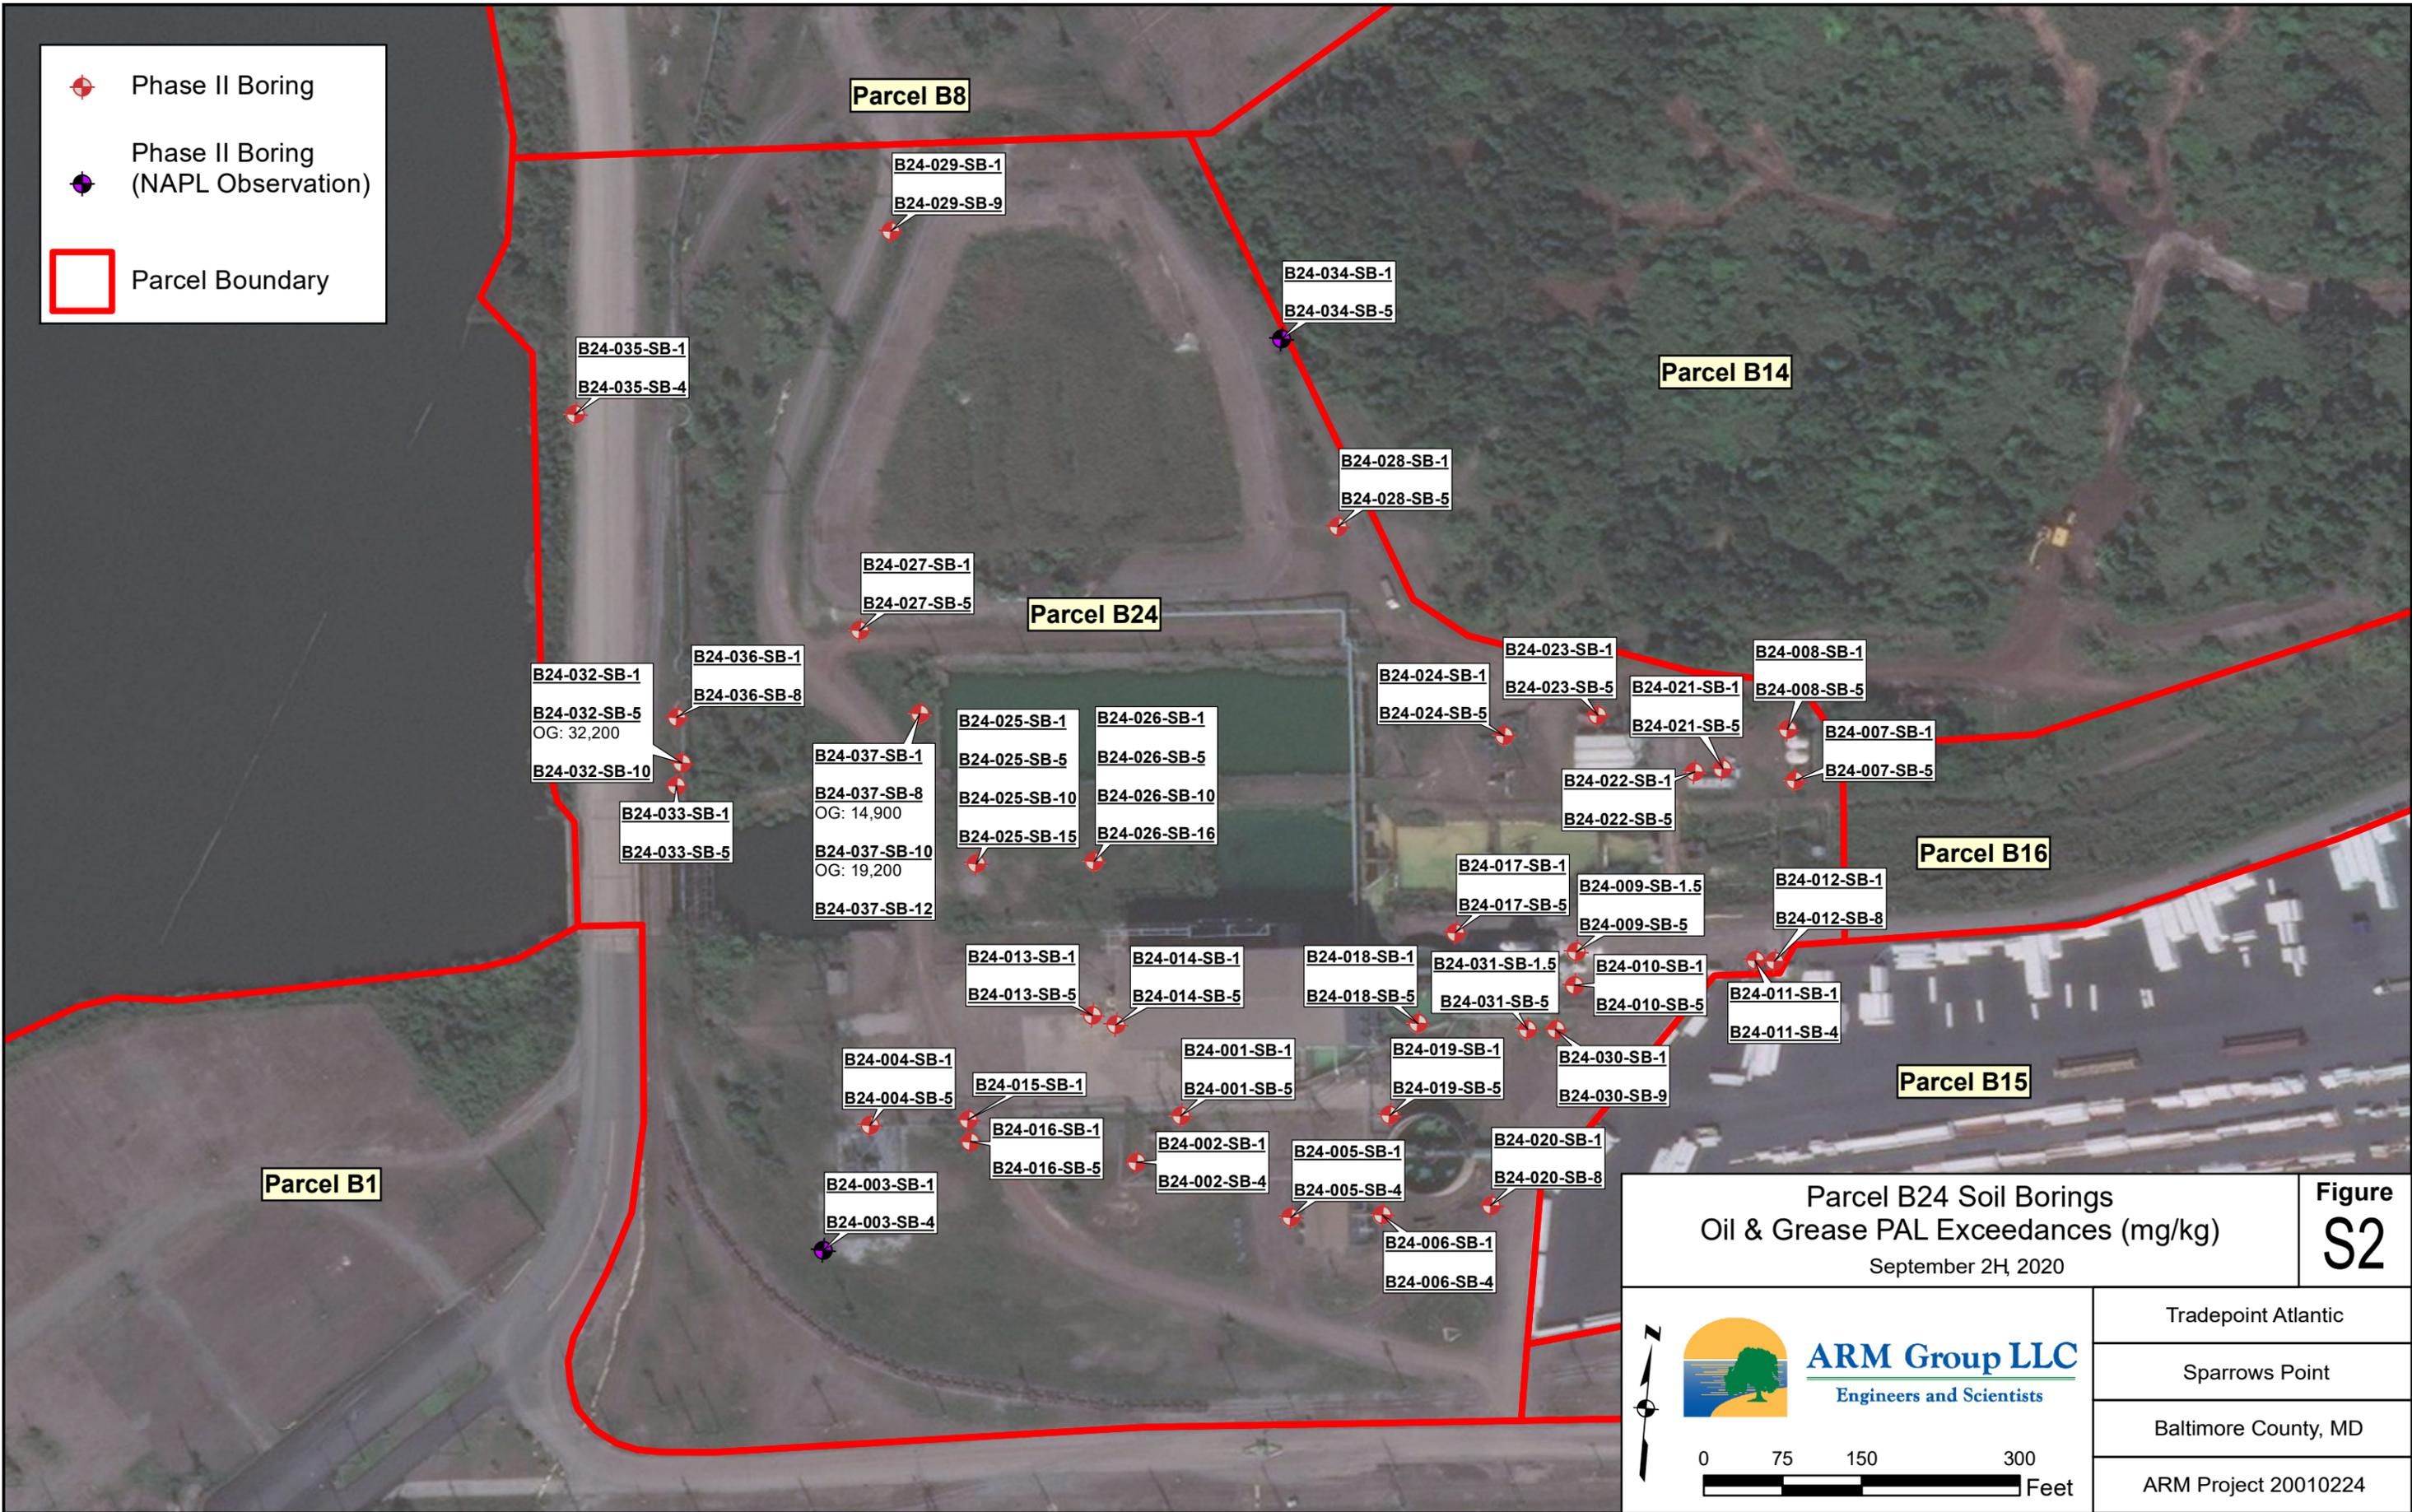
Figure
S2

Parcel B24 Soil Borings
Oil & Grease PAL Exceedances (mg/kg)
 September 2H, 2020

Table 6 provides a summary of the TPH/Oil & Grease detections above the laboratory’s MDLs in the soil samples collected in the parcel. Exceedances of the Oil & Grease PAL (6,200 mg/kg) were noted in three samples: B24-032-SB-5 with a detection of 32,200 mg/kg, B24-037-SB-8 with a detection of 14,900 mg/kg, and B24-037-SB-10 with a detection of 19,200 mg/kg. These locations had underlying soil samples which had significantly lower detections of Oil & Grease that did not exceed the PAL. The 10-foot sample at B24-032-SB had an Oil & Grease detection

Elevated concentrations of Oil & Grease were identified above the PAL (6,200 mg/kg) in three samples: B24-032-SB-5 at 32,200 mg/kg, B24-037-SB-8 at 14,900 mg/kg, and B24-037-SB-10 at 19,200 mg/kg. However, no physical evidence of NAPL was noted in the soil cores at these two locations, and Oil & Grease detections in the underlying soil samples were significantly below the PAL in both cases. Two other boring locations had physical evidence of NAPL identified in the soil cores (B24-003-SB and B24-034-SB). These boring locations with observed NAPL are discussed in Section 6.3.

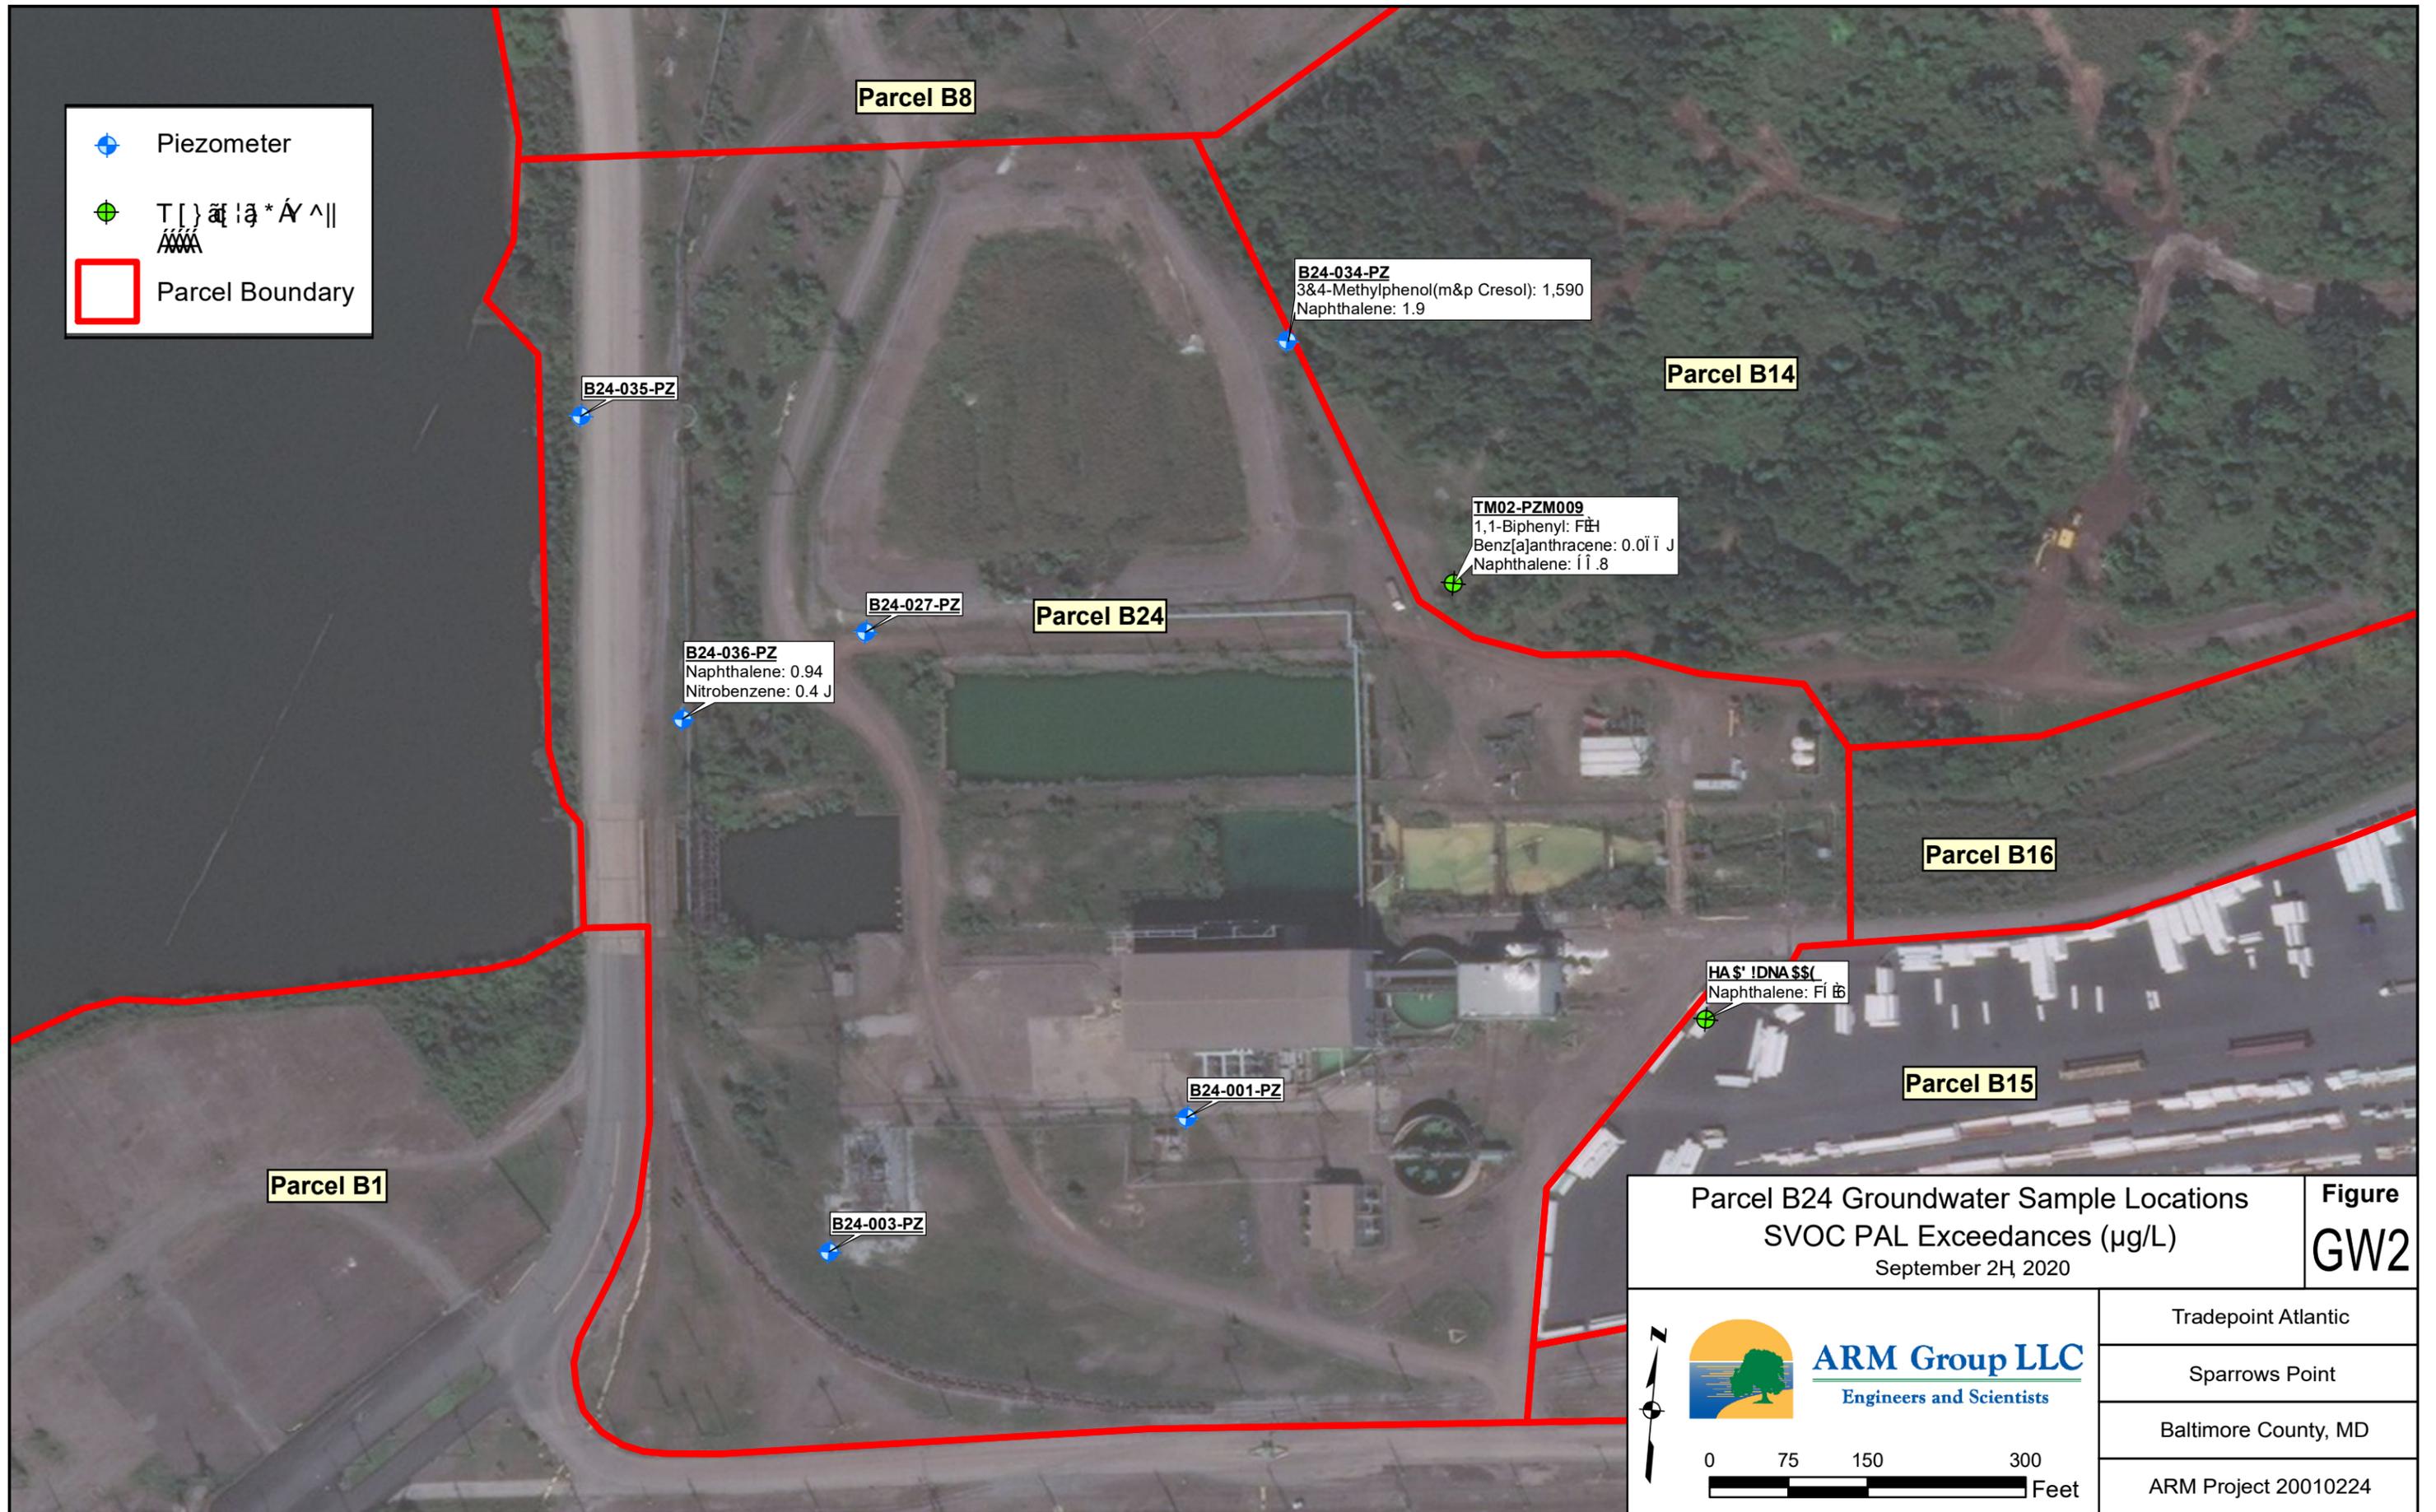
Parcel B24 Groundwater Sample Locations SVOC PAL Exceedances (µg/L) September 2H, 2020		Figure GW2
ARM Group LLC Engineers and Scientists		
Tradepoint Atlantic Sparrows Point Baltimore County, MD		
ARM Project 20010224

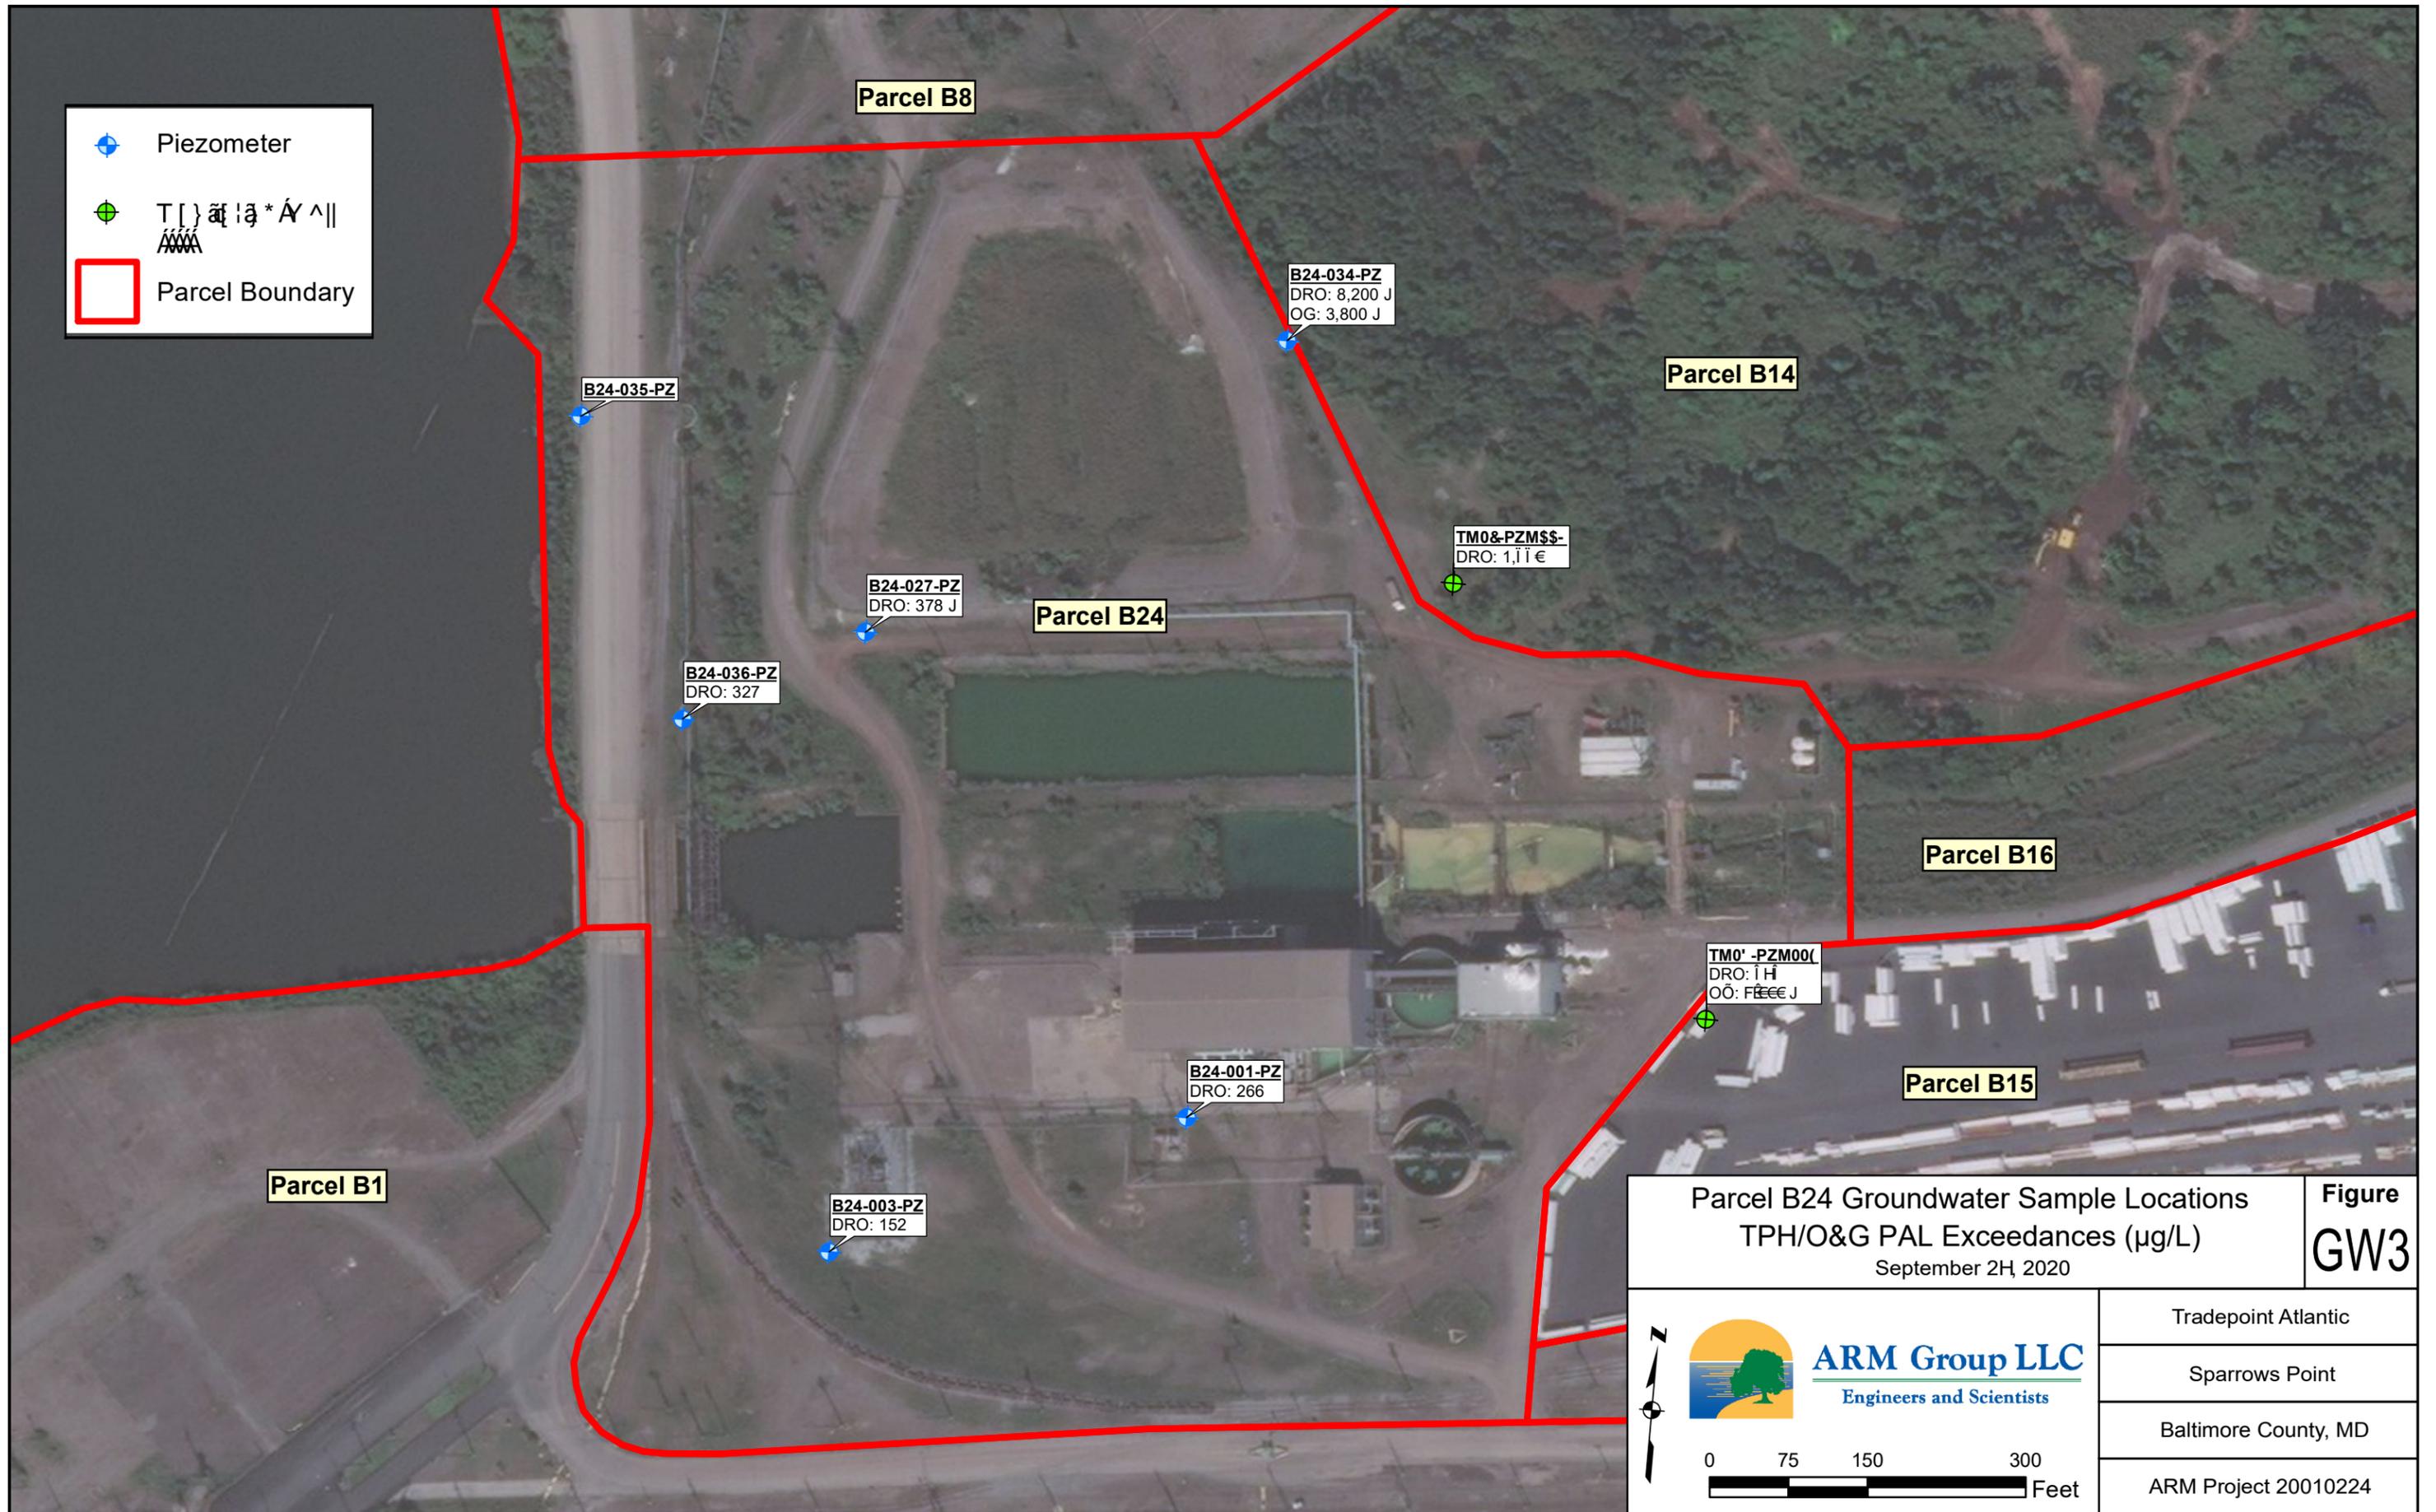
4.2.3. Groundwater Conditions: Results Summary

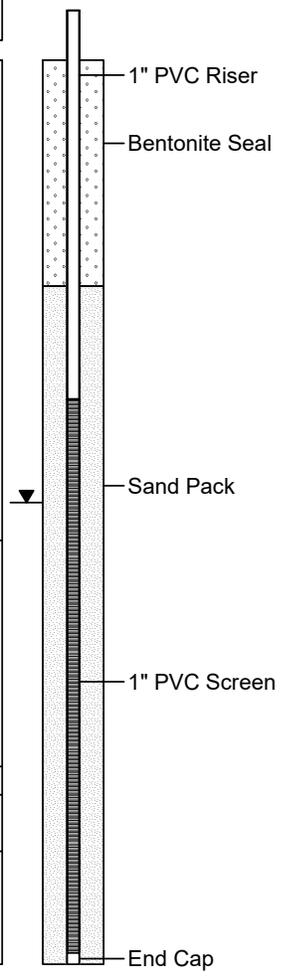
Boring terminated at 16' bgs due to water and piezometer installation
 TOC: Top of PVC casing
 DTW: Depth to water
 bgs: Below ground surface

Riser Stickup: 2.78'
 Riser: 0 - 6' bgs
 Screen: 6 - 16' bgs [Slot Size: 0.010"]
 Sand Pack: 4 - 16' bgs [Grain Size: WG #2]
 Bentonite Seal: 0 - 4' bgs [Grain Size: bentonite chips]
