PHASE II INVESTIGATION REPORT

AREA B: PARCEL B9
TRADEPOINT ATLANTIC
SPARROWS POINT, MARYLAND

Revision 0 – December 17, 2020

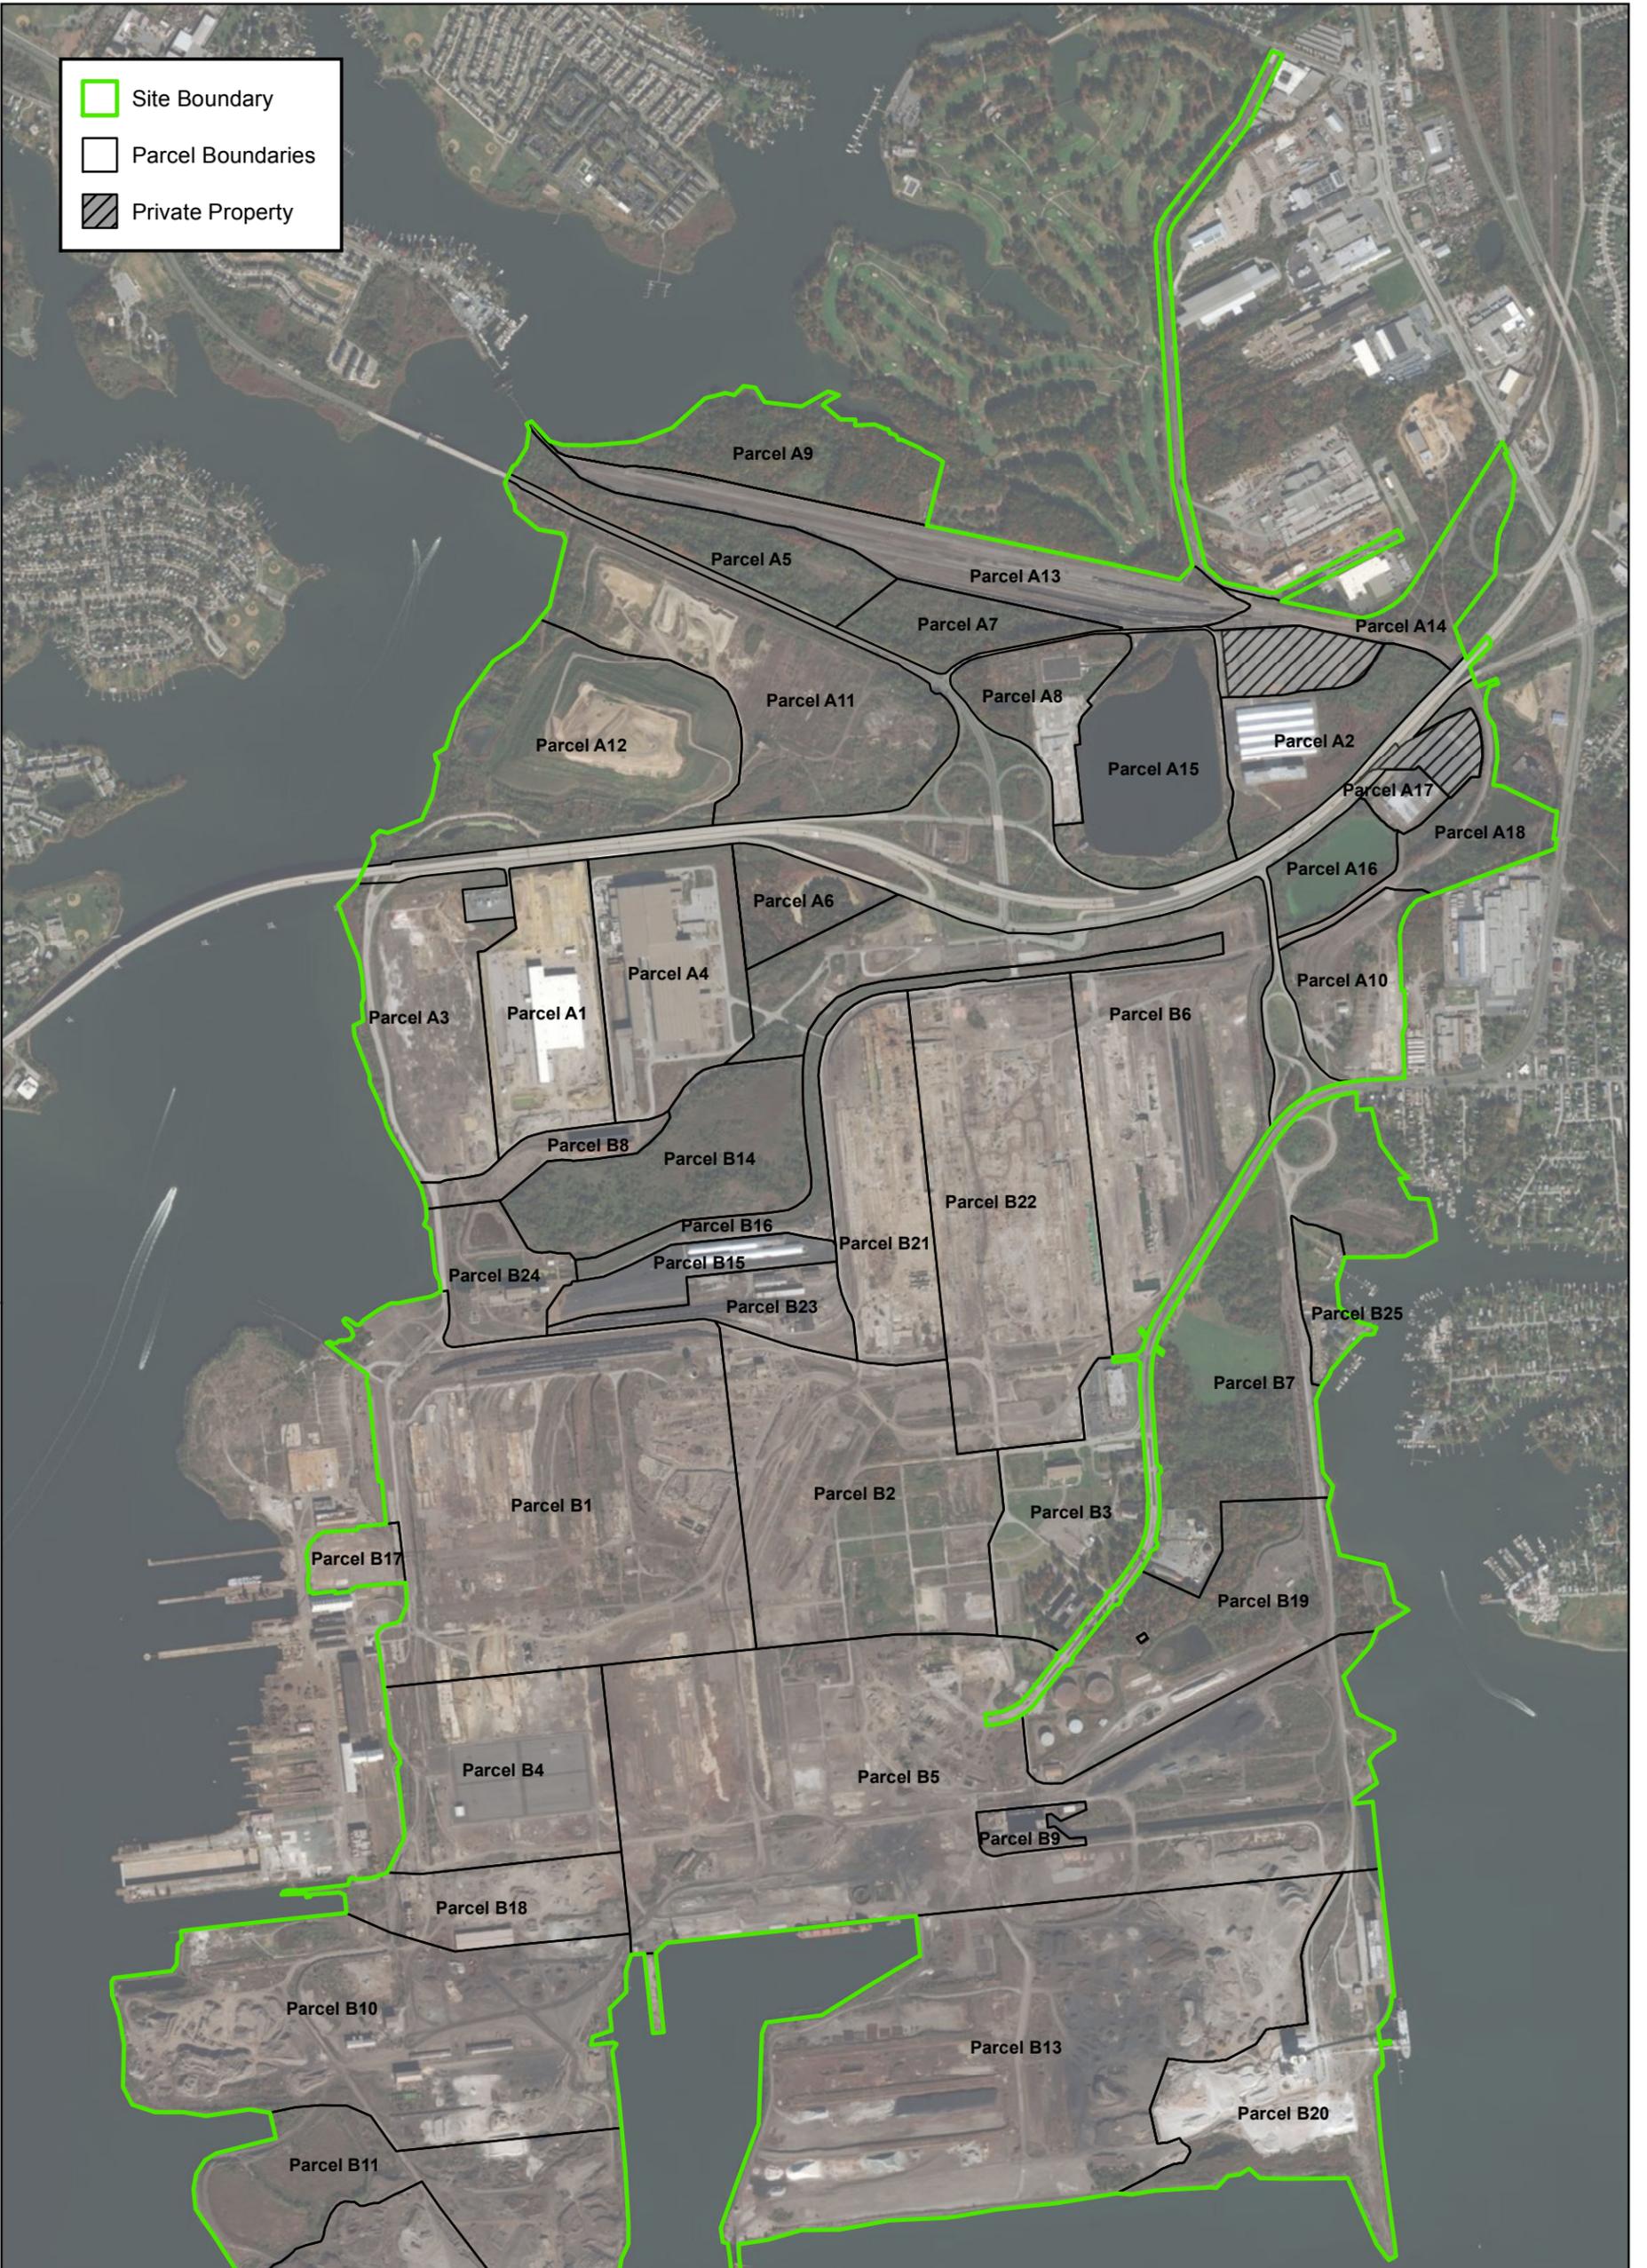
Approximate Shoreline 1916 September 22, 2020		Figure 2
Adapted from Figure 2-20 of the Description of Current Conditions Report prepared by Rust Environmental and Infrastructure, dated January 1998		
	 ARM Group LLC Engineers and Scientists	Tradepoint Atlantic Sparrows Point Baltimore County, MD
	Area A: Project 200101 Area B: Project 200102

Groundcover at the Site is comprised of approximately 81% natural soils and 19% non-native fill materials (i.e., slag), based on the approximate shoreline of the Sparrows Point Peninsula in 1916, as shown on **Figure 2** (adapted from Figure 2-20 in the Description of Current Conditions (DCC) Report prepared by Rust Environment and Infrastructure dated January 1998).

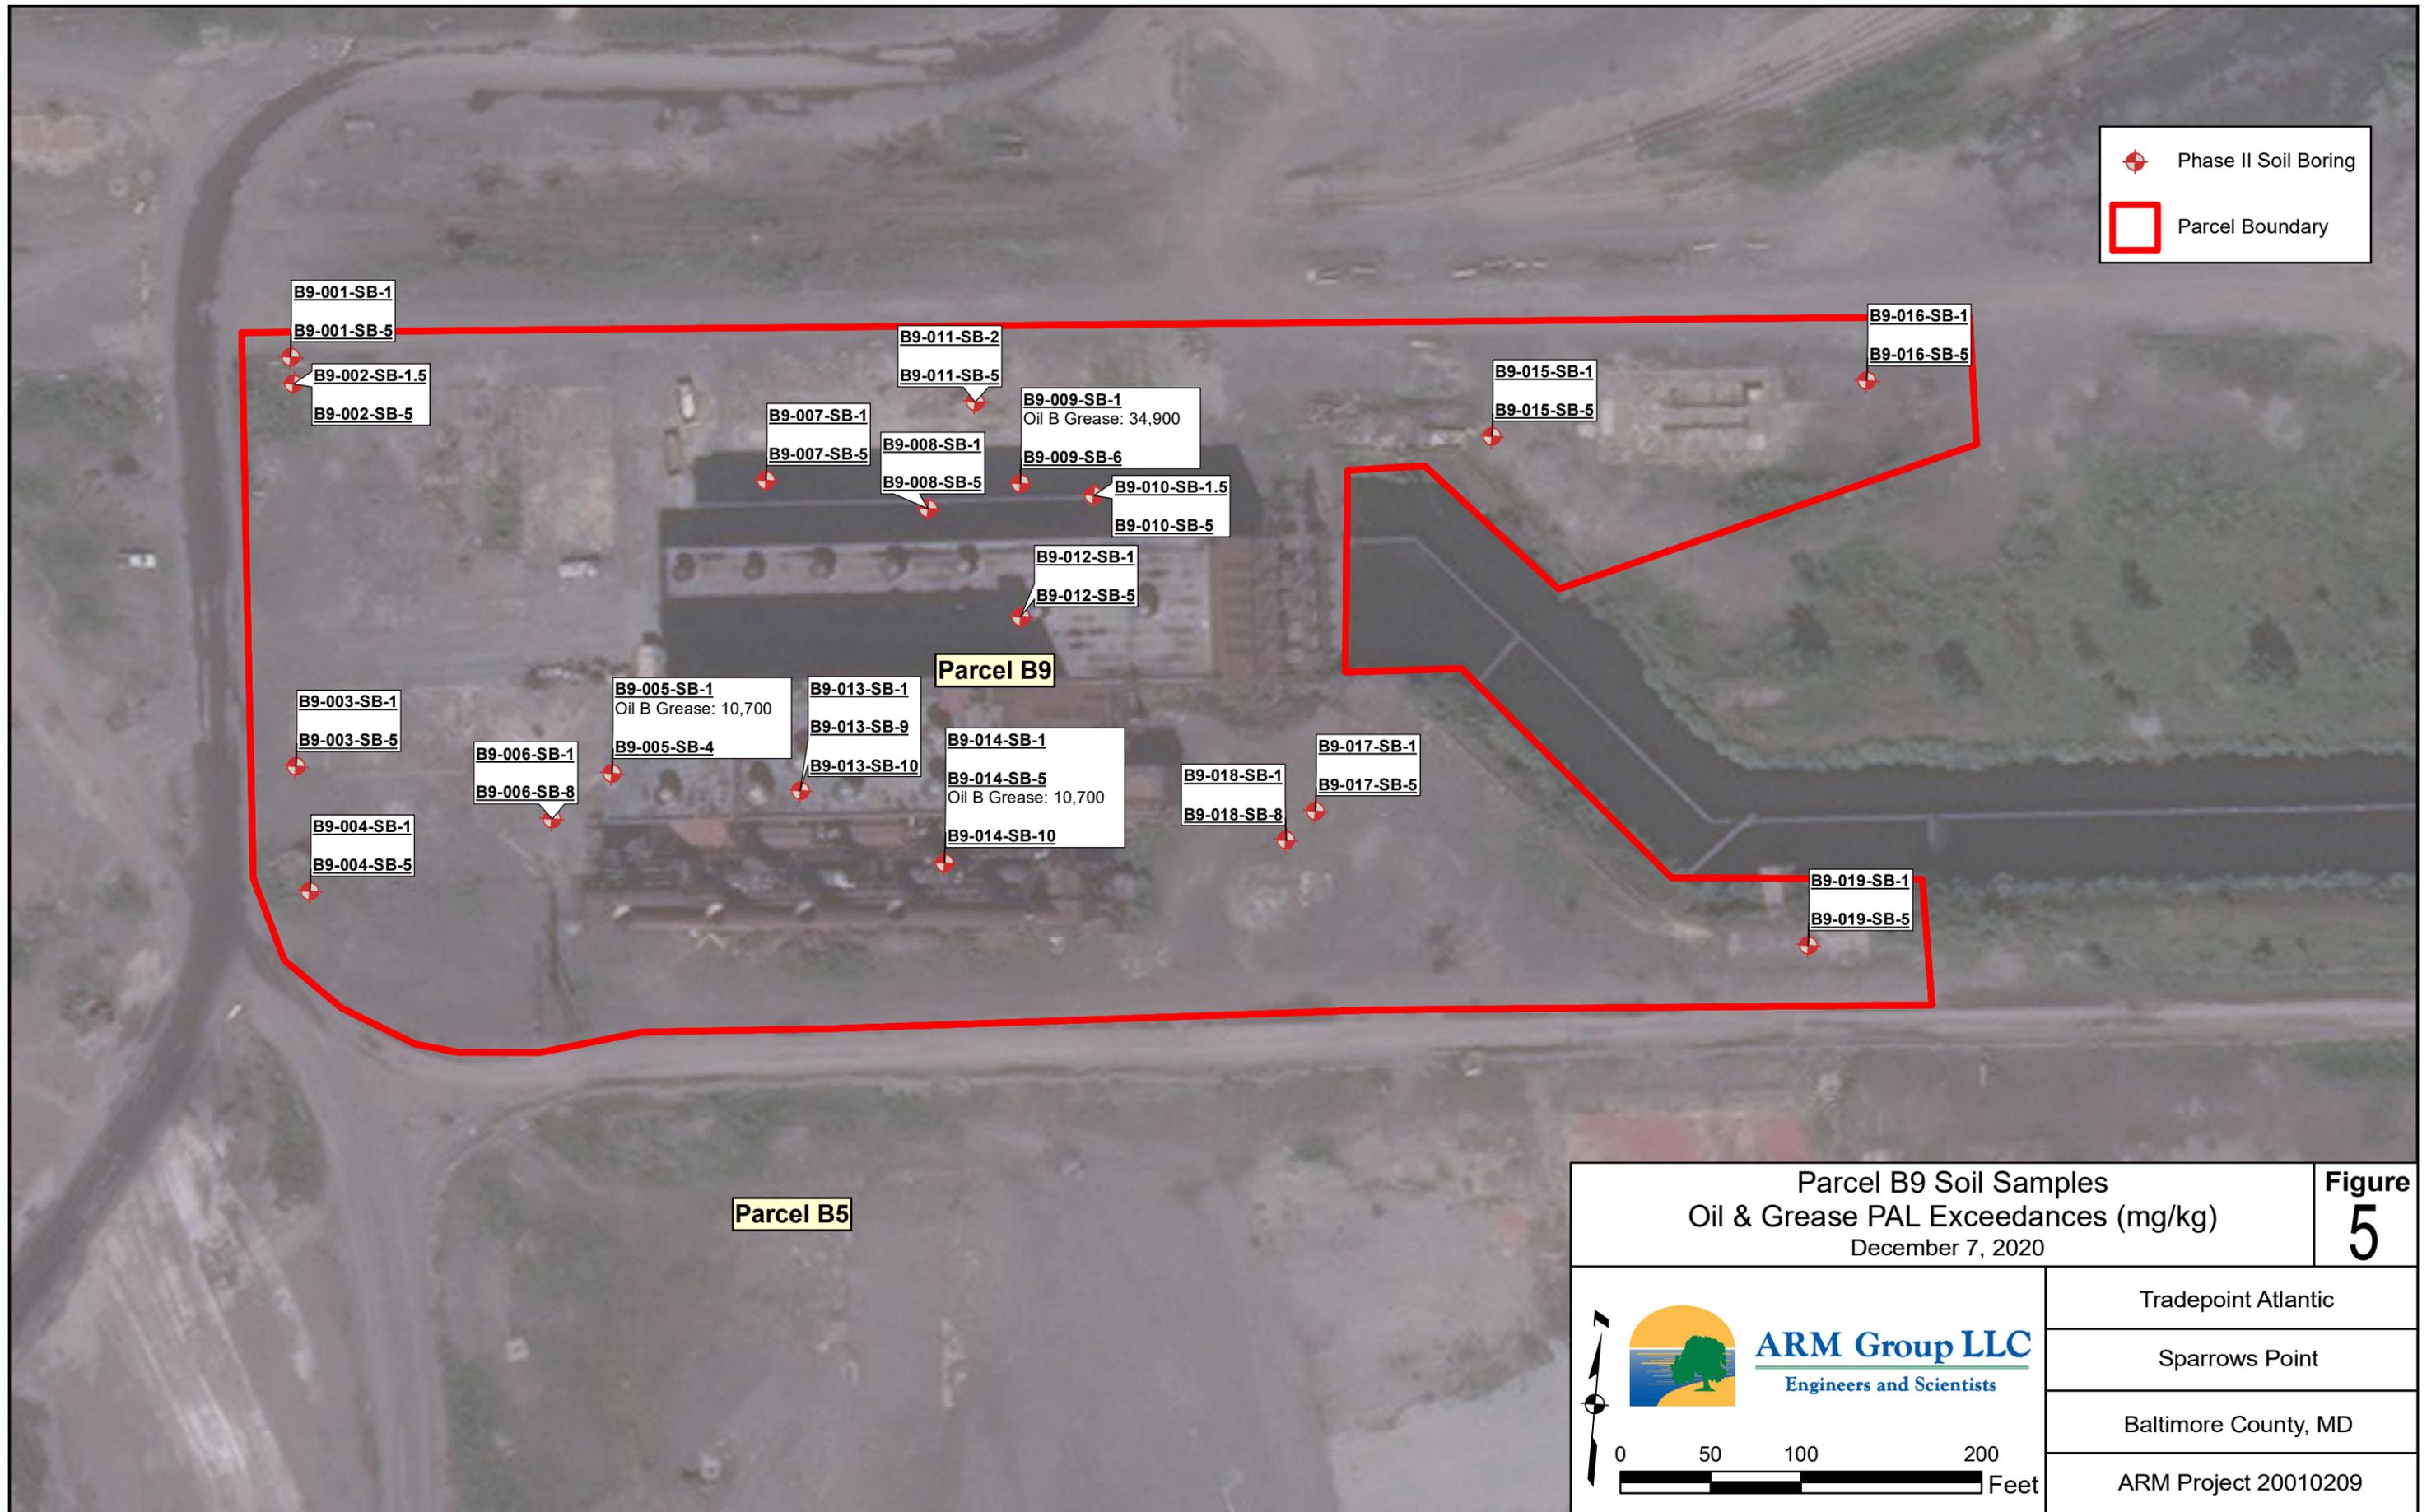
Parcel B9 Soil Samples Inorganic PAL Exceedances (mg/kg) December 7, 2020		Figure 6
 ARM Group LLC Engineers and Scientists	Tradepoint Atlantic	
	Sparrows Point	
	Baltimore County, MD	
	ARM Project 20010209

Table 6 provides a summary of inorganic constituents detected above the laboratory's MDLs in the soil samples collected from across the Site. Four inorganic constituents (arsenic, lead, manganese, and thallium) were detected above their respective PALs. Arsenic was detected above (or equal to) its PAL of 3 mg/kg in 38 total soil samples analyzed for this constituent with a maximum detection of 56 mg/kg in B9-014-SB-5. Arsenic was by far the most common PAL exceedance. Lead was detected above its PAL of 800 mg/kg in two samples with a maximum detection of 1,790 mg/kg in B9-004-SB-5. Manganese was detected above its PAL of 26,000 mg/kg in one sample (B9-006-SB-8) with a detection of 29,100 mg/kg. Thallium was detected above its PAL of 12 mg/kg in four samples with a maximum detection of 23.1 mg/kg in B9-005-SB-4. The inorganic PAL exceedances are shown on **Figure 6**.

Table 5 and **Table 6** provide a summary of the detected organic compounds and inorganics in the soil samples submitted for laboratory analysis, while **Figure 4** through **Figure 6** present the soil sample results that exceeded the PALs. PAL exceedances in soil within Parcel B9 were limited to benzo[a]pyrene, Oil & Grease, and four metals (arsenic, lead, manganese, and thallium). **Table 8** provides a summary of results for all PAL exceedances in soil, including maximum values and detection frequencies. VOCs, PCBs, and TPH-DRO/GRO were not detected above their respective PALs and are not considered to be significant soil contaminants in Parcel B9.
