RE: Assessment of Existing Geosynthetic Cap and Surface Soil Sampling Event  
**Stansbury Park**  
Dundalk, Maryland  
Remedial Management Services Contract  
CGS Project No. CG-08-0357

#### Assessment of Existing Geosynthetic Cap

Subject: Assessment of Existing Cap and LLDPE Liner Adjacent to Pond  
Stansbury Park  
Dundalk, Maryland

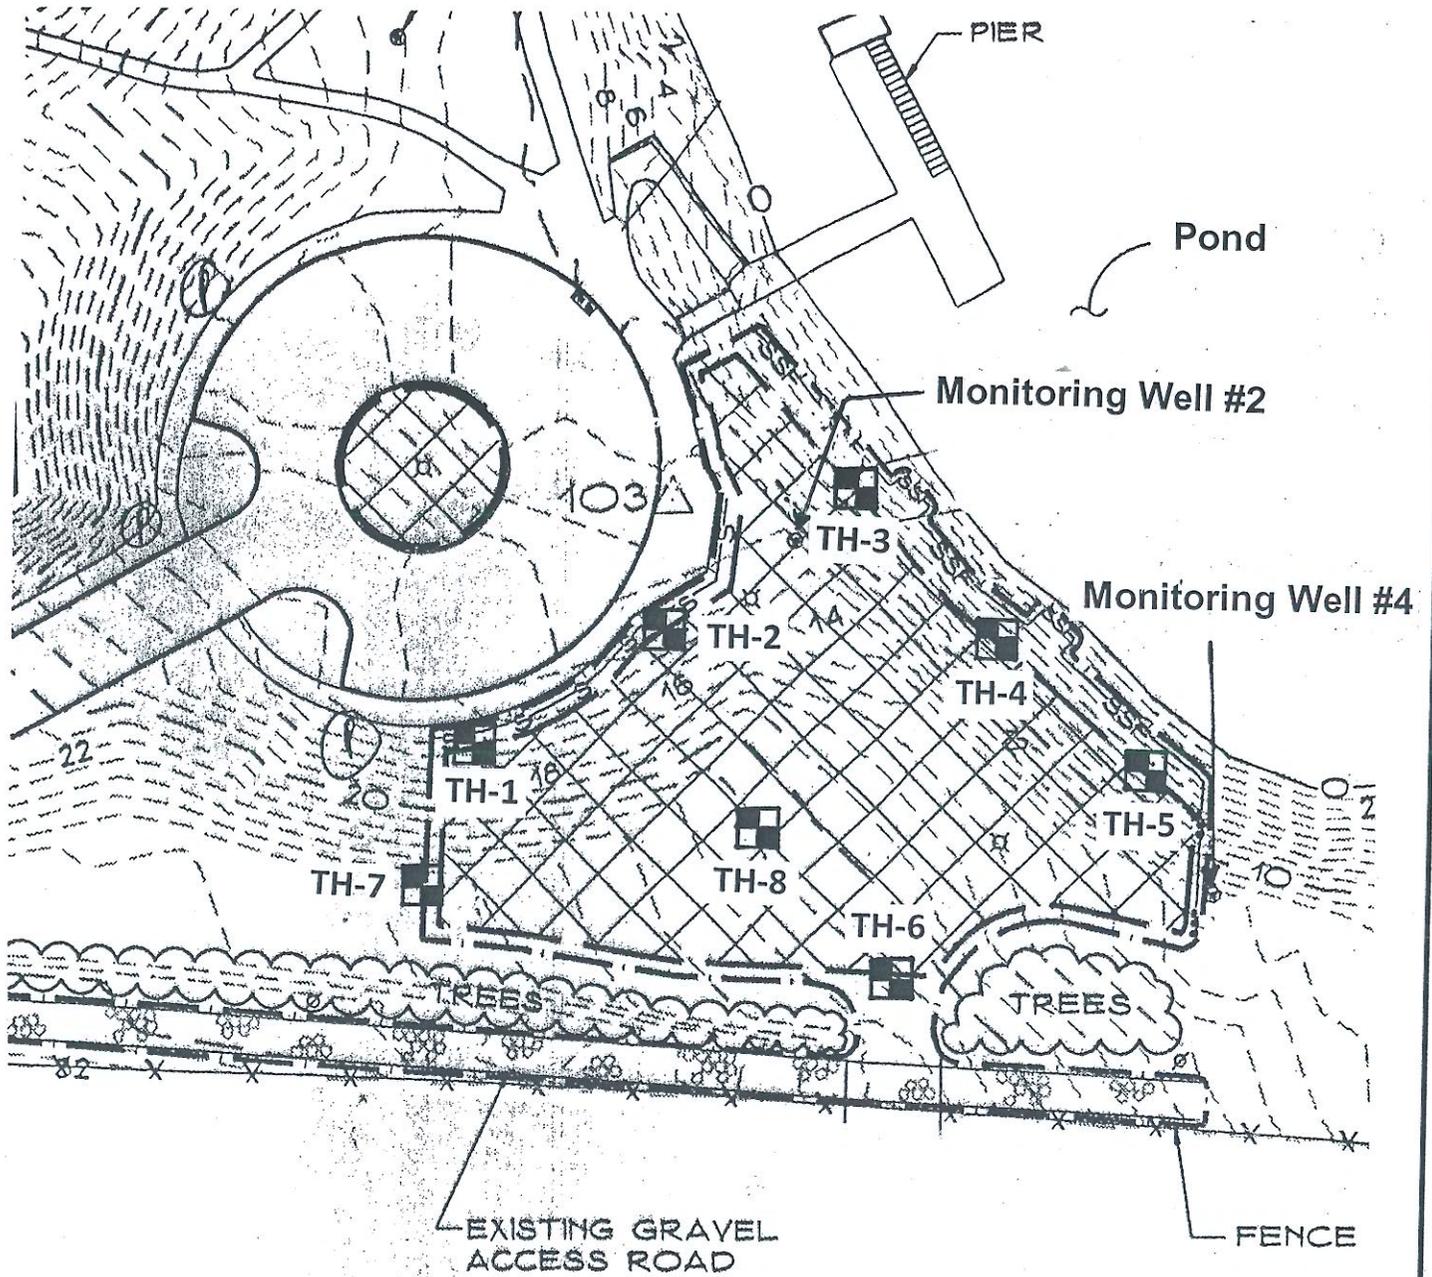
The subsurface investigation included eight test holes numbered TH-1 to TH-8. The test holes were excavated using hand tools including a shovel and a 3.5-inch bucket style hand auger. The location of each test pit is shown on the attached Test Hole Location Plan. Descriptions of the soils encountered in the test pits are provided on the attached Summary of Test Hole Observations. The test holes were backfilled with the excavated materials after completion. The existing ground surface elevations indicated on the Summary of Test Hole Observations were estimated from the proposed contours shown on the drawings.

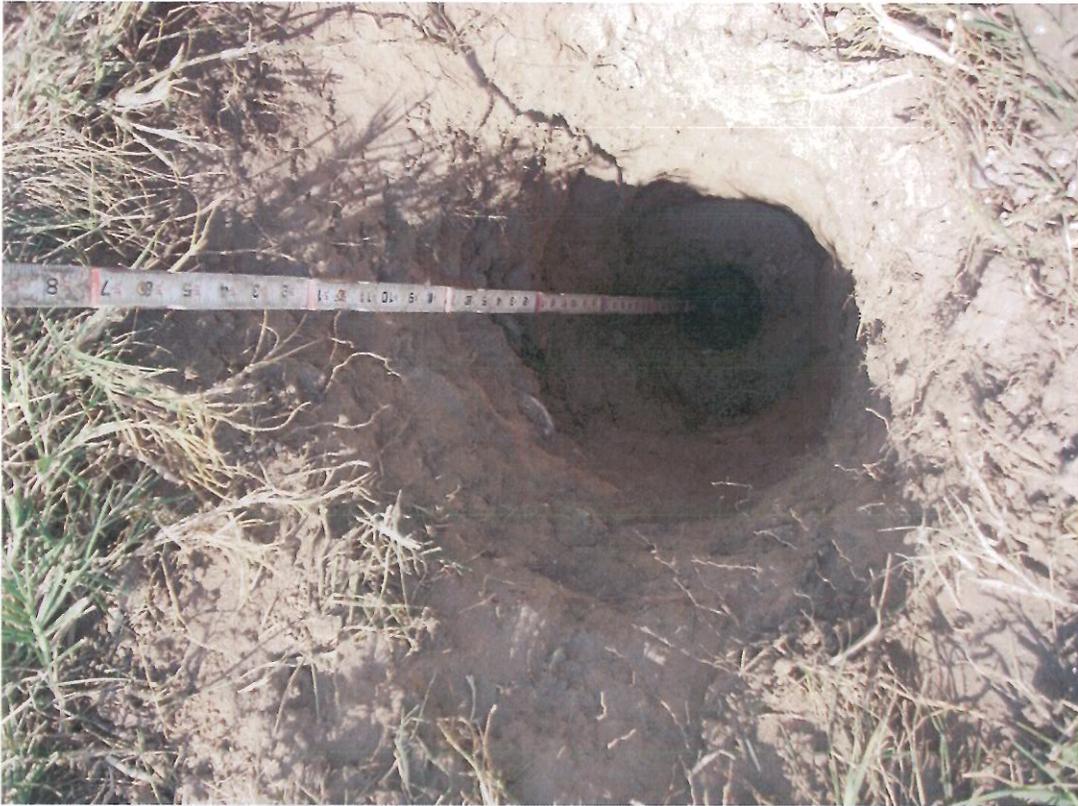
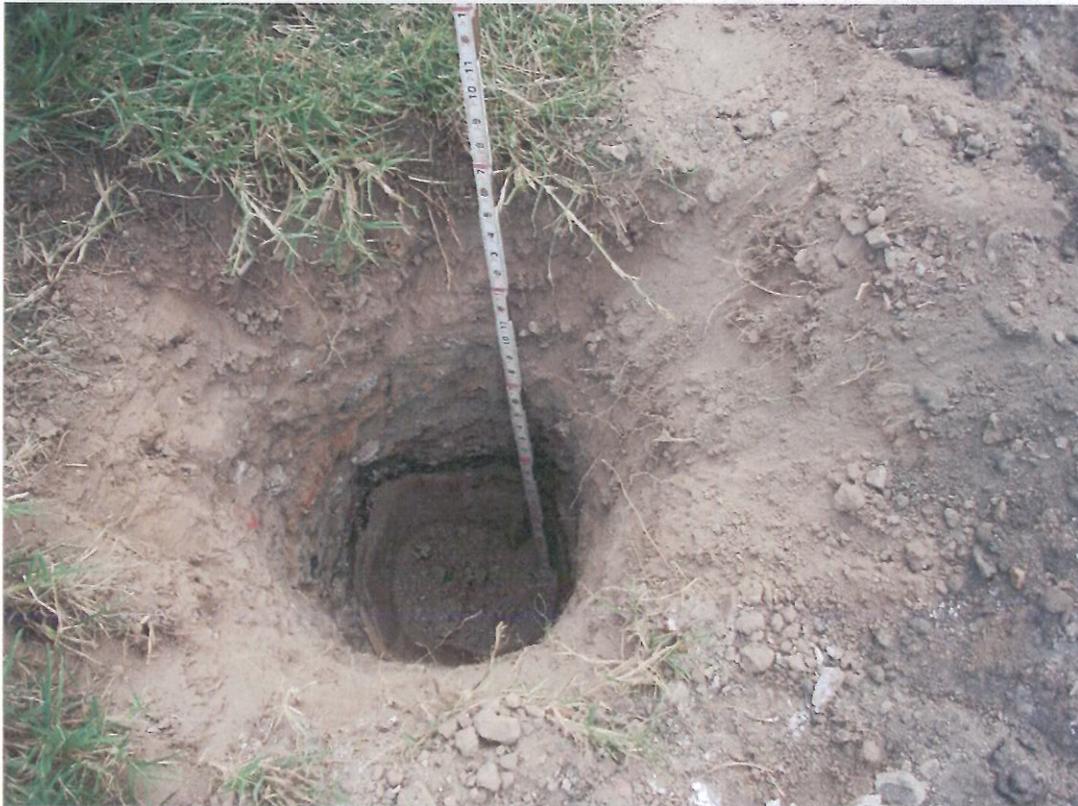
**TEST HOLE TH-1**

Fill soil was encountered in each test hole. The fill soil generally consisted of brown, dry to damp, sandy SILT and silty SAND, with concrete fragments, rock fragments and gravel, and traces of oyster shells and debris. Additionally, dark brown slag was observed in Test Hole TH-1 at a depth of 1.5 to 1.8 feet. Natural, undisturbed soil was encountered under the fill soil in Test Holes TH-1 and TH-6 at depths of 1.8 and 3.2 feet, respectively. The natural soil consisted of pale brown and white, damp to moist, sandy SILT and silty SAND. No groundwater was observed in the test holes. All the test holes were dry at completion.

Test Hole No.	Location	Surface Elevation (ft)	Test Hole Depth (ft)	Soil Description	Remarks
TH-1	39° 15' 34.751" N 76° 30' 01.476 W	15	5.4	0 to 1.5 feet: Brown, dry, dense, silty SAND, with gravel and concrete fragments, trace metal debris (Fill). 1.5 to 1.8 feet: Dark brown, damp, silty SAND, with gravel and slag (Fill). 1.8 to 5.4 feet: Pale brown and white, moist, medium stiff, sandy SILT (natural)	Liner not encountered at this location. The test hole was hand augered from 2.6 to 5.4 feet. Groundwater was not observed in the test hole.
TH-2	39° 15' 35.310" N 76° 30' 01.368 W	14	1.2	0.0 to 1.2 feet: Brown, dry, dense, silty SAND, with gravel and concrete fragments (Fill)	A layer of filter fabric was observed at the bottom of the test hole. Size No. 57 stone was observed under the filter fabric.
TH-3	39° 15' 35.957" N 76° 30' 01.439 W	6	3.2	0 to 3.2 feet: Brown, moist, sandy SILT, little rock fragments and gravel (Fill)	Liner not encountered at this location. Groundwater was not observed in the test hole.

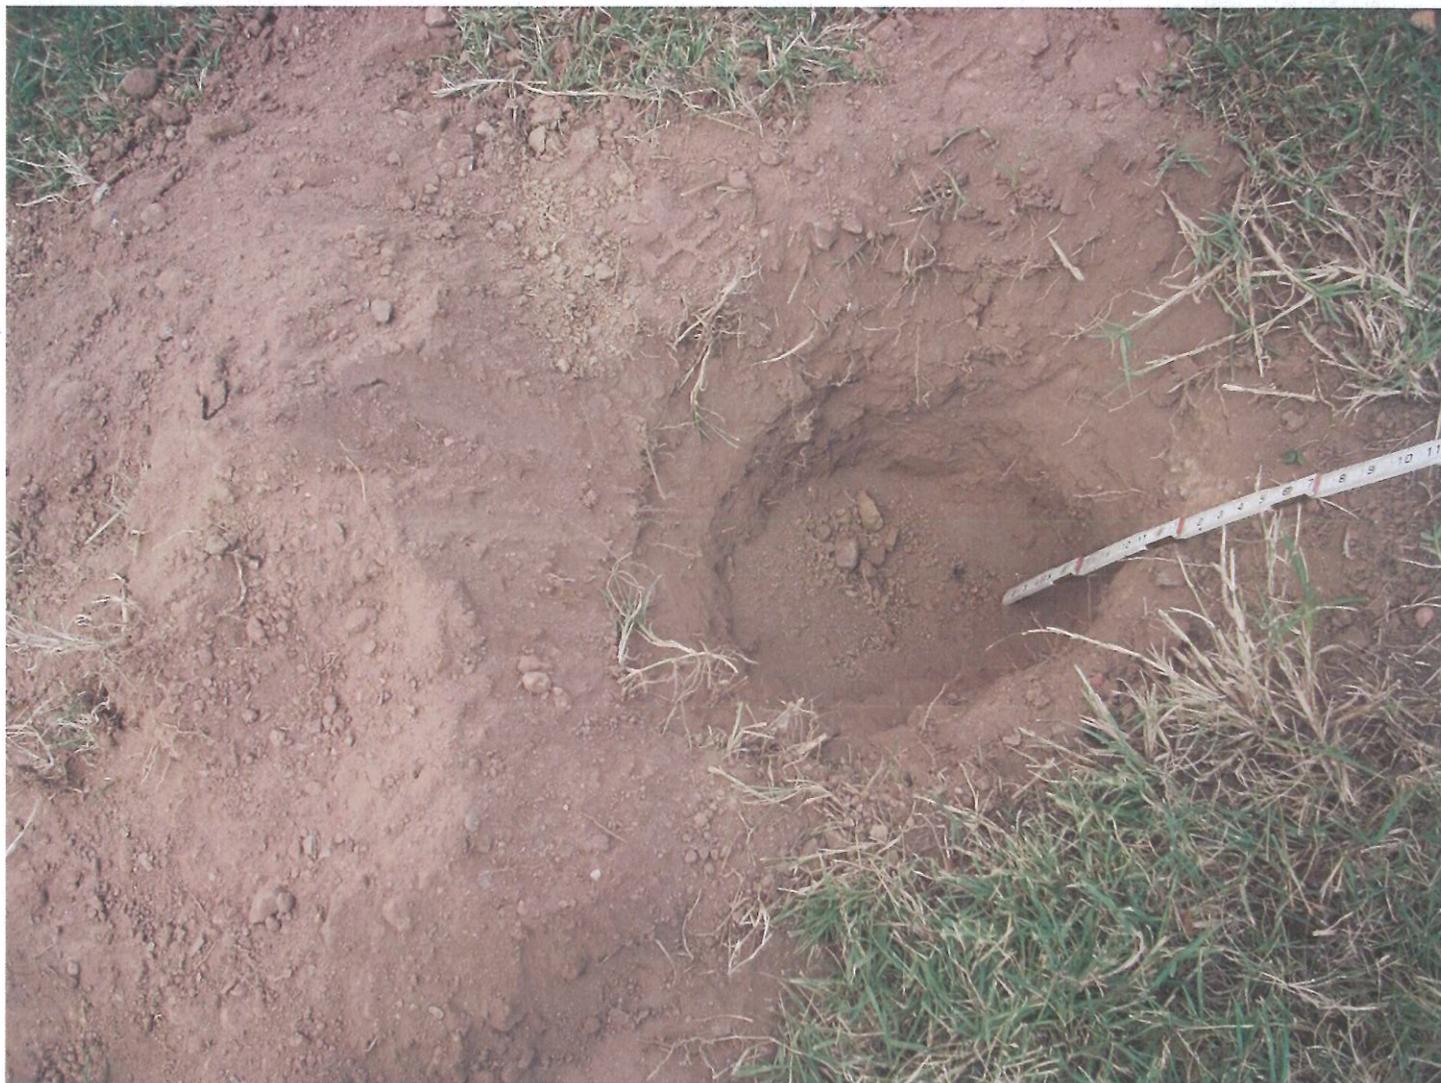
**TEST HOLE TH-2**

A layer of filter fabric and Size No. 57 stone was encountered at the bottom of Test Holes TH-2, TH-5 and TH-7. The filter fabric and Size No. 57 stone was consistent with the drainage trench materials indicated on the drawings. A geonet and heavy geosynthetic liner were encountered at the bottom of Test Holes TH-4 and TH-8. The geonet and geosynthetic liner were consistent with the geonet and LLDPE liner indicated on the drawings. Elements of the liner system were not encountered in Test Holes TH-1, TH-3 and TH-6. Photographs of all the test holes are attached.

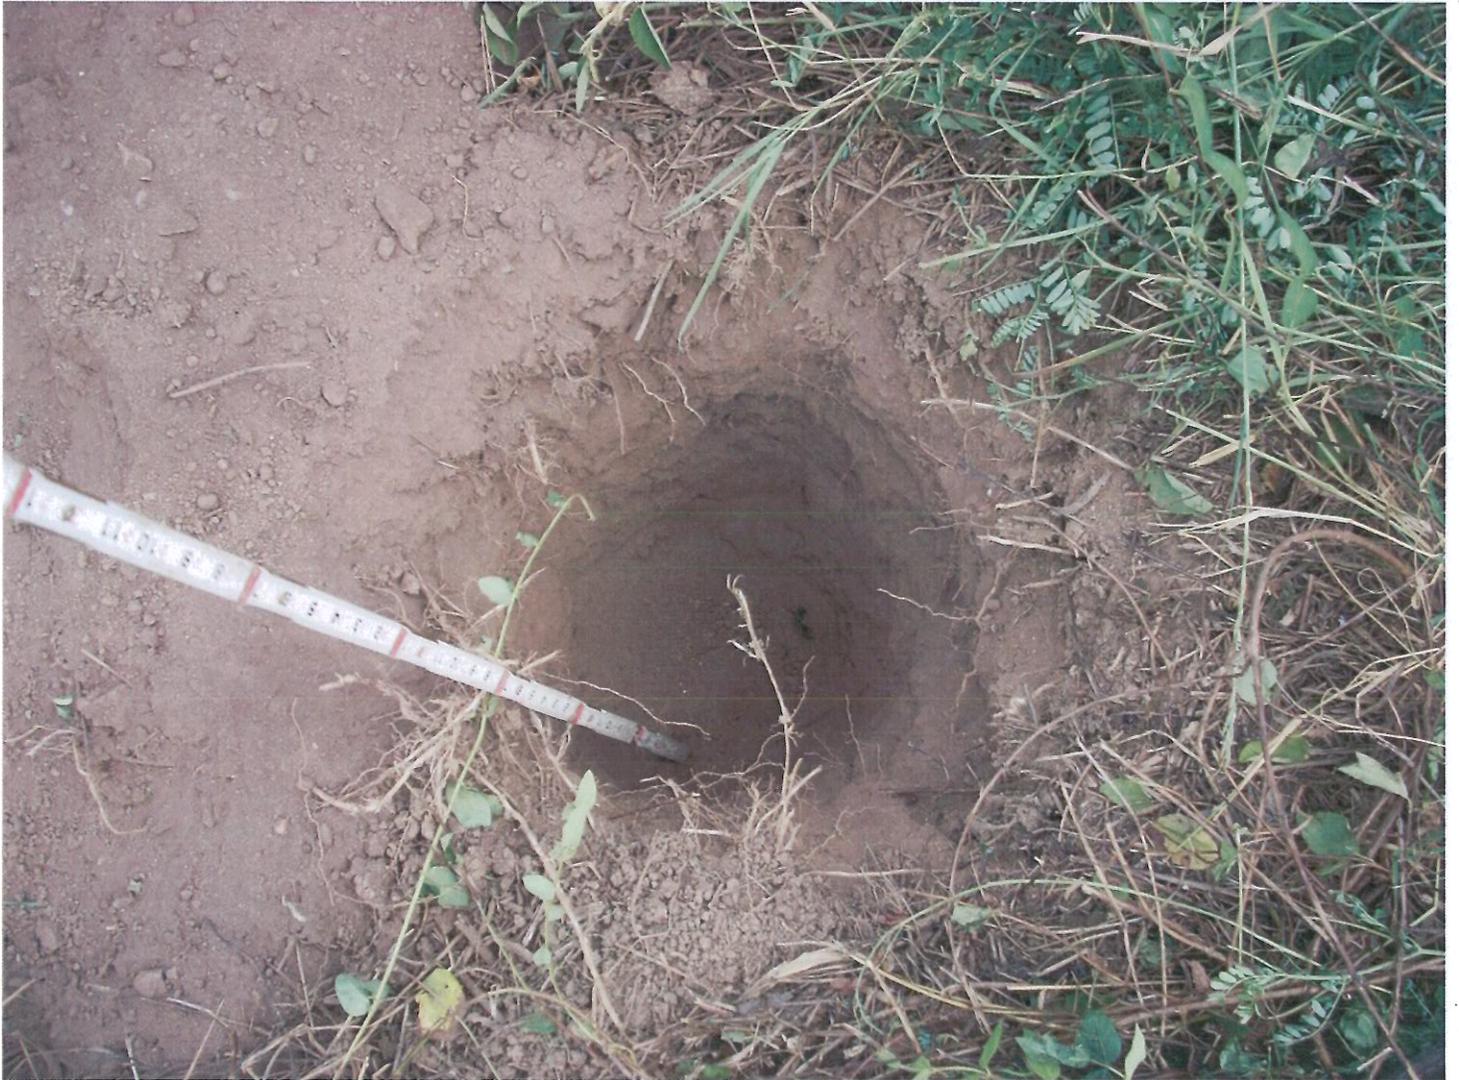
**TEST HOLE TH-4**

TH-4	39° 15' 35.898" N 76° 30' 00.448 W	7	1.7	0 to 1.7 feet: Brown, damp, sandy SILT, little rock fragments and gravel (Fill)	A geocomposite drainage layer was observed at the bottom of the test hole. A geomembrane liner was observed under the geocomposite drainage layer.
TH-5	39° 15' 36.190" N 76° 30' 00.010 W	7	2.5	0 to 2.5 feet: Brown, damp, sandy SILT, little rock fragments and gravel (Fill)	A layer of filter fabric was observed at the bottom of the test hole. Size No. 57 stone was observed under the filter fabric.
TH-6	39° 15' 35.271" N 76° 30' 00.195 W	21	5.6	0 to 3.2 feet: Brown, dry to damp, dense, silty SAND, with gravel, rock and concrete fragments, trace asphalt, oyster shells and debris (Fill). 3.2 to 5.6 feet: Pale brown, damp, silty SAND and white SILT (natural).	Liner not encountered at this location. The test hole was hand augered from 3.2 to 5.6 feet. Groundwater was not observed in the test hole.

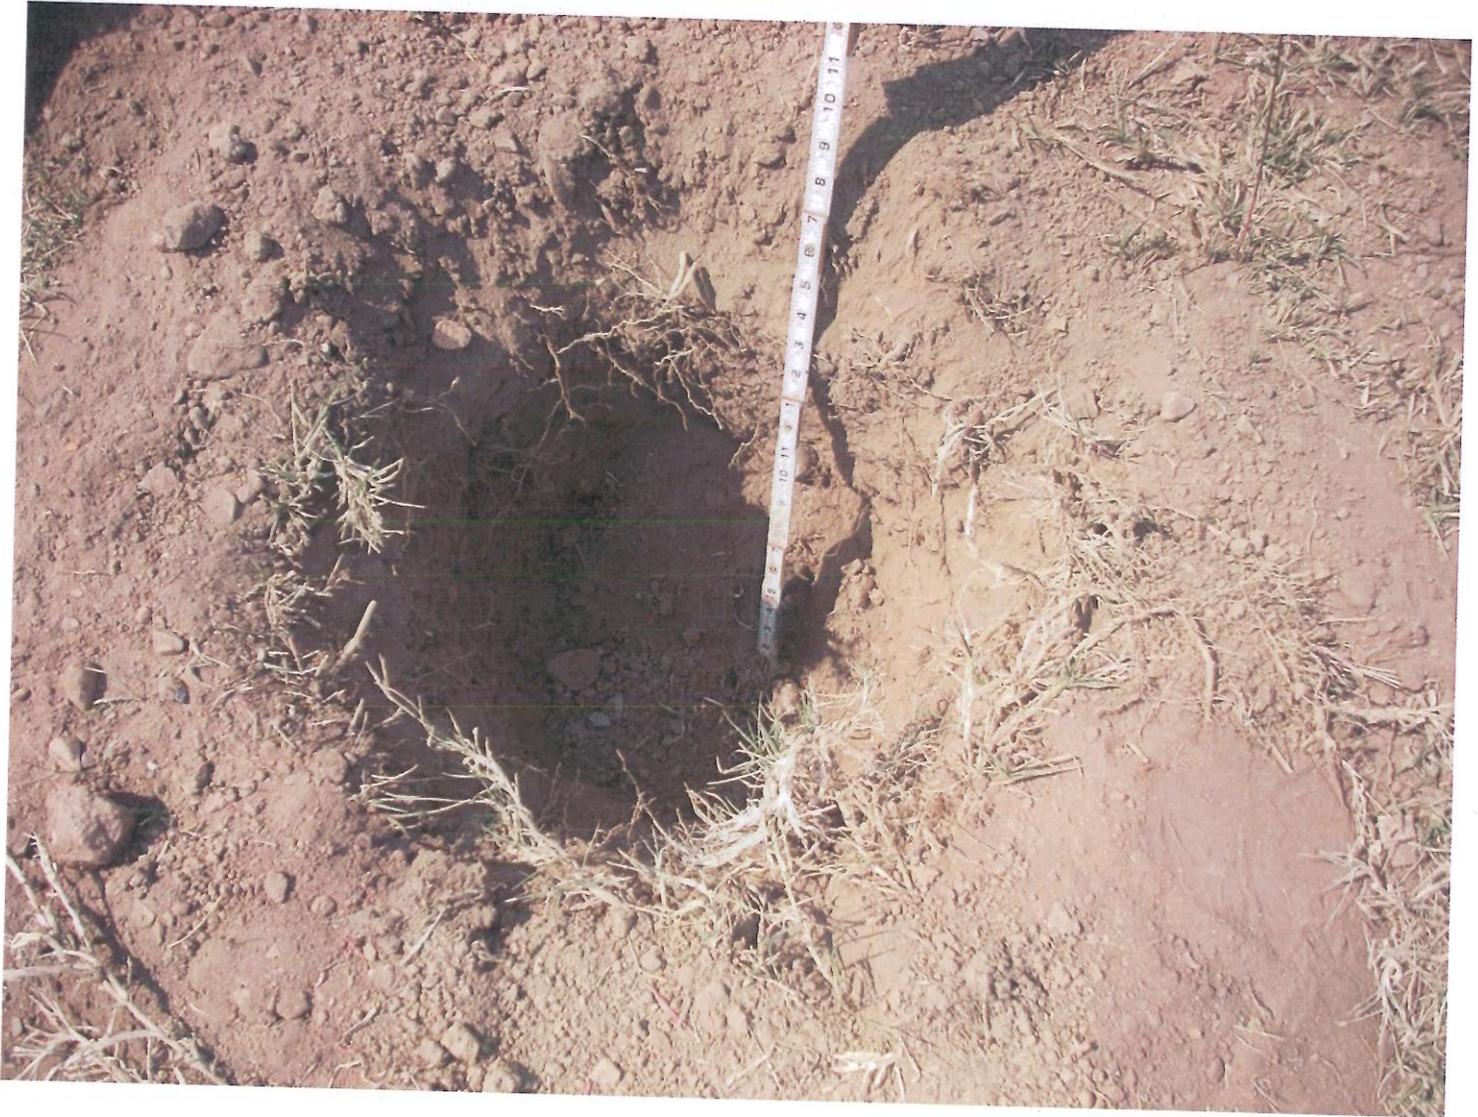
**TEST HOLE TH-7**

TH-7	39° 15' 34.570" N 76° 30' 01.059 W	25	1.5	0 to 1.5 feet: Brown, dry to damp, dense, silty SAND, with gravel, concrete and rock fragments (Fill)	A layer of filter fabric was observed at the bottom of the test hole. Size No. 57 stone was observed under the filter fabric.
TH-8	39° 15' 35.116" N 76° 30' 00.676 W	21	2.2	0 to 2.2 feet: Brown, dry to damp, dense, silty SAND, little gravel, concrete and rock fragments (Fill)	A geocomposite drainage layer was observed at the bottom of the test hole. A geomembrane liner was observed under the geocomposite drainage layer.
