RESPONSE AND DEVELOPMENT COMPLETION REPORT

AREA B: SUB-PARCEL A11-1
TRADEPOINT ATLANTIC
SPARROWS POINT, MARYLAND

Revision 0 – April 13, 2021

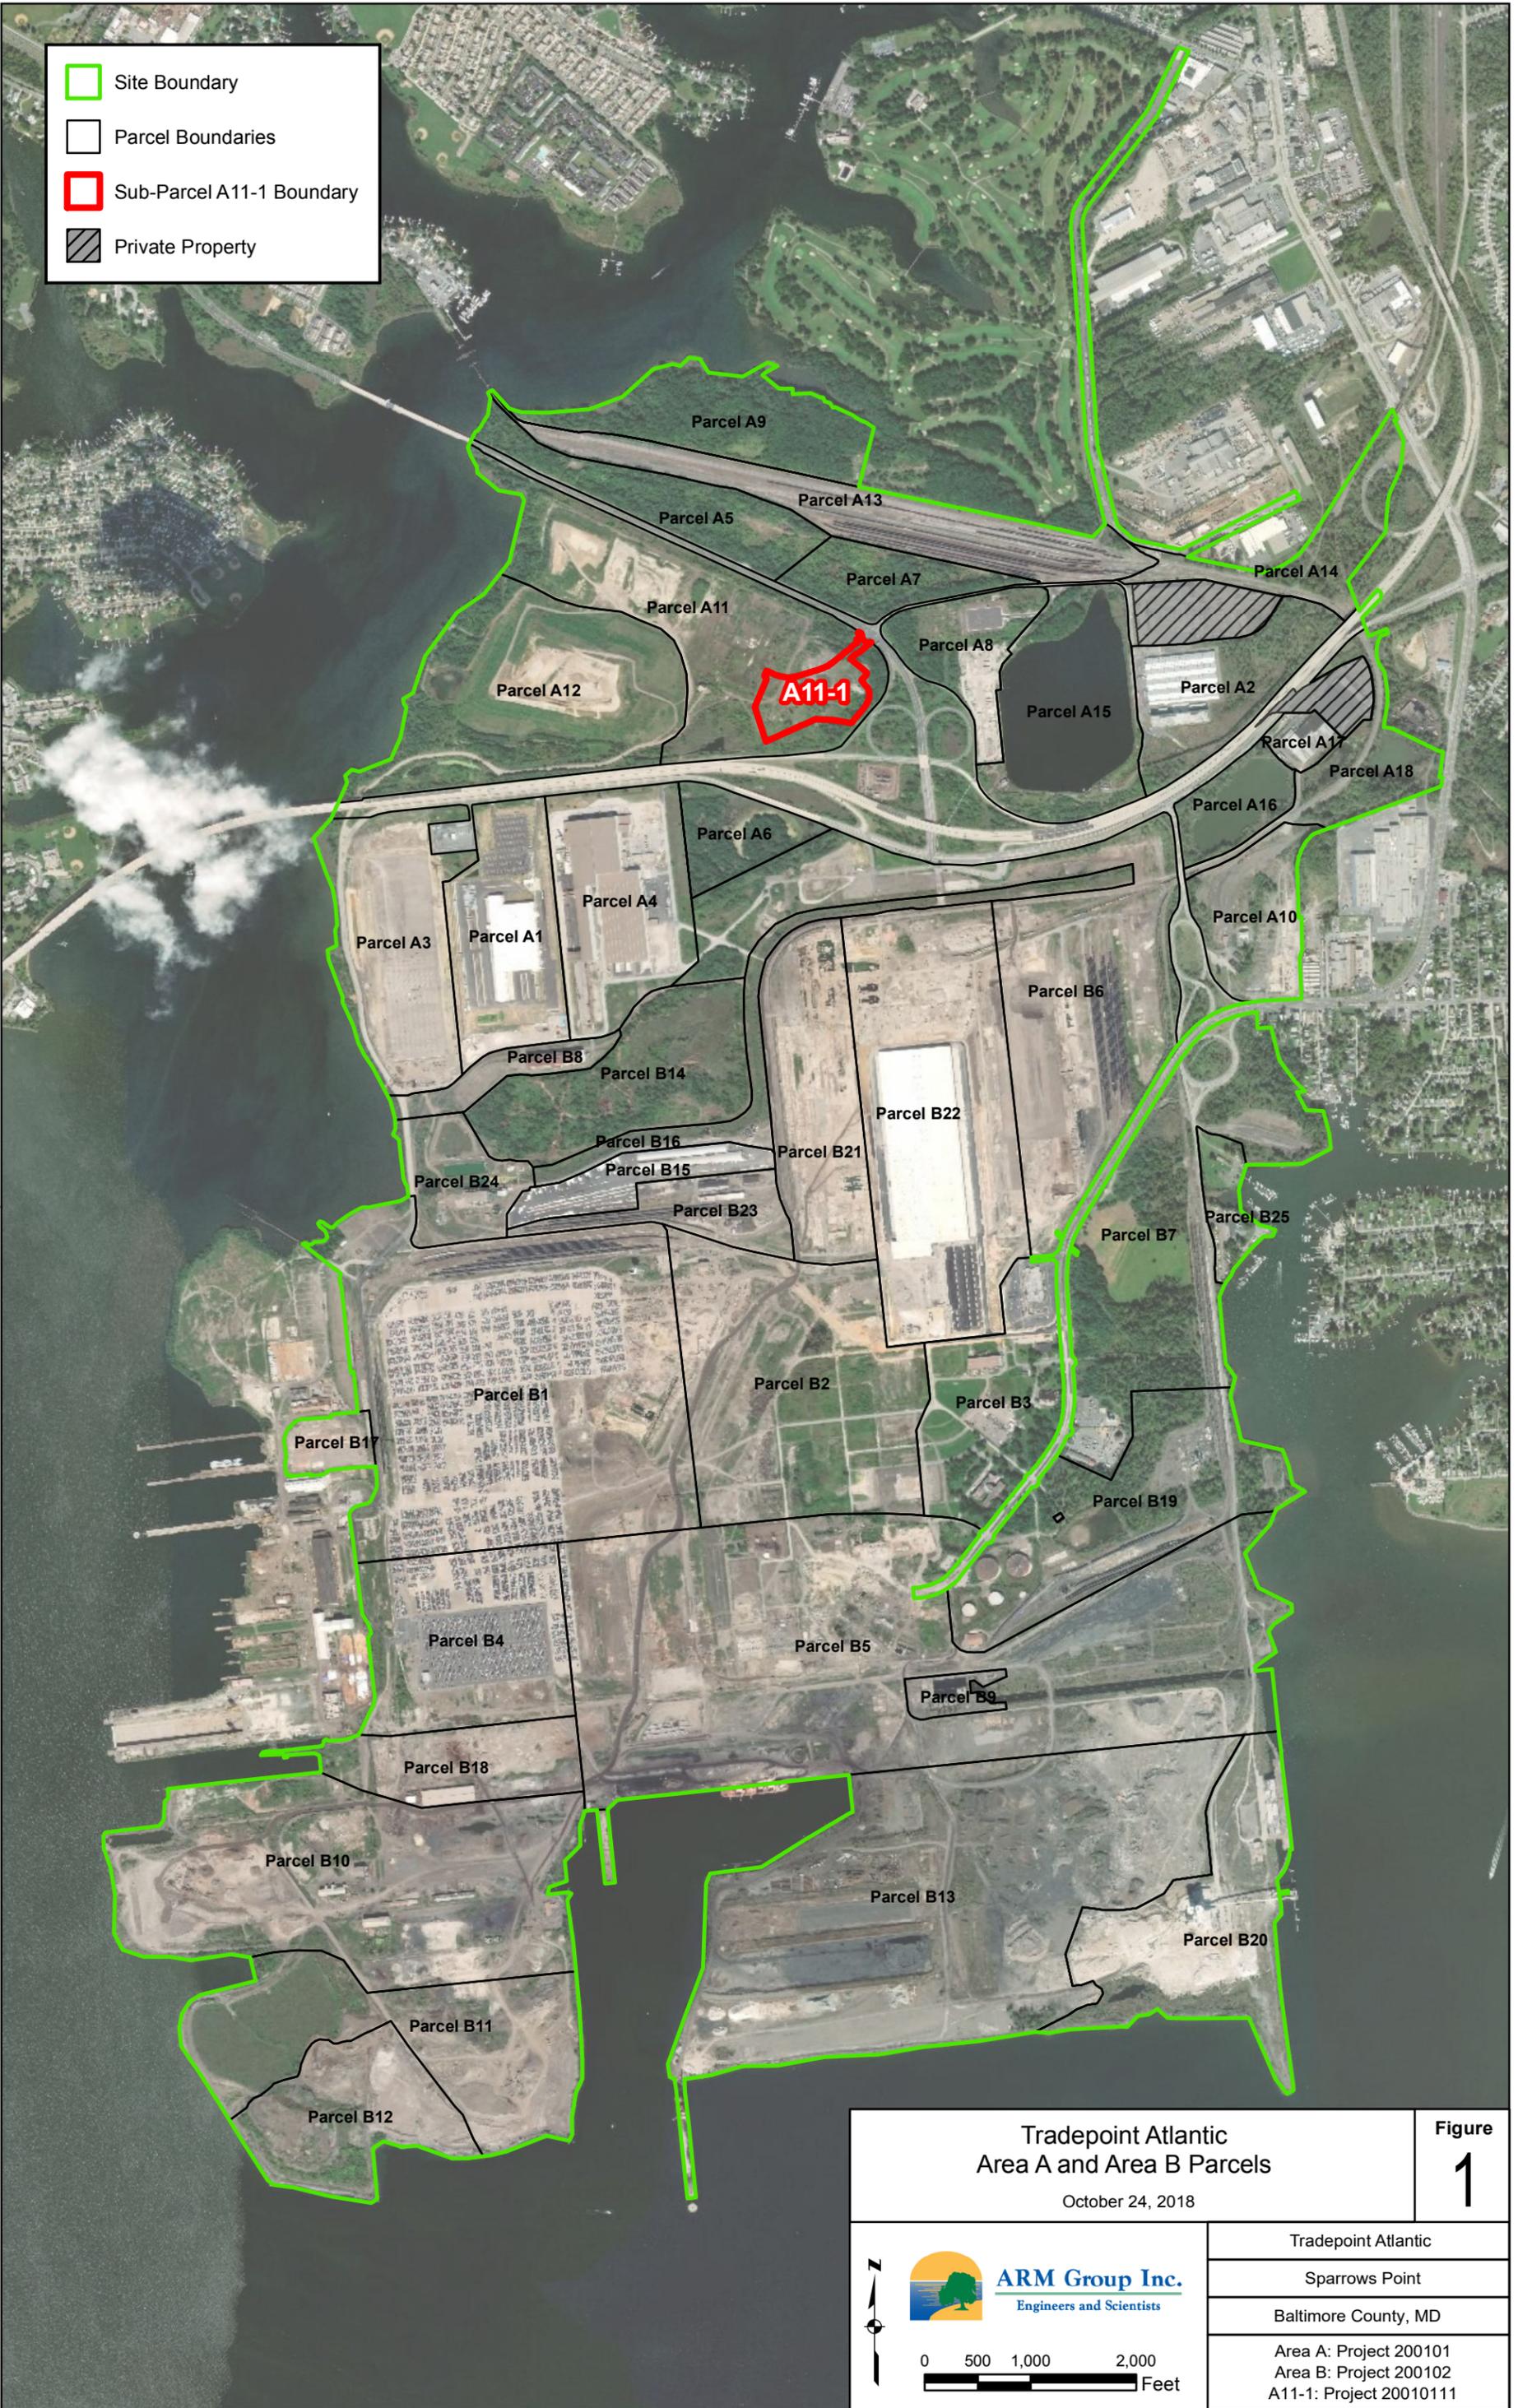
Tradepoint Atlantic Area A and Area B Parcels October 24, 2018		Figure 1
ARM Group Inc. Engineers and Scientists		Tradepoint Atlantic Sparrows Point Baltimore County, MD
 		Area A: Project 200101 Area B: Project 200102 A11-1: Project 20010111

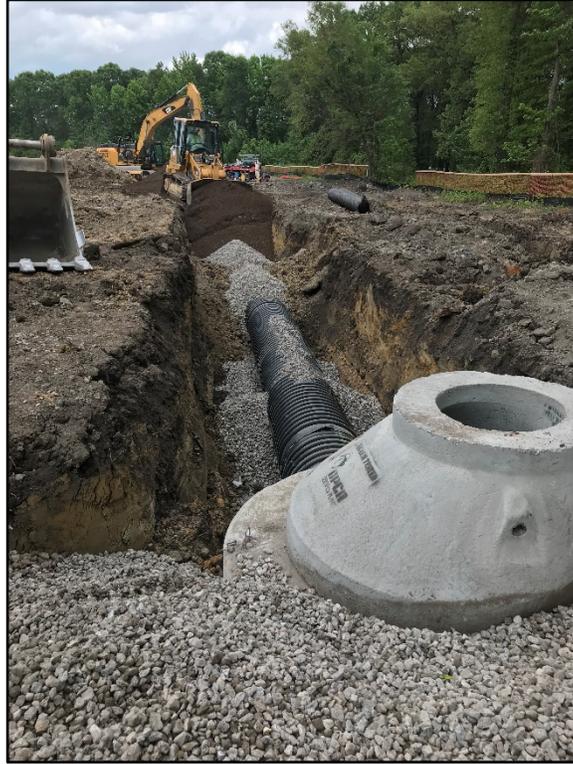
Photo 1: Utility installation

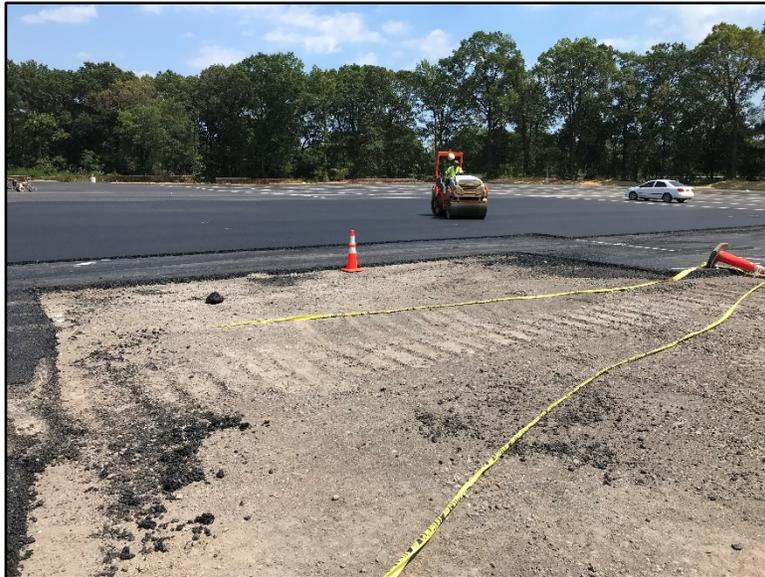
Photo 2: Paving in progress

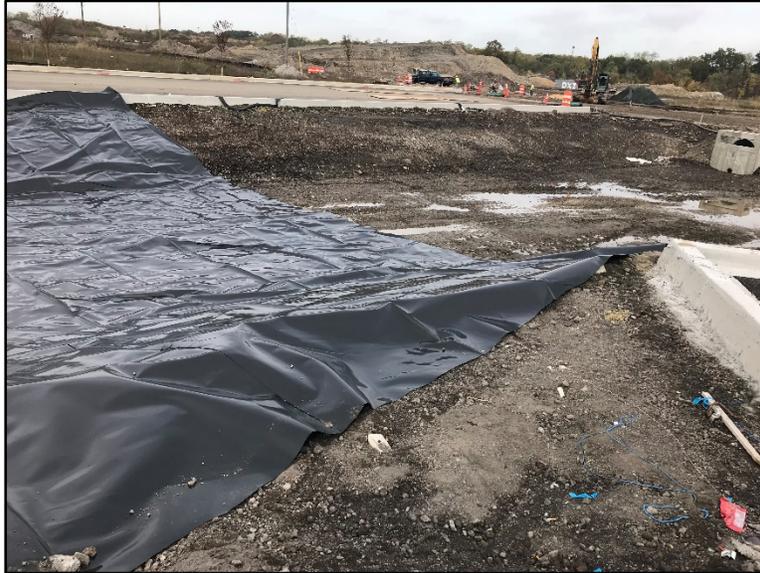
Photo 3: Installation of impermeable liner in stormwater basin

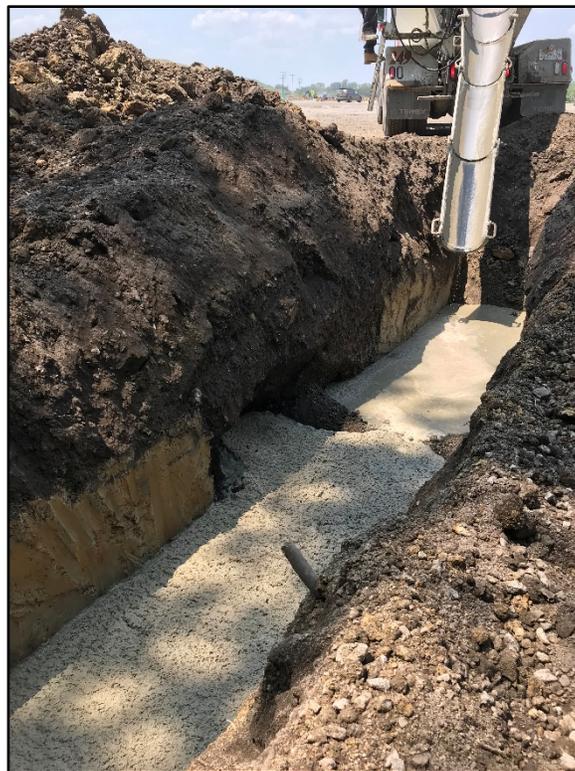
Photo 4: Trench plug construction

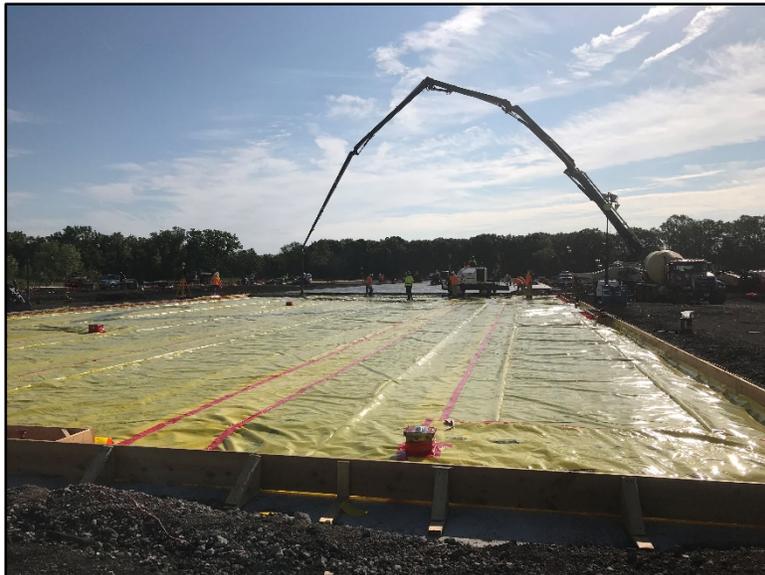
Photo 6: Vapor barrier

system conveyance piping were backfilled with slag aggregate ground to #57 size material. The venting system was installed by ARCO. The vapor barrier was installed by ARCO's mechanical subcontractor in accordance with the product manufacturer's recommendations. Periodic site visits were completed by ARM to observe the installation of the venting system and backfilling. Material specifications for the STEGO® vapor barrier products and a photograph log documenting the installation is included in **Appendix N**.

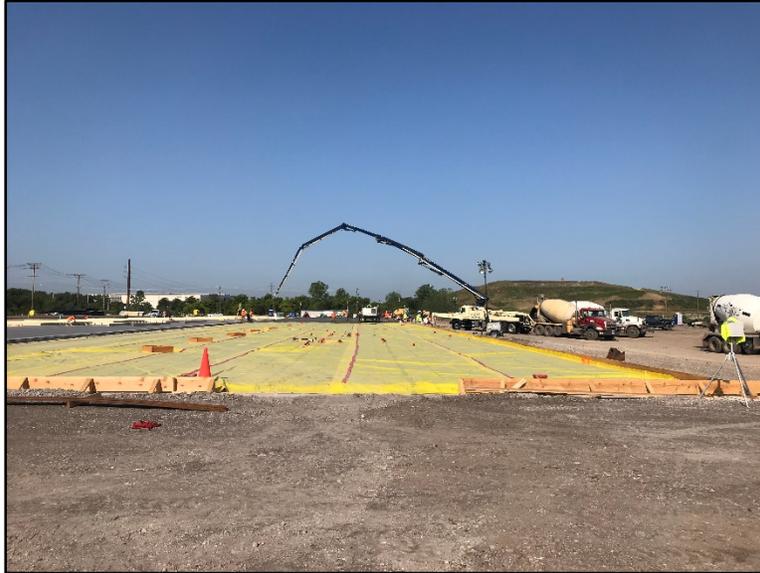
Photo 7: Vapor barrier

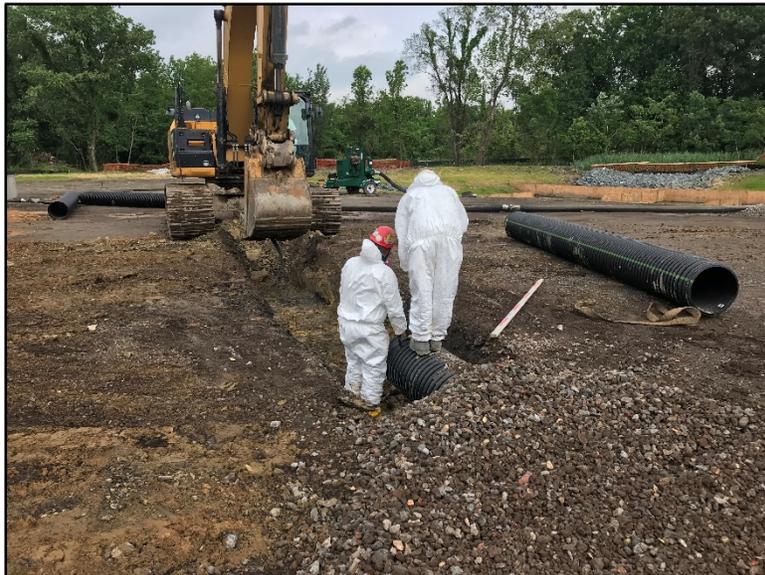
Photo 8: Modified Level D PPE

The contractor was responsible for following safety procedures, including schedule limitations, to control contact with potentially contaminated soil or groundwater. The contractor adopted Modified Level D personal protective equipment (PPE) and had an Occupational Safety and Health Administration (OSHA) Hazardous Waste Operations and Emergency Response (HAZWOPER) trained crew for intrusive activities. The acknowledgement form signed by the site contractor is provided in **Appendix L**.

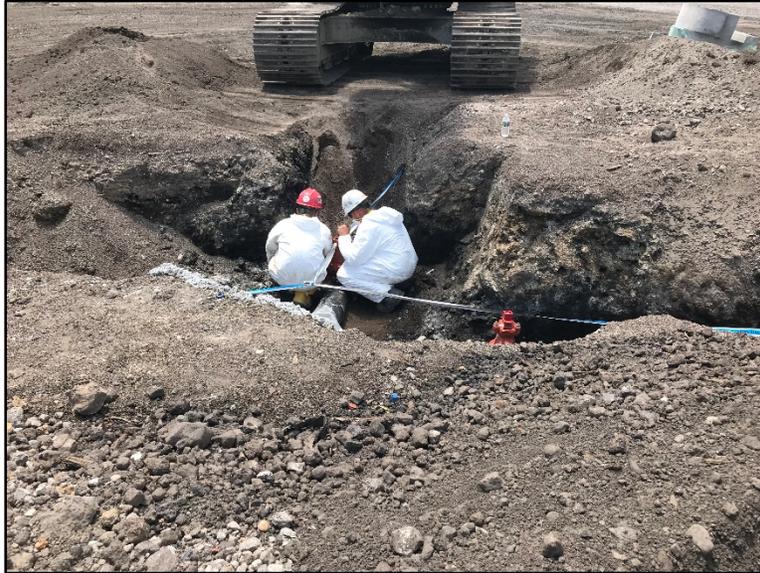
Photo 9: Modified Level D PPE

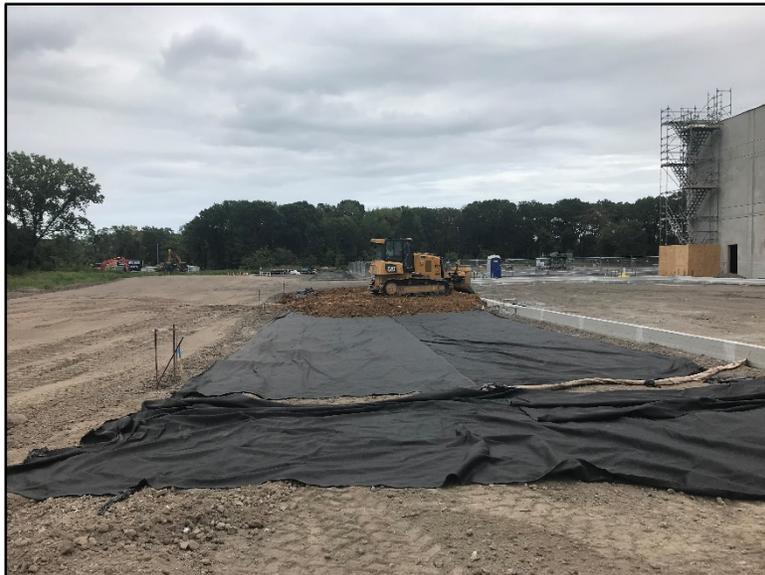
Photo 10: Clean fill placement

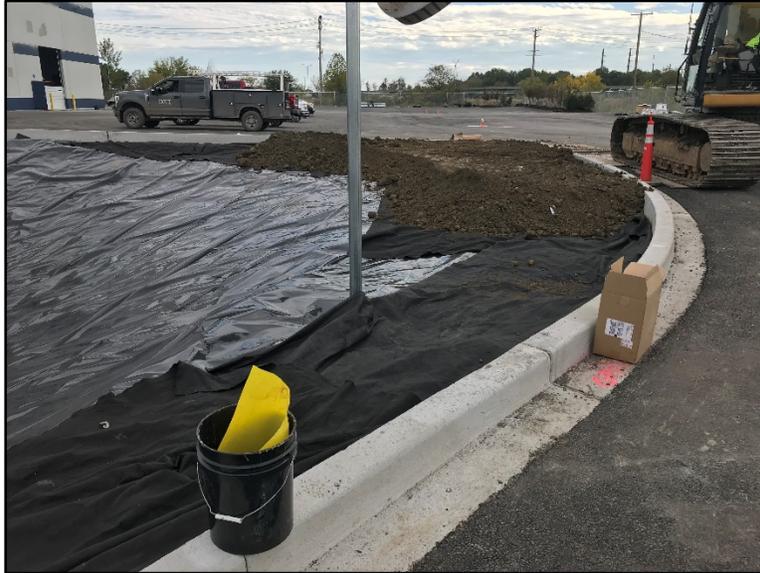
Photo 11: Clean fill placement

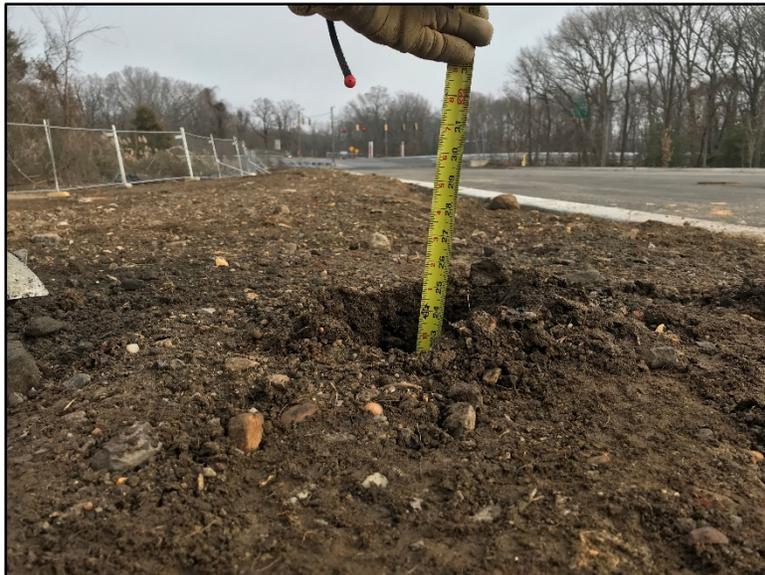
Photo 12: Clean fill depth verification

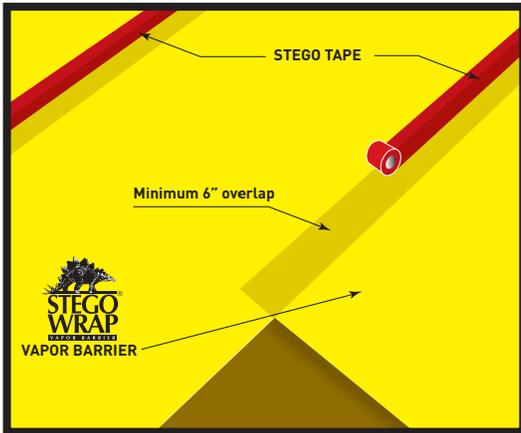
FIGURE 1: UNDER-SLAB INSTALLATION

1. Stego Wrap can be installed over an aggregate, sand, or tamped earth base. It is not necessary to have a cushion layer or sand base, as Stego Wrap is tough enough to withstand rugged construction environments.
2. Unroll Stego Wrap over the area where the slab is to be placed. Stego Wrap should completely cover the concrete placement area. All joints/seams both lateral and butt should be overlapped a minimum of 6" and taped using Stego® Tape.

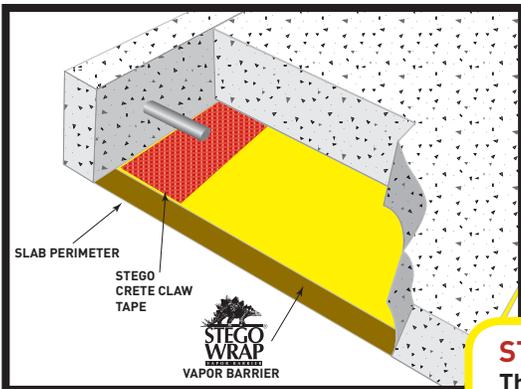
FIGURE 2a: SEAL TO SLAB AT PERIMETER

SEAL TO SLAB AT PERIMETER:*

NOTE: Clean the surface of Stego Wrap to ensure that the area of adhesion is free from dust, dirt, moisture, and frost to allow maximum adhesion of the pressure-sensitive adhesive.

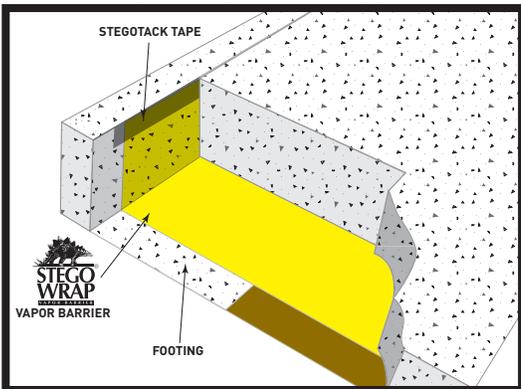
FIGURE 2b: SEAL TO PERIMETER WALL

OR SEAL TO PERIMETER WALL WITH STEGOTACK® TAPE:*

- a. Make sure area of adhesion is free of dust, dirt, debris, moisture, and frost to allow maximum adhesion.
- b. Remove release liner on one side and stick to desired surface.
- c. When ready to apply Stego Wrap, remove the exposed release liner and press Stego Wrap firmly against StegoTack Tape to secure.

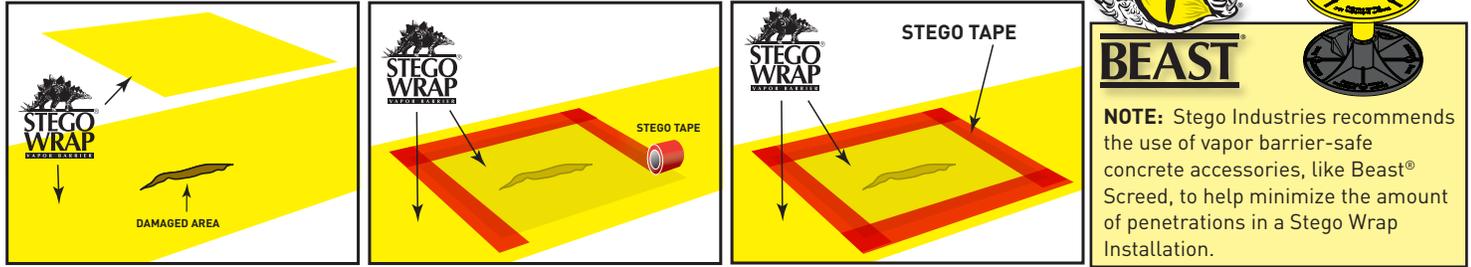
FIGURE 3: SEALING DAMAGED AREAS

- In the event that Stego Wrap is damaged during or after installation, repairs must be made. For holes, cut a piece of Stego Wrap to a size and shape that covers any damage by a minimum overlap of 6" in all directions. Clean all adhesion areas of dust, dirt, moisture, and frost. Tape down all edges using Stego Tape (See Figure 3).

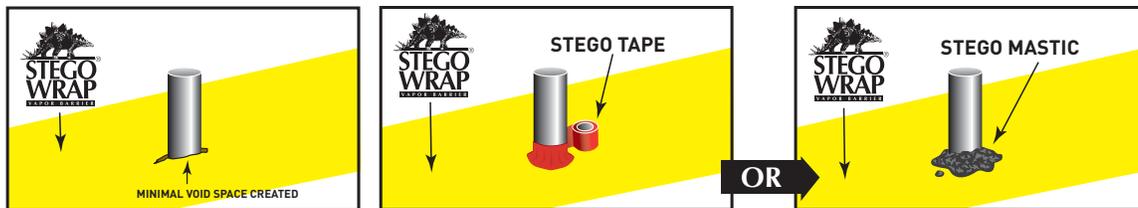
FIGURE 4a: PIPE PENETRATION SEALING

- IMPORTANT: ALL PENETRATIONS MUST BE SEALED.** All pipe, ducting, rebar, wire penetrations and block outs should be sealed using Stego Wrap, Stego Tape and/or Stego Mastic (See Figure 4a). If penetrations are encased in other materials, such as expansive materials like foam, unless otherwise specified, Stego Wrap should be sealed to the underlying penetration directly.

STEGO WRAP PIPE PENETRATION REPAIR DETAIL:

- 1: Install Stego Wrap around pipe penetrations by slitting/cutting material as needed. Try to minimize the void space created.
- 2: If Stego Wrap is close to pipe and void space is minimized then seal around pipe penetration with Stego Tape and/or Stego Mastic. (See Figure 4a)
- 3: If detail patch is needed to minimize void space around penetration, then cut a detail patch to a size and shape that creates a 6" overlap on all edges around the void space at the base of the pipe. Stego Pre-Cut Pipe Boots are also available to speed up the installation.
- 4: Cut an "X" the size of the pipe diameter in the center of the pipe boot and slide tightly over pipe.
- 5: Tape down all sides of the pipe boot with Stego Tape.
- 6: Seal around the base of the pipe using Stego Tape and/or Stego Mastic. (See Figure 4b)

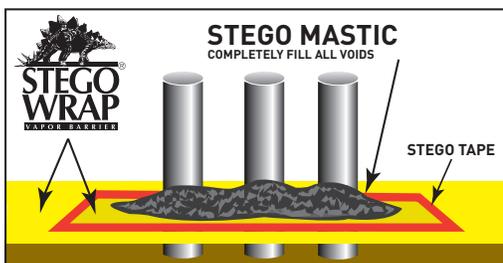
FIGURE 5: MULTIPLE PIPE PENETRATION SEALING

MULTIPLE PIPE PENETRATION SEALING:

Multiple pipe penetrations in close proximity and very small pipes may be sealed using Stego Wrap and Stego Mastic for ease of installation (See Figure 5).
