This *Description of Current Conditions Report* (DCC Report) has been prepared to satisfy the requirements of Section V-B1 of the Multimedia Consent Decree (Consent Decree) among Bethlehem Steel Corporation (BSC), the Maryland Department of the Environment (MDE), and the U.S. Environmental Protection Agency Region III (EPA) [United States of America, et al. v. Bethlehem Steel Corporation, Civil Action No. JFM-97-558, entered October 8, 1997 in U.S. District Court for the District of Maryland]. The complete text of this section of the Consent Decree is as follows:

This DCC Report describes the current conditions at BSC's Sparrows Point Facility that are relevant to RCRA Corrective Action and supplements the Final RCRA Facility Assessment Phase II Report (RFA Report) dated August 12, 1993. It serves as the starting point for planning and conducting a Site-Wide Investigation (SWI) of BSC's Sparrows Point Facility. The SWI will provide a basis from which any subsequent Corrective Measures activities will be studied and/or implemented.

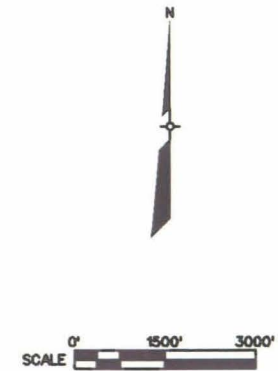
Rust Environment & Infrastructure Inc.	FIGURE 5-8
	REGIONAL LAND USE MAP
	BETHLEHEM STEEL CORPORATION SPARROWS POINT, MARYLAND
JANUARY 1998	200123

RC-20: NATURAL RESOURCE, AGRICULTURAL AND RESIDENTIAL AREAS ZONED FOR THE PROTECTION OF THE NATURAL RESOURCES OF THE CHESAPEAKE BAY CRITICAL AREA

RC-50: NATURAL RESOURCE, AGRICULTURAL AND RESIDENTIAL AREAS ZONED FOR THE PROTECTION OF AGRICULTURE IN A MANNER CONSISTENT WITH THE CHESAPEAKE BAY CRITICAL AREA
- CULTIVATED/TILLED AGRICULTURAL FIELDS
- CATTLE GRAZING
- MARINA

Figure 5-8 shows the land uses in the vicinity of Sparrows Point. This map is based on information compiled from two sources: 1) direct observations by Rust staff during site/area visits in 1996 and 1997; and 2) the Dundalk-Patapsco Neck Zoning-Map (Baltimore County Base Map Series, Sheet Number 4A, dated September 1994). According to the Baltimore County Office of Planning, the

As shown in Figure 5-8, the City of Edgemere is located northeast of and adjacent to the BSC property. Edgemere is a medium-density, urban-residential area (i.e., permitted by Baltimore County for 3.5 to 5.5 residential units per acre of land). Edgemere is characterized by single family homes and duplexes, with yards, lawns, and garages. Some of the homes located adjacent to surface water bodies also have docks and boats in their backyards. Although less commonly observed during site/area visits, apartment complexes are also present. Edgemere has some open areas such as City parks and undeveloped lots with meadows and trees (some of these open areas are designated by Baltimore County as Resource Conservation Zones -- shown in green on Figure 5-8).

Areas in the vicinity of Edgemere (i.e., those areas located east and southeast of Edgemere) include Resource Conservation Zones and the residential community of Ft. Howard (which is approximately 0.8 mile east of Sparrows Point across Old Road Bay; Figure 5-8). Ft. Howard is also the site of a Veterans Hospital. The Resource Conservation Zones that occur near Ft. Howard and Edgemere include rural residences, farms with cultivated fields and livestock (e.g., cattle), undeveloped greenspace (meadows, woods and wetlands), and public recreational areas.

The major public recreational site in the area is North Point State Park located northeast of Ft. Howard (Figure 5-8). North Point State Park has hiking trails and campgrounds. Recreational activities at the park also include fishing from the shoreline and boating. There are no swim beaches at North Point State Park.

The Sparrows Point Country Club is a 250-acre, wooded, water-front site adjacent to the BSC facility's northern property boundary (Figures 5-8 and 5-9). A significant portion of the country club tract consists of open, grass-covered fairways alternating with stands of trees. The portion of the country club immediately next to BSC property is wooded. According to the Baltimore County Office of Planning, most of the country club property is classified as "Resource Conservation 20," which represents a County-designated "Critical Area" (i.e., an area zoned to protect the natural resources of the Chesapeake Bay Critical Area). In addition to a 27-hole golf course, the country club offers its members an olympic-size pool, four lighted tennis courts, a 78-slip yacht basin, picnic grounds, a trap and skeet range, and a clubhouse with dining and banquet facilities. There are no swim beaches at the Sparrows Point Country Club. According to country club staff, swim beaches are not characteristic of this region, and swimming from the shoreline would be unusual due to shallow and/or rocky conditions.

The City of Dundalk is located across Bear Creek west of BSC property. As shown in Figure 5-8, Dundalk is characterized by medium- and high-density, urban-residential areas (i.e., permitted by Baltimore County for 3.5 to 5.5 and 10.5 to 16 residential units per acre, respectively). Dundalk consists largely of single family homes (including multi-story units) with yards, lawns, and garages. Some of the homes located adjacent to surface water bodies also have docks and boats in their backyards. Apartment buildings and numerous brick row-house/townhouse complexes (two- and three-stories) are also present in Dundalk. This City has some open areas such as parks, wetlands, and undeveloped fields covered by grasses and trees, and some of these open areas are designated by Baltimore County as Resource Conservation Zone Critical Areas (shown in green on Figure 5-8).

Nearby residents of Edgemere and Dundalk (Figure 5-8) represent a receptor population with the potential for exposure to site contaminants under current conditions at the site. Because possible trespassers are considered under the on-site scenarios, nearby residents, as a group, are considered to have primarily indirect contact with site contaminants (i.e., exposure to contaminants that might migrate away from the site).

The second potentially exposed human receptor population considered under current land use conditions of this site consists of off-site (nearby) workers. These adult receptors are evaluated conceptually because of their known proximity to the facility (Figures 5-8 and 5-9). Off-site workers include those personnel employed by the industrial firms located to the north and east of the
