Section 319

NONPOINT SOURCE PROGRAM SUCCESS STORY

Restoring Stream Improves Water Quality and Fish Community Health

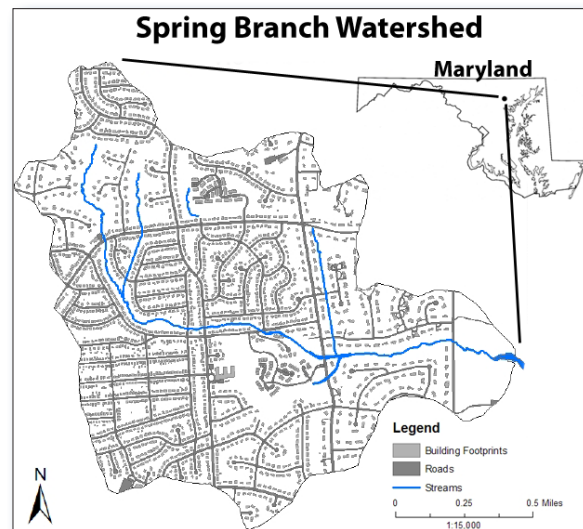
Figure 1. Impervious surfaces in northern Maryland's Spring Branch watershed.

Spring Branch was once a narrow, shallow trout stream. Fifty years of rapid urbanization created many impervious surfaces with few stormwater controls (Figure 1). Consequently, rainfall generates high volumes of runoff that quickly exceed the capacity of Spring Branch. Stormwater flows have eroded the stream channel so that it is now 30 feet deep and 15 feet wide. Erosion has exposed sewer pipes and created high sediment and nutrient loads that flow into the Loch Raven Reservoir.

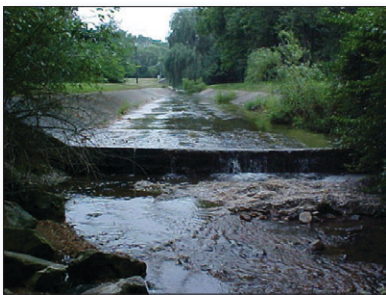
Figure 2. At this site (looking toward Pot Spring Road) before restoration efforts, Spring Branch flowed through a concrete channel. The concrete step seen here obstructed fish passage.

In phase I, DEPRM created a new channel of Spring Branch and added step pools, meander patterns and flood plains. That and other parts of the stream channel were stabilized using natural materials such as boulders, tree root wads, brush mattresses and live branch layers. In addition, DEPRM removed 1,740 feet of concrete channel (Figure 2), stabilized or removed sanitary sewer lines, added rock-lined step pools below storm drain pipes to dissipate energy from the flow, and constructed a stormwater wet pond to treat runoff from the headwaters. Replanting 12 acres with native trees and shrubs restored 10,000 linear feet of stream (Figure 3).

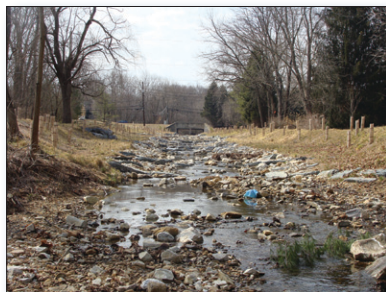
Figure 3. After restoration, the concrete channel seen in Figure 2 has been removed. Sewer lines running along both sides of the stream prevented partners from restoring a natural meandering pattern.

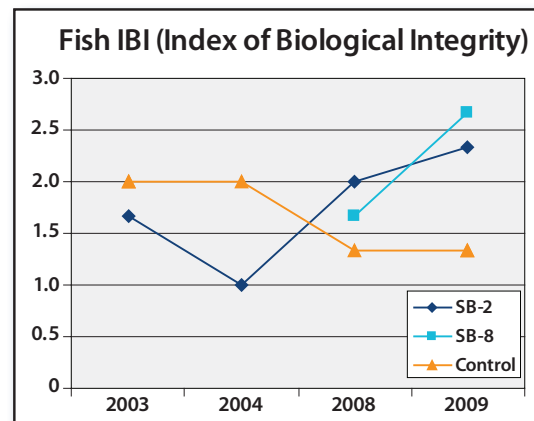
The phase I work reduced phosphorus loads by 27 percent, nitrogen loads by more than 30 percent and sediment loads by 45 percent. In 2003 and 2004, monitoring at station SB-2 (downstream end of the phase I portion of the project) showed that few or no fish were present, and the fish index of biotic integrity score (IBI) was classified as *very poor* (score of less than 1.9). However, the fish community responded to phase II restoration efforts. Fish monitoring in 2009 (less than one year after phase I was completed) showed significant increases in fish biomass and fish IBI at stations SB-2 and SB-8 (headwaters). Removing the concrete channel (see Figure 2) allowed the fish to swim upstream and colonize the area. As seen in Figure 4, Fish IBI scores at both stations improved to a classification of *poor* (scores between 2.0 and 2.9).

Figure 4. After phase II of the restoration (2008), fish IBI levels increased above (SB-8) and below (SB-2) the project area.
