Middle Gwynns Falls Small Watershed Action Plan Volume II

APPENDIX E:
Middle Gwynns Falls Watershed Characterization Report
(PB 2013)

Middle Gwynns Falls Watershed Characterization Report

September 2013

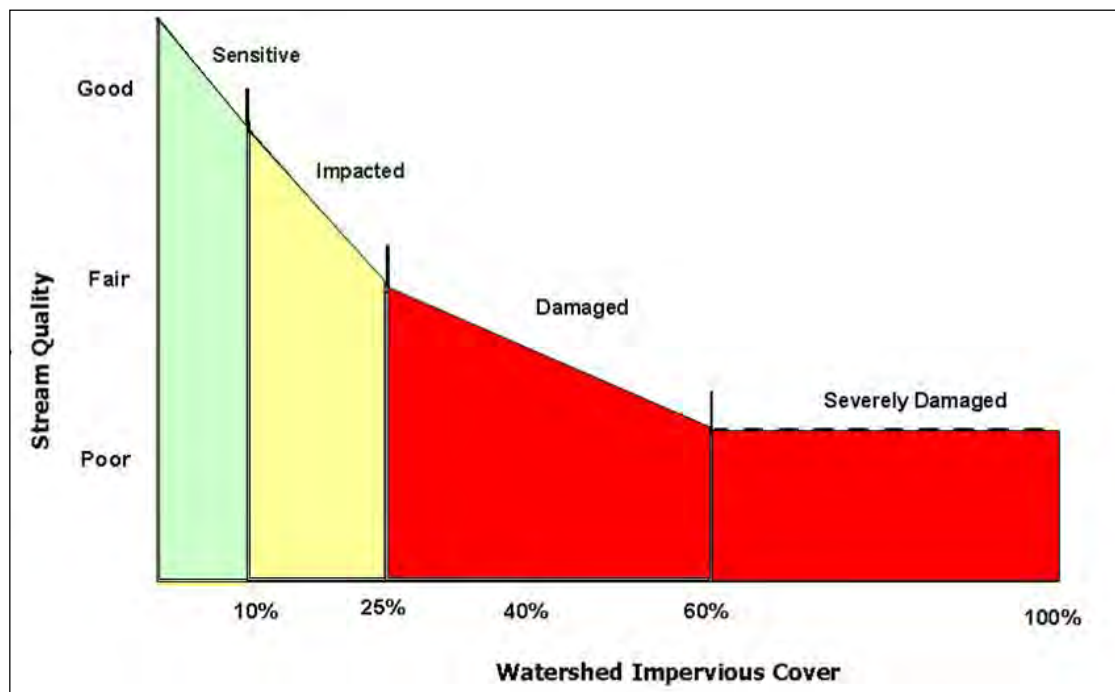
Figure 2-9: Impervious Cover Model (adapted from CWP, 2003)

Impervious cover is a primary factor when determining pollutant characteristics and quantities in stormwater runoff. Research has been conducted to link the degree of urbanization (typically measured by amount of impervious cover) with various watershed-based indicators of water quality such as diversity and abundance of aquatic and terrestrial life. The Center for Watershed Protection (CWP) compiled stream research conducted in various parts of the country and developed a simple model that relates stream quality to percentage of impervious cover in a watershed. Studies used to develop the impervious cover model measured stream quality based on a variety of indicators such as number of aquatic insect species, stream temperature, channel stability, aquatic habitat, wetland plant diversity, and fish communities present. CWP's impervious cover model is shown in Figure 2-9.

Based on the compiled research, CWP determined four classifications to predict stream quality based on watershed imperviousness: sensitive; impacted; damaged; or severely damaged. Watersheds with less than 10% impervious cover are referred to as sensitive and typically have high quality streams with stable channels, good habitat conditions, and good to high water quality. These watersheds are

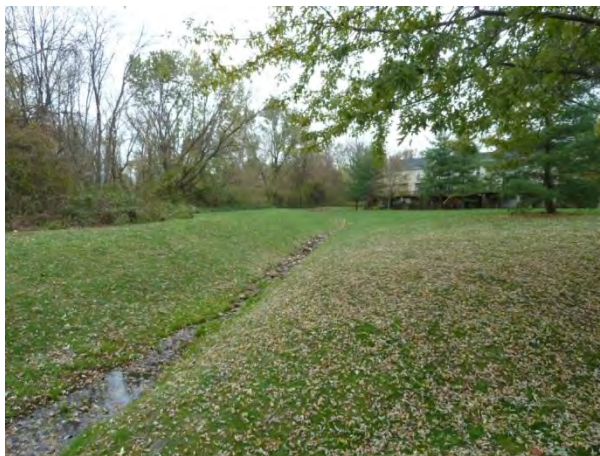
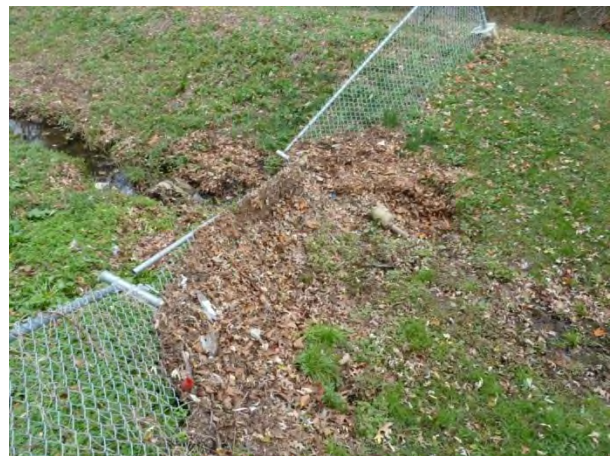
Figure 3-16: Channelized Grass Inflow (left) and Damaged Fence (right) at SWM_C_334

- Replace the existing, inflowing V-ditch with trapezoidal grass channel that could serve as a bioswale.
- Construct pretreatment forebays at the existing pipe outfalls draining to pond.
- The existing low-flow channel in the pond could be converted into a grass swale to provide water quality treatment for smaller storms which contain the majority of pollutants from the drainage area.

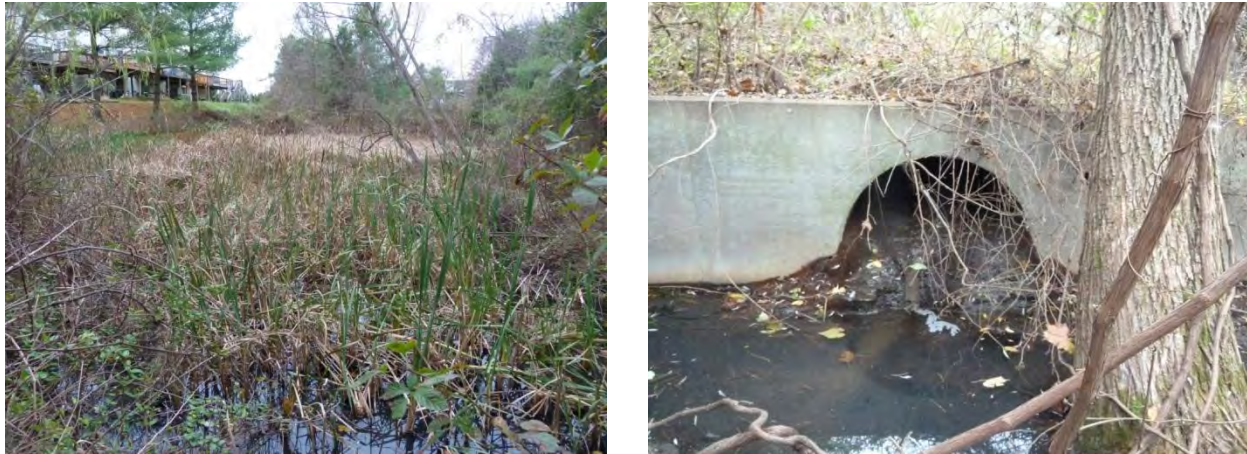
Figure-3-17: Invasive Species, Ponding (left) and Sediment Blocking the Downstream Outfall (right) at SWM_C_432

- Construct pretreatment forebay at the pond inflow channel.
- Construct maintenance access road to the riser.
- Extend the flow path from the inflow to the outfall by constructing concrete baffle wall and/or berms on the pond bottom.
- The large area of the pond provides potential retrofit possibilities including installation of pretreatment forebay at pond inflow channel that could flow into shallow wetlands and then into a deep micropool in front of riser with submerged reverse slope low flow pipe. Because of the current blockage at the pipe outfall, the pond is performing similarly to a stormwater wetland facility. If flooding during larger events has not been an issue, there is the potential for the pond to be permanently converted to a stormwater wetland facility.

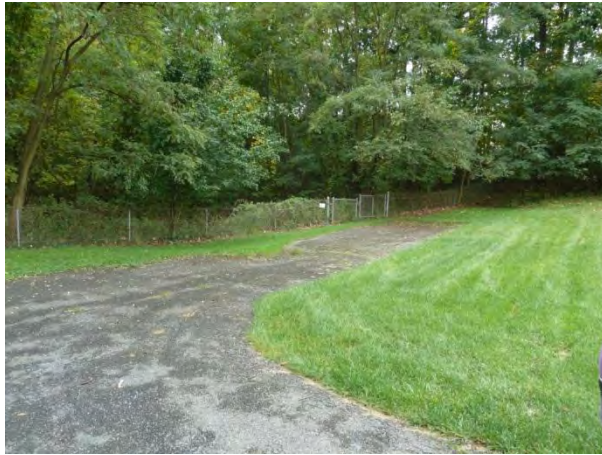
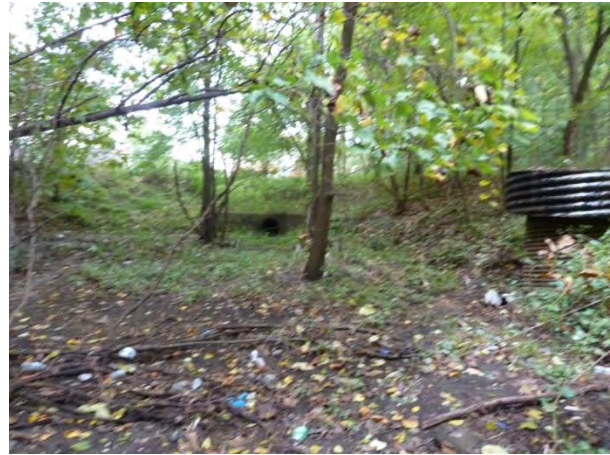
Figure-3-18: Impervious Access Road (left) and Trees, Trash near Riser (right) at SWM_C_441

- Construct a micropool at pond inflow.
- Investigate the existing capacity of the pond and the need for horizontal expansion to support conversion to an extended detention facility.

- Investigate the potential for installation of trash and debris collection measures.

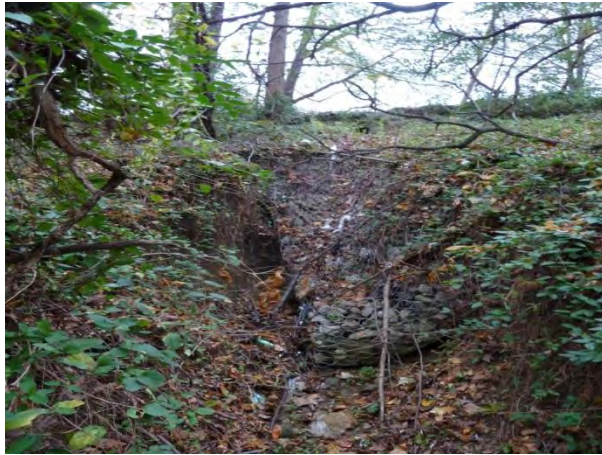
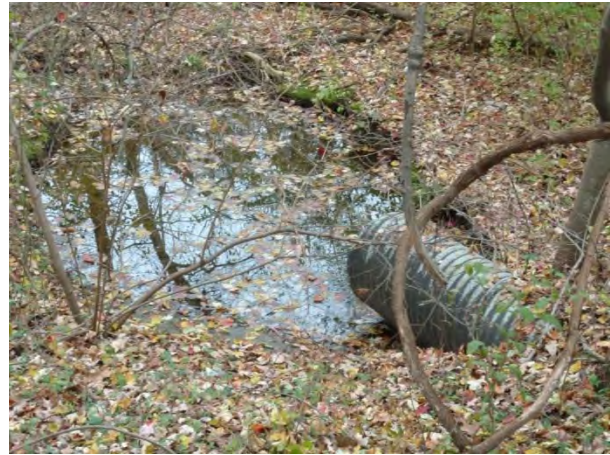
Figure-3-19: Side Slope Failure (left) and Erosion & Undercutting at Outfall (right) at SWM_C_450

- Stabilize the pond side slopes to prevent the erosion.
- Repair erosion around the riser.
- Stabilize the gabion structure at pond inflow.
- Construct the riprap outlet protection to prevent the erosion at downstream channel.
- Construct maintenance access roads to the riser and pond inflow.

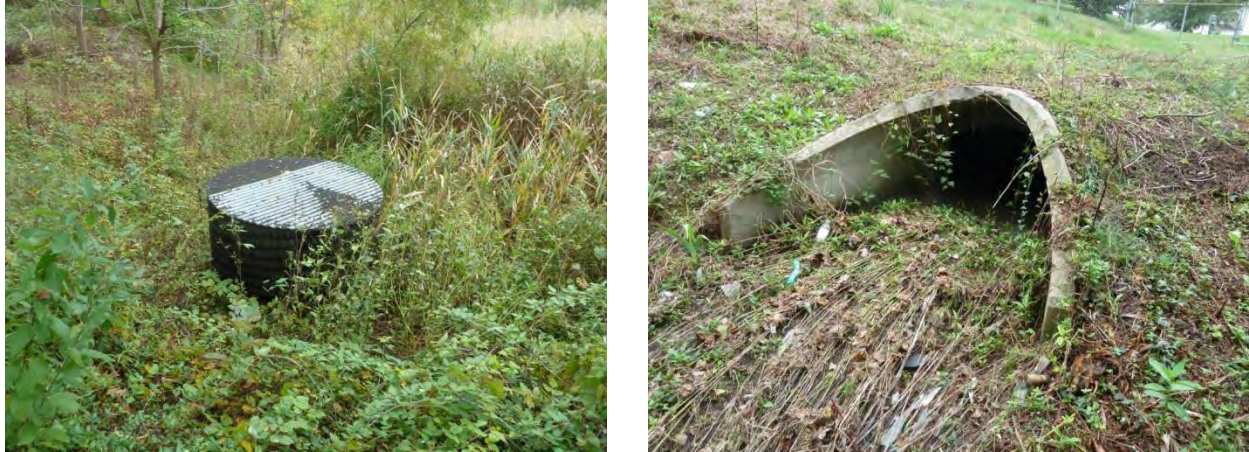
Figure -3-20: Outlet Structure (left) and Sediment at Inflow (right) at SWM_C_651

- Remove trees from the pond embankment and bottom.
- Invasive species management
- Unclog existing inflow filled with sediment from the inlet at Lawnwood Circle draining to the pond.
- Construct the riprap outlet protection at the pipe outfall draining into pond.

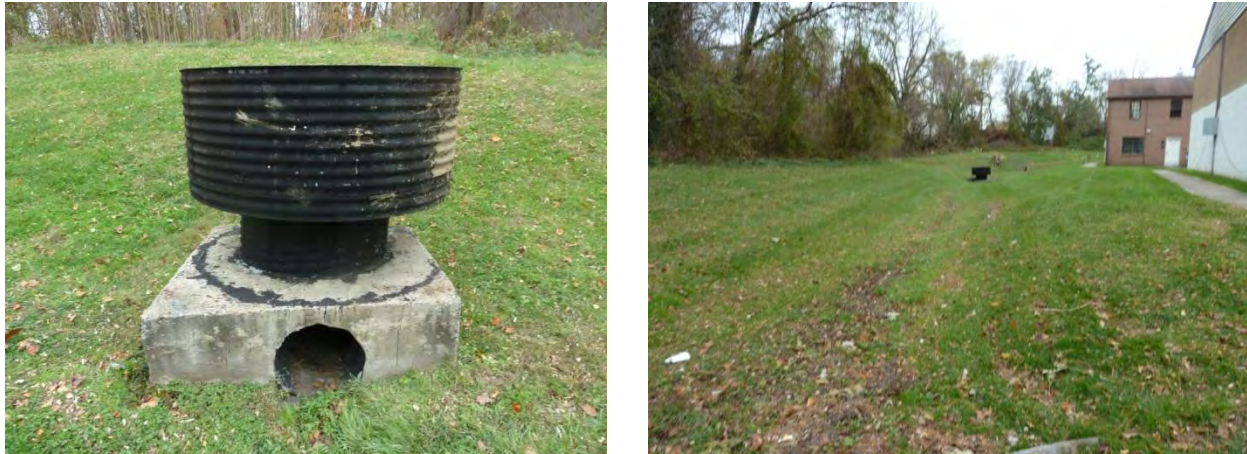
Figure-3-21: Riser with 18" Low Flow Pipe (left) and Grass Swale Leading to Riser (right) at SWM_C_715

- Construct a micropool at pond inflow channel.
- If the pond has adequate capacity, the 18" low flow orifice of the riser structure should be altered in order to detain water for a 24 hour detention time, which is the current standards for extended detention ponds in Use I waters.

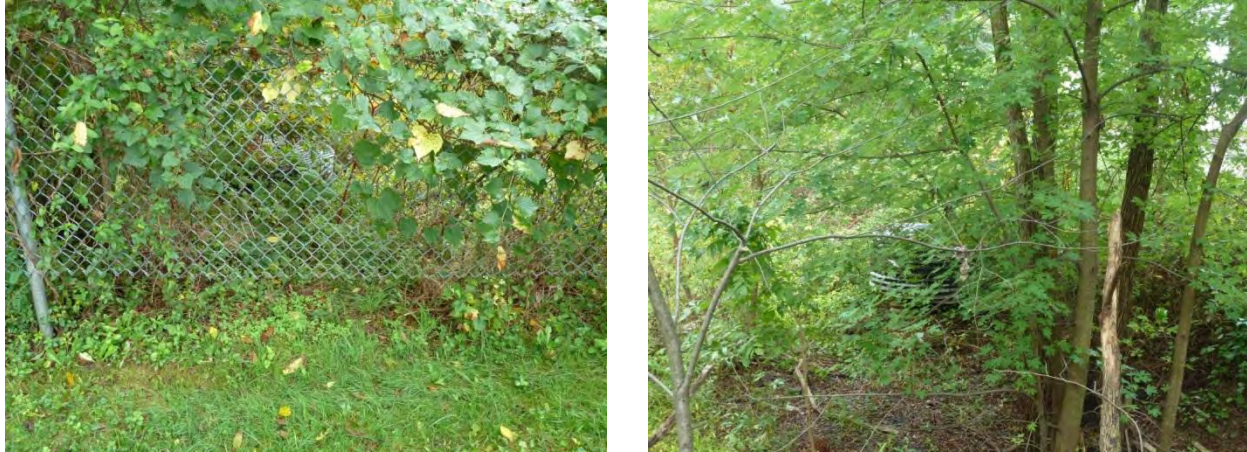
Figure-3-22: Fence Not Extended to Ground (left) and Vegetation Around Riser (right) at SWM_C_738

- The fence should be repaired to prevent access to the riser structure as well as being cleared of vegetation and vines.
- Remove trees threatening the stability of the pond embankment and at pond bottom.
- The pond bottom can be cleaned and the inflow channel upgraded to provide long detention times and potential evapotranspiration to low flows.

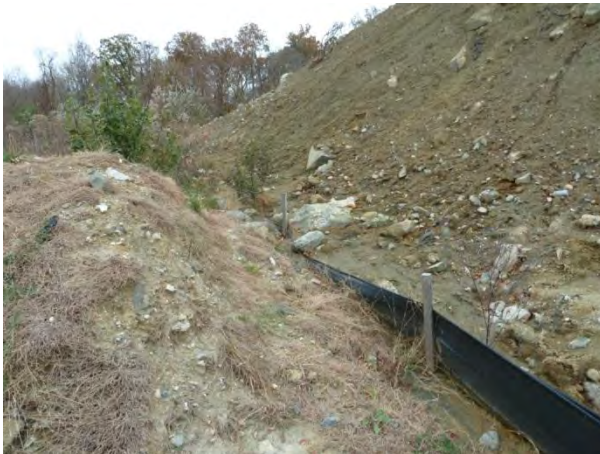
- There are trees on pond embankment and a lot of vines and vegetation growing on the fence.
- A large soil stockpile area for the new construction was observed along Rolling Crossroads. Erosion and sediment control practices seemed to be poorly maintained causing an accumulation of sediment against the silt fence. Sediment has overtopped the silt fence at numerous locations and was susceptible to being washed into the stormwater facility during a rain event.

Figure-3-23: Sediment from Adjacent Stockpile Overtopping Silt Fence (left) and Dense Vegetation around Riser (right) at SWM_C_817

- Invasive species management.
- Clear vegetation and vines at fence.
- Remove trees threatening the stability of the pond embankment.
- Construct maintenance access road to the riser, pond inflow.
- At the time of the assessment, observations on the poor erosion and sediment control practices were provided to representatives at EPS. It is recommended that the site be inspected regularly to ensure that sediment from the adjacent property does not wash into the pond.

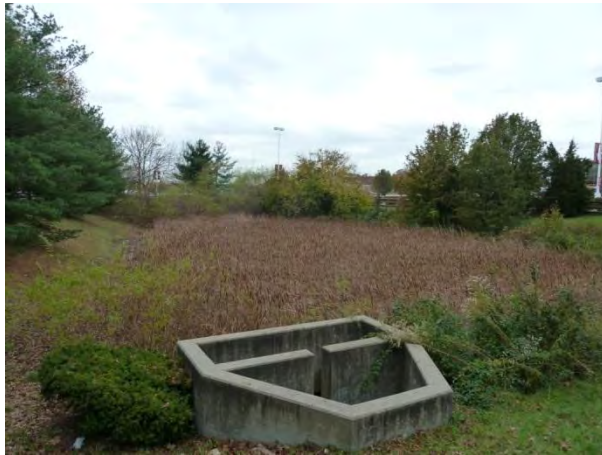
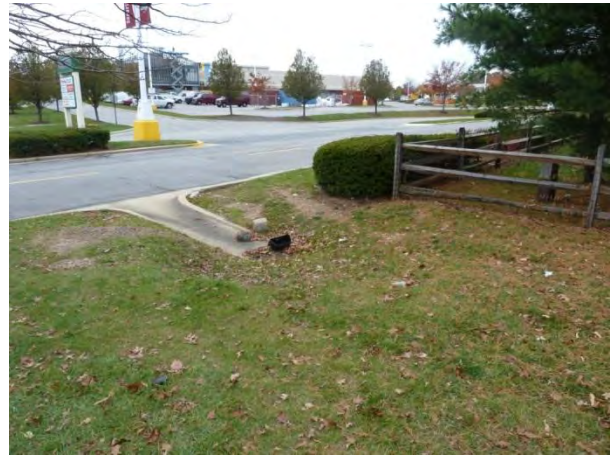
Figure-3-24: Dense Invasive Vegetation Around the Outlet Structure (left) and Curb Cut Inlet Configuration (right) Draining to SWM_C_857

- Construct pretreatment forebay at existing pipe outfall into the pond.
- Extend the pond horizontally to provide additional capacity for conversion to an extended detention facility.

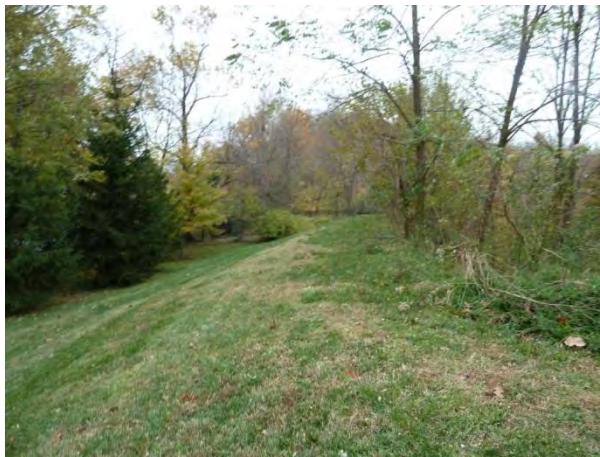
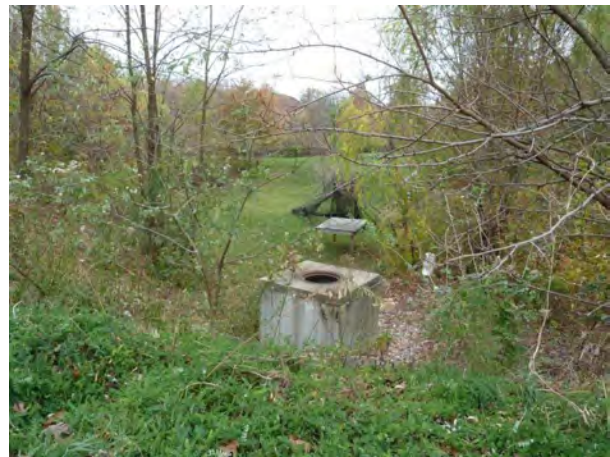
Figure-3-25: Pond Embankment (left) and Control Structure with Missing Lid (right) at Detention Pond SWM_C_859

- Construct a micropool at pond inflow.
- Extend the pond horizontally to provide additional capacity for conversion to an extended detention facility.

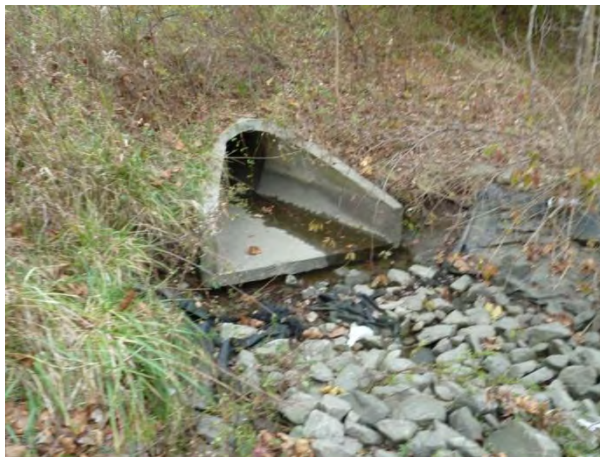
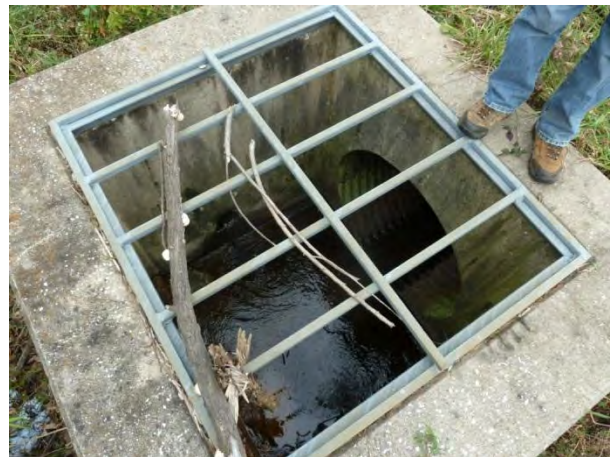
Figure-3-26: Undercutting and Erosion at Inflow Endsection (left) and Control Structure with Flowing Underdrains (right) at SWM_C_961

- Construct a micropool at pond inflow.
- Extend the pond horizontally to provide additional capacity for conversion to an extended detention facility.

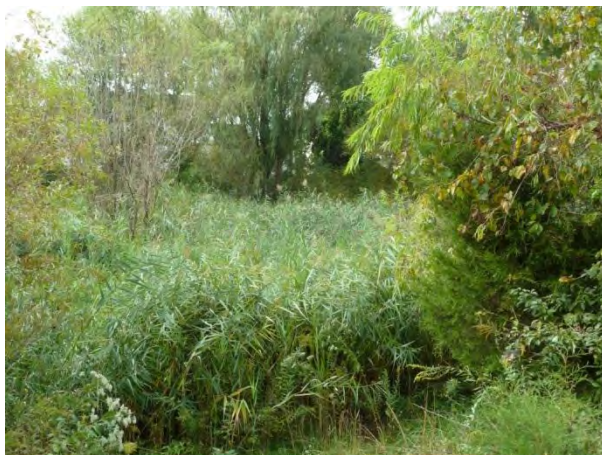
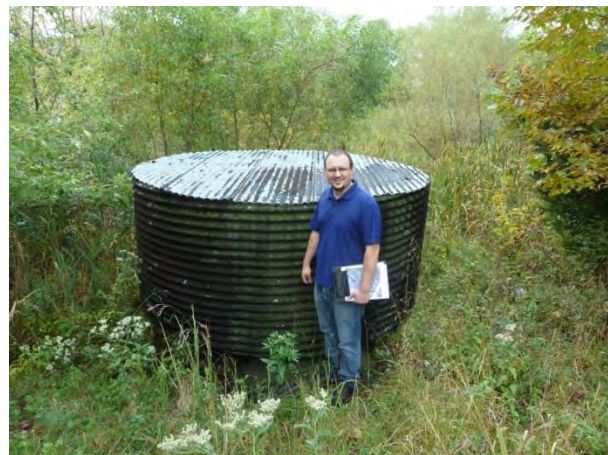
Figure-3-27: Invasive Species (left) and Control Structure (right) at SWM_C_967

- The large area of the pond provides potential retrofit possibilities including installation of pretreatment forebay at pond inflow channel that could flow into shallow wetlands and then into a deep micropool in front of riser with submerged reverse slope low flow pipe.
- The low flow channel could be upgraded to remove the invasive species.

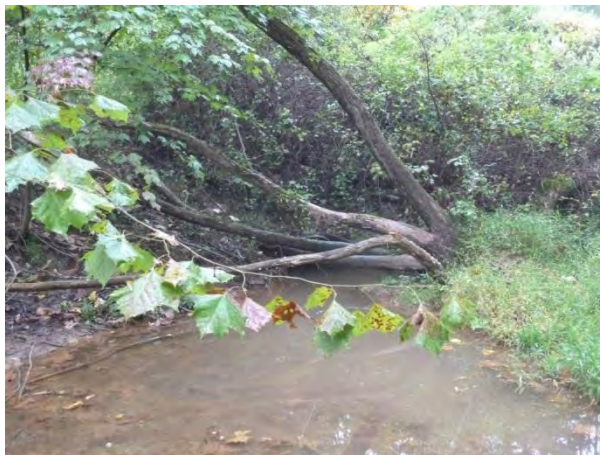
Figure-3-28: Down Tree Branches at Pond Outfall (left) and Low Flow Channel (right) at SWM_C_984

- The flow path could be lengthened by constructing a meandering channel.
- Construct maintenance access road to the riser.
- The large area of the pond provides potential retrofit possibilities including installation of pretreatment forebay at pond inflow channel that could flow into shallow wetlands or wet detention pond and then into a deep micropool in front of riser with submerged reverse slope low flow pipe.
- The capacity of the pond should be determined to verify if there is potential for conversion to an extended detention facility.

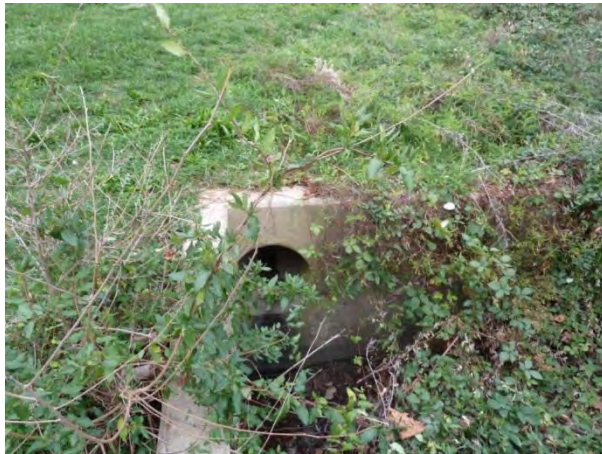
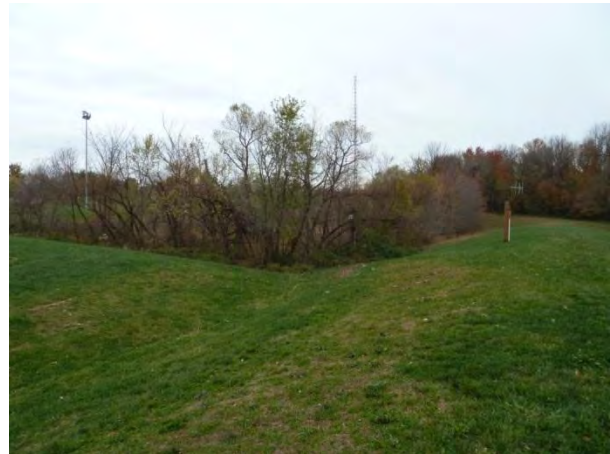
Figure-3-29: Pipe Invert at Inflow Endwall above Grade (left) and Wide Grass Swale Draining to Pond (right) at SWM_C_1188

- Construct a micropool at pipe inflow and inflow channels.
- Convert the 3 grassed swales flowing into the pond into bioswales to treat runoff.

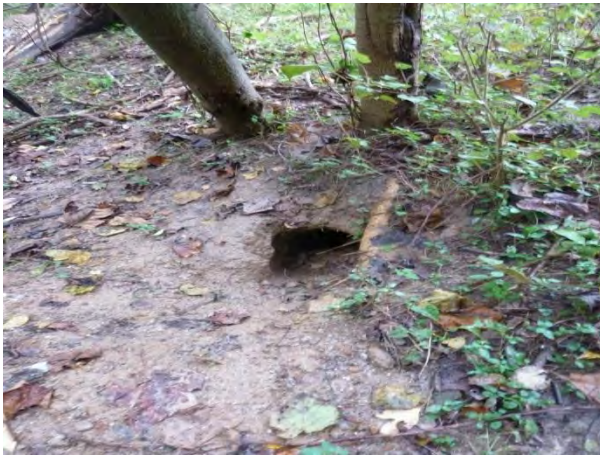
Figure-3-30: Animal Burrow (left) and Trees (right) on the Embankment at SWM_C_1652

- Remove small trees from the pond bottom.
- Remove trees and fill animal burrows threatening the stability of the pond embankment.

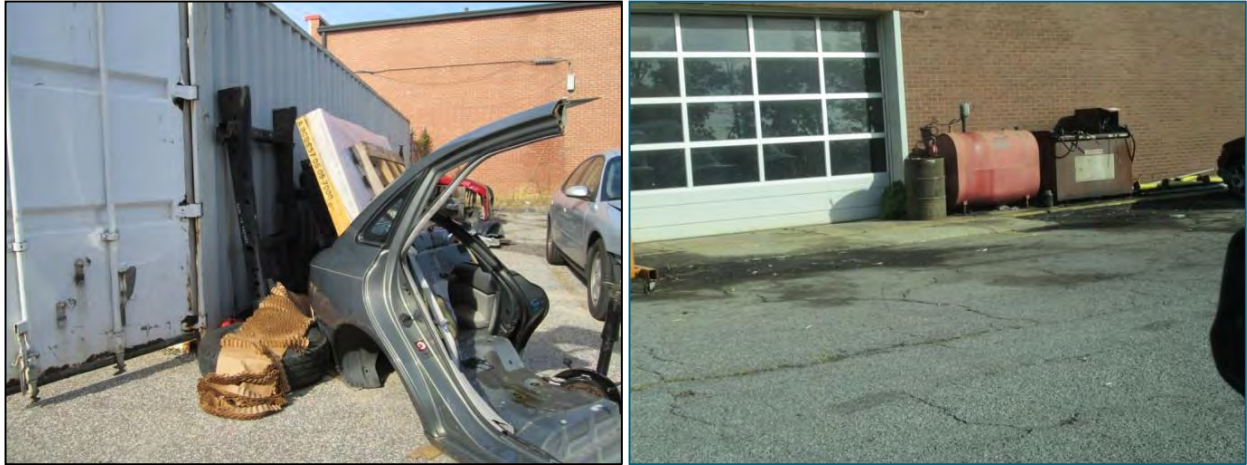
Figure 4-12: Potential Pollution Sources from Outdoor Material Storage at Auto-related Hotspots including uncovered materials stored outside (left) and storage containers without secondary containment (right).

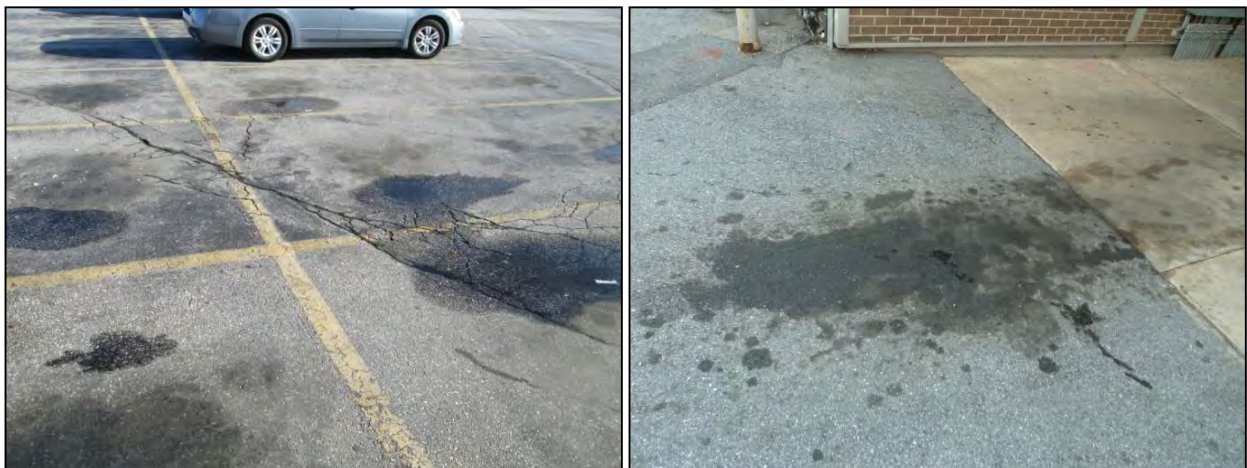
Figure 4-13: Asphalt staining from Outdoor Vehicle Operations at Auto-related Hotspots.

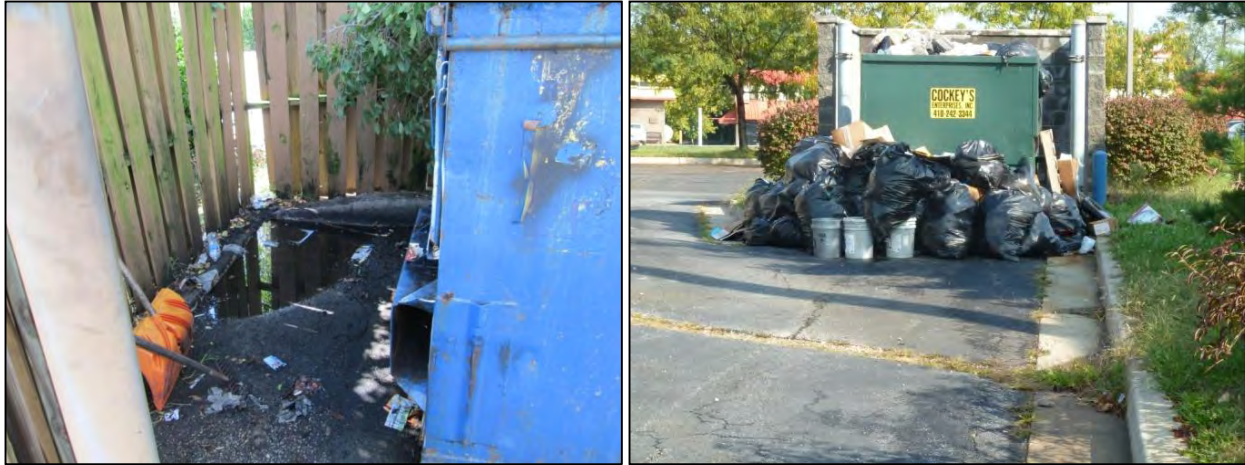
Figure 4-14: Leaking (left) and Overflowing Dumpsters (right) from Waste Management Operations at Auto-related Hotspots Shopping Centers/ Hardware Stores/ Garden Centers

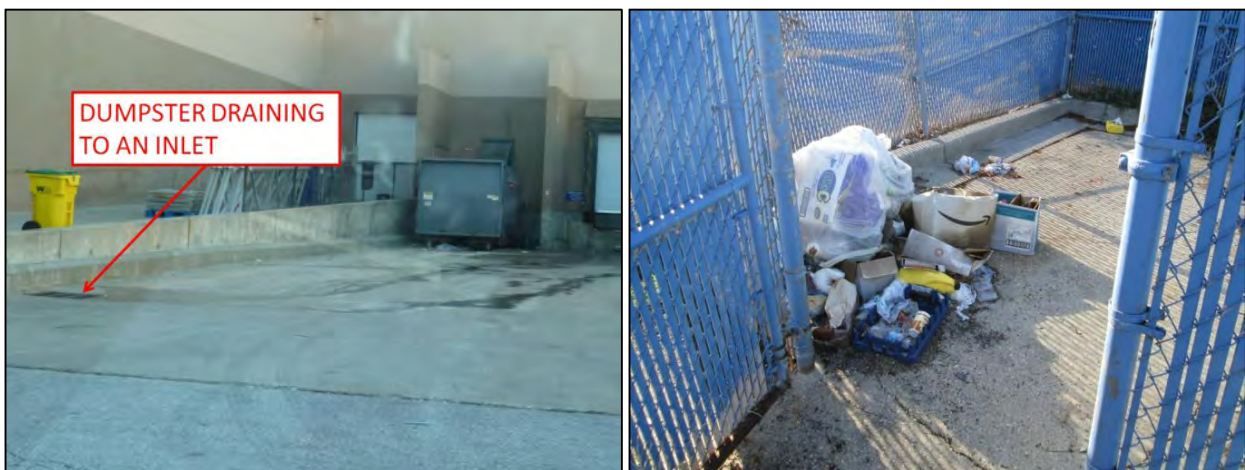
Figure 4-15: Leaking (left) and Overflowing Dumpsters (right) from Waste Management Operations at Commercial Hotspots

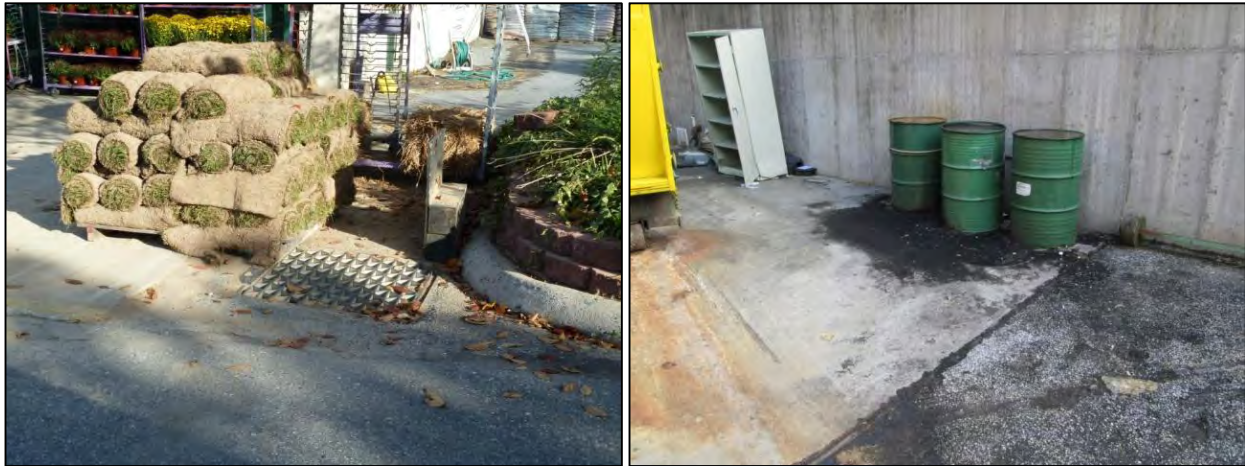
Commercial areas sometimes have outdoor shopping or stockpile areas where materials are stored outside. Similar to the discussion above, if materials are uncovered and on impervious surfaces, runoff from these areas can go directly into the storm drain system along with certain pollutants depending on the type of materials. For example, Figure 4-16 shows an outdoor stockpile of sod that is stored on a shopping center parking lot directly adjacent to an inlet. There is potential for soil, organic matter, and nutrients from the sod and the other garden plants in the lot to be washed away during a rainfall or

Figure 4-16: Outdoor Material Storage at a Garden Center (left) and a Hardware Store (right).

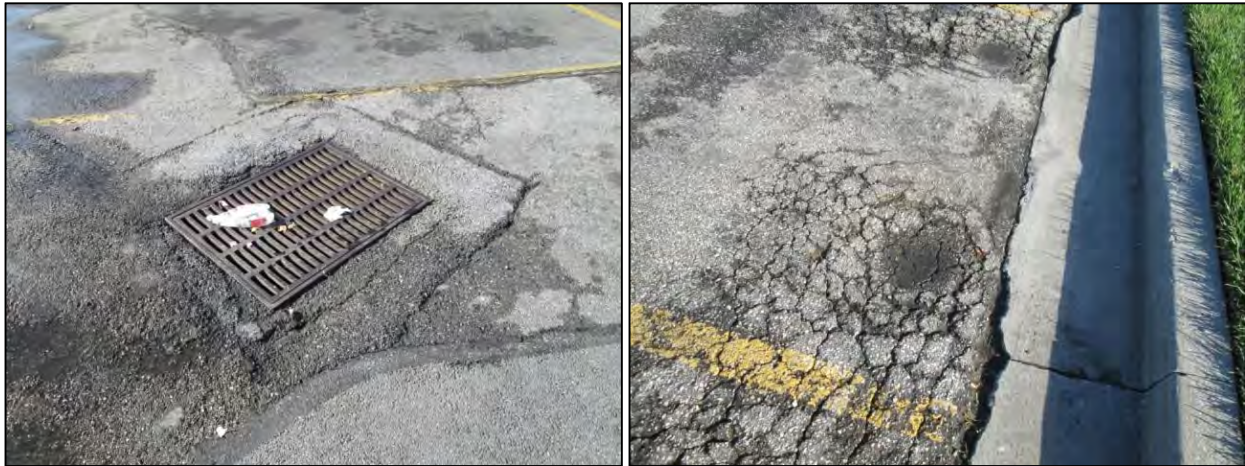
Figure 4-18: Degraded Impervious Surfaces at Commercial Hotspots

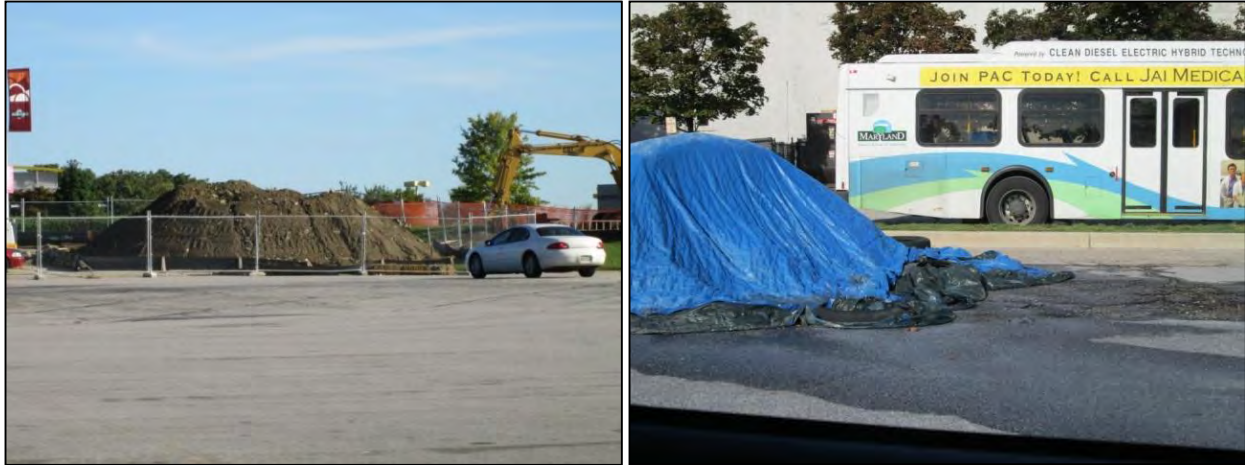
Figure 4-19: Soil Stockpile (left) and Leaking Stockpile Area (right) at Construction Hotspots

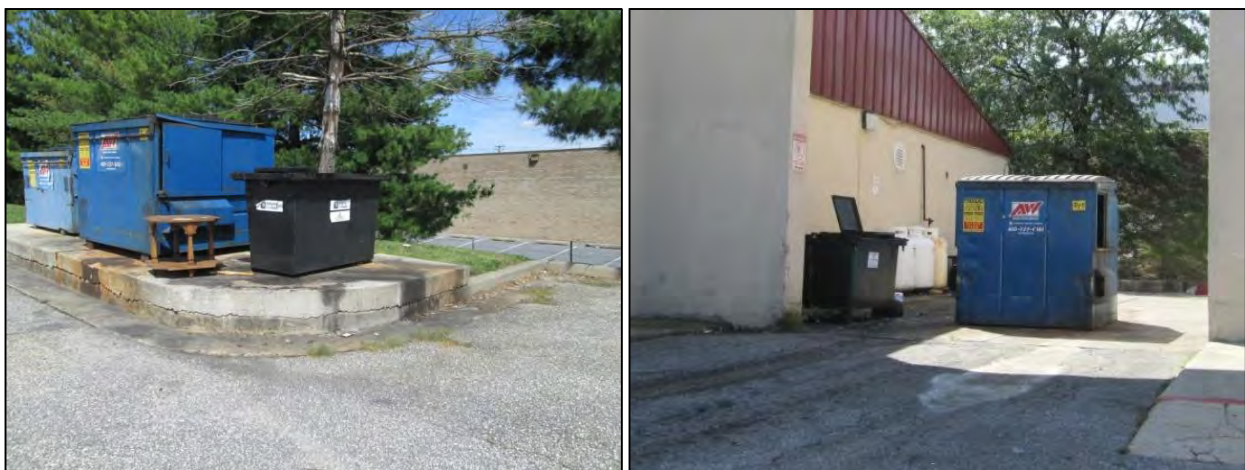
Figure 4-20: Leaking Grease Bins from Waste Management Operations at Restaurant Hotspots

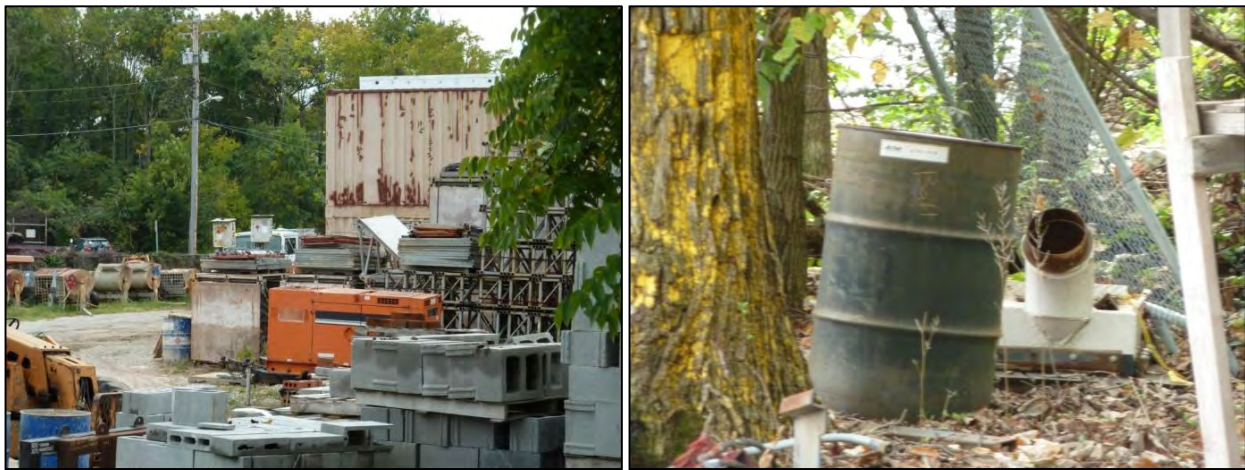
Figure 4-22: Improper Outdoor Materials Storage at Industrial Hotspots

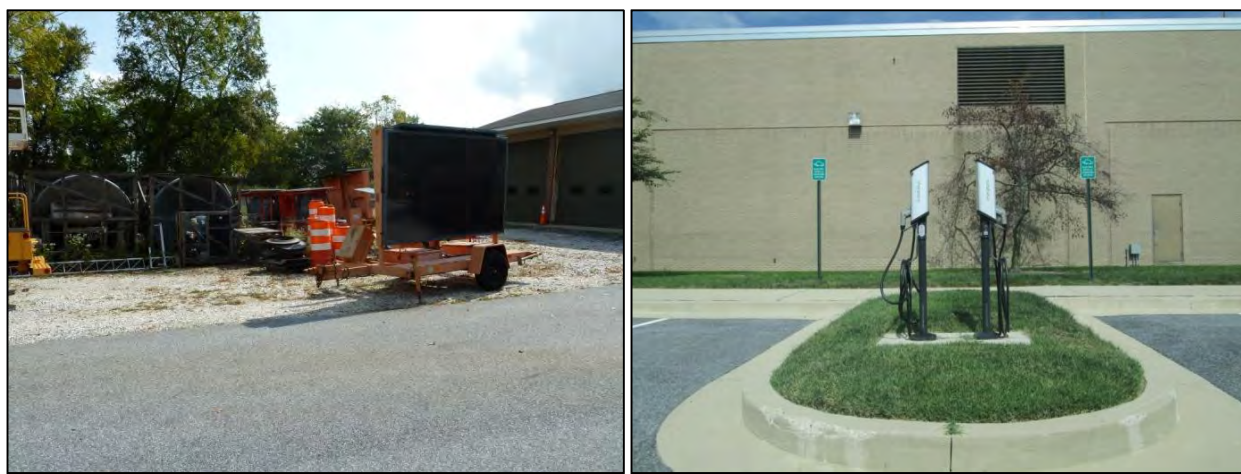
Two (2) municipal operations were assessed within the planning area (see Figure 4-23). The first was the BGE Rutherford Business Center. The second was the SHA Radio Shop at MD 40 and I-695. Both sites contained outdoor storage; however, both had indoor maintenance shops. The SHA site had equipment stored on pervious ground whereas the BGE site had a large impervious lot with electrical equipment stored uncovered. Runoff from each site has the potential for pollutants to enter either groundwater or streams. No SWM facilities were identified at the SHA site, and only one small SWM facility was identified at the BGE site. These municipal operations sites are recommended for future education efforts on modifying municipal infrastructure and maintenance policies. Also, due to the size and nature of municipal sites, it is recommended that it be verified that these sites have NPDES permits.

Figure 4-23: Equipment Storage on Pervious Areas (left) and an Electric Vehicle Charging Station (right) at Municipal Hotspots

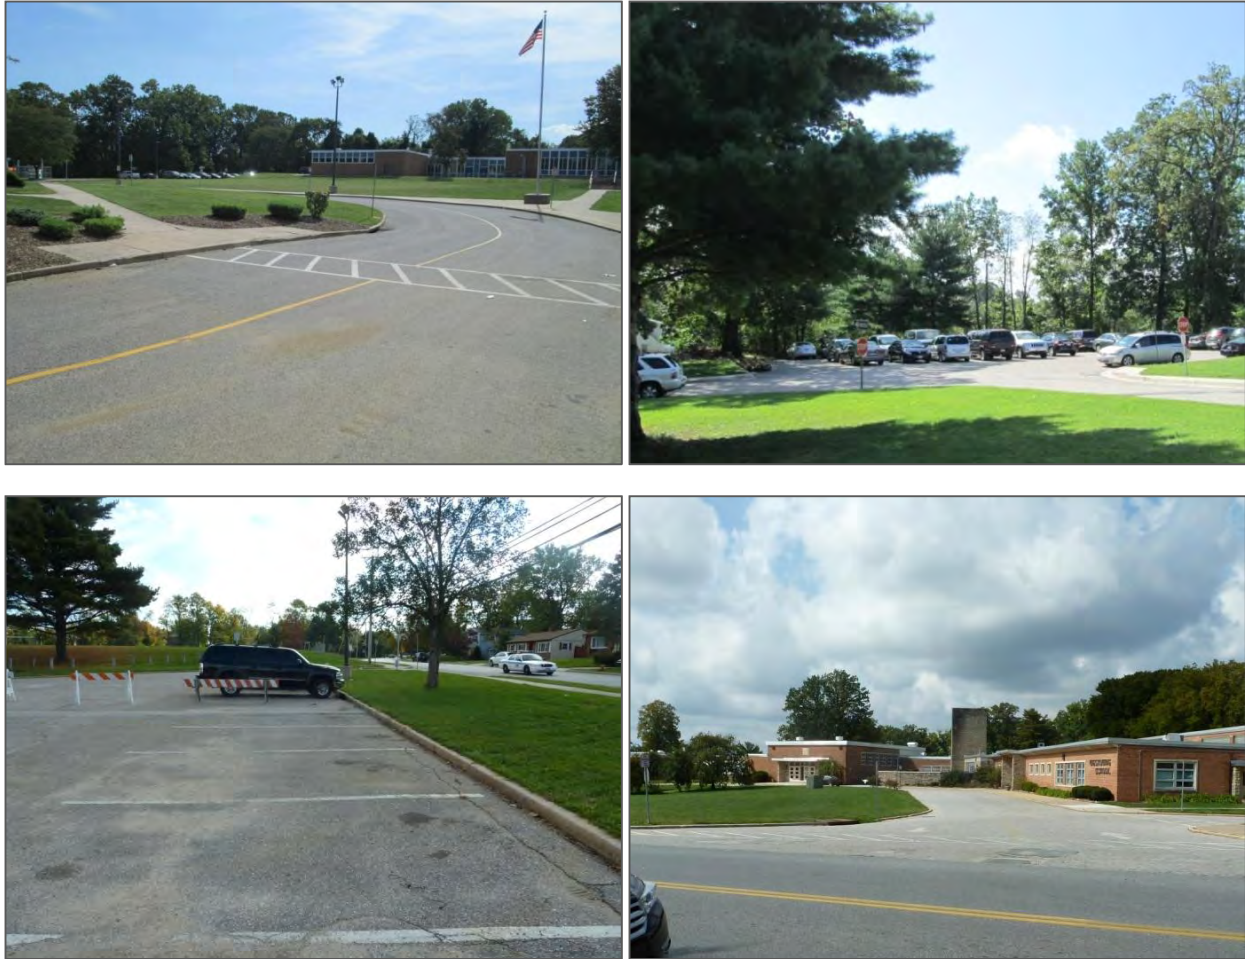
All four sites shown in Figure 4-25 are areas where the bioswale stormwater retrofit is recommended. Each of these sites has a large pervious area located adjacent to impervious parking lots. These areas provide good opportunities to address runoff from the parking lots and potential ponding or sediment build-up issues, and also treat runoff before it enters on-site inlets or streams. Sites ISI_C_117 and ISI_C_401 have impervious areas from an entrance circle in which runoff could be directed to a bioswale. The bioswale could run parallel with the existing curbline. By removing the curb at the location of the bioswale runoff can sheetflow directly into the facility. Sites ISI_C_202 and ISI_C_306 have impervious areas from a parking lot in which runoff could be directed to a bioswale. As with Sites ISI_C_117 and ISI_C_401 the bioswales could run parallel with the existing curbline. By removing the curb at the location of the bioswale, runoff can sheetflow directly into the facility. If runoff enters the facility as concentrated flow, a forebay could be constructed to intercept sediment so as to not clog the filter media. Under drains for each site could be connected directly to the existing storm drain system. Overflows would discharge directly into the inlet. At all four of these sites, minimal modifications to existing curbs and storm drain systems need to occur in order to construct the bioswales. Few if any trees would need to be removed.

Figure 4-25: Parking Lot Retrofit Opportunities at ISI_C_117 (top left), ISI_C_202 (top right), ISI_C_306 (bottom left) and ISI_C_401 (bottom right)

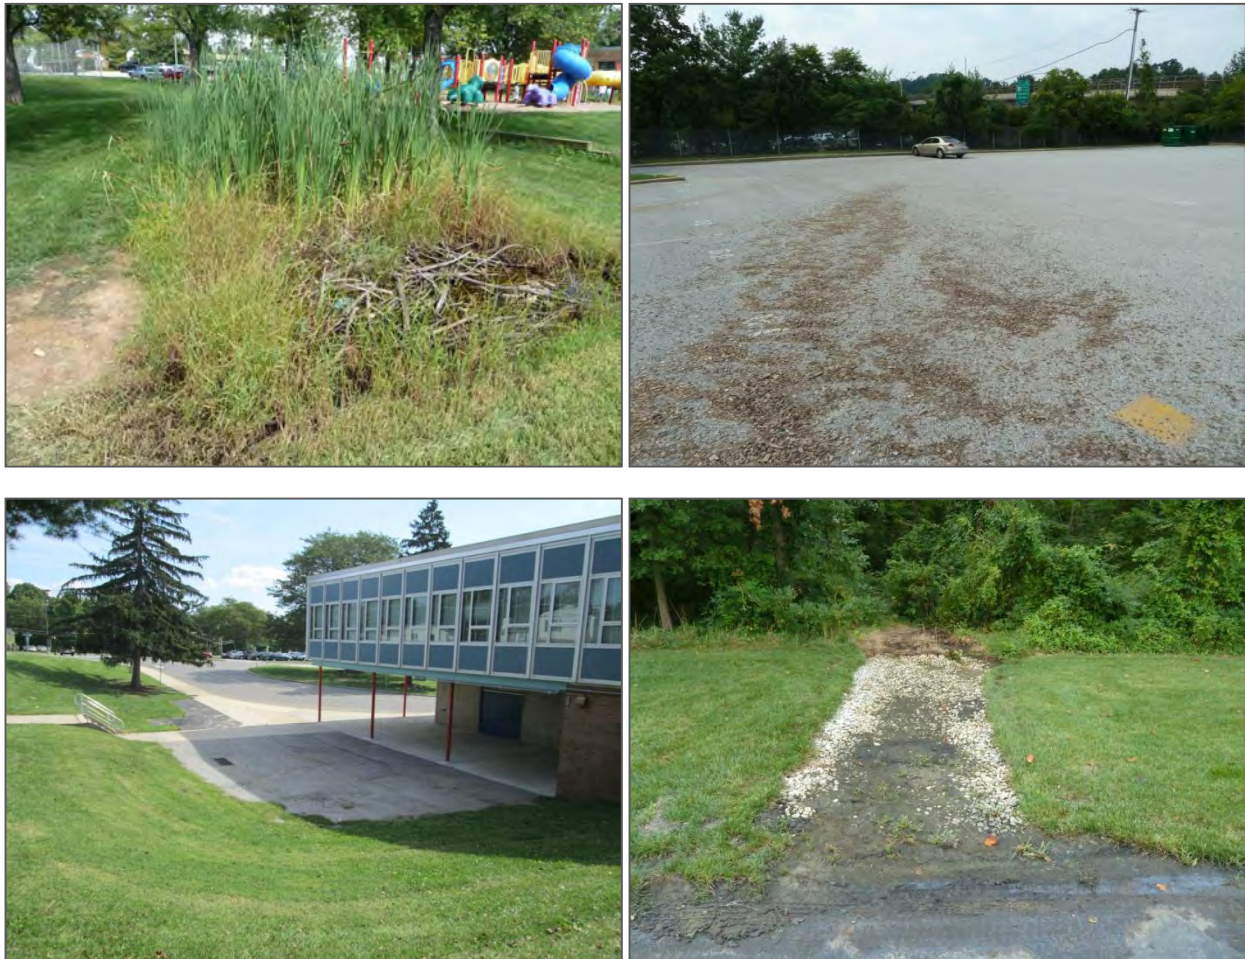
Figure 4-26: Various Retrofit Opportunities such as a level spreader at ISI_C_104 (top left), a microbio-retention at ISI_C_108 (top right), a microbio-retention at ISI_C_117 (bottom left) and wet swale at ISI_C_201 (bottom right)

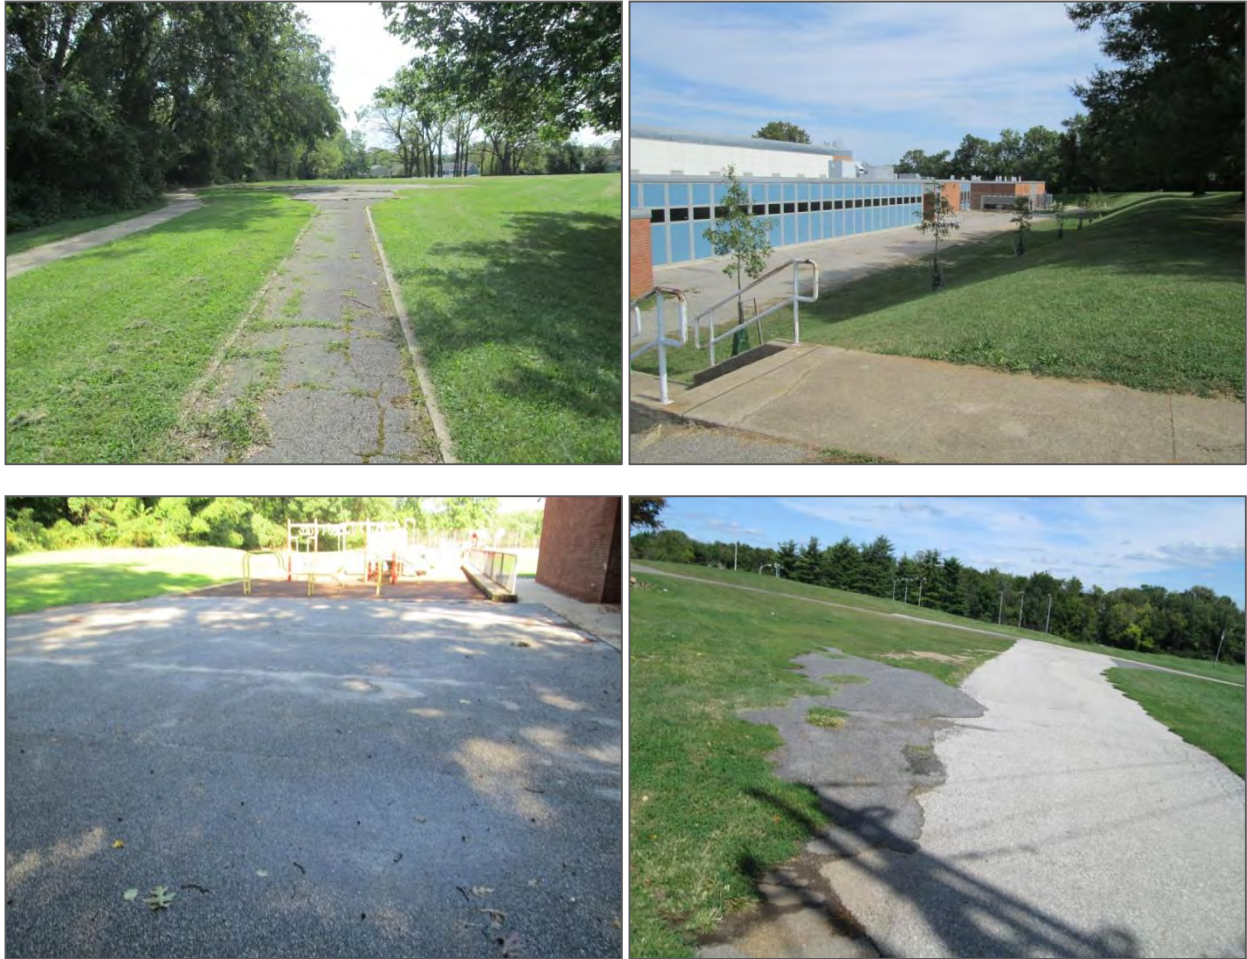
Other examples where impervious cover can be removed are large unused impervious areas behind schools. At sites ISI_C_117, ISI_C_202 and ISI_C_306, wide impervious walkways were observed on the properties. Much of the impervious area at the locations could be removed and replaced with grass leaving a standard 5' walkway for pedestrians. These sites are illustrated in Figure 4-27.

Figure 4-27: Extraneous Asphalt Cover Removal Opportunities at ISI_C_117 (top left and top right), ISI_C_202 (bottom left), and ISI_C_304 (bottom right)

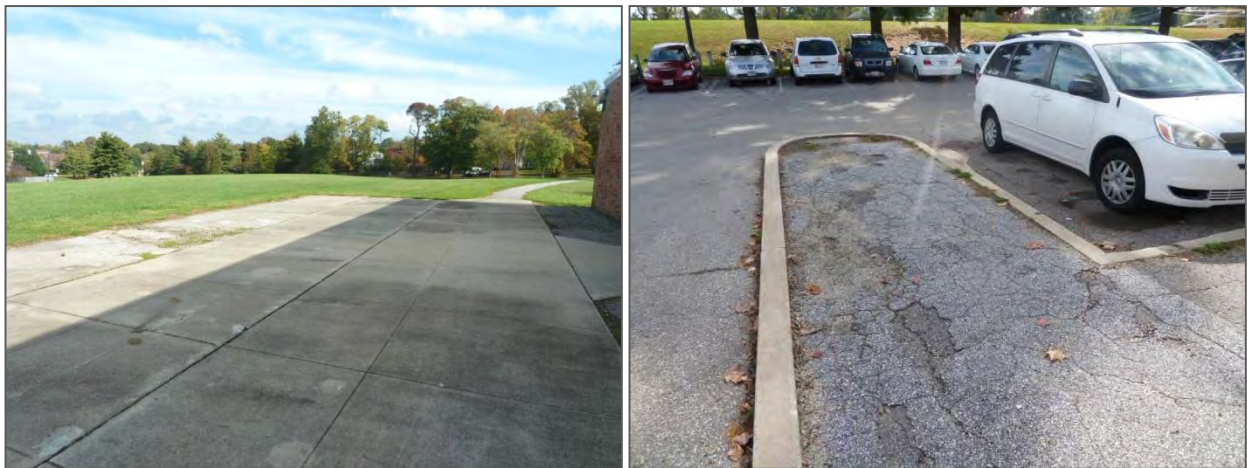
There are a few other examples where excess impervious can be removed. At site ISI_C_304 there was excess asphalt adjacent to a path. At ISI_C_306 the parking lot islands were paved with asphalt. These two sites are illustrated in Figure 4-28. Although these two sites contain very little impervious area that can be removed, the removal of the impervious area will greatly improve the visual quality at these sites.

Figure 4-28: Extraneous Asphalt Cover Removal Opportunities at ISI_C_306
