Middle Gwynns Falls Small Watershed Action Plan Volume II

APPENDIX E:
Middle Gwynns Falls Watershed Characterization Report
(PB 2013)

Middle Gwynns Falls Watershed Characterization Report

September 2013

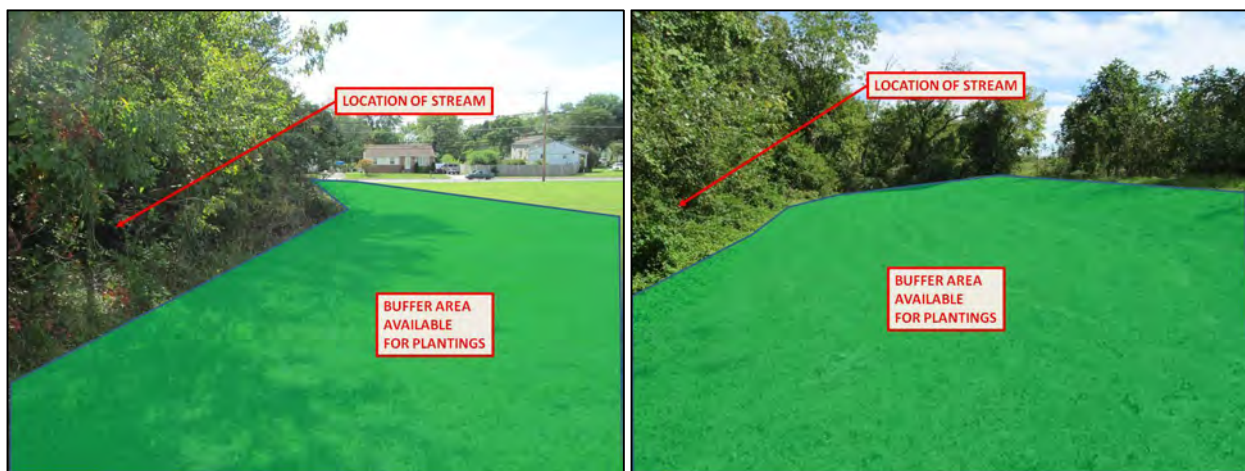
Buffer improvement was identified as a recommended action for 9 out of the 51 institutions assessed. These 9 sites constituted a variety of sites including the following: golf course, cemetery, police precinct, swim club, care center, senior center, and three schools. School properties typically represent a unique opportunity to combine restoration projects with education. The public schools recommended for buffer improvement are ISI_C_115, ISI_C_302, and ISI_C_304 (see Figure 4-29). At site ISI_C_302 the stream runs adjacent to the property. The stream appeared to be in good condition; however nearby development could add additional stress to the stream. Planting along the 100' stream buffer will help reduce any incremental impacts from surrounding activities, and provide additional habitat for riparian plants and animal. At ISI_C_304, the stream was observed to be in very poor condition. Large amounts of trash and steep eroded banks were observed. Buffer planting could be performed at this site in conjunction with a stream cleaning and/or restoration project.

Figure 4-29: Buffer Improvement Opportunity at ISI_C_0302 (left) and ISI_C_0304 (right)

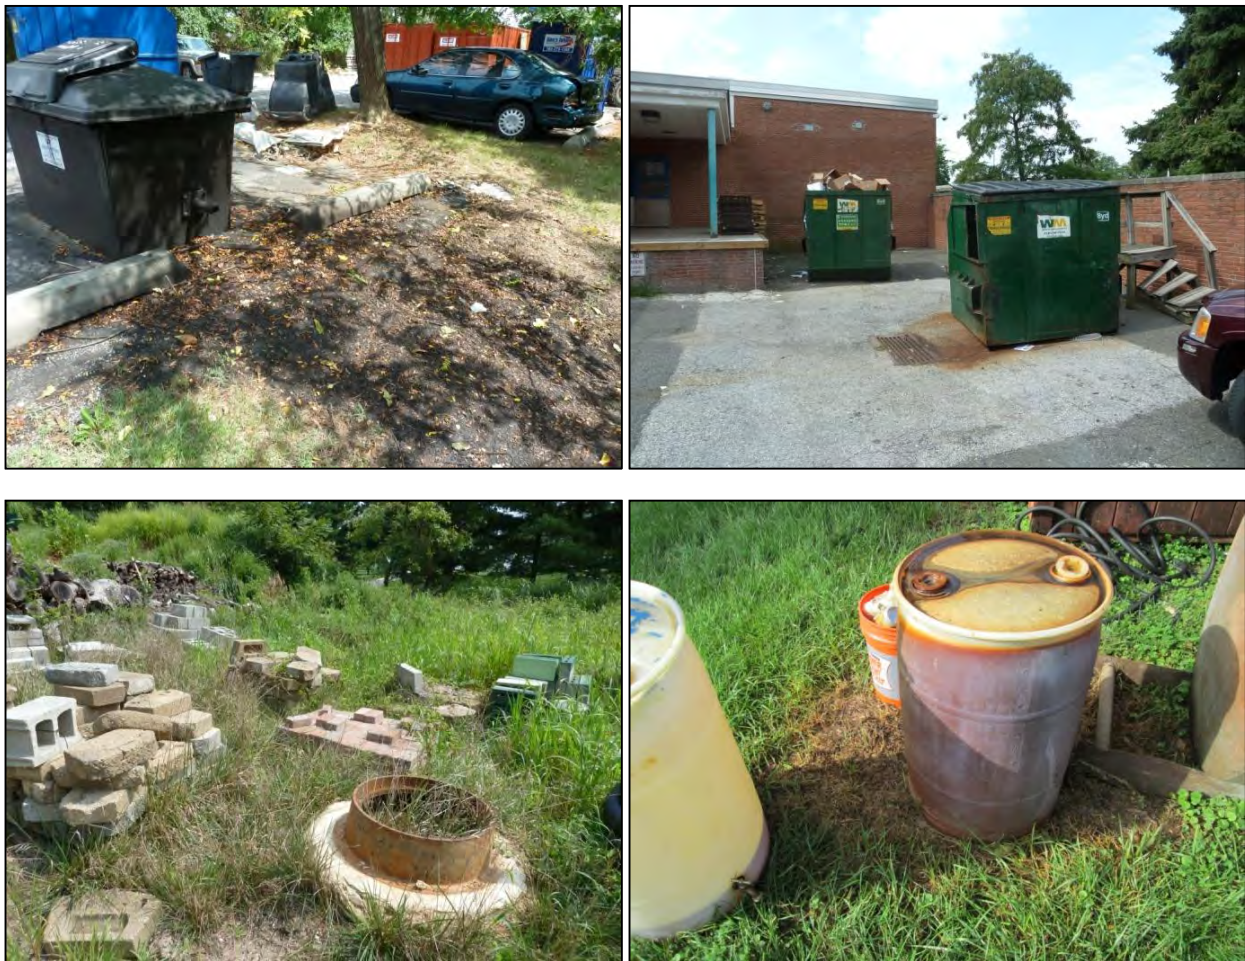
Trash management is an area in need of improvement throughout various areas of the watershed including institutions. A total of 35 institution sites (22 public, 13 private) were recommended for trash management action. Waste management education is recommended to address leaking dumpsters, open or uncovered dumpsters where trash can leave the site, and dumpster placement near storm drain inlets or streams. For example, at ISI_C_103 and ISI_C_105 there was evidence of leakage by stains on the ground. Dumpsters with evidence of leaking should be repaired or replaced. At ISI_C_103 a grease

dumpster was overflowing into a grassed area which was resulting in the vegetation being killed. At site ISI_C_105 staining from the dumpster led to nearby storm drains. Runoff diversion methods should be used to contain leaks and prevent potential pollutants from being carried by stormwater runoff into the storm drains. At some sites, dumpsters were noted as overflowing and with potential for trash to be carried off-site by wind and/or rain. In these cases, it should be determined whether additional dumpsters or increased pick-up frequency is necessary. Dumping was also noted at multiple institutional areas including both litter and bulk items. One trash dumping problem was observed at ISI_C_102 where rubble and other materials were observed in the woods at the rear of the property (see Figure 4-30). At site ISI_C_113 a used 55-gallon oil drum was being stored on the grass. The surrounding dead vegetation indicated evidence of leakage (see Figure 4-30).

Figure 4-30: Trash Management Opportunities at ISI_C_103 (top left), ISI_C_105 (top right), ISI_C_102 (bottom left), ISI C_113 (bottom right).

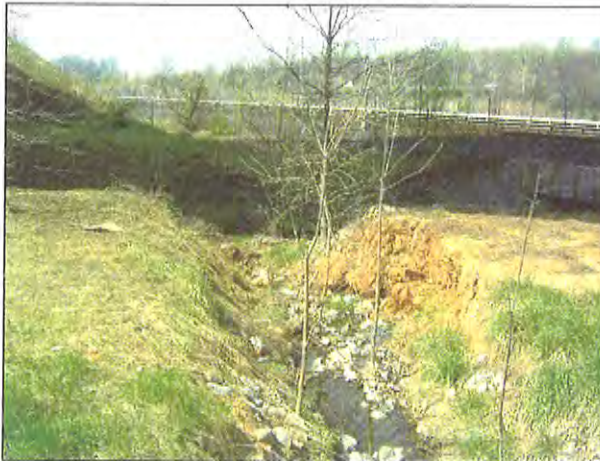
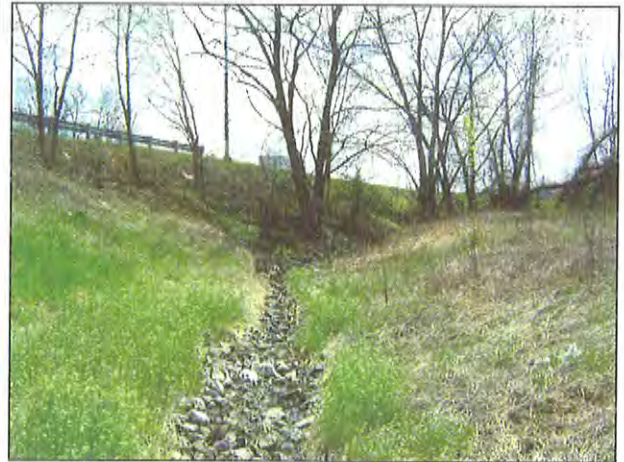
The stream reaches within the I-795 and I-695 interchange are in need of buffer enhancement. Improvement to the riparian buffer (500 linear feet) are recommended.

Riparian Buffer Improvements, assume 100 foot width (1200 linear feet x \$75 per linear foot) = \$90,000

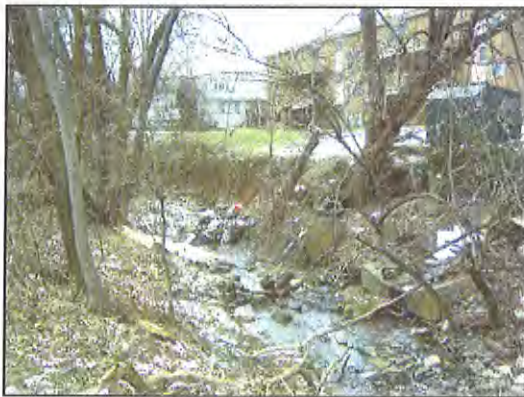
At park entrance off Thayer Terrace

Although it appears that there is a public drainage way in this section, many residents currently mow their lawns to the edge of the stream channel. This is creating channel instabilities and bank erosion. Riparian enhancement and localized stream stabilization, particularly with bioengineering methods, is recommended for both of these reaches. Access to this area is very good. Project would make a nice demonstration project to show the community the benefits of riparian stream buffers. May be able to use citizen volunteer groups to do some of the planting.

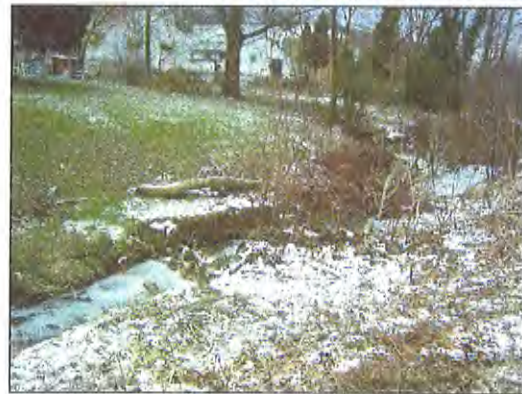
Typical stream buffer along Kinchloe Road

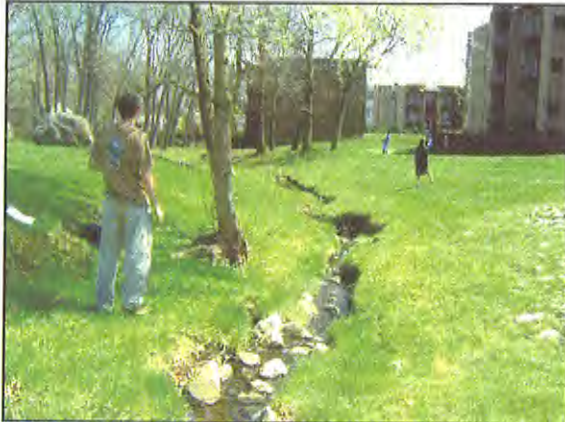
Although it appears that there is a public drainage way in this section, many residents currently mow their lawns to the edge of the stream channel. This is creating channel instabilities and bank erosion. Riparian enhancement for GFM-02-00-01, GFM-02-00-02 and localized stream stabilization for GFM-02-00-03 particularly with bioengineering methods, is recommended for these reaches. Access to this area is very good.

Typical stream buffer

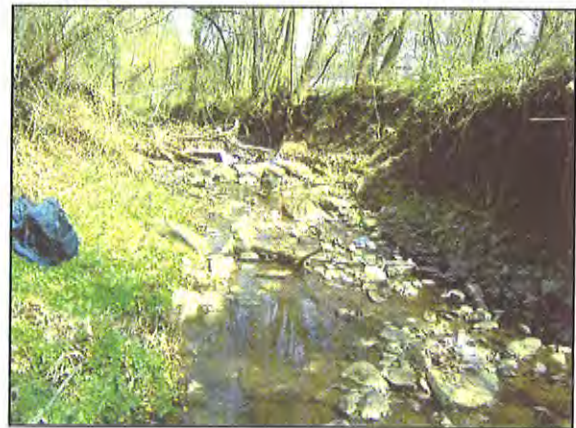
Typical bank erosion

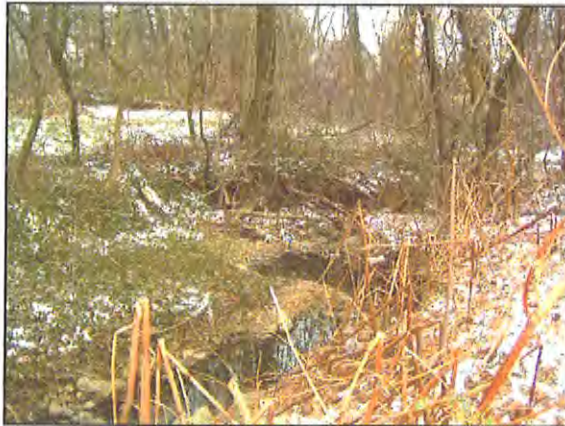
Bank erosion is occurring in reaches GFM-15-00-01, GFM-15-00-02 immediately downstream of Bedford Avenue. Verify that the existing stormwater management pond (not on the inspection list) is an extended detention facility. GFM-15-00-07 has been straightened and lined with gabions. The reach ends at a gabion wall/energy dissipater that has become clogged with debris. The energy dissipater is not functioning properly and is causing severe channel erosion in reach GFM-15-00-07. GFM-15-00-03 downstream from the gabion wall is in need of riparian enhancement and localized stream stabilization, particularly with bioengineering methods. It is assumed that GFM-15-00-02 and GFM-15-00-07 are located in public drainage ways. Therefore, only access easement costs were considered. GFM-15-00-03 appears to be private lands, because the project will split the parcel, DEPRM may need to consider purchasing this land. Purchase costs have been included for this portion of the stream.

GFM-15-00-02 at existing pond outfall

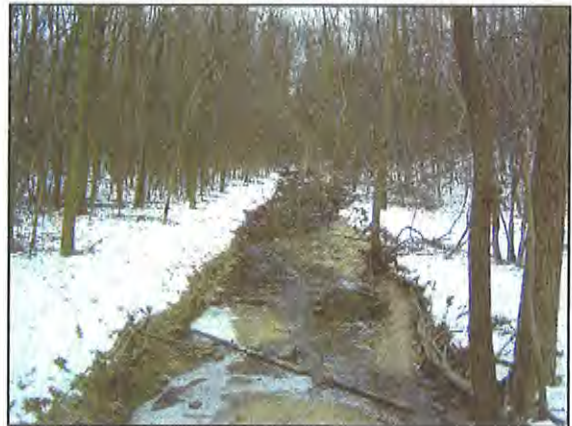
Straightened GFM-15-00-07

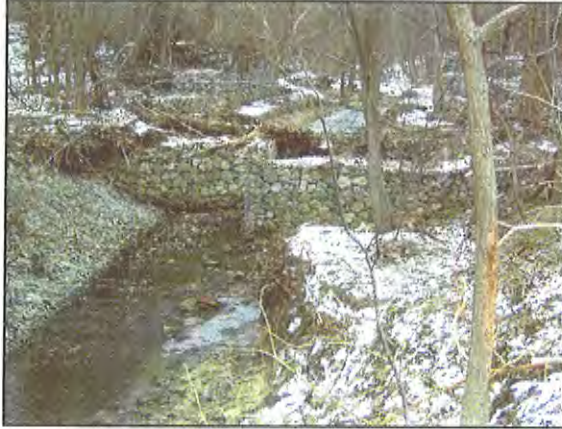
Energy dissipater dividing GFM-15-00-07 & -03

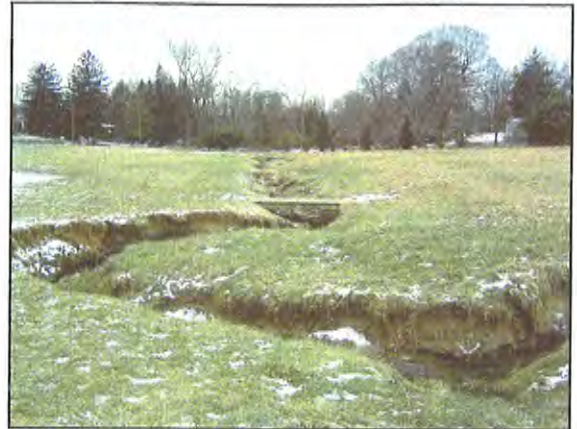
GFM-15-00-03 bank erosion

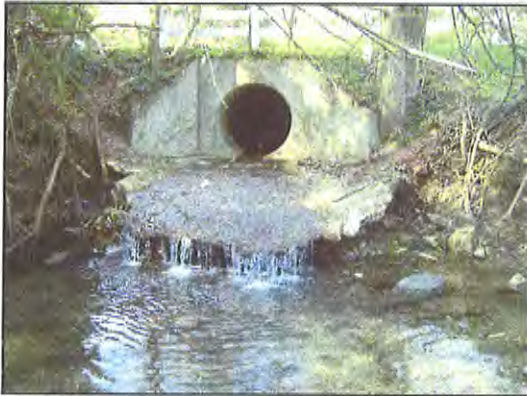
The outfall that starts this stream reach is in need of some apron repair and an energy dissipater. Baltimore County storm drain #235 was not assessed by PB as a major outfall but was inspected as part of the stream assessment. High discharges from the culvert are eroding stream banks and threatening private fences.

Outfall needing energy dissipater

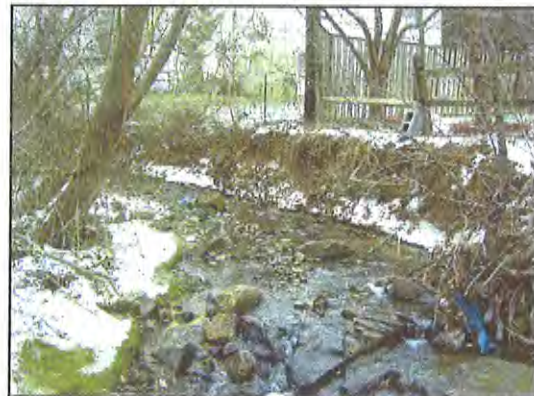
Bank erosion encroaching on a private fence

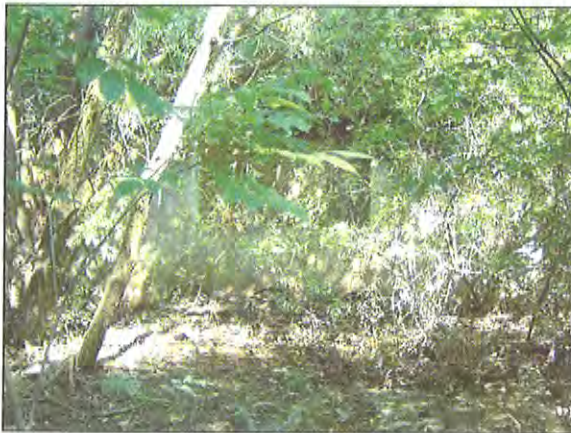
Baltimore County SWM pond #424 (drainage area = 82.4 acres) is in need of retrofit and conversion to extended detention. It is currently an in-line pond with a modified headwall for a riser. The downstream gabion baskets are damaged and the stream flows towards I-695 and runs underneath a right of way fence. Erosion is occurring beneath fence and if left unaddressed it may cause damage to the highway embankment. It appears that there is no room for expansion.

Looking downstream at headwall/riser
(Summer 2003)

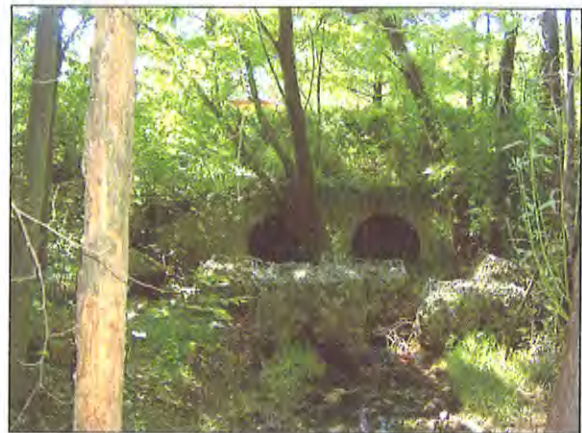
Looking upstream at outfall and failed dissipators
(Summer 2003)

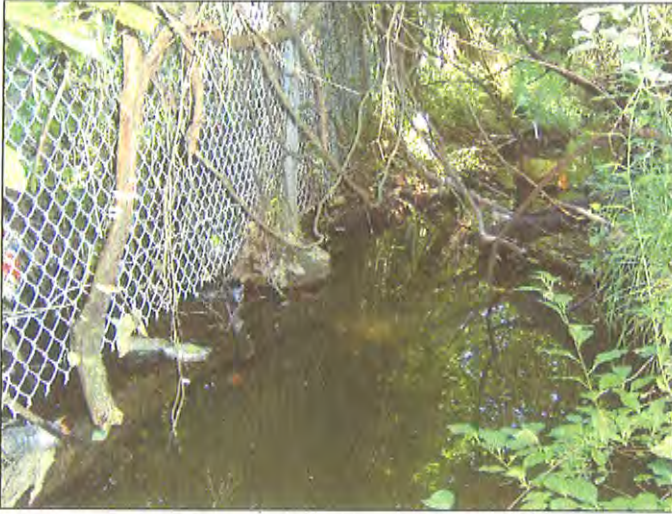
Downstream channel along I-695 right of way fence (Summer 2003)

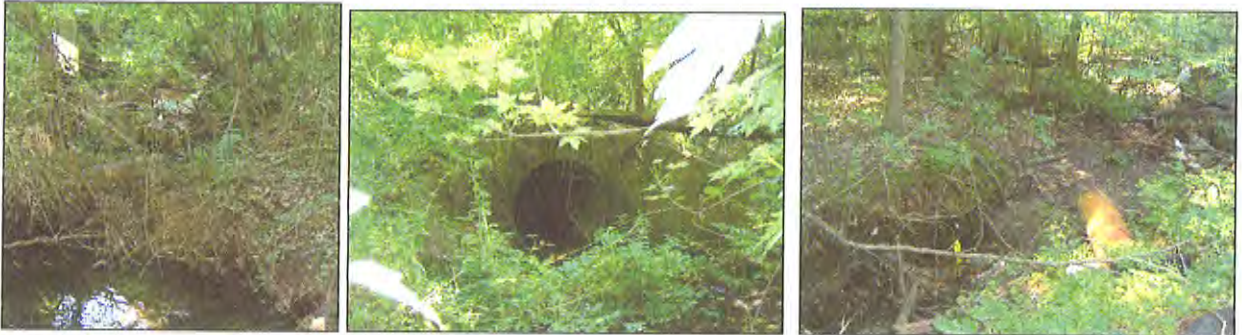
Baltimore County outfall #GFM-390 is a 54" stormdrain (drainage area = 50.5 acres) and is in need of a stilling basin for energy dissipation. Approximately 300 lf of stream needs to be stabilized. Debris cleanup is also recommended.

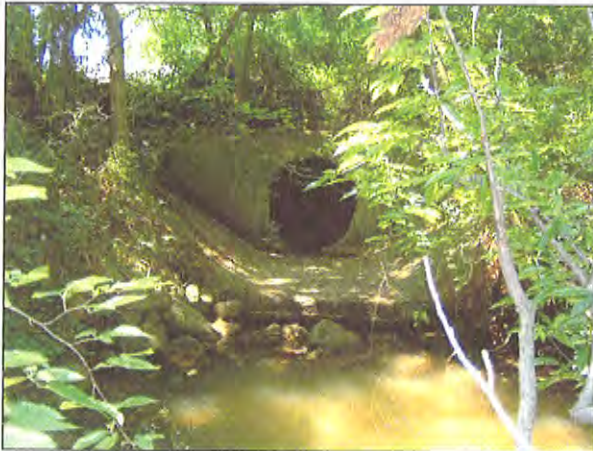
Baltimore County 48" outfall #GFM-626 (drainage area = 41 acres) is in need of a stilling basin for energy dissipation. Approximately 150 lf of stream needs to be stabilized.

Looking upstream at outfall

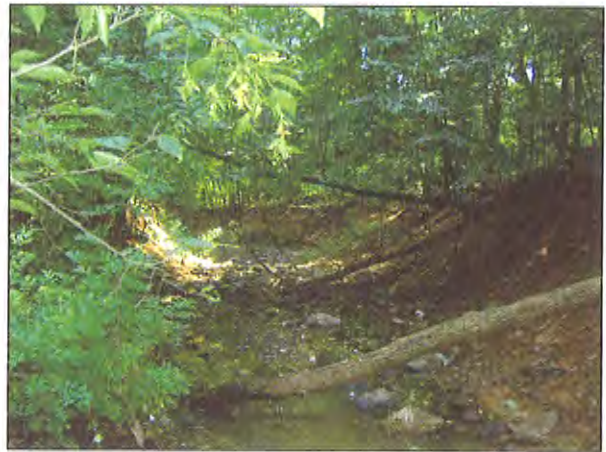
Looking downstream at bank erosion

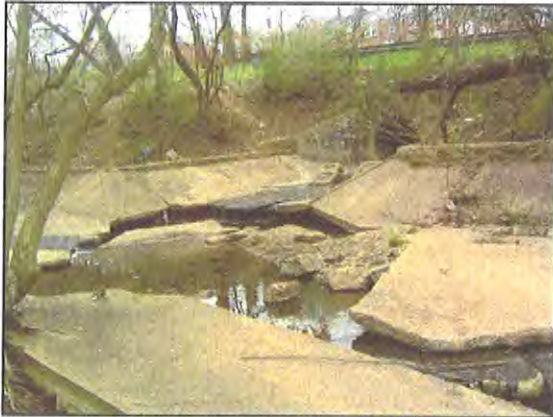
This section of stream within Edmonson Heights Park has severe bank erosion and severe headcut. Several small outfalls along the stream reach are also in need of repair. This site has the potential for BMP creation.

Tributary Outfall

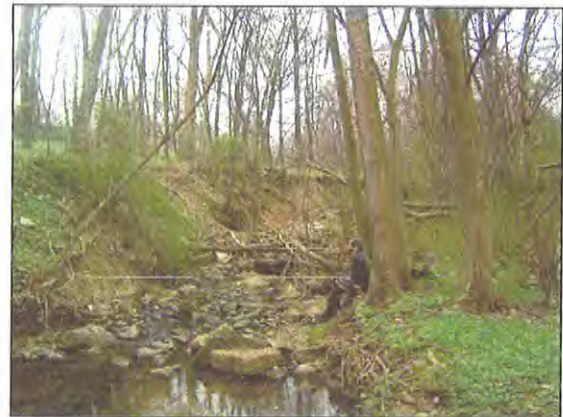
U/S at bank erosion

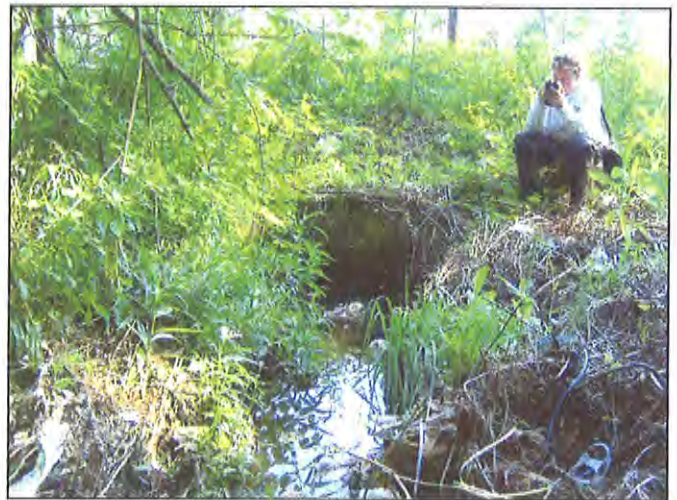
Looking U/S at headwall

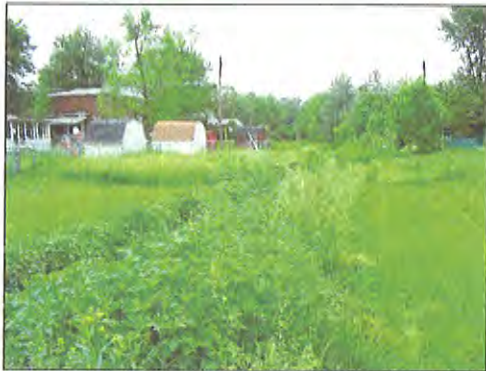
Lower 500 feet of Reach PM-01A, banks are vertical and/or undercutting. (May 2004)

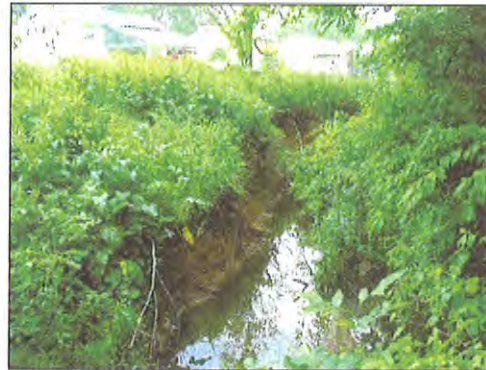
May 2004 vegetation

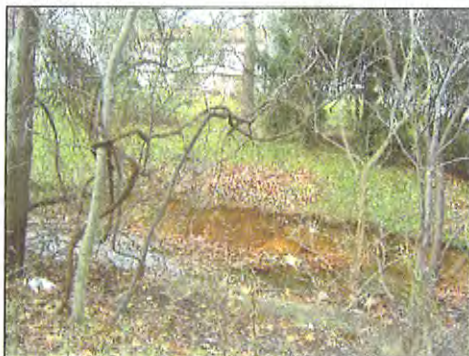
Bank erosion (December 2003)

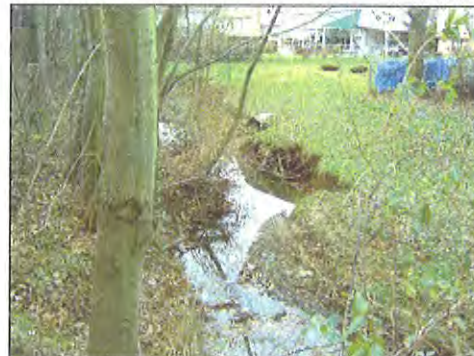
Bank erosion (December 2003)

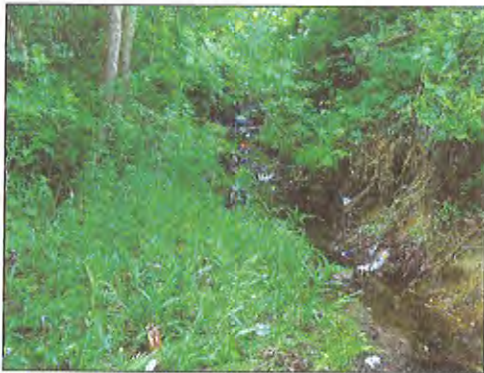
Looking upstream at project .May 2004

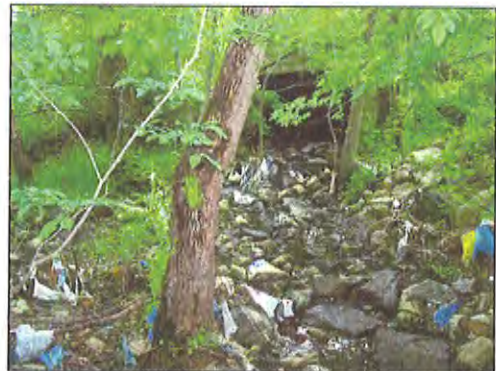
Looking upstream at outfall for project , May 2004

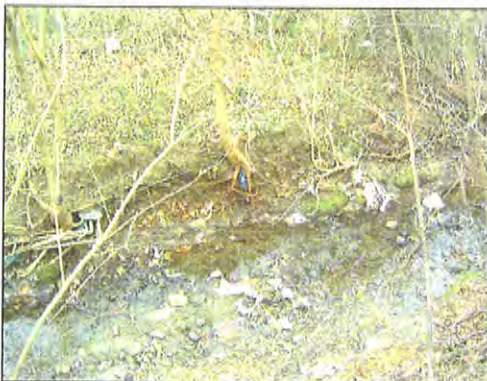
Bank erosion in December 2003.

An evaluation of entrainment properties found excess shear. In other words, the stream is capable of moving larger bed materials. This causes vertical instability, which has resulted in bank erosion and the over-widening of the channel.

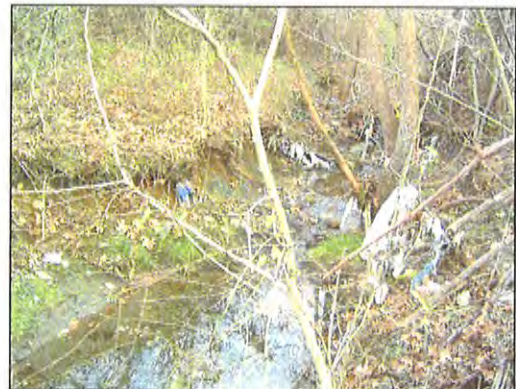
Bank erosion and debris in December 2003.

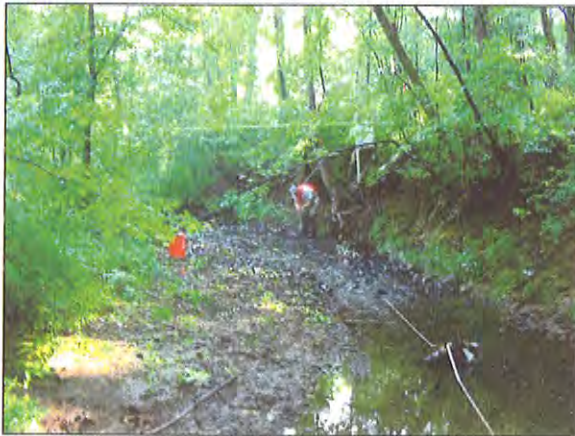
Looking upstream below Cross Section 1

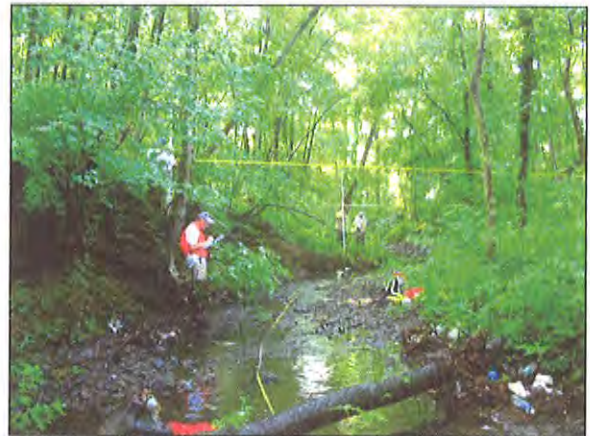
Looking downstream above Cross (May 2004)
Section 1 (May 2004)

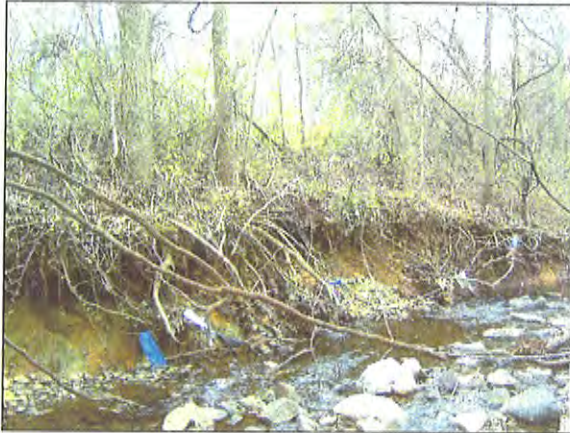
Bank erosion (Dec 2003)

Based on a sediment entrainment analysis, the stream channel in the vicinity of the study area is degrading due to excess shear stress. As a result of the excess shear stress, the stream channel is vertically unstable, shown by the stream's depth and slope that are deeper and steeper than what are hydraulically required to move the largest particle sizes present in the stream. However, there are visual indications that the stream is in transition to a more stable form. The contribution to sediment load through this reach appears to be lower than the contribution farther upstream.

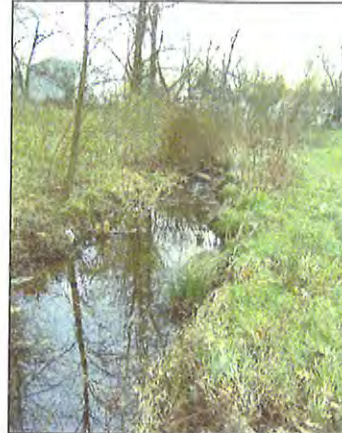
Erosion (Dec 2003)

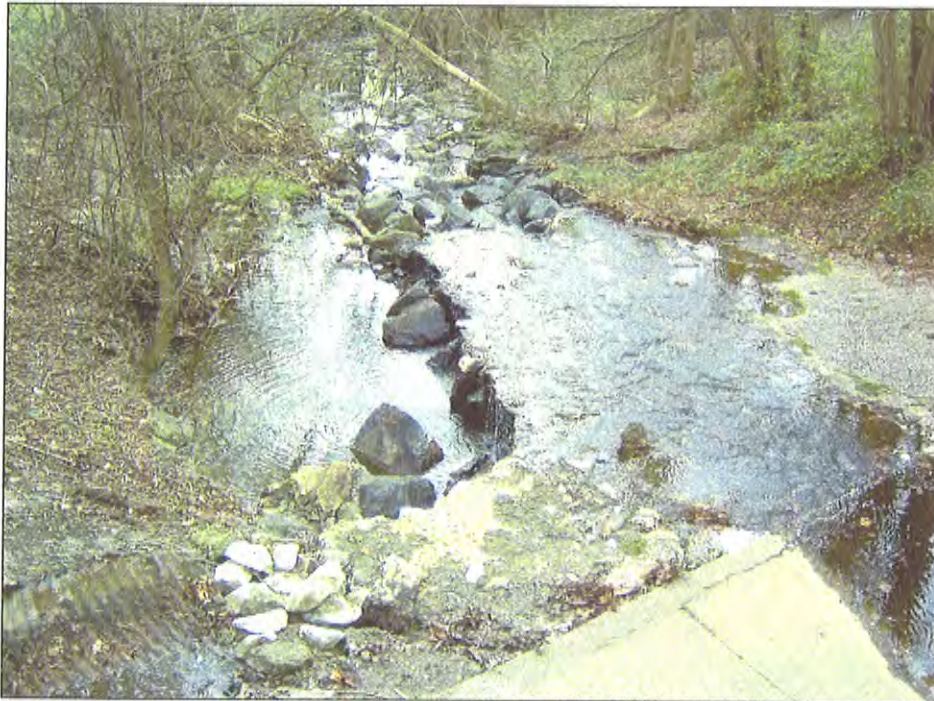
Looking downstream from the Patterson Ave. culvert (Dec. 2004)

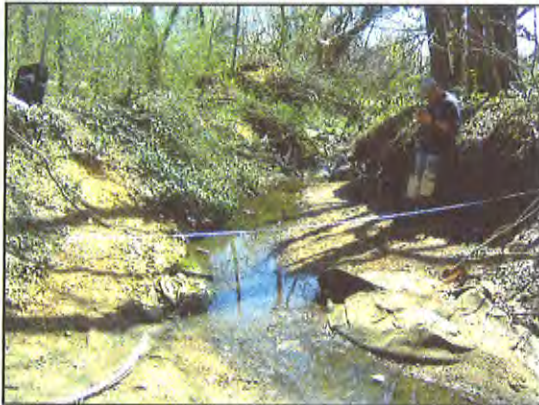
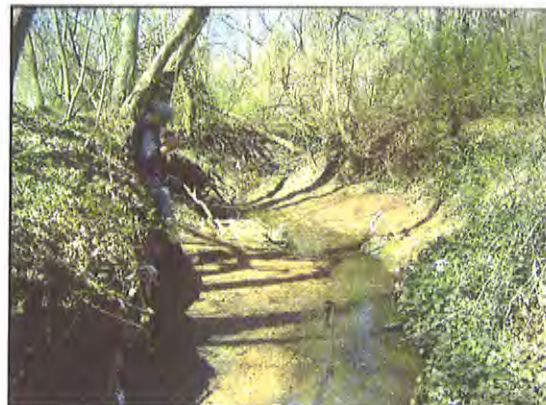
The un-assessed Baltimore County outfall #533 (38' x 60' with DA=21.70 acres) discharges to this stream reach. The reach is in need of stabilization/restoration and utility protection/relocation.

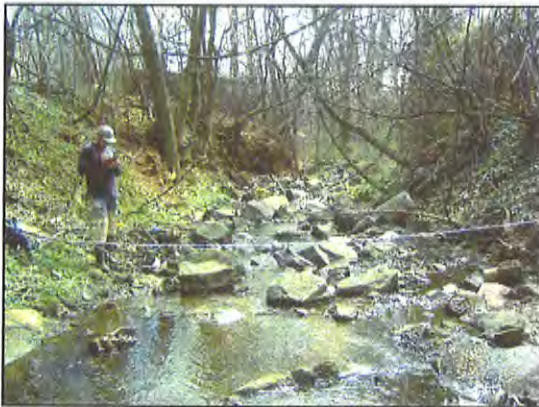
These stream reaches are all in need of localized stabilization. Several structures including parking lots and buildings could be affected if erosion continues. Reach MC-00-00-08 could also benefit from riparian plantings.

Typical stream section

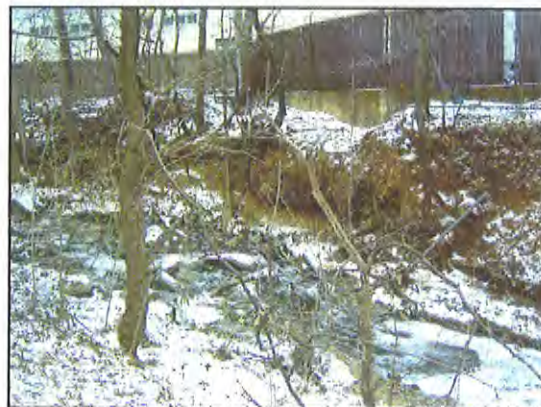
Erosion near parking lot

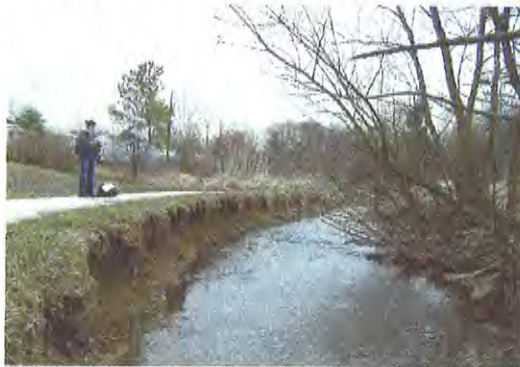
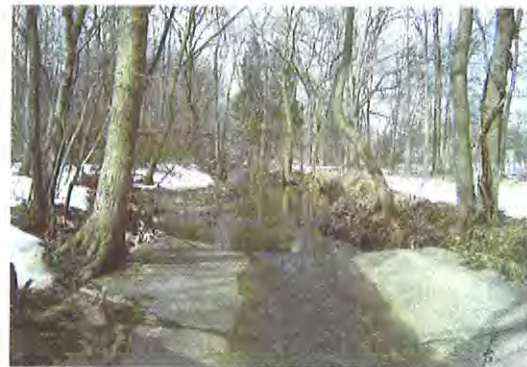
This project includes approximately 3,100 lf of stream restoration and stabilization including the removal of a failing concrete channel. The project also includes the creation of floodplain wetlands for 5 small (<36") and one large (42") stormdrain outfalls.

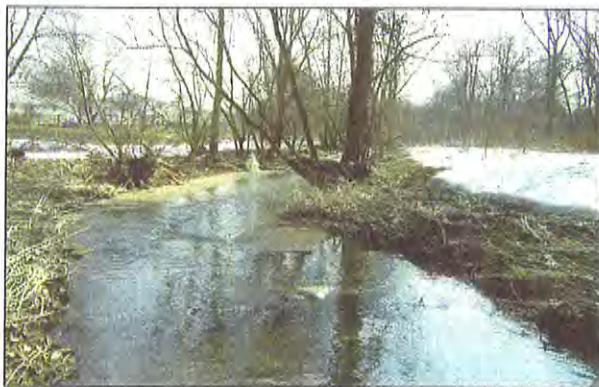
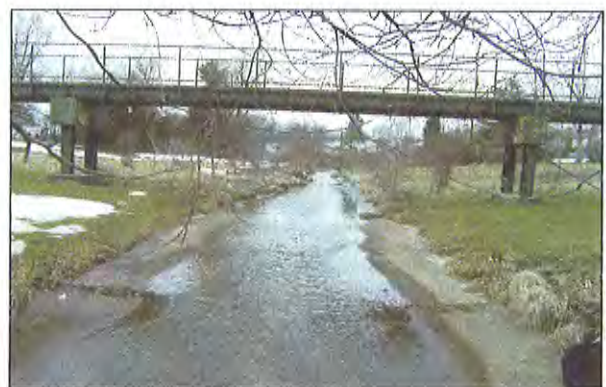
This project includes approximately 2,500 lf of stream restoration and stabilization including the removal of a failing concrete channel. The project also includes the creation of floodplain wetlands for 4 small (<36") and 2 large (42") stormdrain outfalls. Includes Baltimore County storm drain #290 and #291.

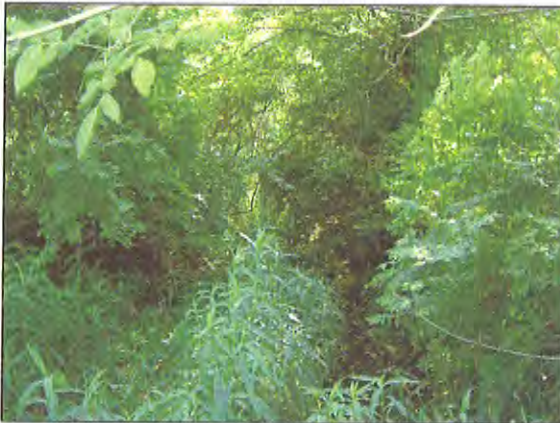
This project involves creating a wetland pond system to treat the runoff from Baltimore County outfall #233 and #389. May have demonstrative value to public in park setting.

D/S from #233

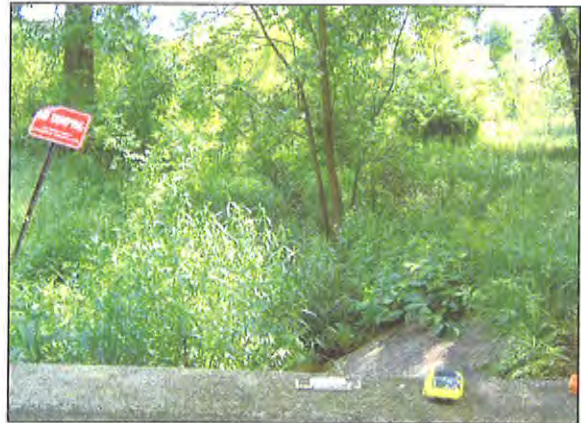
D/S from #389
