MEMORANDUM

Date: March 2, 2018
To: William Pines- MDTA
From: Ed Tinney
CC: James Harkness, Serena Liu, Peter Mattejat, Pam McNicholas, Don MacLean,
Lauren Waesche- MDTA; Mitch Scott & Greg O’Hare- RK&K
Re: I-95 5th Lane Widening from MD 152 to MD 24 – Natural Resource Inventory (Revised)

**I-95 5th LANE WIDENING
FROM MD 152 TO MD 24
FIGURE 2. PROJECT STUDY AREA MAP
NOVEMBER 2017**

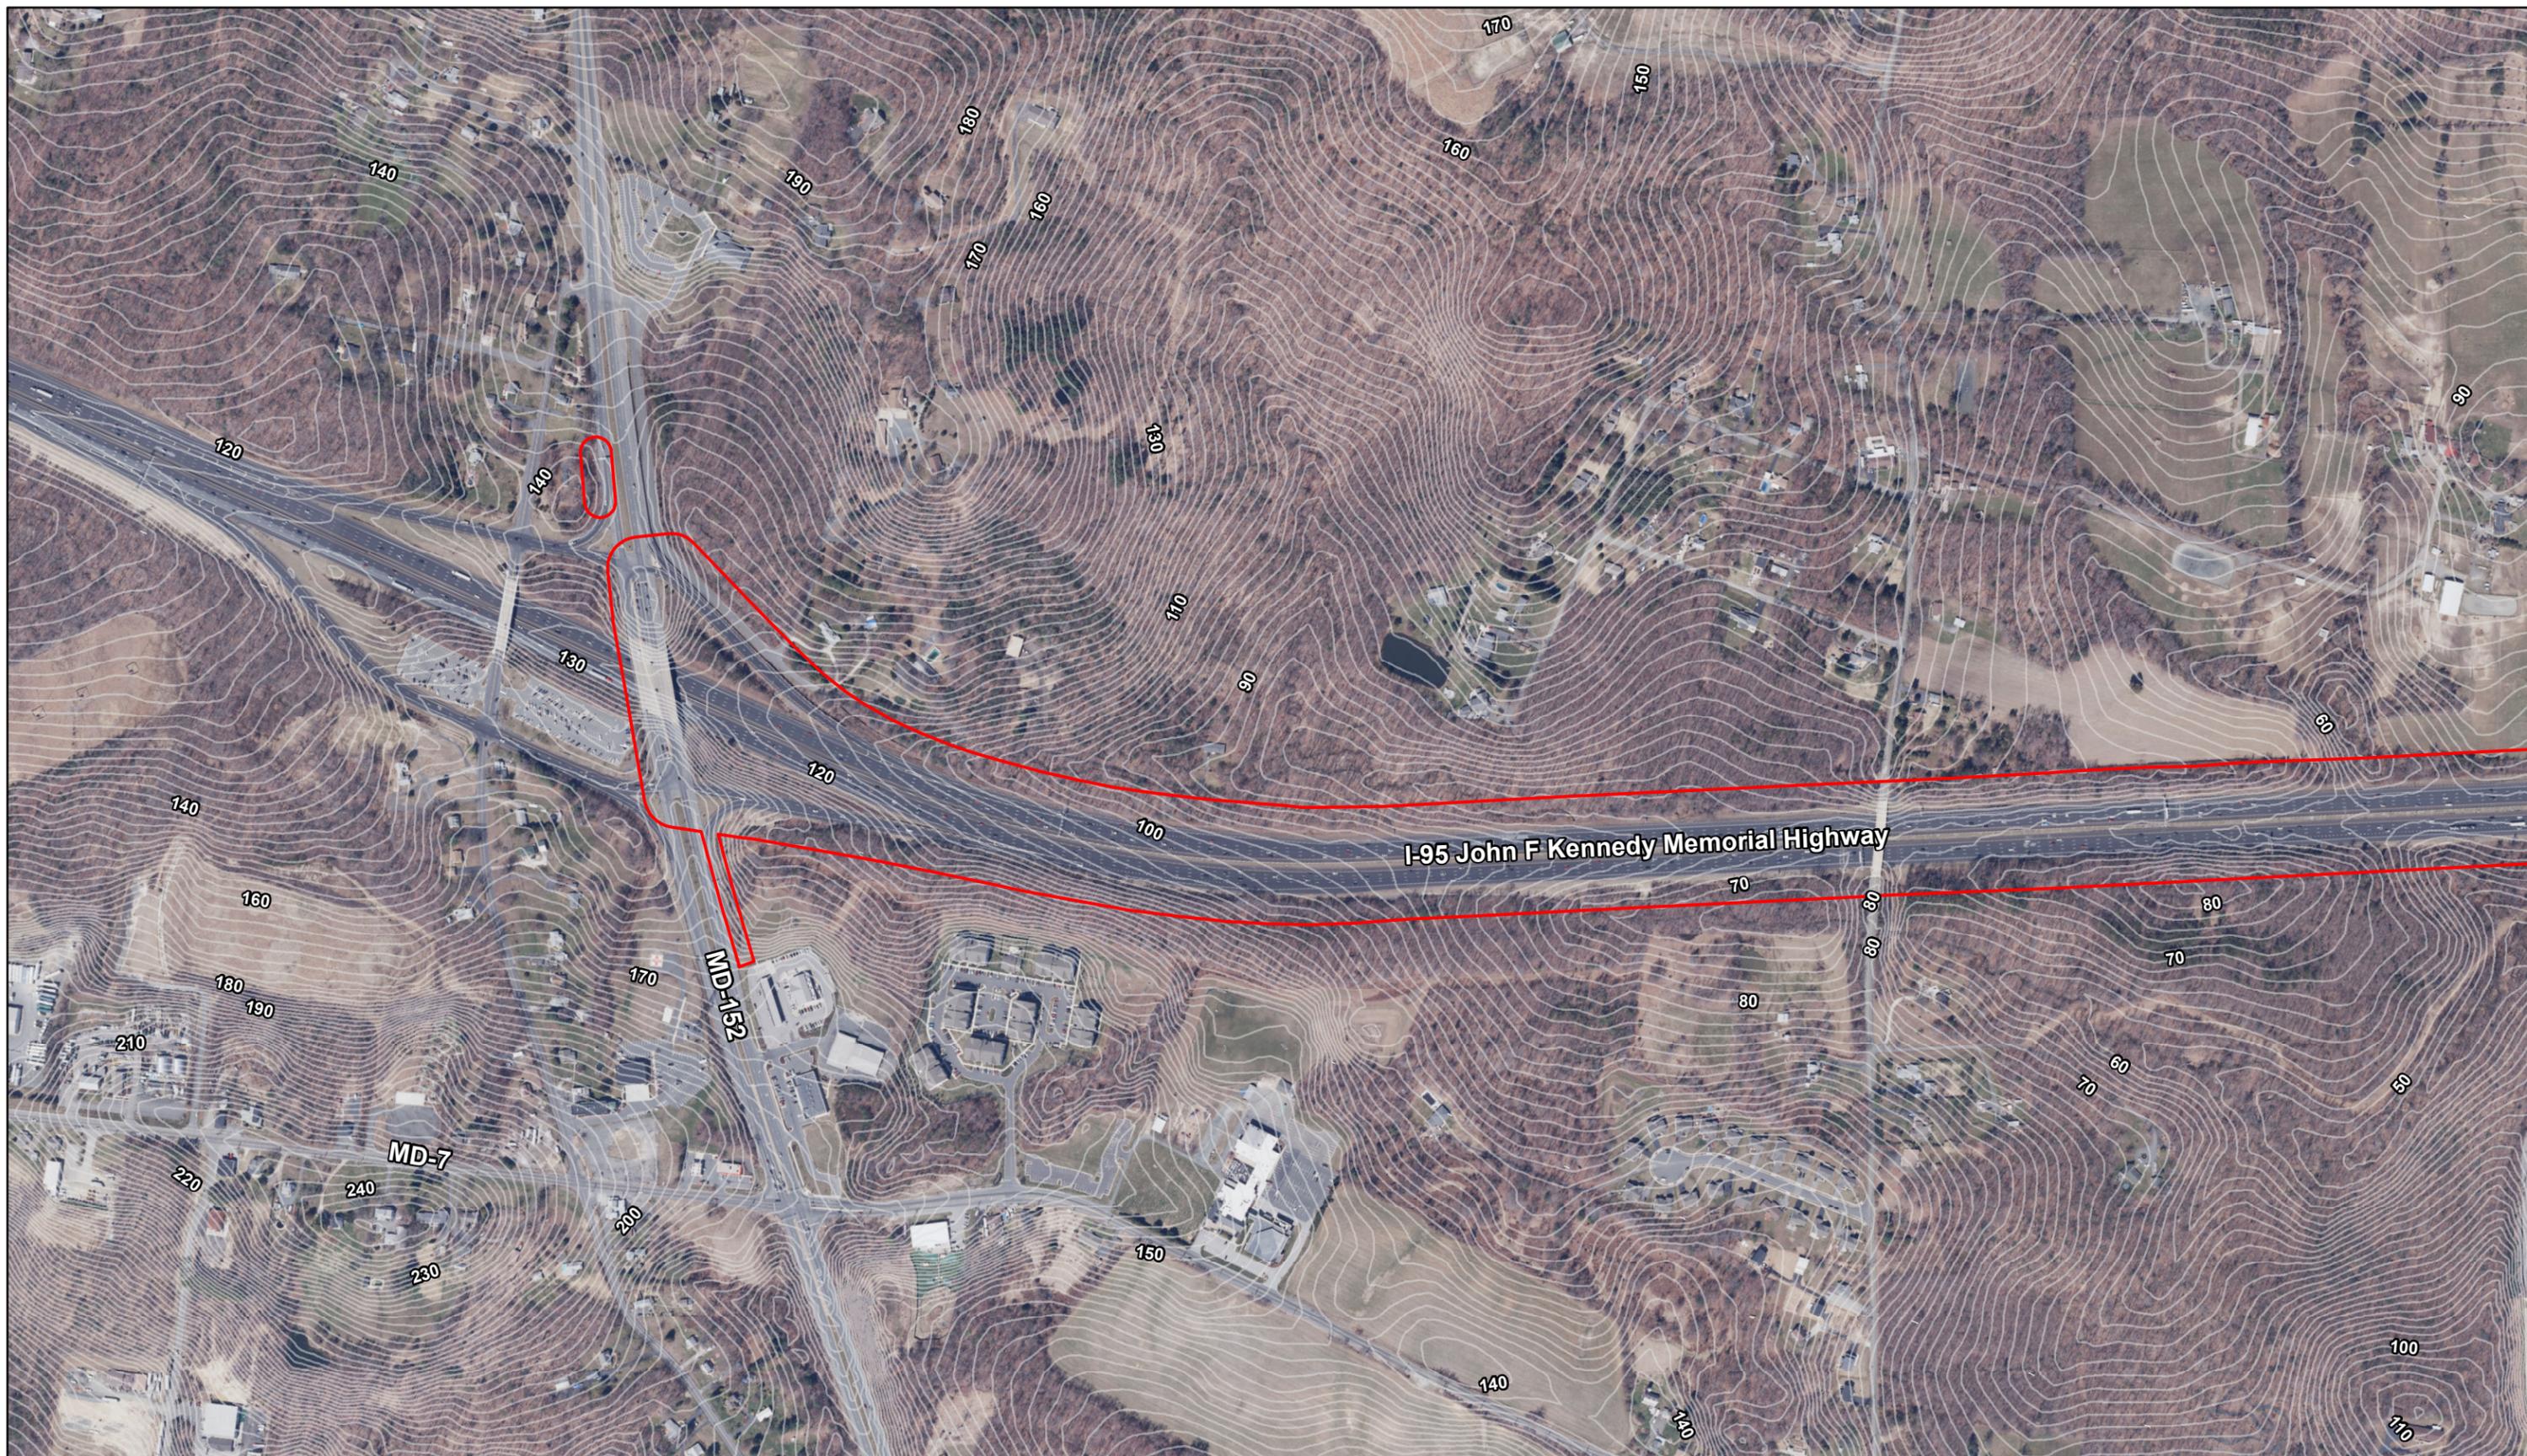
**I-95 5th LANE WIDENING
FROM MD 152 TO MD 24
FIGURE 4. SOILS MAP
NOVEMBER 2017**

The USDA-NRCS Web Soil Survey for Harford County, Maryland identified 26 mapped soil units within the project study area, as shown in **Appendix A, Figure 4**, with three hydric soil units, one predominately hydric soil unit, seven predominately non-hydric soil units and fifteen non-hydric soil units identified. Seventeen highly erodible soils (K-factor ≥ 0.35) are mapped within the study area (**Table 1**).

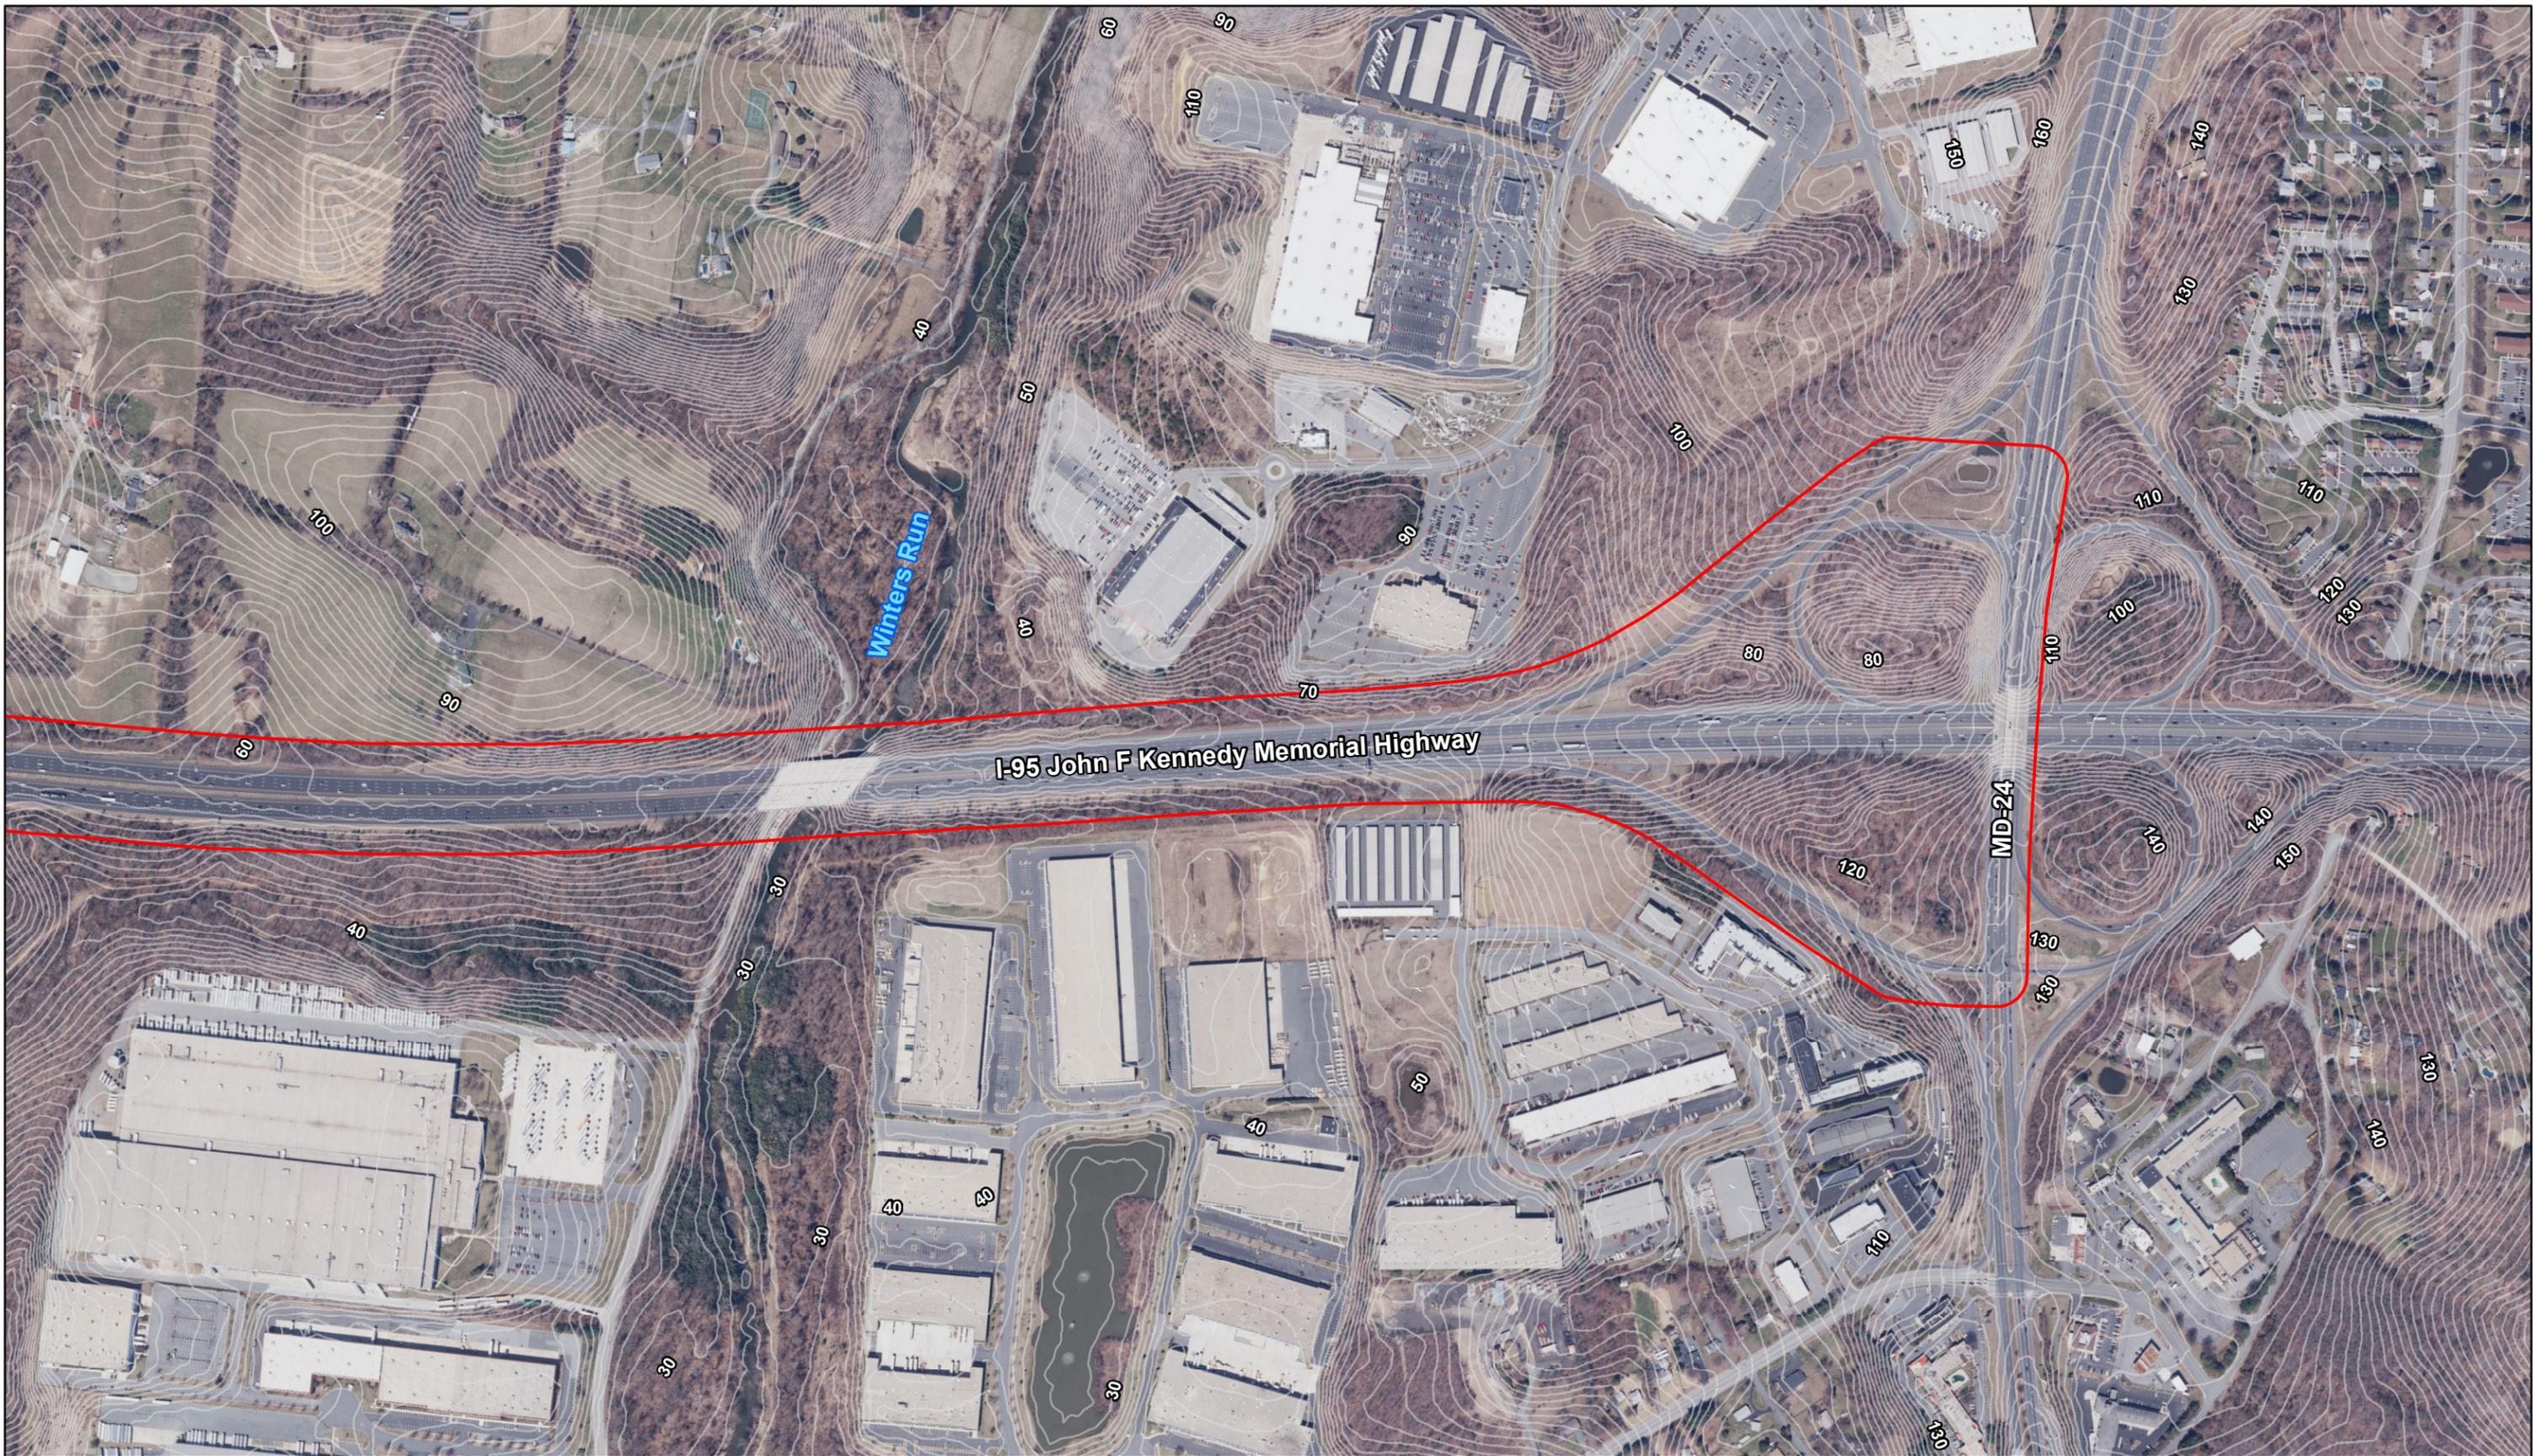
**I-95 5th LANE WIDENING
FROM MD 152 TO MD 24
FIGURE 5a. TOPOGRAPHY MAP
NOVEMBER 2017**

The project study area is located in the Piedmont Plateau physiographic province, within the Perry Hall Upland District of Harford County, which is characterized by a transition between crystalline Piedmont and unconsolidated Coast Plain. Many hilltops are capped by Cretaceous gravels and sediments that thicken to the southeast, and rivers flow across the region in steep-walled valleys incised into crystalline rock. Elevation ranges from 30 to 180 feet above sea level, (**Appendix A, Figure 5**).

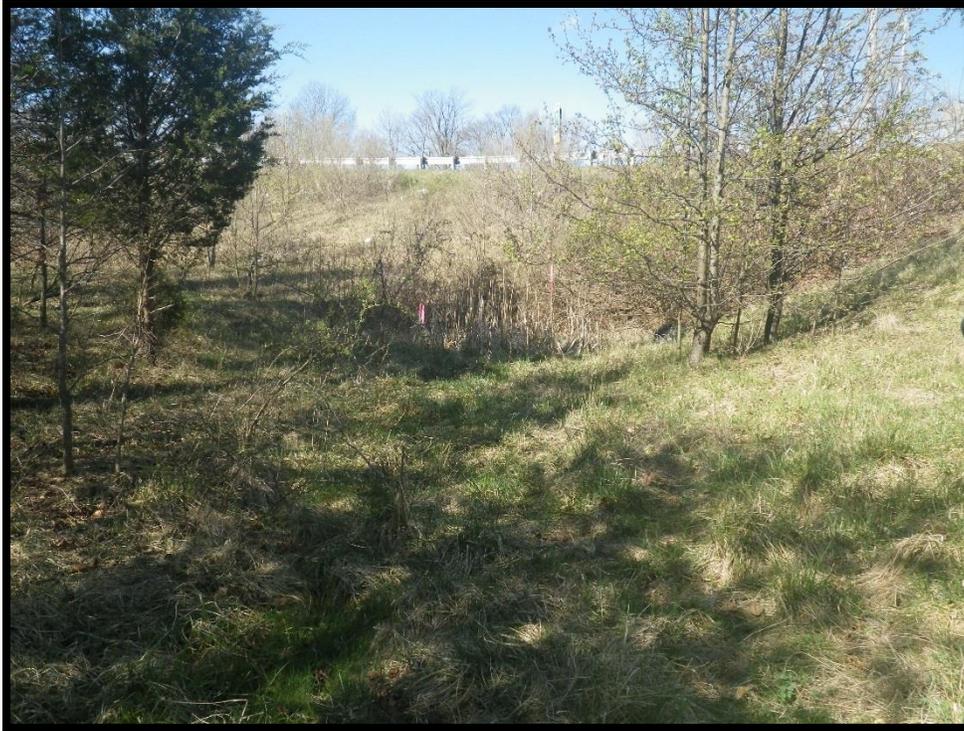
Wetland A – PEM

Wetland A is a palustrine emergent wetland located southeast of the ramp from northbound MD 152 to northbound I-95. Wetland A originates from a pipe that runs under the on ramp and drains to Waters B. Dominant species include an unidentified fescue species (*Festuca* sp.), with inclusions of broad-leaf cattail (*Typha latifolia*, OBL). Although the fescue species could not be identified, the hummock morphology and hydrologic conditions of the wetland indicate it is likely a wetland species. Hydrologic indicators include the presence of surface water, high water table, saturation, drainage patterns, and geomorphic position. The soils in this area met the hydric soil indicator F3: Depleted Matrix. This wetland feature is not shown on NWI or DNR GIS mapping, however this area is considered jurisdictional, since all three wetland parameters were met during field investigations.

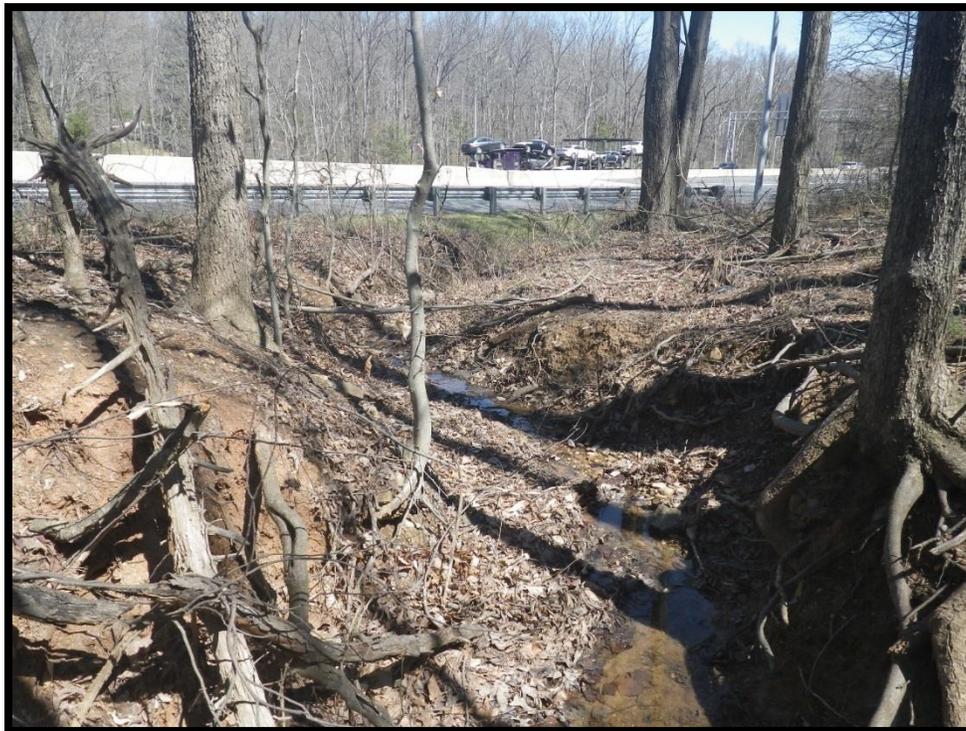
Waters D – Intermittent RPW

Waters D is an intermittent RPW located south of the ramp from MD-152 to northbound I-95. Waters B flows north from outside of the study area and drains to Waters B. Side slopes are 2:1 to 3:1, with moderately eroded banks. Channel substrates consist of silts, sands, and riprap. The channel ranges from 2-5 feet wide, with an average depth of 2 inches, and indicators of Ordinary High Water include clear, natural line impressed on the bank, vegetation matted down, bent, or absent, leaf litter disturbed, water staining, and observed/predicted flow events. Both the right and left banks are forested. This

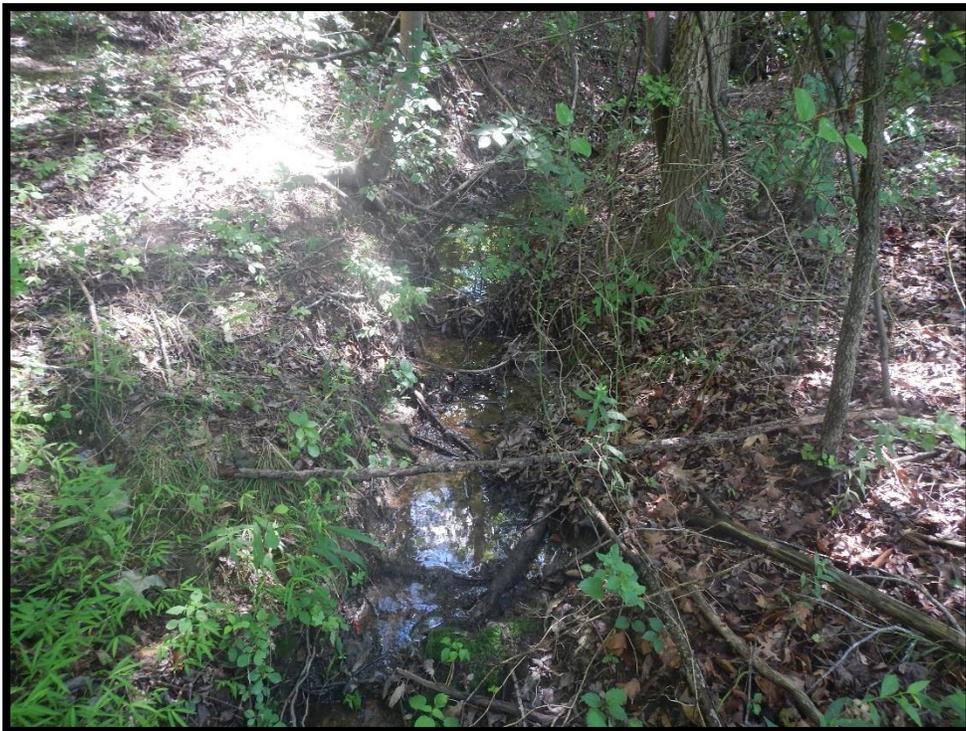
Waters F – Perennial RPW

Waters F is a perennial RPW located south of I-95 northbound, and west of the Clayton Road overpass. Waters F flows east from outside of the study area and drains to Waters G. Side slopes are 2:1 and 4:1, with mostly stable banks. Channel substrates consist of silts, sands, and muck. The channel ranges from 1-4 feet wide, with an average depth of 6 inches, and indicators of Ordinary High Water include clear, natural line impressed on the bank, vegetation matted down, bent, or absent, leaf litter disturbed, water staining, presence of flood litter/debris, presence of wrack line, scour, and observed/predicted flow events. Both the right and left banks are forested. This feature is not shown on NWI or DNR GIS mapping, but is considered jurisdictional under Rapanos guidance as an RPW.

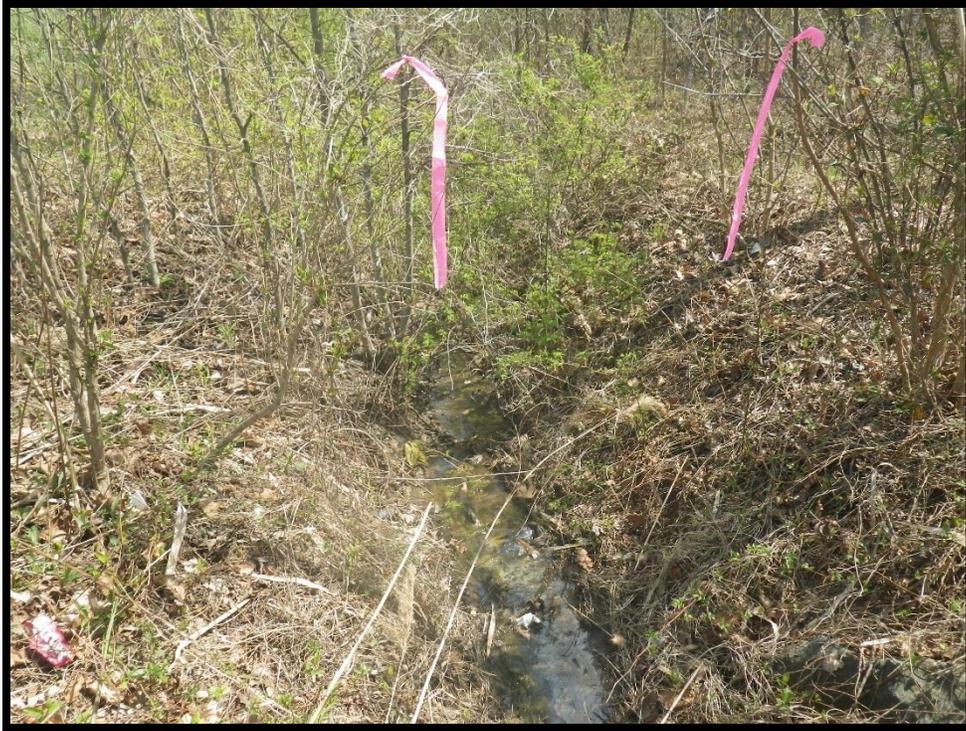
Waters I – Intermittent RPW

Waters I is an intermittent RPW located south of northbound I-95 and west of the Clayton Road overpass. Waters I flows from a stormwater outfall under I-95 east to Waters J. Side slopes are 3:1 with stable banks and channel substrate consists of silt. The channel has an average width of 1 foot, with an average depth of 4 inches, and indicators of Ordinary High Water include vegetation matted down, bent, or absent, leaf litter disturbed, water staining, and observed/predicted flow events. The right bank is forested and the left bank is mowed grass. This feature is not shown on NWI or DNR GIS mapping, but is considered jurisdictional under Rapanos guidance as an RPW.

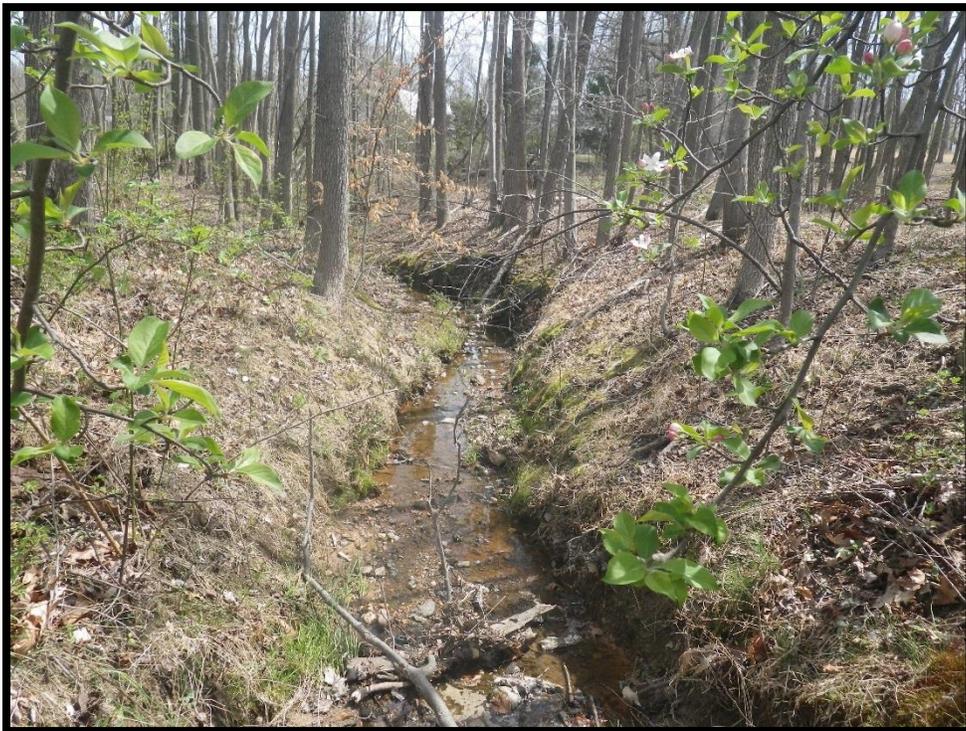
Waters J – Perennial RPW

Waters J is a perennial RPW located west of the Clayton Road overpass. Waters J flows south from outside of the study area, under I-95 through a culvert, and drains to Waters G beyond the study area. Waters J receives contributing hydrology from Wetland LL and Waters I, II and JJ. Side slopes are 1:1, with moderate erosion. Channel substrates consist of silts, cobbles, sands, and gravel. The channel has an average width of 2 feet, with a depth of 2-6 inches, and indicators of Ordinary High Water include vegetation matted down, bent, or absent, leaf litter disturbed, water staining, presence of wrack line, scour, and observed/predicted flow events. Both the right and left banks are forested. This feature is not shown on NWI or DNR GIS mapping, but is considered jurisdictional under Rapanos guidance as an RPW.

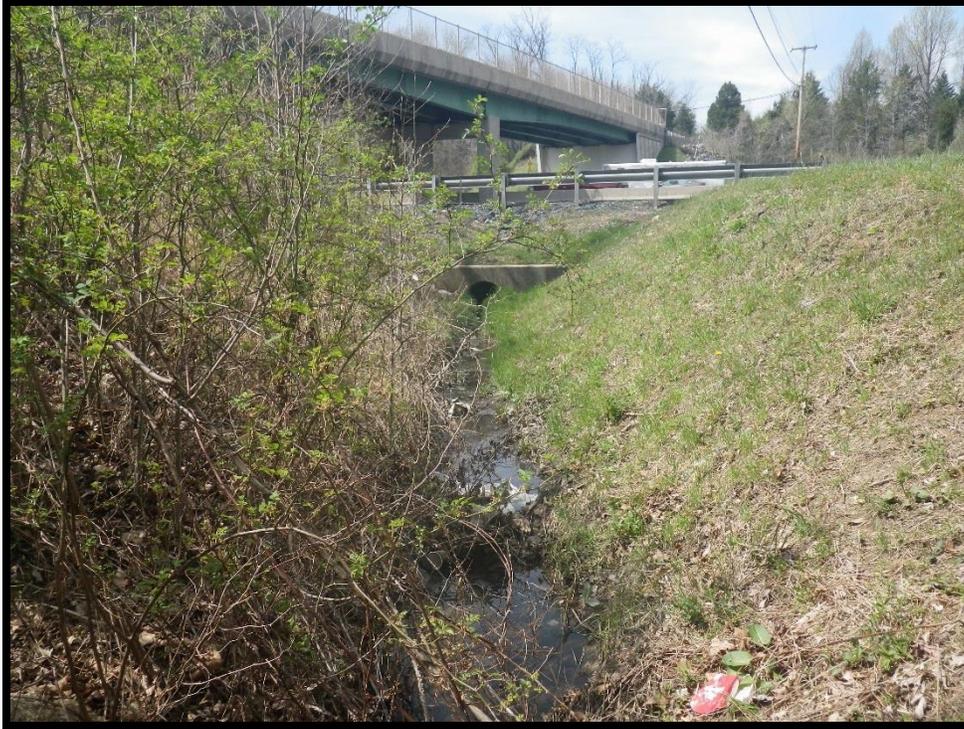
Waters K – Intermittent RPW

Waters K is an intermittent RPW located south of northbound I-95, and east of the Clayton Road overpass. Waters K originates from a stormwater outfall under I-95, flowing south and draining into Waters G outside of the study area. Side slopes are 1:1 to 2:1, with moderate erosion. Channel substrates consist of silts, sands and gravel. The channel ranges from 1-3 feet wide, with an average depth of 3 inches, and indicators of Ordinary High Water include clear, natural line impressed on the bank, vegetation matted down, bent, or absent, water staining, presence of flood litter/debris, and observed/predicted flow events. Both the right and left banks include forest and mowed grass. This feature is not shown on NWI or DNR GIS mapping, but is considered jurisdictional under Rapanos guidance as an RPW.

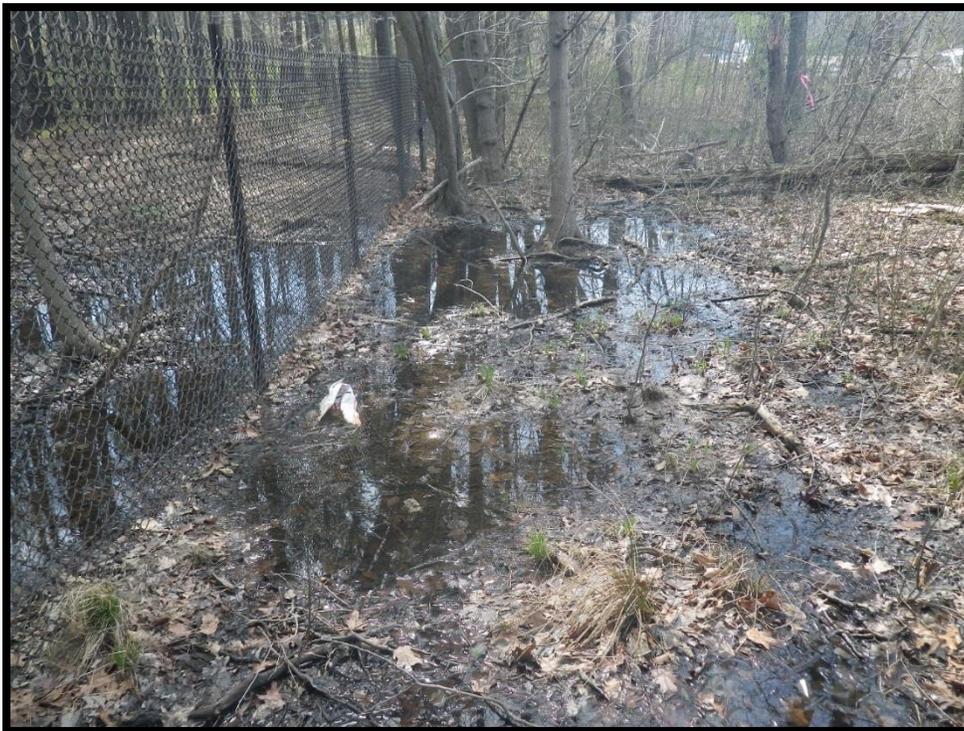
Wetland L – PFO

Wetland L is a palustrine forested wetland located south of northbound I-95, and east of the Clayton Road overpass. Wetland L is an isolated, depressional wetland located beyond the I-95 roadway embankment. Dominant species include red maple (*Acer rubrum*, FAC), sweet gum (*Liquidambar styraciflua*, FAC), soft rush (*Juncus effuses*, FACW) and round-leaf greenbrier (*Smilax rotundifolia*, FAC). Hydrologic indicators include the presence of surface water, high water table, saturation, water-stained leaves, oxidized rhizospheres on living roots, sparsely vegetated concave surface and geomorphic position. The soils in this area met the hydric soil indicator F3: Depleted Matrix. This wetland feature is not shown on NWI or DNR GIS mapping, however this area is considered jurisdictional, since all three wetland parameters were met during field investigations.

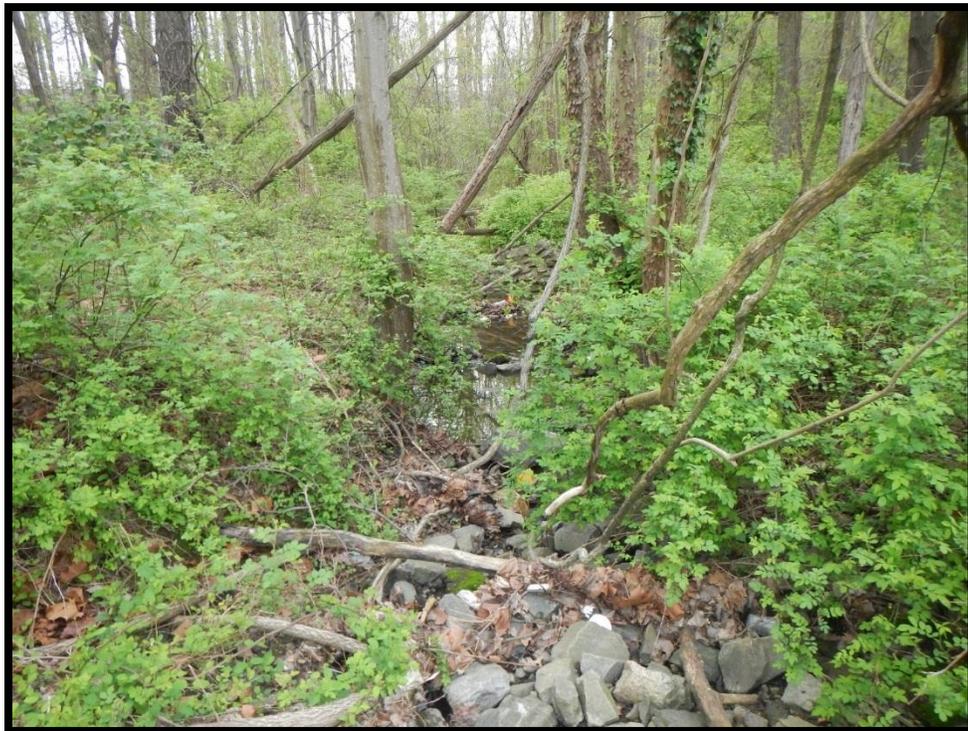
Waters N – Intermittent RPW

Waters N is an intermittent RPW located south of northbound I-95, and east of the Clayton Road overpass. Waters N flows south from a culvert under I-95 and drains to Waters G beyond the study area. Side slopes are 2:1 to 3:1, with minor erosion. Channel substrates consist of sands, gravel, and riprap. The channel has an average width of 3 feet, with a depth of 2-6 inches, and indicators of Ordinary High Water include clear, natural line impressed on the bank, vegetation matted down, bent, or absent, leaf litter disturbed, water staining, presence of flood litter/debris, presence of wrack line, and observed/predicted flow events. Both the right and left banks are forested. This feature is not shown on NWI or DNR GIS mapping, but is considered jurisdictional under Rapanos guidance as an RPW.

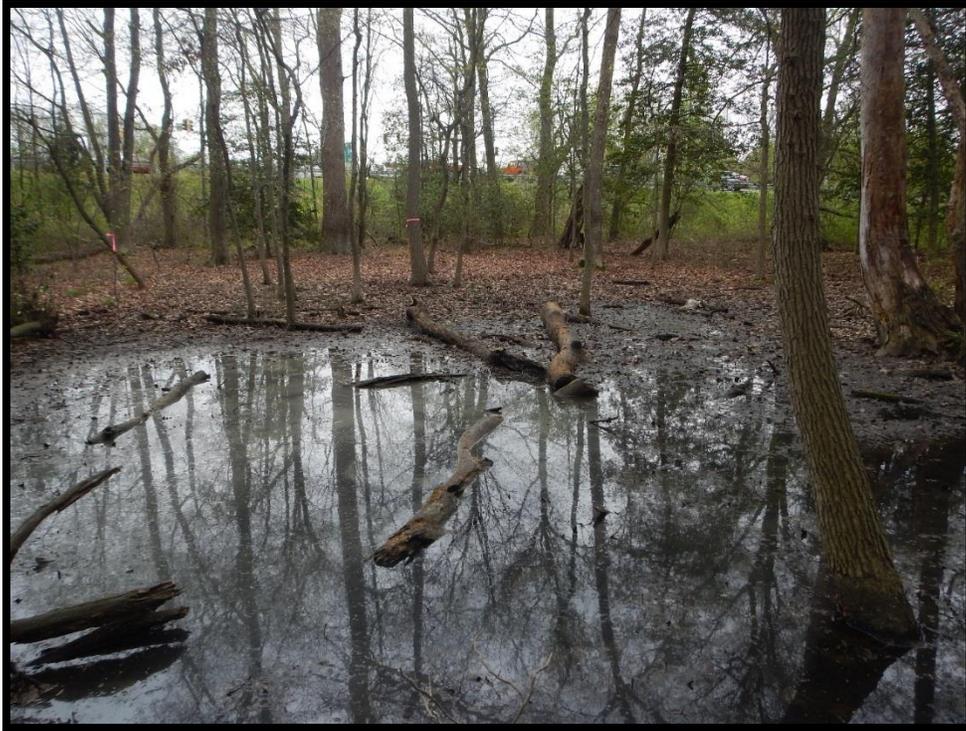
Wetland P – PFO

Wetland P is a palustrine forested wetland located north of the ramp from northbound I-95 to MD-24. Wetland P is a closed depression that collects roadside drainage and appears to be isolated. Dominant species include swamp white oak (*Quercus bicolor*, FACW), black gum (*Nyssa sylvatica*, FAC), and round-leaf greenbrier. Hydrologic indicators include the presence of surface water, water marks, water-stained leaves, oxidized rhizospheres on living roots, sparsely vegetated concave surface, and geomorphic position. The soils in this area met the hydric soil indicator F8: Redox Depressions. This wetland feature is not shown on NWI or DNR GIS mapping, however this area is considered jurisdictional, since all three wetland parameters were met during field investigations.

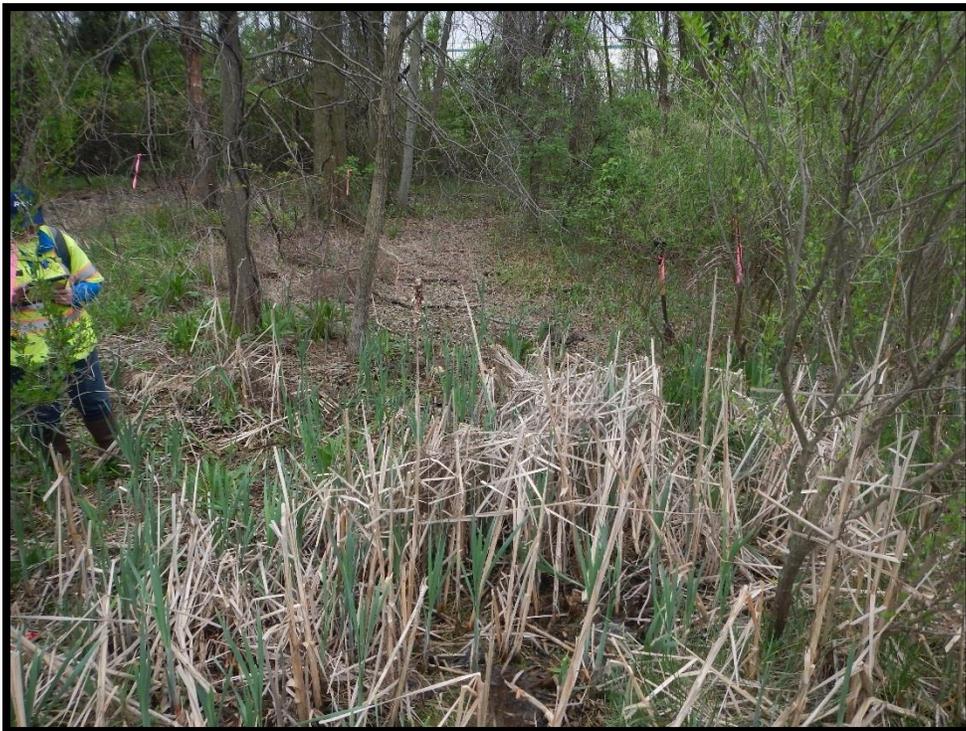
Wetland S – PFO

Wetland S is a palustrine forested wetland located south of northbound I-95, and east of Winter's Run. Wetland S is a small wetland at the toe of the roadway embankment that collects roadside drainage. Dominant species include pin oak (*Quercus palustris*, FACW), red maple and broad-leaf cattail. Hydrologic indicators include the presence of water-stained leaves, drainage patterns, and geomorphic position. The soils in this area met the hydric soil indicator F3: Depleted Matrix. This wetland feature is not shown on NWI or DNR GIS mapping, however this area is considered jurisdictional, since all three wetland parameters were met during field investigations.

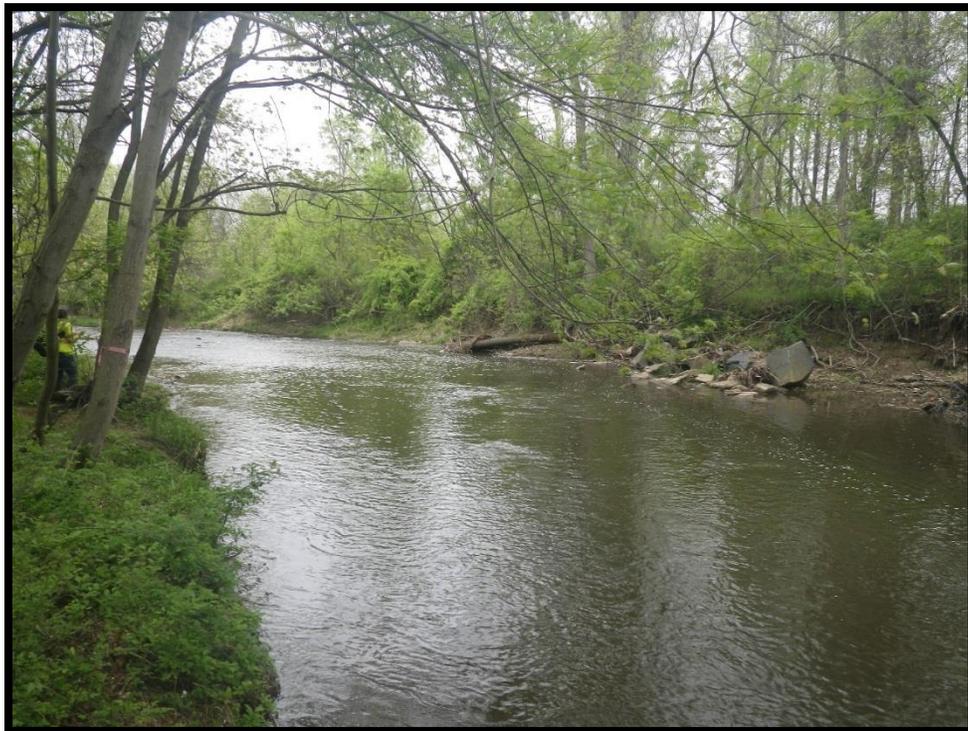
Waters U – Perennial RPW

Waters U is a perennial RPW (Winters Run) located along Fashion Way. Waters U flows south under I-95 and continues beyond the study area. Waters U receives contributing hydrology from Waters V, W and FF within the study area. Side slopes are 2:1, with stable banks. Channel substrates consist of silts, cobbles, sands, and gravel. The channel has an average width of 30 feet, with a depth of 6 inches to 3 feet, and indicators of Ordinary High Water include clear, natural line impressed on the bank, sediment deposition, presence of flood litter/debris, presence of wrack line, and observed/predicted flow events. The left bank is forested and the right bank consists of forest and road. This feature is shown on NWI or DNR GIS mapping, and is considered jurisdictional under Rapanos guidance as an RPW.

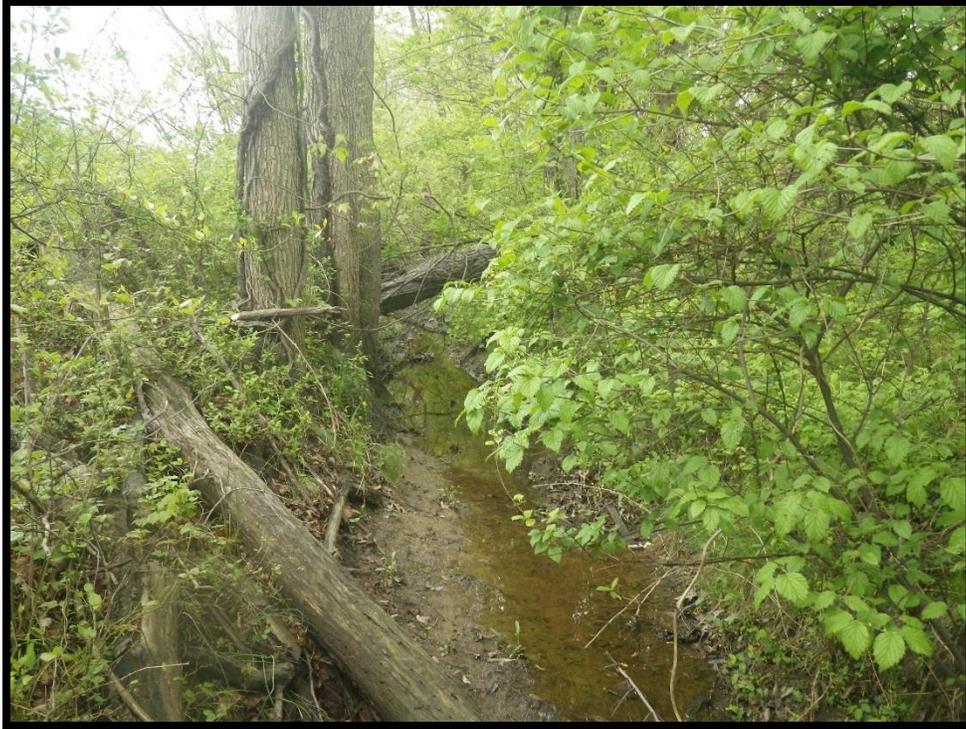
Waters V – Intermittent RPW

Waters V is an intermittent RPW located south of northbound I-95, and east of Winters Run. Waters V flows west from outside of the study area to Waters U, and receives contributing hydrology from Wetlands Q, R, S, and X. Side slopes are 2:1, with stable banks. Channel substrates consist of silts, sands, and gravel. The channel ranges from 2-5 feet wide, with an average depth of 6 inches, and indicators of Ordinary High Water include clear, natural line impressed on the bank, leaf litter disturbed, presence of flood litter/debris, presence of wrack line, and observed/predicted flow events. The right bank is forested and mowed grass, and the left bank is forested. This feature is not shown on NWI or DNR GIS mapping, but is considered jurisdictional under Rapanos guidance as an RPW.

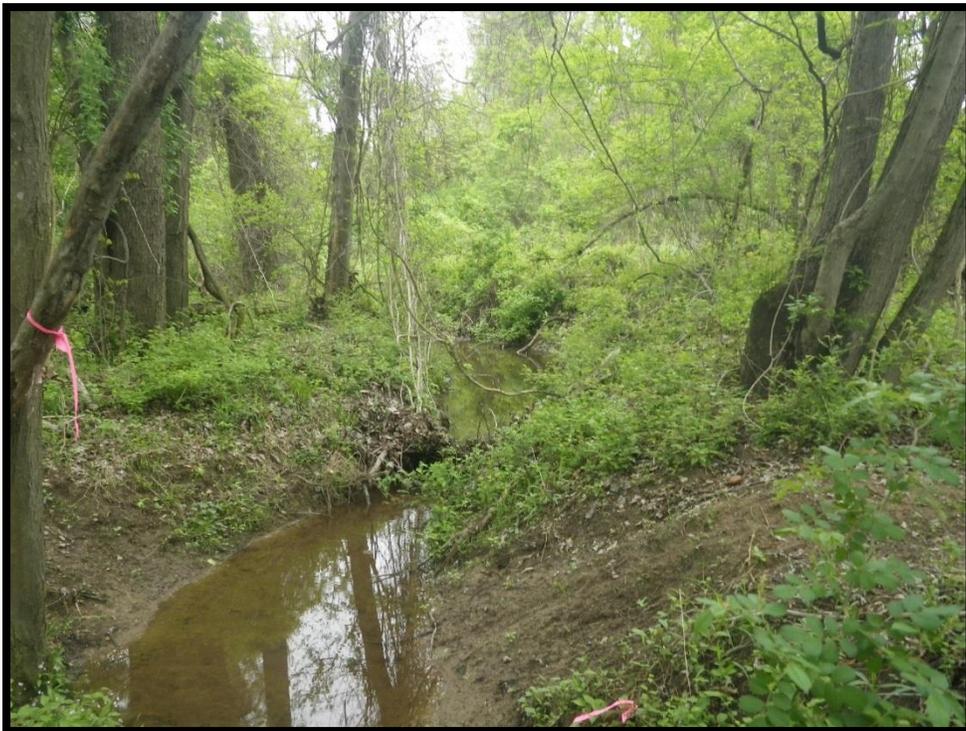
Waters W – Perennial RPW

Waters W is a perennial RPW located north of southbound I-95, and west of Winters Run. Waters W flows southeast from outside of the study area and drains to Waters U. Side slopes are 2:1, with stable banks. Channel substrates consist of silts and sands. The channel ranges from 1-4 feet wide, with a depth of 2-4 inches, and indicators of Ordinary High Water include clear, natural line impressed on the bank and observed/predicted flow events. Both the right and left banks are forested. This feature is not shown on NWI or DNR GIS mapping, but is considered jurisdictional under Rapanos guidance as an RPW.

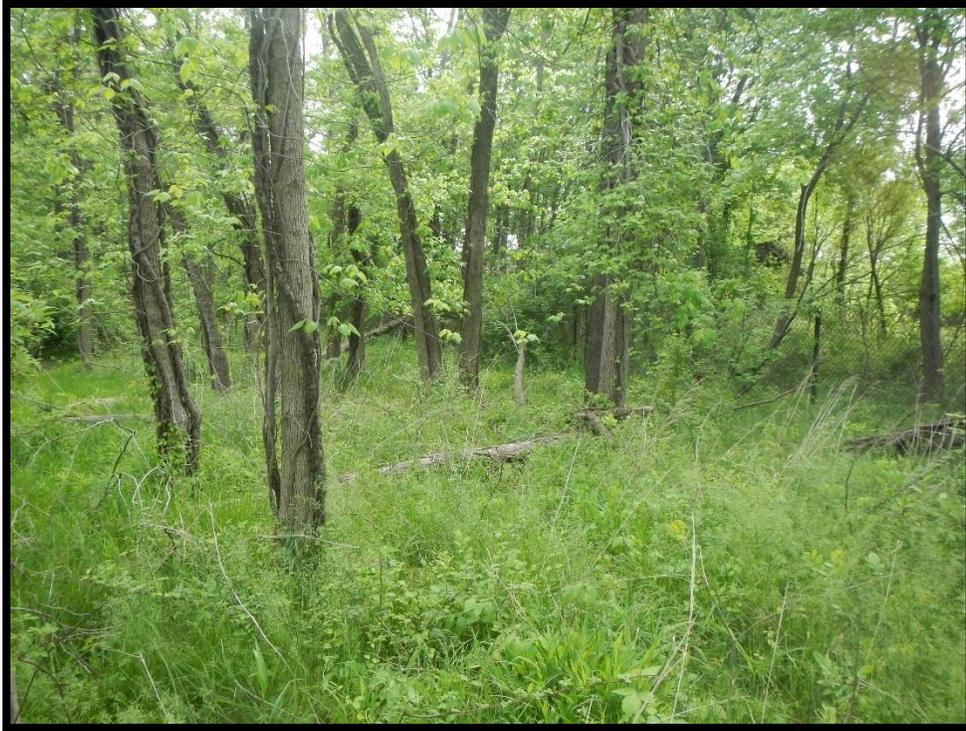
Wetland X – PFO

Wetland X is a palustrine forested wetland located south of northbound I-95, and west of the ramp from I-95 northbound to MD-24. Wetland X is located at the toe of the I-95 roadway slope. Dominant species include green ash, multiflora rose, reedtop (*Agrostis gigantea*, FACW), fox-tail sedge (*Carex alopecoidea*, FACW), and poison ivy. Hydrologic indicators include the presence of water-stained leaves, oxidized rhizospheres on living roots, drainage patterns, and geomorphic position. The soils in this area met the hydric soil indicator F3: Depleted Matrix. This wetland feature is not shown on NWI or DNR GIS mapping, however this area is considered jurisdictional, since all three wetland parameters were met during field investigations.

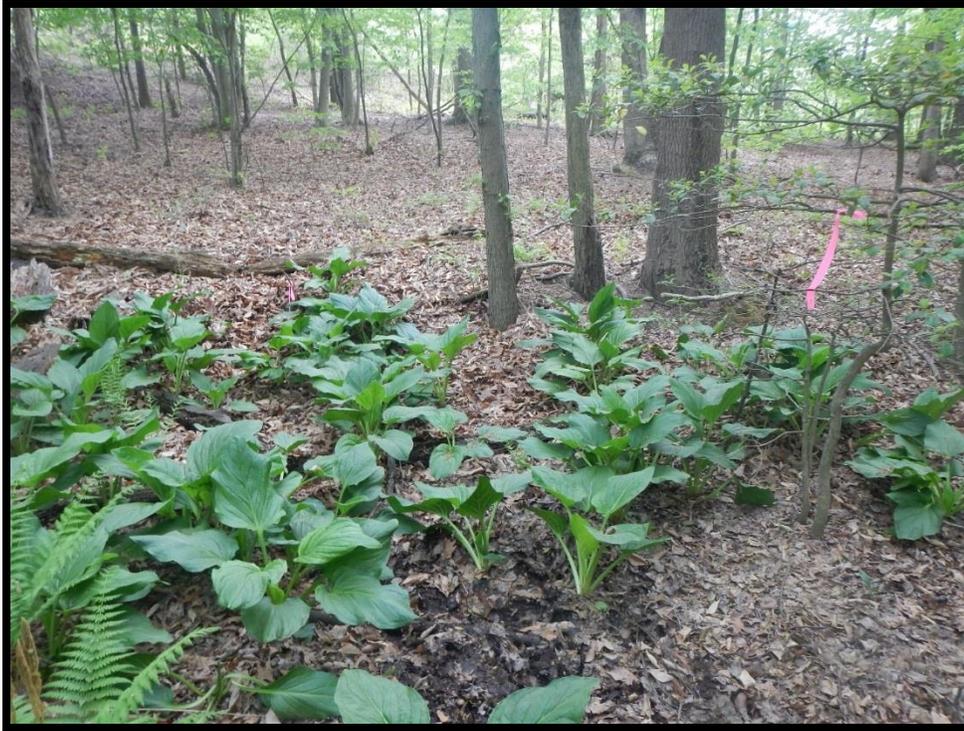
Wetland Z – PFO

Wetland Z is a palustrine forested wetland located within the cloverleaf of the ramp from southbound I-95 to MD-24. Wetland Z is a small floodplain depression that drains to Waters Y. Dominant species include skunk cabbage (*Symplocarpus foetidus*, OBL), with inclusions of cinnamon fern (*Osmundastrum cinnamomeum*, FACW). Hydrologic indicators include the presence of high water table, saturation, water-stained leaves, hydrogen sulfide odor, oxidized rhizospheres on living roots, and presence of reduced iron. The soils in this area met the hydric soil indicator F3: Depleted Matrix. This wetland feature is not shown on NWI or DNR GIS mapping, however this area is considered jurisdictional, since all three wetland parameters were met during field investigations.

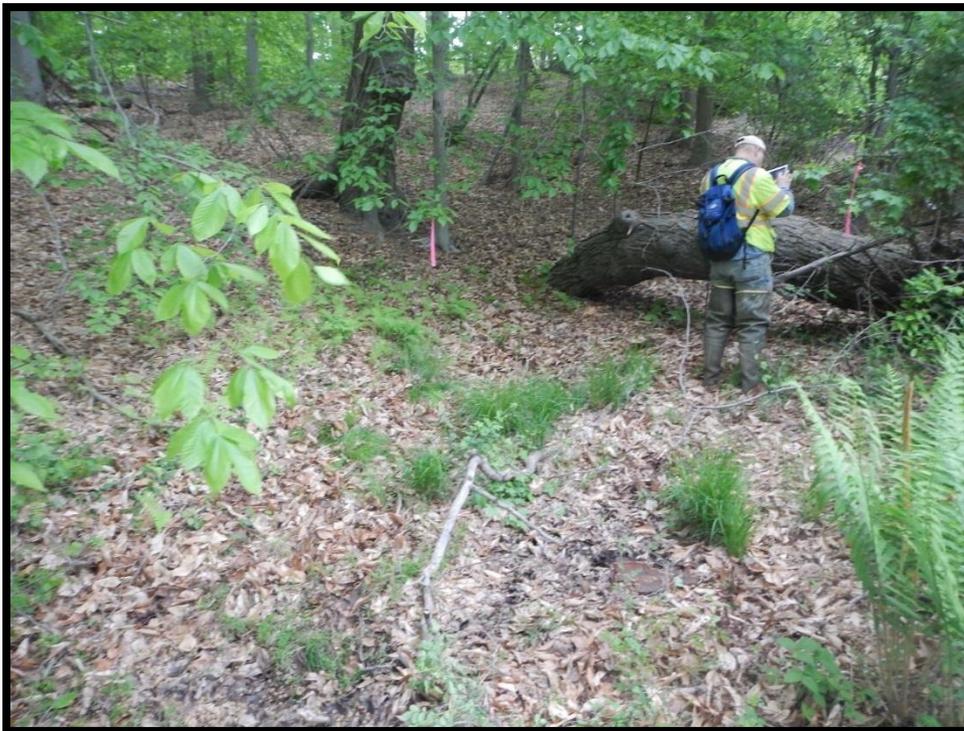
Wetland AA – PFO

Wetland AA is a palustrine forested wetland located within the cloverleaf of the ramp from southbound I-95 to MD-24. Wetland AA emerges as a seep and drains to Waters Y. Dominant species include Japanese stiltgrass (*Microstegium vimineum*, FAC), quill sedge (*Carex tenera*, FAC), and multiflora rose. Hydrologic indicators include high water table, saturation, hydrogen sulfide odor, presence of reduced iron, and drainage patterns. The soils in this area met the hydric soil indicators A4: Hydrogen Sulfide and F3: Depleted Matrix. This wetland feature is not shown on NWI or DNR GIS mapping, however this area is considered jurisdictional, since all three wetland parameters were met during field investigations.
