MEMORANDUM

Date: March 2, 2018
To: William Pines- MDTA
From: Ed Tinney
CC: James Harkness, Serena Liu, Peter Mattejat, Pam McNicholas, Don MacLean,
Lauren Waesche- MDTA; Mitch Scott & Greg O’Hare- RK&K
Re: I-95 5th Lane Widening from MD 152 to MD 24 – Natural Resource Inventory (Revised)

**I-95 5th LANE WIDENING
FROM MD 152 TO MD 24
FIGURE 2. PROJECT STUDY AREA MAP
NOVEMBER 2017**

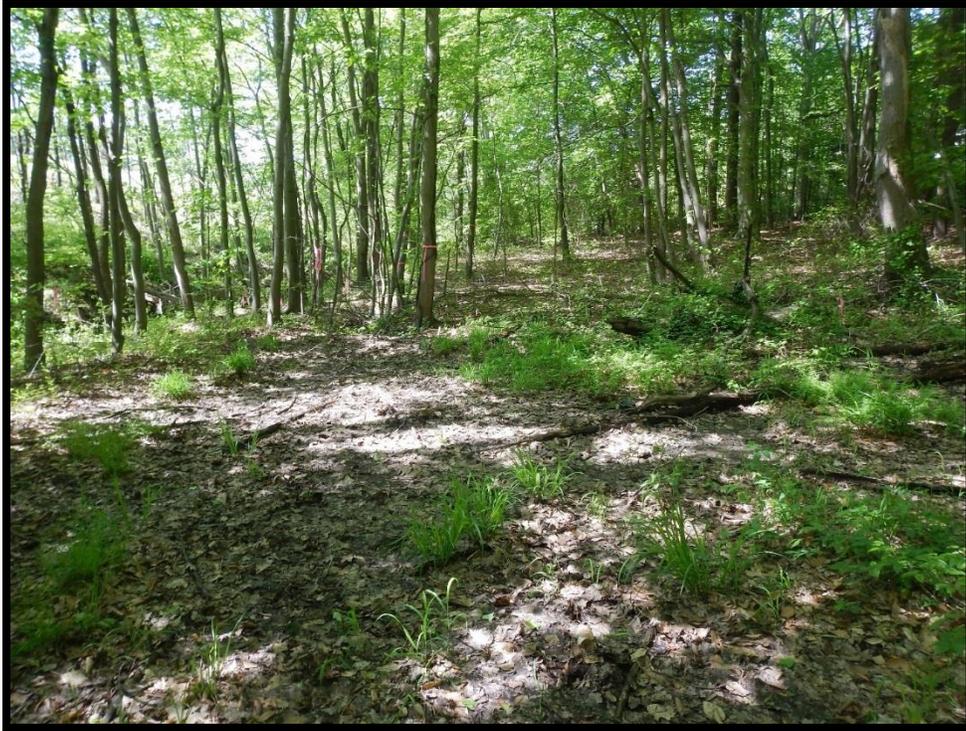
Wetland BB – PFO

Wetland BB is a palustrine forested wetland located within the gore area of the ramp from southbound MD-24 to southbound I-95. Wetland BB is a small, sparsely vegetated wetland depression that drains to Waters CC. Dominant species include red maple and round-leaf greenbrier. Hydrologic indicators include water-stained leaves, sparsely vegetated concave, surface and saturation visible on aerial imagery. The soils in this area met the hydric soil indicator F3: Depleted Matrix. This wetland feature is not shown on NWI or DNR GIS mapping, however this area is considered jurisdictional, since all three wetland parameters were met during field investigations.

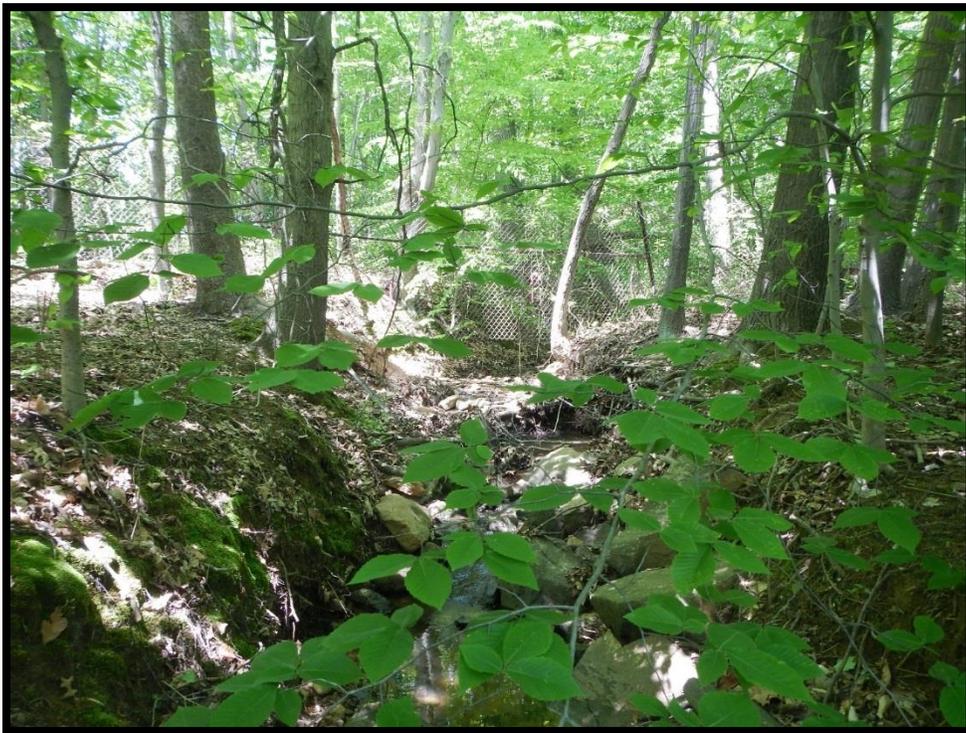
Waters EE – Perennial RPW

Waters EE is a perennial RPW located north of the ramp from southbound MD-24 to southbound I-95. Waters EE flows south from outside of the study area and drains to Waters Y. Side slopes are 2:1, with moderate erosion. Channel substrates consist of silts, cobbles, sands, and gravel. The channel has an average width of 6 feet, with an average depth of 12 inches, and indicators of Ordinary High Water include clear, natural line impressed, on the bank, leaf litter disturbed, water staining, presence of wrack line and observed/predicted flow events. Both the right and left banks are forested. This feature is not shown on NWI or DNR GIS mapping, but is considered jurisdictional under Rapanos guidance as an RPW.

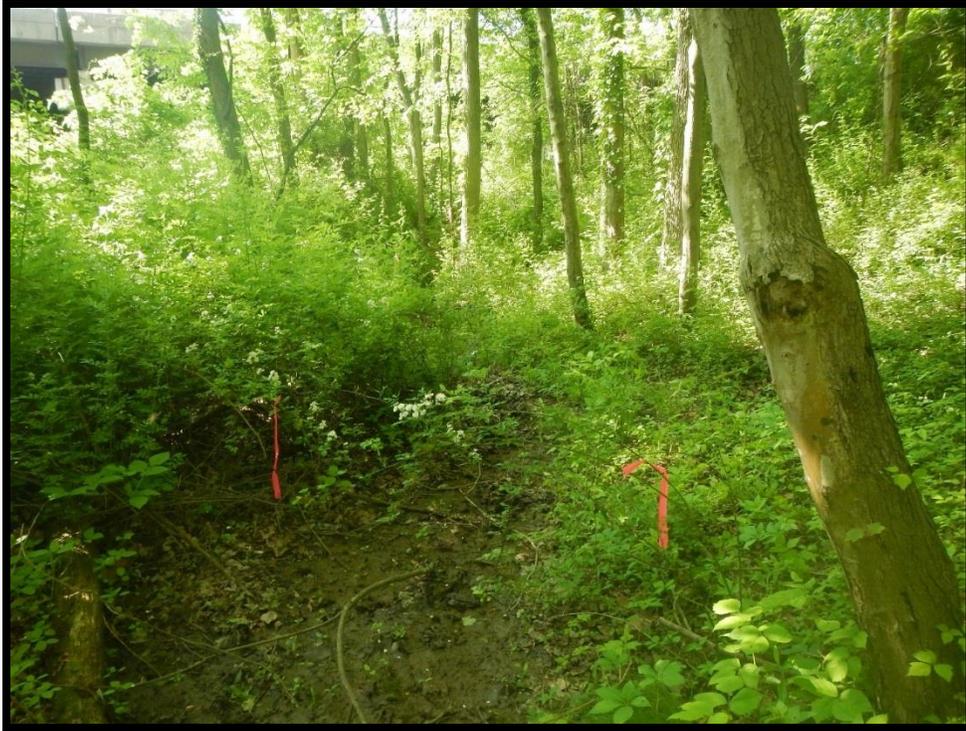
Waters FF – Perennial RPW

Waters FF is an intermittent RPW located north of southbound I-95, and west of Winters Run. Waters FF flows southeast from outside of the study area, continues through a culvert under Fashion Way, and drains to Waters U. Side slopes are 2:1 to 3:1, with stable banks. Channel substrates consist of silts, concrete, and muck. The channel has an average width of 2 feet, with a depth of 2-10 inches, and indicators of Ordinary High Water include vegetation matted down, bent, or absent and water staining. Both the right and left banks are forested. This feature is not shown on NWI or DNR GIS mapping, but is considered jurisdictional under Rapanos guidance as an RPW.

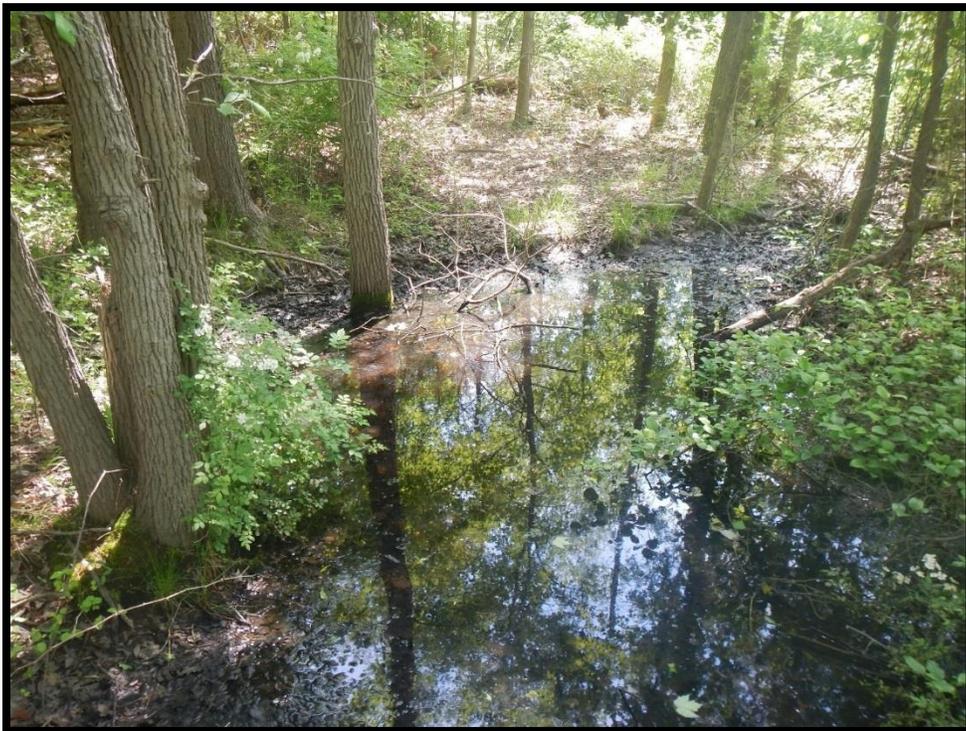
Wetland GG – PFO

Wetland GG is a palustrine forested wetland located north of southbound I-95, and east of the Clayton Road overpass. Wetland GG originates as a depression, and continues as a linear feature before draining to Waters HH. Dominant species include black gum, poison ivy, broom sedge (*Carex scoparia*, FACW), and round-leaf greenbrier. Hydrologic indicators include the presence of surface water, high water table, saturation, water marks, water-stained leaves, hydrogen sulfide odor, oxidized rhizospheres on living roots, sparsely vegetated concave surface, and geomorphic position. The soils in this area met the hydric soil indicator F3: Depleted Matrix. This wetland feature is not shown on NWI or DNR GIS mapping, however this area is considered jurisdictional, since all three wetland parameters were met during field investigations.

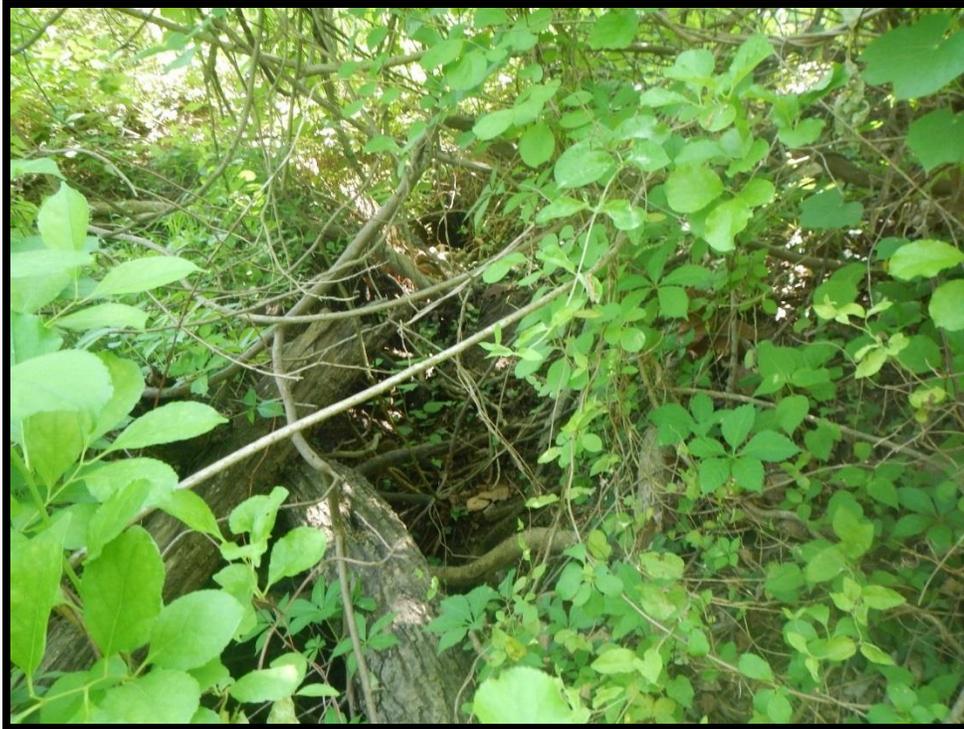
Waters HH – Ephemeral Non-RPW

Waters HH is an ephemeral non-RPW with an abutting wetland located north of southbound I-95, and east of the Clayton Road overpass. Waters HH receives contributing hydrology from Wetland GG, flows northeast and drains to Waters M. Side slopes are 1:1 to 3:1, with stable banks in the upper reach and incision in the lower reach. Channel substrates consist of silts, bedrock, and gravel. The channel ranges from 1-6 feet wide, with an average depth of 3 inches, and indicators of Ordinary High Water include vegetation matted down, bent, or absent, leaf litter disturbed, water staining, and scour. Both

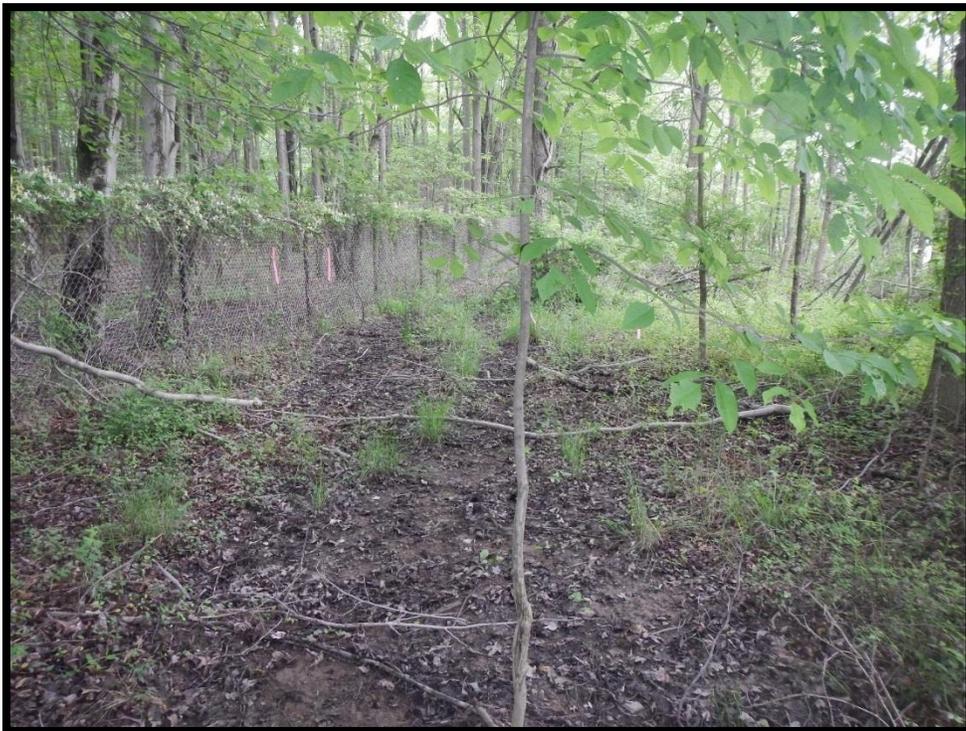
Wetland KK – PFO

Wetland KK is a palustrine forested wetland located north of southbound I-95, and west of the Clayton Road overpass. Wetland KK is a depressional wetland that drains to Waters JJ. Dominant species include green ash (*Fraxinus pennsylvanica*, FAC), red maple, sweet gum, pin oak, fox-tail sedge, path rush (*Juncus tenuis*, FAC), and Japanese honeysuckle. Hydrologic indicators include water-stained leaves, and drainage patterns. The soils in this area met the hydric soil indicator F3: Depleted Matrix. This wetland feature is not shown on NWI or DNR GIS mapping, however this area is considered jurisdictional, since all three wetland parameters were met during field investigations.

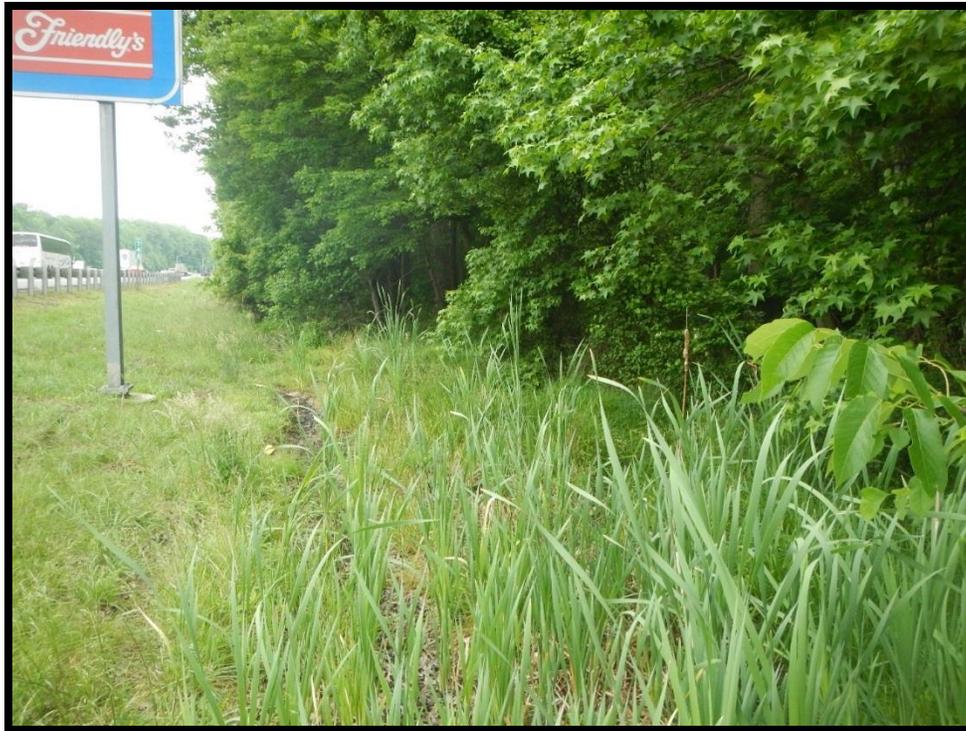
Wetland LL – PEM

Wetland LL is a palustrine emergent wetland located north of southbound I-95, and west of the Clayton Road overpass. Wetland LL is a linear wetland at the toe of the I-95 roadway embankment that drains to Waters J. Dominant species include broad-leaf cattail and fox-tail sedge. Hydrologic indicators include high water table, water-stained leaves, and geomorphic position. The soils in this area met the hydric soil indicator F3: Depleted Matrix. This wetland feature is not shown on NWI or DNR GIS mapping, however this area is considered jurisdictional, since all three wetland parameters were met during field investigations.

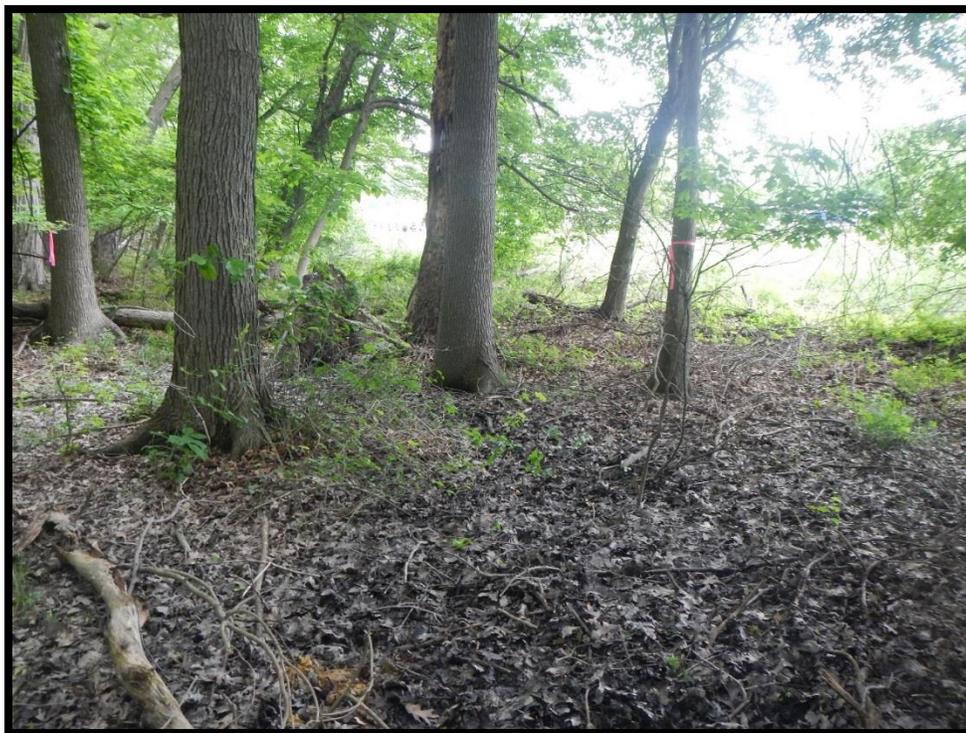
Wetland MM – PFO

Wetland MM is a palustrine forested wetland located north of northbound I-95, and west of the Clayton Road overpass. Dominant species include red maple, pin oak, sweet gum, winterberry (*Ilex verticillata*, FACW), and round-leaf greenbrier. Hydrologic indicators include water-stained leaves, sparsely vegetated concave surface, saturation visible on aerial imagery, and geomorphic position. The

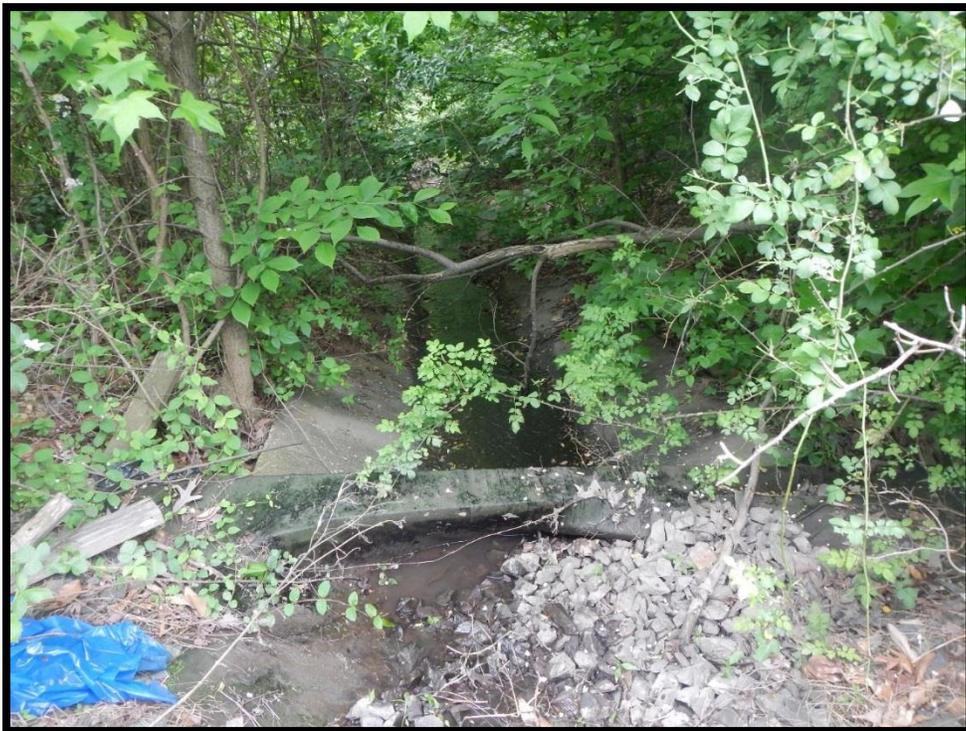
Waters OO – Intermittent RPW

Waters OO is an intermittent RPW located within the cloverleaf of the ramp from southbound I-95 to MD-24. Waters OO receives contributing hydrology from a stormwater management pond and flows south to Waters Y. Side slopes are 3:1, with stable banks. Channel substrates consist of silts, cobbles, concrete, and riprap. The channel ranges from 2-6 feet wide, with a depth of 2-8 inches, and indicators of Ordinary High Water include clear, natural line impressed on the bank, water staining, and observed/predicted flow events. Both the right and left banks are forested. This feature is not shown on NWI or DNR GIS mapping, but is considered jurisdictional under Rapanos guidance as an RPW.

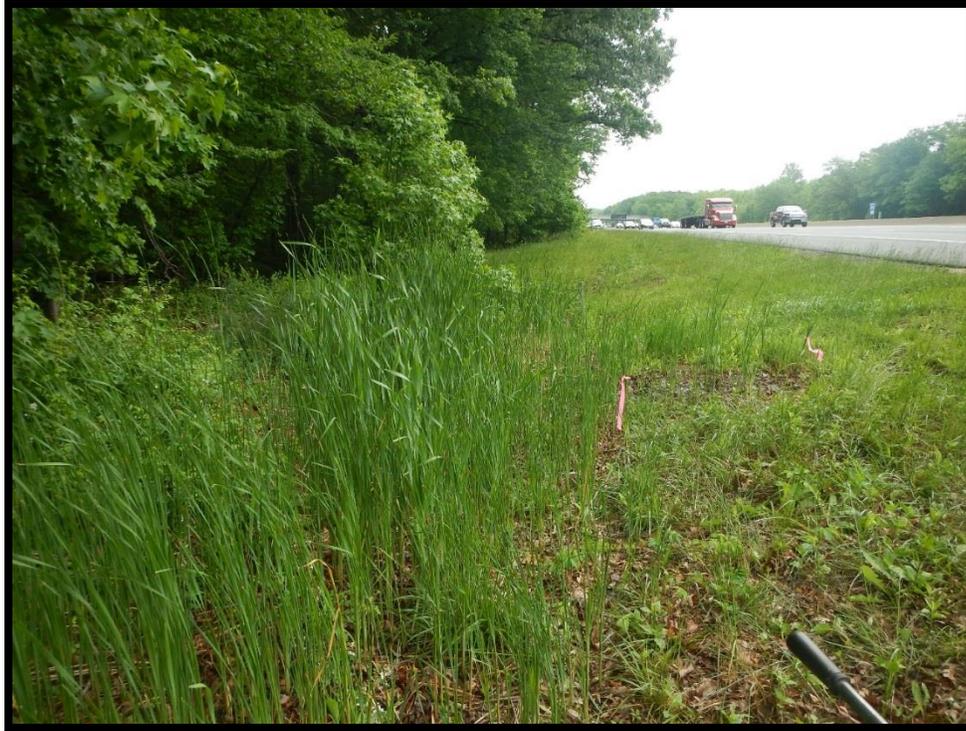
Wetland PP – PEM

Wetland PP is a palustrine emergent wetland located north of southbound I-95, and east of the I-95/MD-152 intersection. Wetland PP drains to an inlet that ultimately flows to Waters E. Dominant species include broad-leaf cattail and narrow-leaf cattail. Hydrologic indicators include the presence of surface water, high water table, saturation, water-stained leaves, and geomorphic position. The soils in this area met the hydric soil indicator F3: Depleted Matrix. This wetland feature is not shown on NWI or DNR GIS mapping, however this area is considered jurisdictional, since all three wetland parameters were met during field investigations.

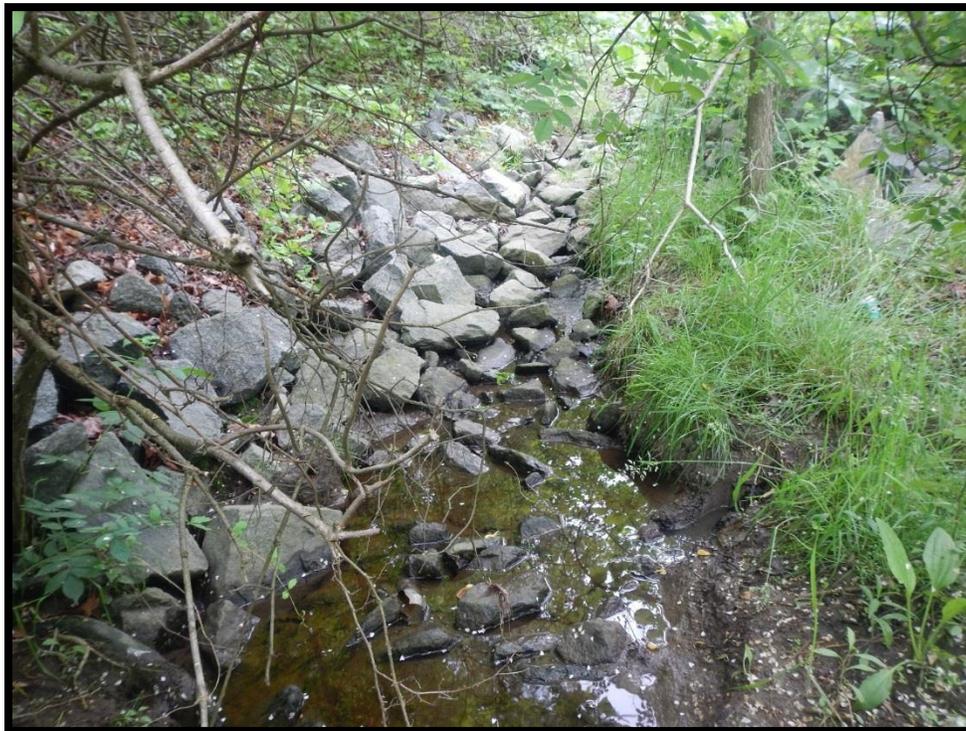
Waters QQ – Intermittent RPW

Waters QQ is an intermittent RPW located within the gore area of the ramp from southbound I-95 to MD-152. Waters QQ originates at a pipe outfall and flows southeast to Waters G. Side slopes are 3:1, with stable banks. Channel substrates consist of silts, sands, and riprap. The channel ranges from 2-4 feet wide, with an average depth of 6 inches, and indicators of Ordinary High Water include vegetation matted down, bent or absent, water staining, and observed/predicted flow events. Both the right and left banks are forested. This feature is not shown on NWI or DNR GIS mapping, but is considered jurisdictional under Rapanos guidance as an RPW.

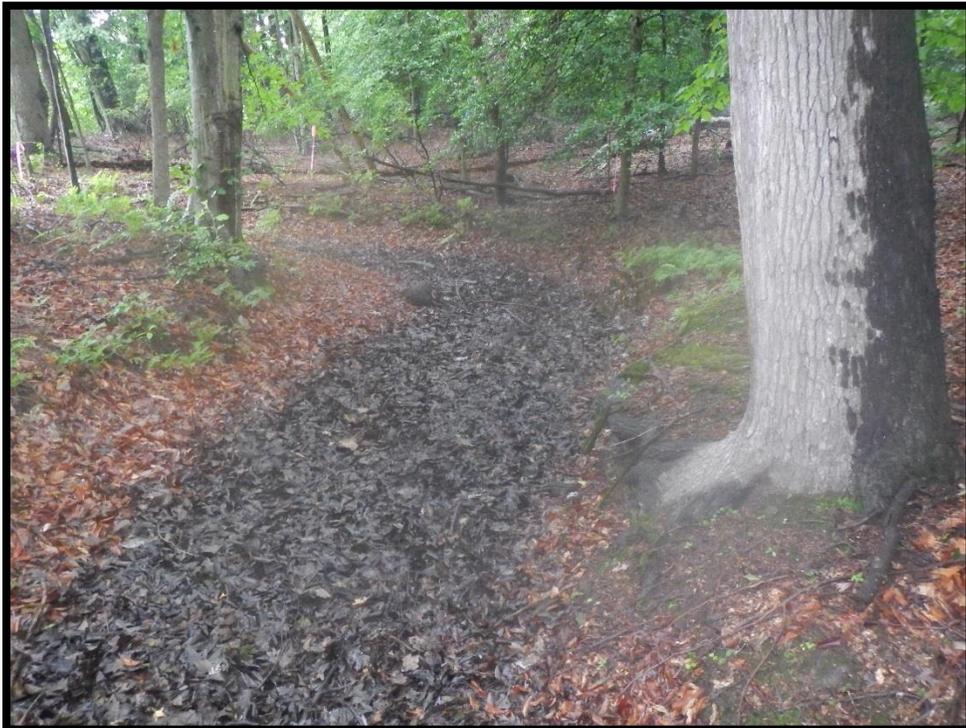
Wetland SS – PFO

Wetland SS is a palustrine forested wetland located north of southbound I-95 and east of the I-95/MD-152 intersection. Wetland SS is adjacent to Waters G, but no visible hydrologic connectivity was observed. The dominant species is red maple, but vegetation is sparse. Hydrologic indicators include high water table, saturation, water-stained leaves, sparsely vegetated concave surface, and geomorphic position. The soils in this area met the hydric soil indicator F3: Depleted Matrix. This wetland feature is not shown on NWI or DNR GIS mapping, however this area is considered jurisdictional, since all three wetland parameters were met during field investigations.

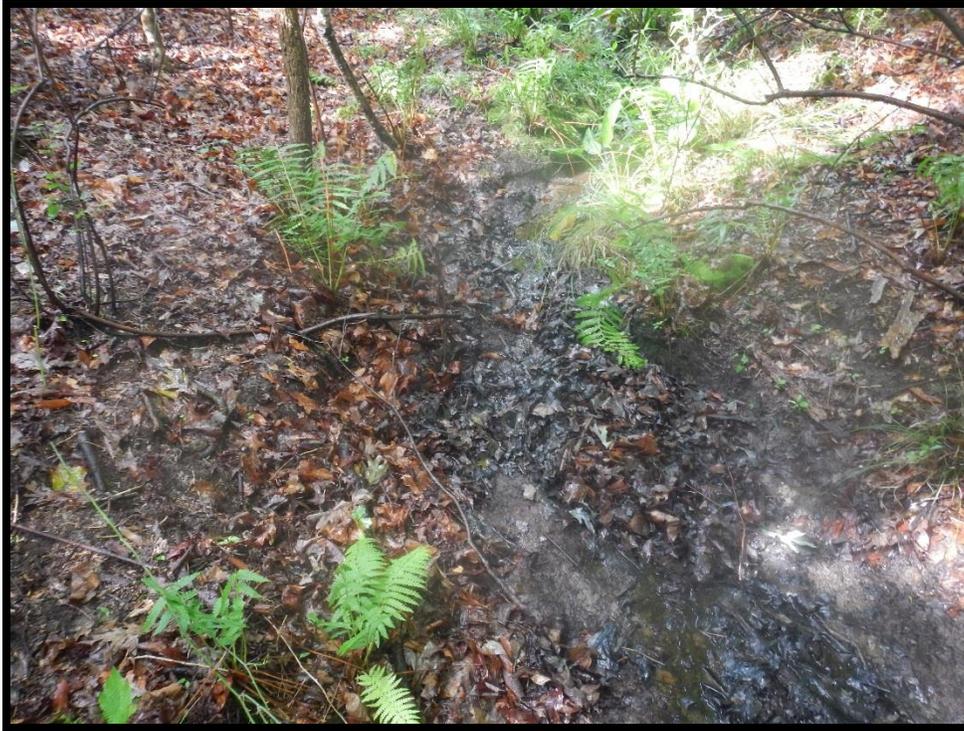
Waters TT – Ephemeral Non-RPW

Waters TT is an ephemeral non-RPW draining uplands located north of southbound I-95, and east of the I-95/MD-152 intersection. Waters TT originates as roadside drainage and flows north to Waters G outside of the study area. Side slopes are 3:1, with moderately stable banks. Channel substrates consist of silts, muck, and leaves. The channel has a width of 1-6 feet, with an average depth 3 inches, and indicators of Ordinary High Water include vegetation matted down, bent or absent, leaf litter disturbed, water staining, and scour. Both the right and left banks are forested. This feature is not shown on NWI or DNR GIS mapping, but is potentially considered jurisdictional pending USACE review.

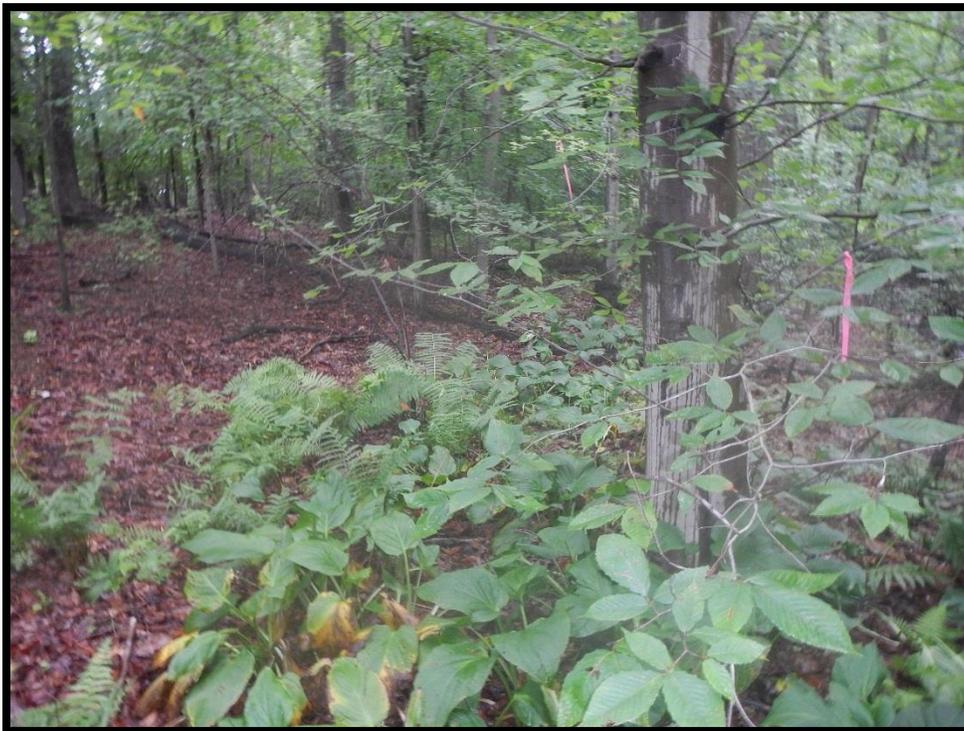
Wetland UU – PFO

Wetland UU is a palustrine forested wetland located north of southbound I-95, and east of the I-95/MD-152 intersection. Wetland UU is a floodplain depression that drains to Waters G outside of the study area. Dominant species include red maple, arrowwood, highbush blueberry (*Vaccinium corymbosum*, FACW), American beech (*Fagus grandifolia*, FACU), and skunk cabbage. Hydrologic indicators include the presence of surface water, high water table, saturation, water-stained leaves, drainage patterns, crayfish burrows, geomorphic position, and microtopographic relief. The soils in this area met the hydric soil indicator F3: Depleted Matrix. This wetland feature is not shown on NWI or DNR GIS mapping, however this area is considered jurisdictional, since all three wetland parameters were met during field investigations.

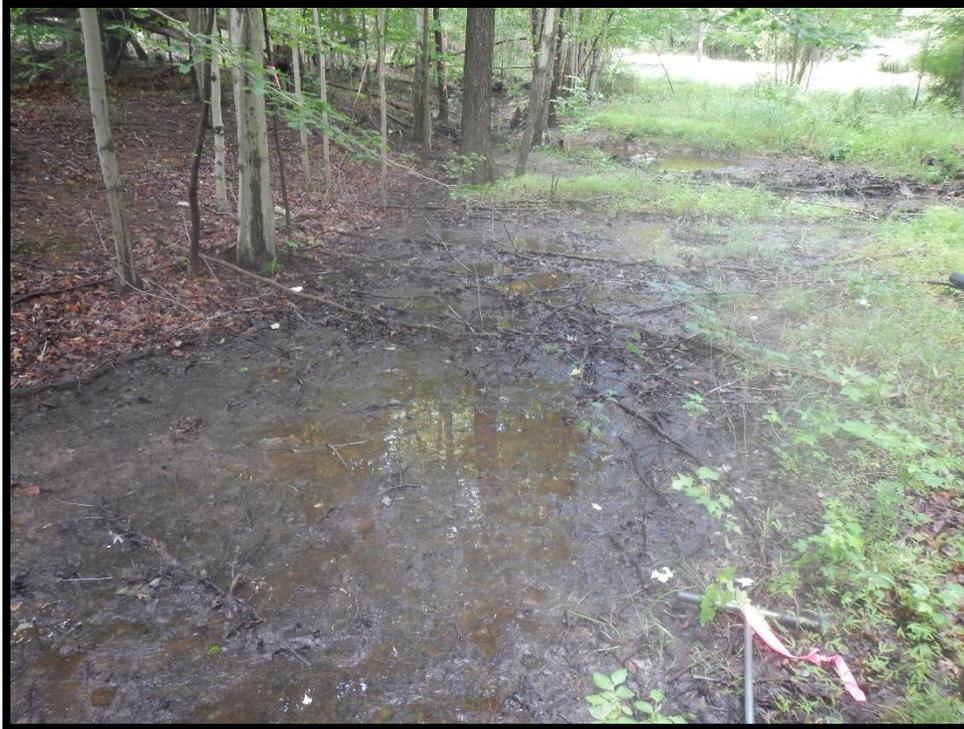
Wetland VV – PFO

Wetland VV is a palustrine forested wetland located north of southbound I-95, and east of the I-95/MD-152 intersection. Wetland VV is a disturbed wetland adjacent to Waters G. Dominant species include red maple and sweet gum. Hydrologic indicators include the presence of surface water, high water table, saturation, drift deposits, water-stained leaves, presence of reduced iron and sparsely vegetated concave surface. The soils in this area are significantly disturbed and contain fill material throughout the profile. The soil did not exhibit the chroma requirements to meet a hydric soil indicator, but alpha alpha-dipyridyl strips tested positive for reducing conditions in the upper four inches, and the upper 2-14 inches contained abundant redoximorphic features. This wetland feature is not shown on NWI or DNR GIS mapping, but is potentially considered jurisdictional pending MDE and USACE review.

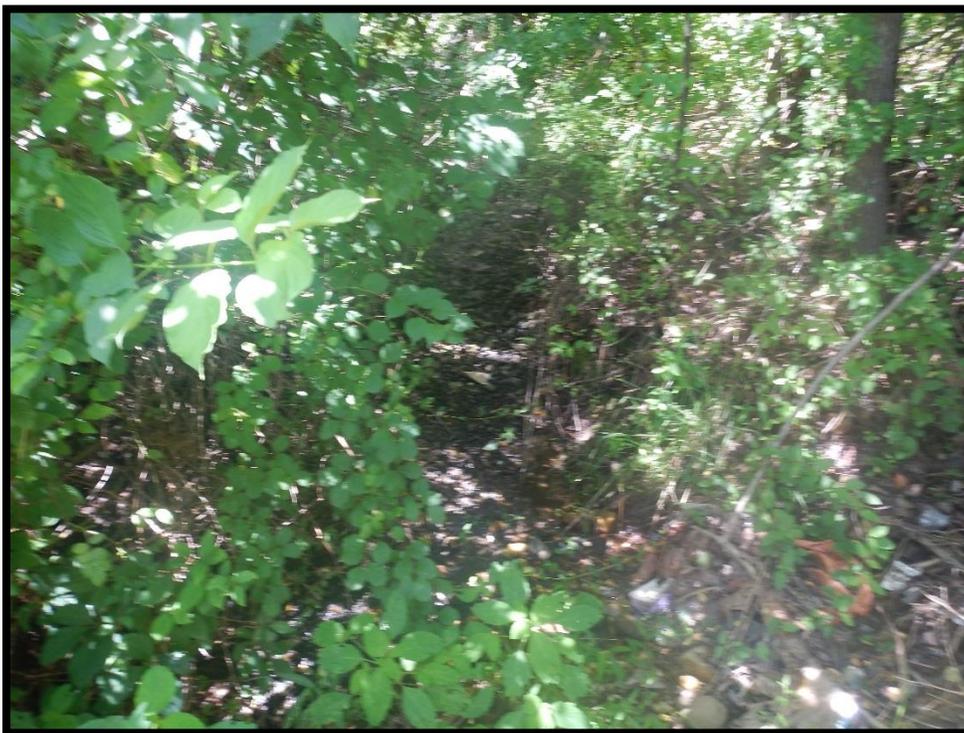
Waters WW – Ephemeral Non-RPW

Waters WW is an ephemeral non-RPW draining uplands located north of southbound I-95, and east of the Clayton Road overpass. Waters WW originates outside of the study and flows south under I-95 through a culvert to Waters N. Side slopes are $\geq 1:1$, with moderate erosion. Channel substrates consist of silts, cobbles, sands and gravels. The channel has a width of 4-6 feet, with an average depth 3 inches, and indicators of Ordinary High Water include vegetation matted down, bent or absent, leaf litter disturbed, sediment deposition, presence of flood litter/debris, destruction of terrestrial vegetation, presence of wrack line, sediment sorting, and scour. Both the right and left banks are volunteer hedgerow. This feature is not shown on NWI or DNR GIS mapping, but is potentially considered jurisdictional pending USACE review.

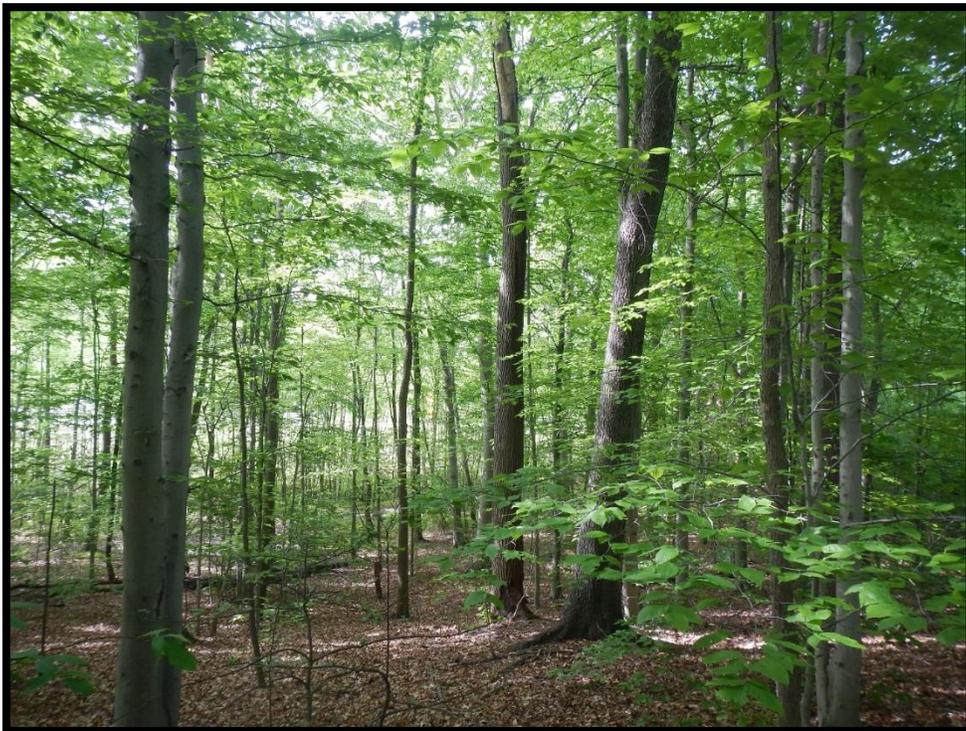
Forest Stand 6

FS6 is a mid-successional Tulip Poplar Association forest located within the gore area of the ramp from southbound MD-24 to southbound I-95, in the northeastern portion of the study area. The dominant size class is 12-20 inches DBH, with a canopy closure estimated at approximately 90%. The dominant canopy species in FS6 consist of American beech, tulip poplar, white oak and red maple. The dominant understory species include American beech, sweet gum and red maple. The herbaceous layer includes round-leaf greenbrier, and American beech and red maple seedlings. FS6 is in good condition overall, with moderate downed woody debris, and low levels of invasive species. FS6 has high retention value due to low invasive species cover, and the presence of streams, wetlands, and specimen trees within the stand.

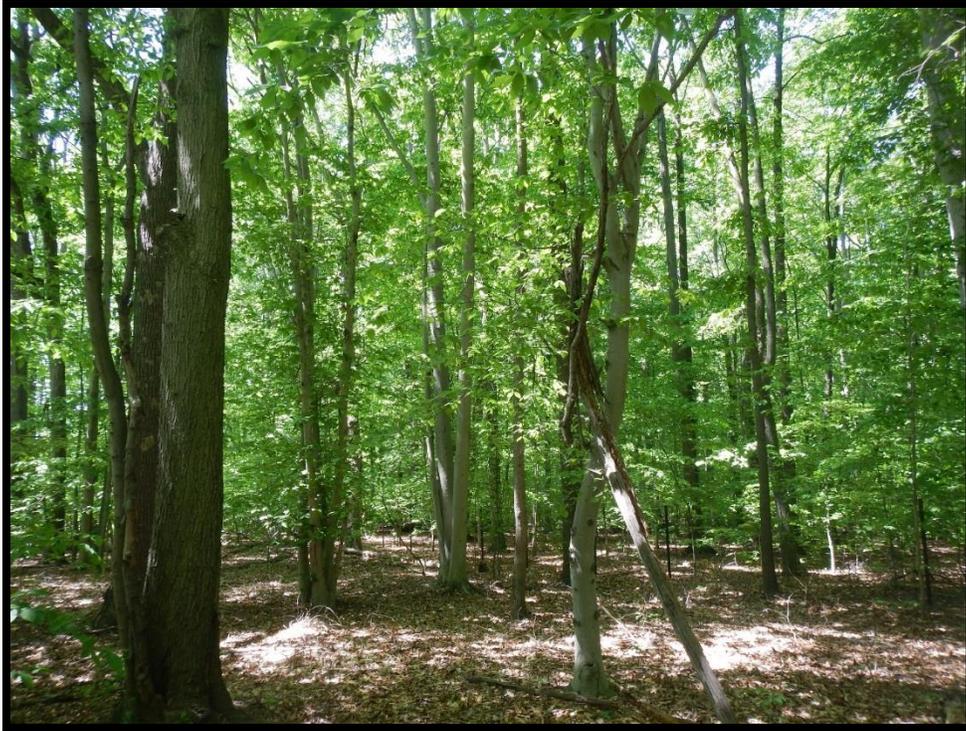
Forest Stand 7

FS7 is a mid-successional Tulip Poplar Association forest located northwest of the ramp from southbound MD-24 to southbound I-95, in the northeastern portion of the study area. The dominant size class is 6-20 inches DBH, with a canopy closure estimated at approximately 80%. The dominant canopy species in FS7 consist of red maple, American beech, tulip poplar, and white oak. The dominant understory species include American beech, and black gum. The dominant species in the herbaceous layer is American beech seedlings. FS7 is in good condition overall, with moderate downed woody debris, and low levels of invasive species. FS7 has moderate retention value due to low invasive species cover, overall stand condition, and presence of specimen trees within the stand.

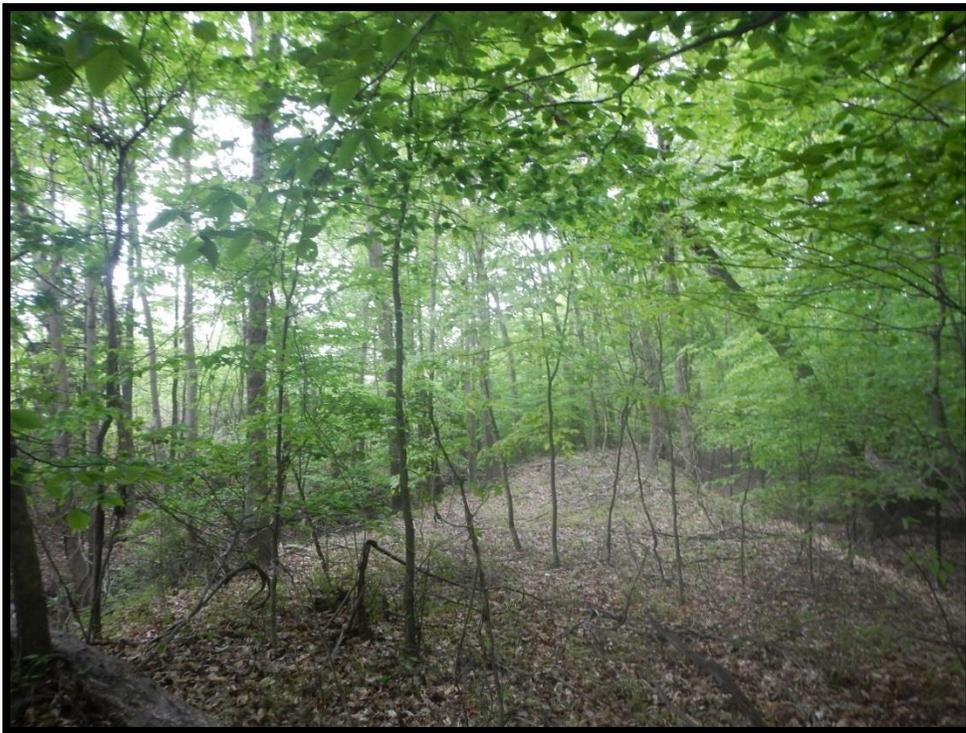
Forest Stand 8

FS8 is an early successional Tulip Poplar Association forest located north of southbound I-95, west of MD-24 in the northeastern portion of the study area. The dominant size class is 6-20 inches DBH, with a canopy closure estimated at approximately 75%. The dominant canopy species in FS8 consist of red maple, sweet gum, tulip poplar, and American beech. The dominant understory species include American beech, sweet gum and red maple. The herbaceous layer includes round-leaf greenbrier, multiflora rose, poison ivy and Japanese honeysuckle. FS8 is in fair condition overall, with low downed woody debris, and high levels of invasive species. FS8 has high retention value due to the presence of streams within the stand.

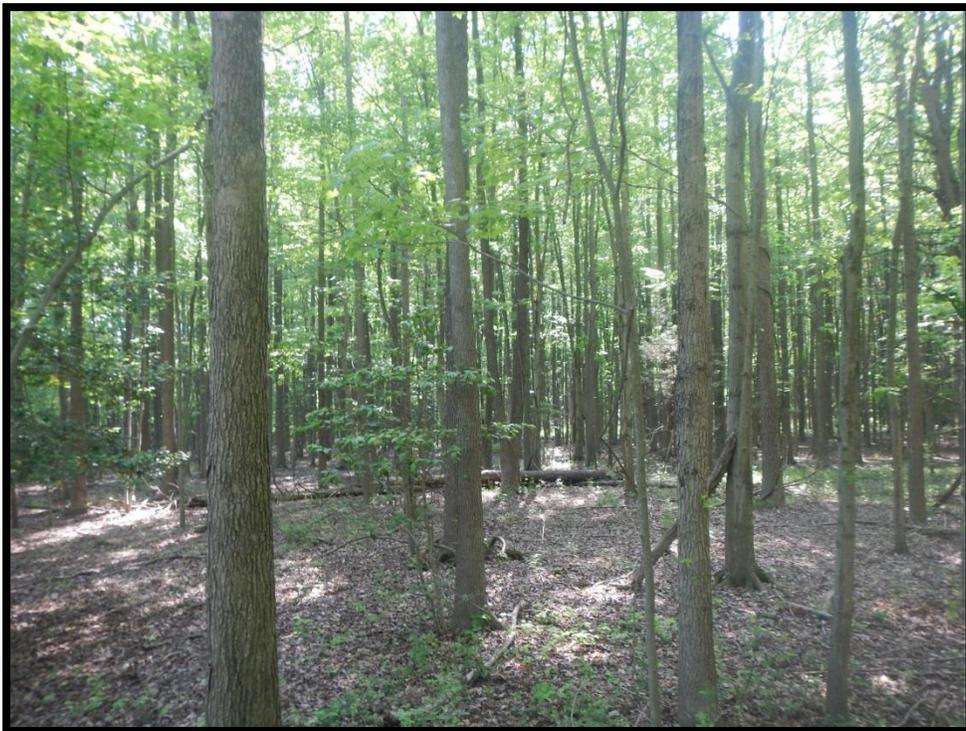
Forest Stand 10

FS10 is a mid-successional Red Maple Association forest located north of southbound I-95, and east of MD-152 in the southwestern portion of the study area. The dominant size class is 6-20 inches DBH, with a canopy closure estimated at approximately 75%. The dominant canopy species in FS10 consist of red maple and sweet gum. The dominant understory species include American beech, sweet gum and red maple. The herbaceous layer includes round-leaf greenbrier, multiflora rose, red maple and sweet gum. FS10 is in good condition overall, with moderate downed woody debris, and low levels of invasive species. FS10 has high retention value due to good overall condition, low invasive species cover, and presence of streams, wetlands and specimen trees within the stand.

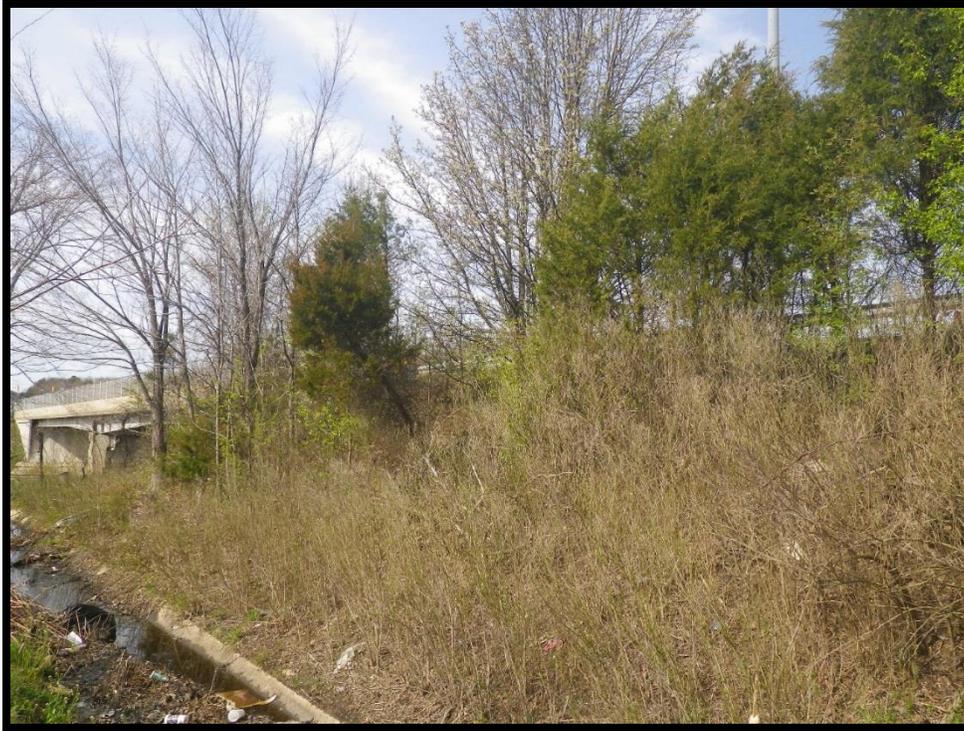
Hedgerow 1

This vegetated area was classified as a hedgerow during the field investigation, since it lacked the woody stem density to meet the MD DNR definition of forest. H1 is an early-successional Eastern Red Cedar Association. The dominant species include red cedar and callery pear (*Pyrus calleryana*), with a dominant size class of 2-6 inches DBH. The dominant understory species include eastern baccharis (*Baccharis halimifolia*) and sweet gum. The dominant herbaceous layer species is Japanese honeysuckle. H1 is in fair condition overall, with moderate downed woody debris and high levels of invasive species. H1 has low retention value due to its early successional stage and extensive invasive species cover.

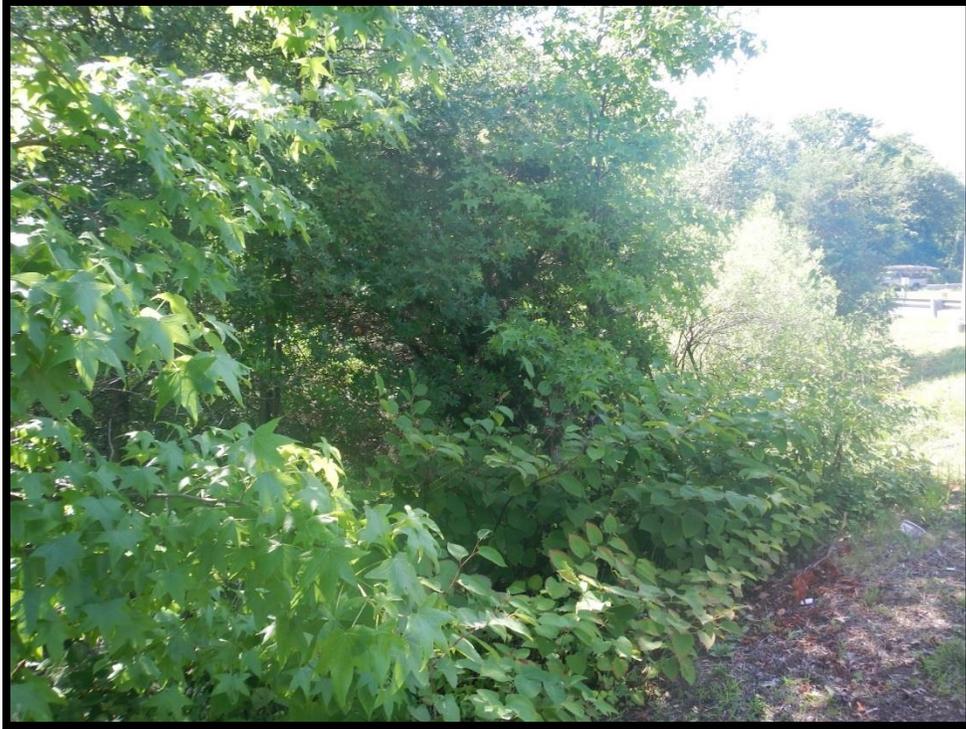
Hedgerow 5

This vegetated area was classified as a hedgerow during the field investigation since it lacked the woody stem DBH and density requirements to meet the MD DNR definition of forest. H5 is an early-successional Pin Oak-Sweet Gum Association. The dominant species include pin oak, sweet gum and callery pear, with a dominant size class of 6-11 inches DBH. The dominant understory species include sweet gum, eastern baccharis and Japanese knotweed. The dominant herbaceous layer species include poison ivy, Japanese honeysuckle and Japanese knotweed. H5 is in poor condition overall, with low downed woody debris and high levels of invasive species. H5 has low retention value due to high invasive species cover and poor overall condition.

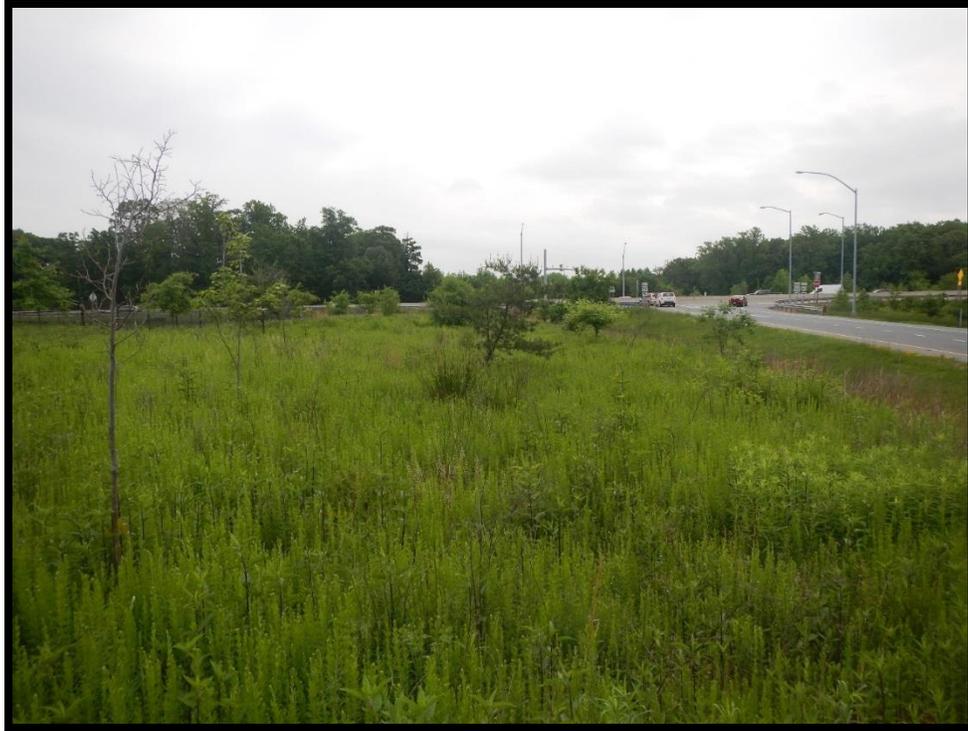
Reforestation Area 1

REF1 is an early successional reforestation planting next to a stormwater management facility in the northeastern portion of the study area. The dominant canopy species include black gum, willow oak, Virginia pine, sweet gum, black oak and black locust, with a dominant size class of 2-6 inches DBH. There are no dominant understory species. The dominant herbaceous layer species include white snakeroot (*Ageratina altissima*), soft rush (*Juncus effusus*), pennycress (*Thlaspi* sp.), lespedeza (*Lespedeza cuneata*) and broom sedge (*Andropogon virginicus*). REF1 is in good condition overall, with low downed woody debris and no invasive species.

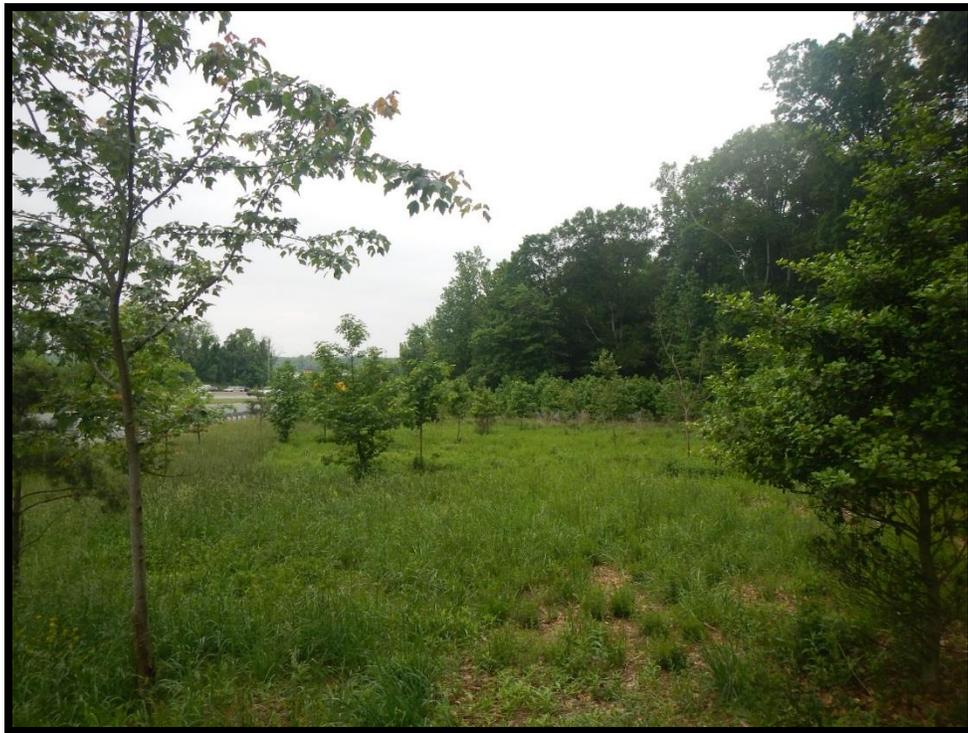
Reforestation Area 2

REF2 is an early successional reforestation planting that bridges a canopy gap between FS7 and FS8 in the northeastern portion of the study area. The dominant canopy species include sweet gum, red maple, pin oak, swamp white oak (*Quercus bicolor*) and American holly, with a dominant size class of 2-6 inches DBH. There are no dominant understory species. The dominant herbaceous layer species include white snakeroot, lespedeza and mugwort (*Artemisia* sp.). REF2 is in good condition overall, with low downed woody debris and low levels of invasive species.
