# RESPONSE ACTION COMPLETION REPORT

AREA A: PARCEL A3  
METALS RESPONSE AREAS  
TRADEPOINT ATLANTIC  
SPARROWS POINT, MARYLAND

Revision 0 – December 3, 2021

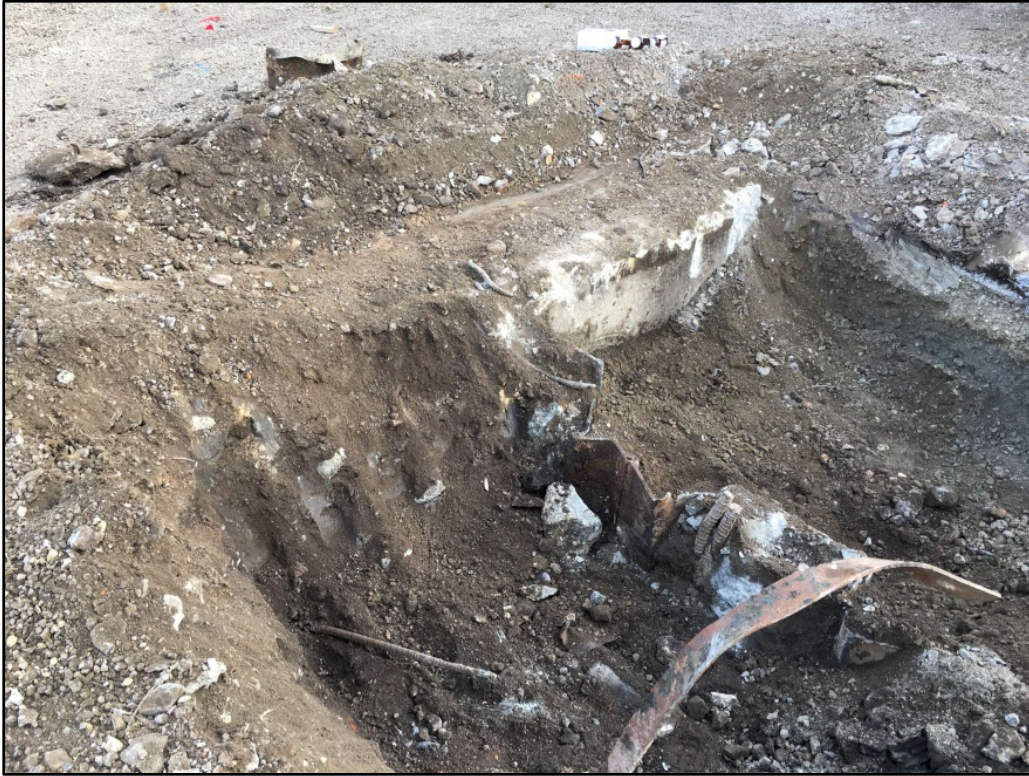
021617-3: Completed excavation. Take note of the concrete wall along the northern sidewall of the RW-025 Response Area.

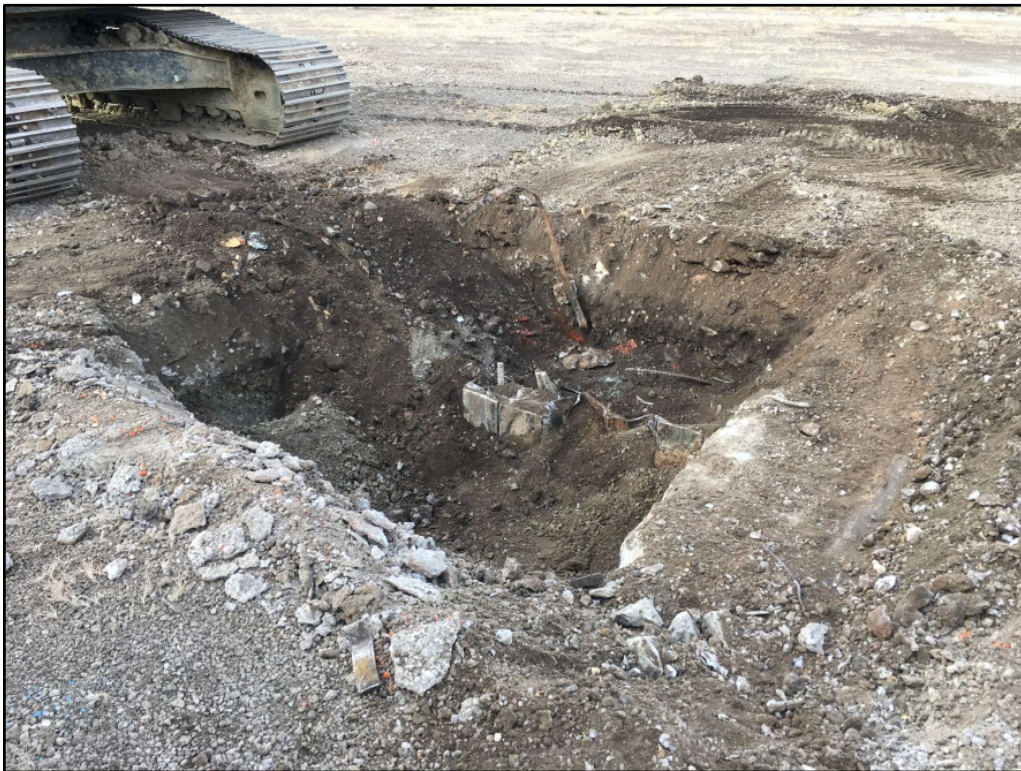
021617-4: Completed excavation. Little to none impacts were observed.

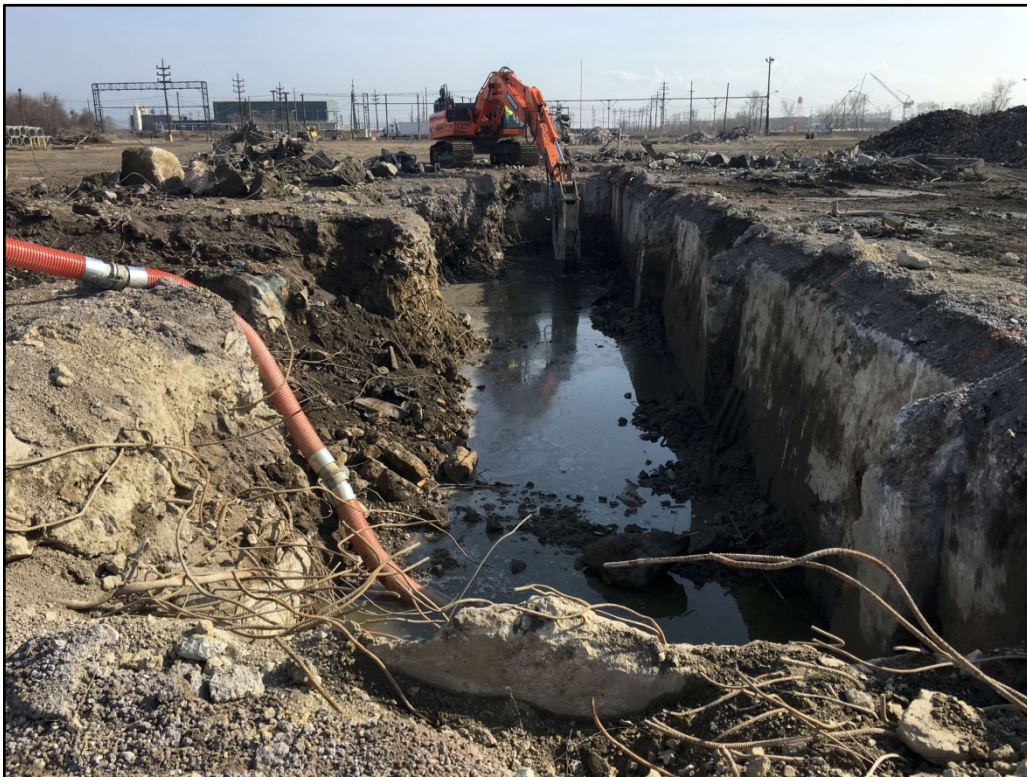
032717-1: View to the south of excavation in progress. The excavator with a hammer attachment can be observed making holes along the concrete bottom of this excavation. Take note that the west sidewall is concrete.

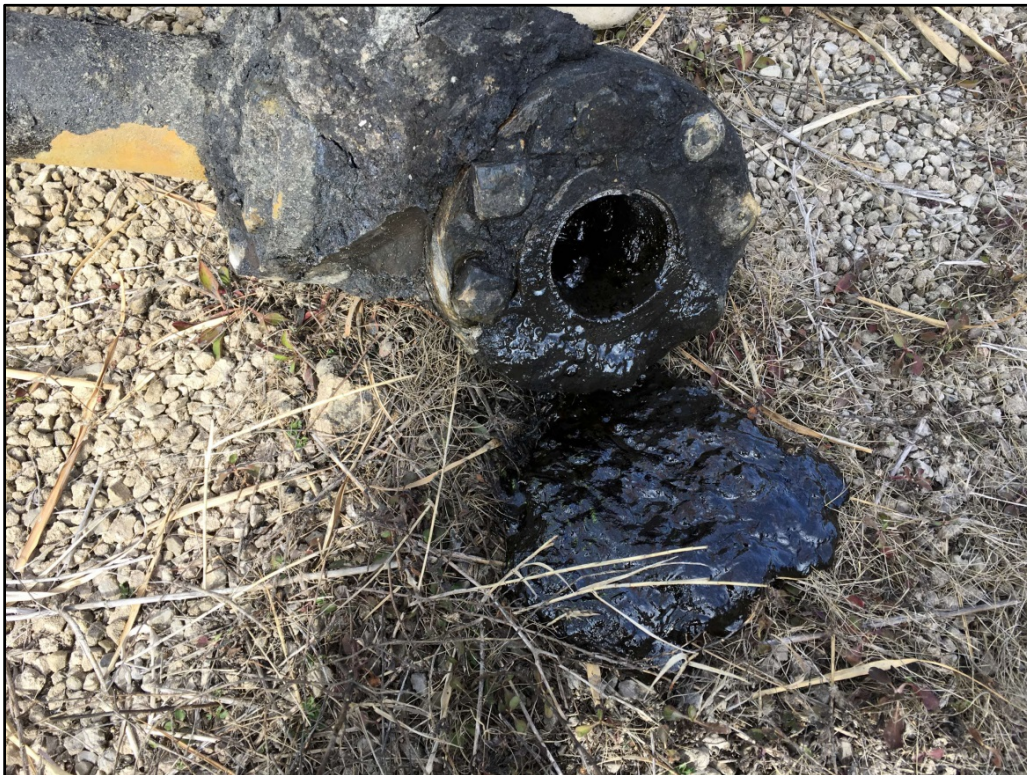
021717-2: A NAPL bearing pipe was observed and removed from the excavation.

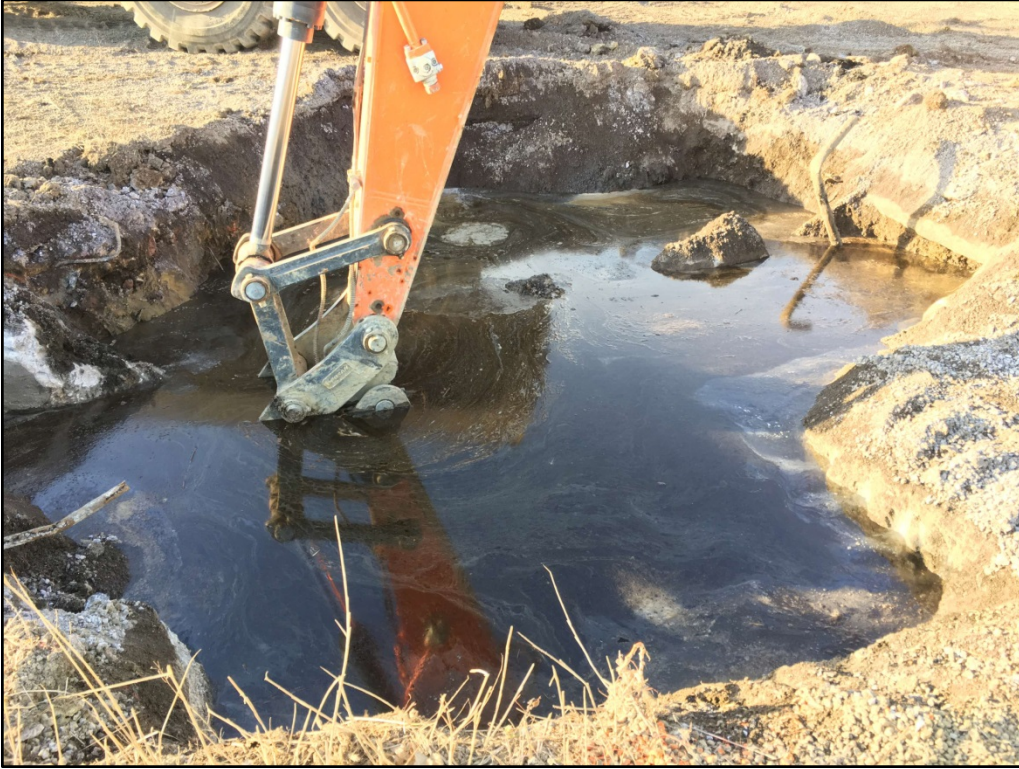
022017-1: NAPL observed in the groundwater during excavation activities.

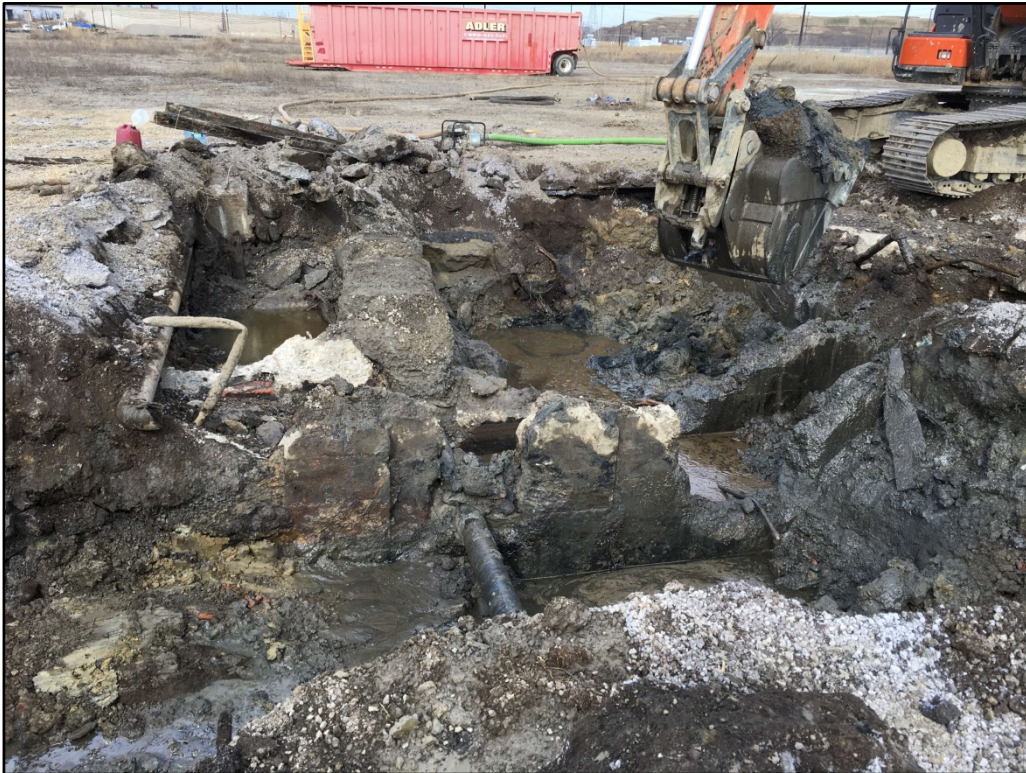
022117-1: Excavation in progress. Visible in background is an Adler tank used as a temporary storage unit to dewater the excavation.

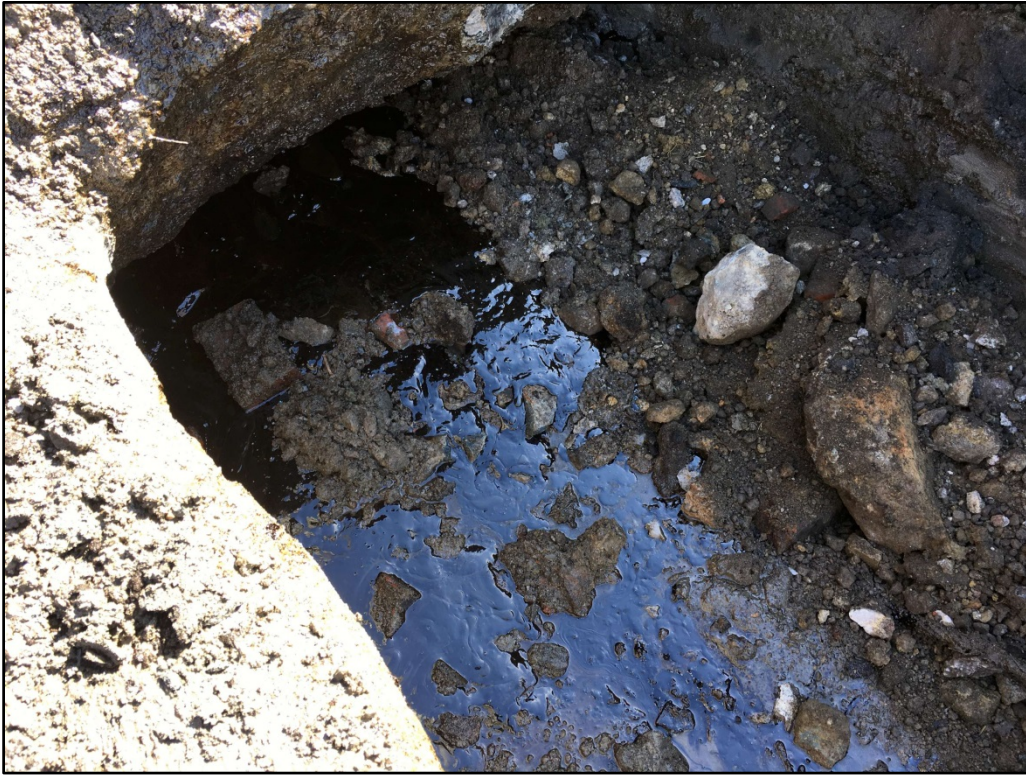
022417-3: Another view of the NAPL found in the photo above leaching out of the concrete box.

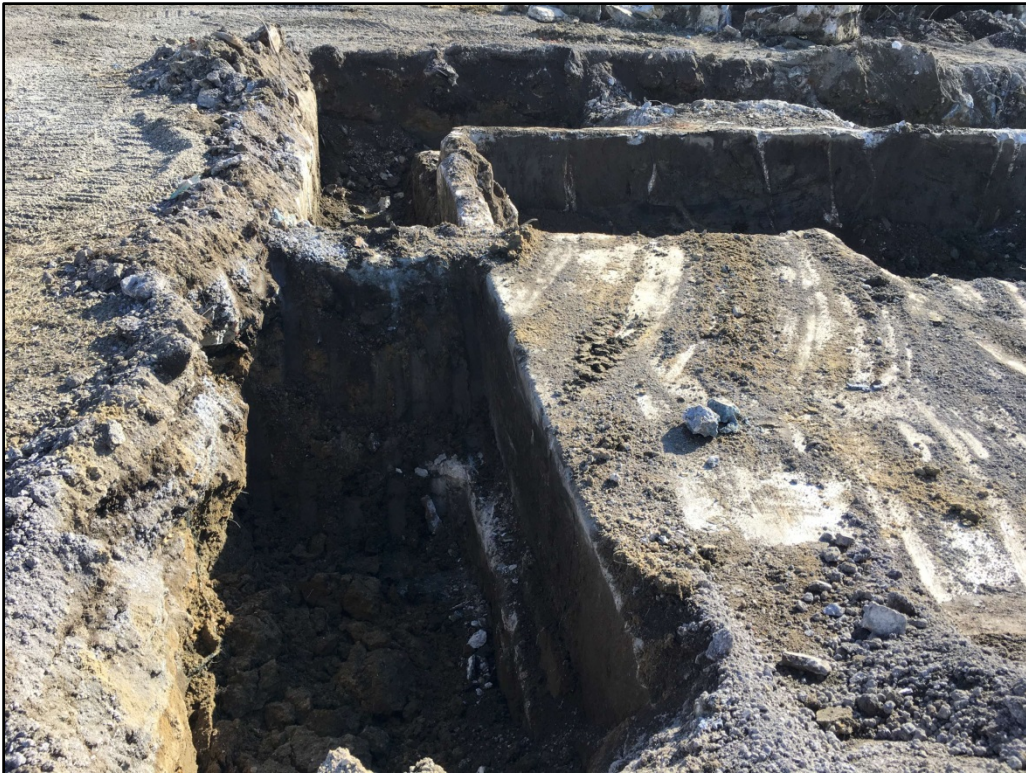
022417-4: View of the southeast corner of the exaction where the NAPL filled concrete box was located along with other concrete boxes and structures.

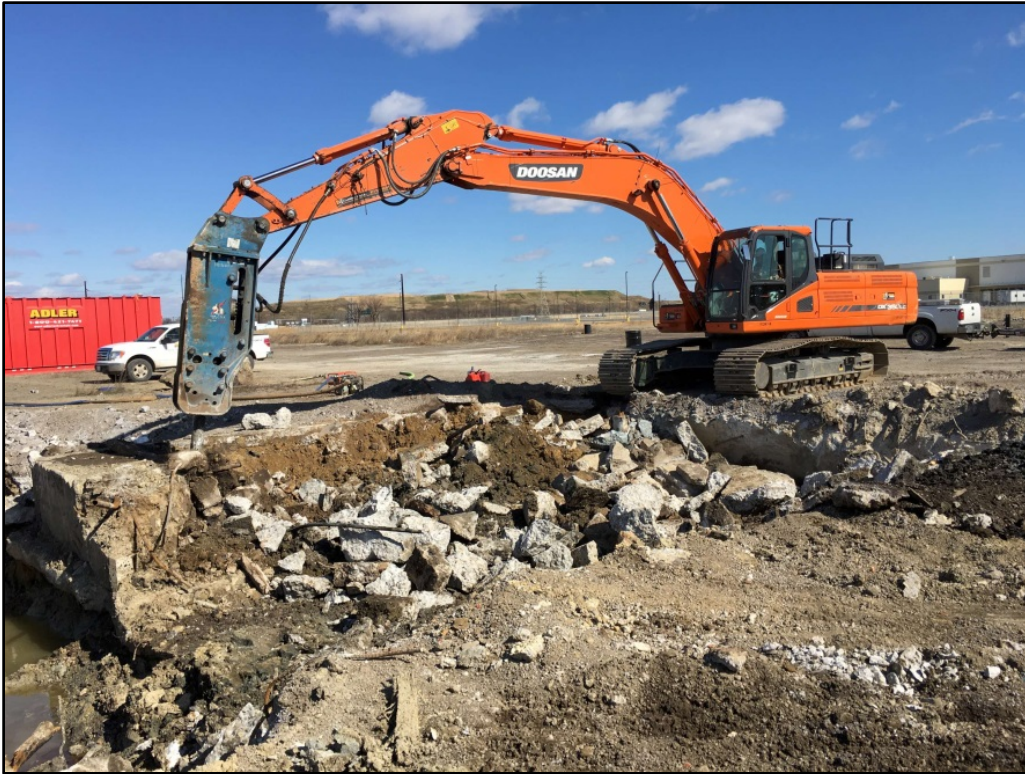
030217-1: Excavator with hammer attachment used to break up and remove NAPL stained concrete floors, walls, footers, and boxes.

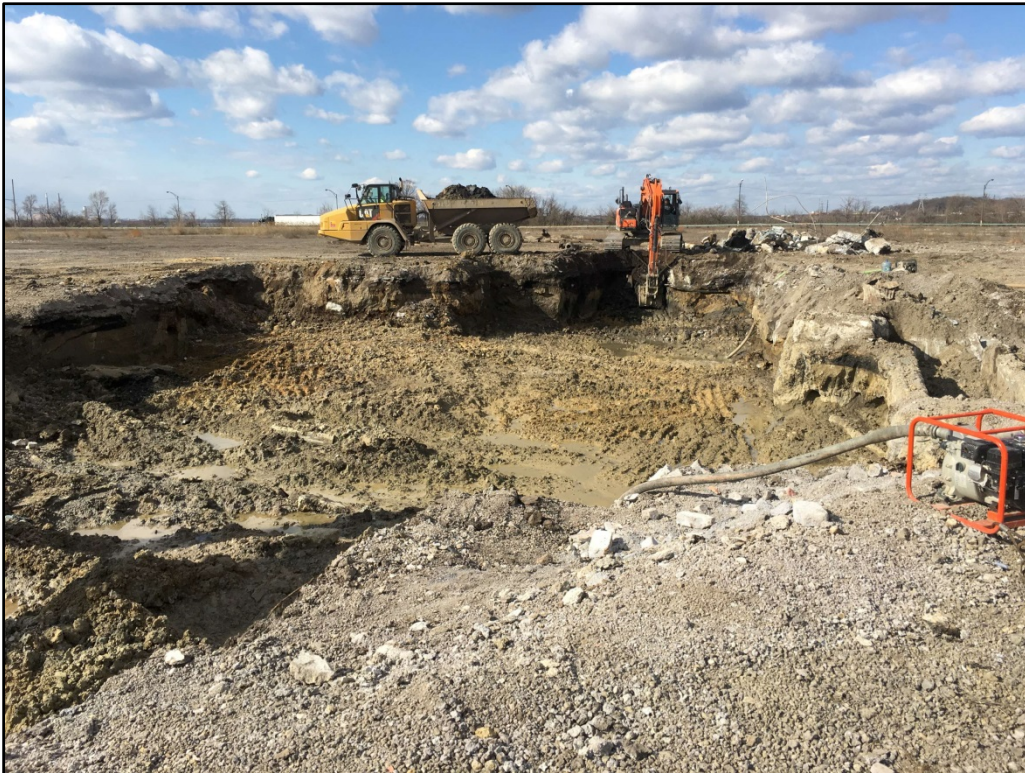
030317-1: An Oil & Grease exceedance was identified along the west wall where the excavator is located; this area was extended.

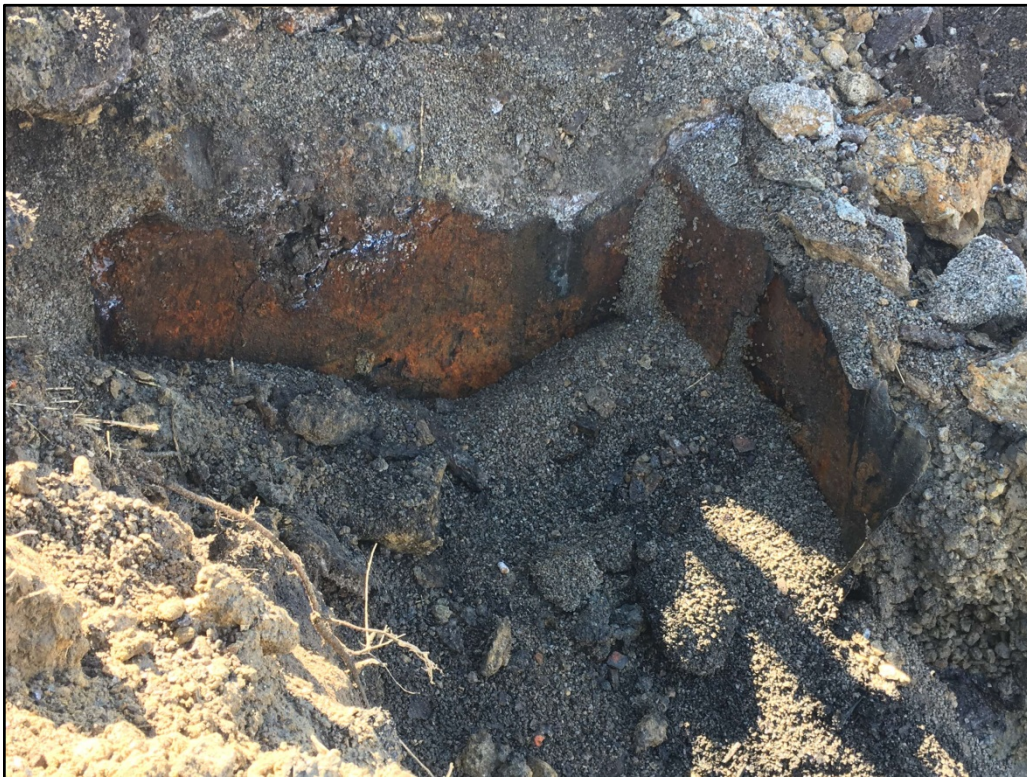
031617-1: View of a metallic tank located along the southeast corner of the excavation. Black NAPL impacted soil was observed in and around the tank.

During excavation activities at the RW-033 Response Area, steel sheeting was uncovered with NAPL impacted soil in the vicinity. Utility lines were also observed in the area. The sheeting and utility lines were removed during excavation activities.

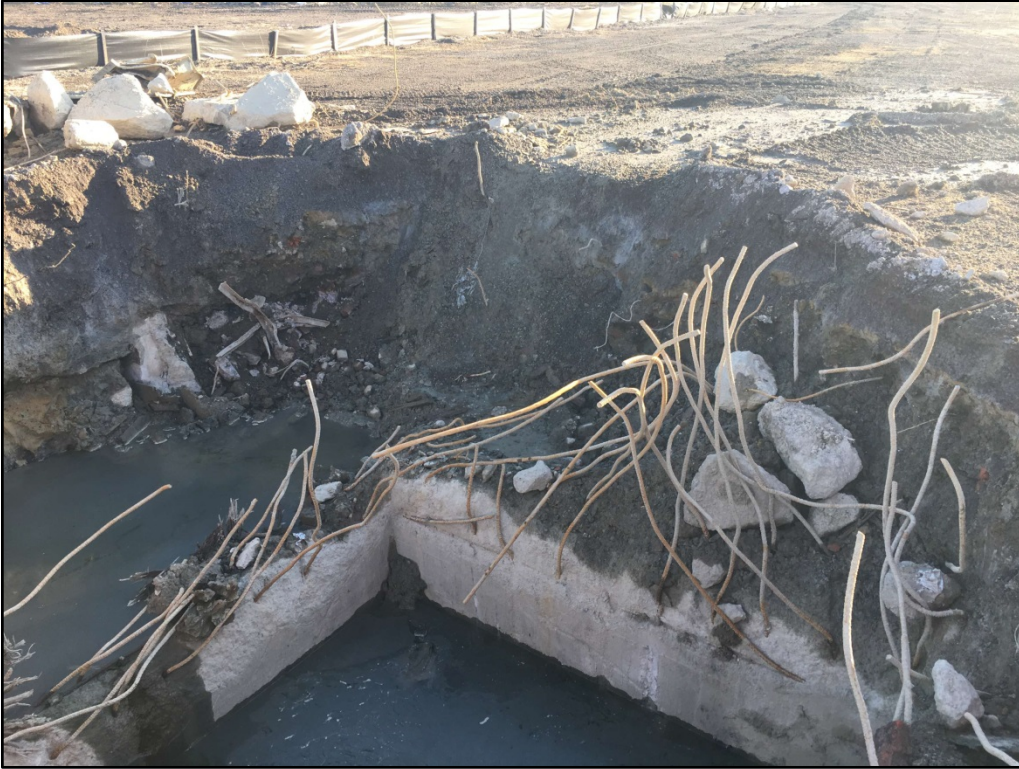
032617-1: Excavation in progress. No impacts observed around the concrete boxes.

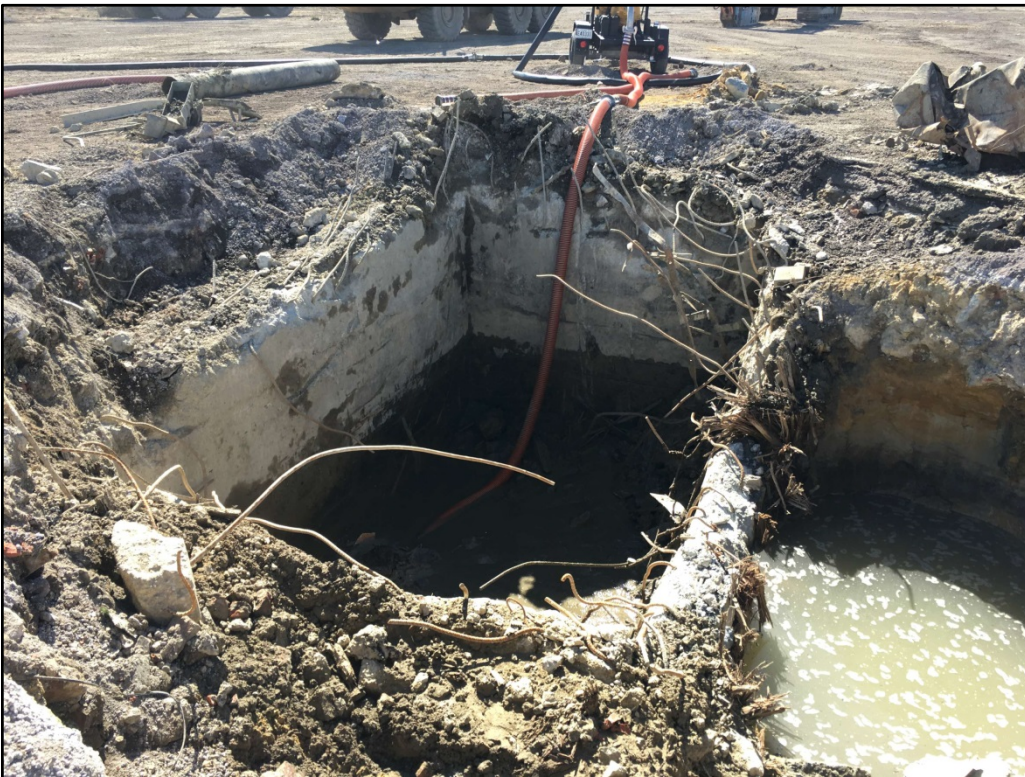
032917-1: View of dewatering completed excavation for backfilling. Concrete boxes were not NAPL stained.

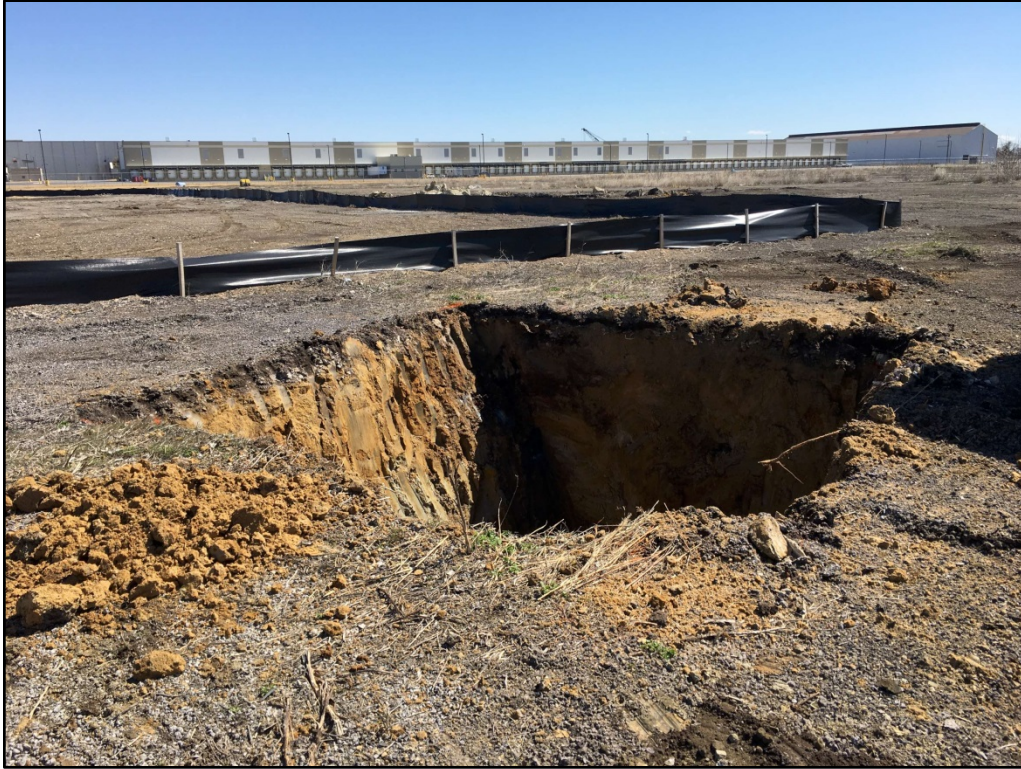
032217-3: Completed excavation to target depth. Little to none impacts observed.

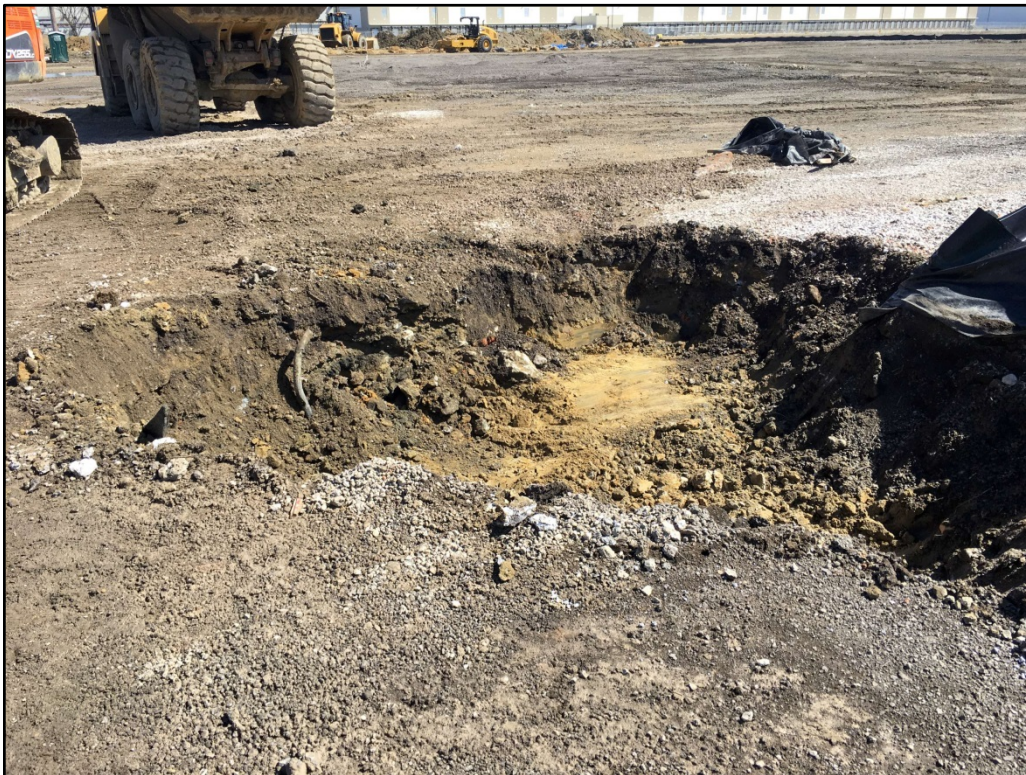
032217-2: View to the east of the complete excavation. Little to none impacts were observed.

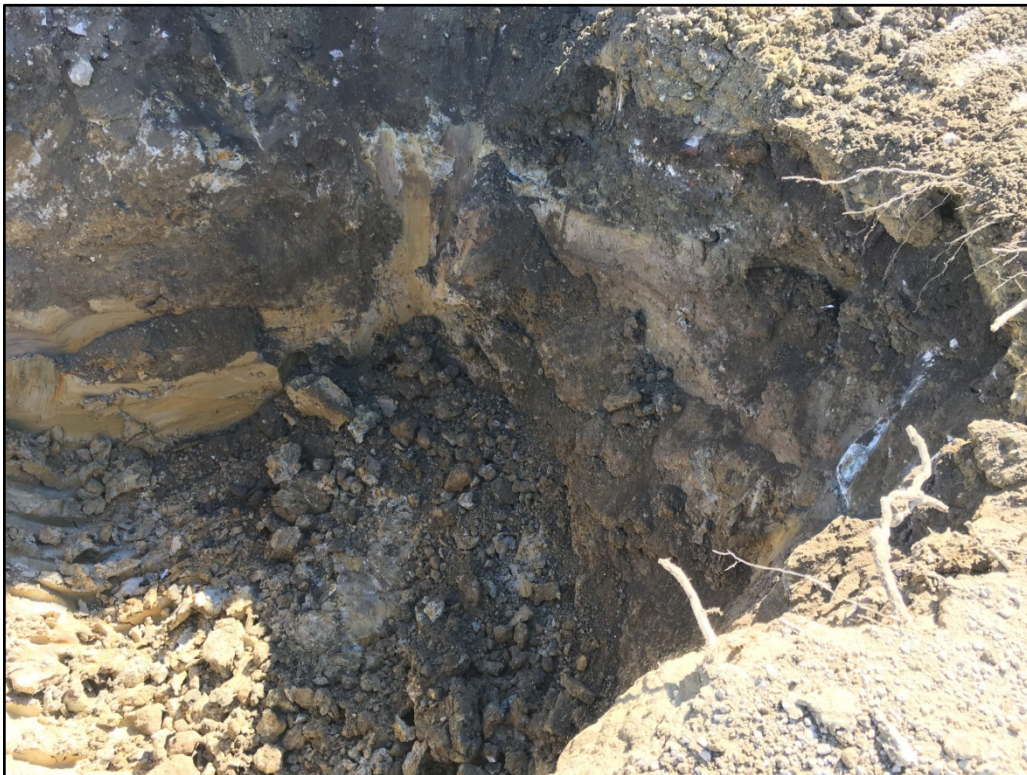
032217-2: View of the completed excavation. Little to none impacts observed.

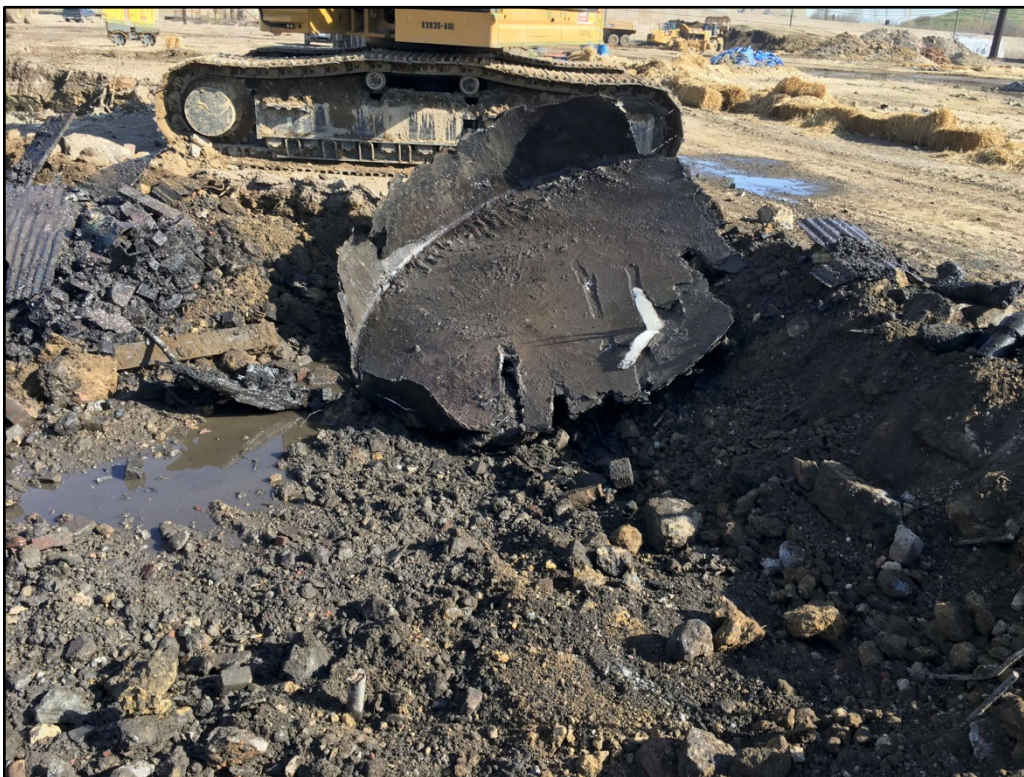
041917-1: View of bottom fragments of a fiberglass tank. Soil impacts were observed around the location of this along with four other tanks of similar size in the same vicinity. Tanks were located on the concrete pad.

During the start of the RW-052 Response Area, five fiberglass tank bottoms were observed on a concrete pad. These tanks appeared to be cut just below grade, potentially as a result of historical on-site building demolition. Several liquid pumps and pipes saturated in NAPL were also removed from the vicinity of these tanks. The tank bottoms were removed during excavation activities.

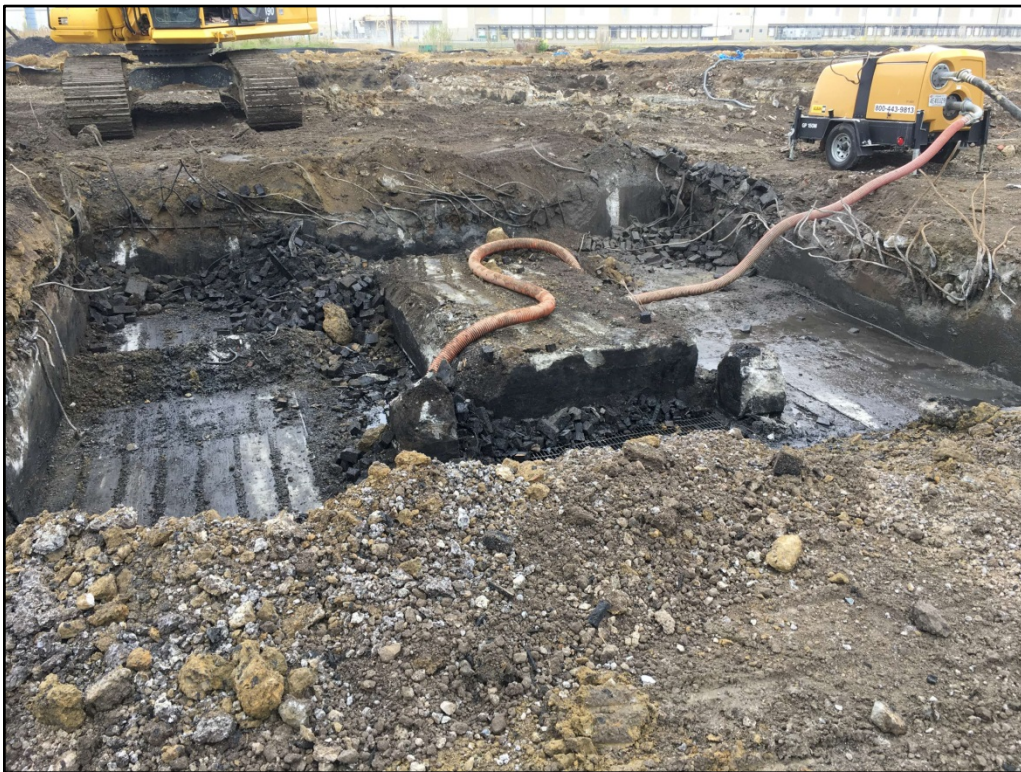
042117-2: Excavation in progress. Take note of the NAPL stained concrete box.

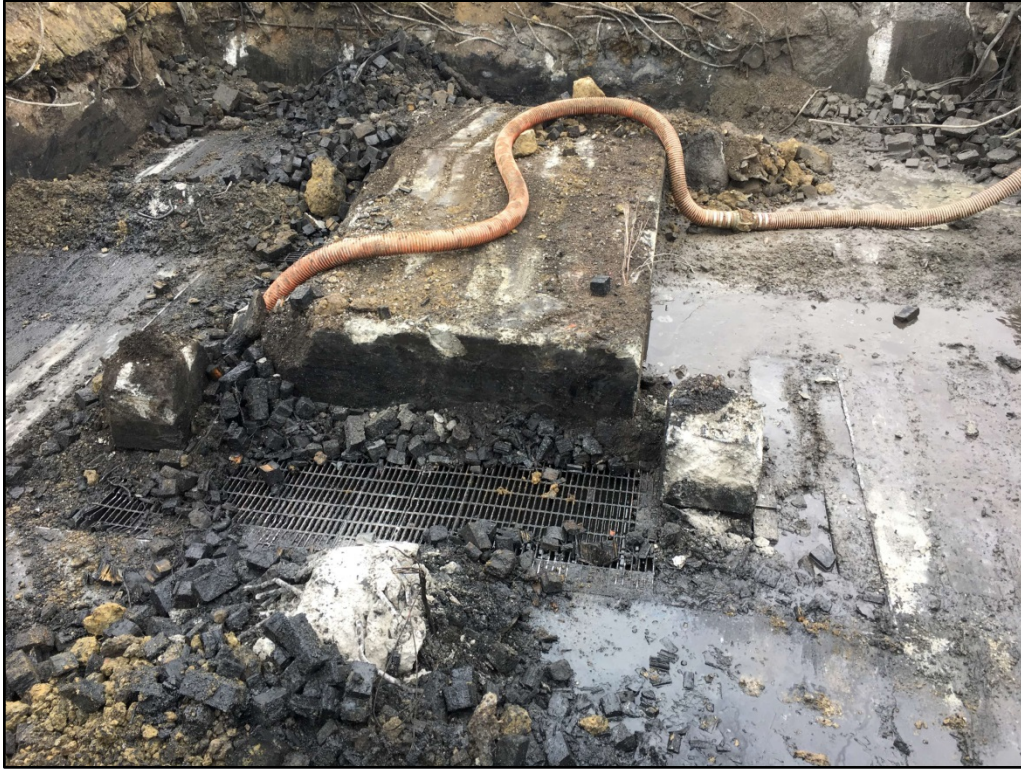
042217-1: Trench drains located around the raised concrete box.

While completing the excavation in the RW-045 Response Area, a large concrete box with a raised section in the middle was observed. NAPL impacted water and material were removed from trench drains surrounding the raised concrete section and from within the concrete box. The entire concrete box was stained by NAPL; therefore, it was broken up and removed from the excavation. Minimal impacts were observed below the removed concrete. Also, an open-face dipping tank was observed along the eastern sidewall of the excavated area. Impacted material was observed below the open-face tank and removed from the excavation along with the tank.

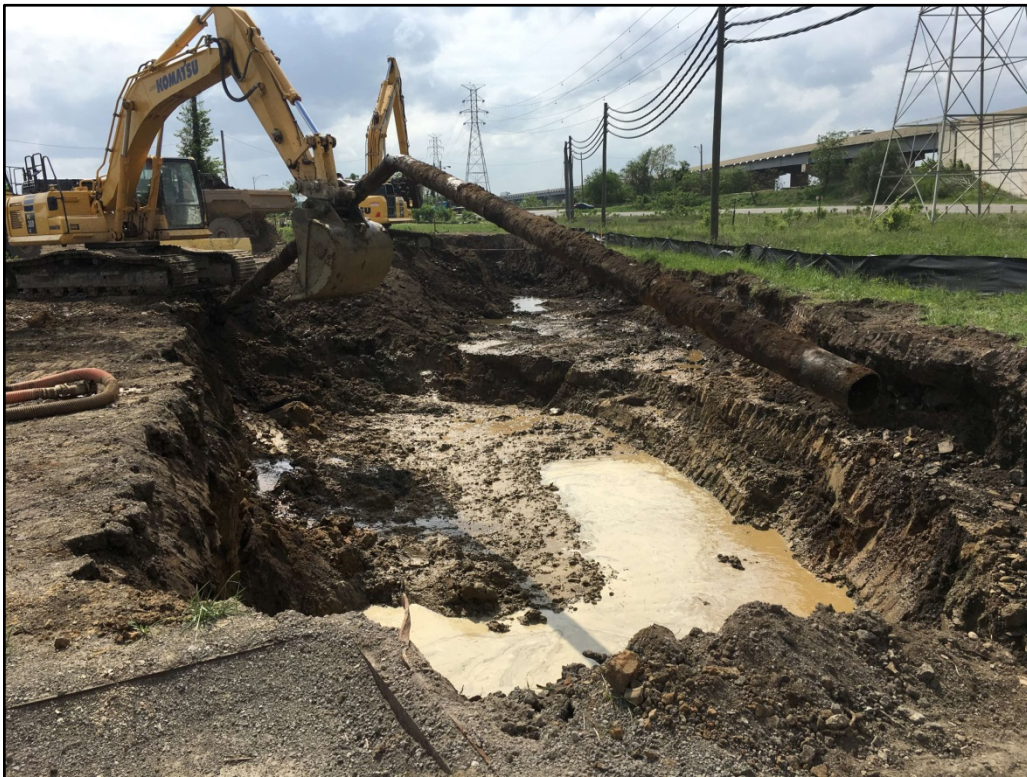
050117-2: View to the west of excavation in progress. An empty corroded utility pipe was found and removed.

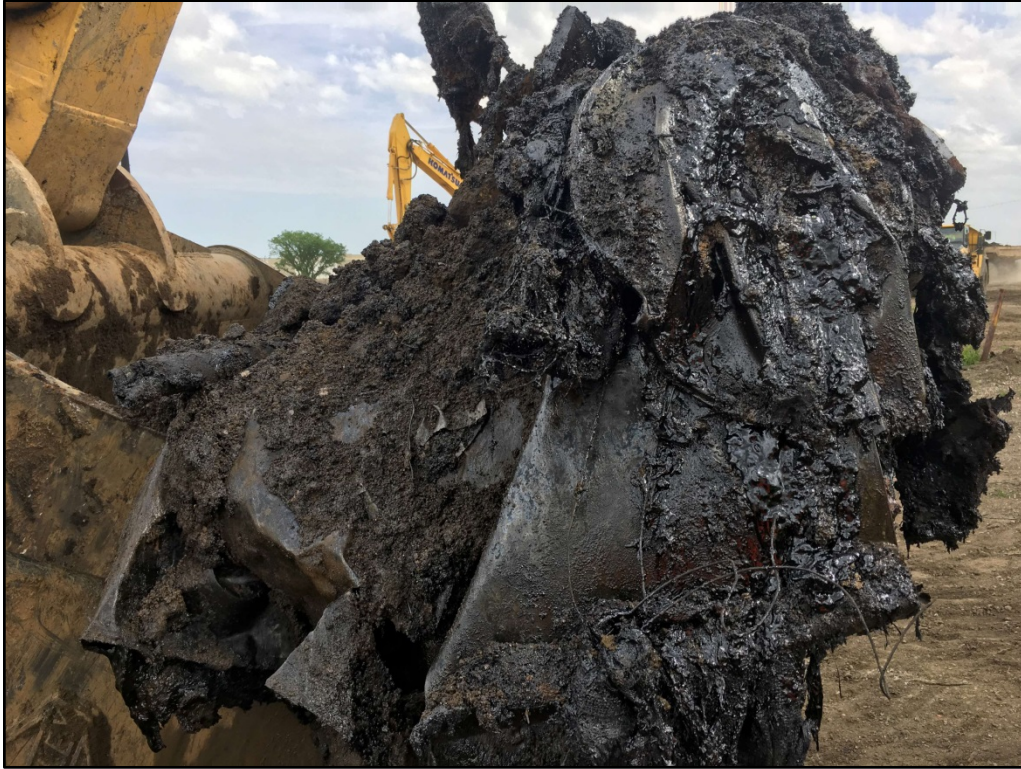
050117-3: Fragments of steel drums saturated in NAPL from the RW-003 Response Area.

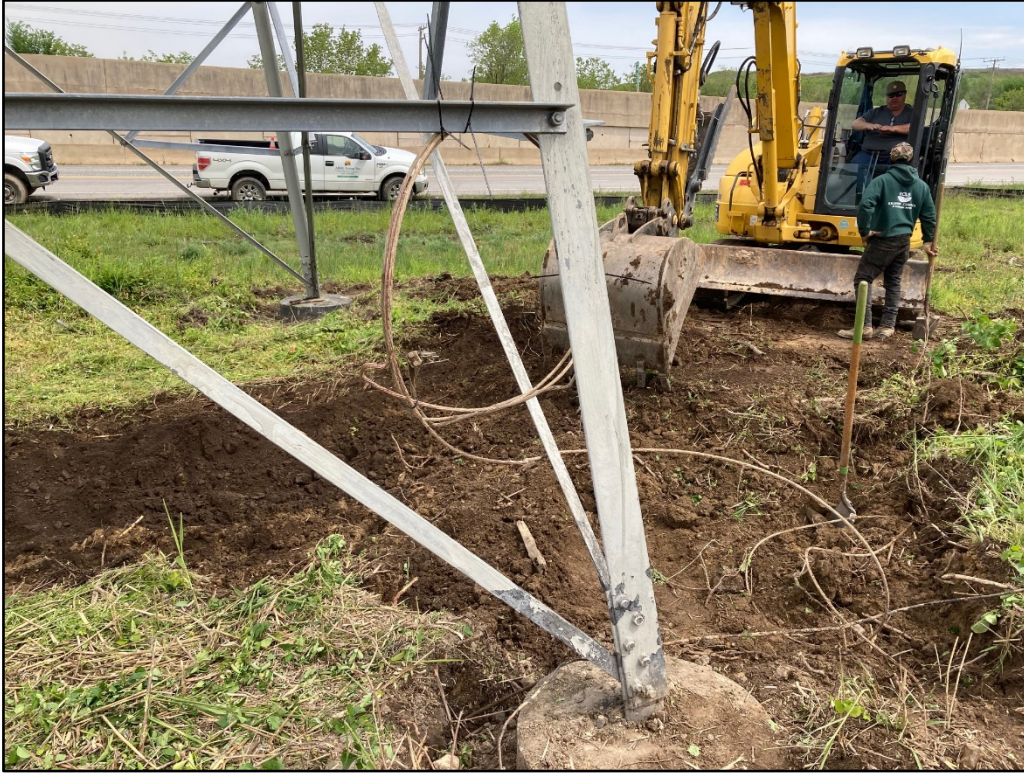
050520-1: Grounding cables exposed just below the surface while cutting around the electrical tower in the northern capping area. Cables were replaced by BGE contractors prior to filling in the area.
