RESPONSE AND DEVELOPMENT COMPLETION REPORT

AREA B: PARCEL B22, PHASE 1
TRADEPOINT ATLANTIC
SPARROWS POINT, MARYLAND

ARM Project No. 20010222

Revision 0 – July 15, 2020

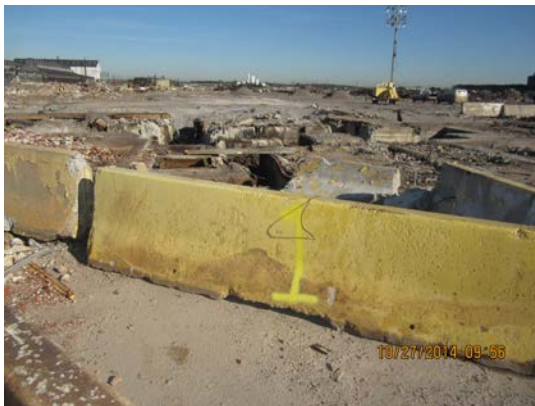
SGS#1 – South End of Cold Mill Complex

OBSERVATIONS: (1) Prior to demolition and backfilling the concrete SGS structures were observed to be intact and devoid of major cracks or fissures. There were no sumps visible or observed. No openings and/or channels to contiguous structures were able to be observed. (2) SGS #1 was observed to contain a small amount (< 55 gals) of rainwater mixed with oil. Other bulk and residual material present included, scrap metal, and electrical conduit; (3) SGS#2 was dry; (4) Water from SGS#1 was collected into drums and placed in MCM's on-site storage for disposal; (5) Following removal of the water from SGS#1 and debris from both structures, heavy equipment was used to scourer concrete surfaces in order to remove additional layers of oil and grease to the extent practical.

BACKFILL MATERIAL: MCM utilized concrete and brick generated from the demolition of the Cold Mill Complex as backfill material. The concrete/brick was inspected prior to use as backfill material. The concrete/brick was free of any visible staining the material was also free of any deleterious materials such as trash, organics, plastics, and rebar.

BACKFILLING: In November 2014 MCM begin backfilling with processed concrete/brick was to be placed in successive 1 foot lifts and crushed/tamped in-place using the equipment bucket loader or by driving over the material with the bulldozer. The non-metallic slag was to be placed in lifts not exceeding 8 inches in thickness. The slag was compacted using a vibrating roller. Structural backfilling and compaction began and was completed during the month of November 2014. JEI conducted periodic site visits during cleaning/backfilling and observed the process to be sound and in general conformance with backfill requirements.

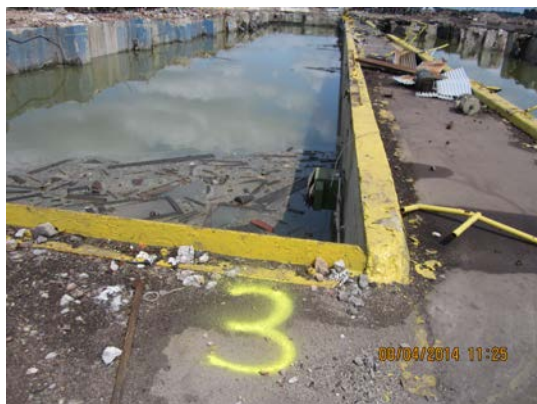
SGS#3 – South End of Cold Mill Complex

OBSERVATIONS: (1) Prior to demolition and backfilling the concrete SGS structures were observed to be intact and devoid of major cracks or fissures. There were no sumps visible or observed. No openings and/or channels to contiguous structures were observed. Concrete surface staining was minimal to non-existent. The integrity of the structures was evidenced by their ability to retain considerable quantities of rainwater; (2) Bulk materials (wood, trash, etc.) and other miscellaneous debris was present in the both structures; (3) Structural backfilling began after the removal of the water and miscellaneous debris from SGS#3 and SGS#4 .

BACKFILL MATERIAL: MCM utilized concrete and brick generated from the demolition of the Cold Mill Complex as backfill material. The concrete/brick was inspected prior to use as backfill material. The concrete/brick was free of any visible staining the material was also free of any deleterious materials such as trash, organics, plastics, and rebar.

BACKFILLING: On 9/29/14 MCM begin backfilling with processed concrete/brick was placed in successive 1 foot lifts and crushed/tamped in-place using the equipment bucket loader or by driving over the material with the bulldozer. The non-metallic slag was placed in lifts not exceeding 8 inches in thickness. The slag was compacted using a vibrating roller. Structural backfilling and compaction began and was completed during the month of October 2014. JEI conducted periodic site visits during cleaning/backfilling and observed the process to be sound and in general conformance with backfill requirements.

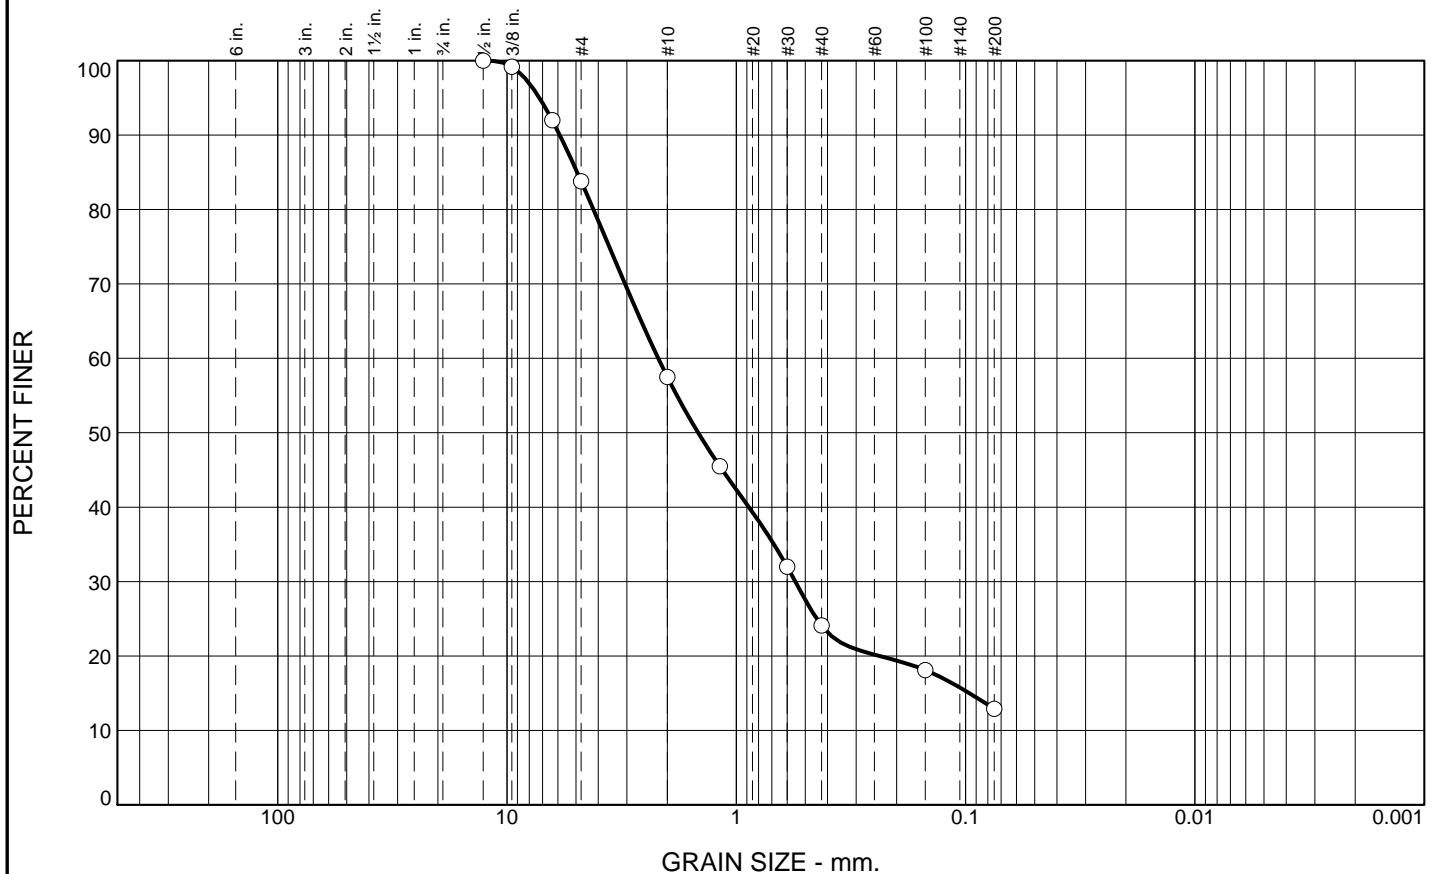
Particle Size Distribution Report

% +3"	% Gravel		% Sand			% Fines	
	Coarse	Fine	Coarse	Medium	Fine	Silt	Clay
0.0	0.0	16.2	26.3	33.4	11.2	12.9

SIEVE SIZE	PERCENT FINER	SPEC.* PERCENT	PASS? (X=NO)
0.5	100.0		
.375	99.2		
.25	92.0		
#4	83.8		
#10	57.5		
#16	45.5		
#30	32.0		
#40	24.1		
#100	18.1		
#200	12.9

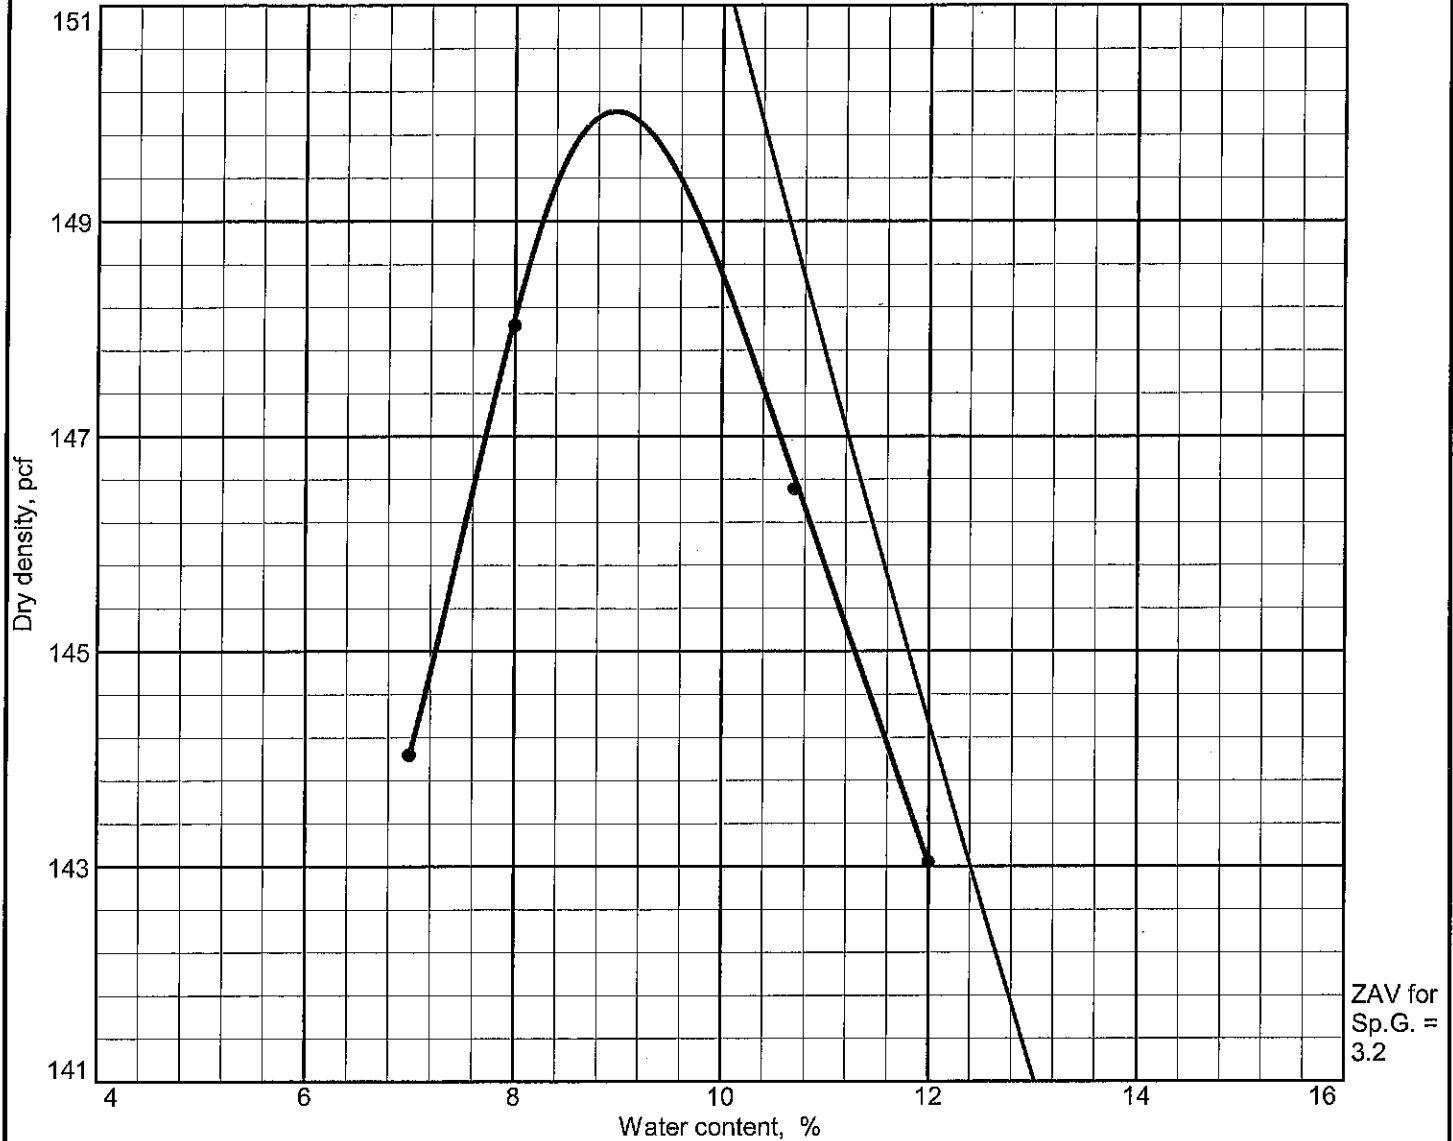
COMPACTION TEST REPORT

Test specification: AASHTO T 180 Method A Modified

Elev/ Depth	Classification		Nat. Moist.	Sp.G.	LL	PI	% > No.4	% < No.200
	USCS	AASHTO						
	SM	A-1-b			NV	NP	16.2	12.9

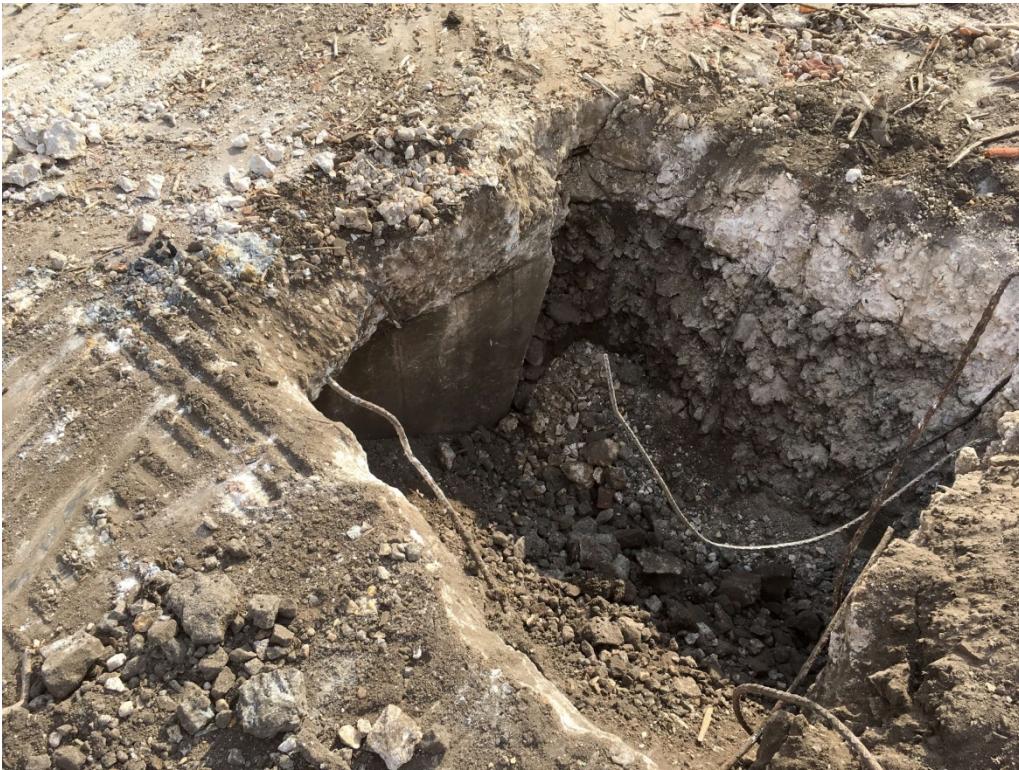
**Parcel B22: B22-028 Excavation
Photograph Log
Sparrows Point, Maryland**

B22-028 East excavation completed to a depth of 2 feet below ground surface. All four sidewalls composed of either concrete, with no visible staining, and/or large gravel therefore only a bottom confirmation sample was taken.

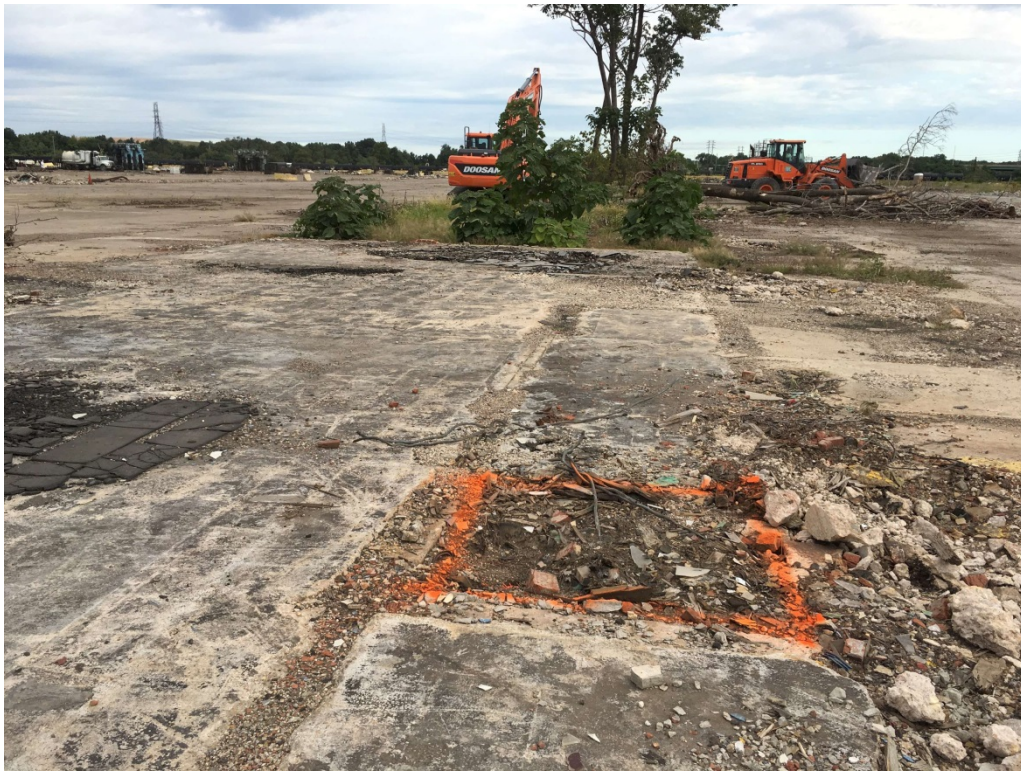
B22-028 South excavation limits prior to removal of impacted material.

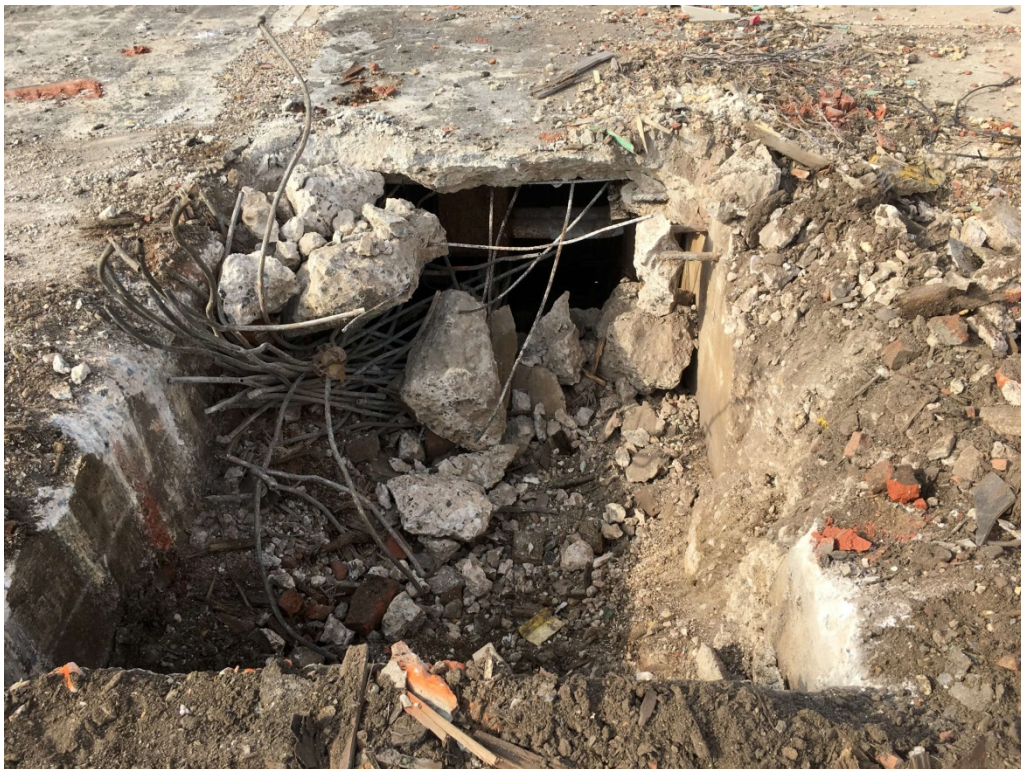
**Parcel B22: B22-028 Excavation
Photograph Log
Sparrows Point, Maryland**

B22-028 South excavation completed to a depth of 2 feet below ground surface. Three of the four sidewalls composed of concrete, with no visible staining, and the northern portion of this excavation had no sidewall therefore only a bottom confirmation sample was taken.

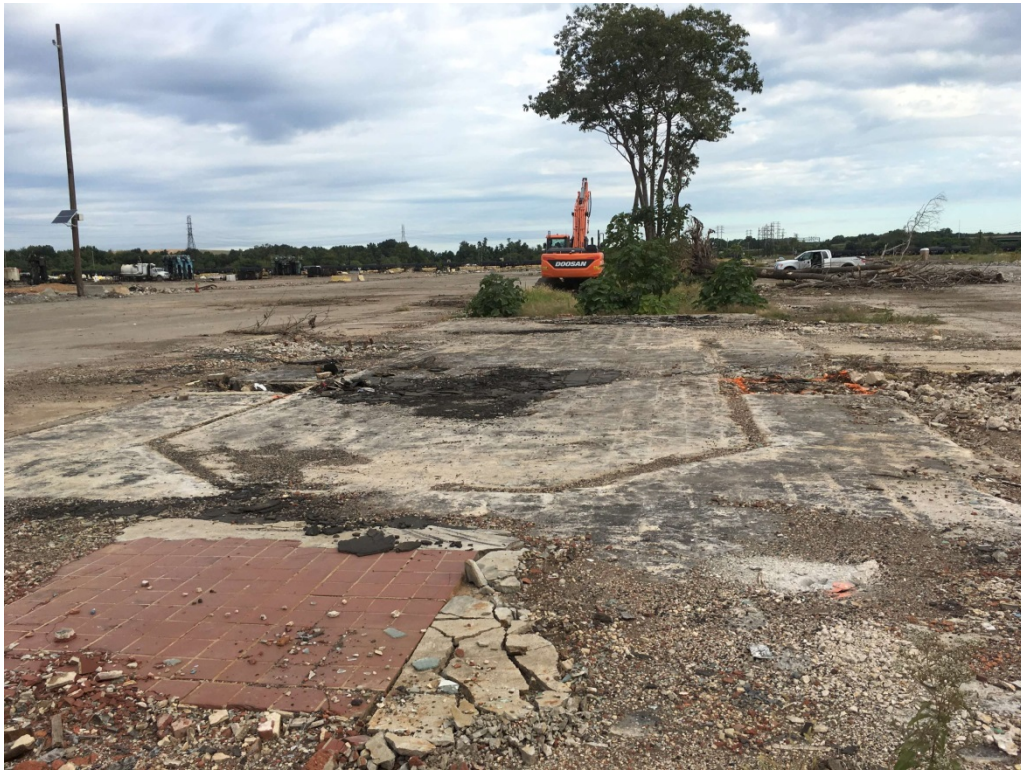
B22-028 Main excavation limits prior to removal of impacted material.

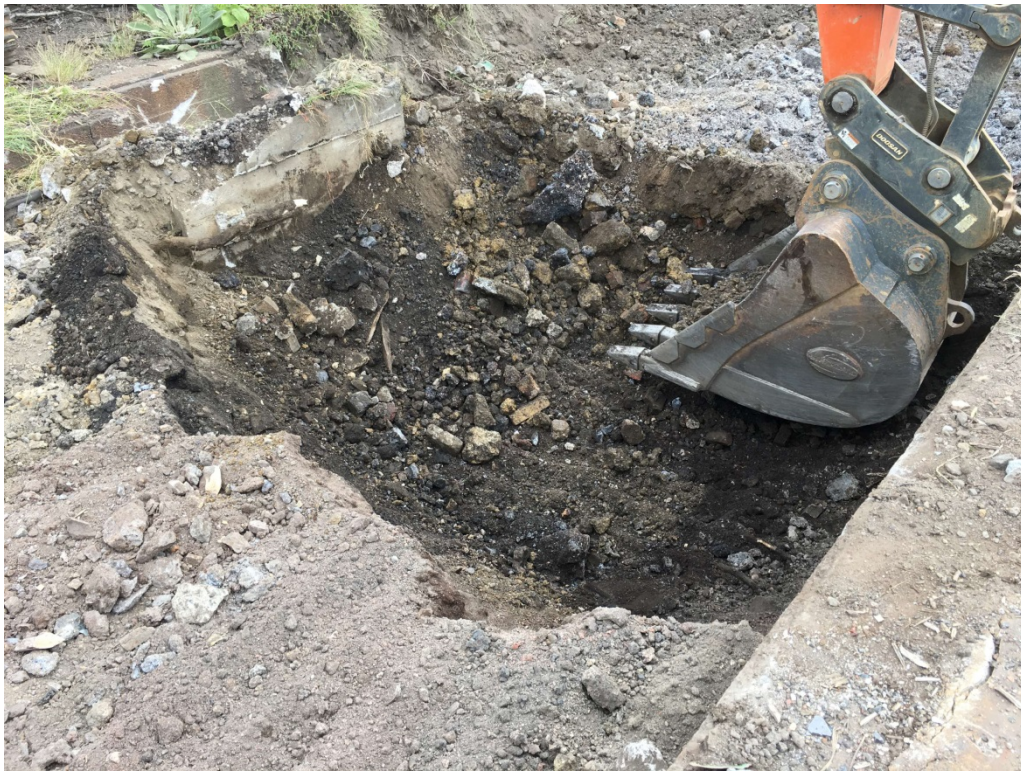
Impacted material observed in the middle of the Main excavation adjacent to the trench manhole. An additional three feet of impacted material was removed.

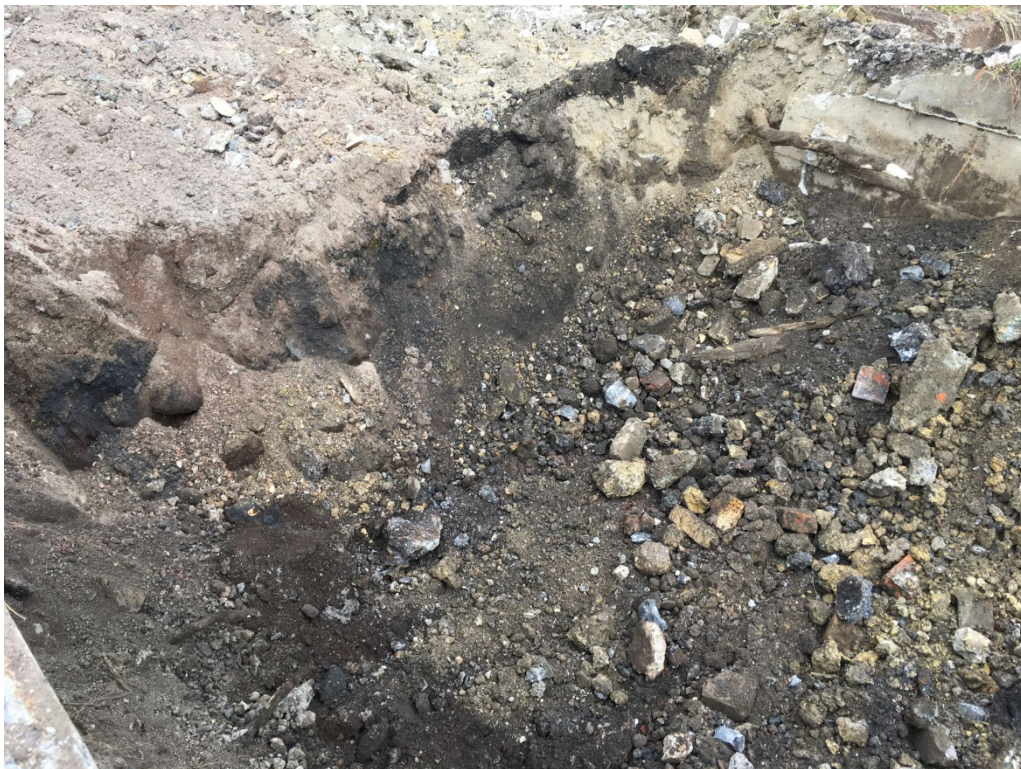
A view of the north wall of the additional impacted material observed in the middle of the Main excavation adjacent to the trench manhole.

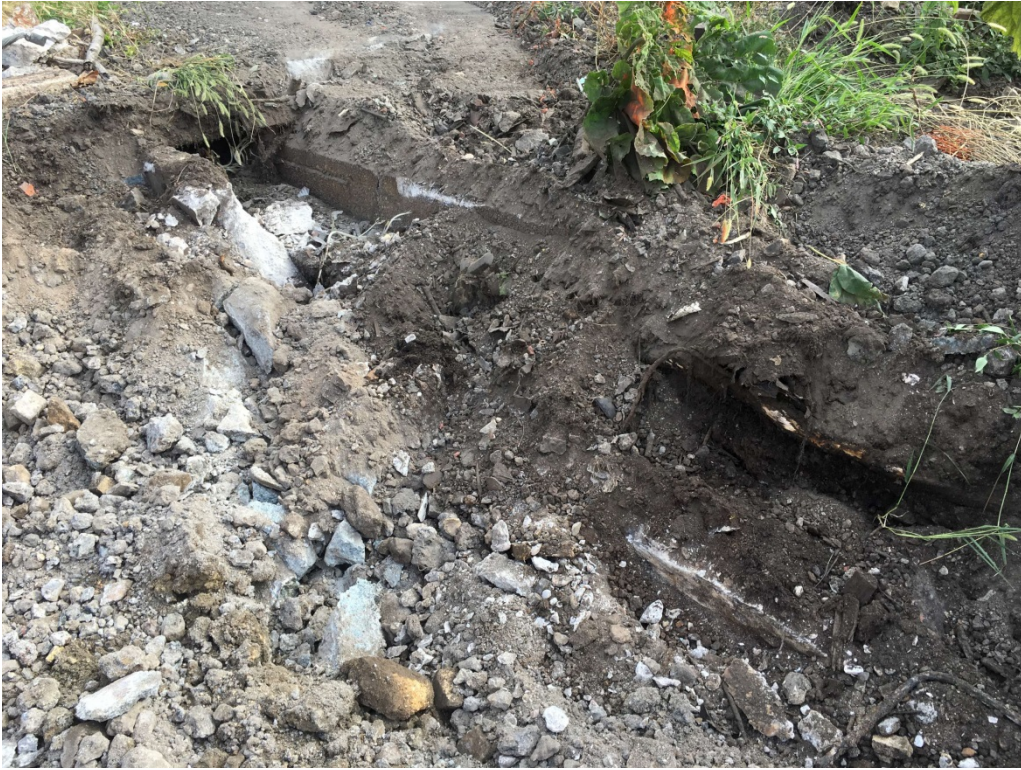
View of the french drain observed within the Main excavation. The french drain extends from the north wall to the south wall within the excavated area.

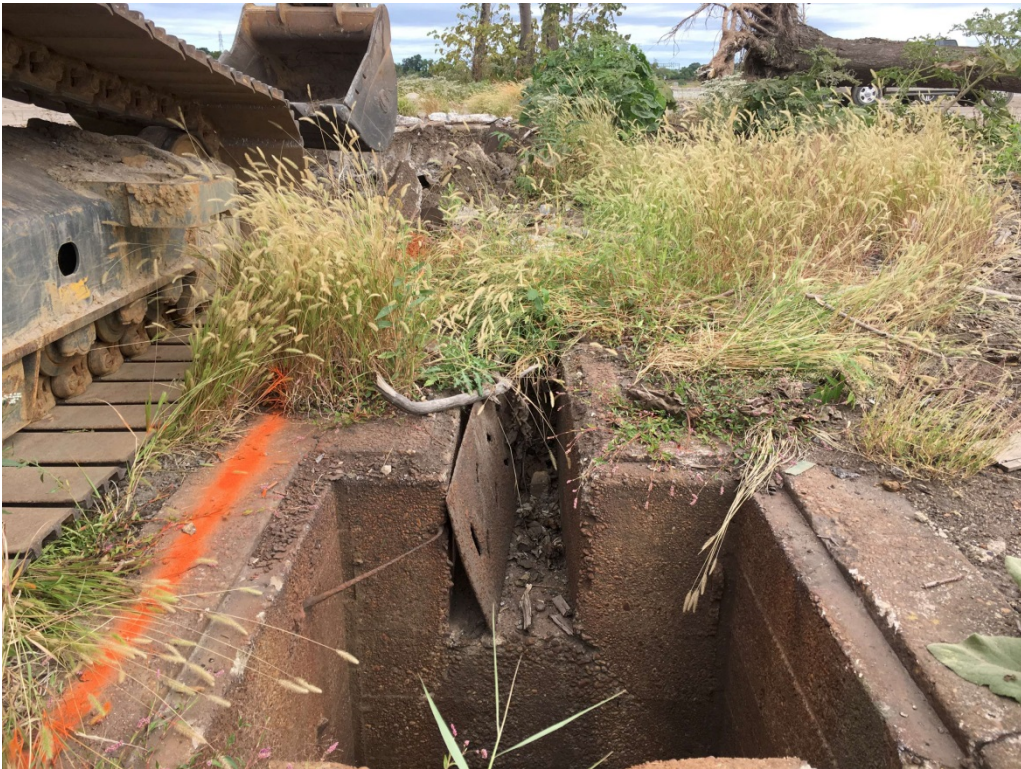
View of the french drain connected to the manhole facing north.

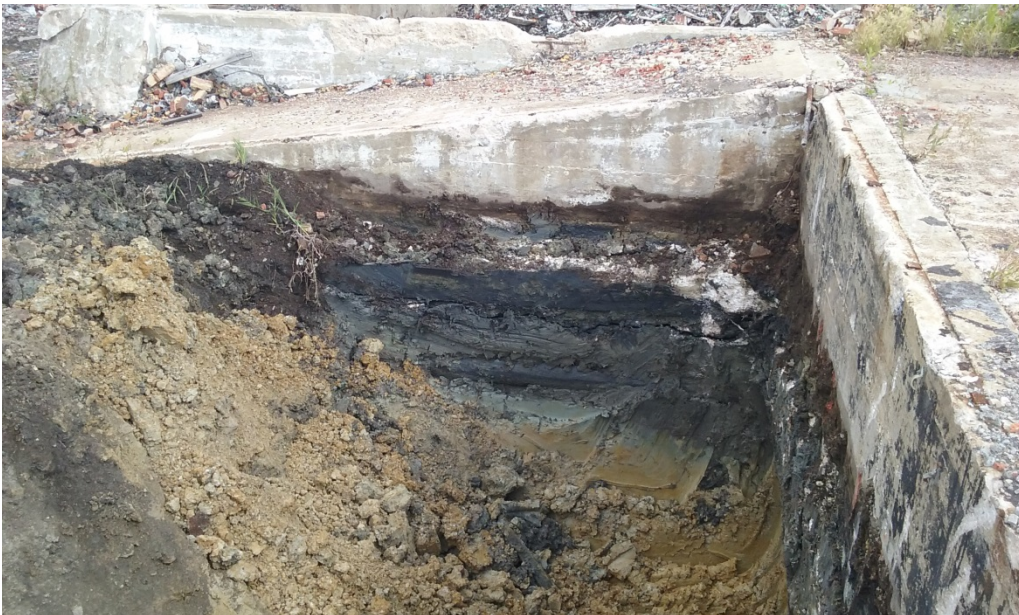
View of impacted material observed along the east wall of the main excavation area.

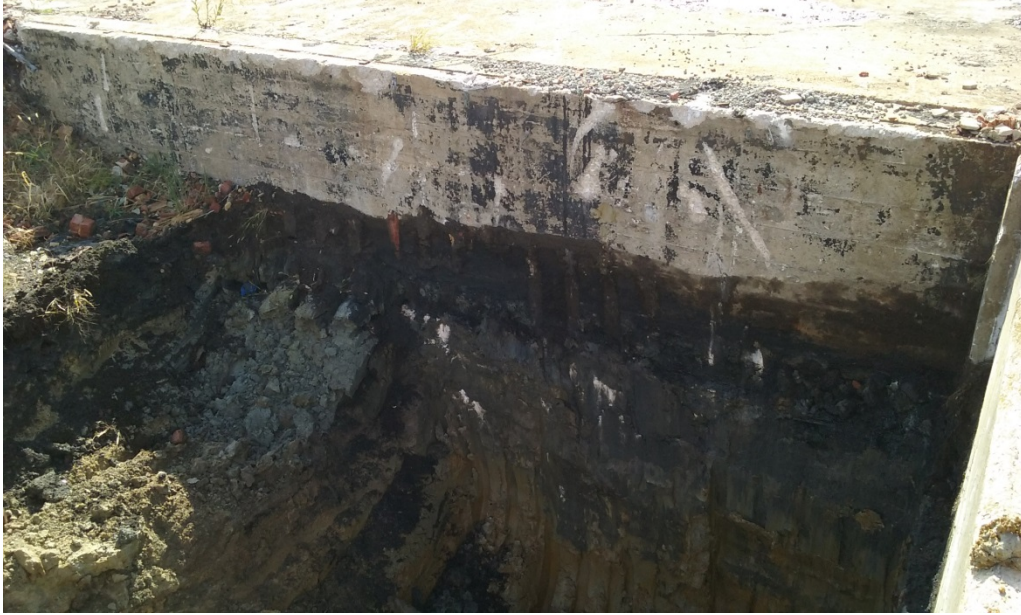
View of impacted material observed along the south wall of the main excavation area.

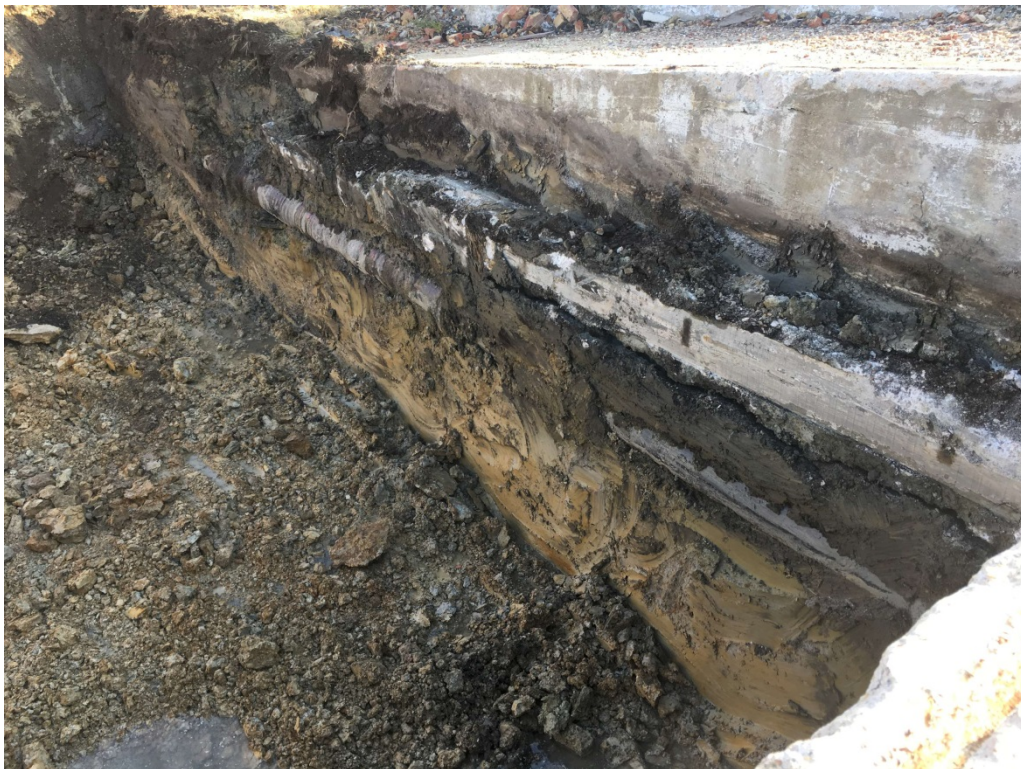
View of impacted material and the utility pipe observed along the east wall of the main excavation area. Highly impacted material was observed between the utility pipe and the bottom of the slab above it.

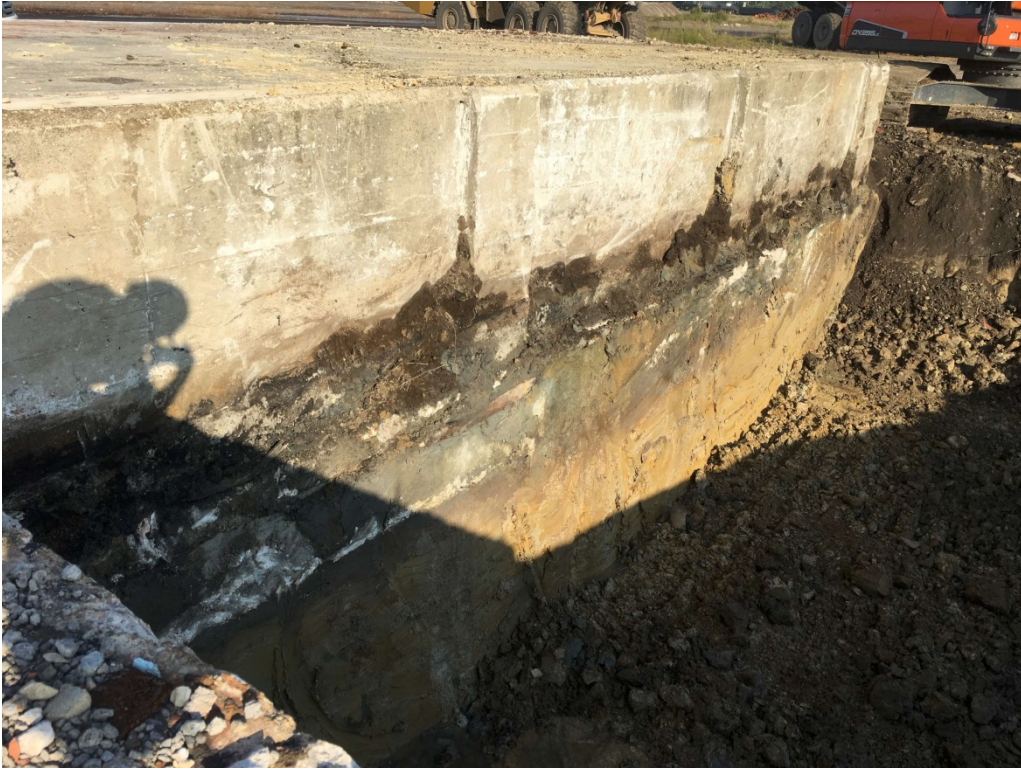
View of impacted material observed along the west wall of the main excavation area.

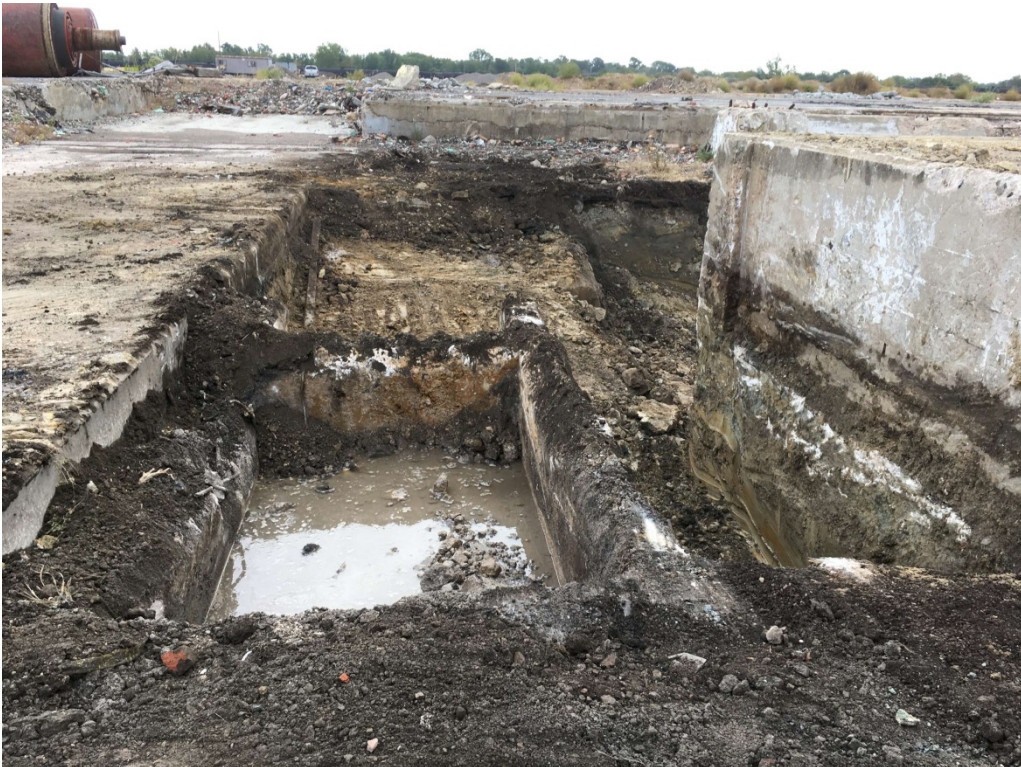
View of concrete box located in the northwest corner of the main excavated area. The benched area, approximately three feet below grade, is seen beyond the end of the concrete box.

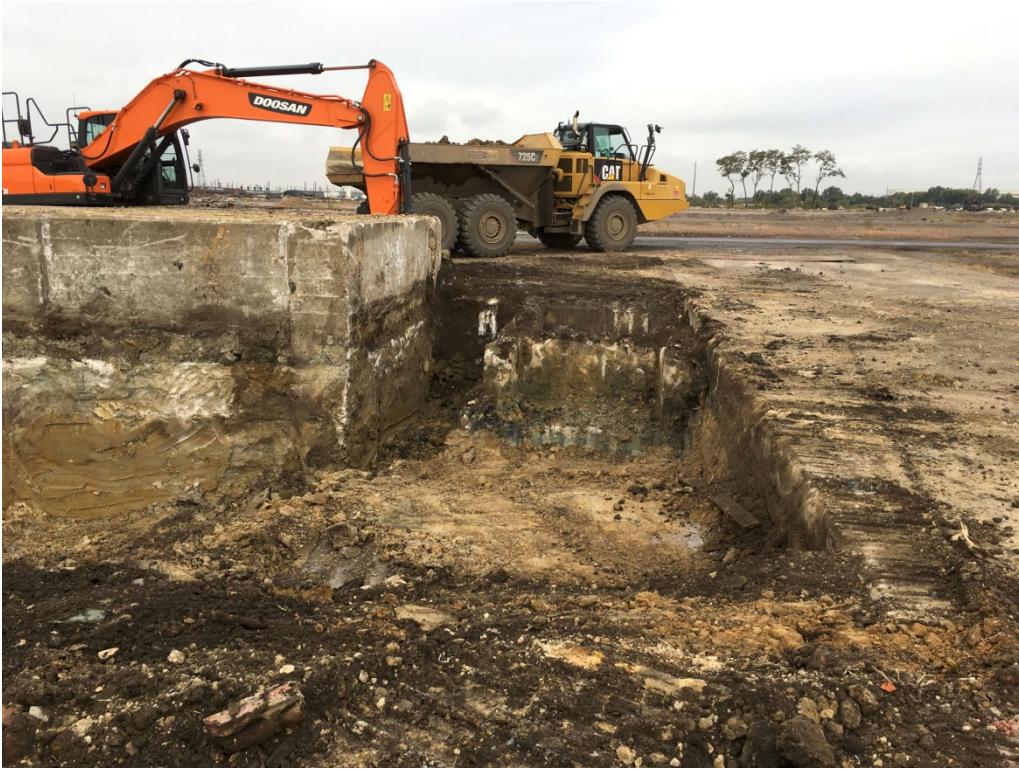
View of impacted material observed along the concrete box. The non-impacted benched area is located in front of the concrete box.

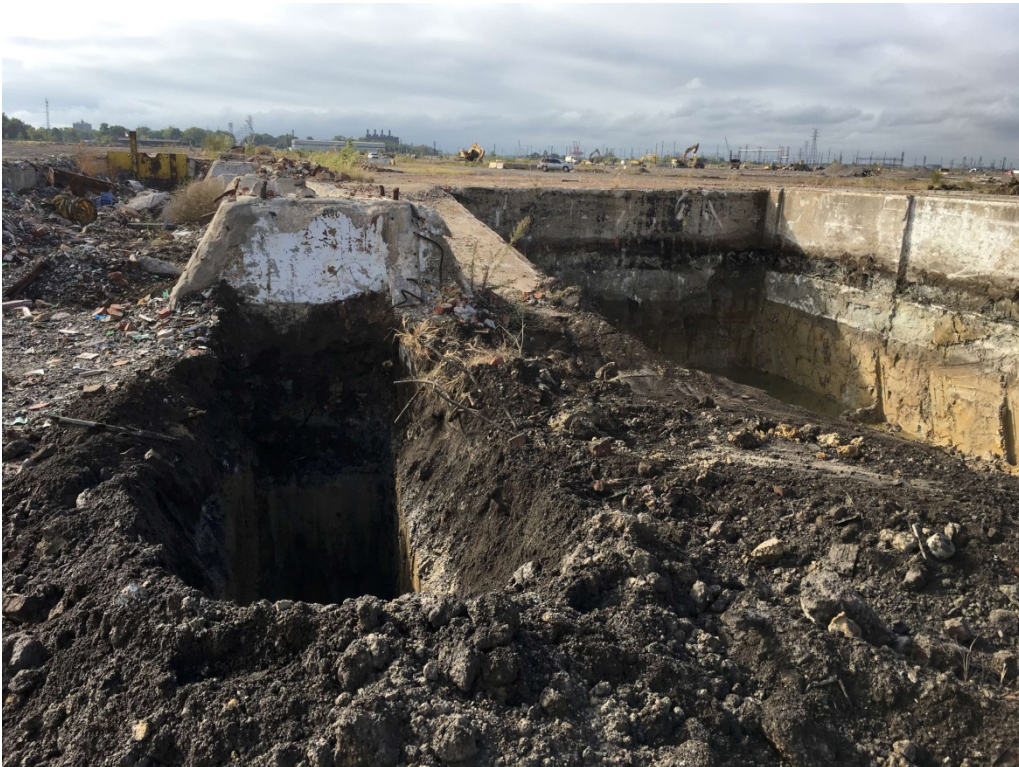
View of the location of the east excavation area facing south.

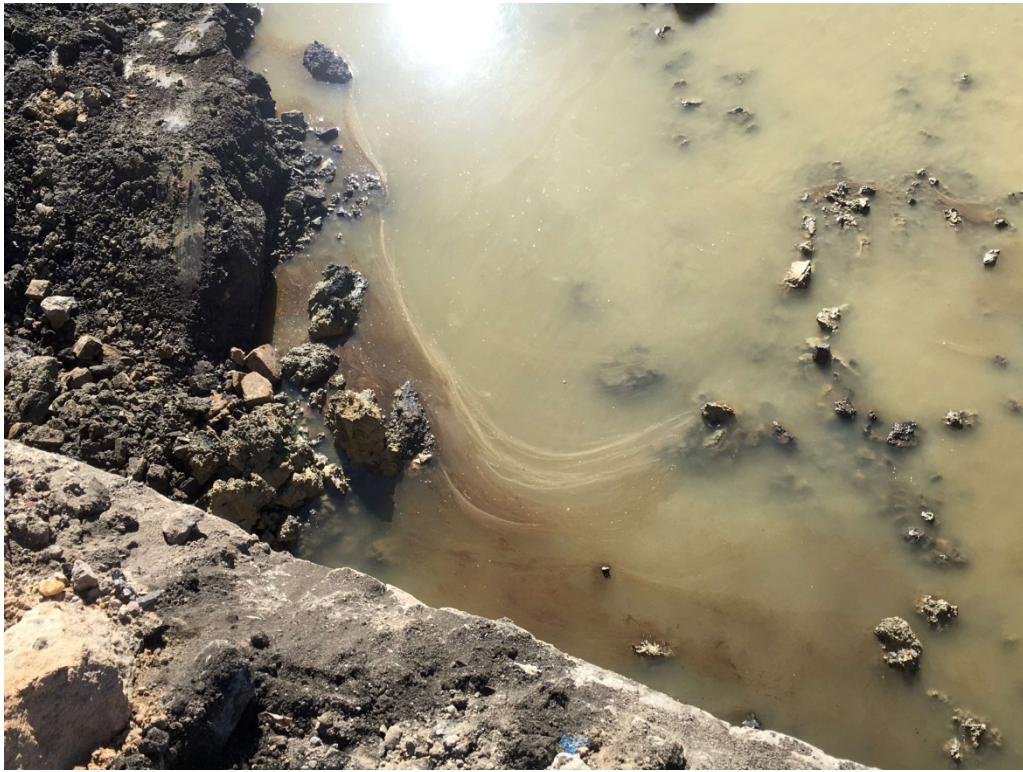
View of product observed on the bottom of the excavation.

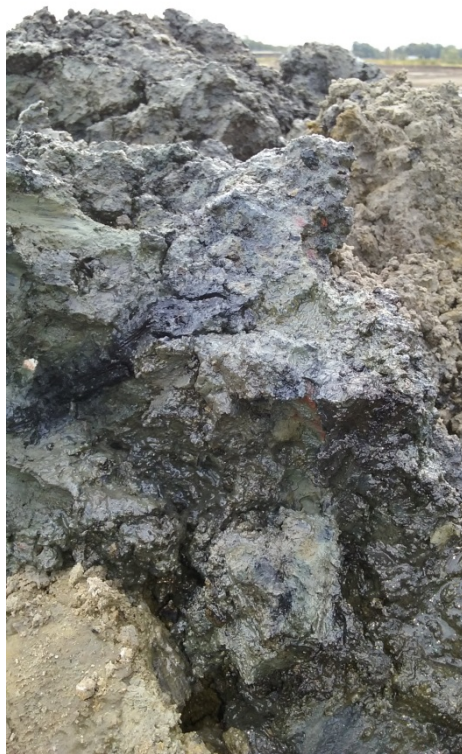
View of the impacted excavated material.

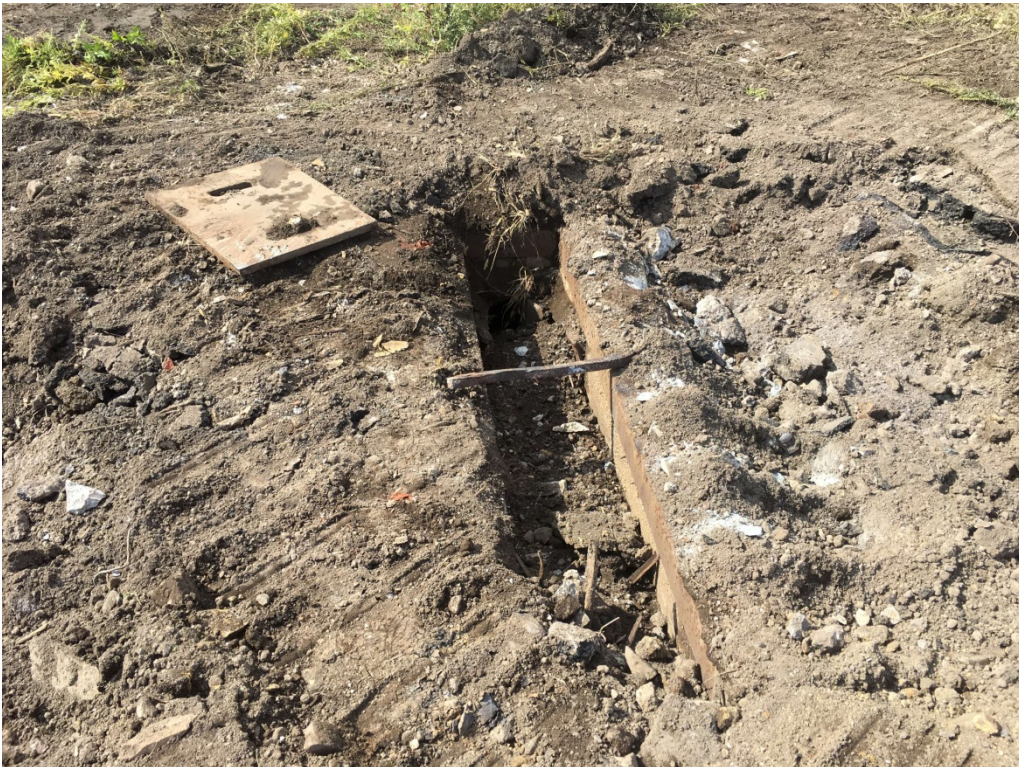
View of the french drain observed in the northwest corner of the excavation.

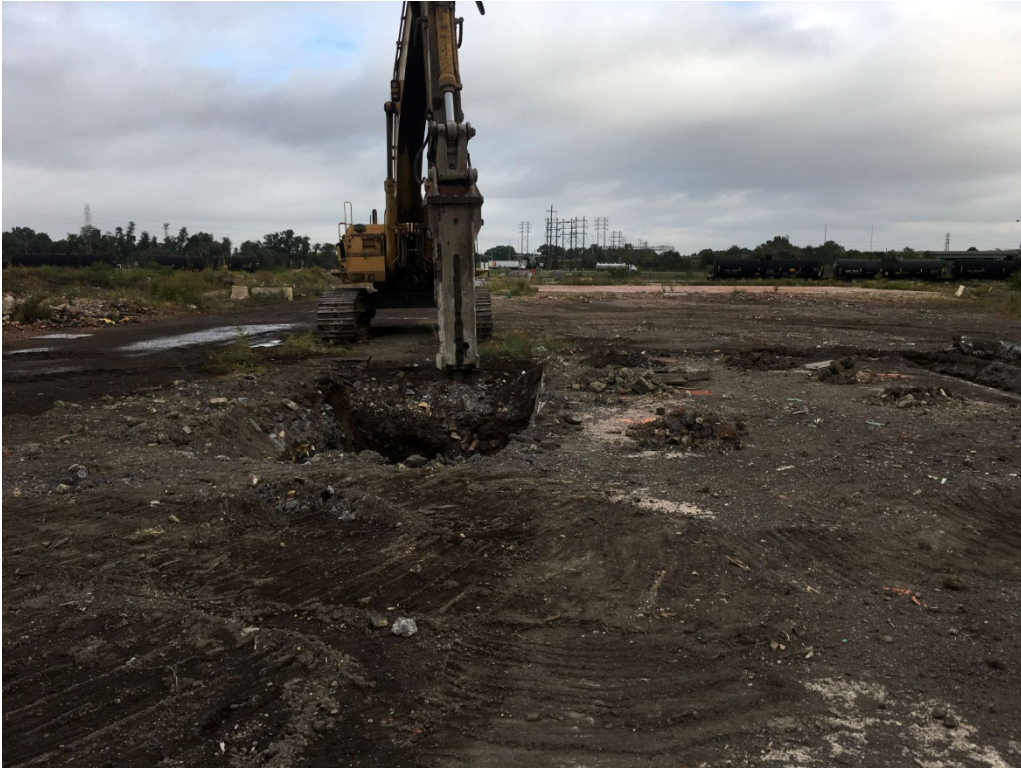
View of the MCM excavator with the jack hammer attachment used to break-up the french drain and slag.

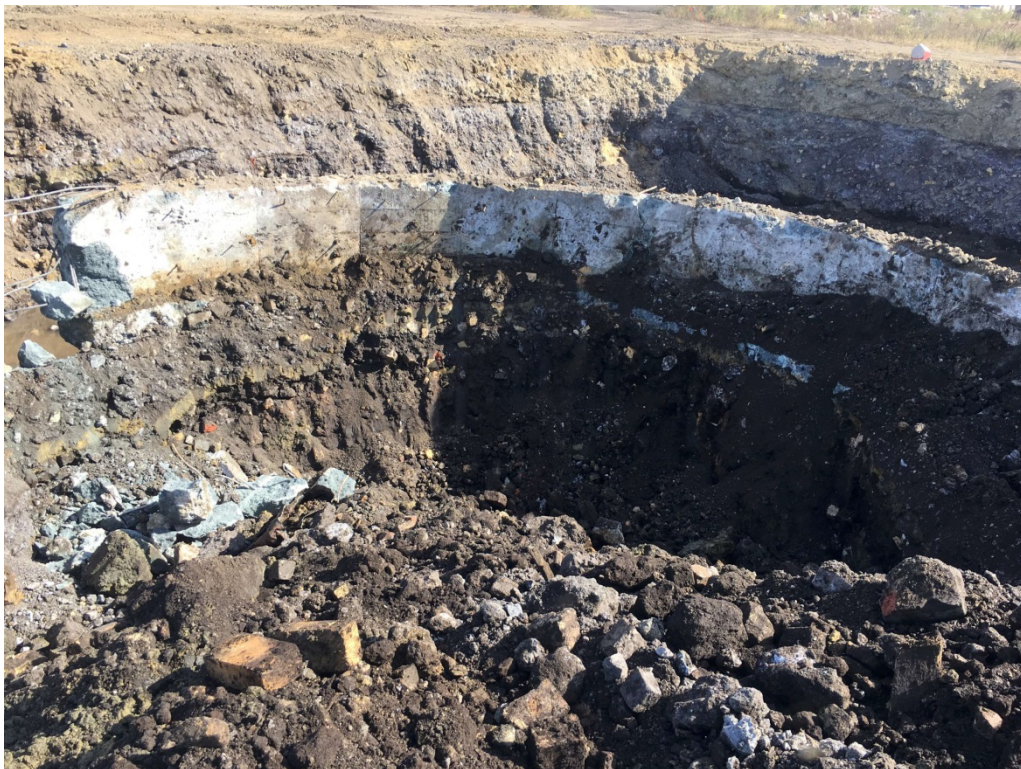
View of the material under the tank pad slag. Minor impacts were observed in this area. No impacts were observed on the tank's concrete pad and support ring.

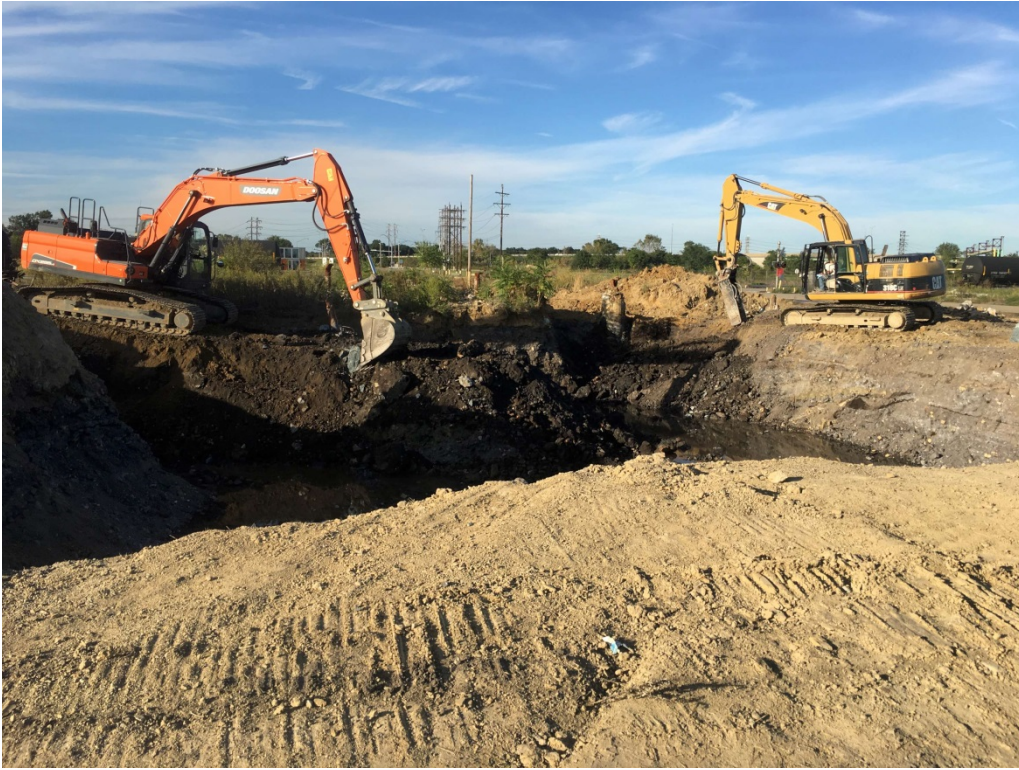
View of the MCM and ENR equipment completing excavation activities.

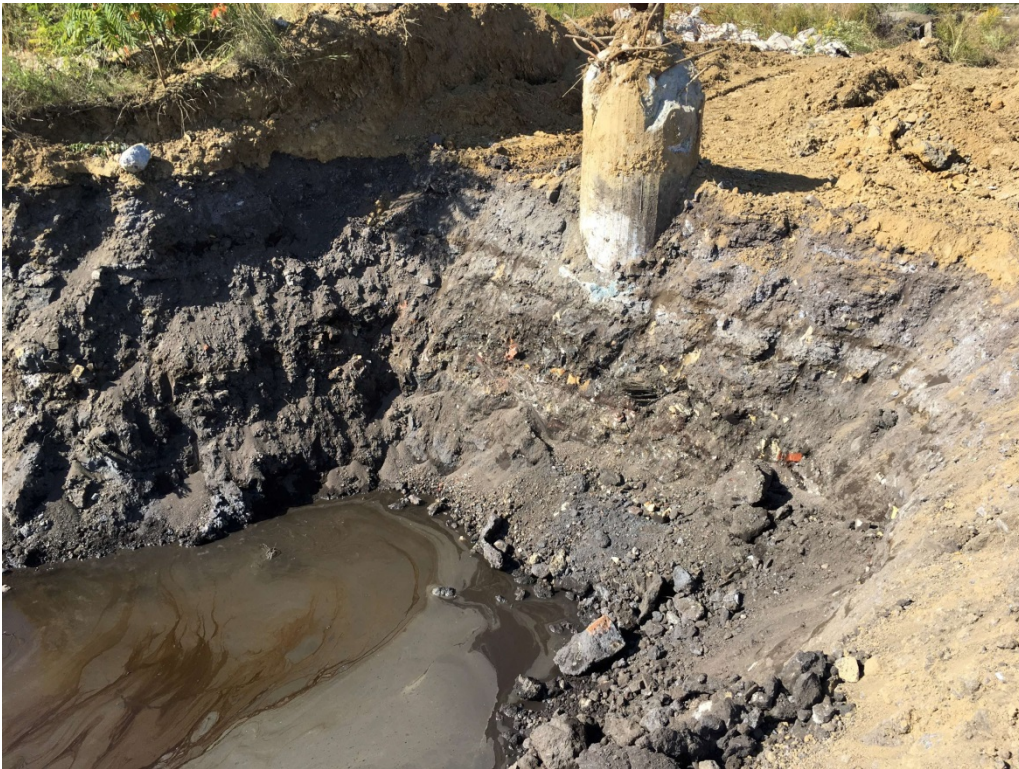
View of the northeast corner extension, due to significant impacts, and product observed on the bottom of the excavation.

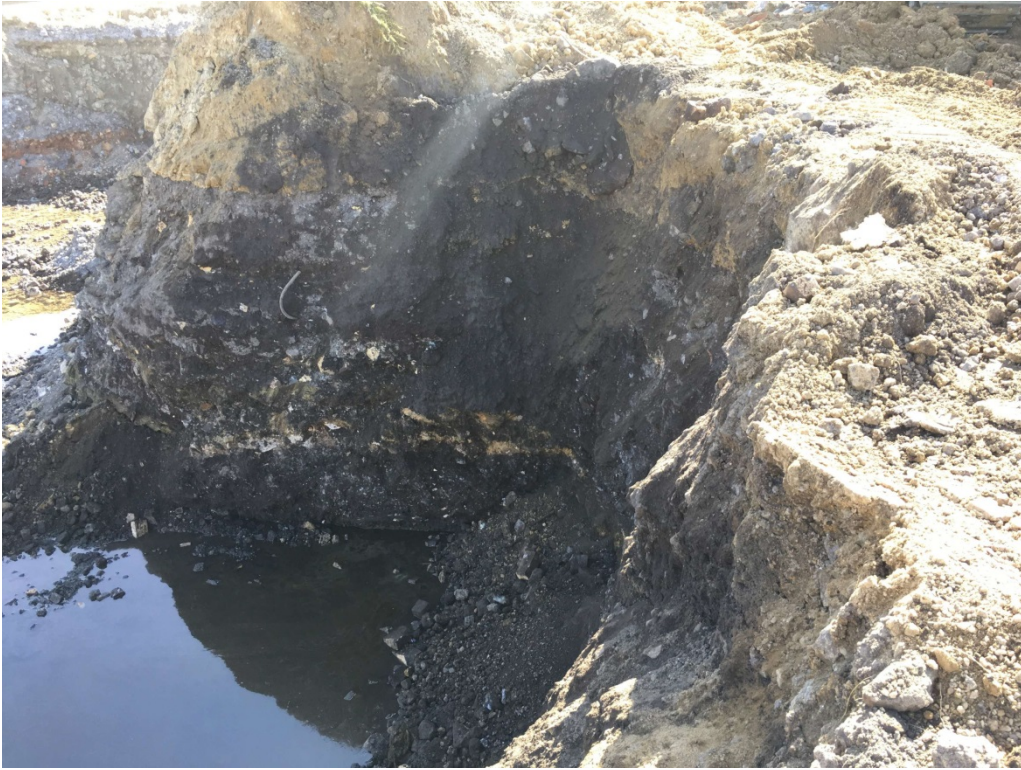
View of the west wall extension due to significant impacts observed. The product pipe was routed through this area.
