RESPONSE AND DEVELOPMENT COMPLETION REPORT

AREA B: PARCEL B22, PHASE 1
TRADEPOINT ATLANTIC
SPARROWS POINT, MARYLAND

ARM Project No. 20010222

Revision 0 – July 15, 2020

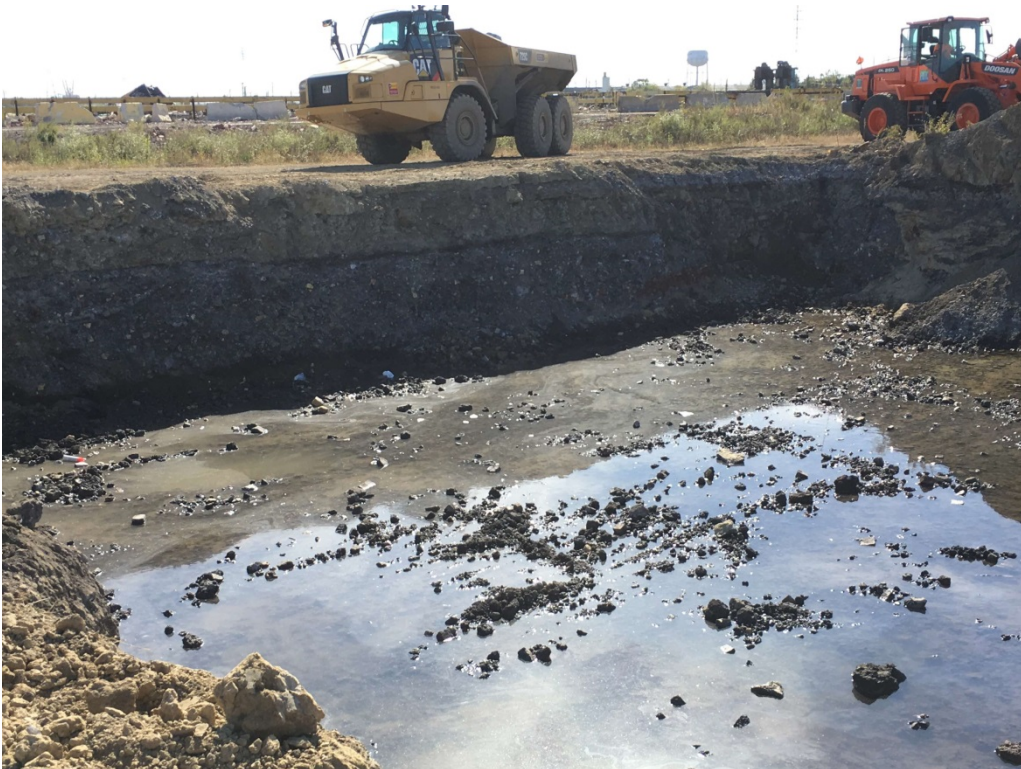
View of the south wall of the completed excavation.

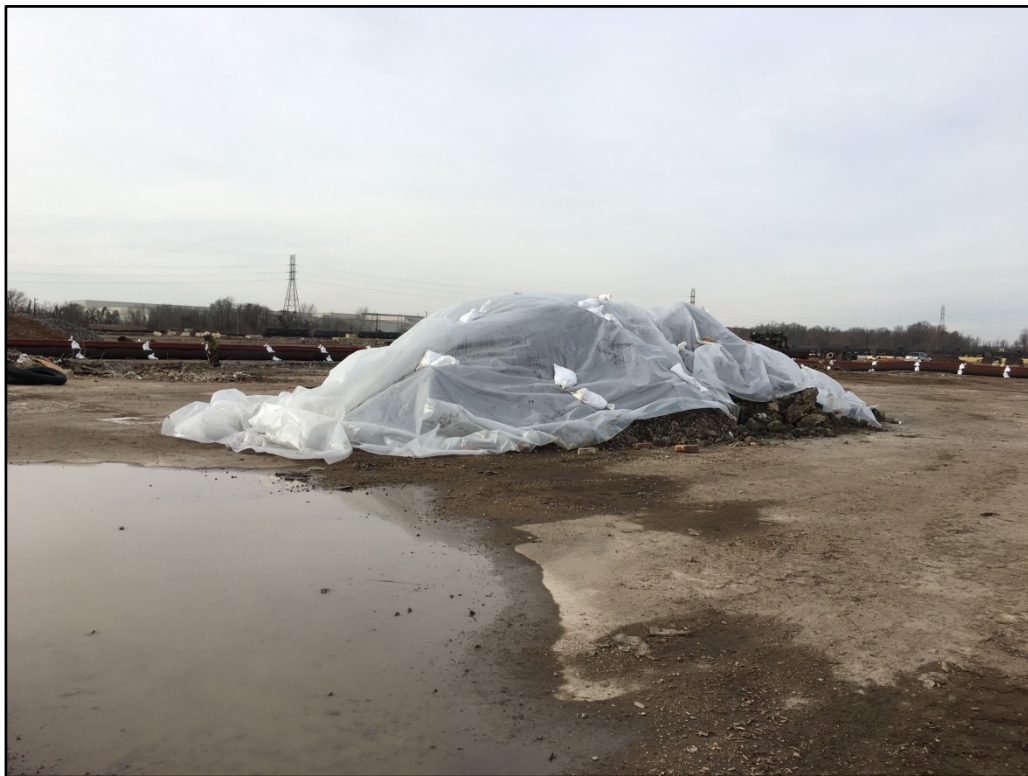
Photo 4: Stockpiled soil that exhibited evidence of environmental impacts

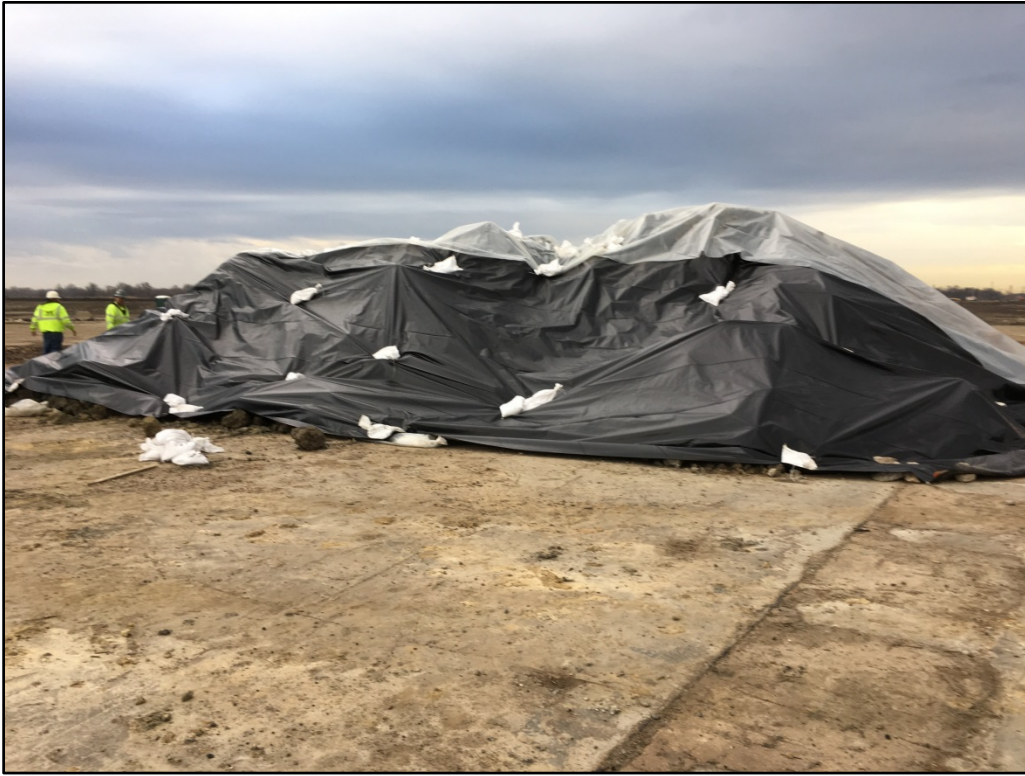
Photo 5: Stockpiled soil exhibiting evidence of environmental impacts
