RESPONSE AND DEVELOPMENT COMPLETION REPORT

AREA B: SUB-PARCEL B6-1 TRADEPOINT ATLANTIC SPARROWS POINT, MARYLAND

ARM Project No. 20010201

Revision 0 – December 11, 2020

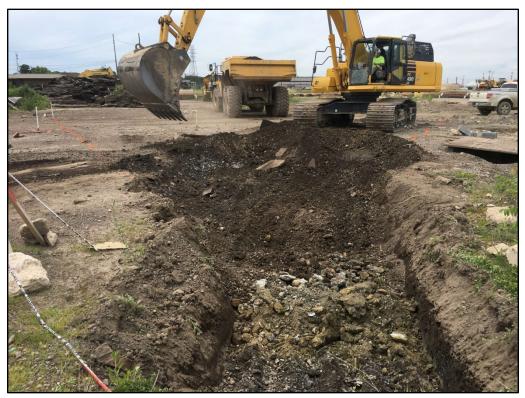
060817-1: View to the west of the start of excavation.

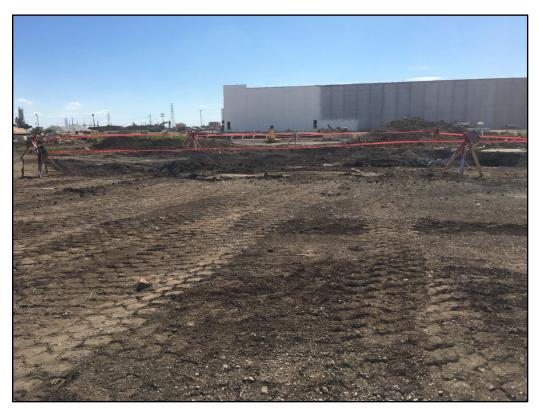
060817-2: View to the west of B22-128 Response Area.

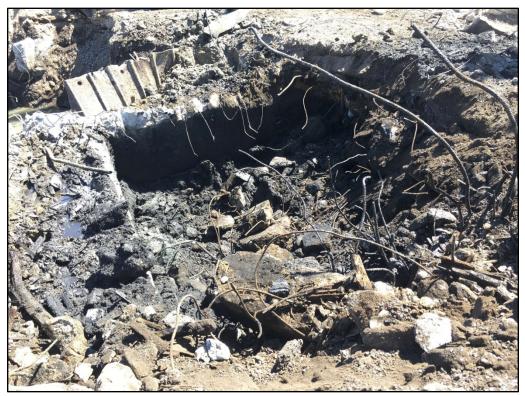
060917-1: View of the excavation in progress.

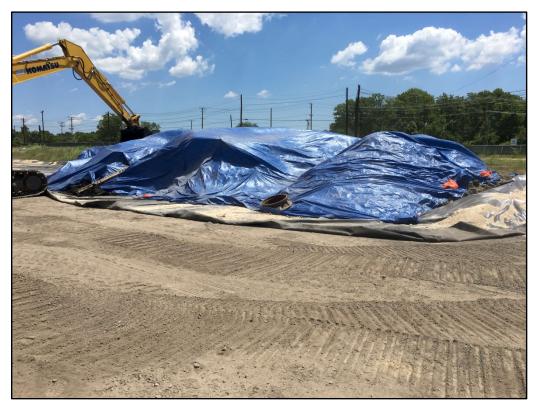
060917-2: View to the east of covered stockpiles of soil from the B22-128 excavation.

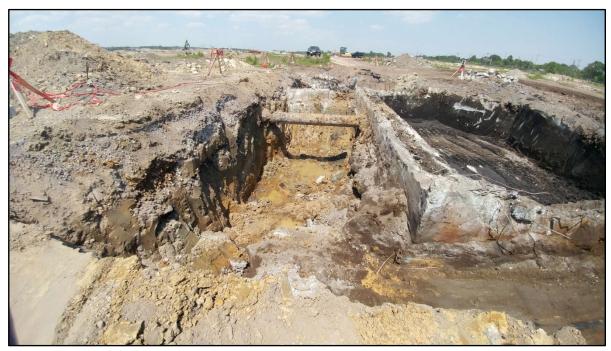
061217-1: View to the north of the western exterior trench of the excavation. A trench was dug around the concrete box to confirm if vertical and horizontal impacts from the concrete box were evident.

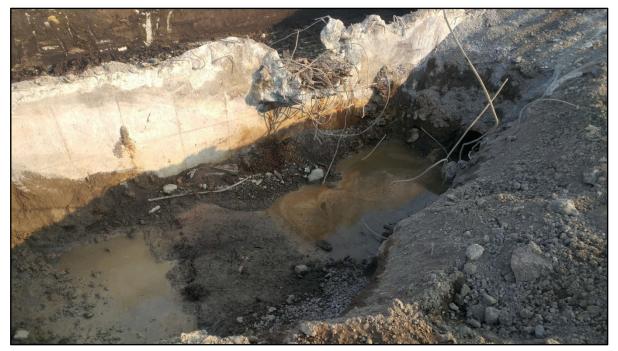
061417-1: View of the eastern exterior trench of the excavation..

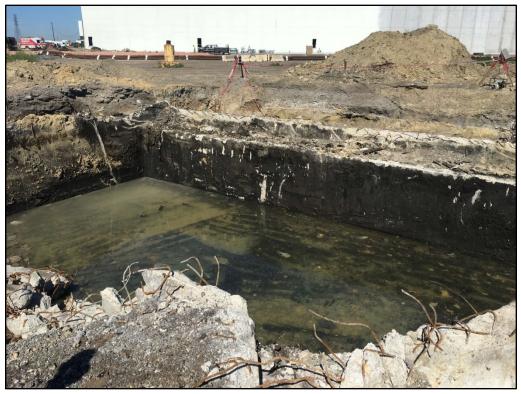
062617-1: View to the southwest of final excavated state of B22-128 Response Area.

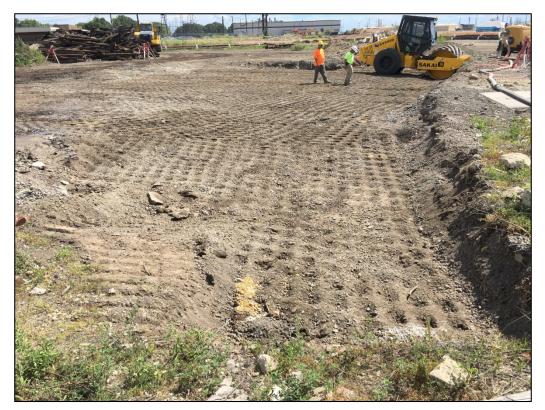
062817-1: View to the south of backfilling in progress at the B22-128 Response Area.

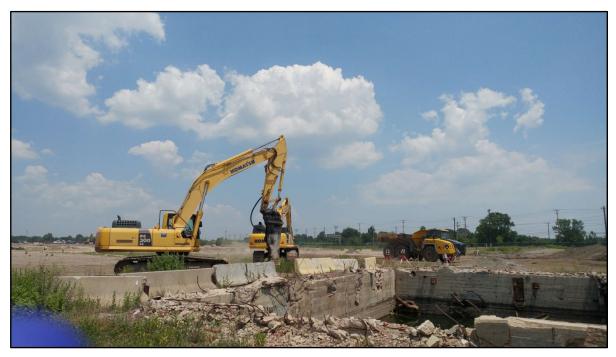
061317-1: View to the northeast of the start of excavation at the B6-011 Response Area. Visible to the right is a former pump house structure uncovered prior to arrival on site.

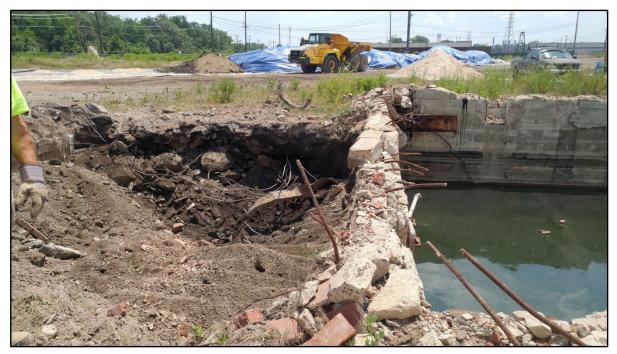
061317-2: View to the south of excavation adjacent to the former pump house structure in progress.

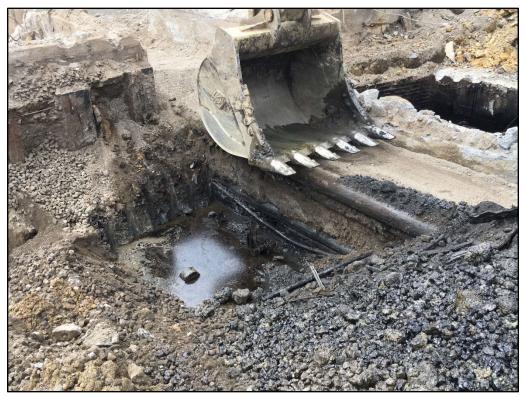
061517-1: View to the west of NAPL encountered during excavation.

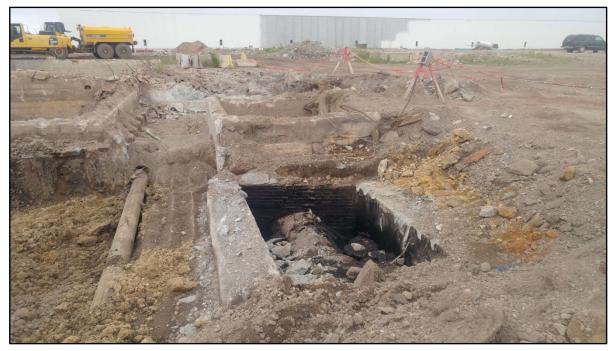
061617-1: View to the west of viscous black NAPL encountered inside concrete box.

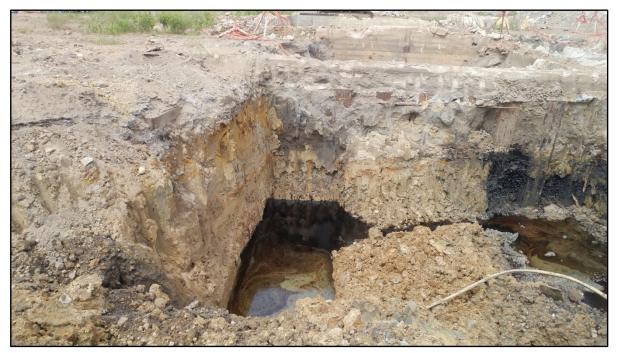
061917-1: View to the west of excavation in progress.

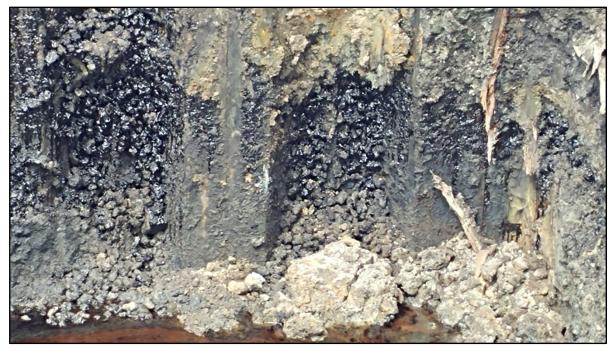
061917-1: View of NAPL encountered on excavation sidewall.

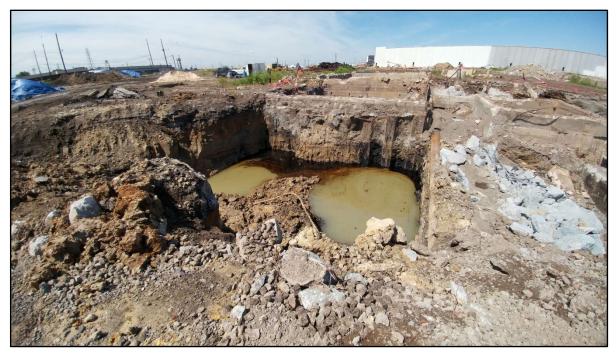
062017-1: View to the west of excavation in progress.

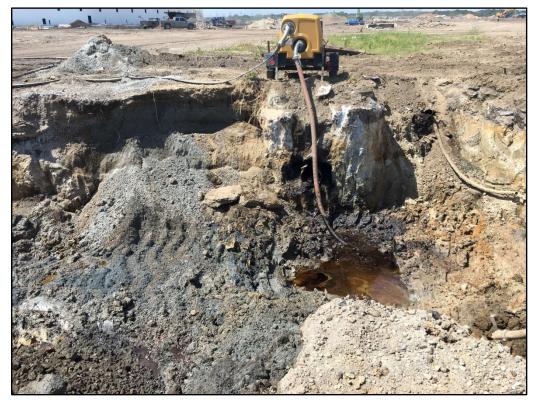
062117-1: View to the northwest of excavation in progress

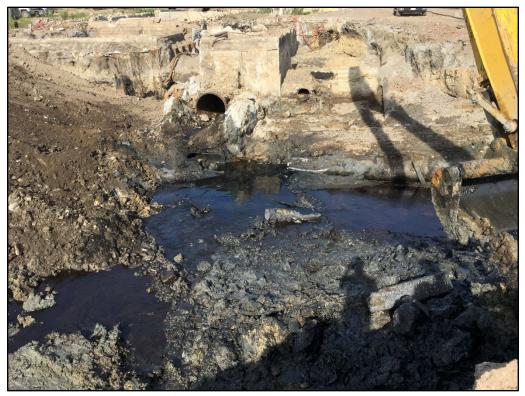
062917-1: View to the north of excavation in progress.

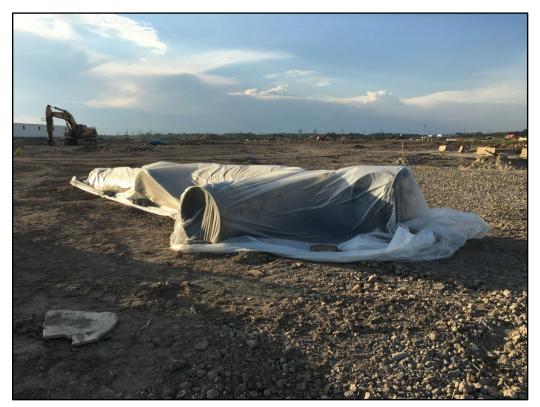
063017-1: Asbestos-wrapped pipe, wrapped in polyethylene.

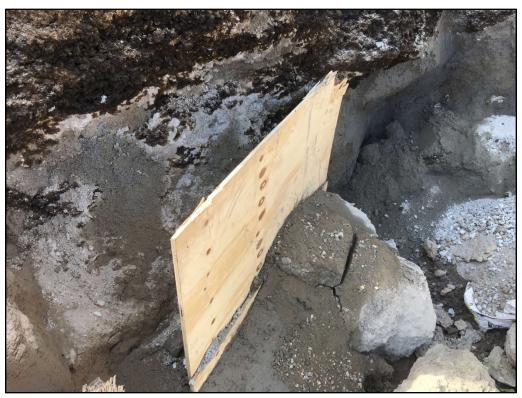
070517-1: Concrete capping, per the MDE request, of a NAPL bearing pipe encountered during excavation.

Several pipes were encountered during excavation activities in the B6-011 Response Area, as indicated on Figure 7. A 48-inch pipe running in the east-west direction had indications of NAPL in the pipe bedding. The 48-inch pipe was demolished and removed from the excavation. The eastern end of the pipe was capped with concrete on October 16, 2017 by HCEA; the western end of the pipe continued beyond the excavation boundary. A 32-inch pipe running in the east-west direction near the northern boundary of the excavation was observed to contain an The 32-inch pipe was similarly demolished and removed from the oily water mixture. excavation. The MDE requested during their field visit on June 29, 2017 that this pipe also be capped with concrete to prevent additional NAPL exiting the pipe into the subsurface. The western end of the pipe was capped with concrete on July 5, 2017. Sections of a 36-inch NAPL bearing pipe running in the north-south direction were also demolished and removed from the excavation. Several concrete boxes were also encountered in the B6-011 Response Area excavation, as shown on Figure 7. A very viscous black NAPL was encountered in the vicinity of the large concrete subgrade structure (former pump house) indicated on Figure 7. The NAPL was stabilized with overburden material before being transported by dump truck to the impacted soil stockpiles.

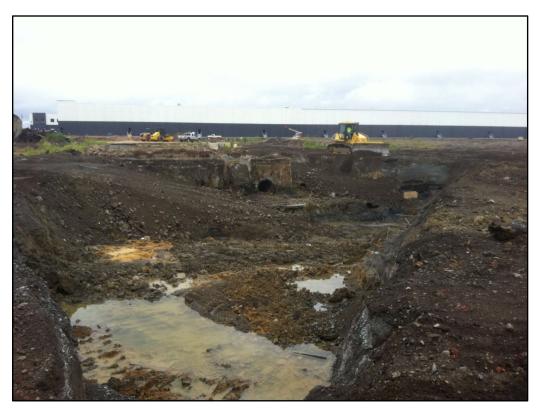
070617-1: View to the west of final excavated state of B6-011 Response Area.

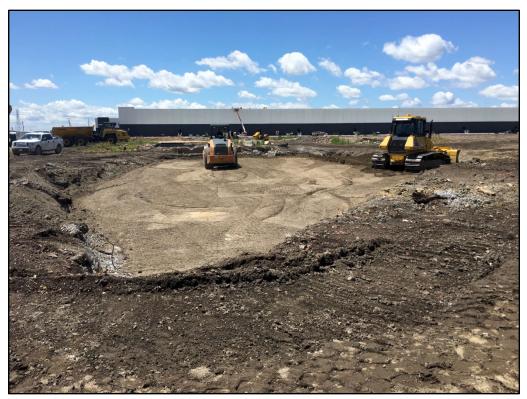
070717-1: View to the west of backfilling in progress.

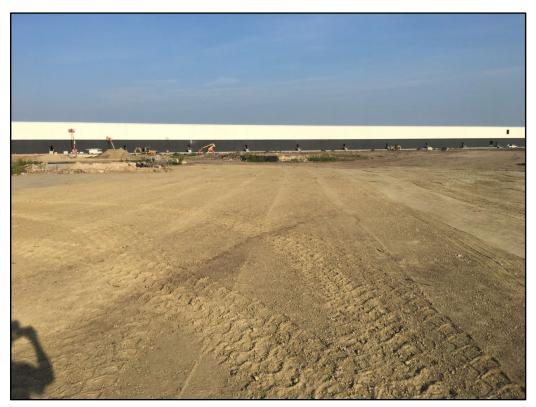
070717-2: View to the west of final backfilled state of B6-011 Response Area.

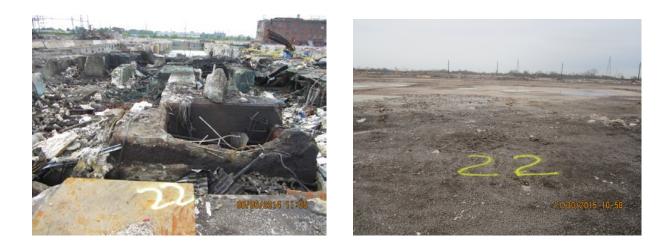
*Area of structural backfill depicted above encompasses SGS-19 and SGS-22.

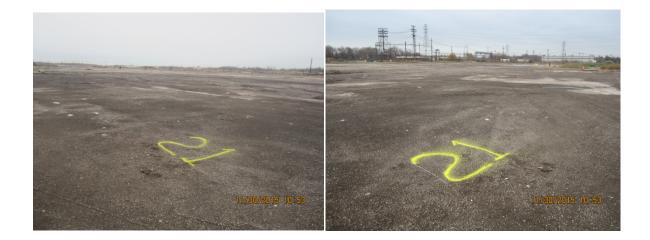
*Area of structural backfill depicted above encompasses SGS-20 and SGS-21.

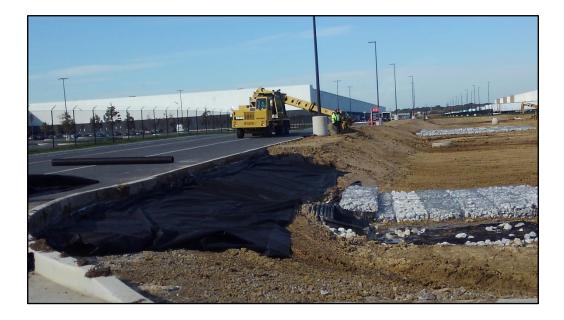
Photo 5: Basin development in progress
