INTERIM RESPONSE AND DEVELOPMENT COMPLETION REPORT

**AREA B: SUB-PARCEL B6-2
TRADEPOINT ATLANTIC
SPARROWS POINT, MARYLAND**

ARM Project No. 20010206

Revision 0 – September 22, 2021

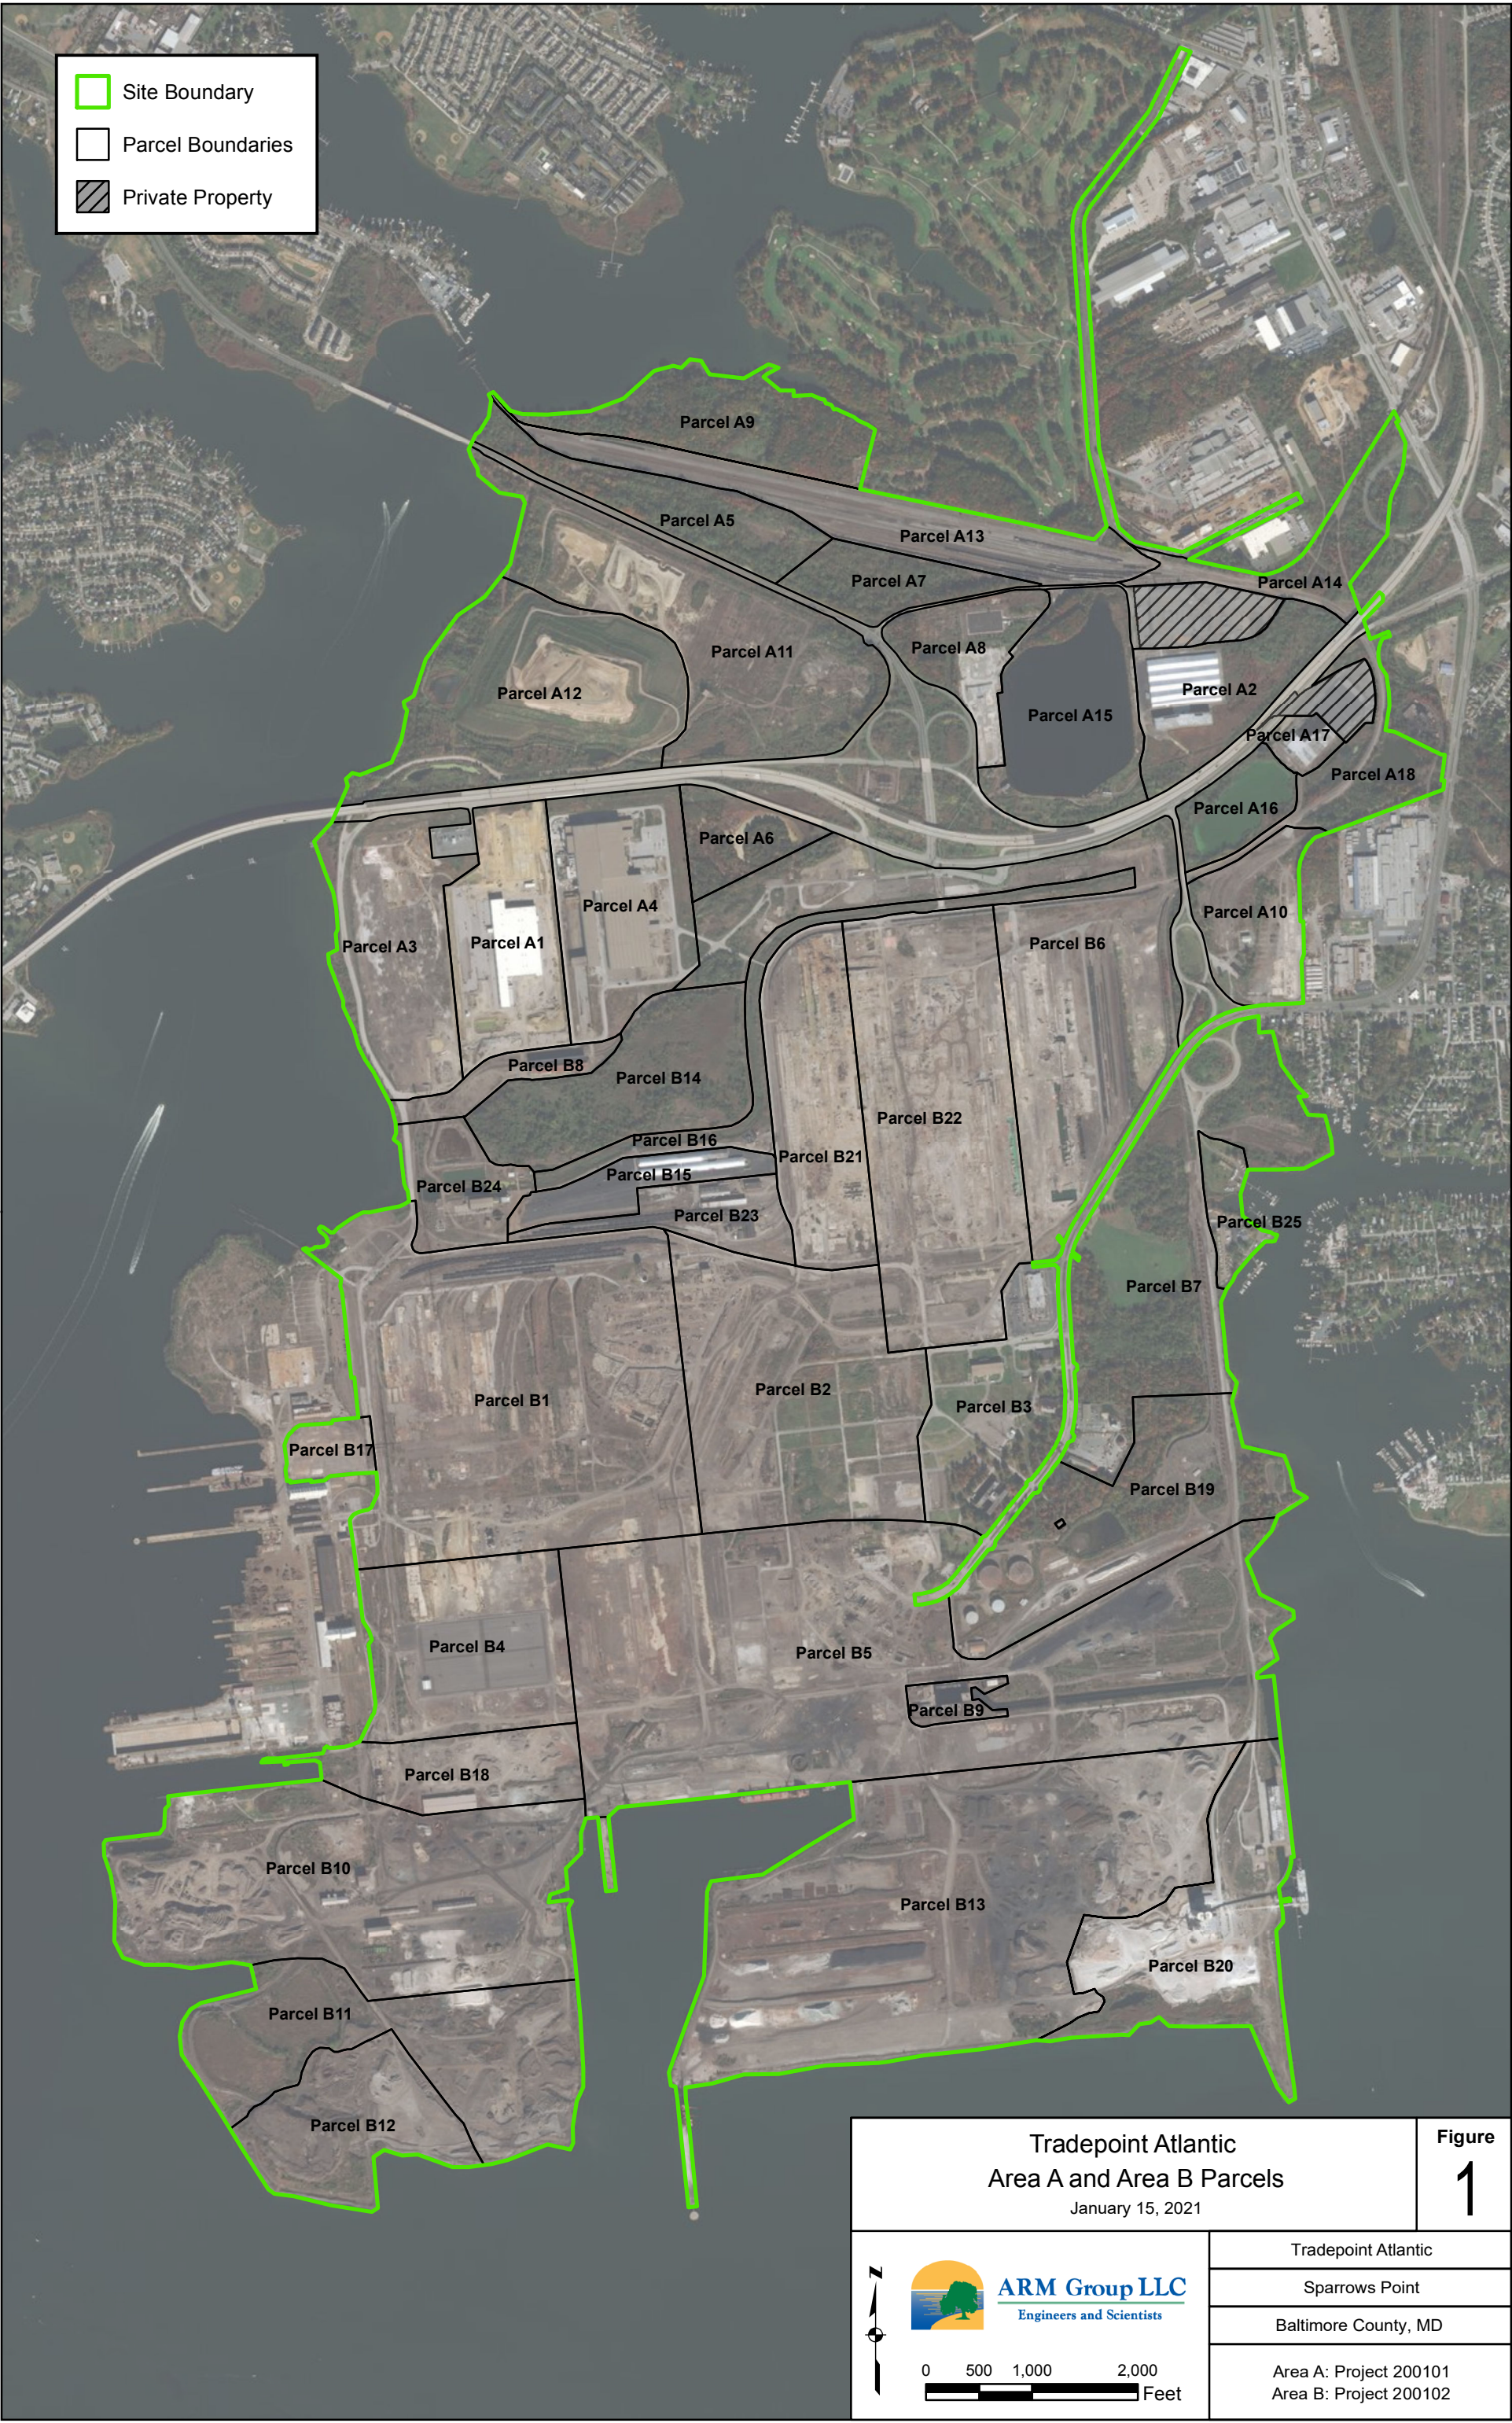
Figure
1

Parcel B6 comprises approximately 148.5 acres of the approximately 3,100-acre former steel mill (**Figure 1**) that operated for over one hundred years. In 2012, steelmaking operations at the facility ceased. From 2013 to the present day, a demolition contractor has been demolishing the majority of the above-grade structures on the site-wide property.

Tradeport Atlantic
Area A and Area B Parcels
January 15, 2021

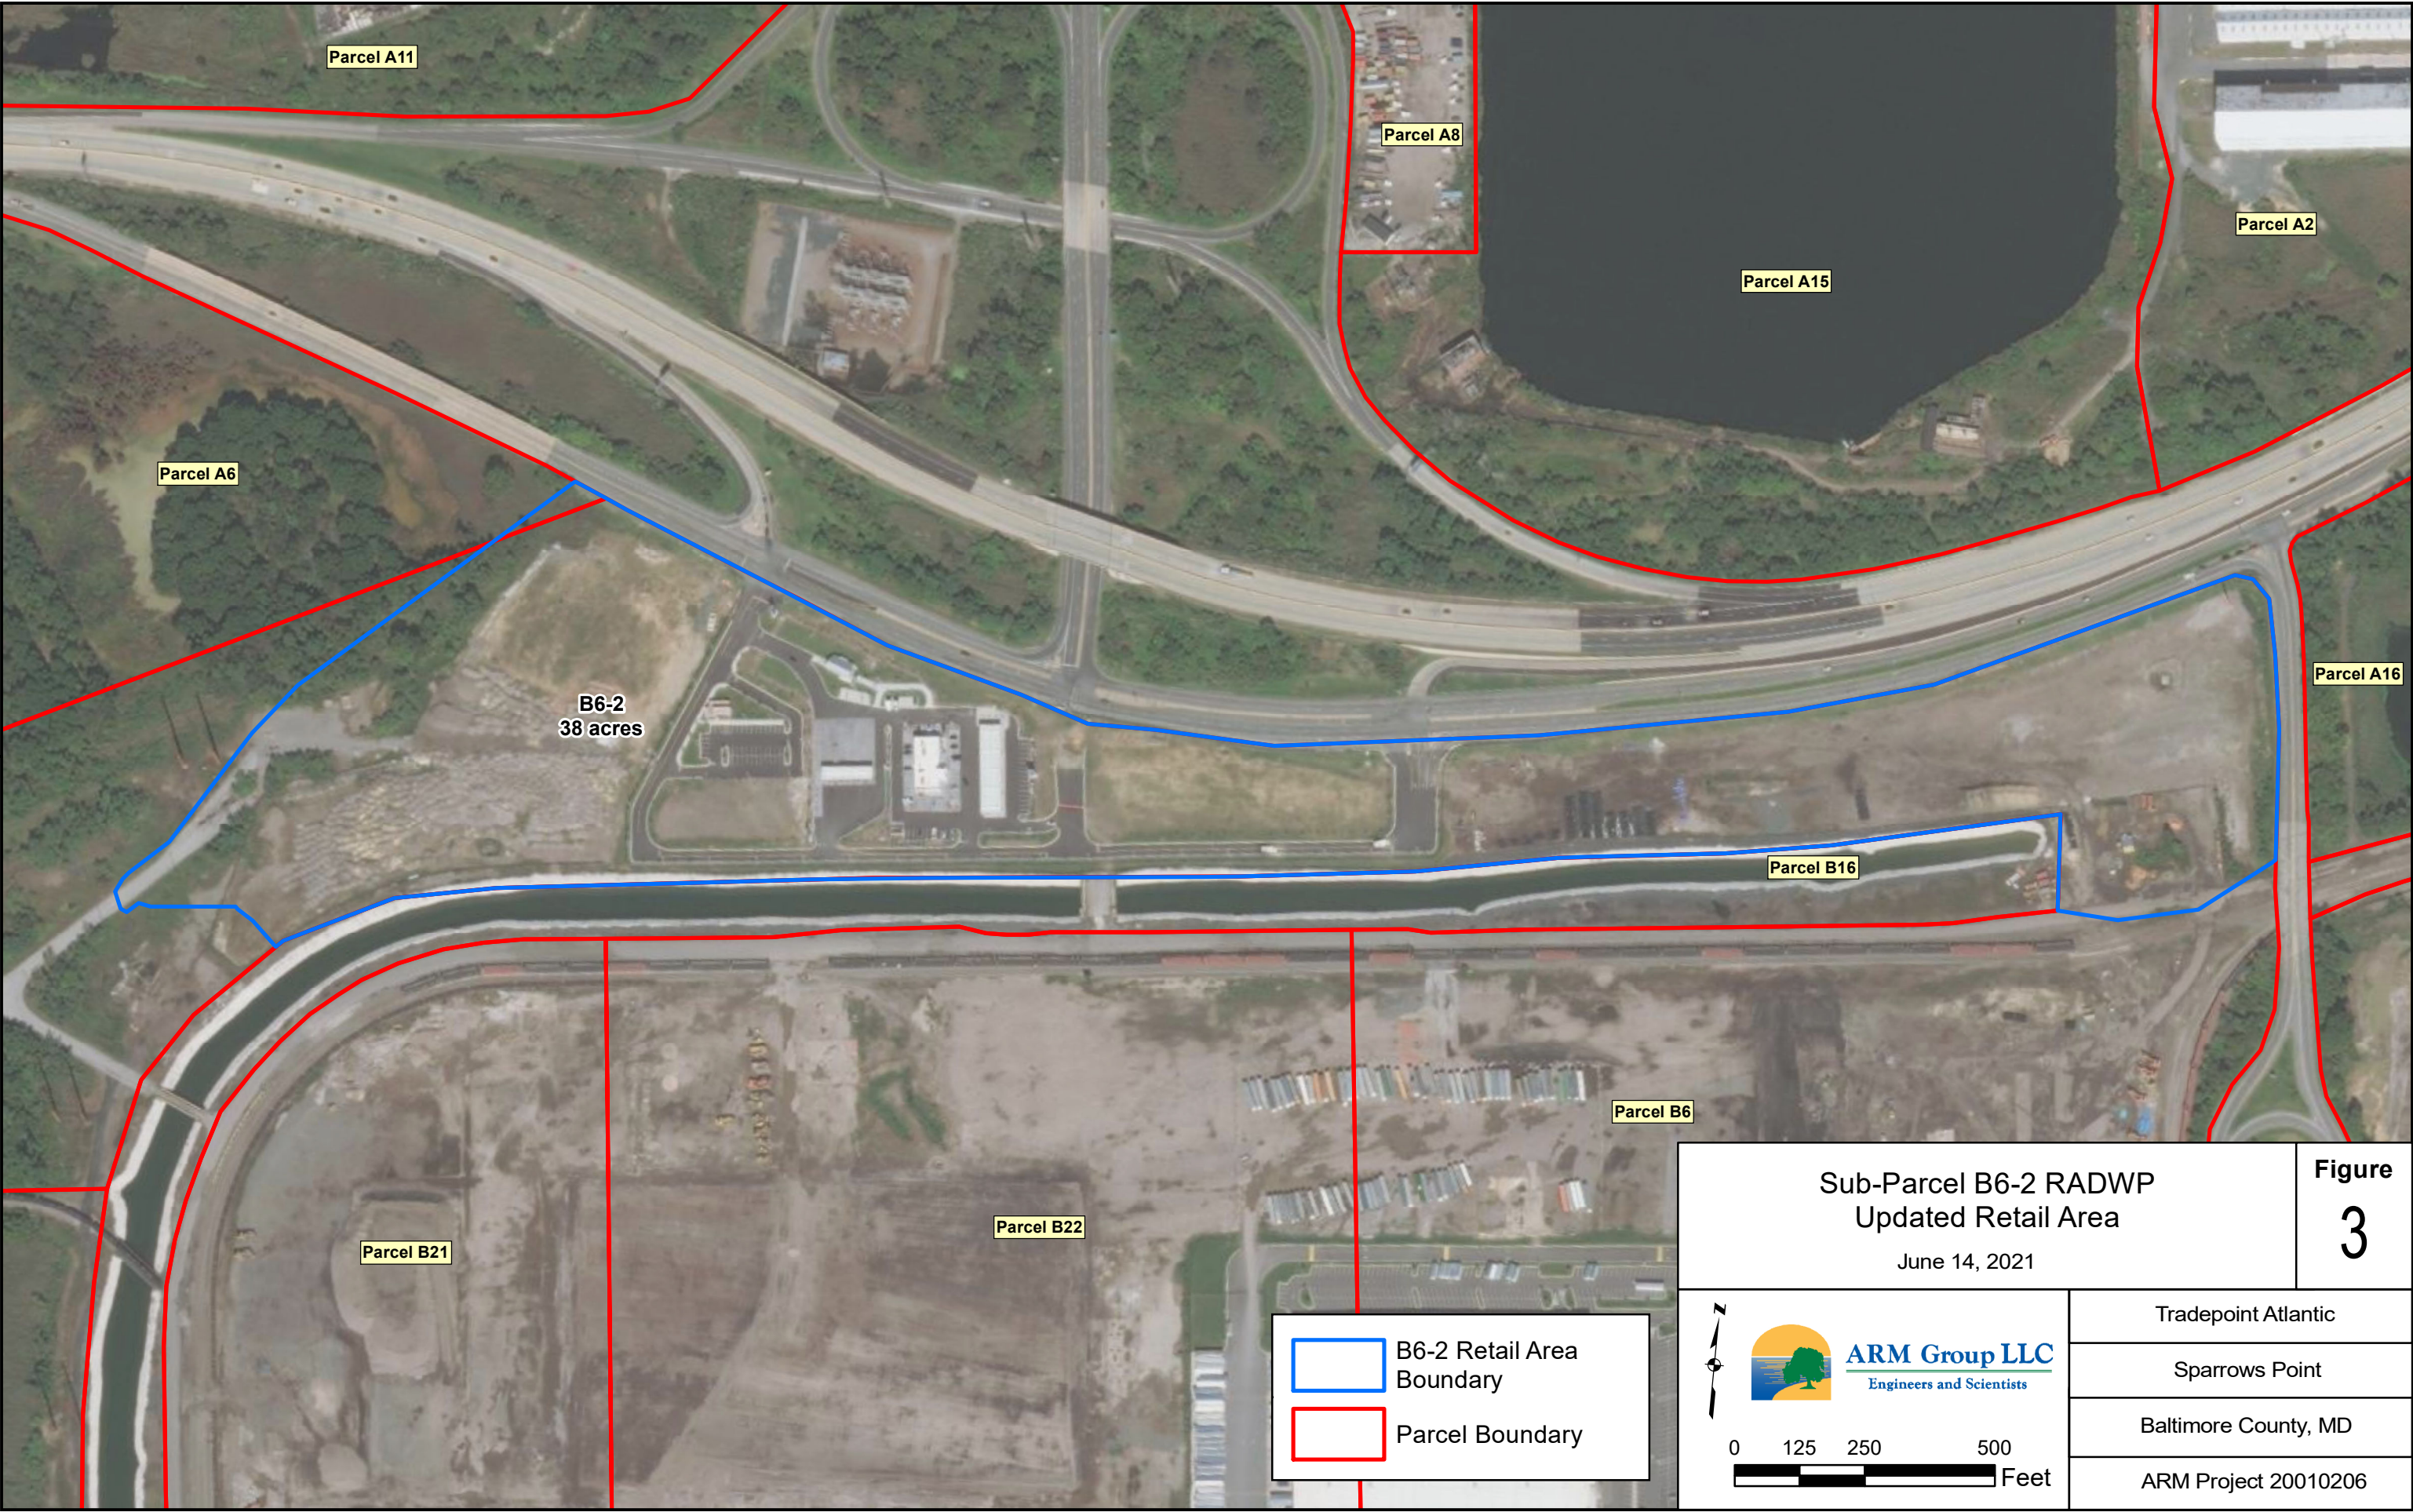
This section presents a summary of the completed development work as well as materials management and other protocols that were followed during the development work performed under the Sub-Parcel B6-2 RADWP to adequately mitigate potential risks for future uses of the property. The general scope of the Sub-Parcel B6-2 RADWP was limited to grading activities and utility installations. The development area is shown in **Figure 3**.
