Response Action Plan Presentation Guardian House

17, 19, and 23 South Gay Street

October 14, 2020

Presented by Geo-Technology Associates, Inc.

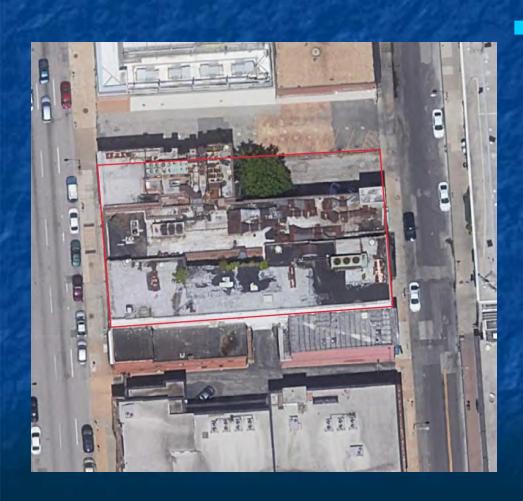
The subject property contains 3 adjoining row-type structures. These structures are 4 to 5 stories and include a basement level. A small surface parking area is present at the northeast corner of the property.

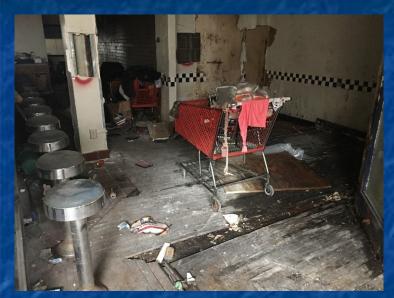
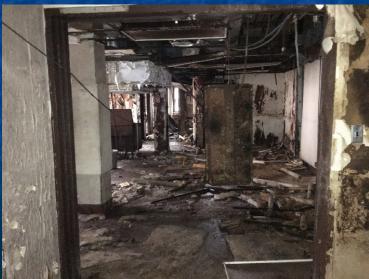
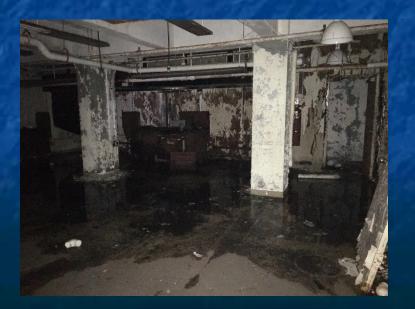
The subject property buildings are vacant, abandoned structures that are in an advanced state of disrepair.

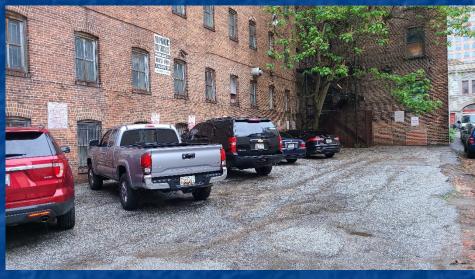
Northeast Parking Area – view looking east

GTA performed a Preliminary Geotechnical Exploration in 2018. During the course of completing subsurface borings in the northeast parking lot, GTA encountered what were believed to be petroleum odors in shallow fill soils. Fill soils were encountered to a maximum reported depth of 7 feet below ground surface.

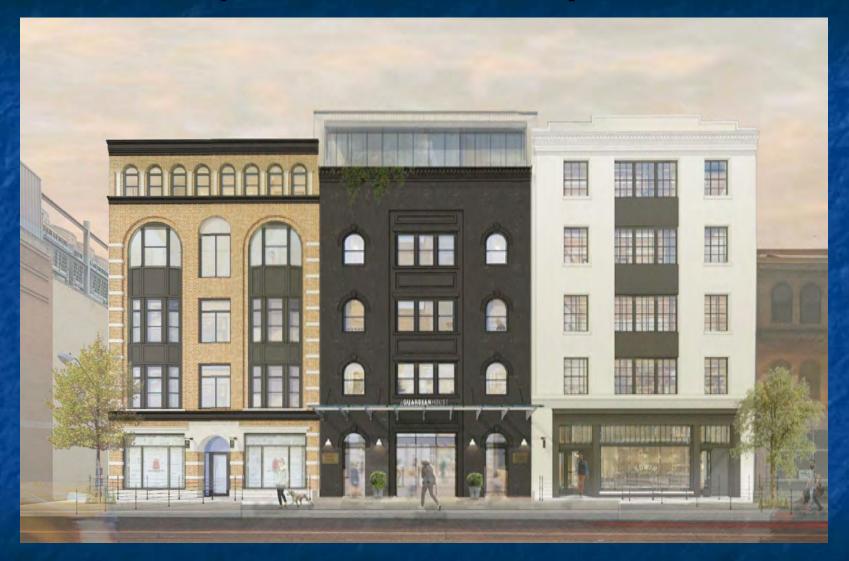
Proposed Development

- Subject property to be redeveloped with residential apartments to include:
 - multi-story apartment building with 66 apartments and two street-level commercial/retail spaces;
 - basement level storage and mechanical spaces, and one commercial space (beneath 23 S. Gay Street);
 - first floor will include entry lobby, management and leasing offices, and five apartment units;
 - floors 2 5 will consist of apartments and will include a rooftop deck amenity space, and;
 - 5 surface-level parking spaces at re-paved northeast parking area.

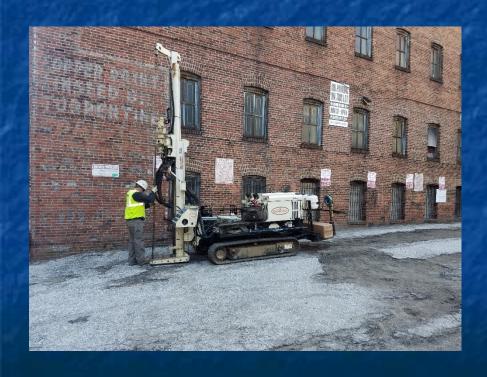
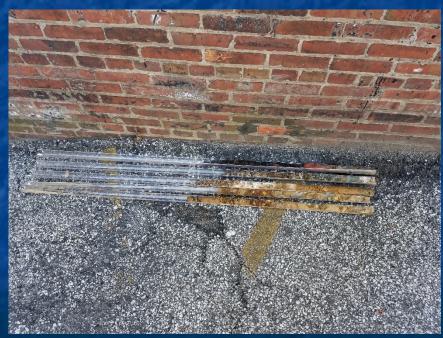
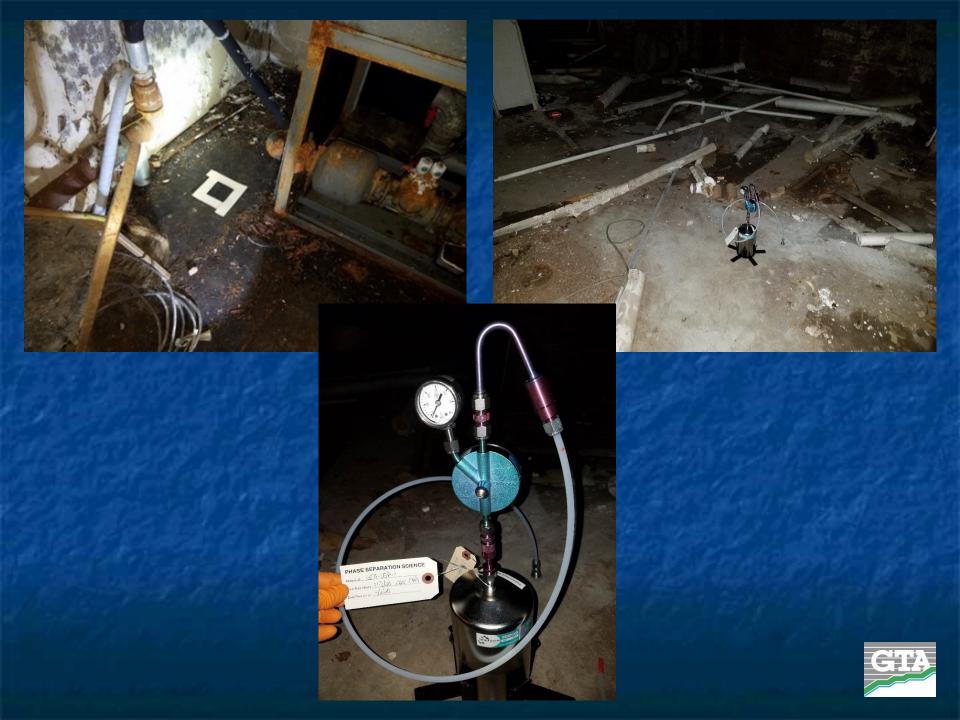
- Phase II ESA (con't)
 - Field activities were performed in two phases between April 1 and April 22, 2020.

- Results of the Phase II ESA
 - Shallow fill soil present beneath asphalt in northeast parking area to depths of 0.5 to 7 feet below grade.
 - Fill soil exceeded the MDE Residential Comparison Standards (RCSs) for:
 - VOCs, SVOCs, and metals
 - Elemental Mercury (Hg) detected in shallow fill soil above
 MDE RCS warranted supplemental Hg vapor evaluation
 - Screening of soil present beneath the identified fill did not indicate elevated VOC concentrations.
 - Subslab soil vapor sampling performed at five locations beneath basement slab.
 - Subslab VOC concentrations were below MDE Tier 1 Values

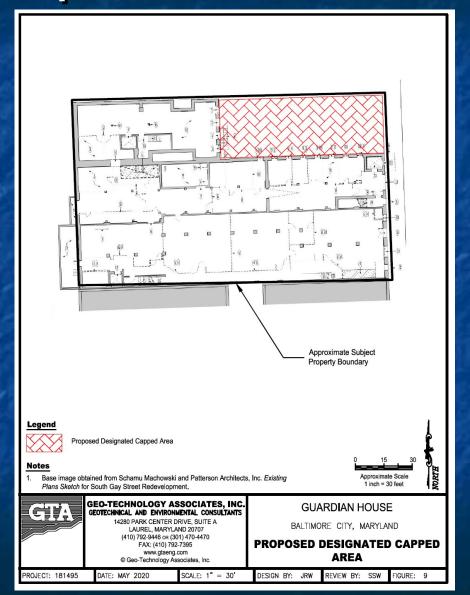
CAP DESIGN SKETCH

NOTE: PRIME COAT AS SHOWN ON PLANS OR AS DIRECTED BY THE ENGINEER

LIGHT DUTY ASPHALT PAVING SECTION

- Site wide remedies:
 - Soil
 - Removal and off-site disposal of any surplus impacted soil from northeast parking area
 - Capping of northeast parking area
 - Hardscaped area asphalt or concrete
 - No exposed or landscaped areas proposed
 - Implementation of a health and safety plan during construction
 - Deed restriction notification to MDE prior to any future breach of the cap
 - Long-term cap maintenance
