RESPONSE AND DEVELOPMENT COMPLETION REPORT

AREA B: PARCEL B15
TRADEPOINT ATLANTIC
SPARROWS POINT, MARYLAND

ARM Project No. 160443M-4

Revision 0 – April 3, 2018

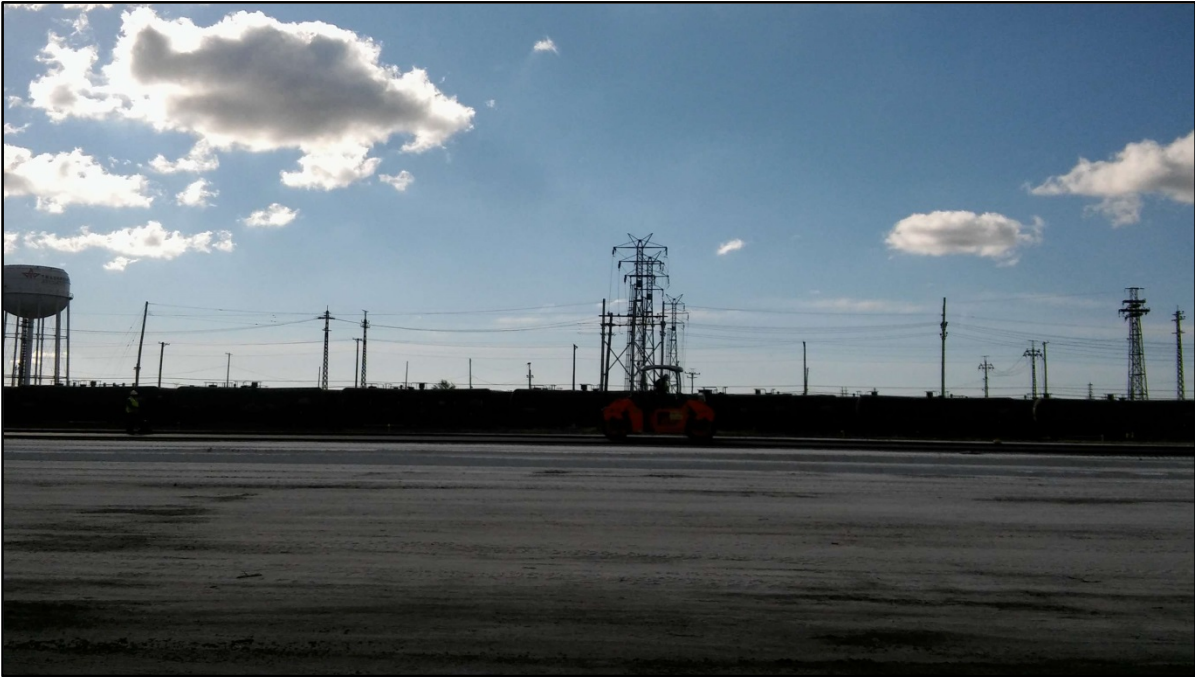
102816-1: View to the south of the unpaved western side of the site.

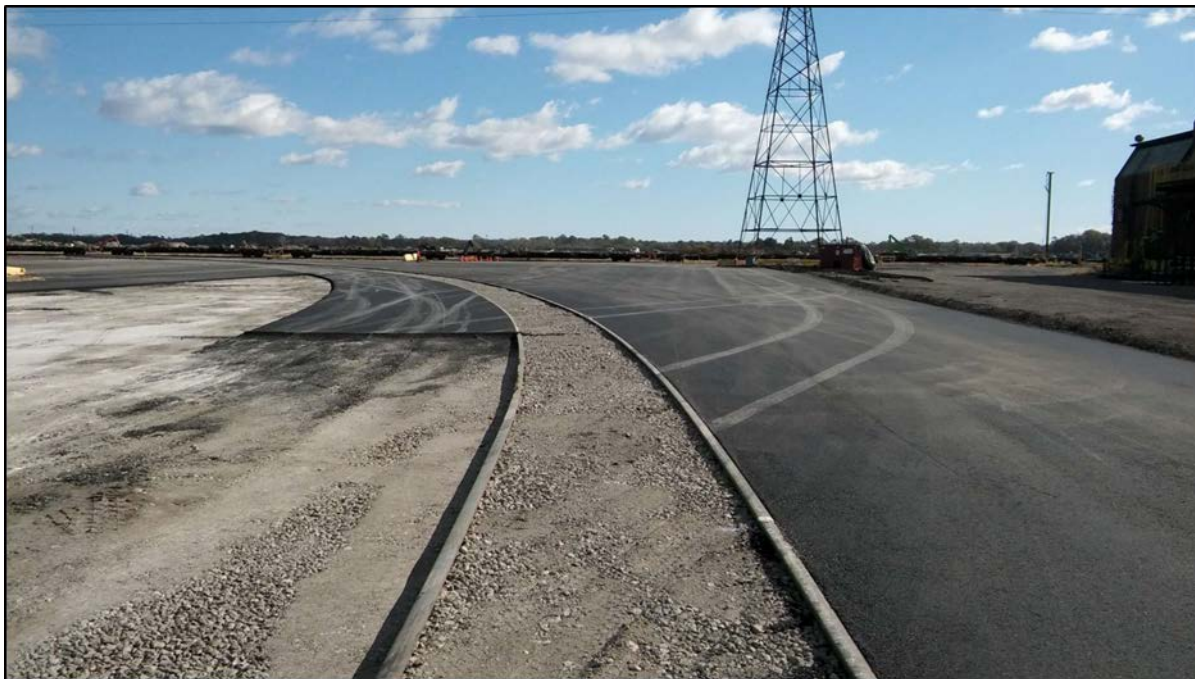
102816-2: Edge of first layer of paving on southeast corner of site.

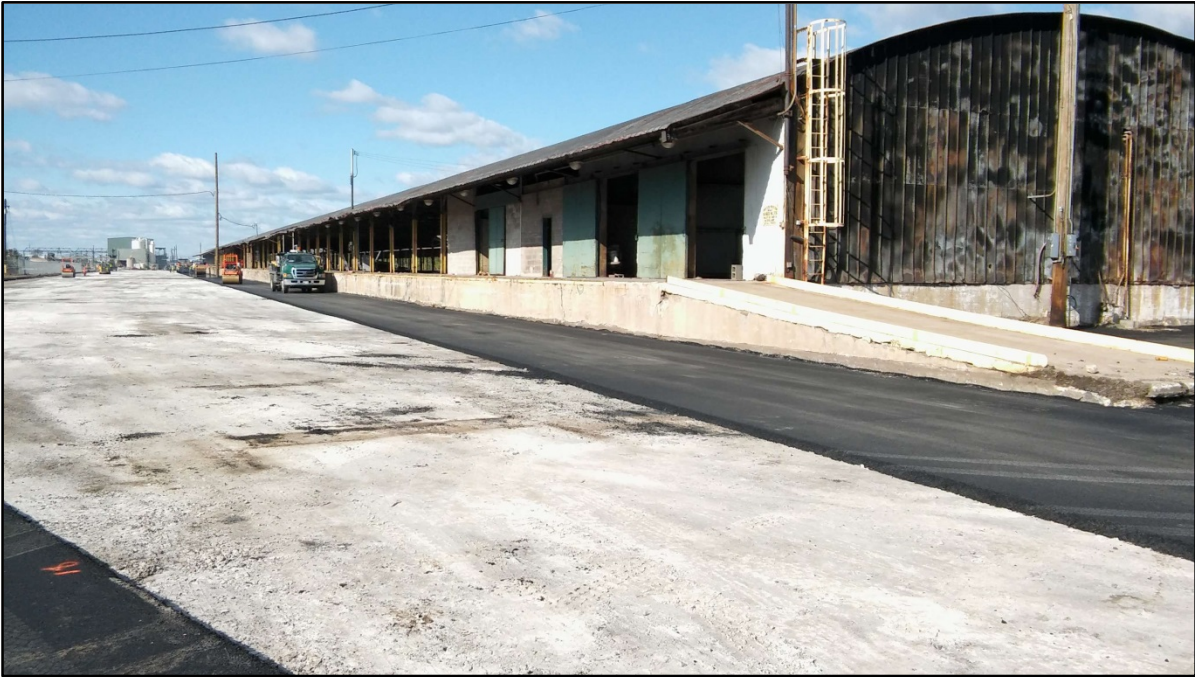
102816-3: View to the west of paving along southern edge of southern building.

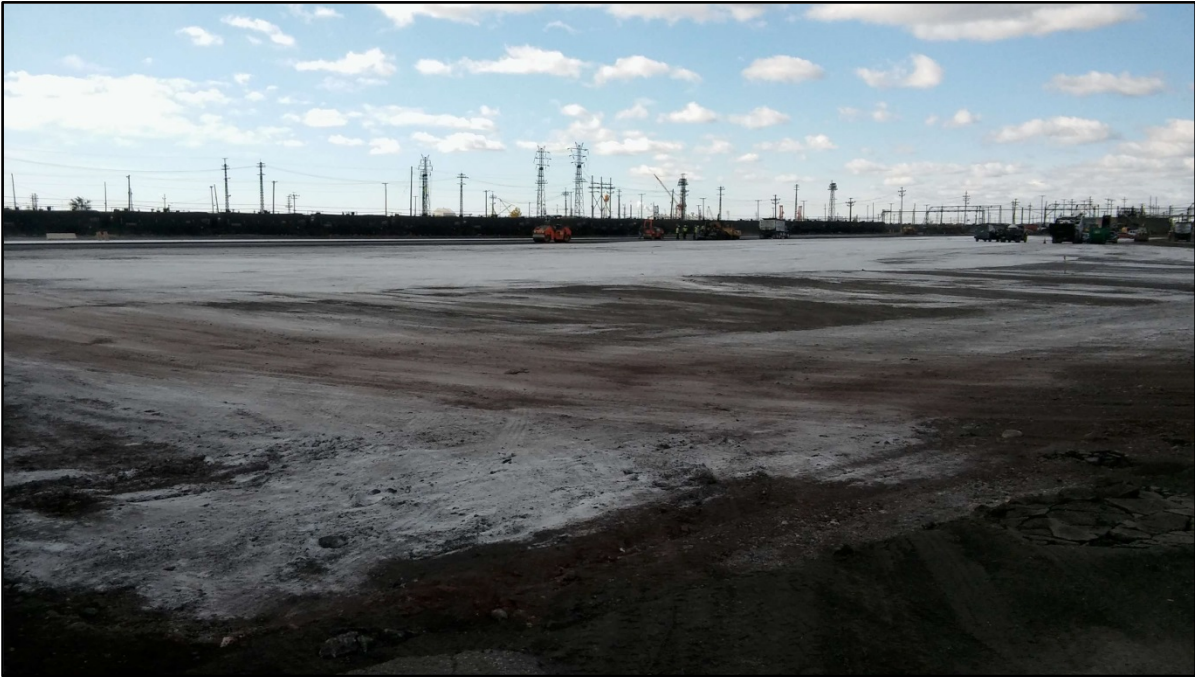
102816-5: View to the southwest of unpaved portion of site.

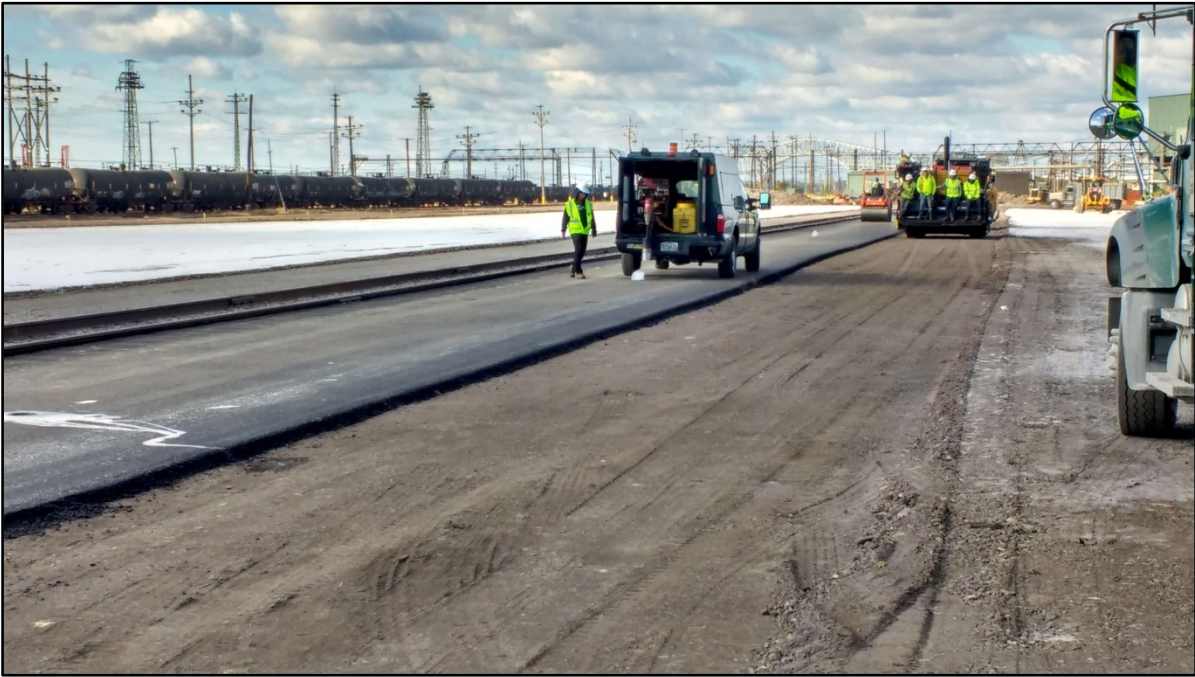
102816-7: View to the west of pavement coring along railroad tracks.

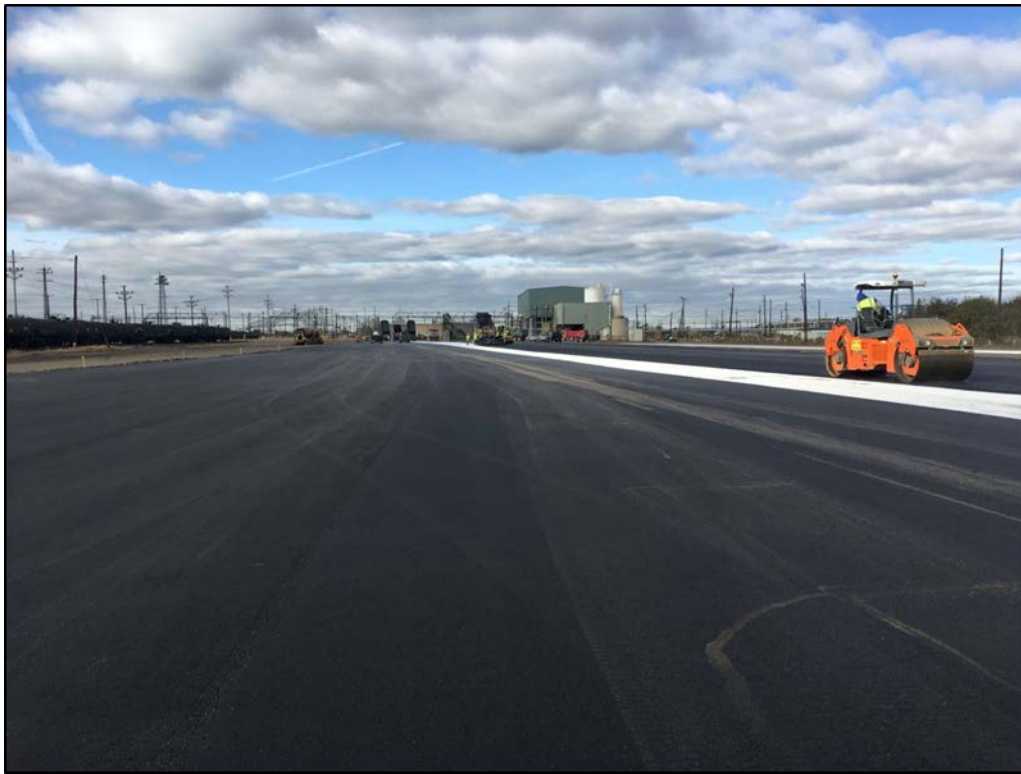
103116-1: View to west from center of site. Visible are first layer light-duty paving activities on western side of site.

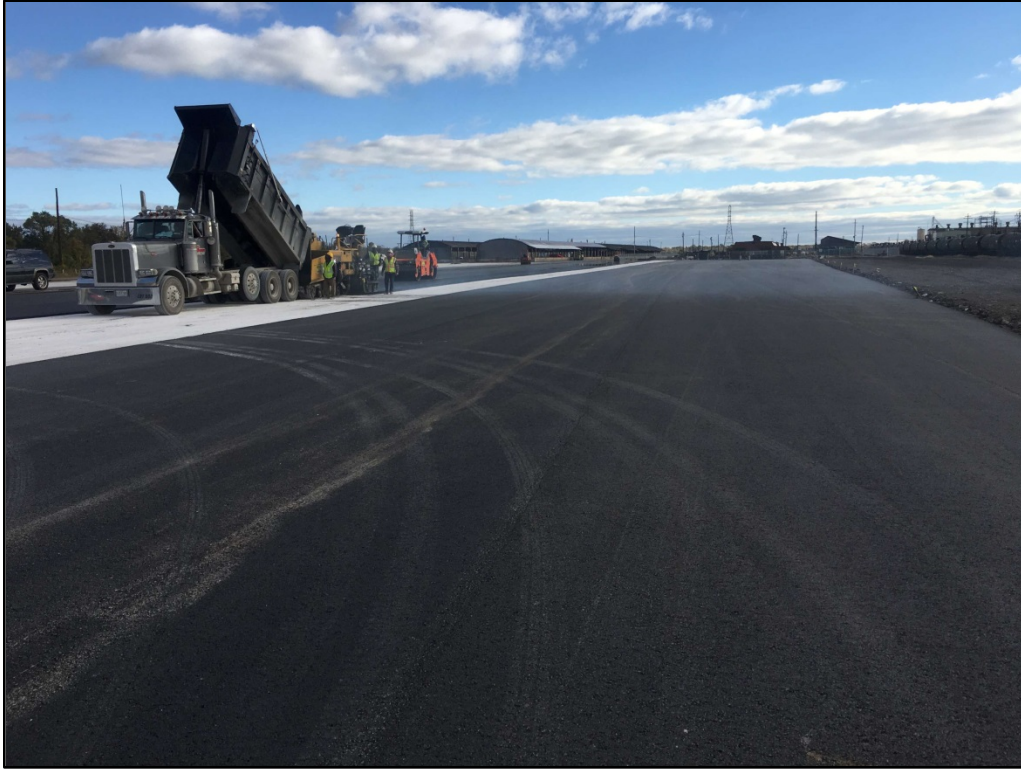
103116-2: View to the east of first light-duty layer paving activities.

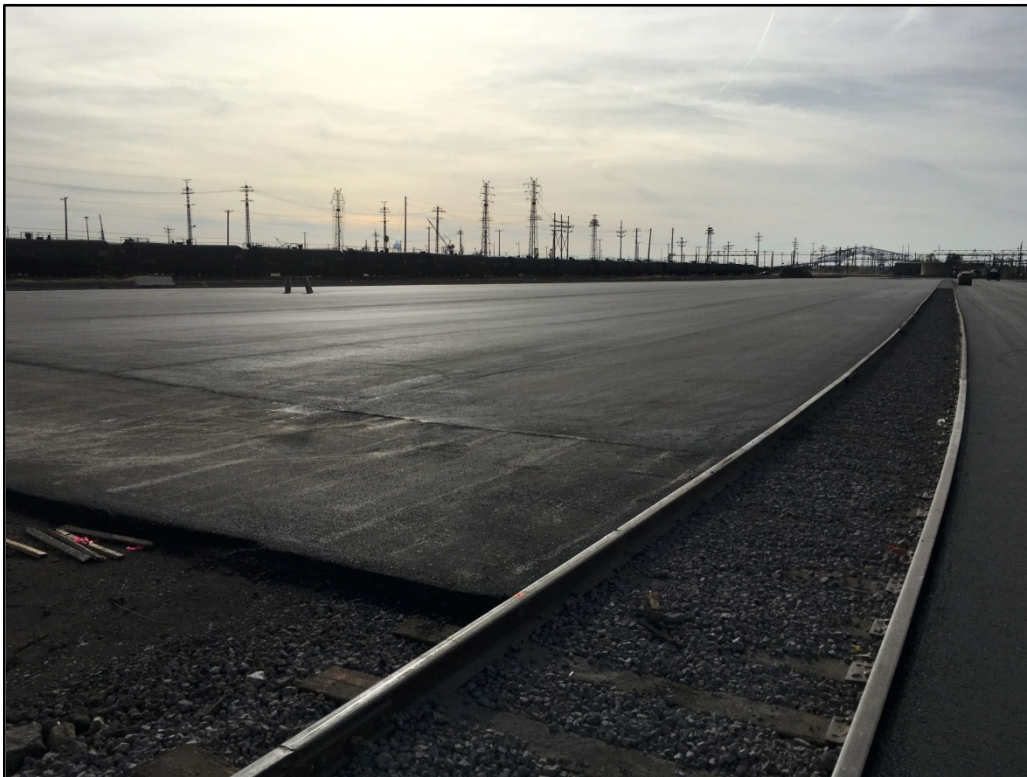
103116-3: View to the west of second layer heavy duty paving on each side of railroad tracks.

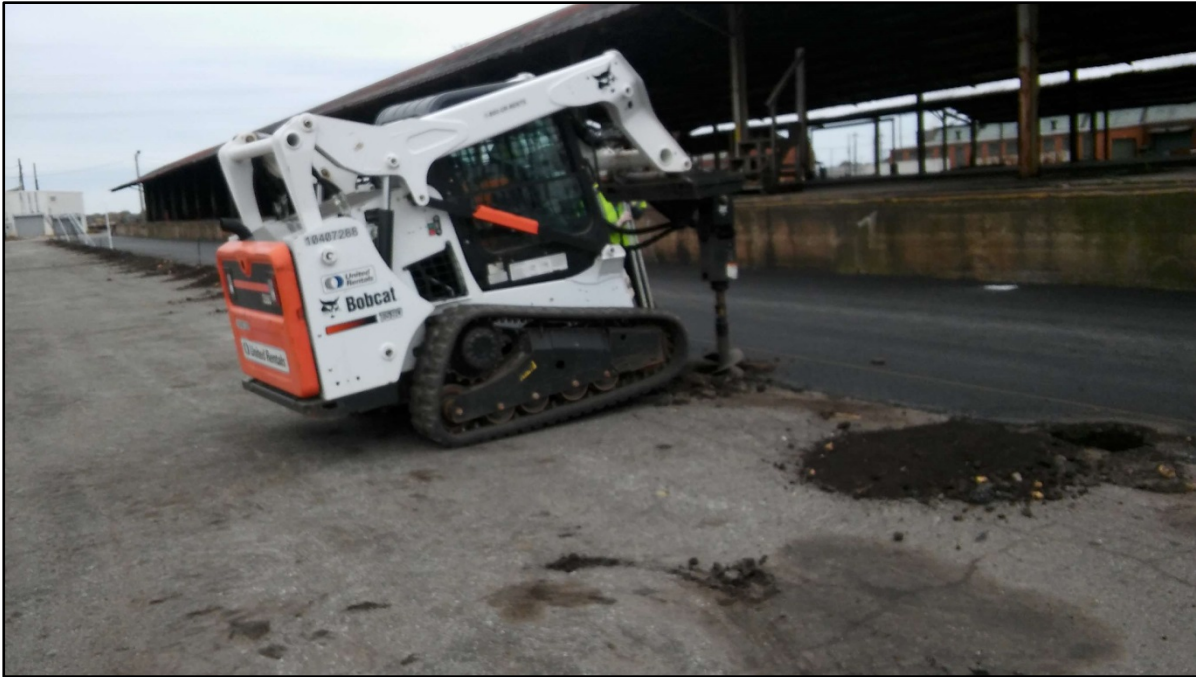
110116-1: Fence post drilling and digging activities along northern edge of building.

During ARM's construction observations, a fence was constructed by Carlos Fence along the northern edge of the northern Brick Shed, approximately 10 feet from the structure. Fence post holes were dug with a Bobcat T590 auger and various hand tools. Steel fence posts were placed in the holes and set in concrete. Photos of the fence during construction may be found in the photograph log (**Appendix C**). Excavated soils from the fence post holes were left in small piles next to their respective fence posts during construction. The fence was near completion at the conclusion of ARM's construction observations on November 10, 2016. During the final fence construction activities, all excavated soils were combined into two stockpiles near the fence. A composite sample was collected using materials from multiple locations throughout each stockpile and submitted for TCLP analysis to facilitate proper disposal. The laboratory reports have been included as **Appendix J**. The excavated soil was determined to be non-hazardous and was taken by MCM Management Corporation (MCM) to another area of the 3,100-acre Tradepoint Atlantic property.

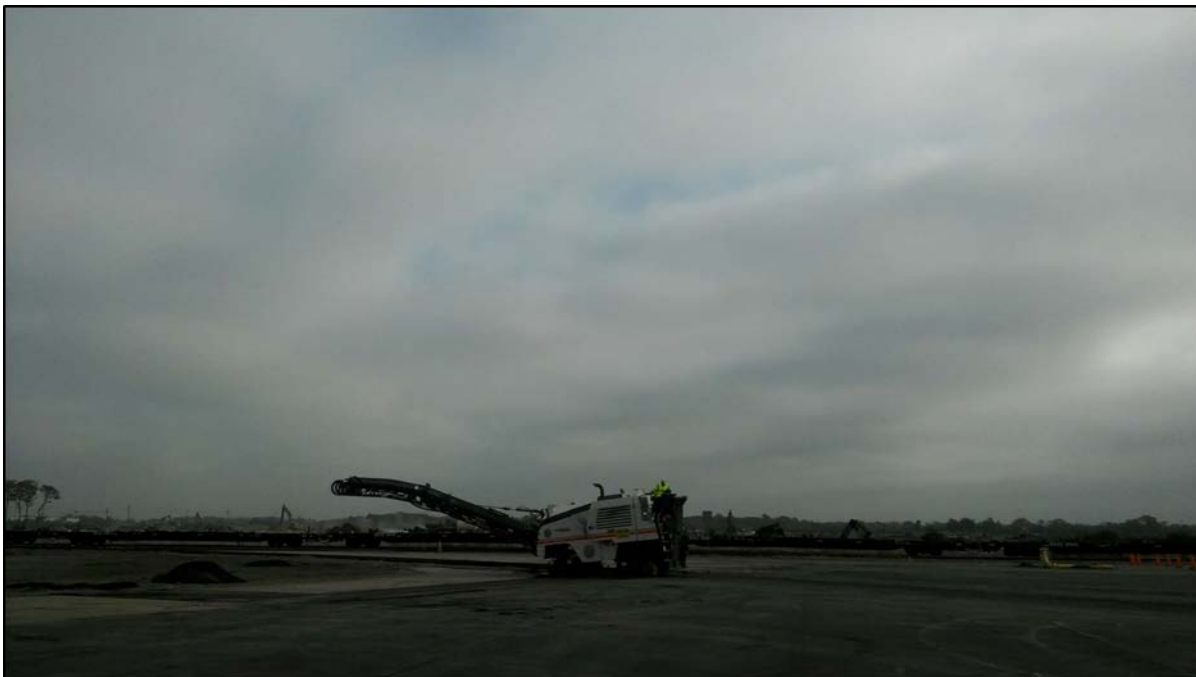
110216-1: Pavement planning at northeastern corner of site.

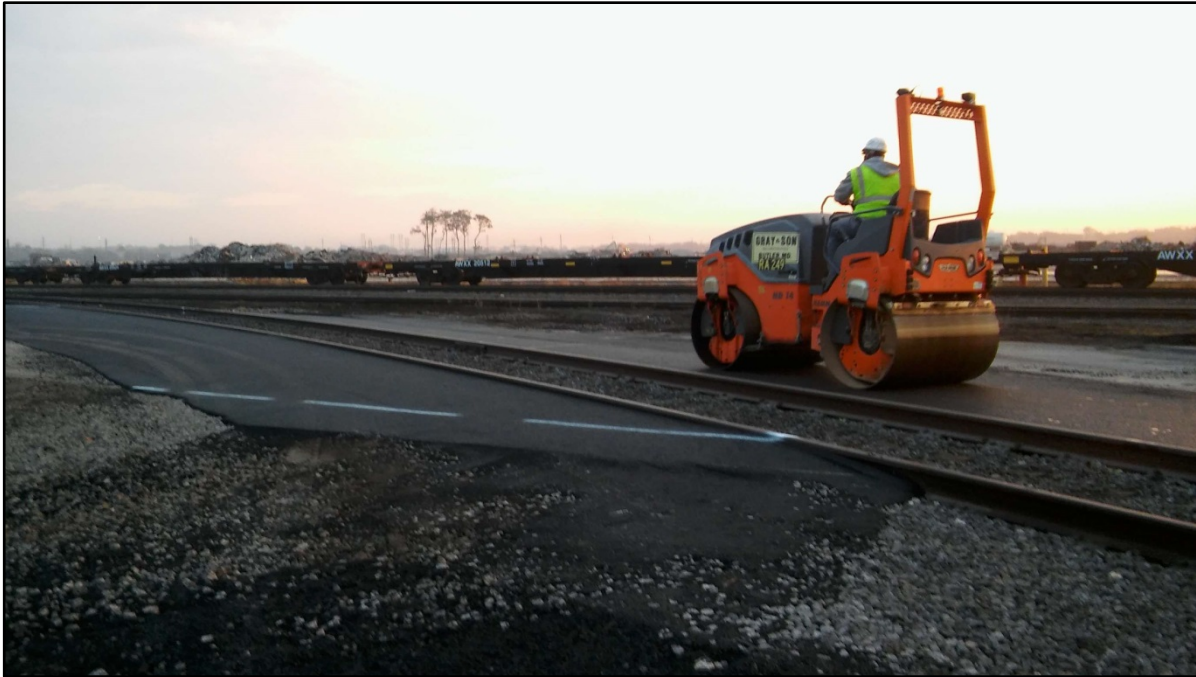
110316-1: View of paving activities in the northeastern corner of site along the railroad tracks (continued slightly off the parcel).

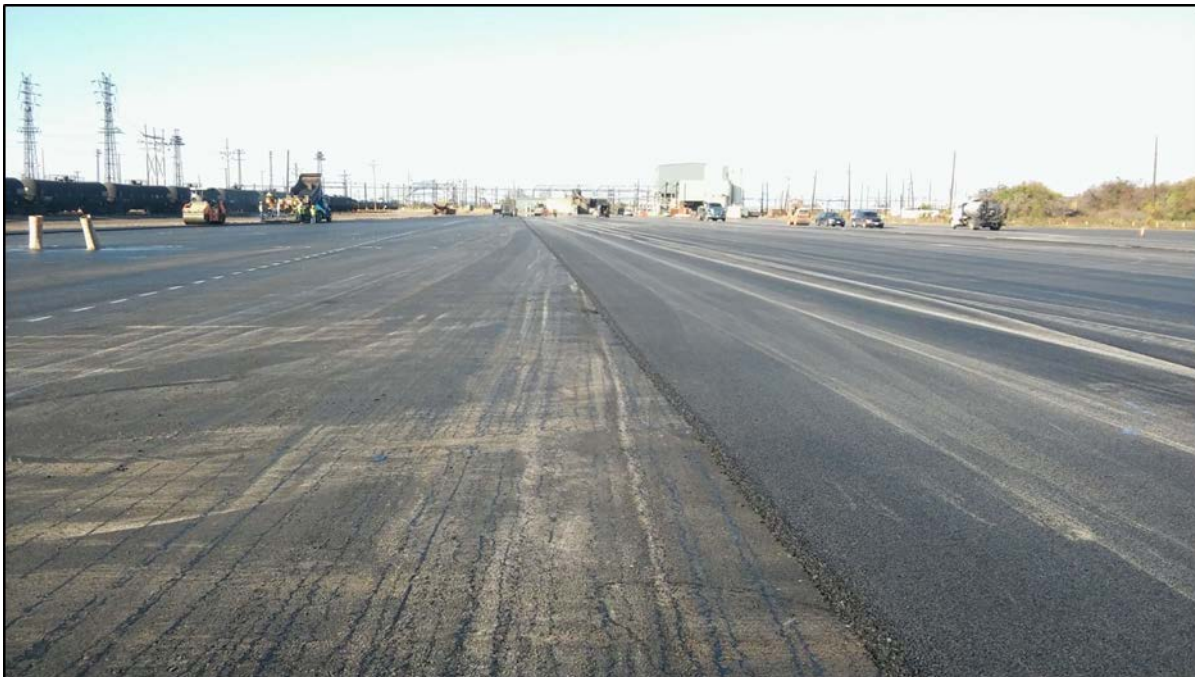
110416-1: View to the west of the start of second layer paving activities on western portion of the site. Visible are the two monitoring wells and tacked areas of the first layer of pavement.

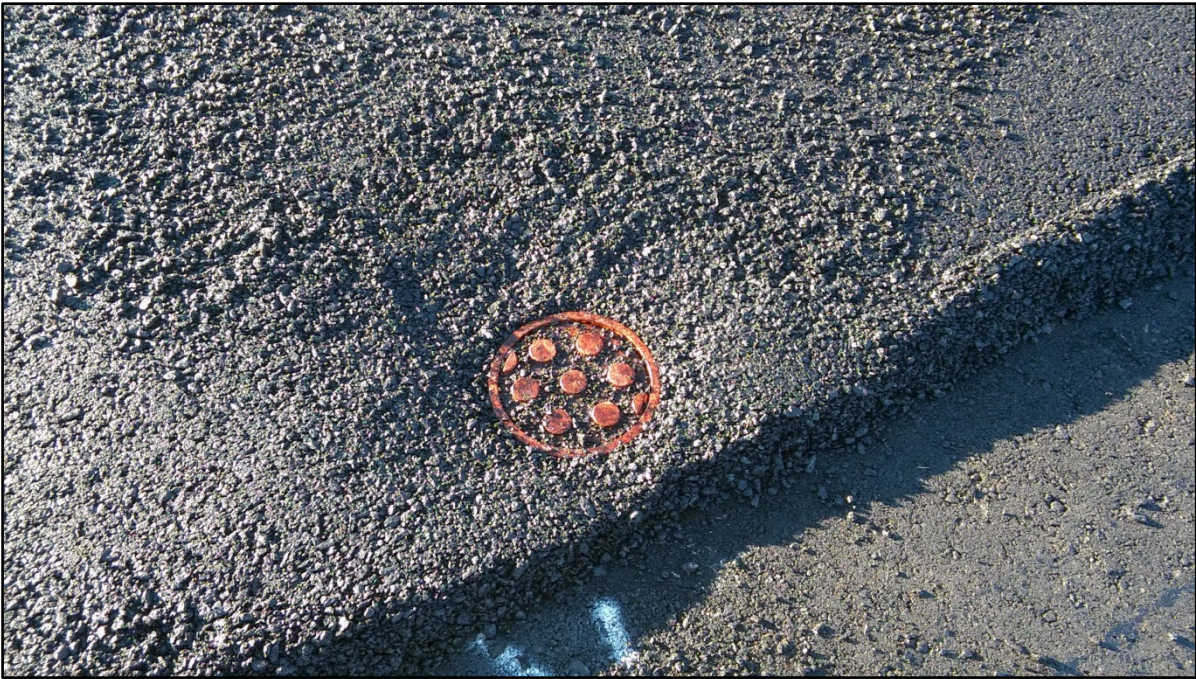
110716-44: View of paved-over and re-exposed piezometer cap.

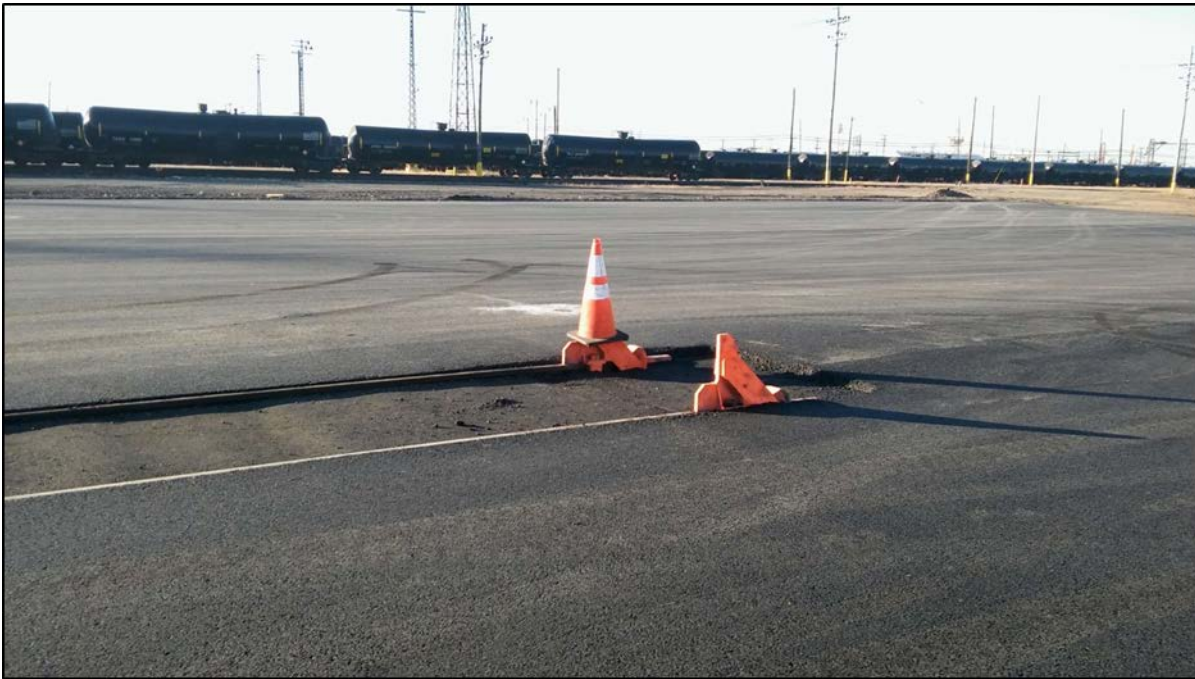
110816-48: Paving at end of railroad tracks on western portion of site.

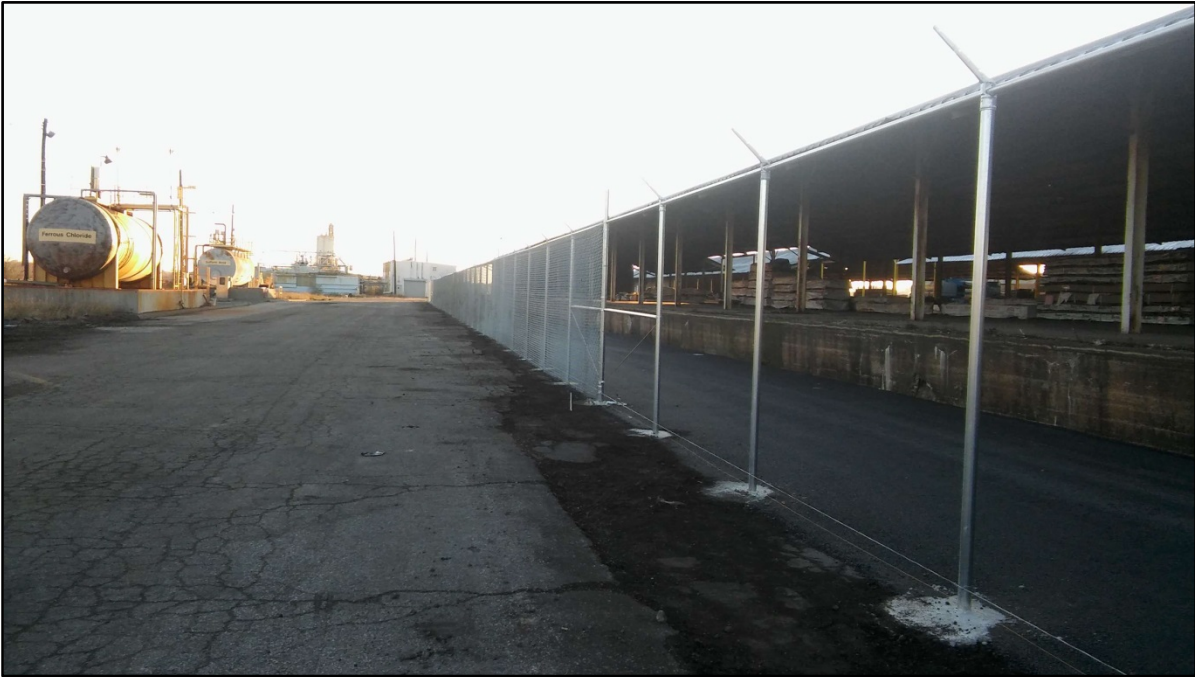
111016-1: View to the east of fence construction.

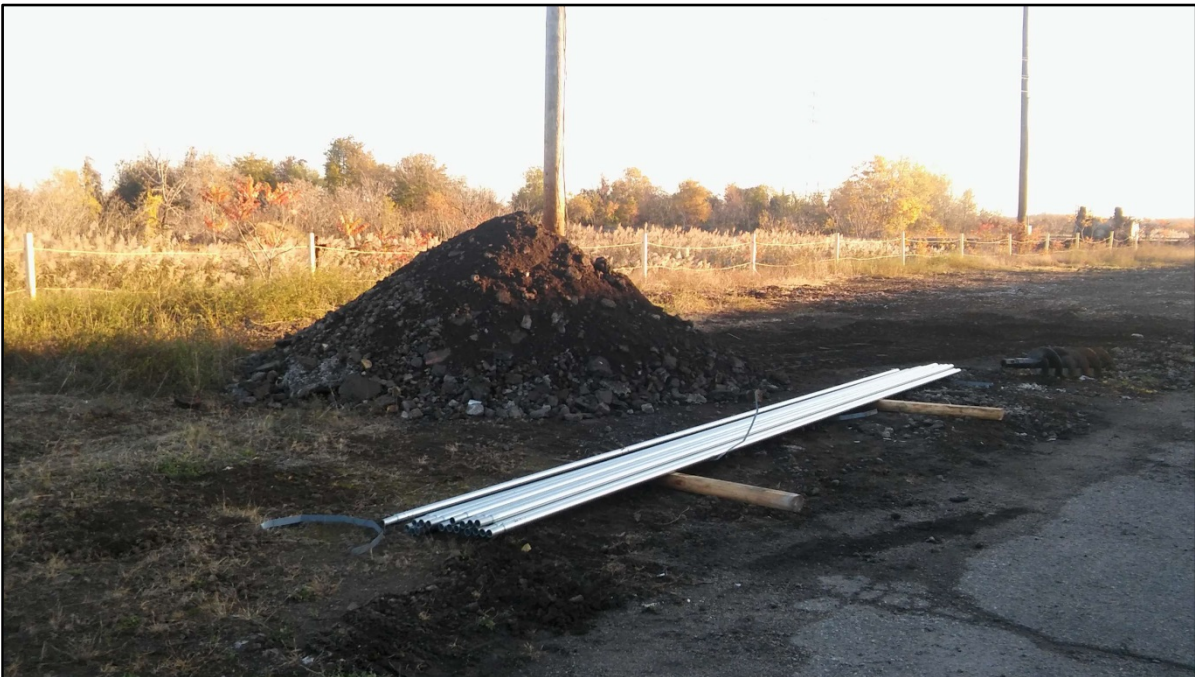
111016-2: Stockpiled soil from fence post hole excavation.

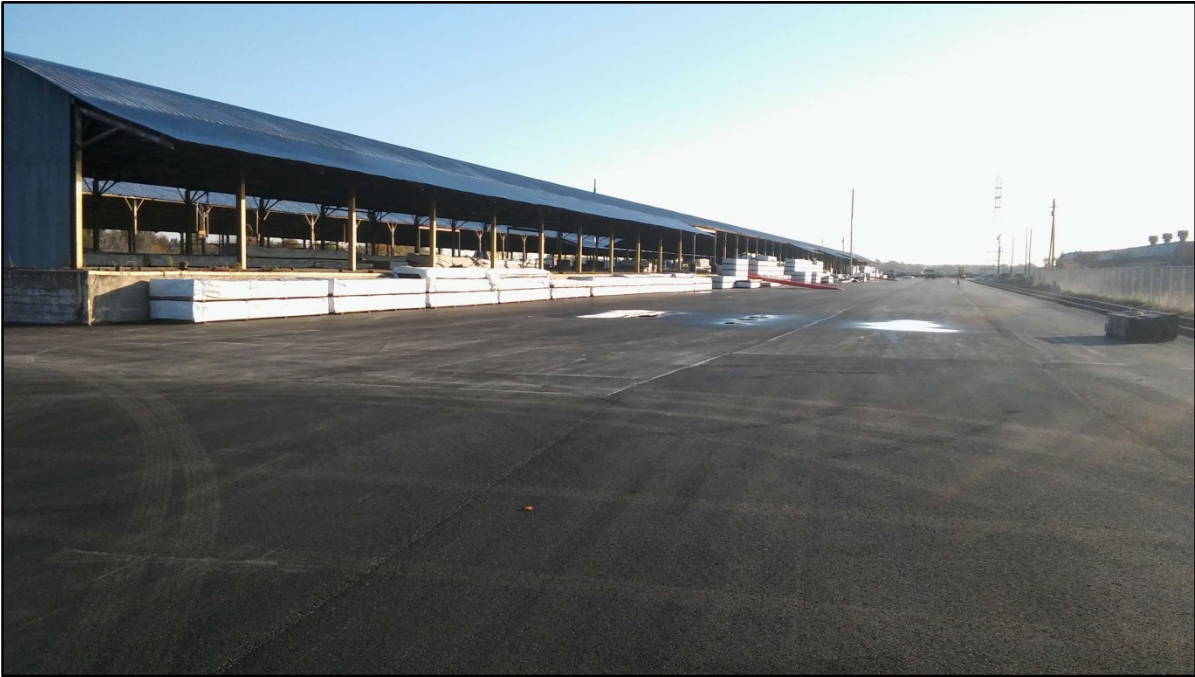
111016-3: View to the east along southern edge of building.

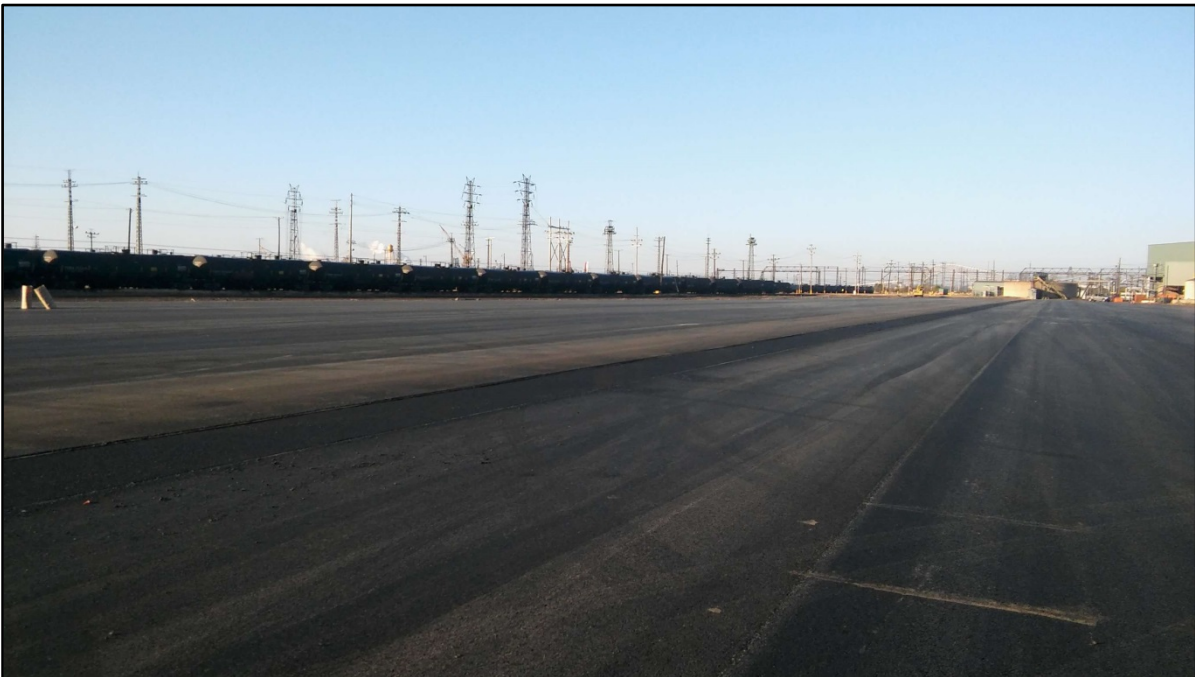
111016-4: View to the west of completed paving of the western portion of the site.
Visible is the completed paving between the railroad tracks.

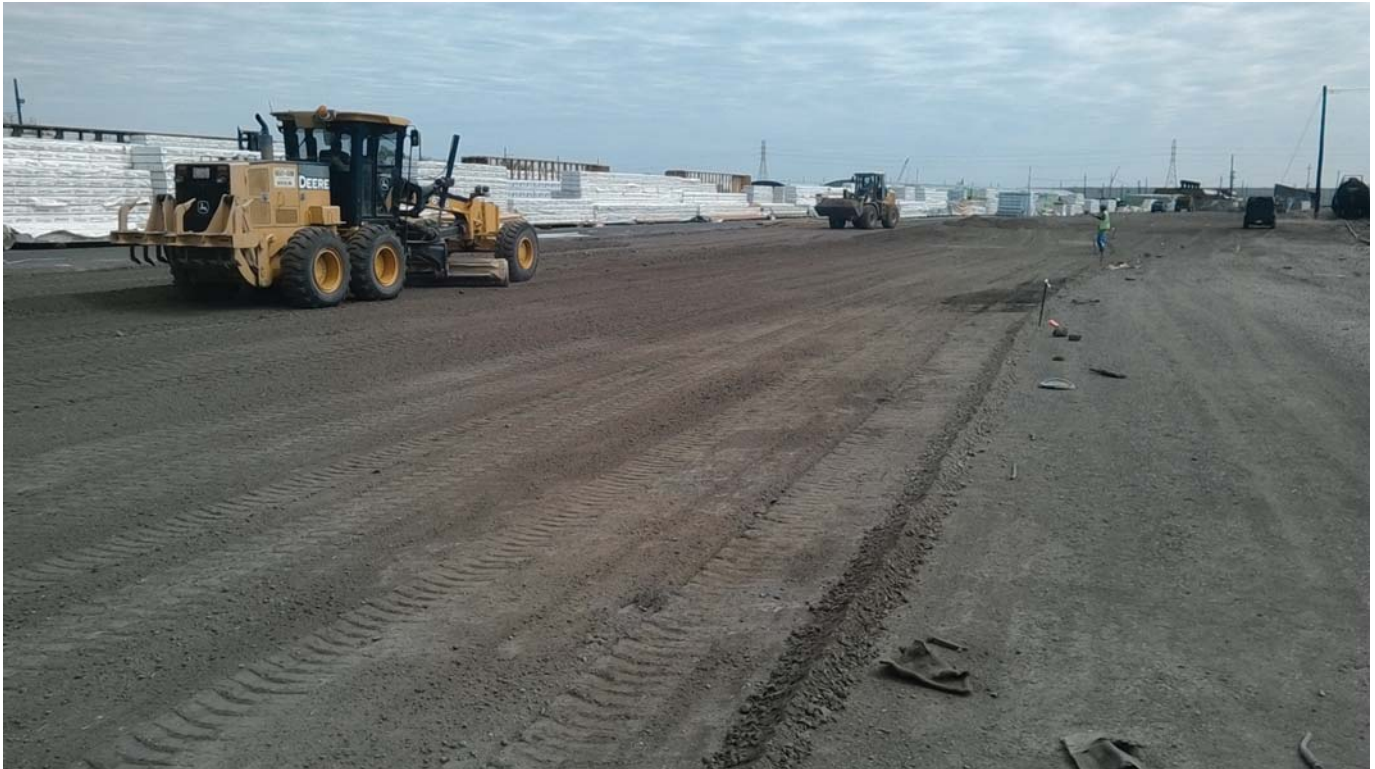
Grader Deere 672D

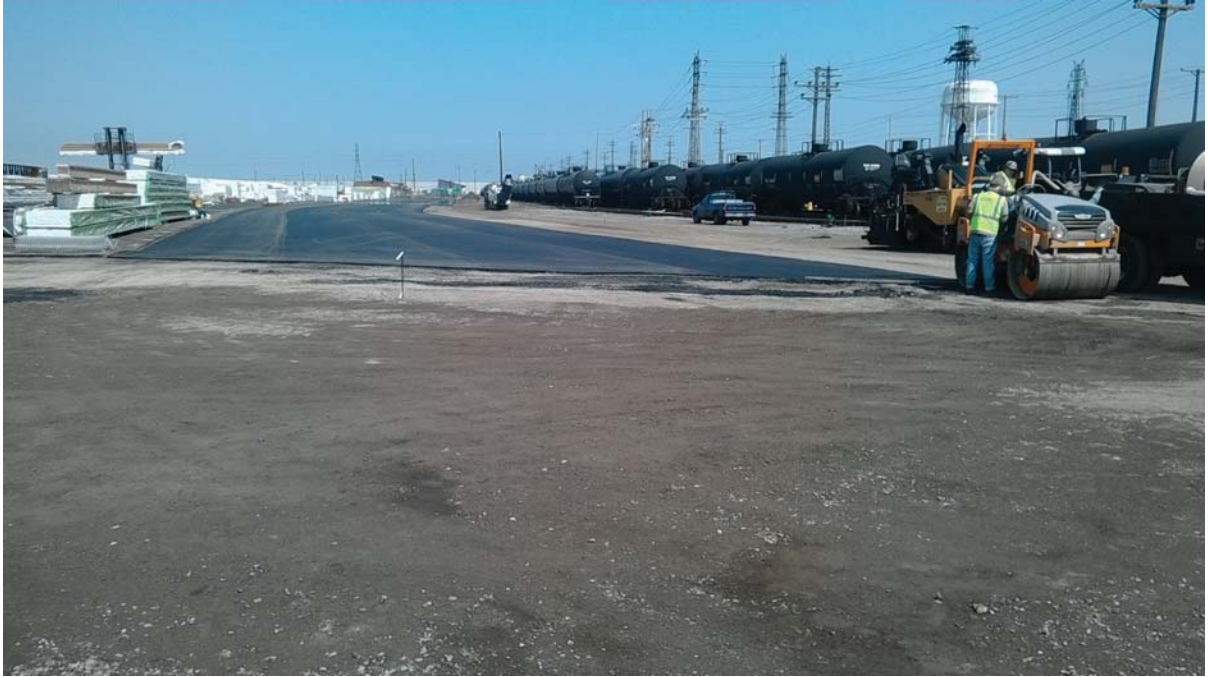
Southern, Eastern side of lot- asphalt

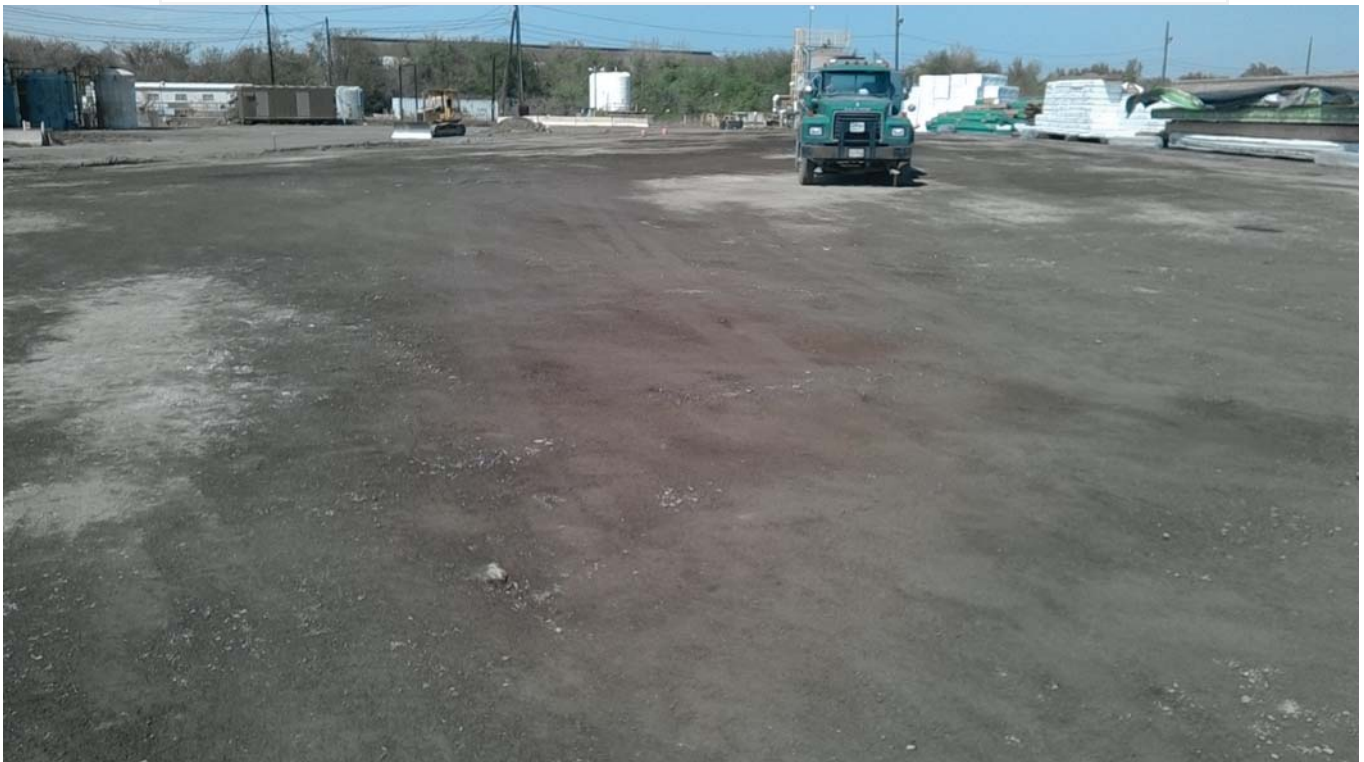
West and NW of lot fine graded

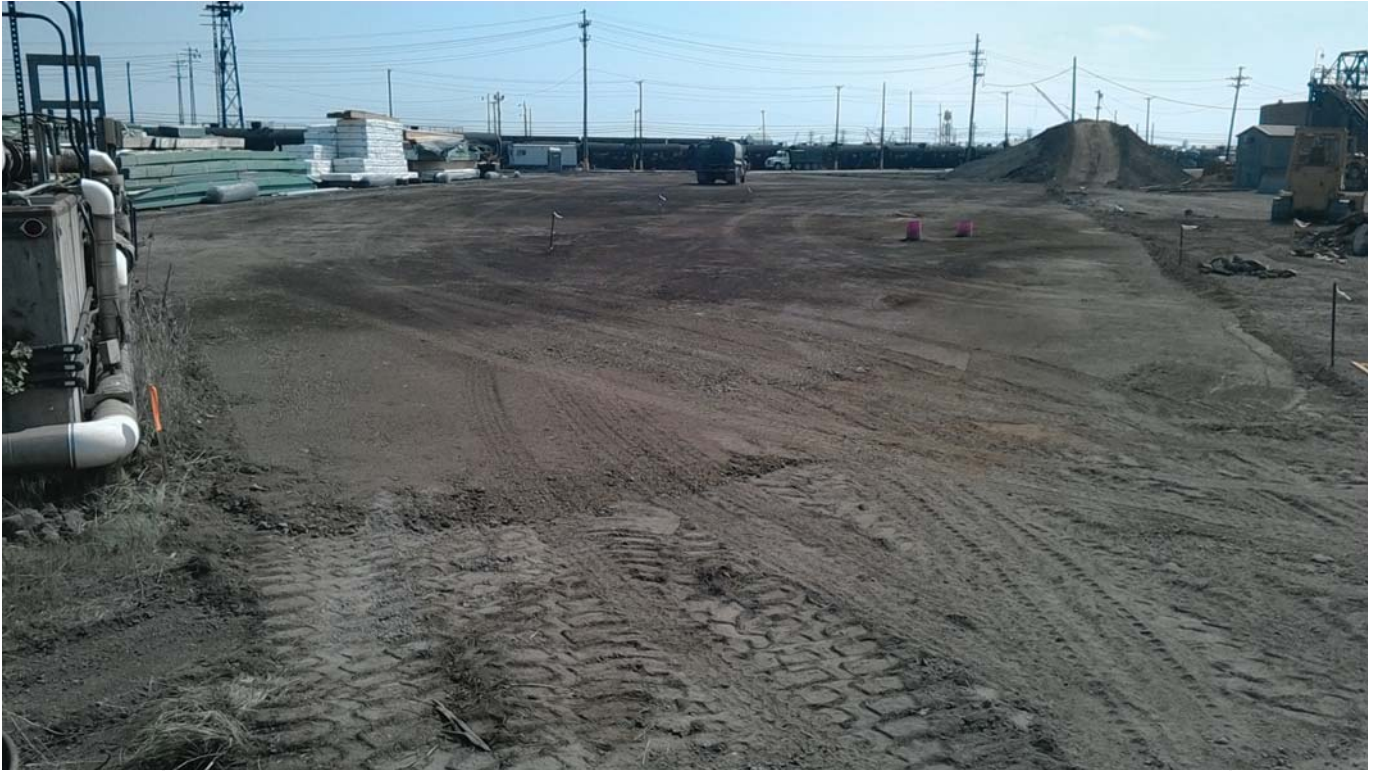
West and NW lot fine graded

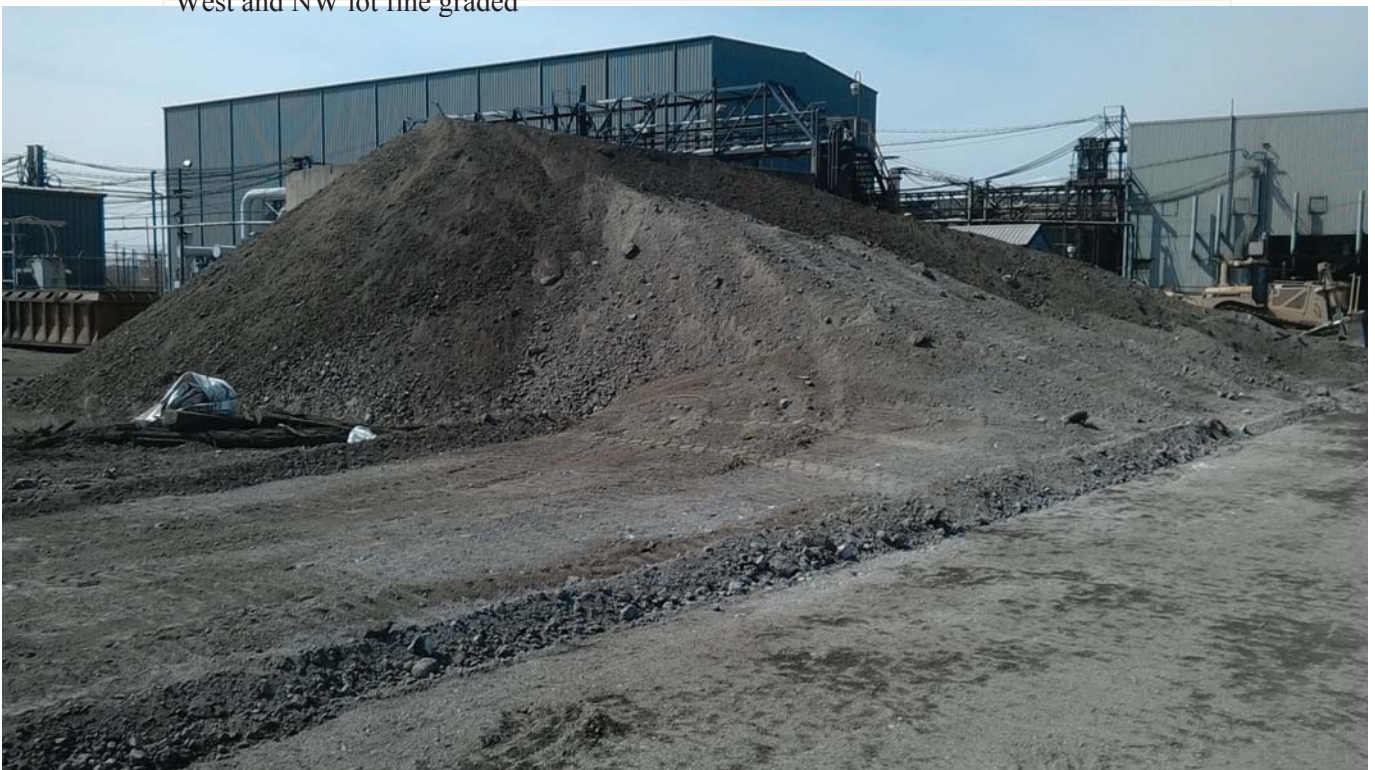
West of lot Slag fines stockpile

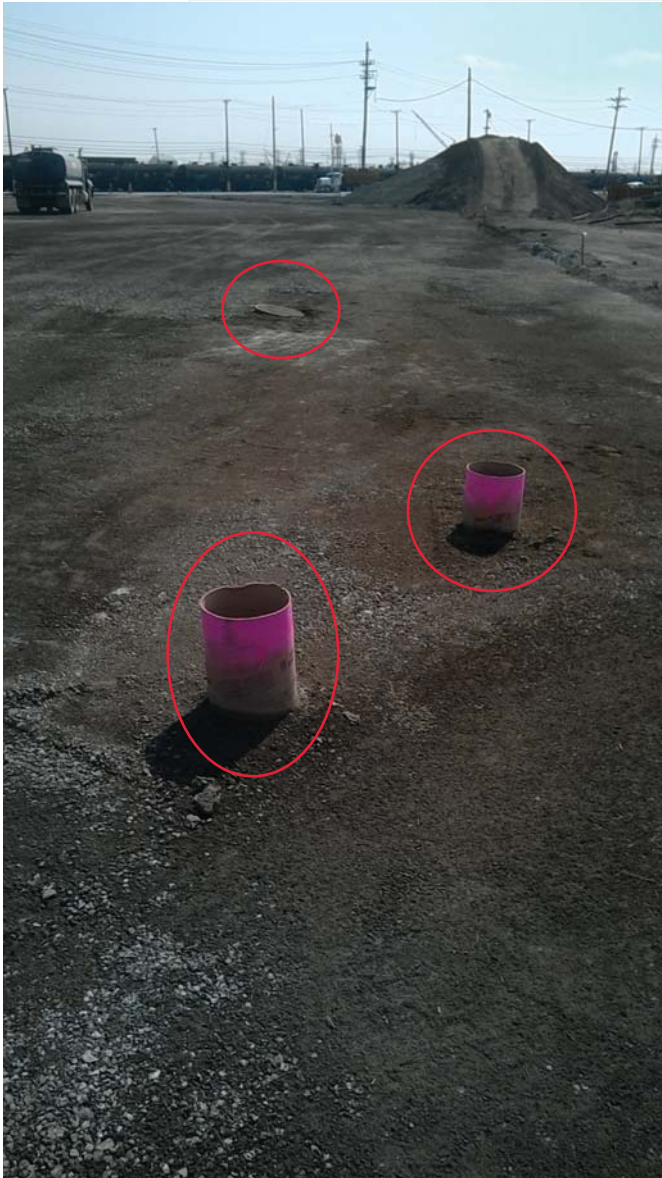
Observation wells, which get mini slabs and caps, manhole gets 4" riser

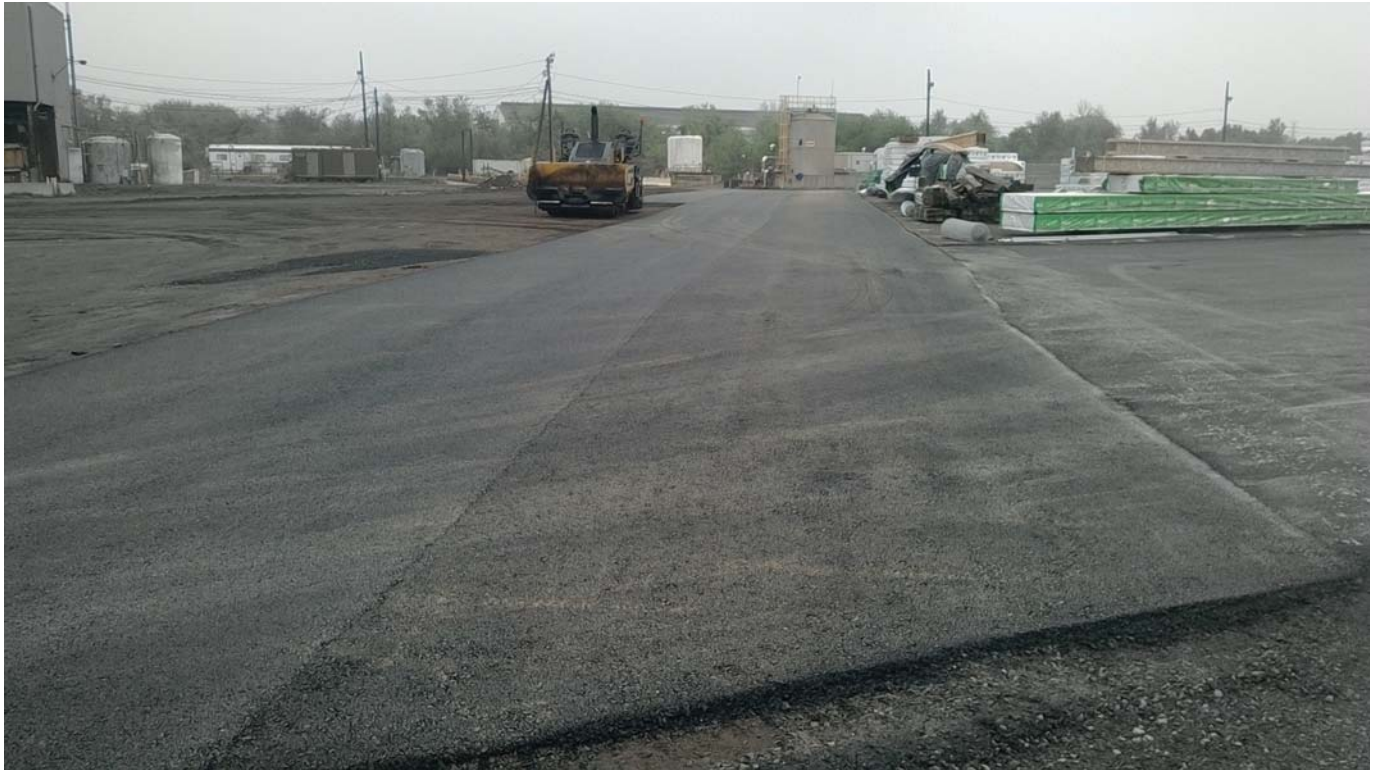
West lot facing North

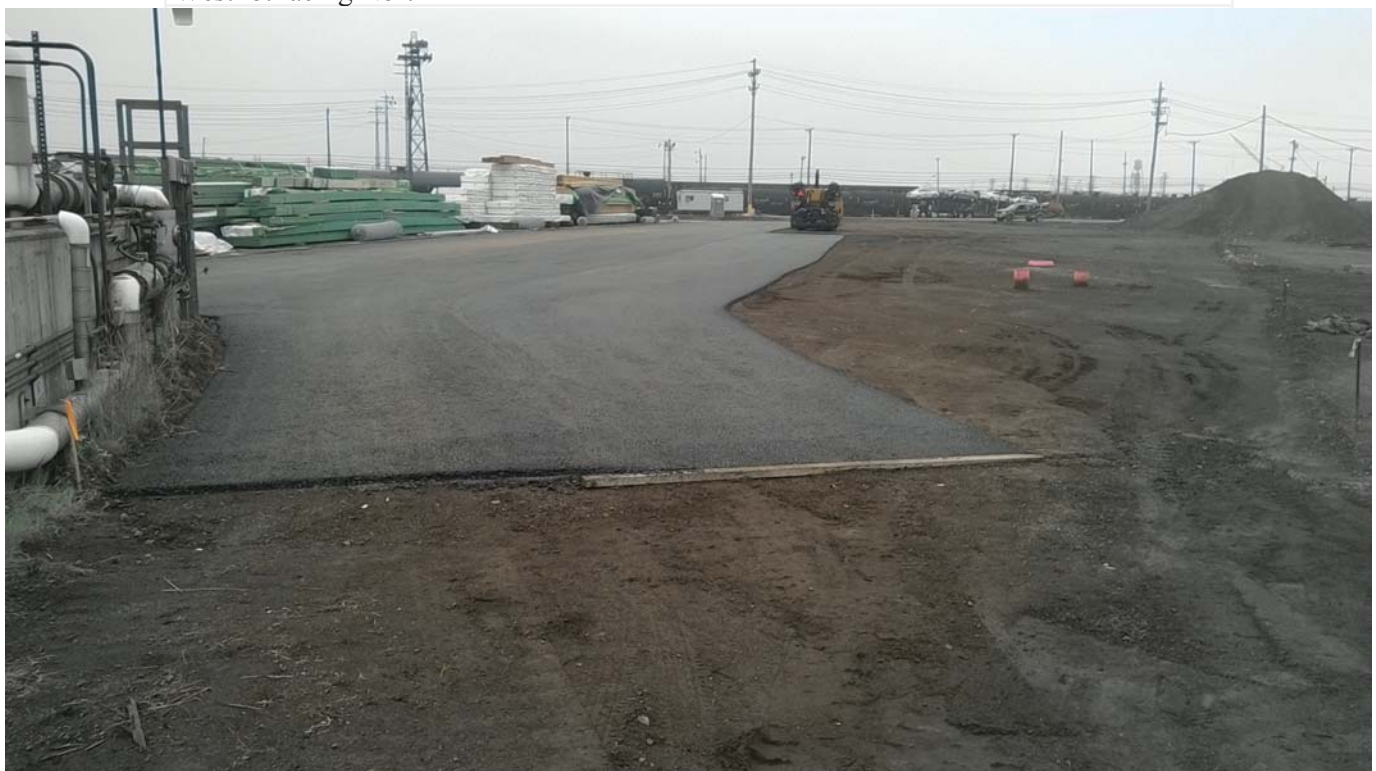
West lot facing South
