**No. 10 Tank Investigation**  
**Work Plan Addendum**  
*Expansion: Groundwater Investigation*

**Area B: Parcel B18**  
**Tradepoint Atlantic**  
**Sparrows Point, Maryland**

Revision 0  
February 16, 2018

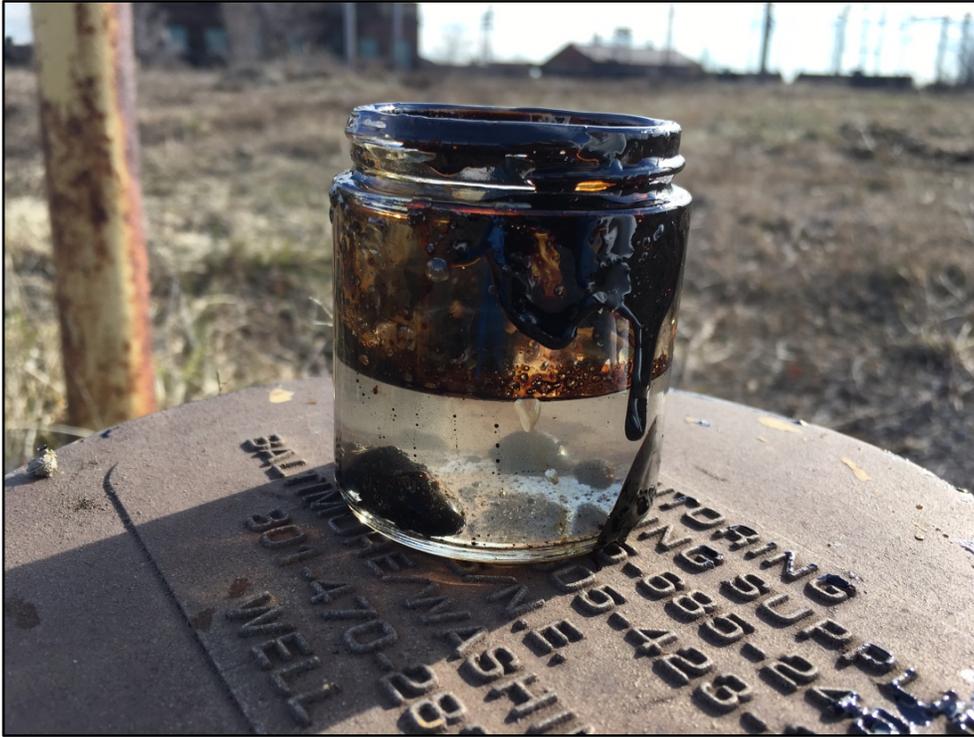
Photo 1: View of NAPL collected from a B18 well. Take note of the NAPL observed as LNAPL and DNAPL.

On December 22, 2016, NAPL samples were extracted from historical wells BA-81-7941, BA-81-7942, and BA-81-7944, as well as from piezometer B18-045-PZ. A photograph log of the collected NAPL samples is included as **Appendix B**. The photographs and field observations indicate that both light (LNAPL) and dense (DNAPL) fractions appear to be present at the Site. The NAPL samples were submitted to Pace Analytical Services, Inc. (PACE) for Whole Oil (ASTM D3328) and Full Scan (ASTM D5739) analytical testing to determine the “fingerprint” of the hydrocarbons and determine the type(s) of petroleum. All four samples were determined to be 100% aromatic hydrocarbons and were comprised mostly of naphthalene, 1-methyl-naphthalene, and 2-methyl-naphthalene. **Appendix C** presents the fingerprint laboratory reports received from PACE for the four samples.

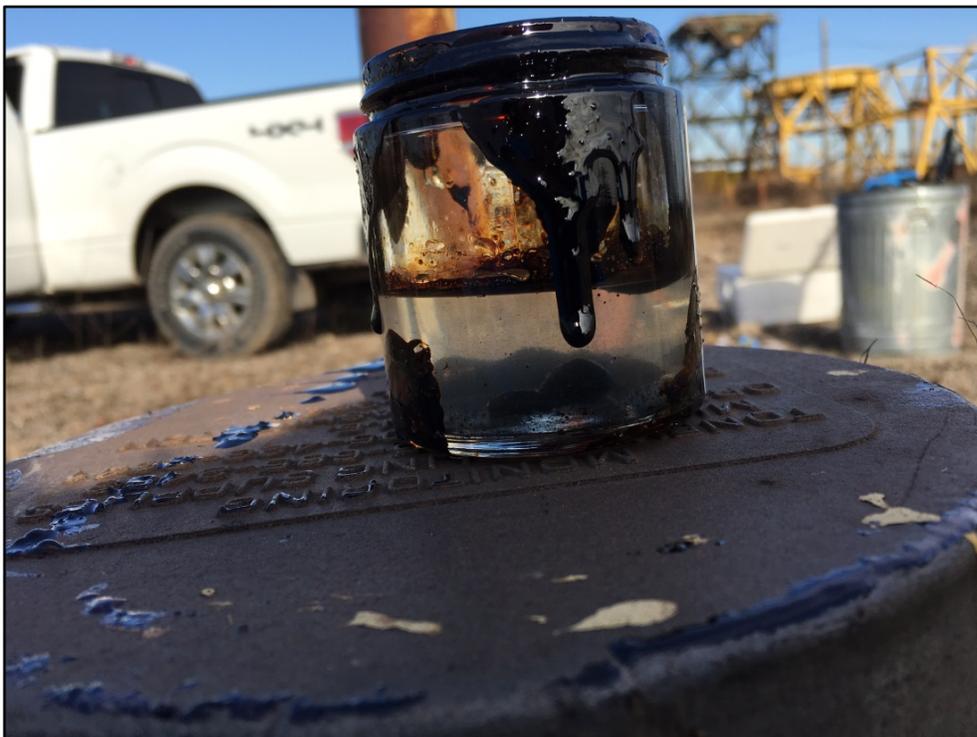
Photo 2: Another view of the NAPL collected in Photo 1.

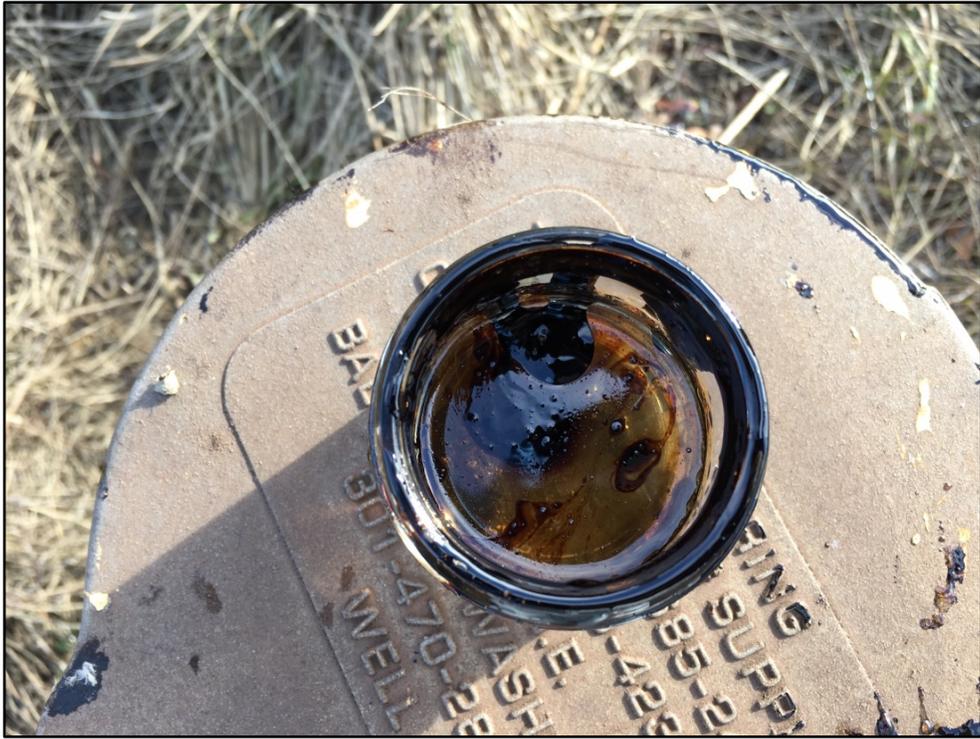
Photo 3: View from the top of the same NAPL jar from Photo 1.

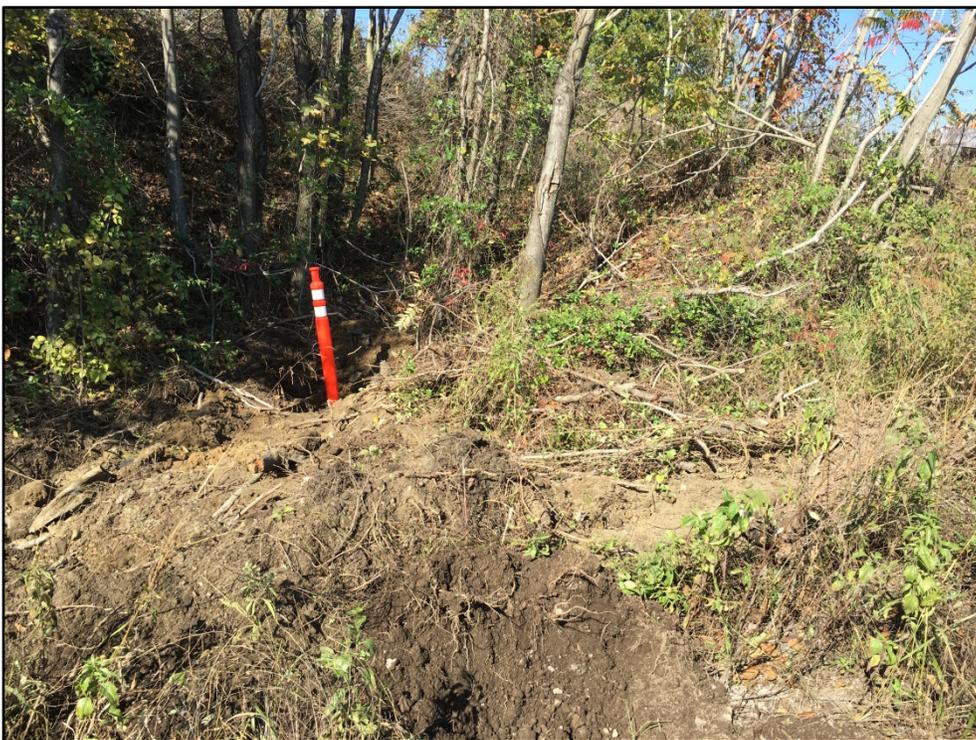
Photo 2: Northern extent of the sheet piling.

To verify the existence of the cut-off wall, the approximate location indicated on the plan drawing was investigated using excavation equipment. Portions of the cut-off wall were successfully located in the field, and soil was removed from the area to expose the top of the sheet piling across the entire length of the cut-off wall. The cut-off wall was determined to be approximately 125 feet in length. A photograph log of the uncovered sheet piling is included in **Appendix E**. The sheet piling alignment was recorded by ARM personnel using a hand-held GPS unit, and the extent of the cut-off wall is indicated on relevant figures included with this Work Plan Addendum. The location of the cut-off wall was taken into account while developing the groundwater sampling plan.

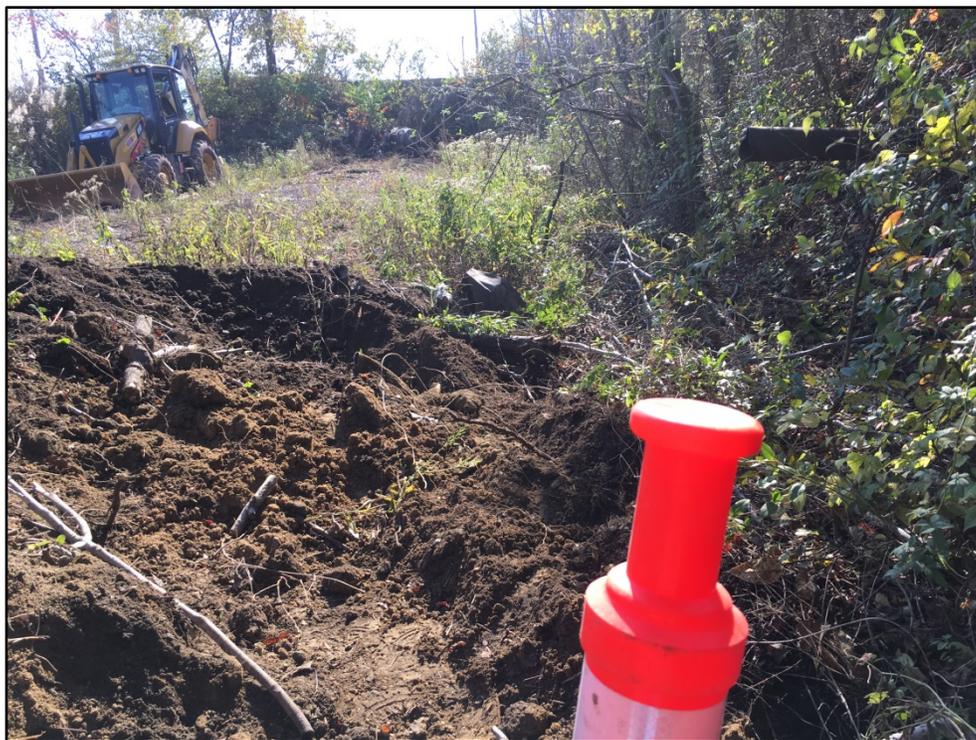
Photo 4: View of the sheet piling's northern extent and its alignment in the south direction.
