PHASE II INVESTIGATION REPORT

AREA B: PARCEL B8
TRADEPOINT ATLANTIC
SPARROWS POINT, MARYLAND

ARM Project No. 150300M-2

Revision 1 – March 16, 2018

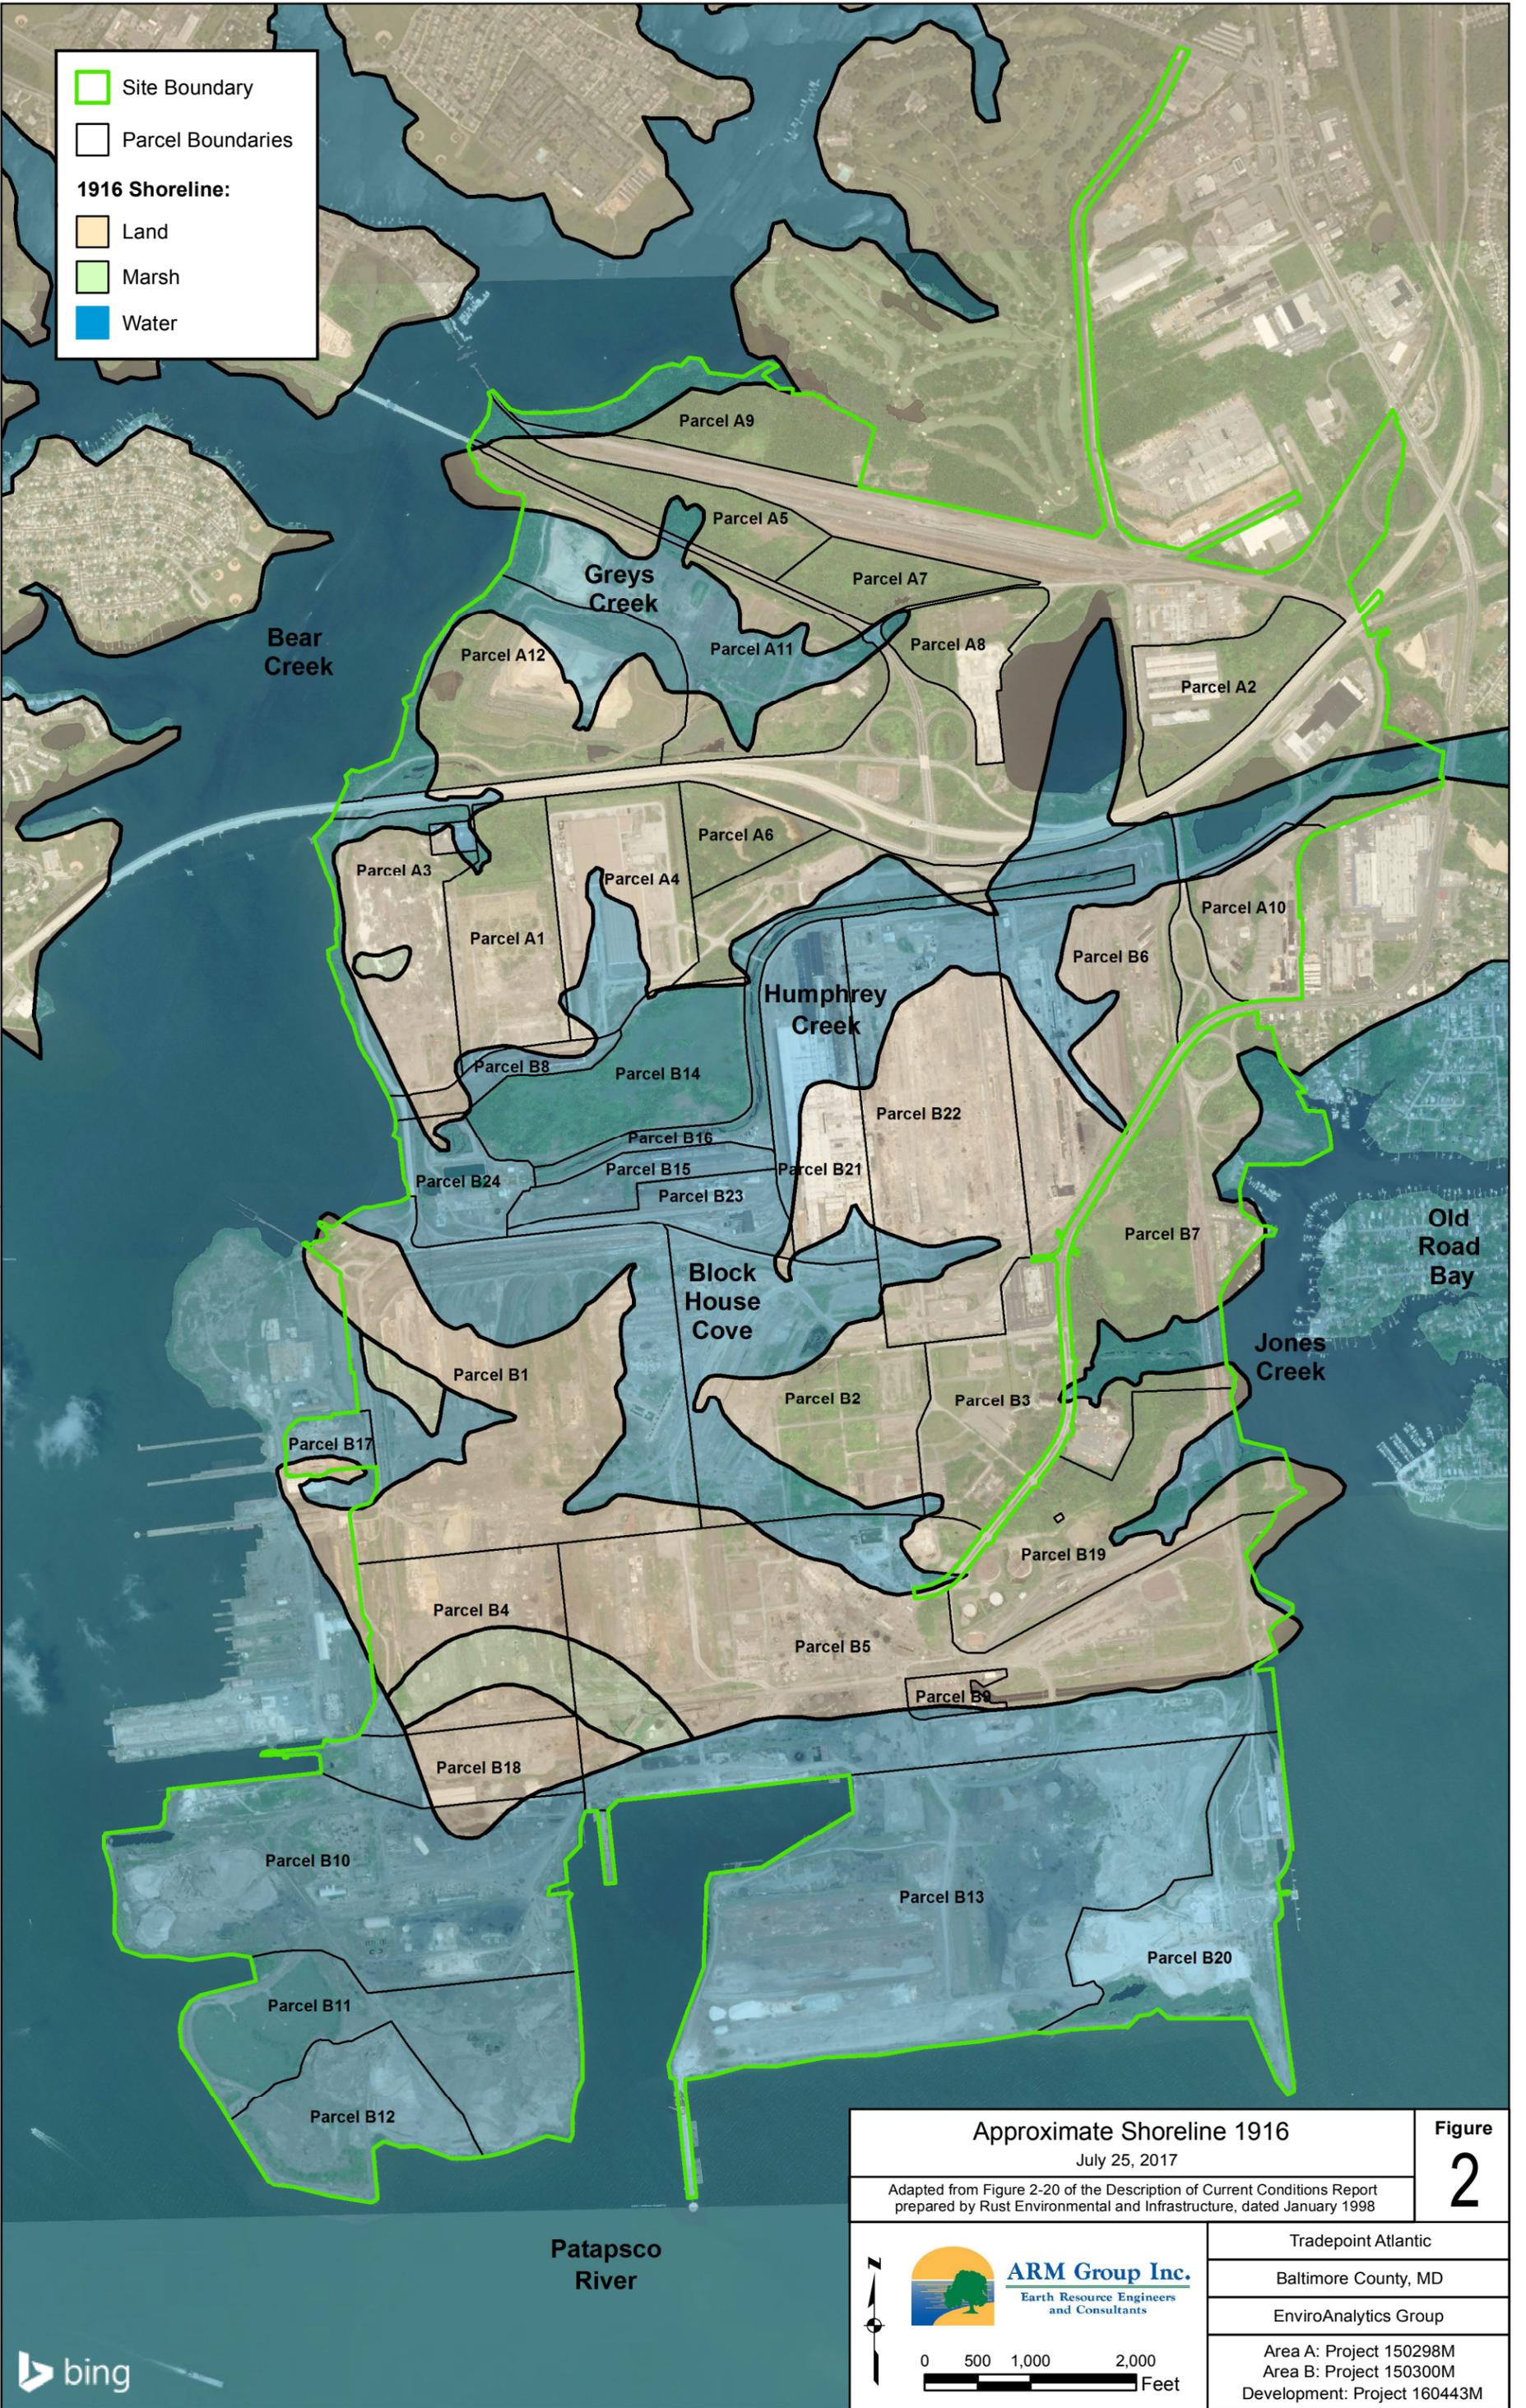
Approximate Shoreline 1916 July 25, 2017		Figure 2
Adapted from Figure 2-20 of the Description of Current Conditions Report prepared by Rust Environmental and Infrastructure, dated January 1998		
	Tradepoint Atlantic Baltimore County, MD	
	EnviroAnalytics Group	
	Area A: Project 150298M Area B: Project 150300M Development: Project 160443M

Groundcover at the Site is comprised of approximately 36% natural soils and 64% slag-fill based on the approximate shoreline of the Sparrows Point Peninsula in 1916, as shown on **Figure 2** (adapted from Figure 2-20 in the DCC Report prepared by Rust Environment and Infrastructure).

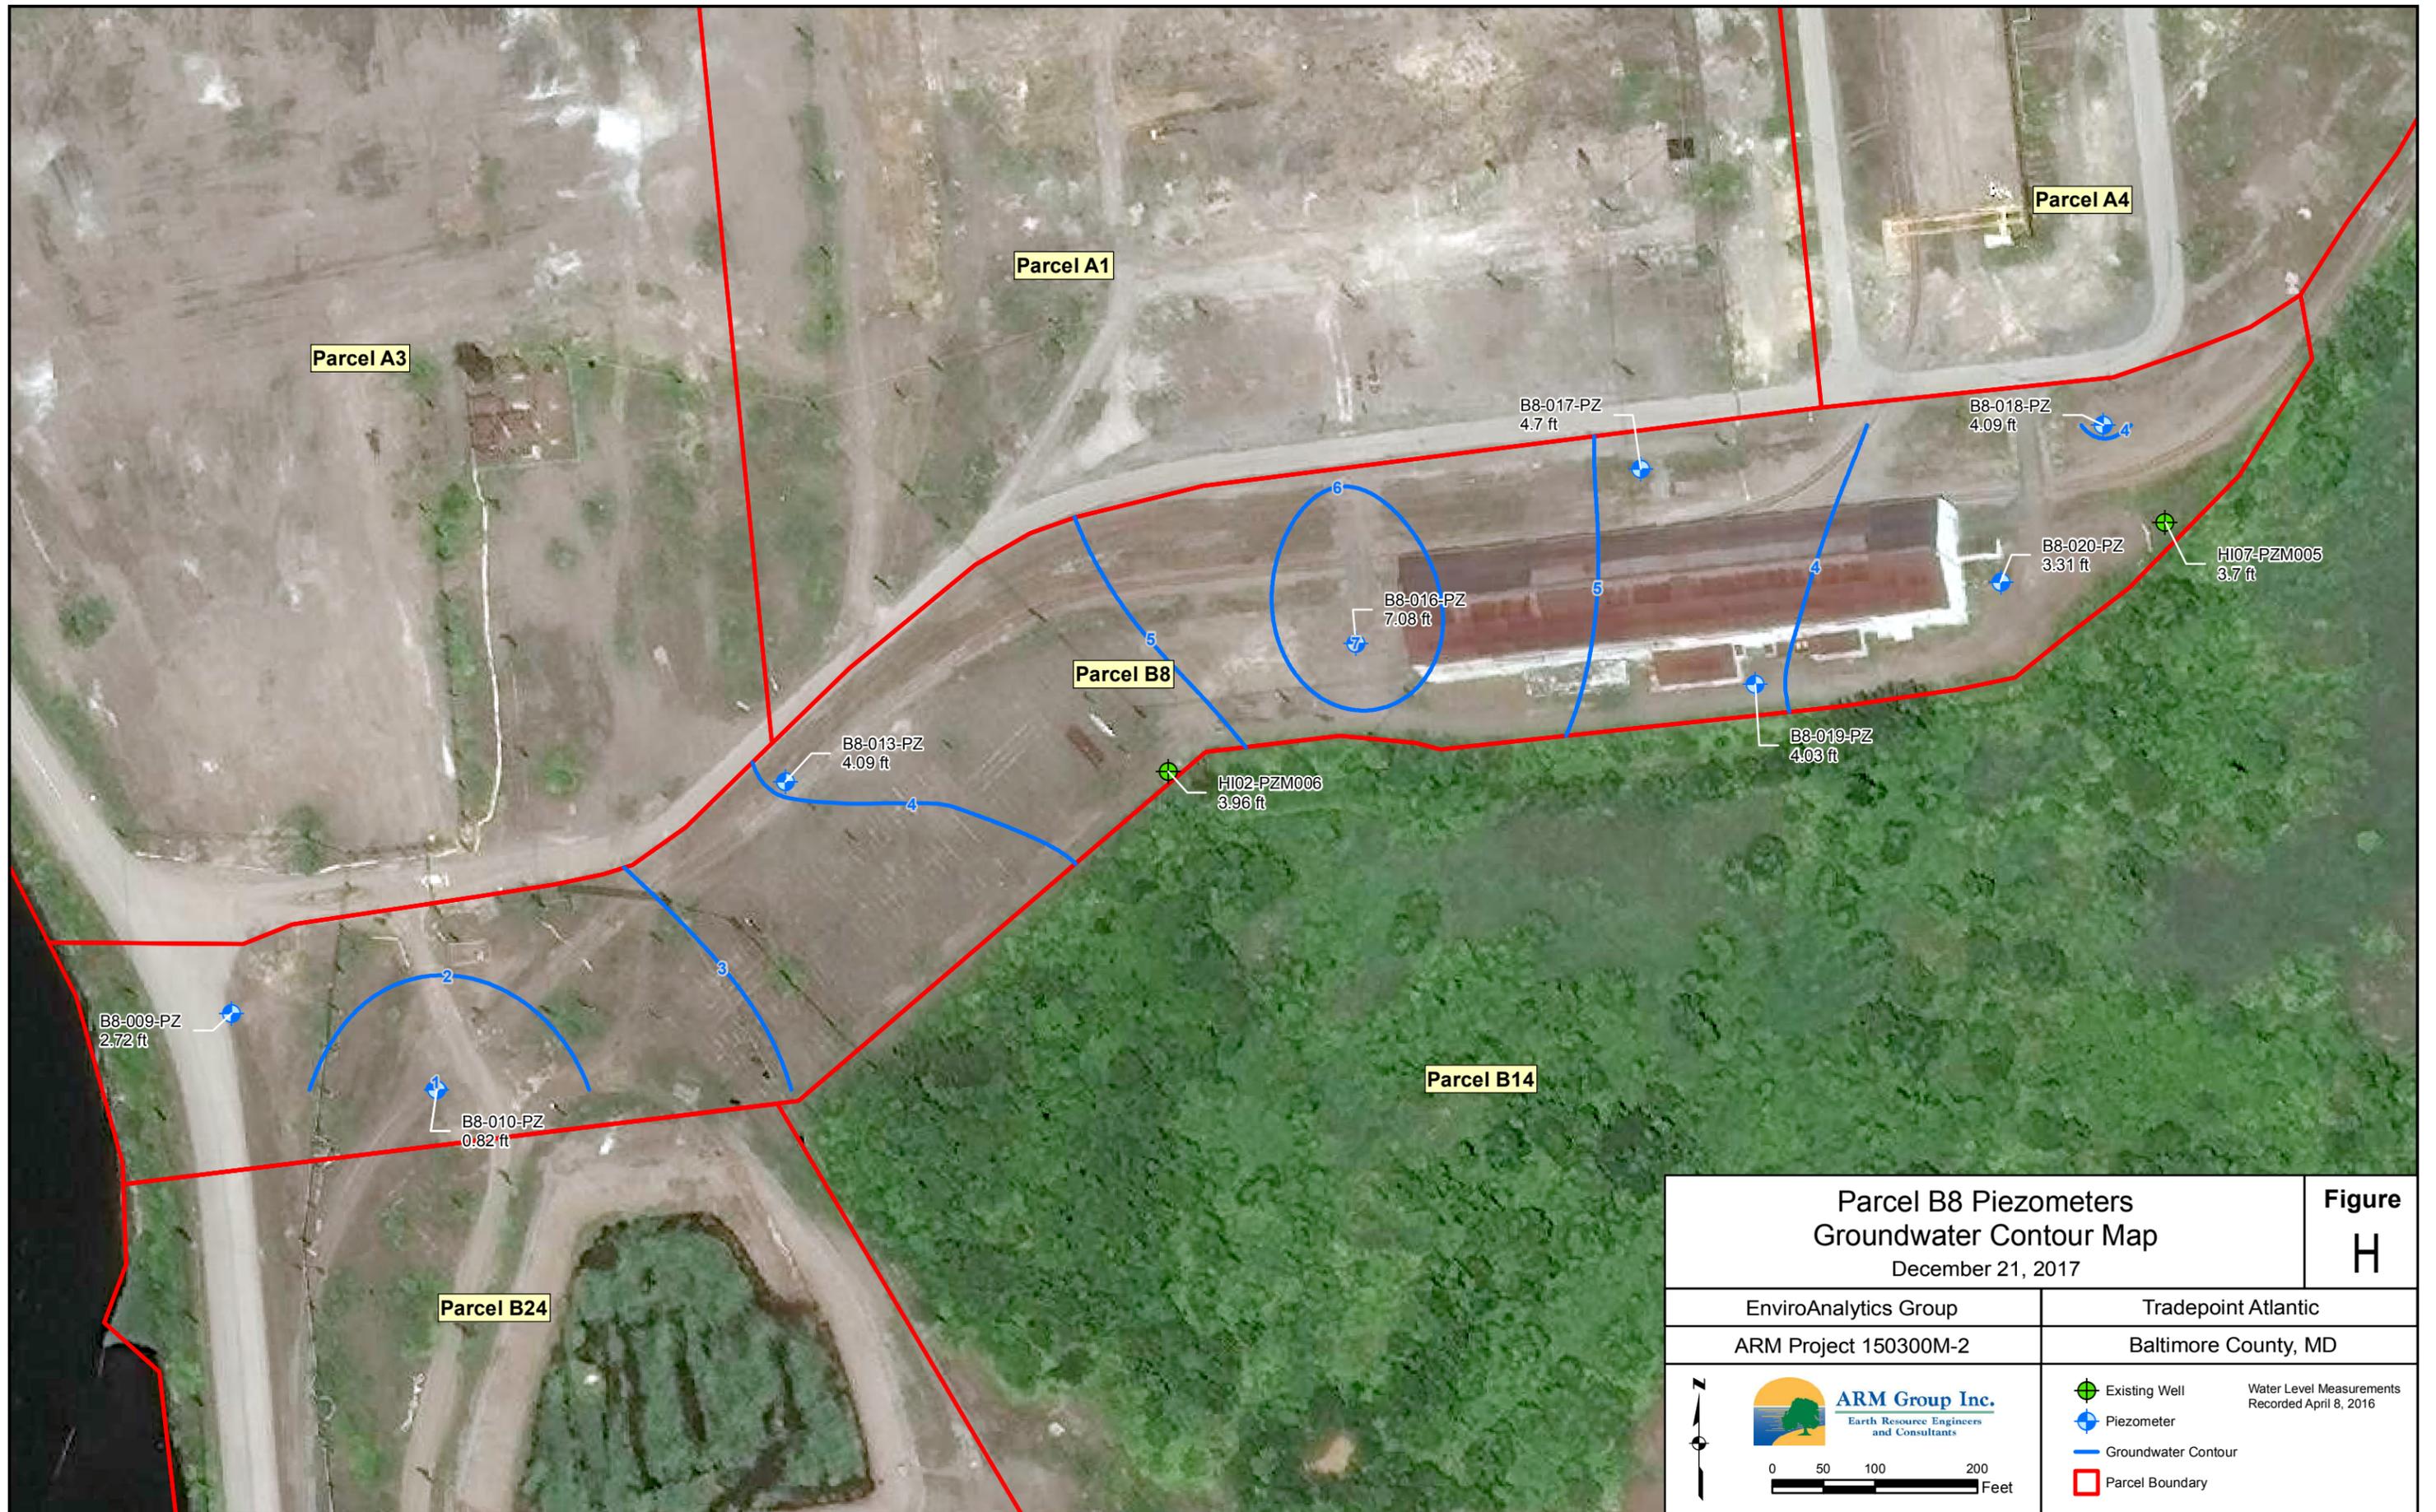
Figure
H

Parcel B8 Piezometers
Groundwater Contour Map
December 21, 2017

A groundwater potentiometric surface map was constructed for the shallow hydrogeologic zone based on the field measurements from this date. The potentiometric map for shallow groundwater has been included on **Figure 3**. Groundwater in the shallow zone at the Site appears to flow radially in all directions from the central portion of the Site (with the highest recorded groundwater elevation of 7.08 feet amsl observed at B8-016-PZ). In the eastern half of the Site, shallow groundwater appears to flow to the east and south towards the Humphrey Impoundment (currently designated as Parcel B14). In the western half of the Site, groundwater generally flows in a southwest direction toward the coastline (Bear Creek) or the HCWWTP.

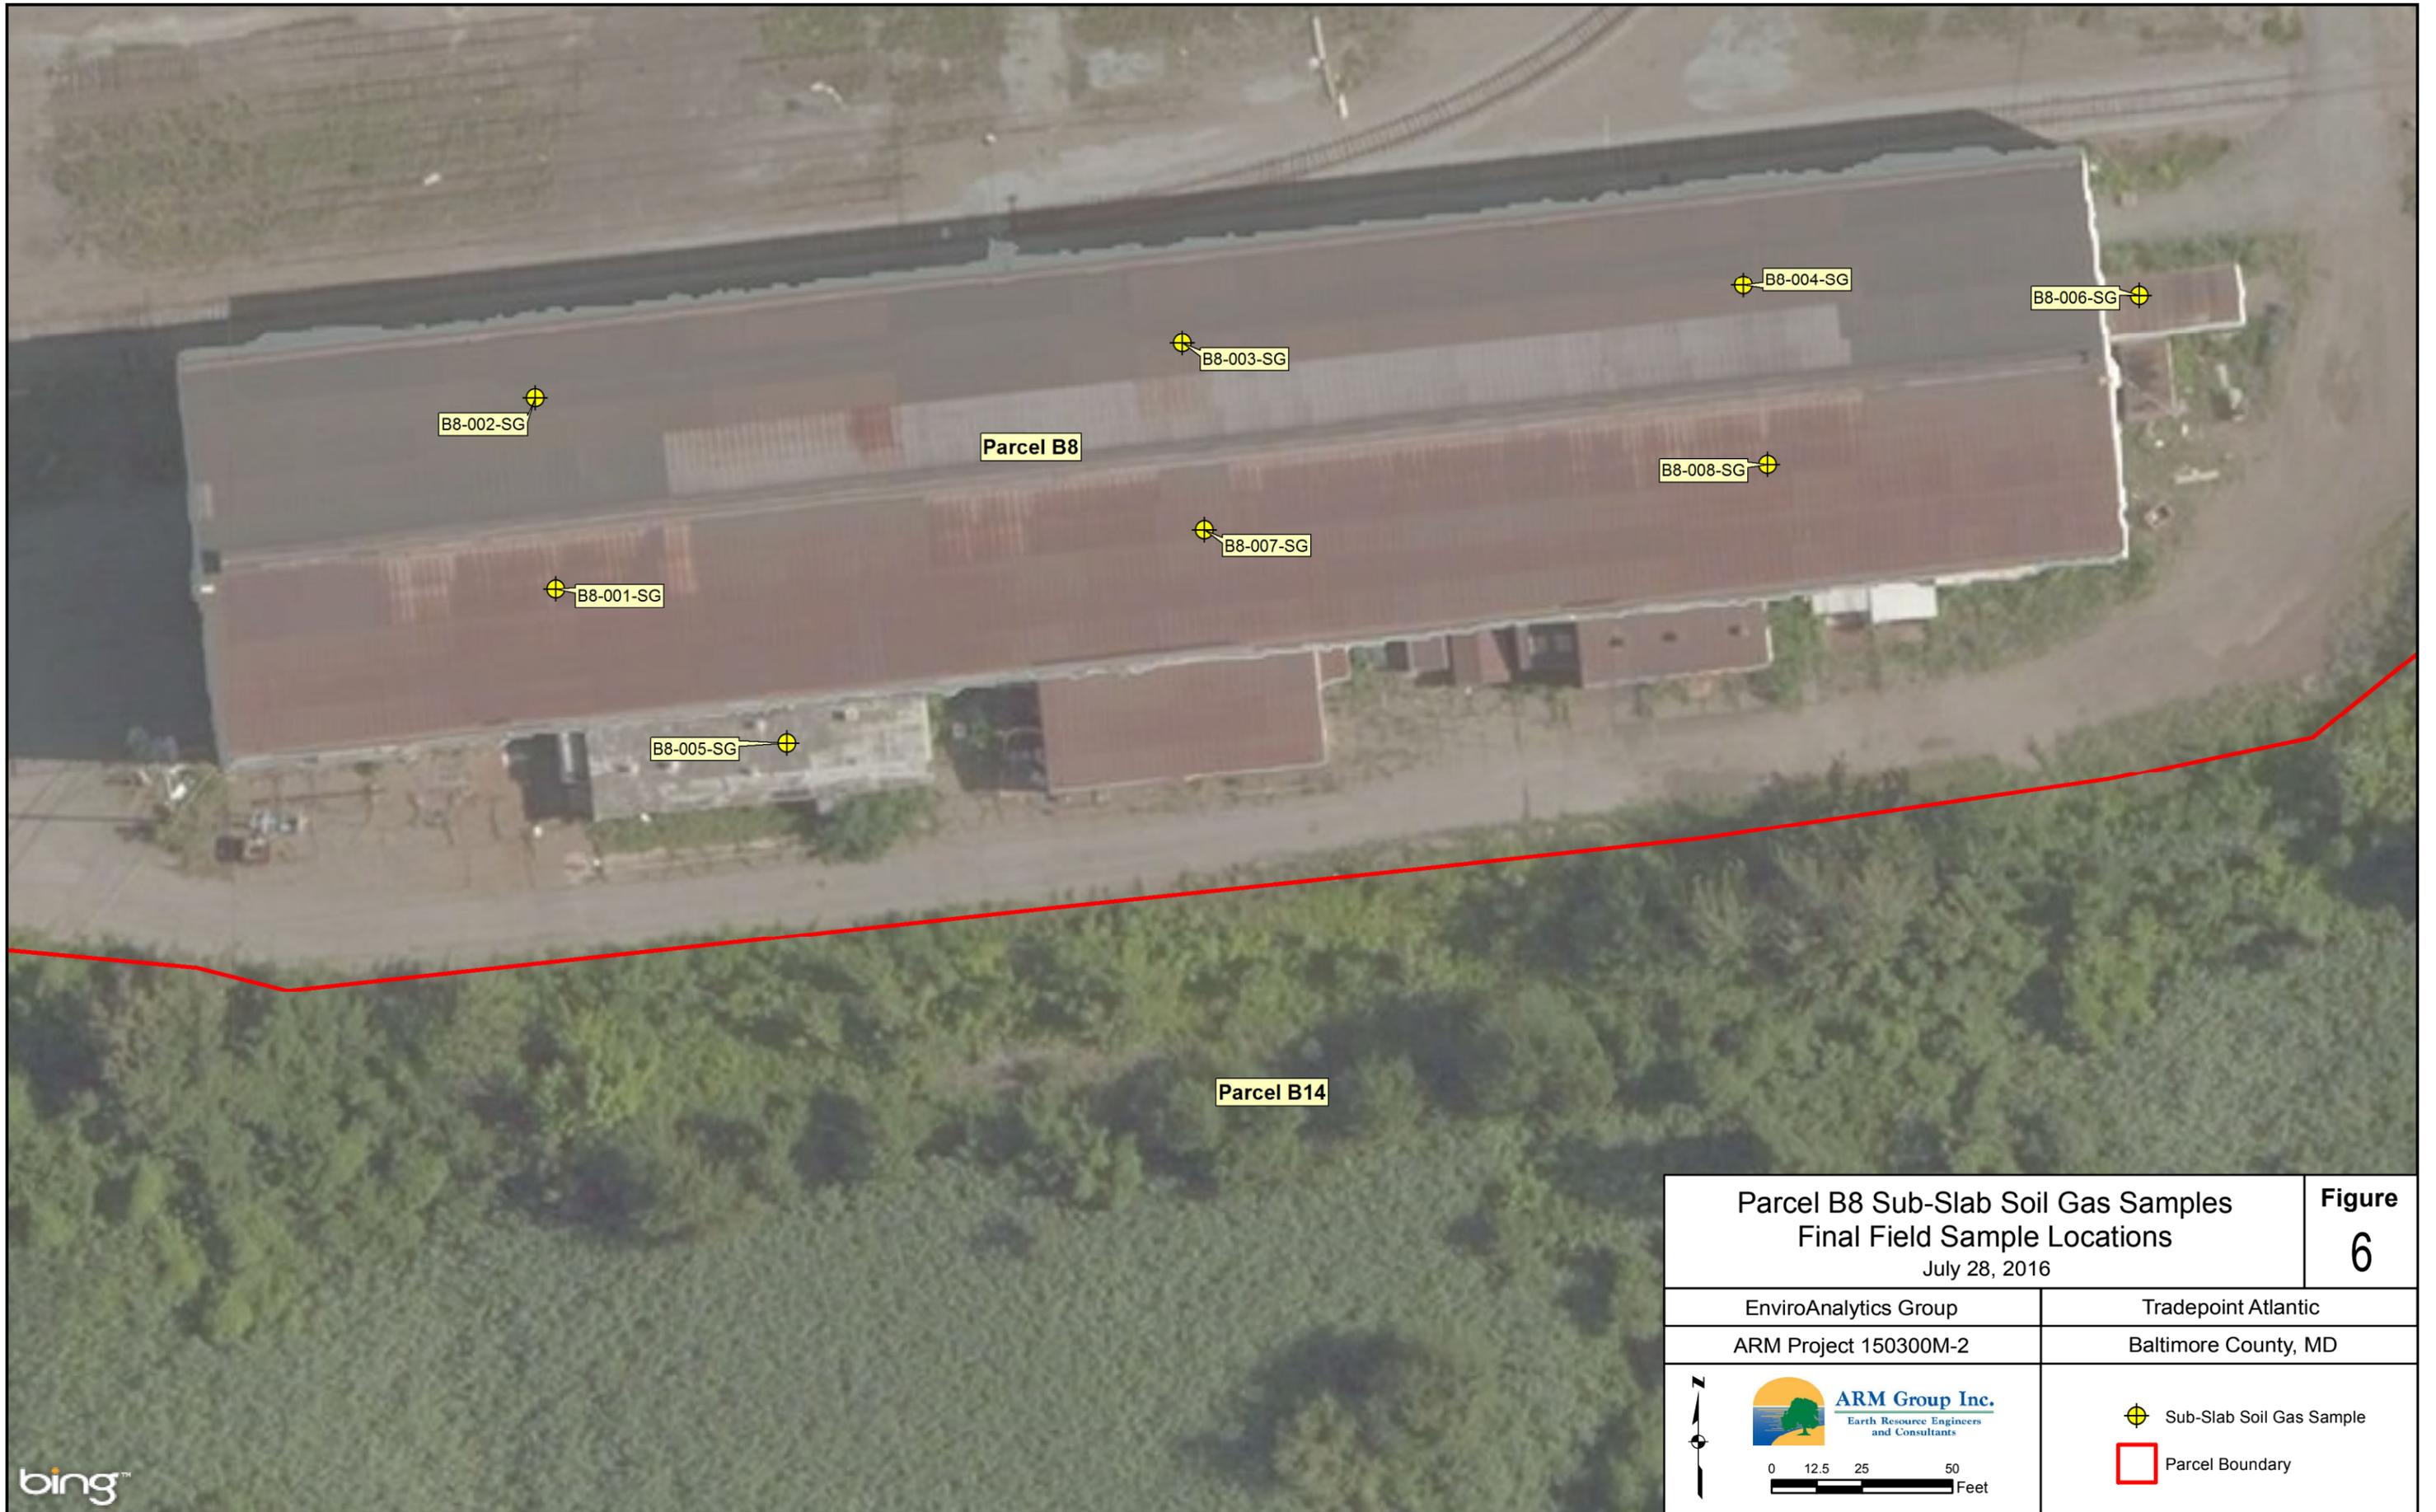
<p align="center">Parcel B8 Sub-Slab Soil Gas Samples Final Field Sample Locations July 28, 2016</p>		<p>Figure 6</p>
EnviroAnalytics Group	Tradepoint Atlantic	
ARM Project 150300M-2	Baltimore County, MD

A total of eight temporary monitoring probes were installed at the locations shown on **Figure 6** to collect sub-slab soil gas samples. Two of the sample locations were originally proposed in the Work Plan as deep soil gas samples (B8-007-SG and B8-008-SG), but were replaced with sub-slab soil gas samples when an intact floor slab was identified at the proposed locations. The sub-slab soil gas samples were collected according to procedures and methods referenced in **Field SOP Number 002** provided in Appendix A of the QAPP.

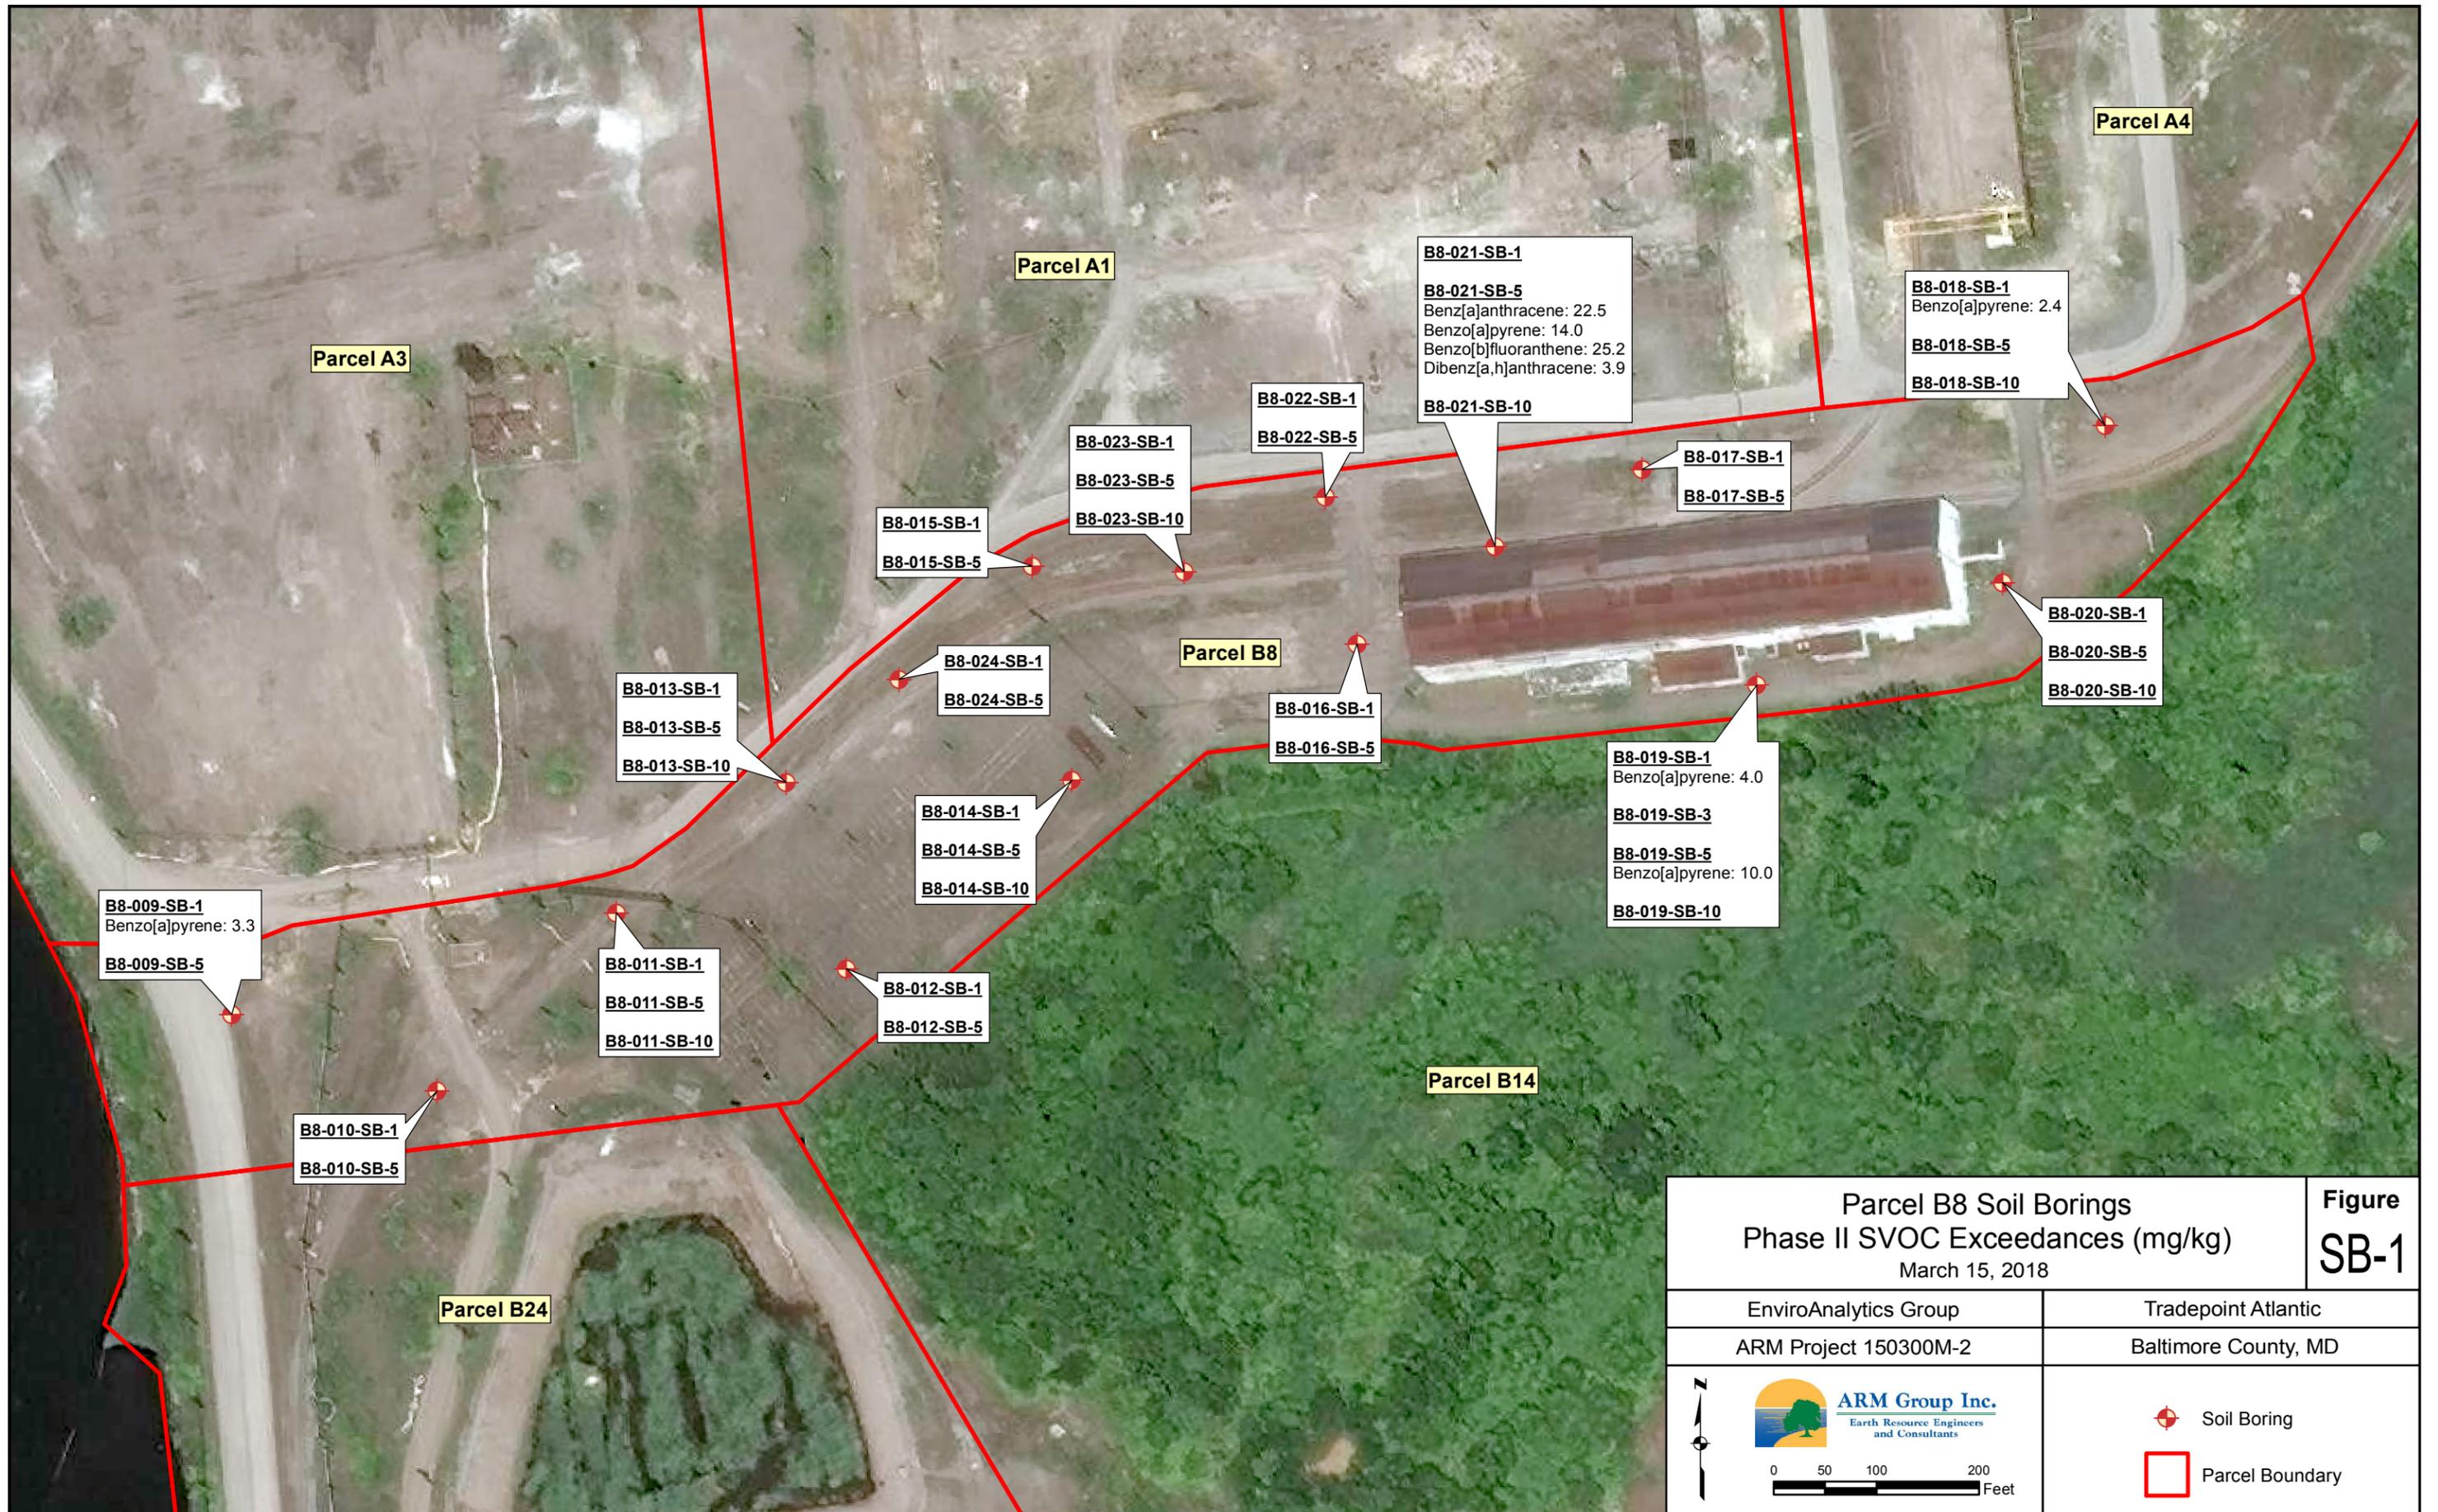
Parcel B8 Soil Borings Phase II SVOC Exceedances (mg/kg) March 15, 2018		Figure SB-1
EnviroAnalytics Group	Tradepoint Atlantic	
ARM Project 150300M-2	Baltimore County, MD

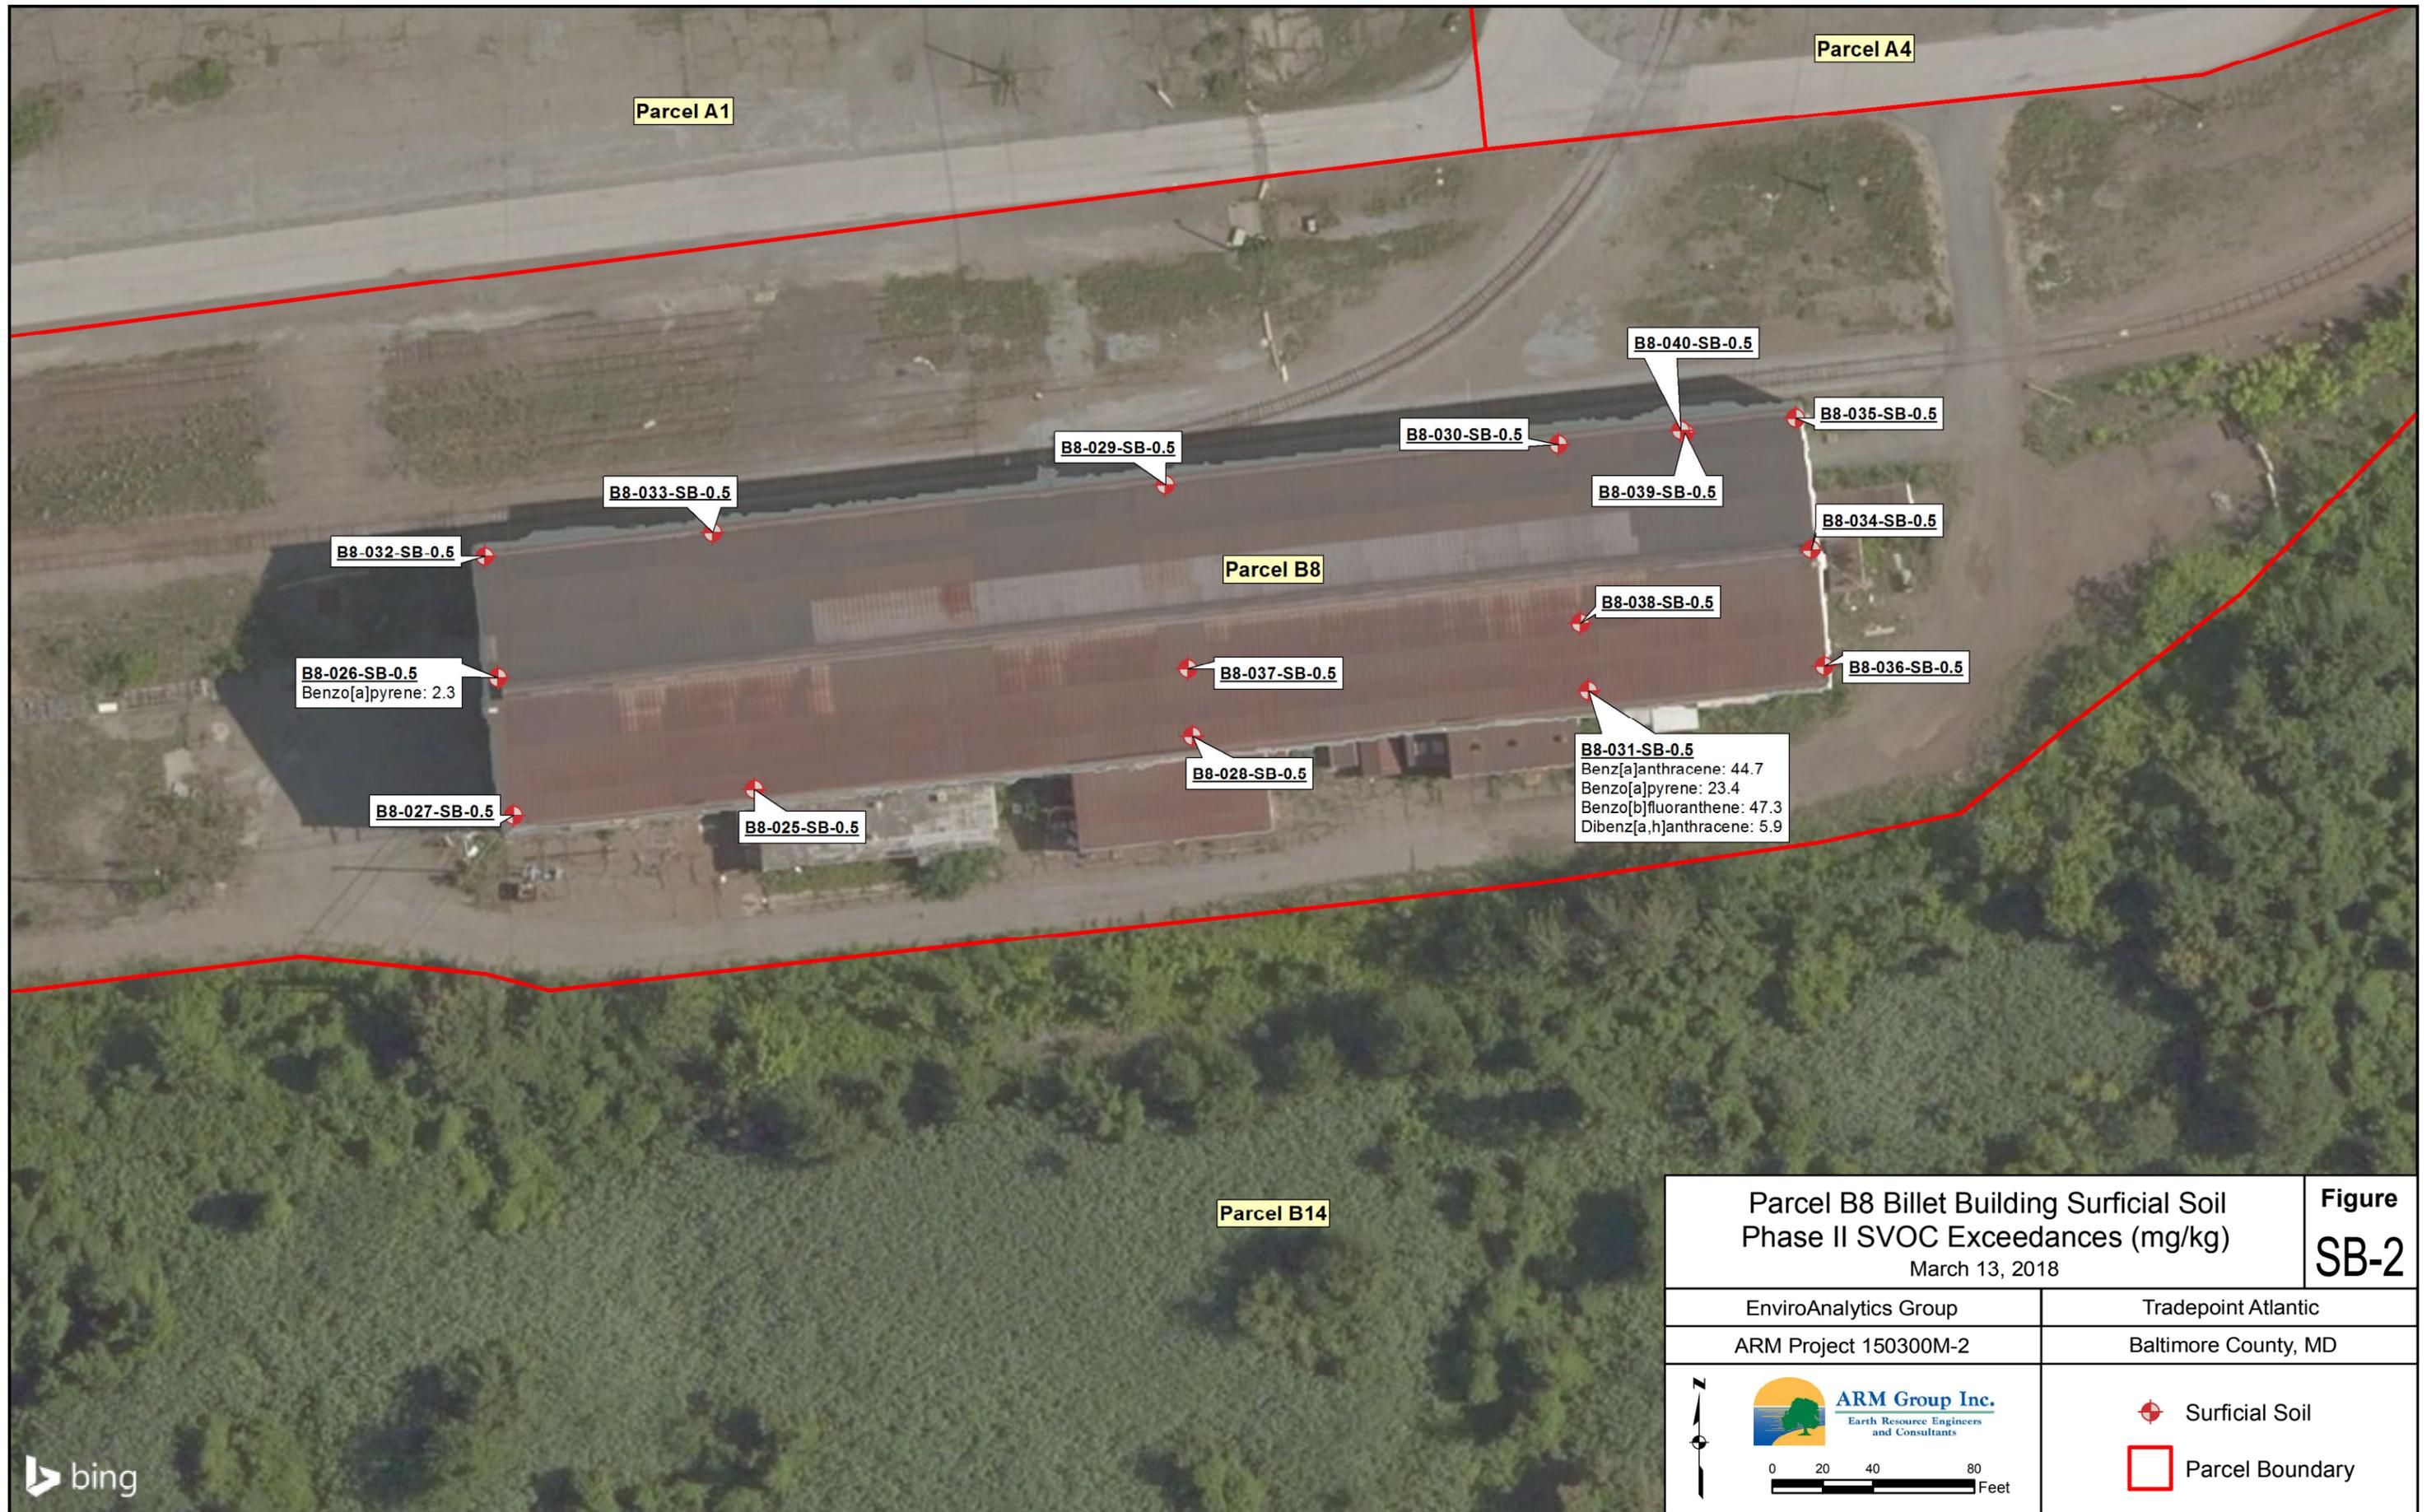
<p align="center">Parcel B8 Billet Building Surficial Soil Phase II SVOC Exceedances (mg/kg) March 13, 2018</p>		<p align="center">Figure SB-2</p>
<p>EnviroAnalytics Group</p>	<p>Tradeport Atlantic</p>	
<p>ARM Project 150300M-2</p>	<p>Baltimore County, MD</p>	
<p align="center">

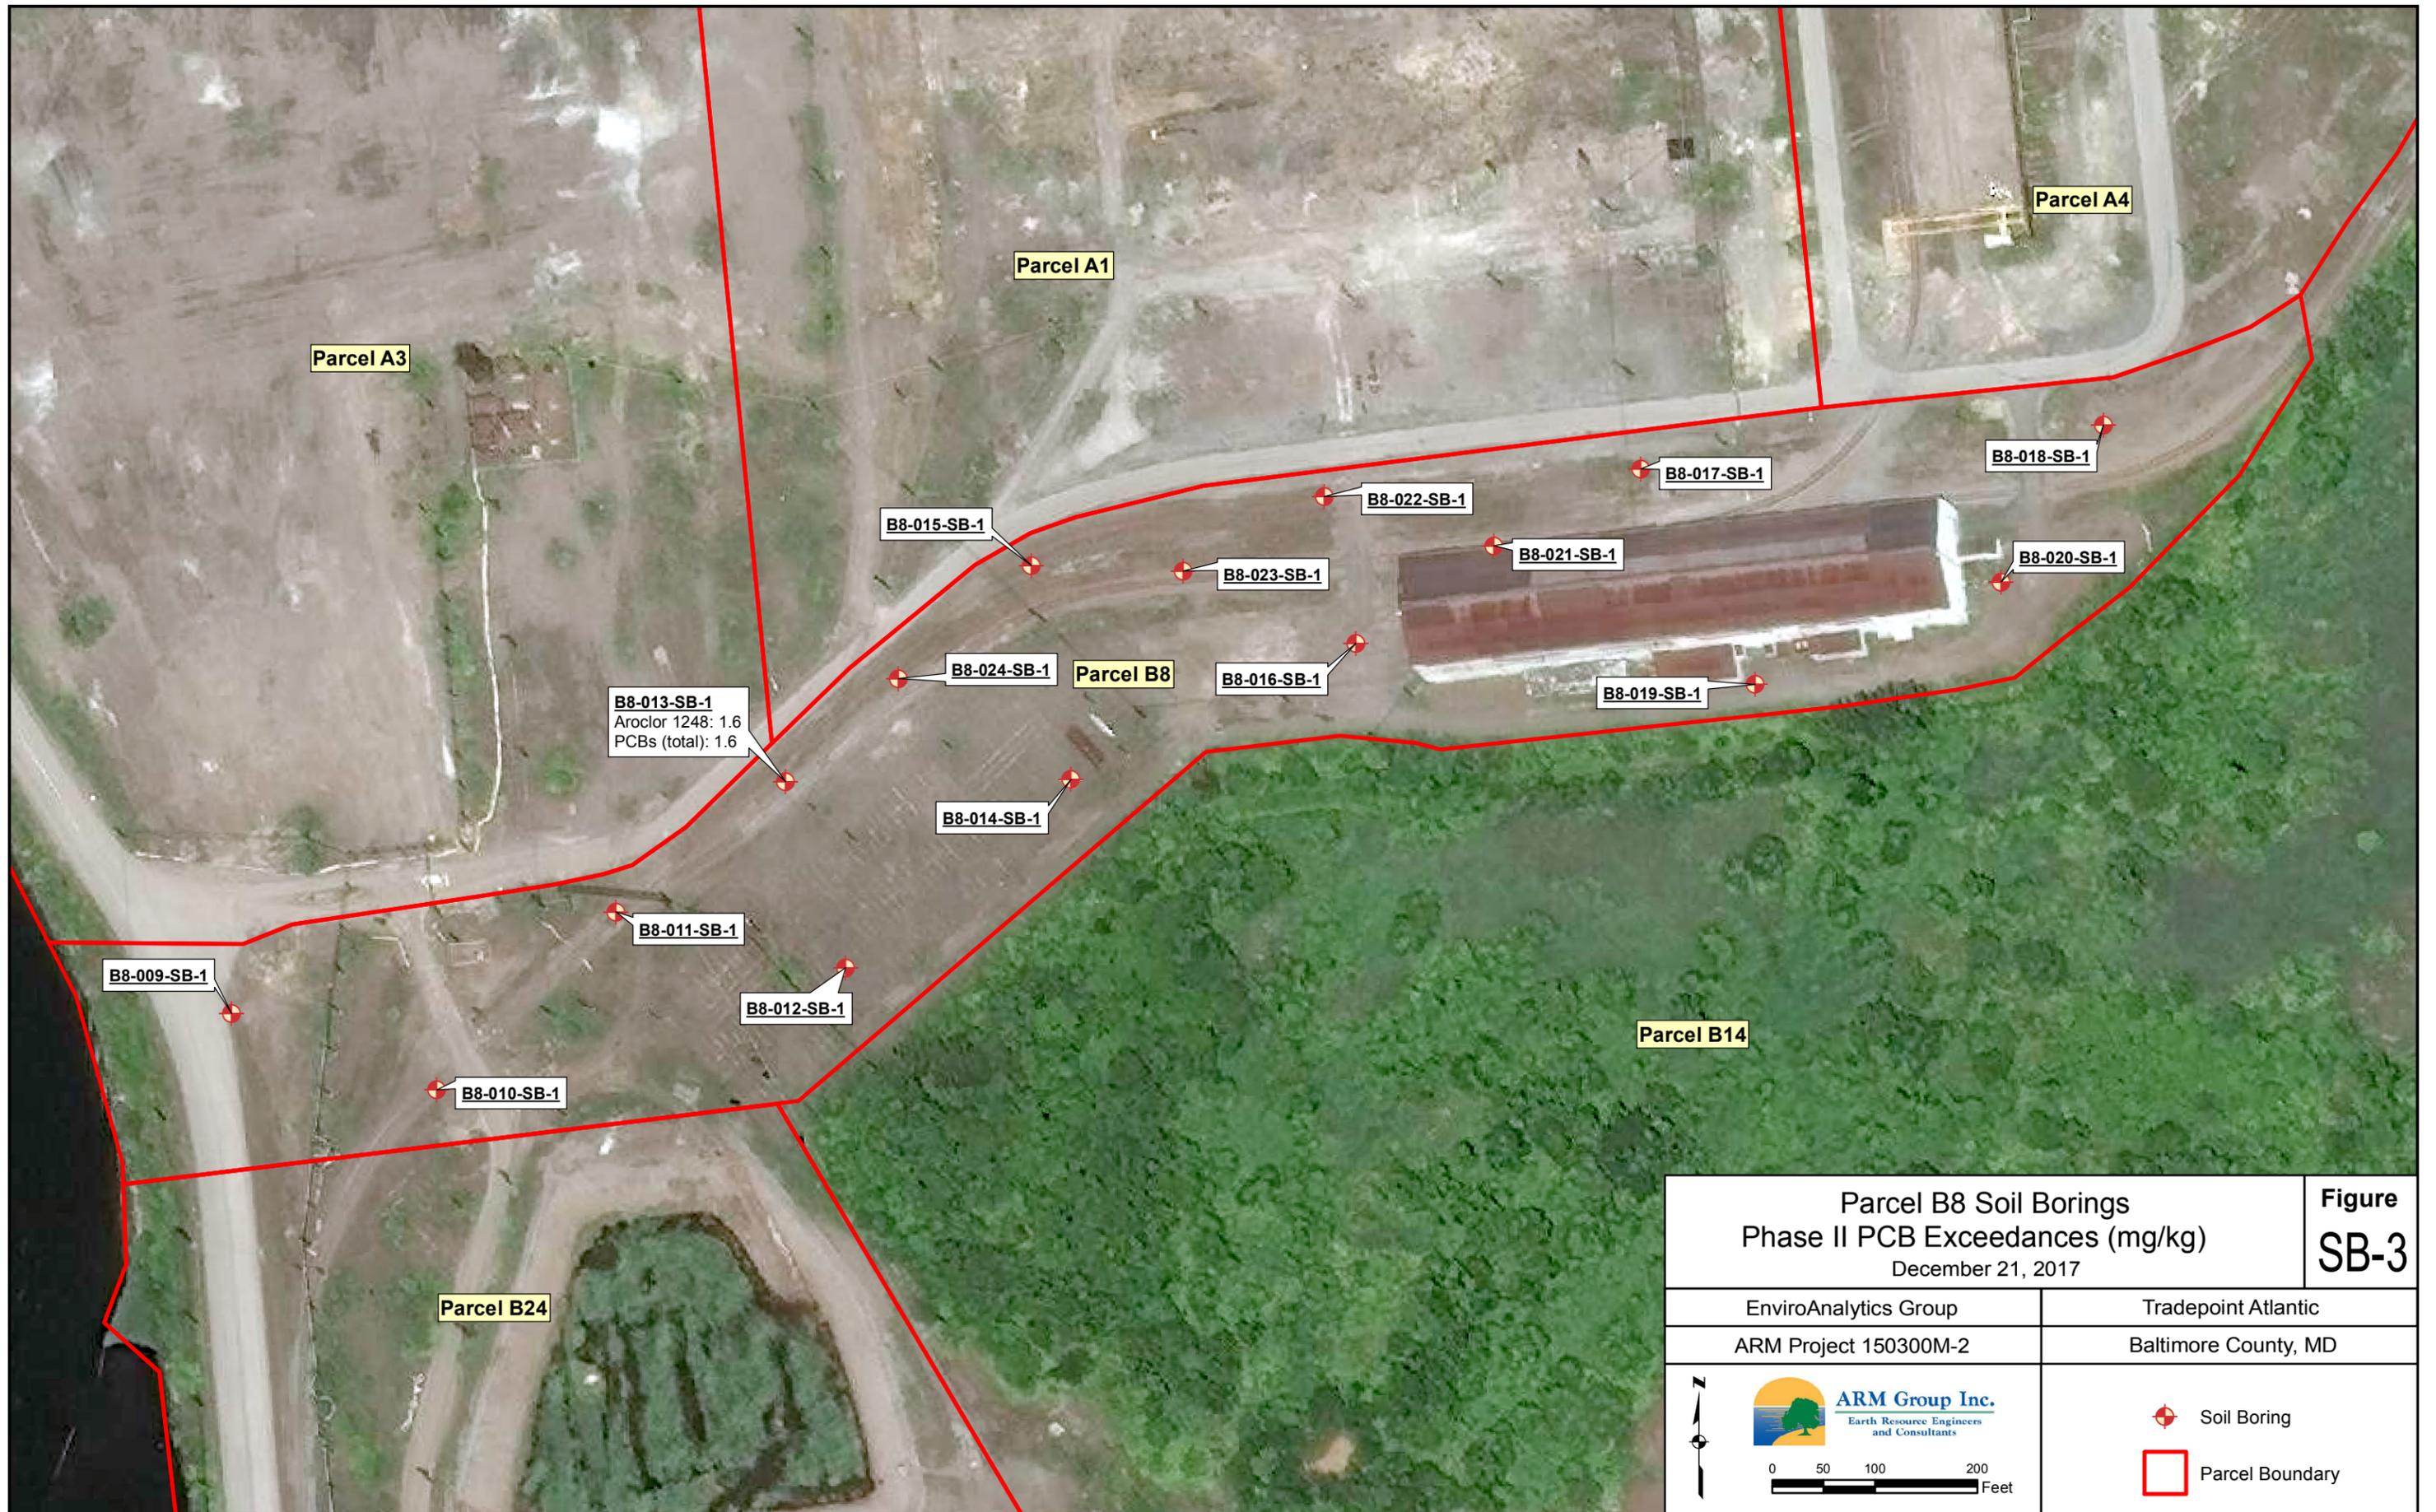
Parcel B8 Soil Borings Phase II PCB Exceedances (mg/kg) December 21, 2017		Figure SB-3
EnviroAnalytics Group	Tradepoint Atlantic	
ARM Project 150300M-2	Baltimore County, MD
