PHASE II INVESTIGATION REPORT

AREA B: PARCEL B8
TRADEPOINT ATLANTIC
SPARROWS POINT, MARYLAND

ARM Project No. 150300M-2

Revision 1 – March 16, 2018

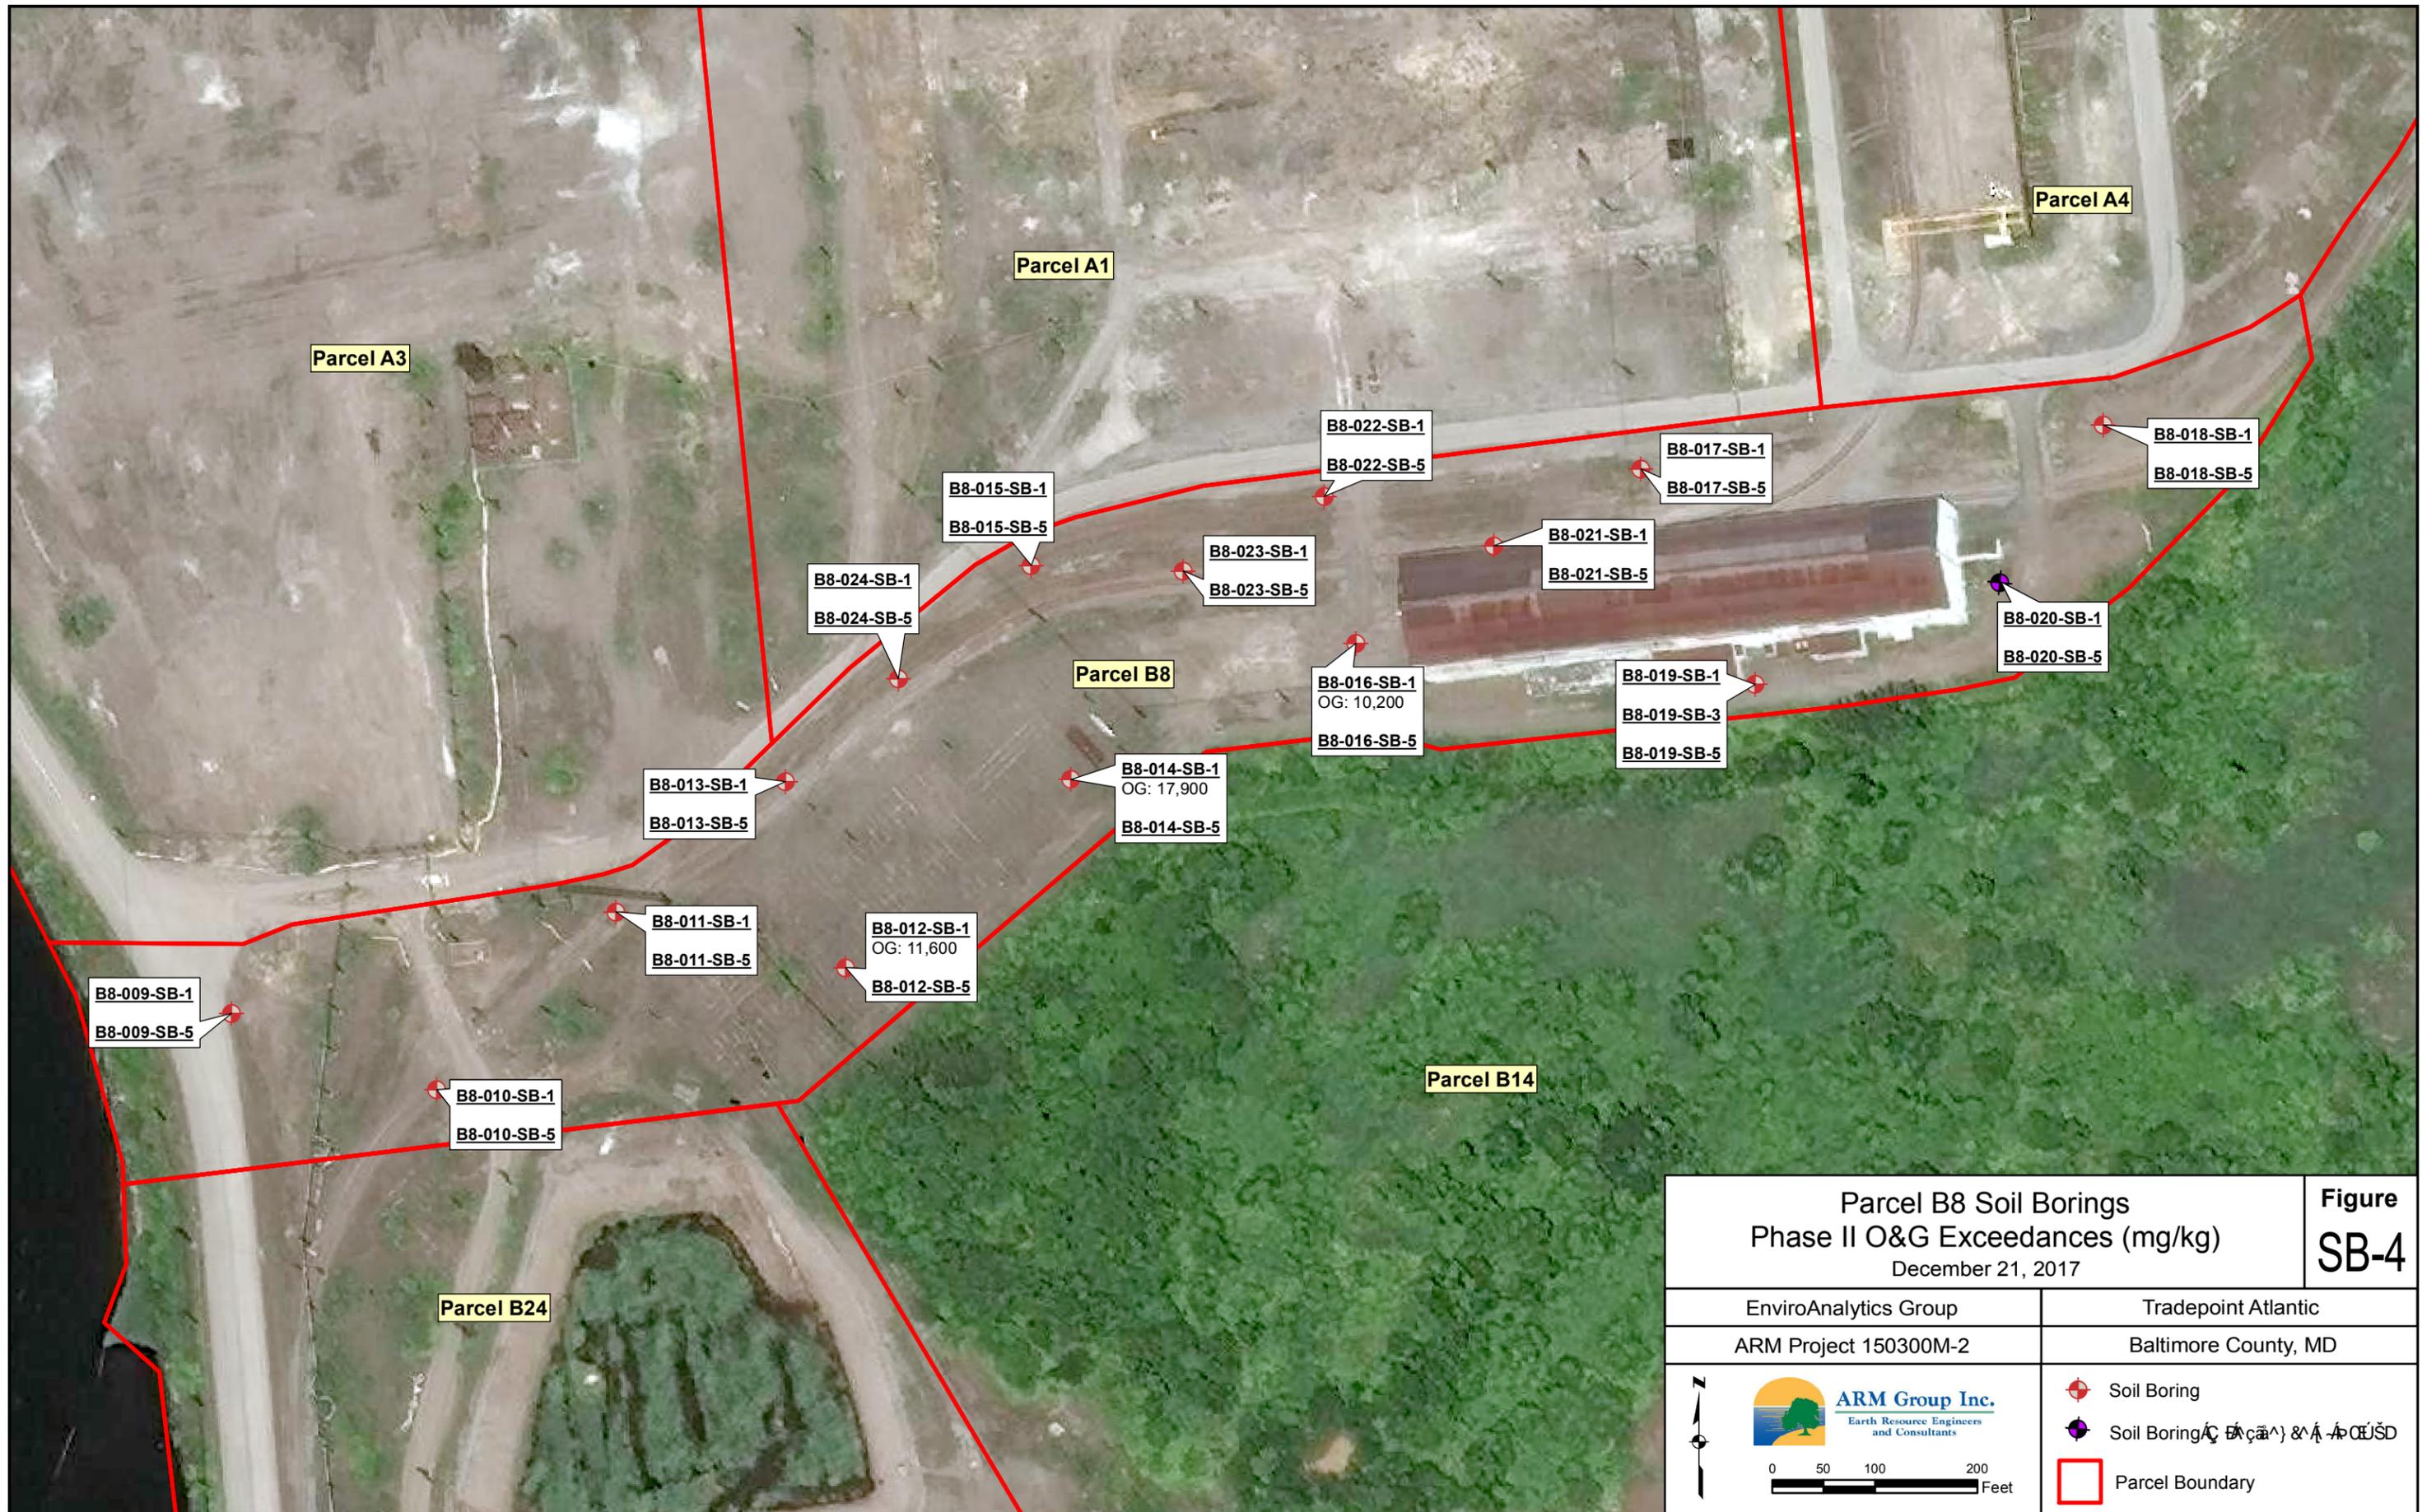
Parcel B8 Soil Borings Phase II O&G Exceedances (mg/kg) December 21, 2017		Figure SB-4
EnviroAnalytics Group	Tradepoint Atlantic	
ARM Project 150300M-2	Baltimore County, MD	
		<ul style="list-style-type: none"> Soil Boring Soil Boring (C&A) & A-A-C&SD Parcel Boundary

Soil cores were screened for evidence of possible NAPL contamination during the completion of the Phase II soil borings in Parcel B8. Field screening indicated that one location (B8-020-SB) had physical evidence of possible product noted on the boring log. This boring is highlighted on **Figure SB-4**, which also displays Oil & Grease PAL exceedances in the parcel. Sample location

B8-020-SB had the appearance of a black sheen in the core from 7 to 11 feet bgs and 12.2 to 15 feet bgs. A petroleum odor was also noted accompanying the sheen from 7 to 11 feet bgs. An intermediate soil sample (B8-020-SB-5) collected from the 4 to 5 foot bgs interval had an Oil & Grease detection of 4,610 mg/kg. A piezometer was installed at this location in accordance with the parcel-specific sampling plan, and product was later identified and delineated in the vicinity of B8-020-SB. The analytical samples from this location were not analyzed for TPH-DRO/GRO based on the sampling plan at the time of Work Plan approval which did not require these analyses. However, samples from this soil boring were analyzed for Oil & Grease.

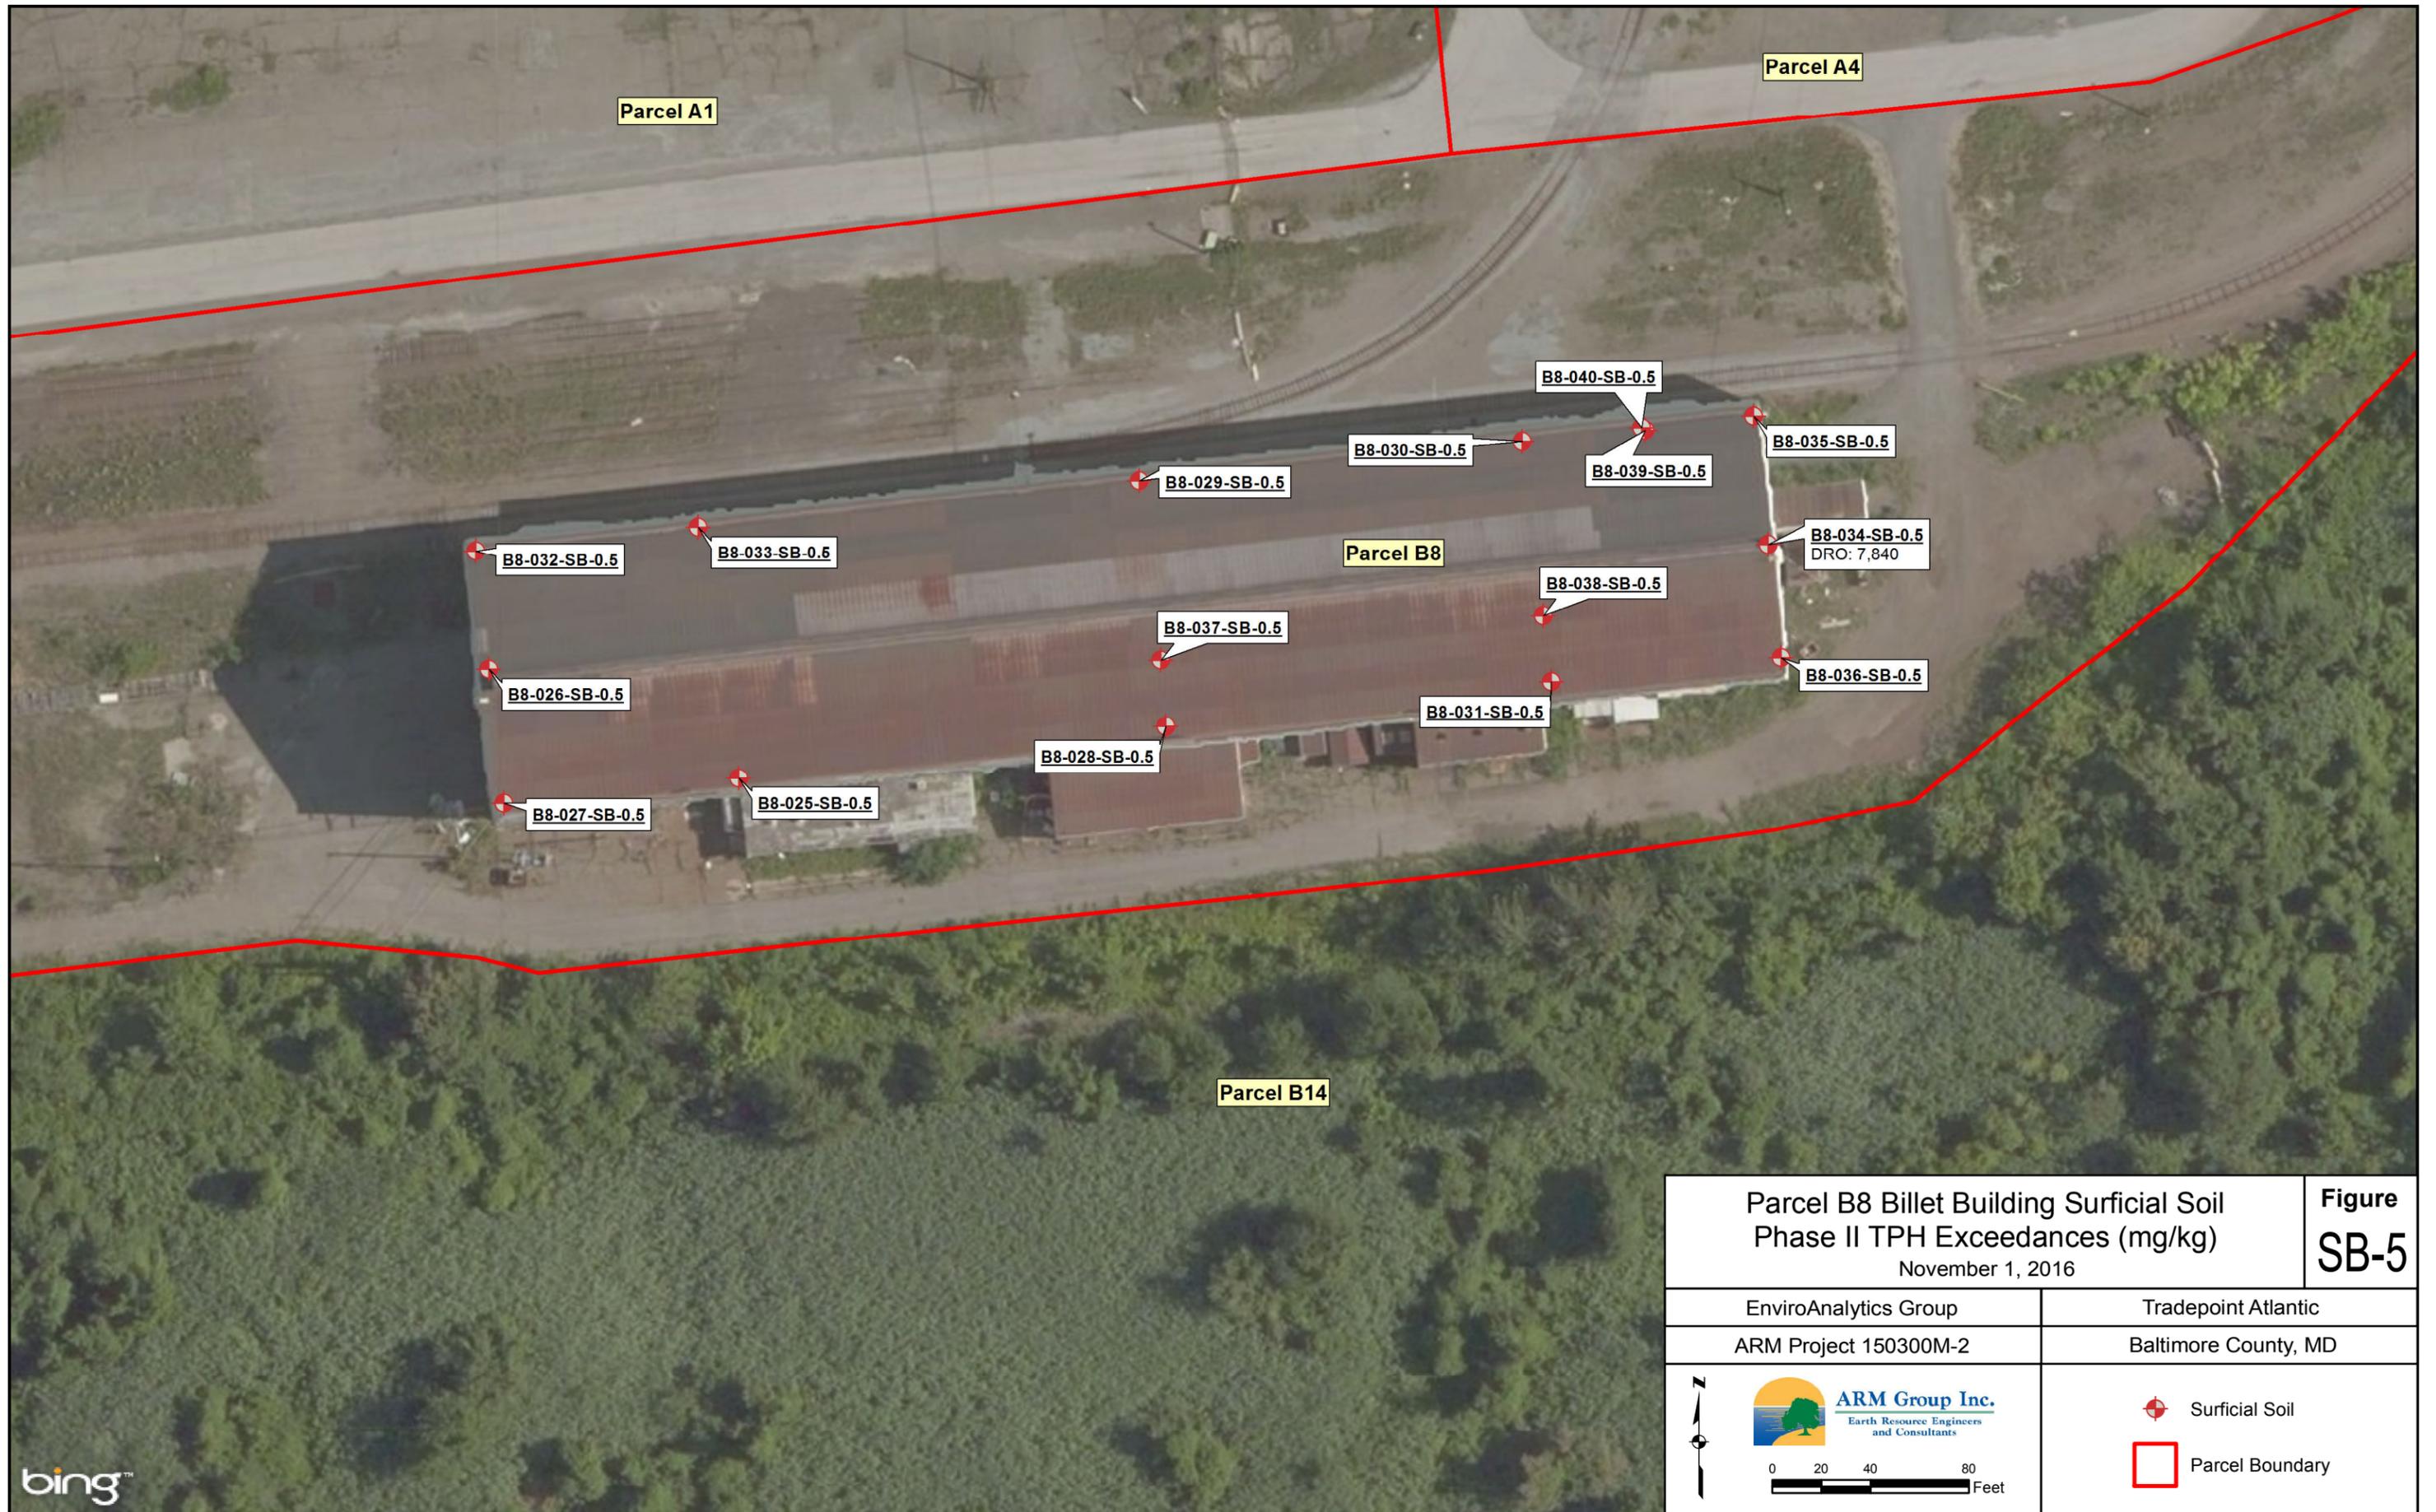
Parcel B8 Billet Building Surficial Soil Phase II TPH Exceedances (mg/kg) November 1, 2016		Figure SB-5
EnviroAnalytics Group	Tradepoint Atlantic	
ARM Project 150300M-2	Baltimore County, MD	
		Surficial Soil Parcel Boundary

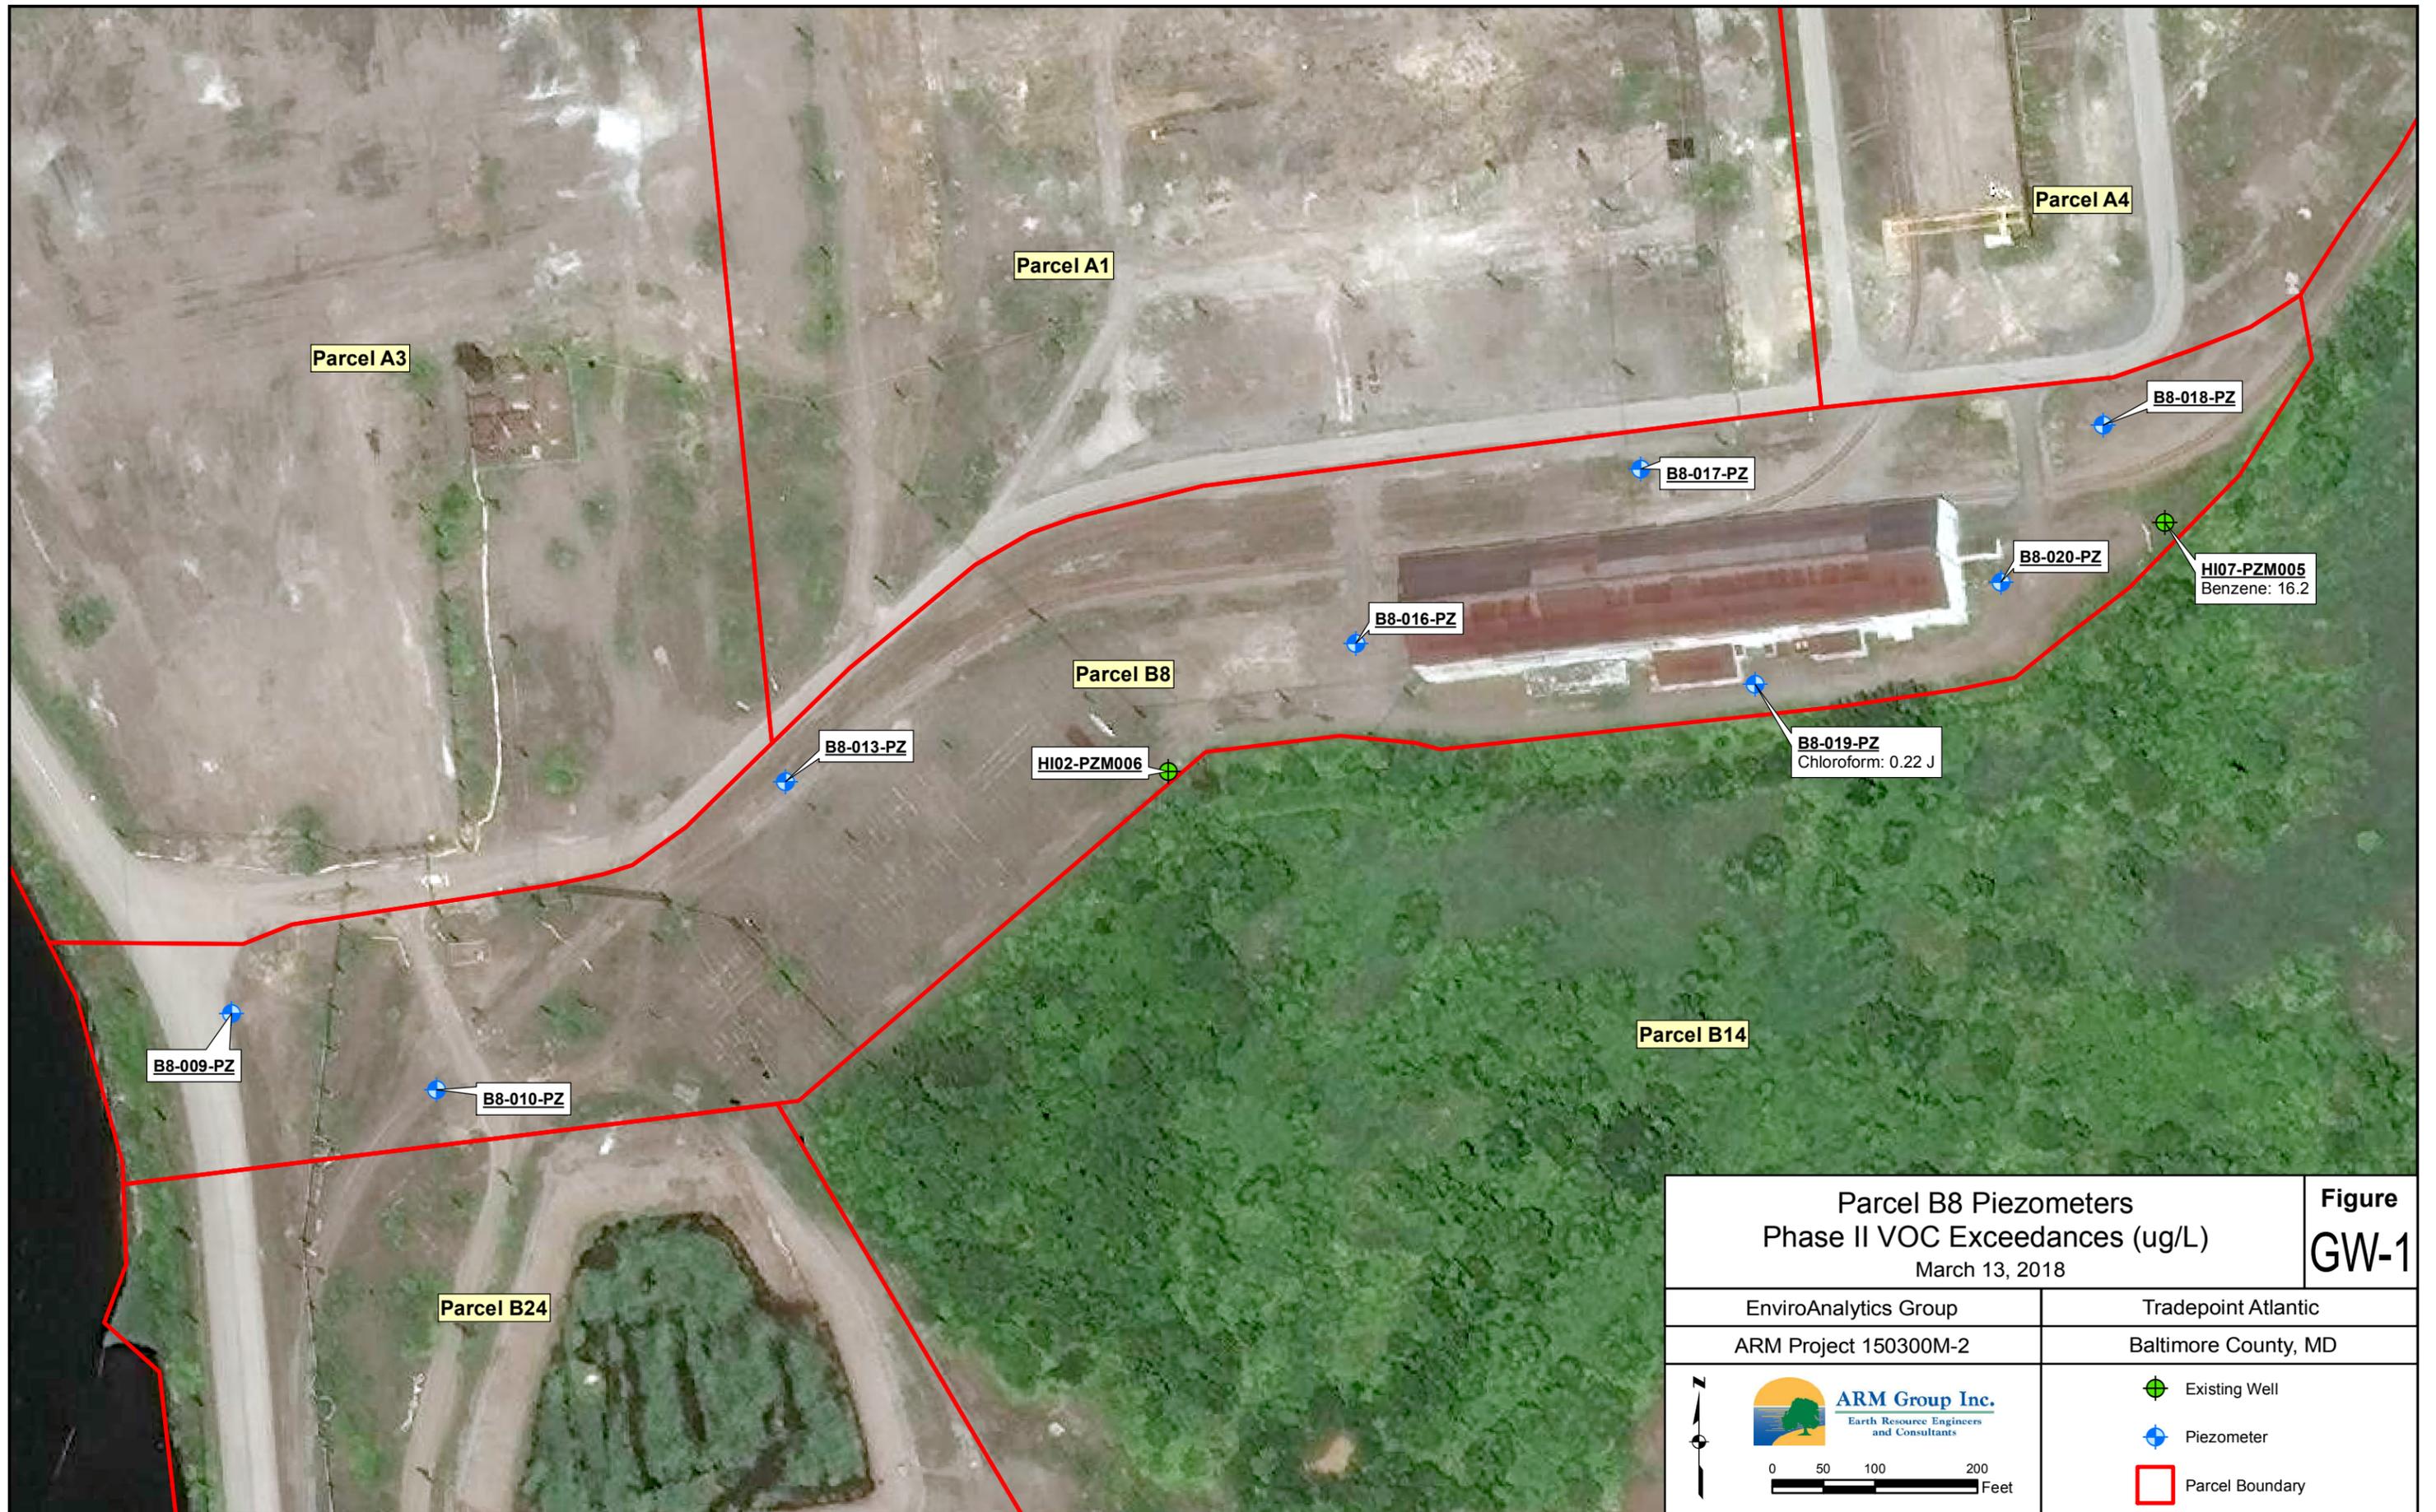
Figure
 GW-1

Parcel B8 Piezometers
 Phase II VOC Exceedances (ug/L)
 March 13, 2018

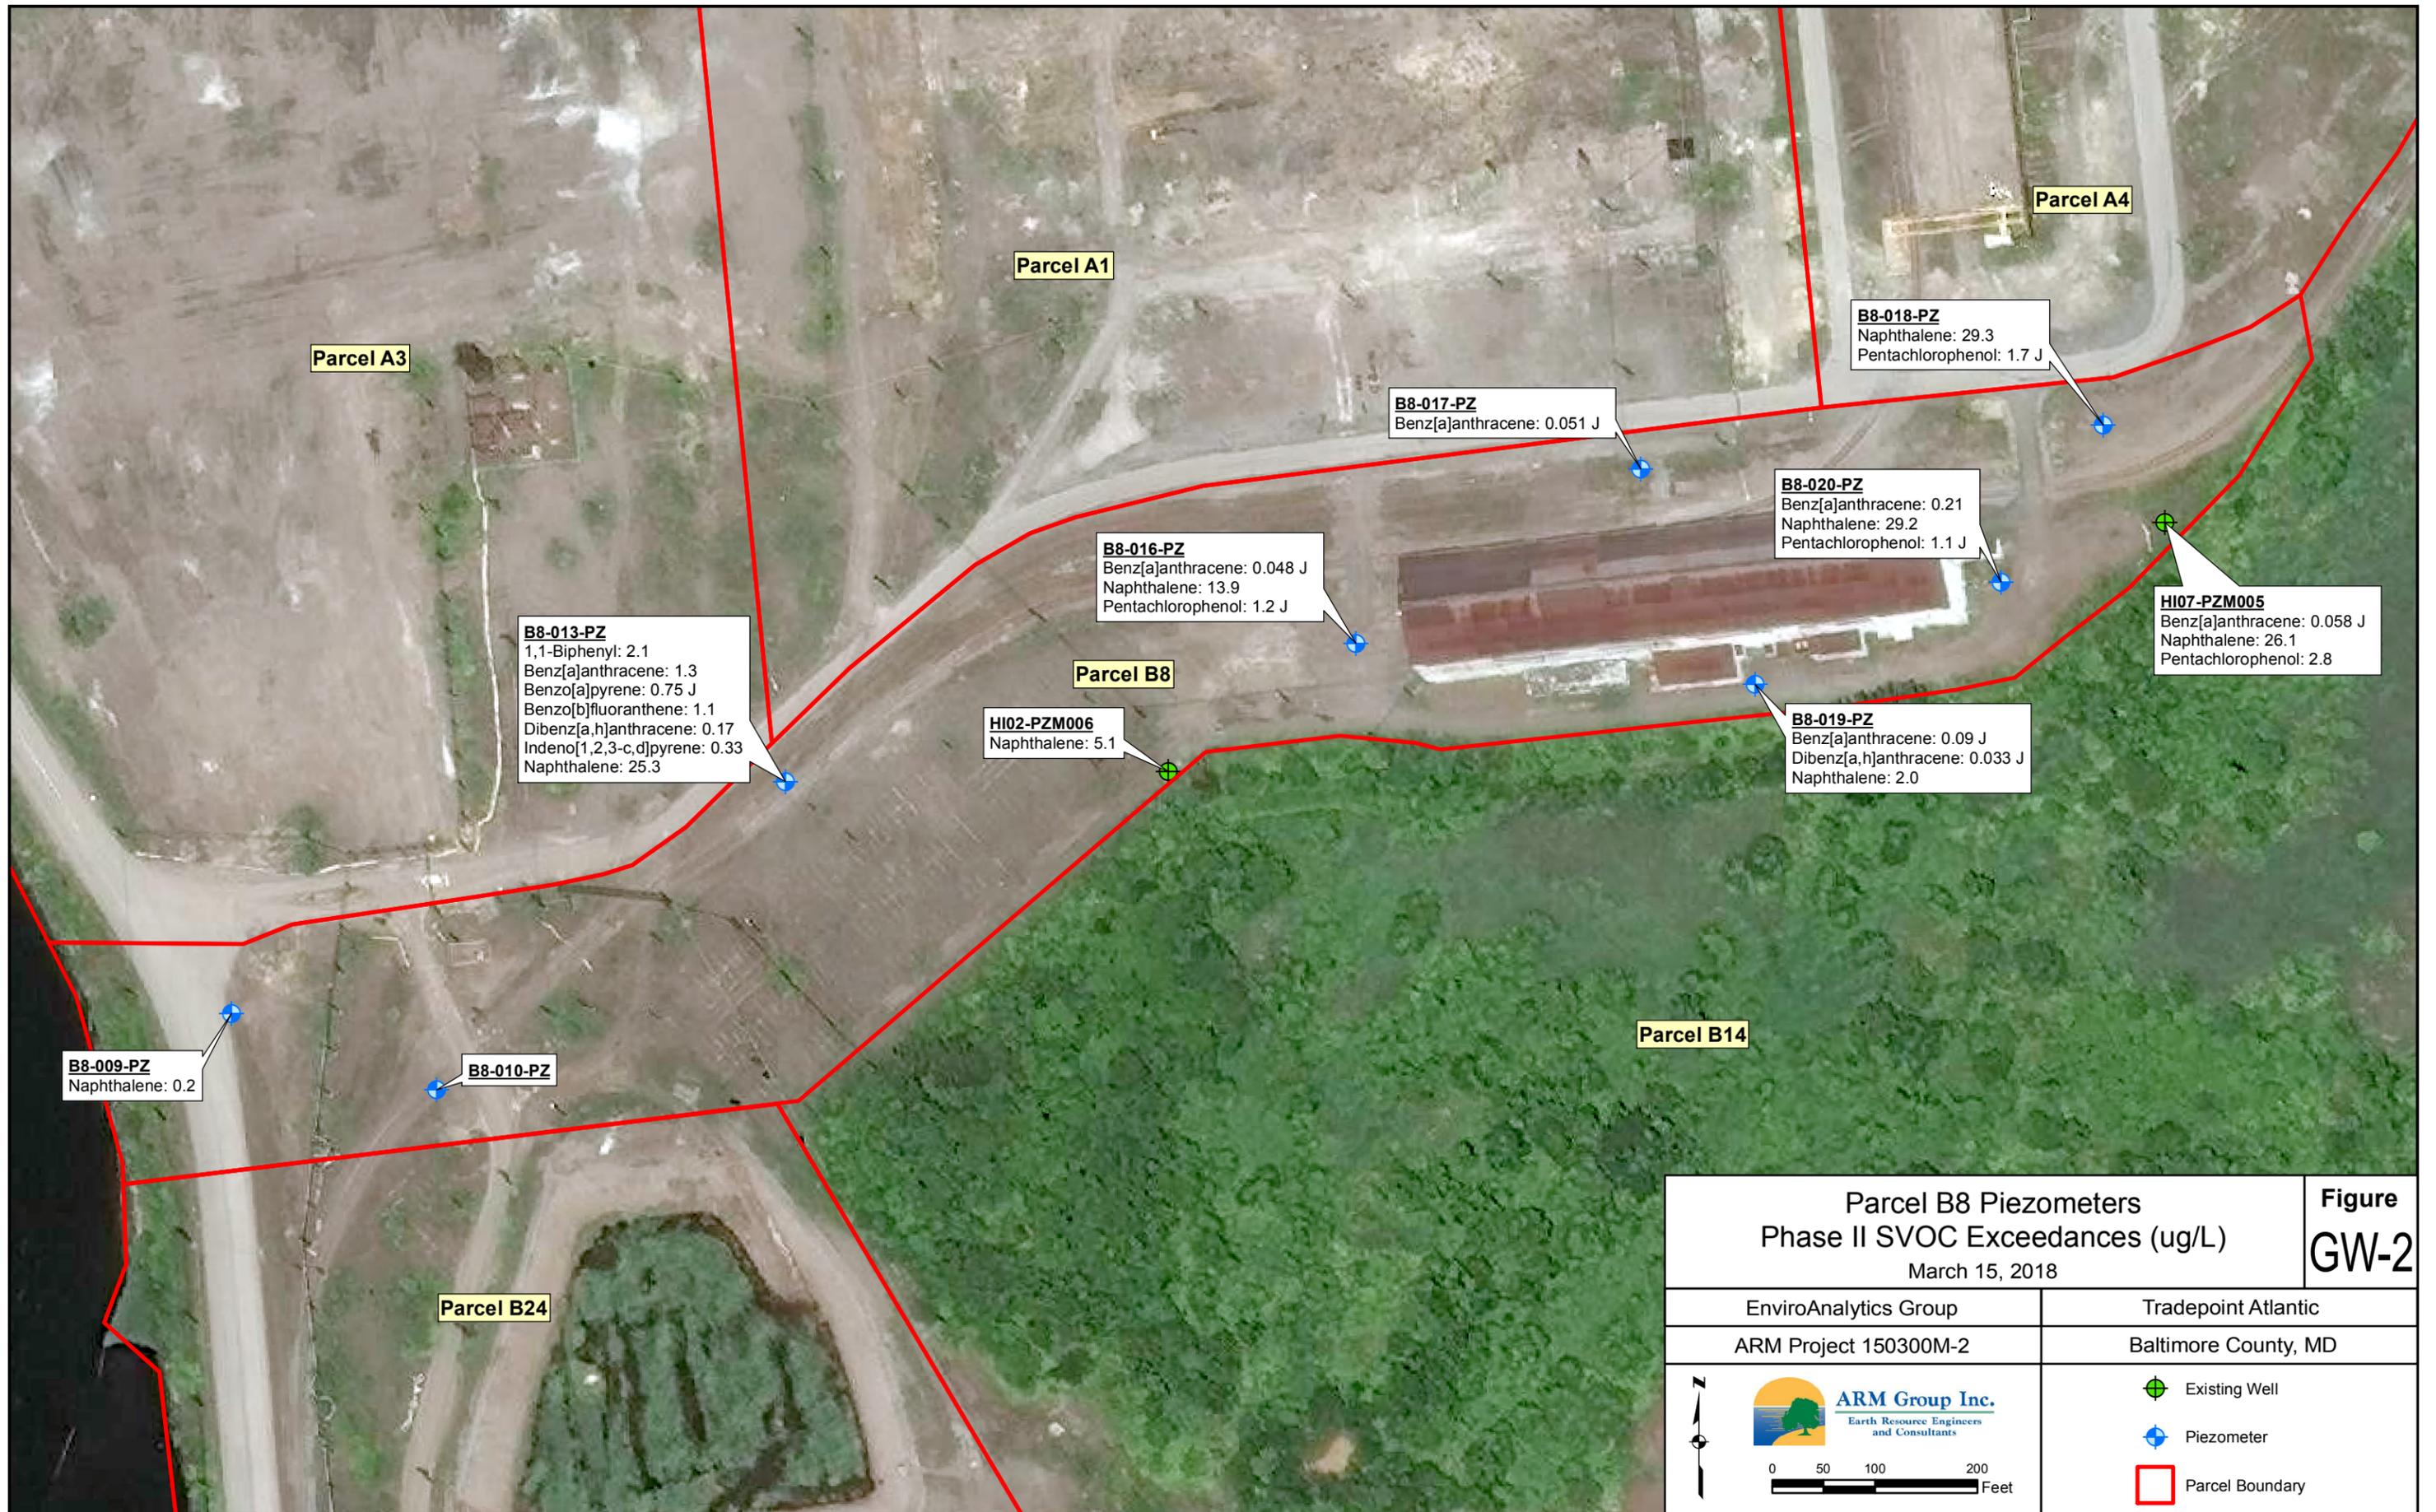
Parcel B8 Piezometers Phase II SVOC Exceedances (ug/L) March 15, 2018		Figure GW-2
EnviroAnalytics Group	Tradepoint Atlantic	
ARM Project 150300M-2	Baltimore County, MD

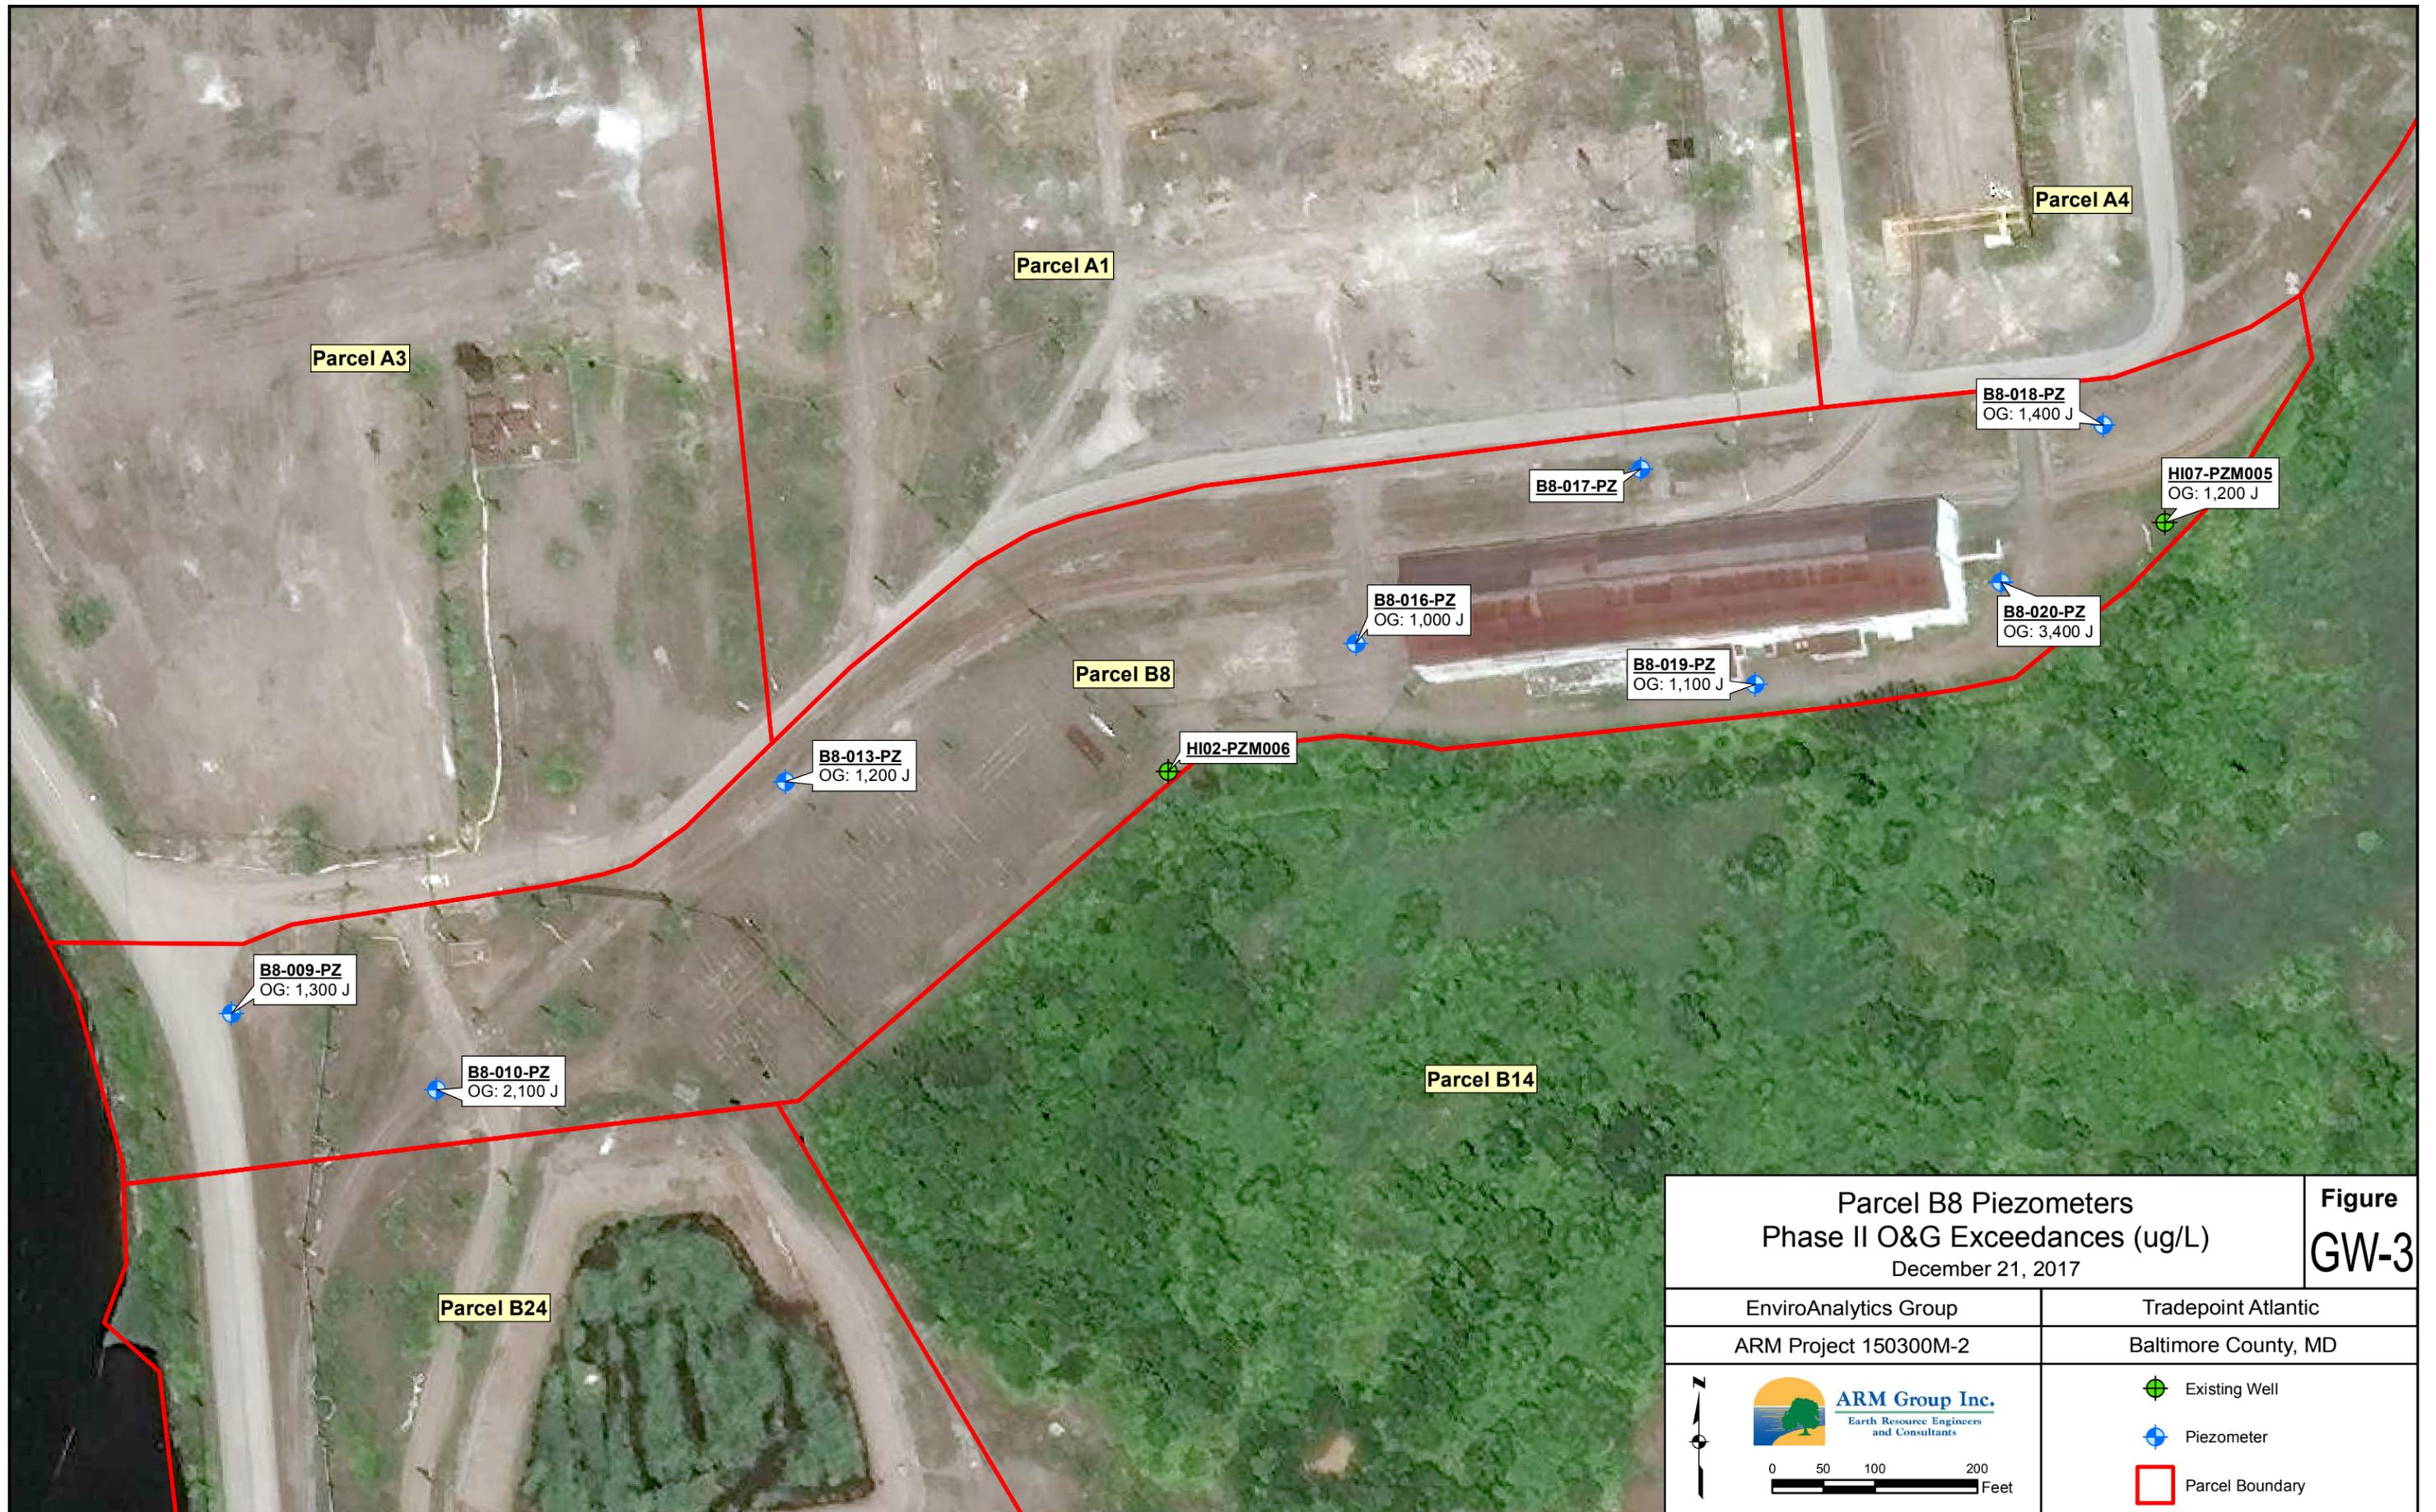
Parcel B8 Piezometers Phase II O&G Exceedances (ug/L) December 21, 2017		Figure GW-3
EnviroAnalytics Group	Tradepoint Atlantic	
ARM Project 150300M-2	Baltimore County, MD

Table 12 provides a summary of the Oil & Grease groundwater detections. There were detections of Oil & Grease in eight of the 10 samples, and all eight of the detections exceeded the applicable PAL (47 µg/L). The highest detection of Oil & Grease was 3,400 µg/L at B8-020-PZ, with the result flagged with a “J” qualifier. This groundwater sample location was impacted by measureable LNAPL (discussed below). The product present at this groundwater location influences and invalidates the Oil & Grease detection (as well as other parameters) at B8-020-PZ. The observed LNAPL has been delineated around B8-020-PZ, as discussed in other sections of this Phase II Investigation Report. Aside from the Oil & Grease exceedance in B8-020-PZ, the next highest detection of Oil & Grease in groundwater was at sample location B8-010-PZ (2,100 µg/L). All of the Oil & Grease detections were flagged with the “J” qualifier, indicating that they are estimated values. A summary of Oil & Grease PAL exceedance locations has been provided as **Figure GW-3**.
