PHASE II INVESTIGATION REPORT

AREA B: PARCEL B8
TRADEPOINT ATLANTIC
SPARROWS POINT, MARYLAND

ARM Project No. 150300M-2

Revision 1 – March 16, 2018

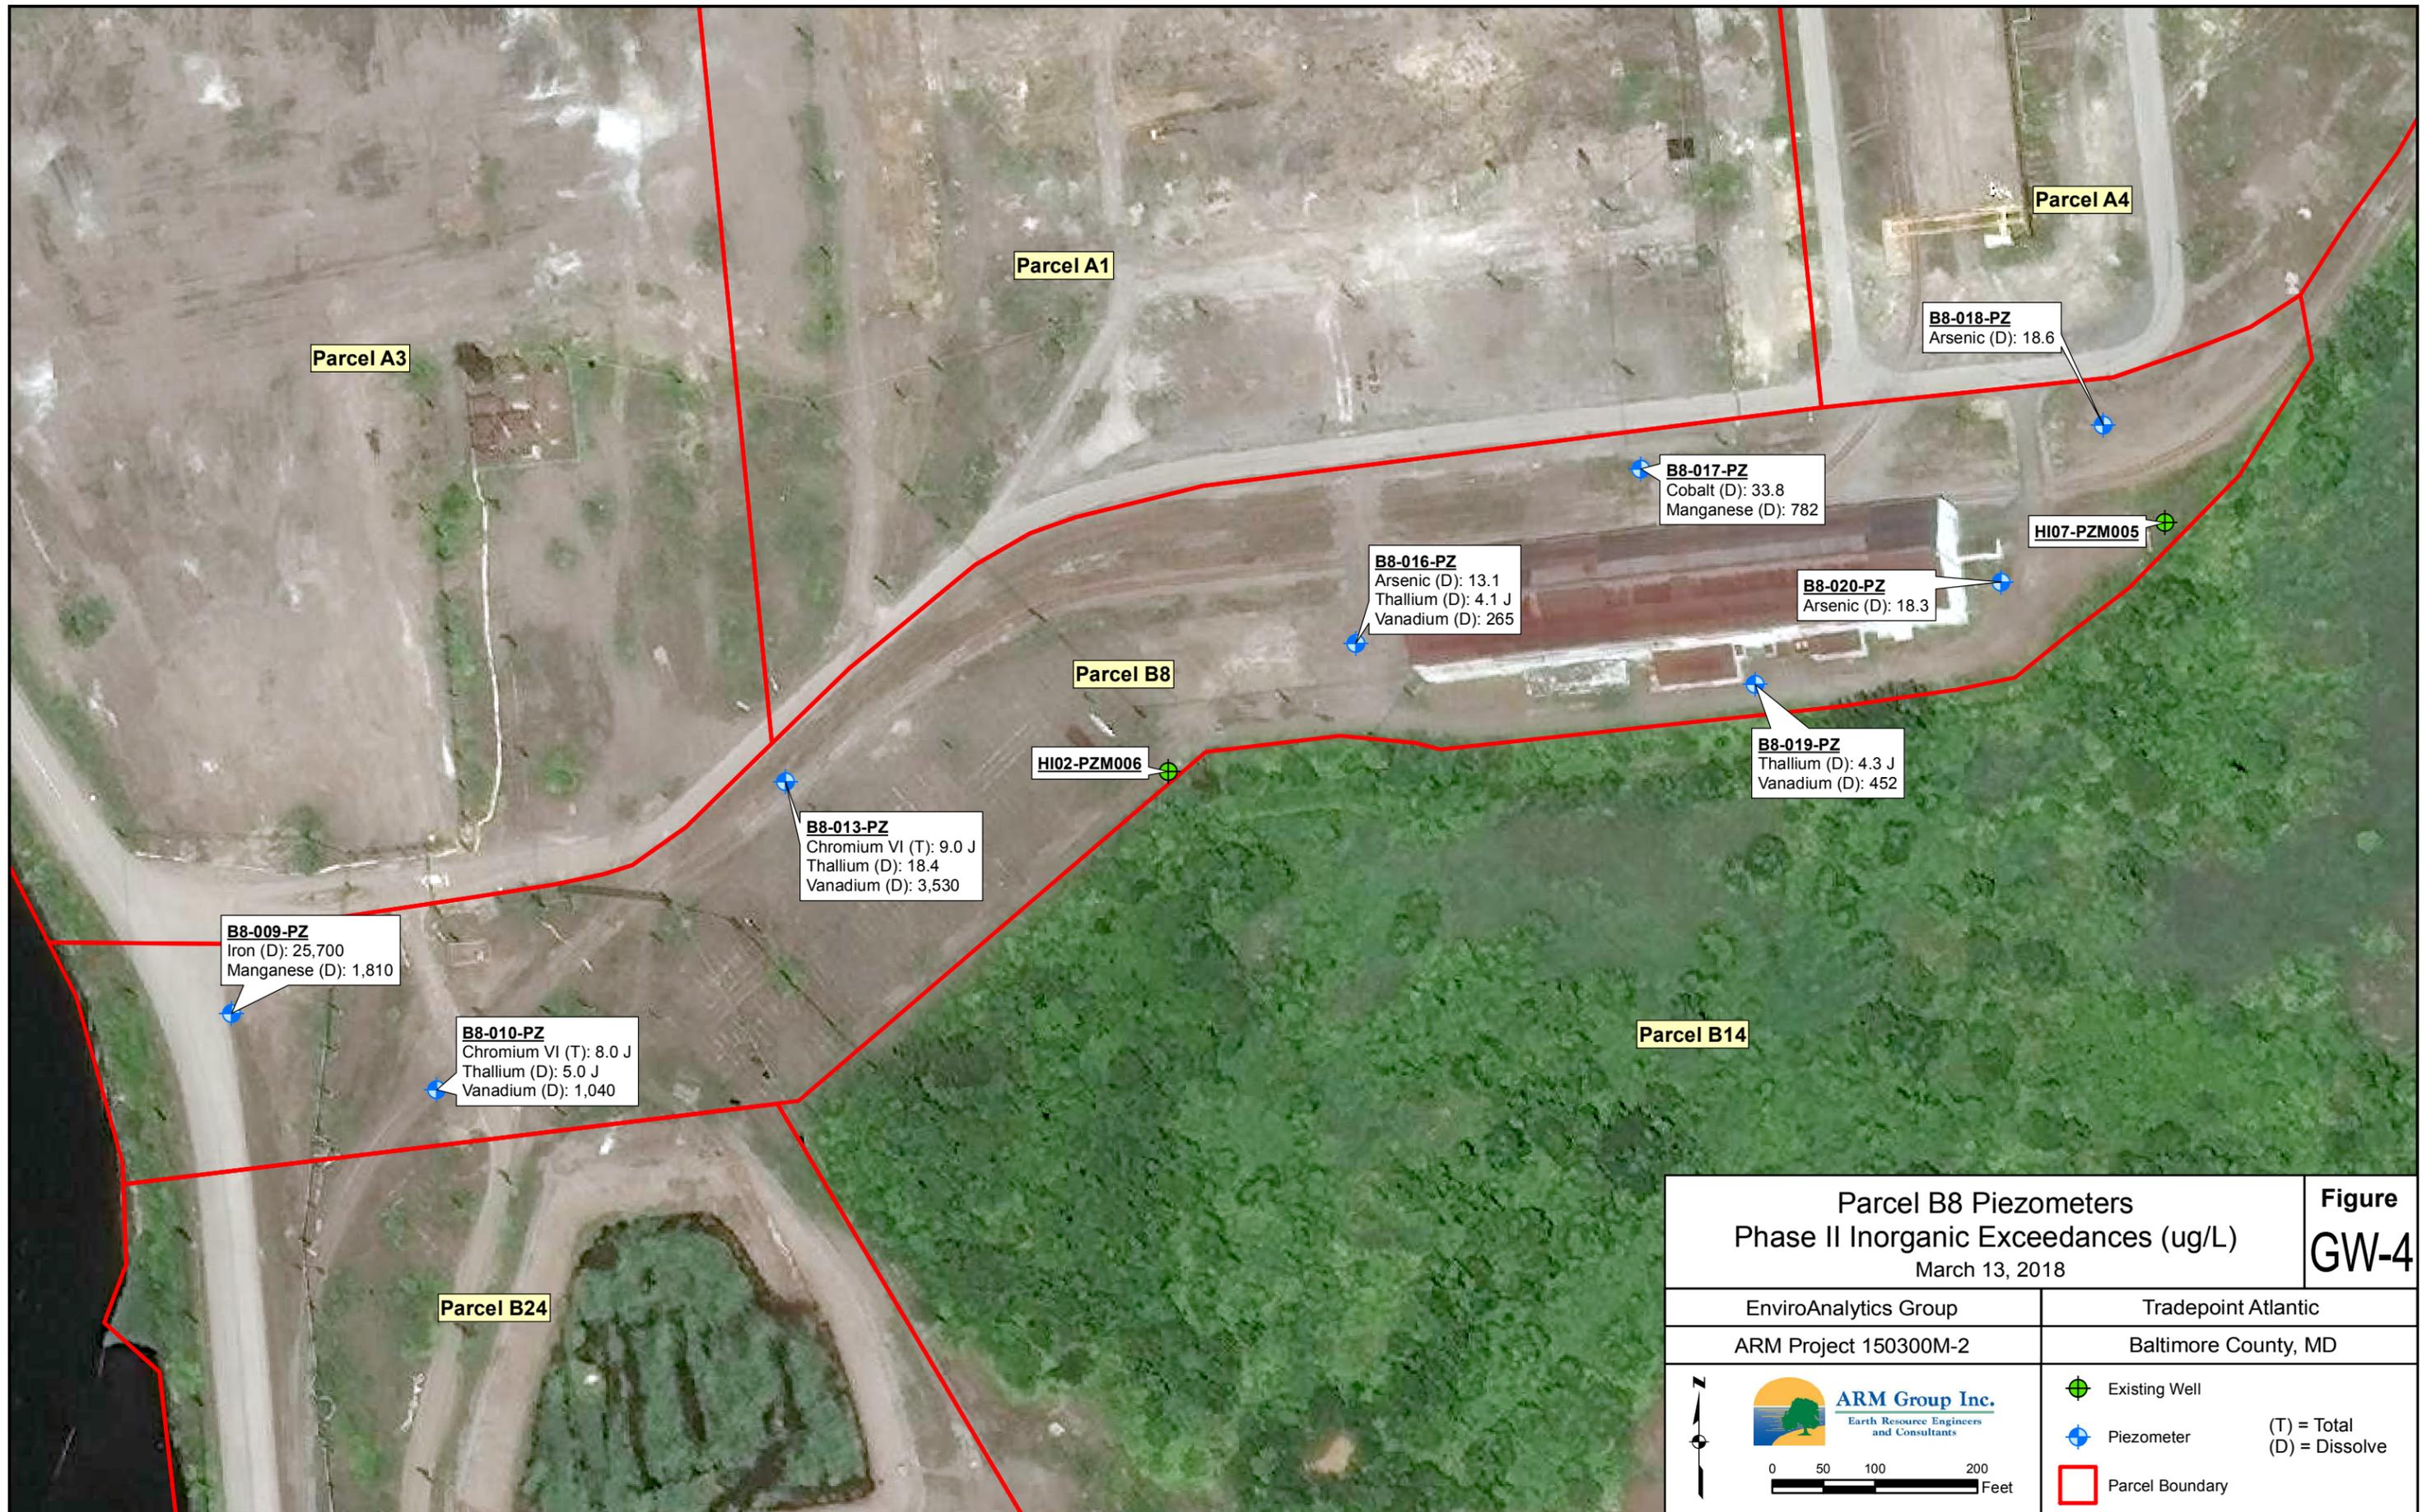
Parcel B8 Piezometers Phase II Inorganic Exceedances (ug/L) March 13, 2018		Figure GW-4
EnviroAnalytics Group ARM Project 150300M-2	Tradepoint Atlantic Baltimore County, MD

Analysis of the groundwater samples identified concentrations of seven inorganic compounds that exceeded their PALs (arsenic, cobalt, hexavalent chromium, iron, manganese, thallium, and vanadium). Thallium and vanadium were the most widespread exceedances, with four PAL exceedances each. Two hexavalent chromium exceedances were noted; however, these results were both flagged with the “J” qualifier as estimated values below the laboratory quantitation limit. The only VOC compounds to exceed their respective PALs were benzene and chloroform detected at relatively low concentrations in one sample each (HI07-PZM005 and B8-019-PZ, respectively). A total of eight SVOCs (1,1-biphenyl, benz[a]anthracene, benzo[a]pyrene, benzo[b]fluoranthene, dibenz[a,h]anthracene, indeno[1,2,3-c,d]pyrene, naphthalene, and pentachlorophenol) were detected at concentrations above the aqueous PALs. B8-013-PZ appeared to be the location which was most heavily impacted by SVOC contamination, despite LNAPL detections in B8-018-PZ and B8-020-PZ.

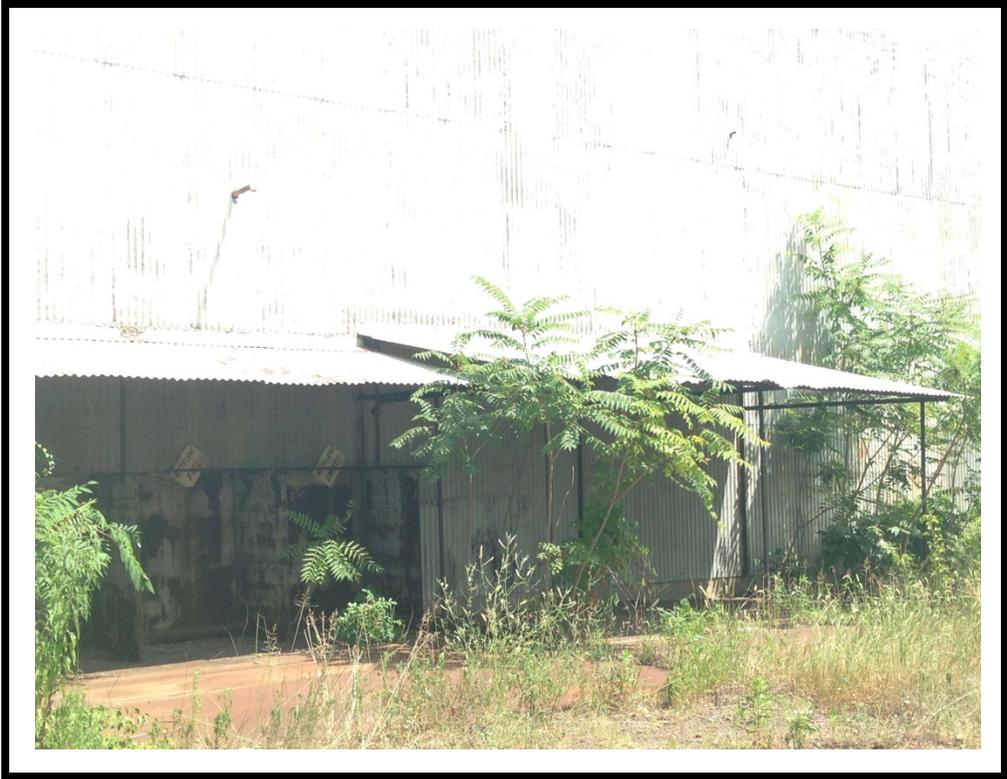
Photo 7: View of acetylene storage area along south wall, facing northeast

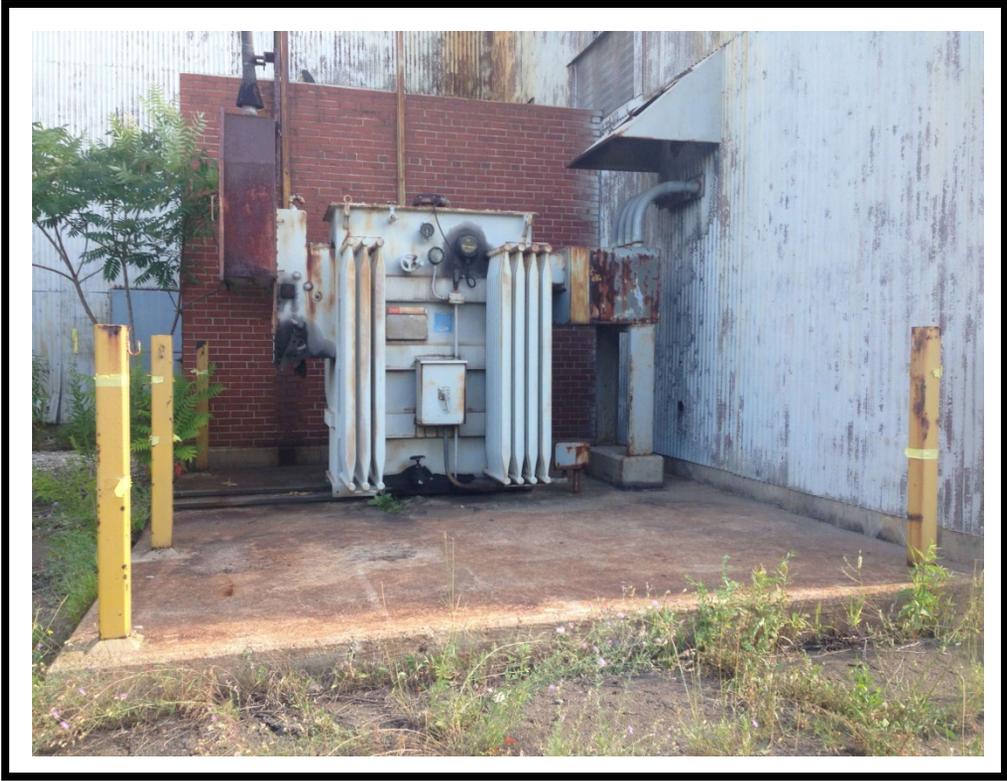
Photo 15: View of active grey transformer on south wall, facing north

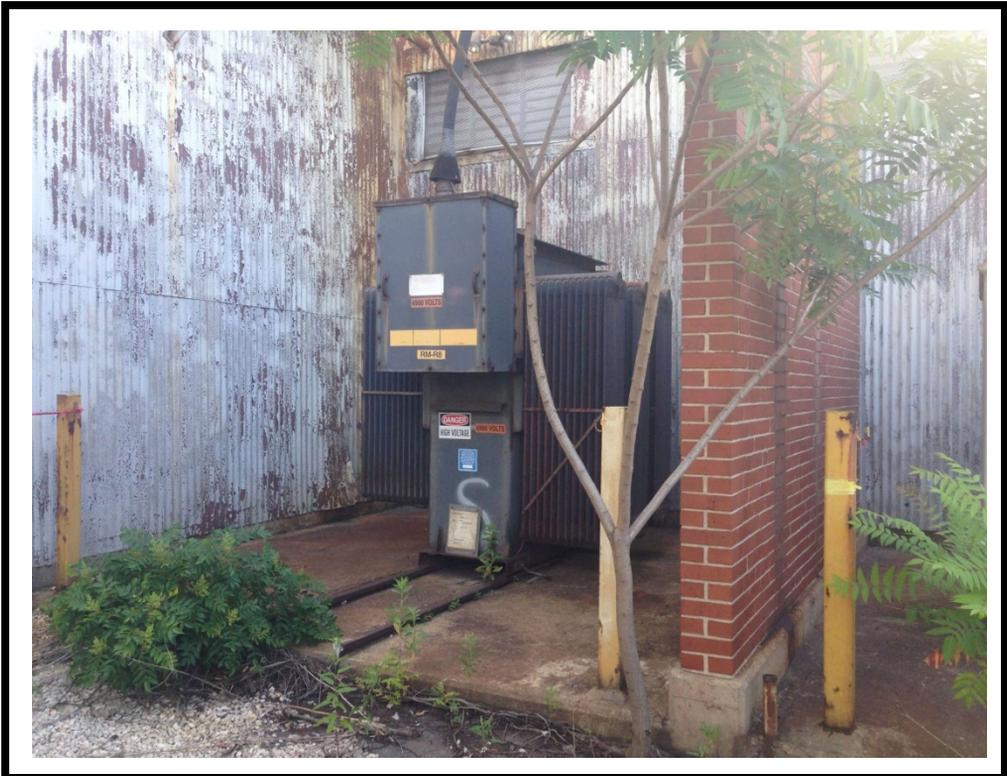
Photo 16: View of possibly active black transformer on south wall, facing east
