RESPONSE AND DEVELOPMENT COMPLETION REPORT

AREA B: SUB-PARCEL B6-2 *RETAIL AREA #1 – ROYAL FARMS* TRADEPOINT ATLANTIC SPARROWS POINT, MARYLAND

ARM Project No. 20010206

Revision 0 – October 18, 2021

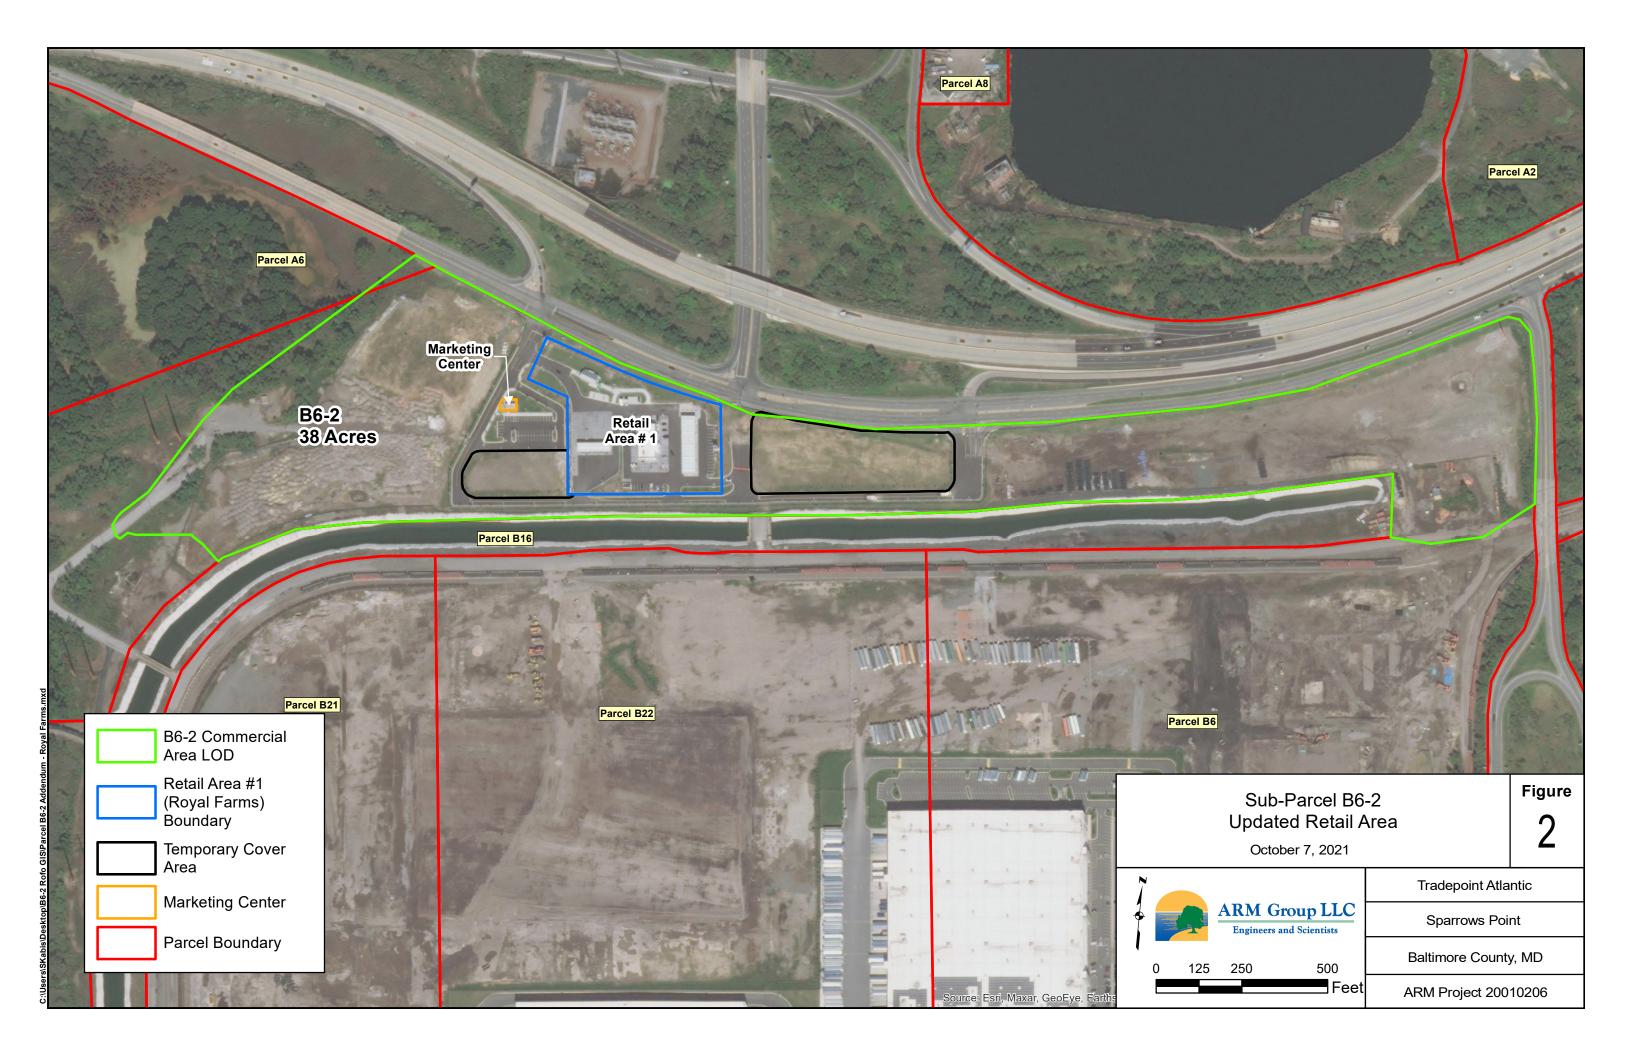
The Site represents approximately 3.8 acres and is located within the central portion of Sub-Parcel B6-2 and is north and east of the TMC, as indicated on **Figure 2**. Retail Area #1 is zoned Tier 2 (Commercial) and is currently occupied by a gas station (Royal Farms). It is located to the north of the former Hot Strip Mill Area and all former buildings have been demolished.

The response and development actions approved for protection of human health and the environment at the Site included piezometer abandonments and environmental capping. The placement of slag aggregate beneath the parking areas requires the entire sub-parcel to be subject to an environmental capping requirement. In addition, two areas, per the Request for Modifications to Response and Development Work Plan Addendum (Revision 2) Royal Farms Station – Retail Area #1 Area B: Sub-Parcel B6-2, have a temporary cap with one foot of clean fill installed. The additional temporary cover areas are shown on **Figure 2** and **Figure 3**.

This section presents a summary of the completed development work as well as materials management and other protocols that were followed during the development work performed under the Sub-Parcel B6-2 RADWP Addendum for Retail Area #1 to adequately mitigate potential risks for future uses of the property. The development area is shown in **Figure 2** and **Figure 3**.

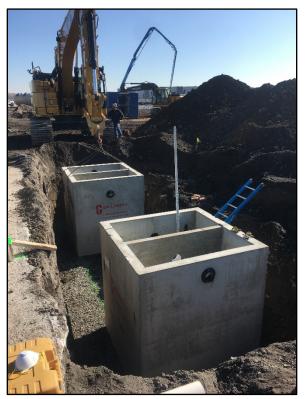
Photo 1: General excavation activities

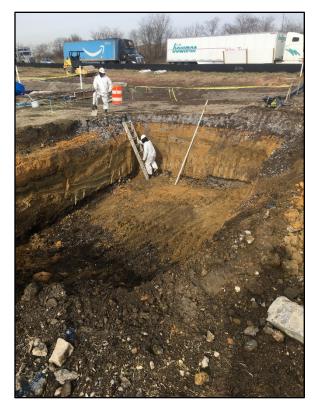
Photo 2: General excavation activities with PPE practices visible

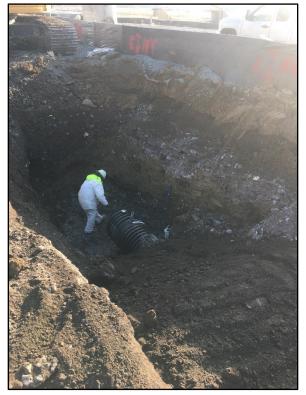
Photo 3: Utility excavation activities

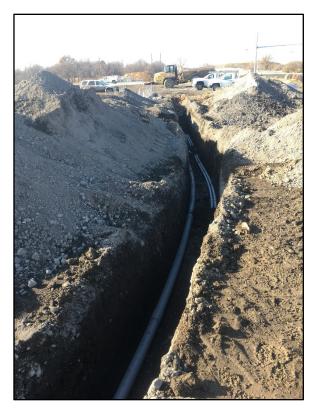
Photo 4: Utility installation

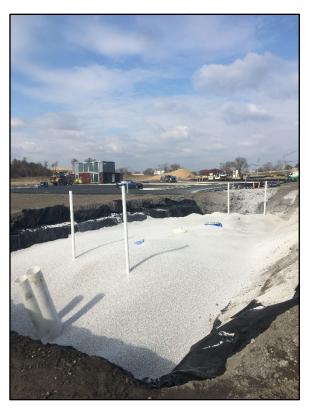
Photo 6: UST excavation backfilling

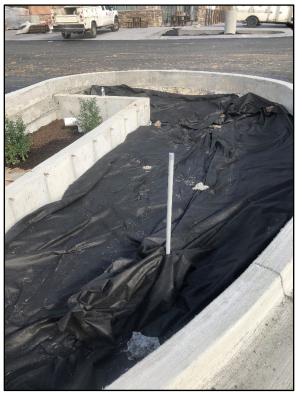
Photo 7: Placement of marker fabric

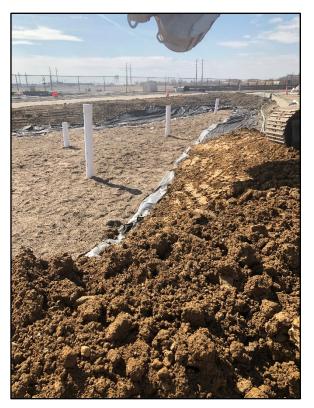
Photo 8: Placement of marker fabric and clean fill

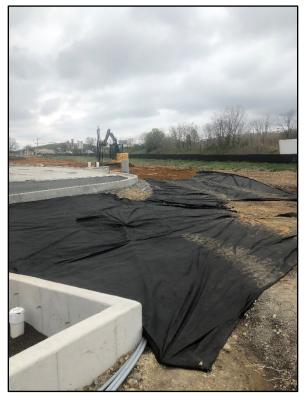
Photo 9: Placement of marker fabric and clean fill

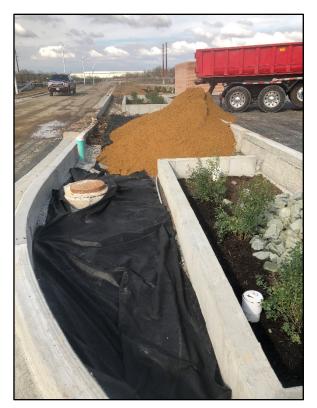
Photo 10: Placement of marker fabric and clean fill
