PHASE II INVESTIGATION REPORT

COKE POINT CONTAINER TERMINAL
AREA B: PARCELS B10, B11, B12, and B18
TRADEPOINT ATLANTIC
SPARROWS POINT, MARYLAND

Revision 0 – January 18, 2024

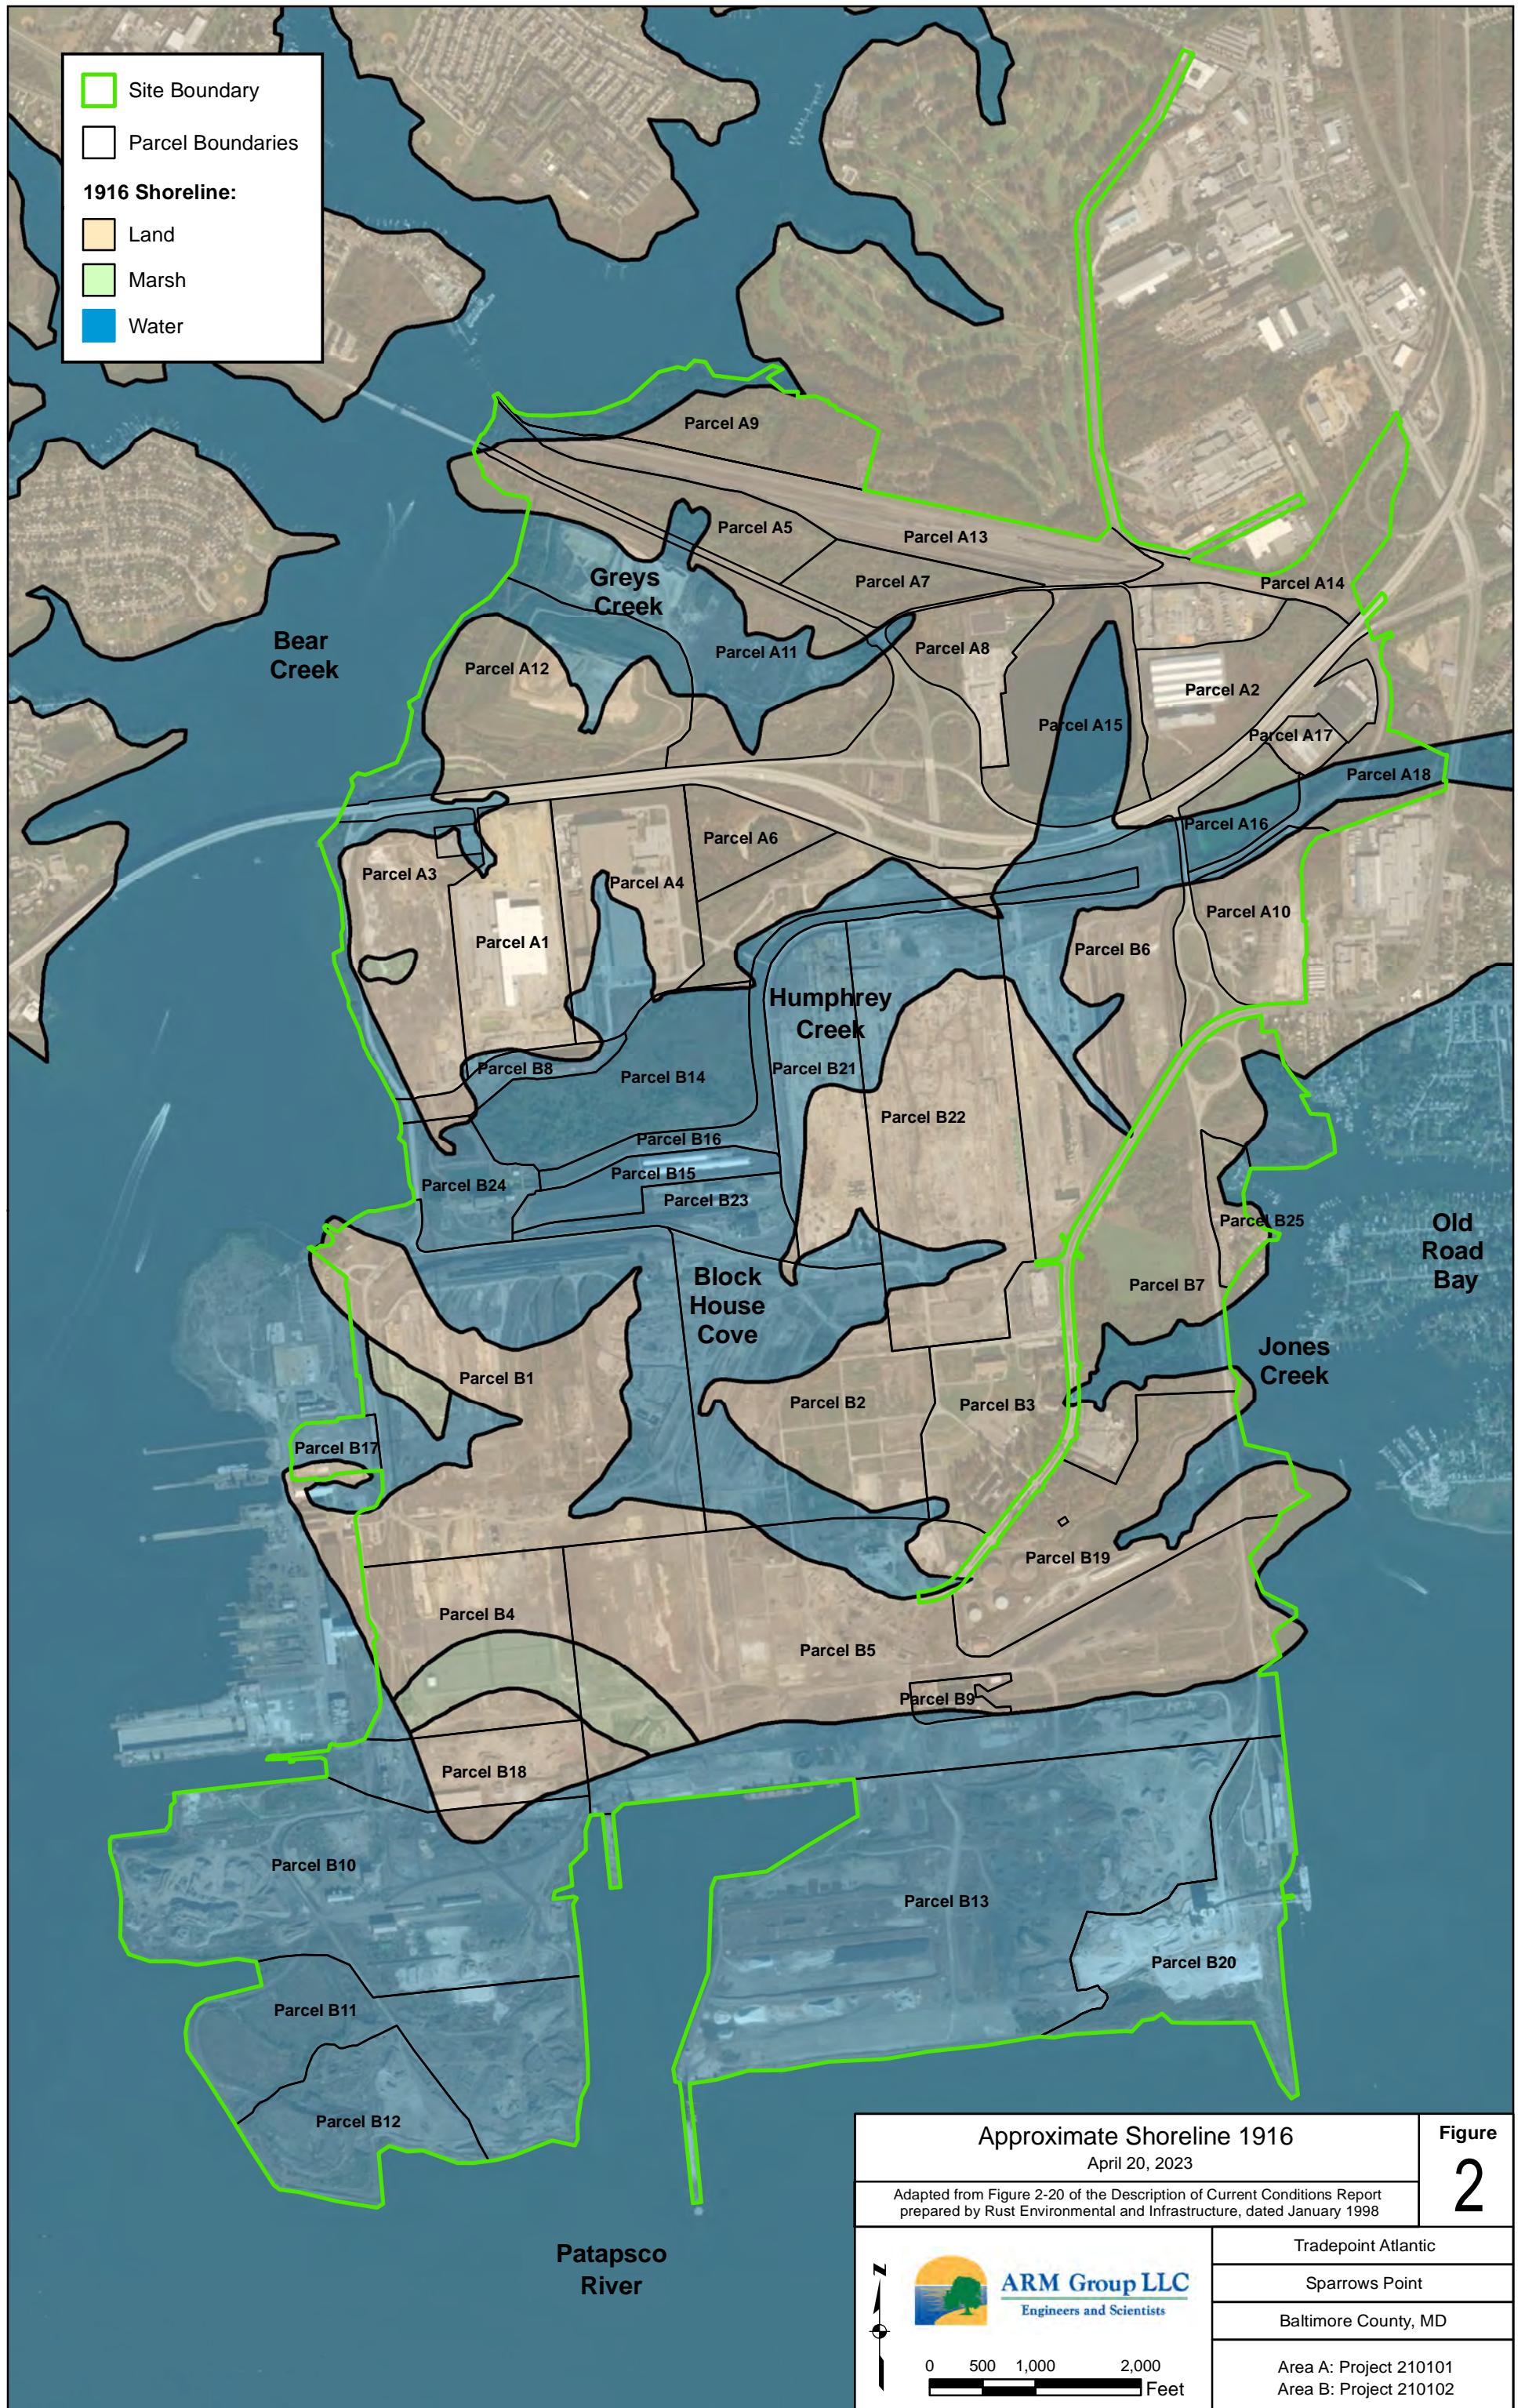
Groundcover at the Site is comprised of approximately 94% non-native fill materials (i.e., slag) based on the approximate shoreline of the Sparrows Point Peninsula in 1916, as shown on **Figure 2** (adapted from Figure 2-20 on the Description of Current Conditions (DCC) Report prepared by Rust Environment and Infrastructure, dated January 1998).

The approximate shoreline of the Sparrows Point Peninsula in 1916 is shown in **Figure 2** (adapted from Figure 2-20 in the DCC Report prepared by Rust Environment and Infrastructure dated January 1998). In general, the encountered subsurface geology was comprised of non-native fill materials including slag, concrete, wood, sand, and gravel, as well as natural soils including fine-grained sediments (clays and silts) and coarse-grained sediments (sands). Shallow groundwater was observed in soil borings at varying depths ranging from approximately 5 to 16 feet below ground surface (bgs) across the Site. Soil boring observation logs are provided in **Appendix B**.

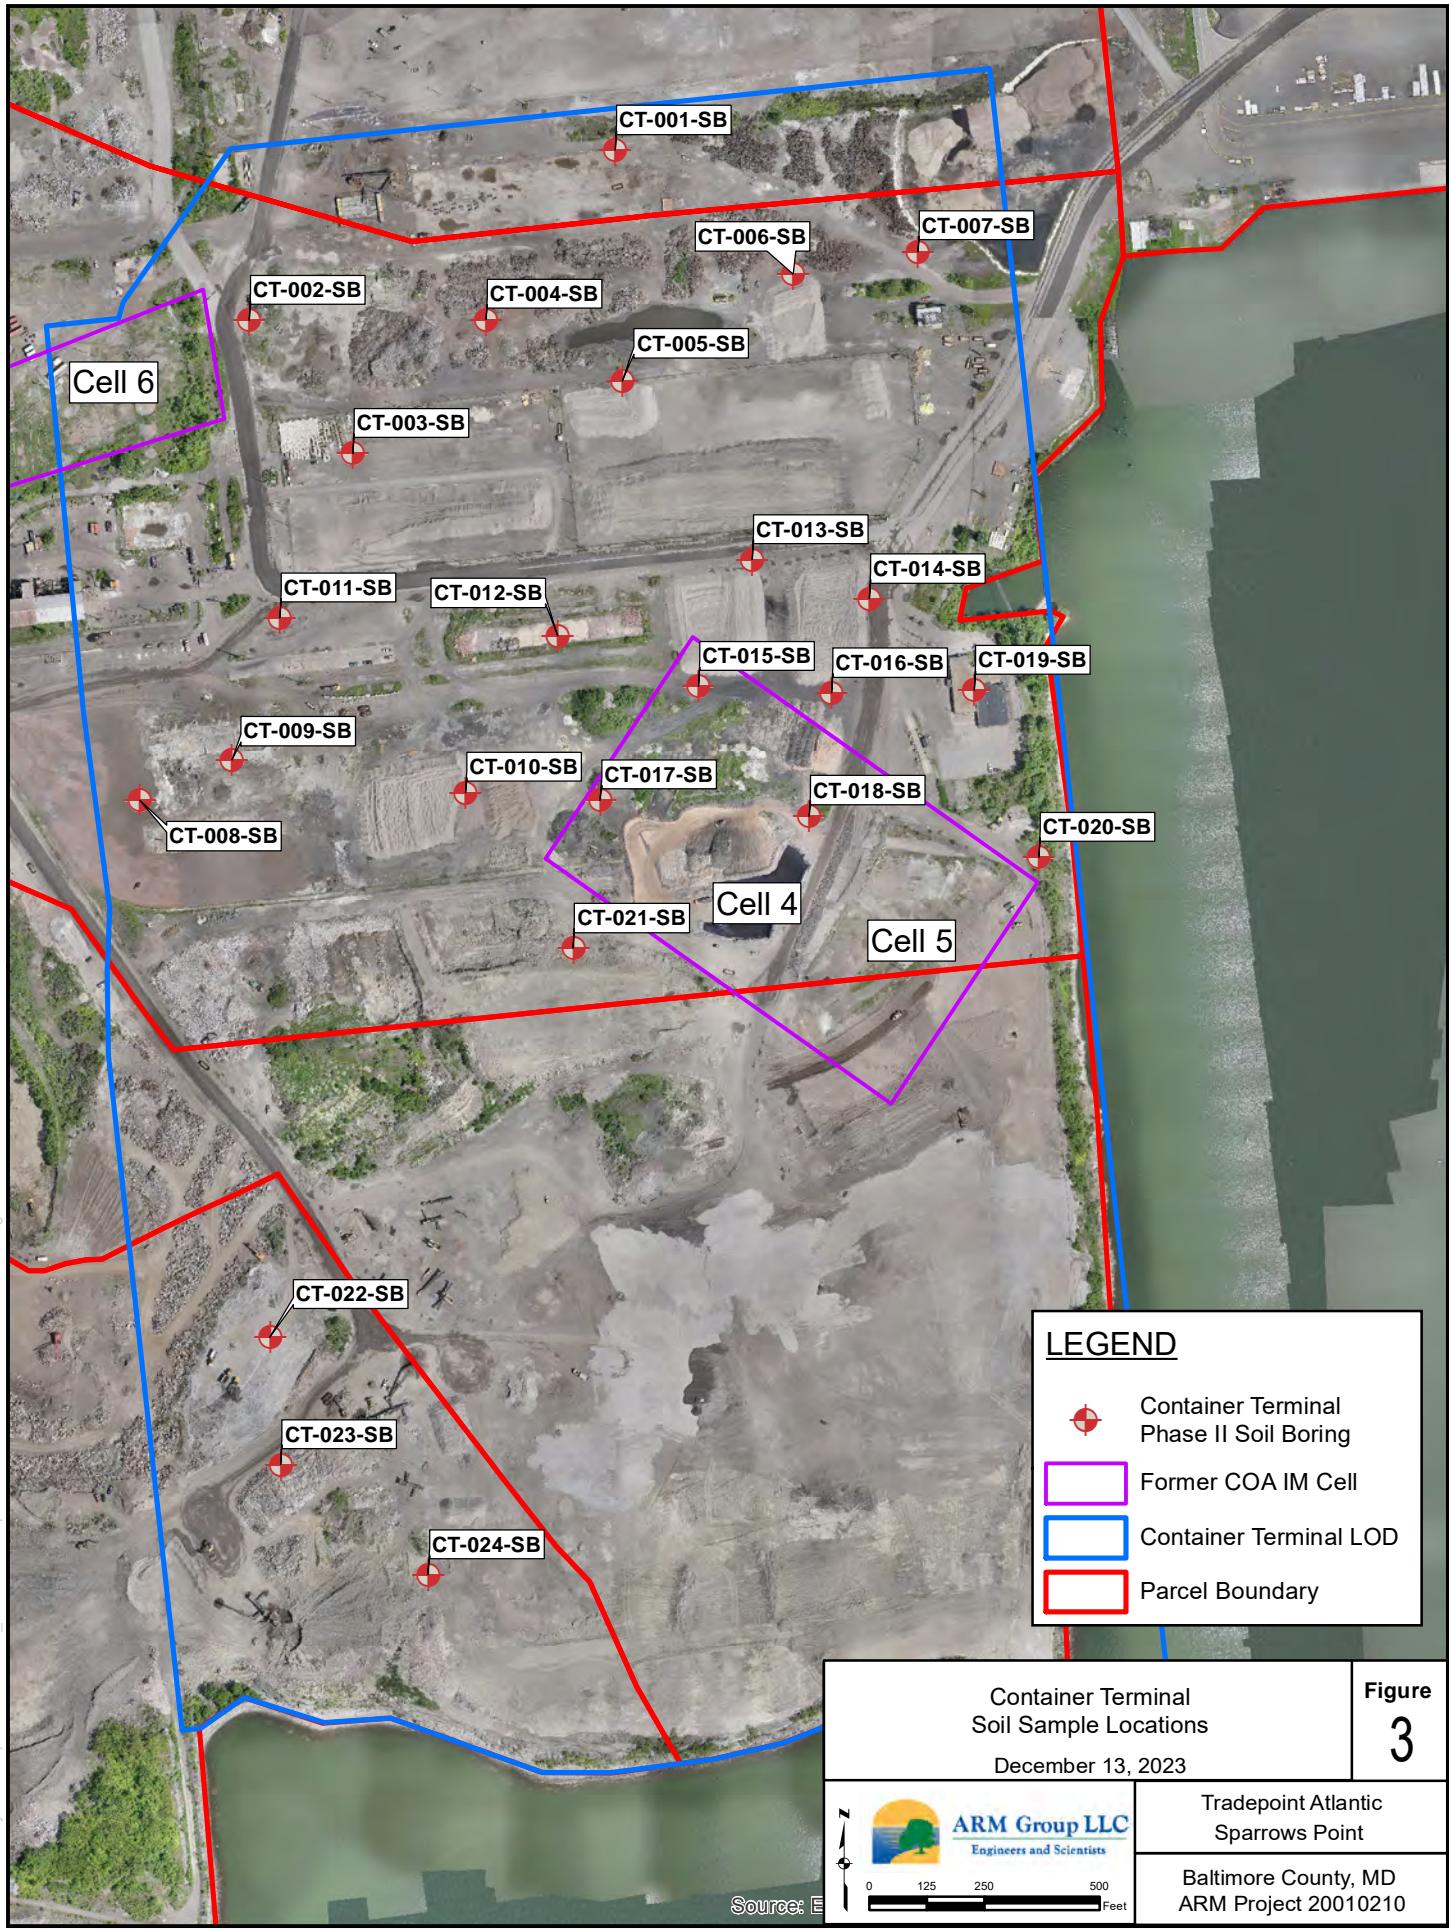
Continuous core soil borings were advanced at 24 locations across the Site to assess the presence or absence of soil contamination, and to assess the vertical distribution of any encountered contamination (**Figure 3**). The 24 soil borings were advanced using a sonic rig to a maximum depth of 20 feet bgs, or to 5 feet deeper than observed groundwater, whichever was first. At each of the 24 boring locations, the soil core was visually inspected and screened with a hand-held photoionization detector (PID) prior to logging soil types. Soil boring logs have been included as **Appendix B**, and the PID calibration log has been included as **Appendix D**.

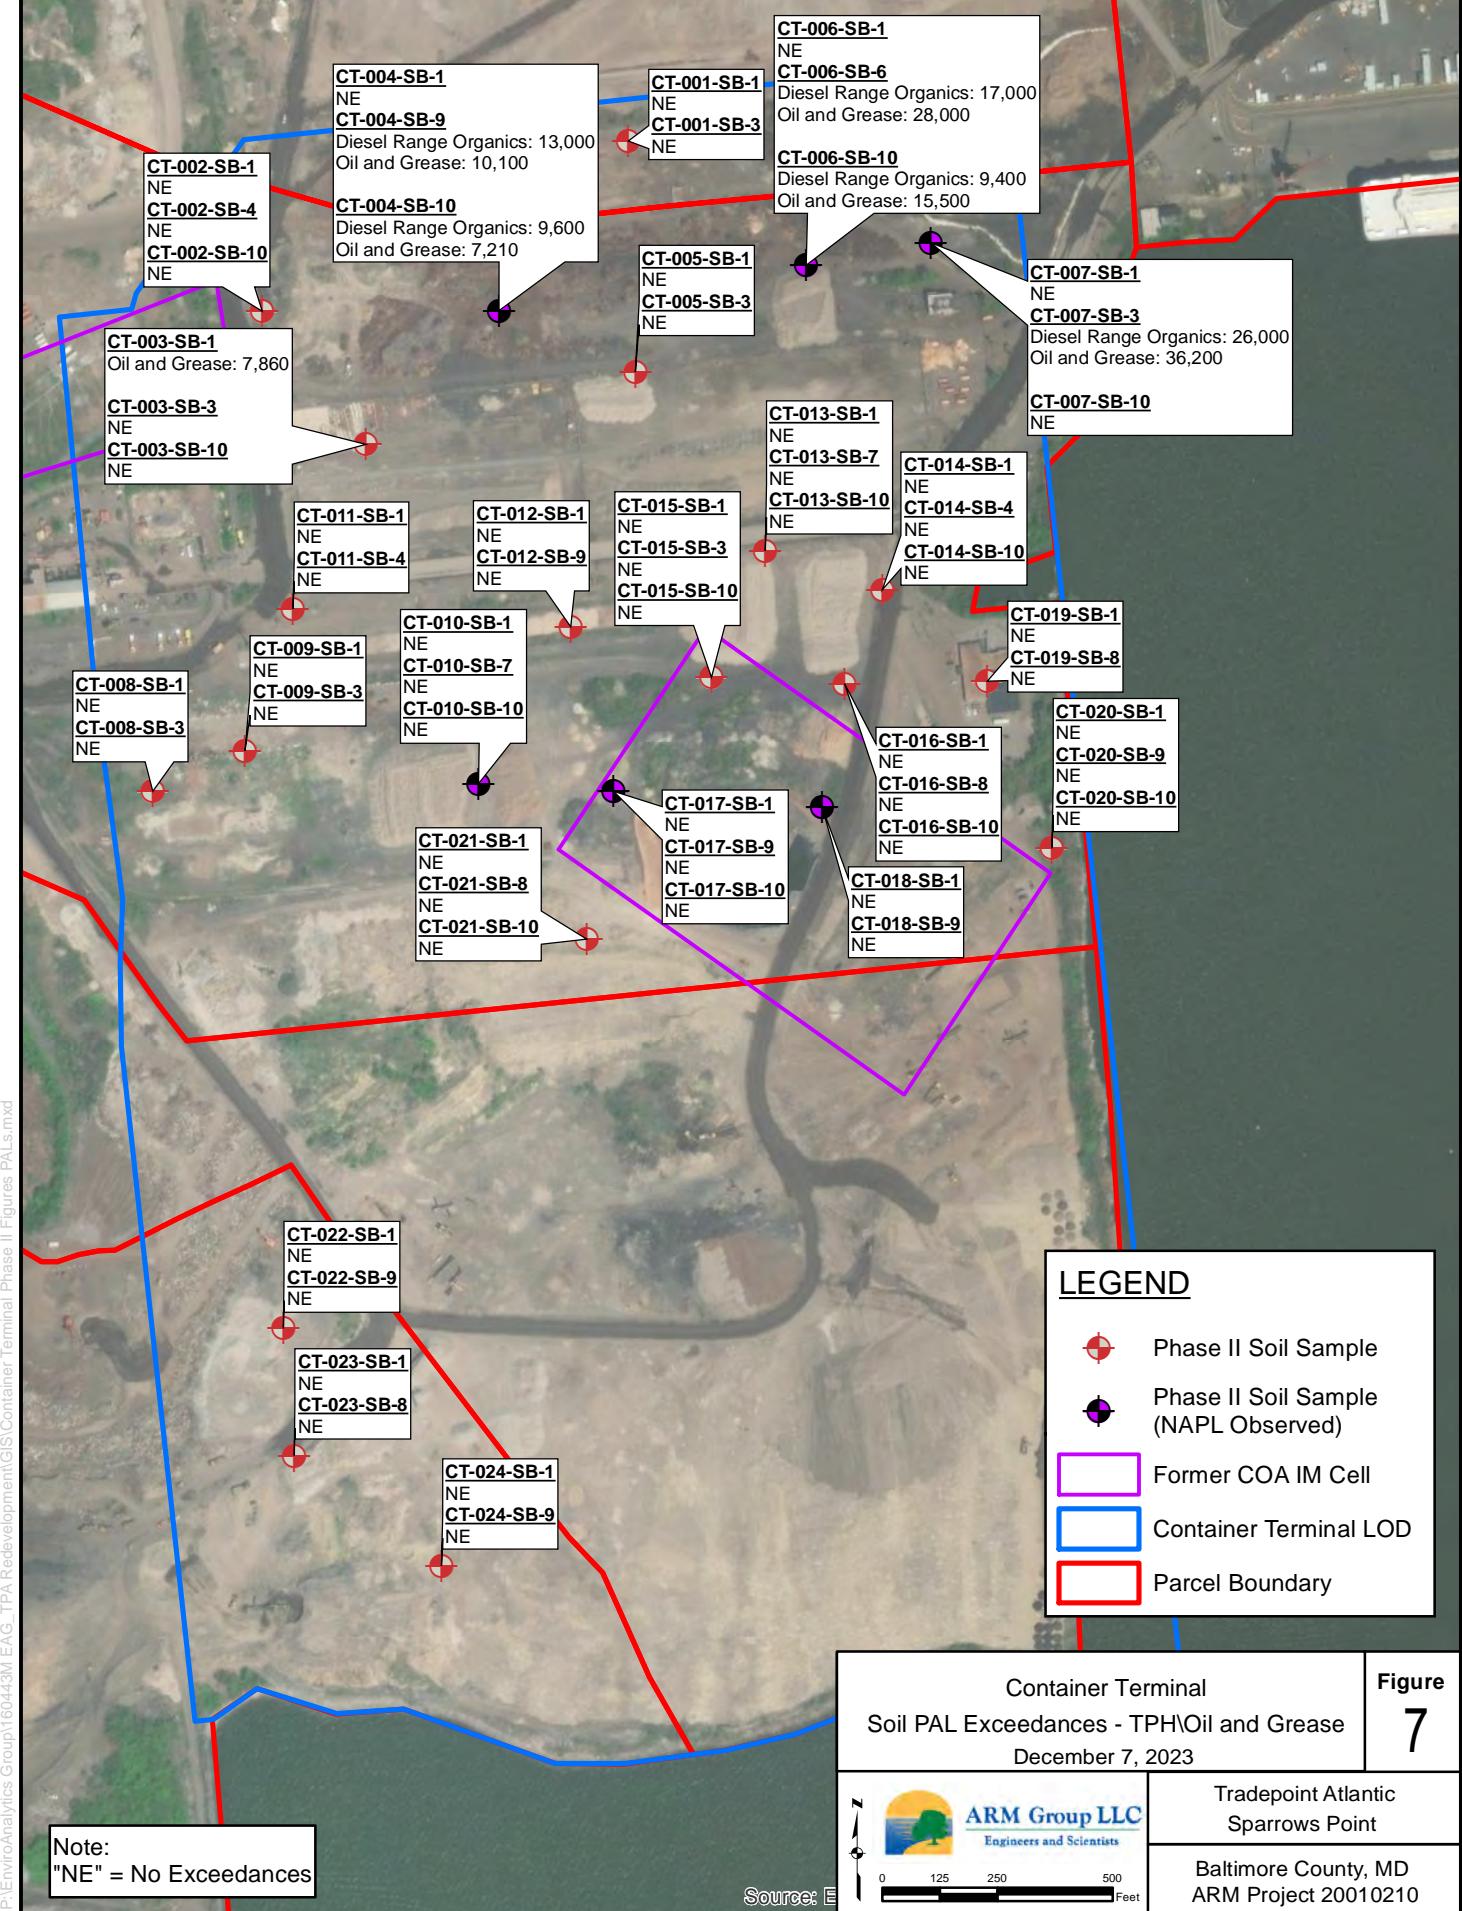
Table 3 provides a summary of the TPH/Oil & Grease detections above the laboratory's RLs in the soil samples collected from across the Site. There were no PAL exceedances of TPH-GRO, however multiple samples showed TPH-DRO and Oil & Grease exceedances. The maximum concentrations for both TPH-DRO (26,000 mg/kg) and Oil & Grease (36,200 mg/kg) were both observed at CT-007-SB-3. The TPH/Oil & Grease PAL exceedances are shown on **Figure 7**.

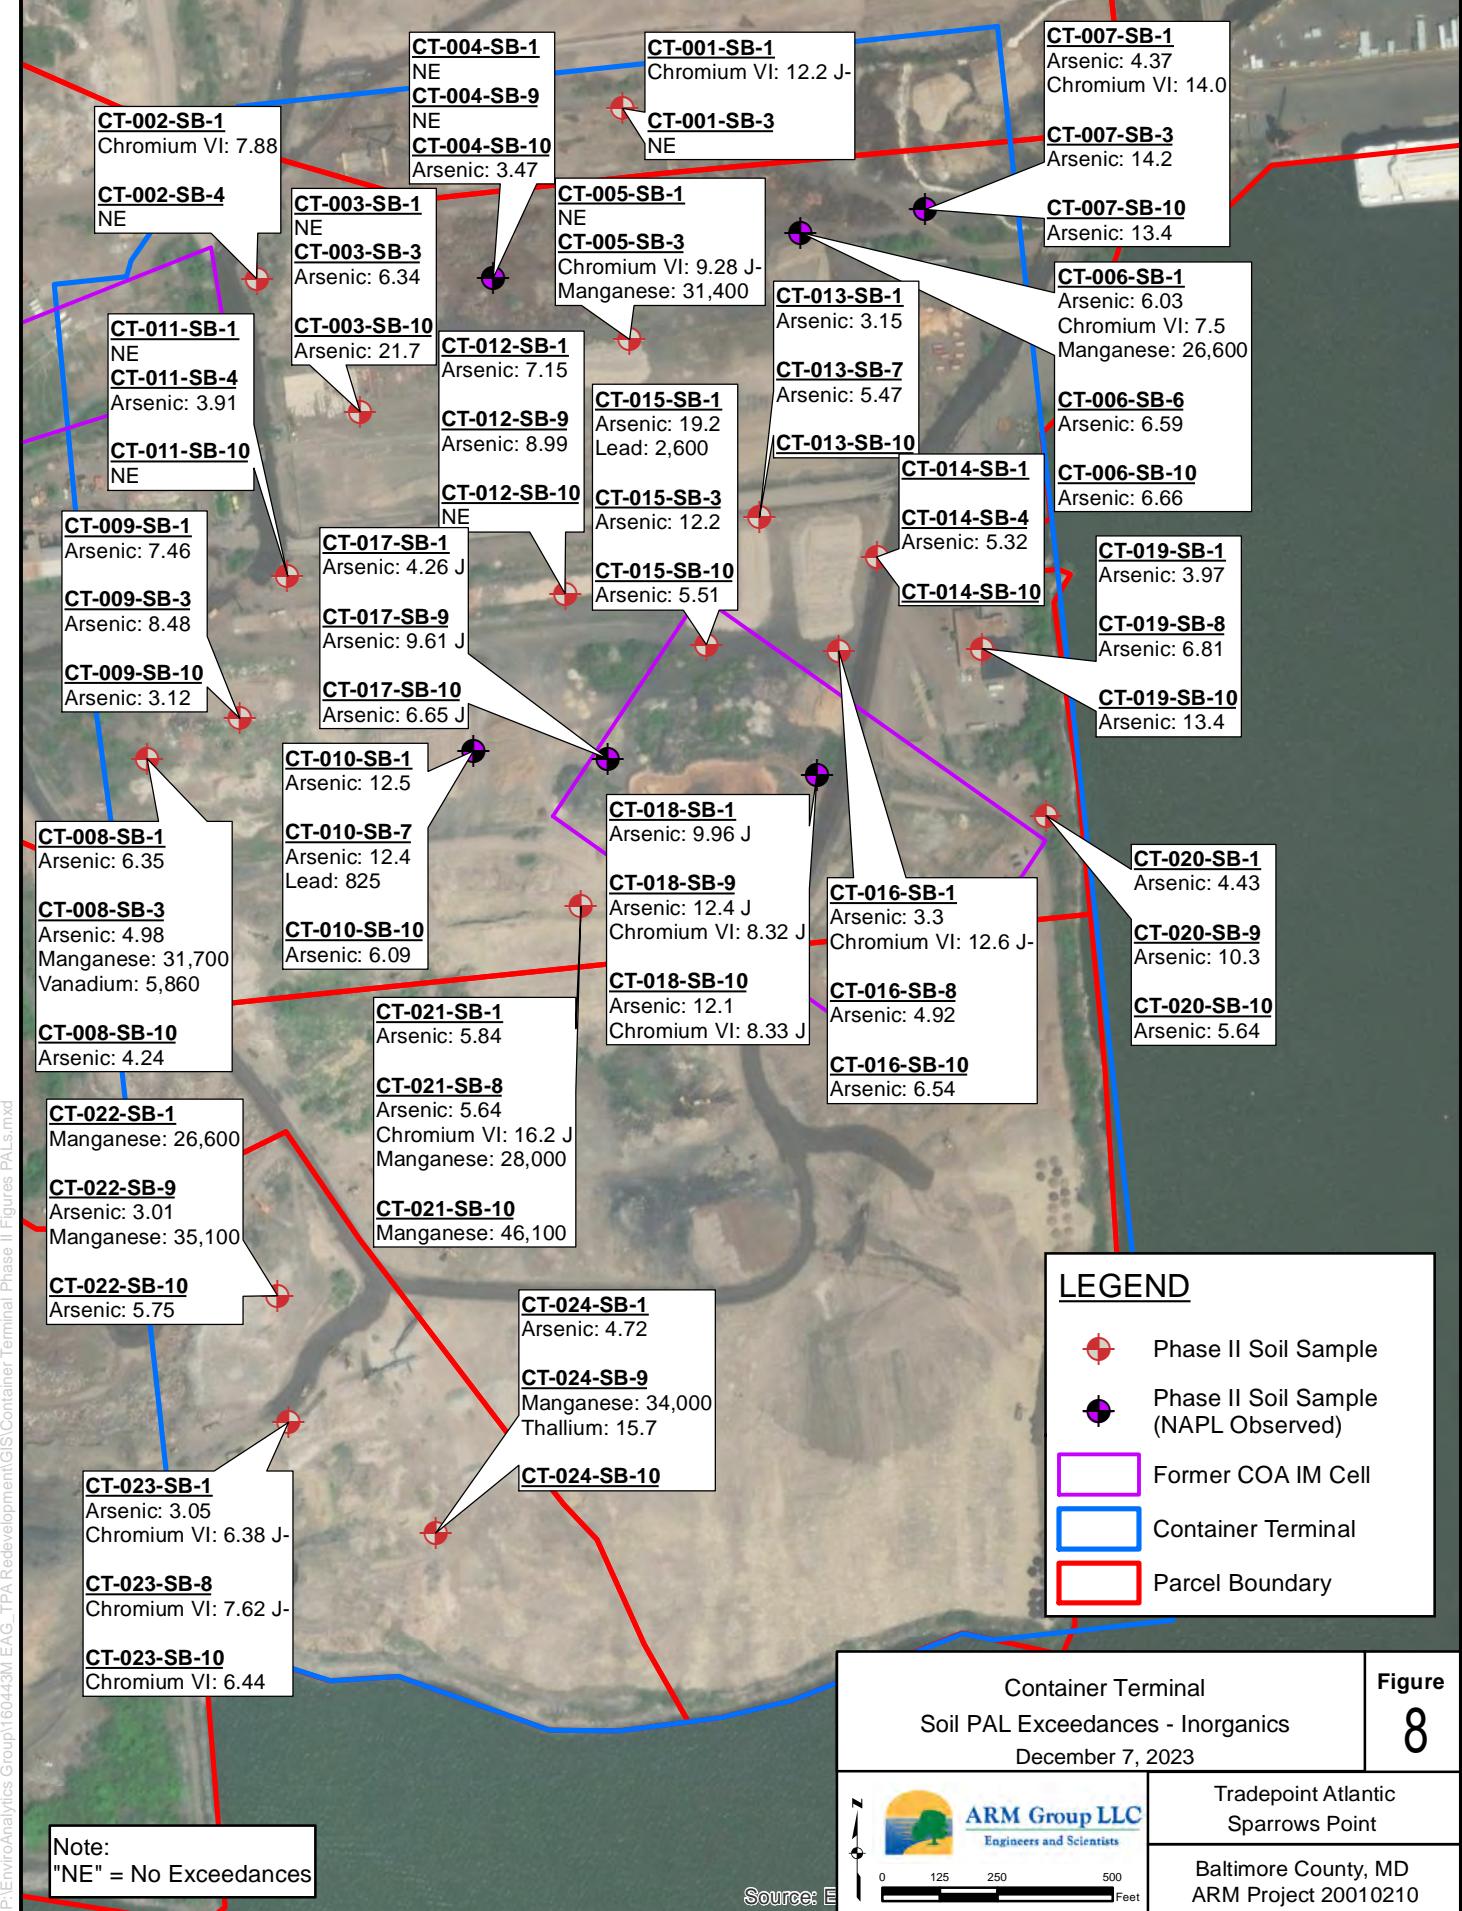
Table 4 provides a summary of inorganic constituents detected above the laboratory's RLs in the soil samples collected from across the Site. Six inorganic constituents (arsenic, hexavalent chromium, lead, manganese, thallium, and vanadium) were detected above their respective PALs. Arsenic was detected above (or equal to) its PAL of 3 mg/kg in 48 of the 67 samples where it was analyzed, with a maximum detection of 21.7 mg/kg in CT-003-SB-10. The maximum detection of hexavalent chromium was observed at CT-021-SB-8, with a value of 16.2 mg/kg. The maximum detection of lead was observed at CT-015-SB-1, with a value of 2,600 mg/kg. The maximum detection of manganese was observed at CT-021-SB-10, with a value of 46,100 mg/kg. The maximum detection of thallium was observed at CT-024-SB-9, with a value of 15.7 mg/kg. The maximum detection of vanadium was observed at CT-008-SB-3, with a value of 5,860 mg/kg. The inorganic PAL exceedances are shown on **Figure 8**.

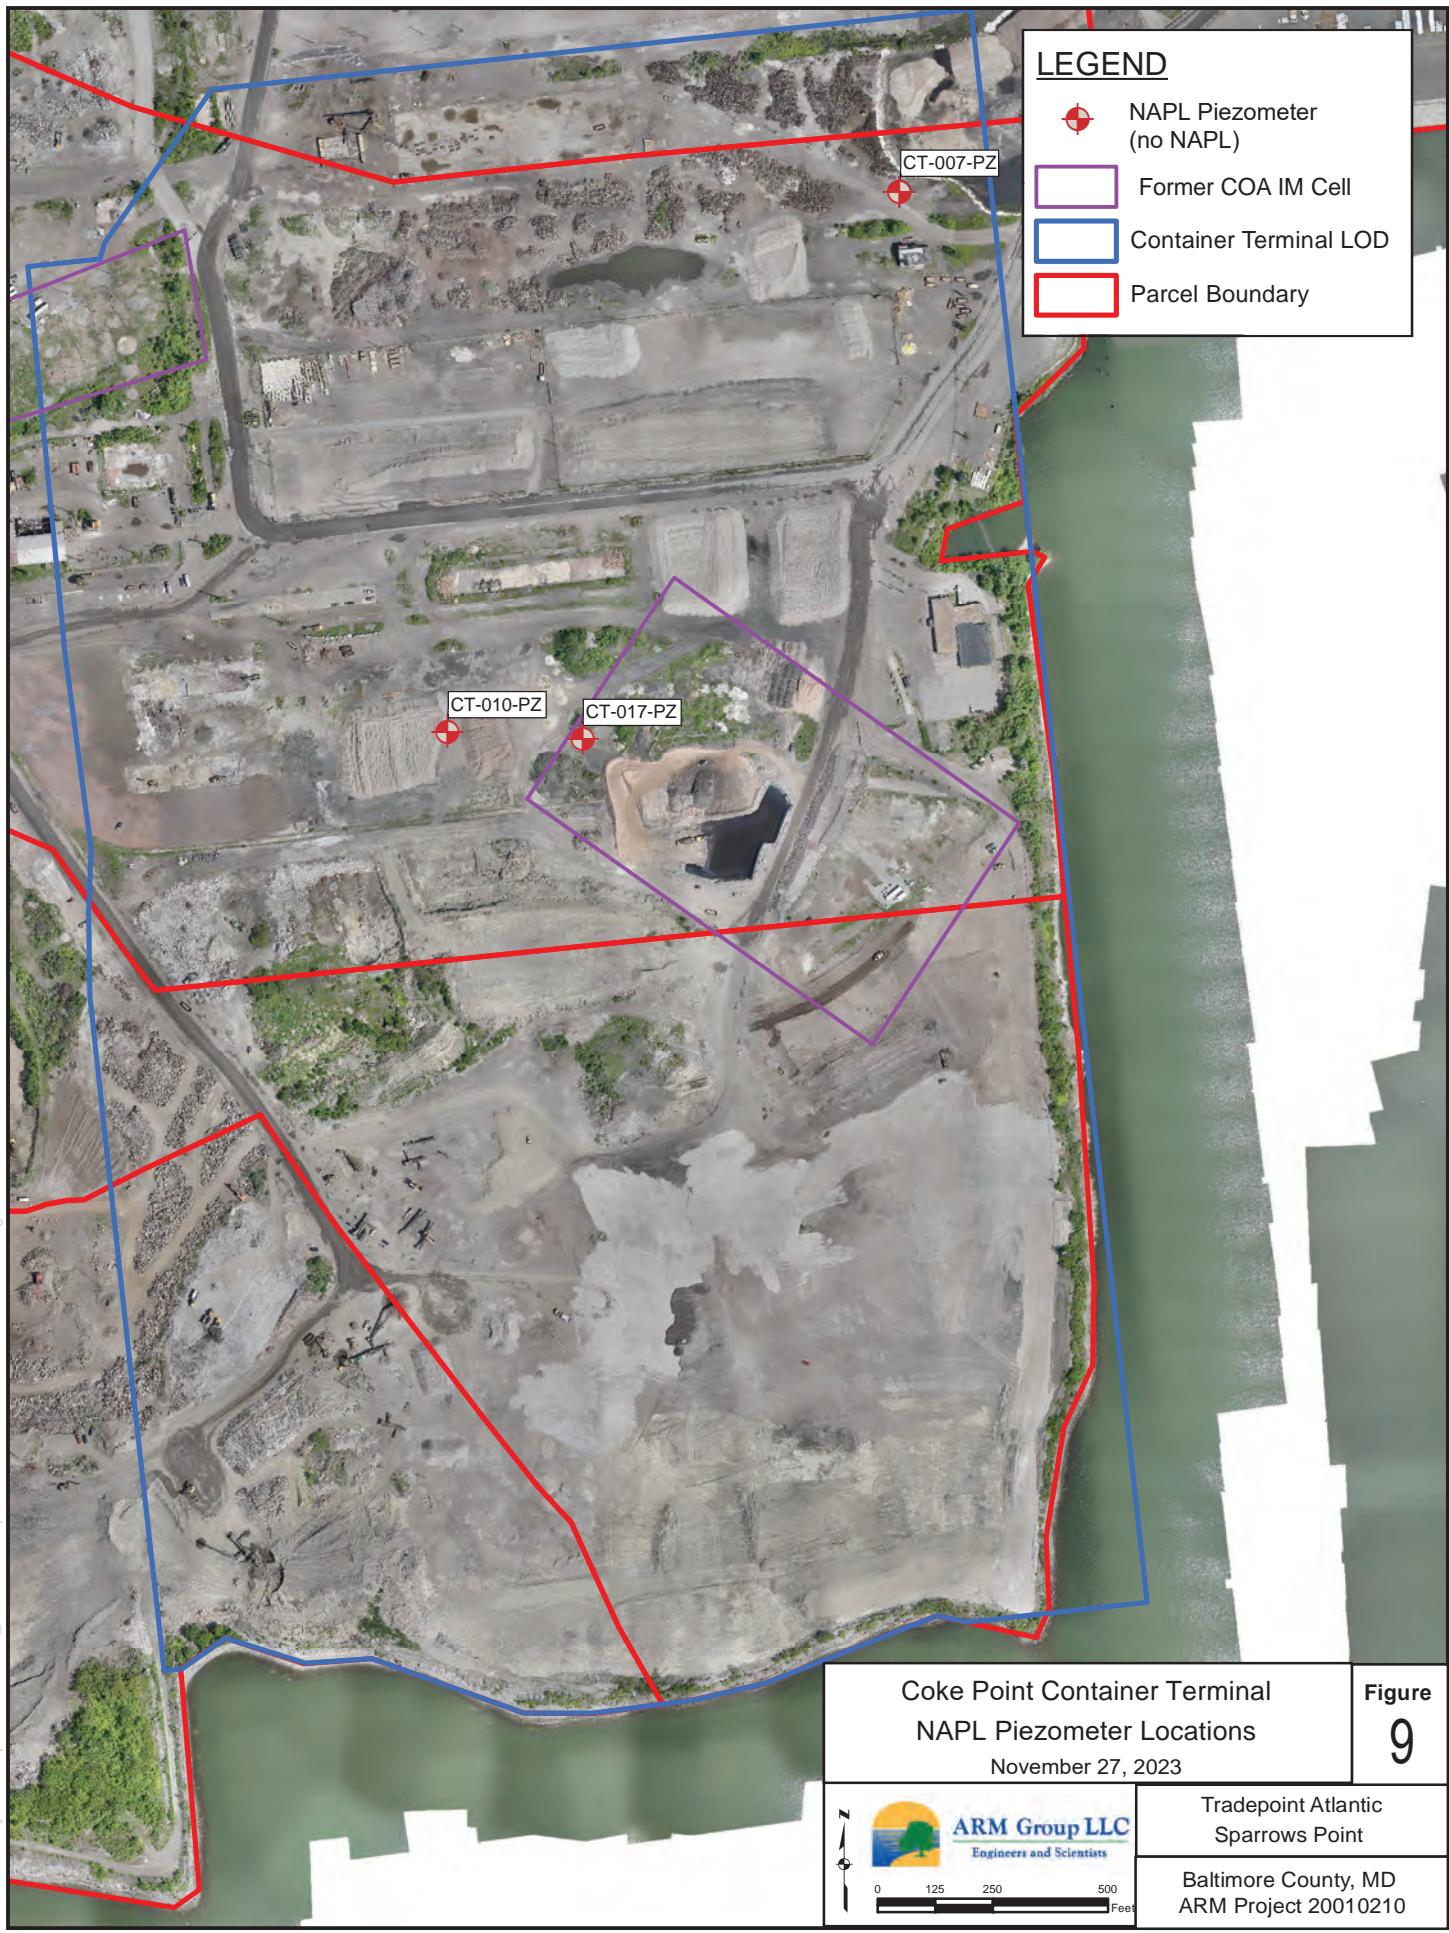
Physical evidence of non-aqueous phase liquid (NAPL) was observed in six soil cores (CT-004-SB, CT-006-SB, CT-007-SB, CT-010-SB, CT-017-SB, and CT-018-SB) completed during this investigation. On October 26, and October 27, 2023, three NAPL screening piezometers with screened intervals from 10 to 20 feet bgs were installed as CT-007-PZ, CT-010-PZ, and CT-017-PZ, as shown on **Figure 9**. Note that piezometers were not installed at CT-004-SB and CT-006-SB due to rig refusal, but were addressed subsequently via test pitting, which is discussed separately in a forthcoming report. Additionally, a piezometer was not installed at CT-018-SB because dense NAPL observed in the soil boring was likely associated with Cell 4. The three screening piezometers were then checked for the potential presence of NAPL using an oil-water interface probe. NAPL was not observed in any of the piezometers during the 0-hr, 48-hr, 7-day, or 30-day gauging events, and the piezometers were abandoned on November 30, 2023, with Agency approval. Additional NAPL delineation activities via test pitting are ongoing in the area and are summarized in separate reports.
