PHASE II INVESTIGATION REPORT

AREA A: PARCEL A15
TRADEPOINT ATLANTIC
SPARROWS POINT, MARYLAND

Revision 1 – August 28, 2023

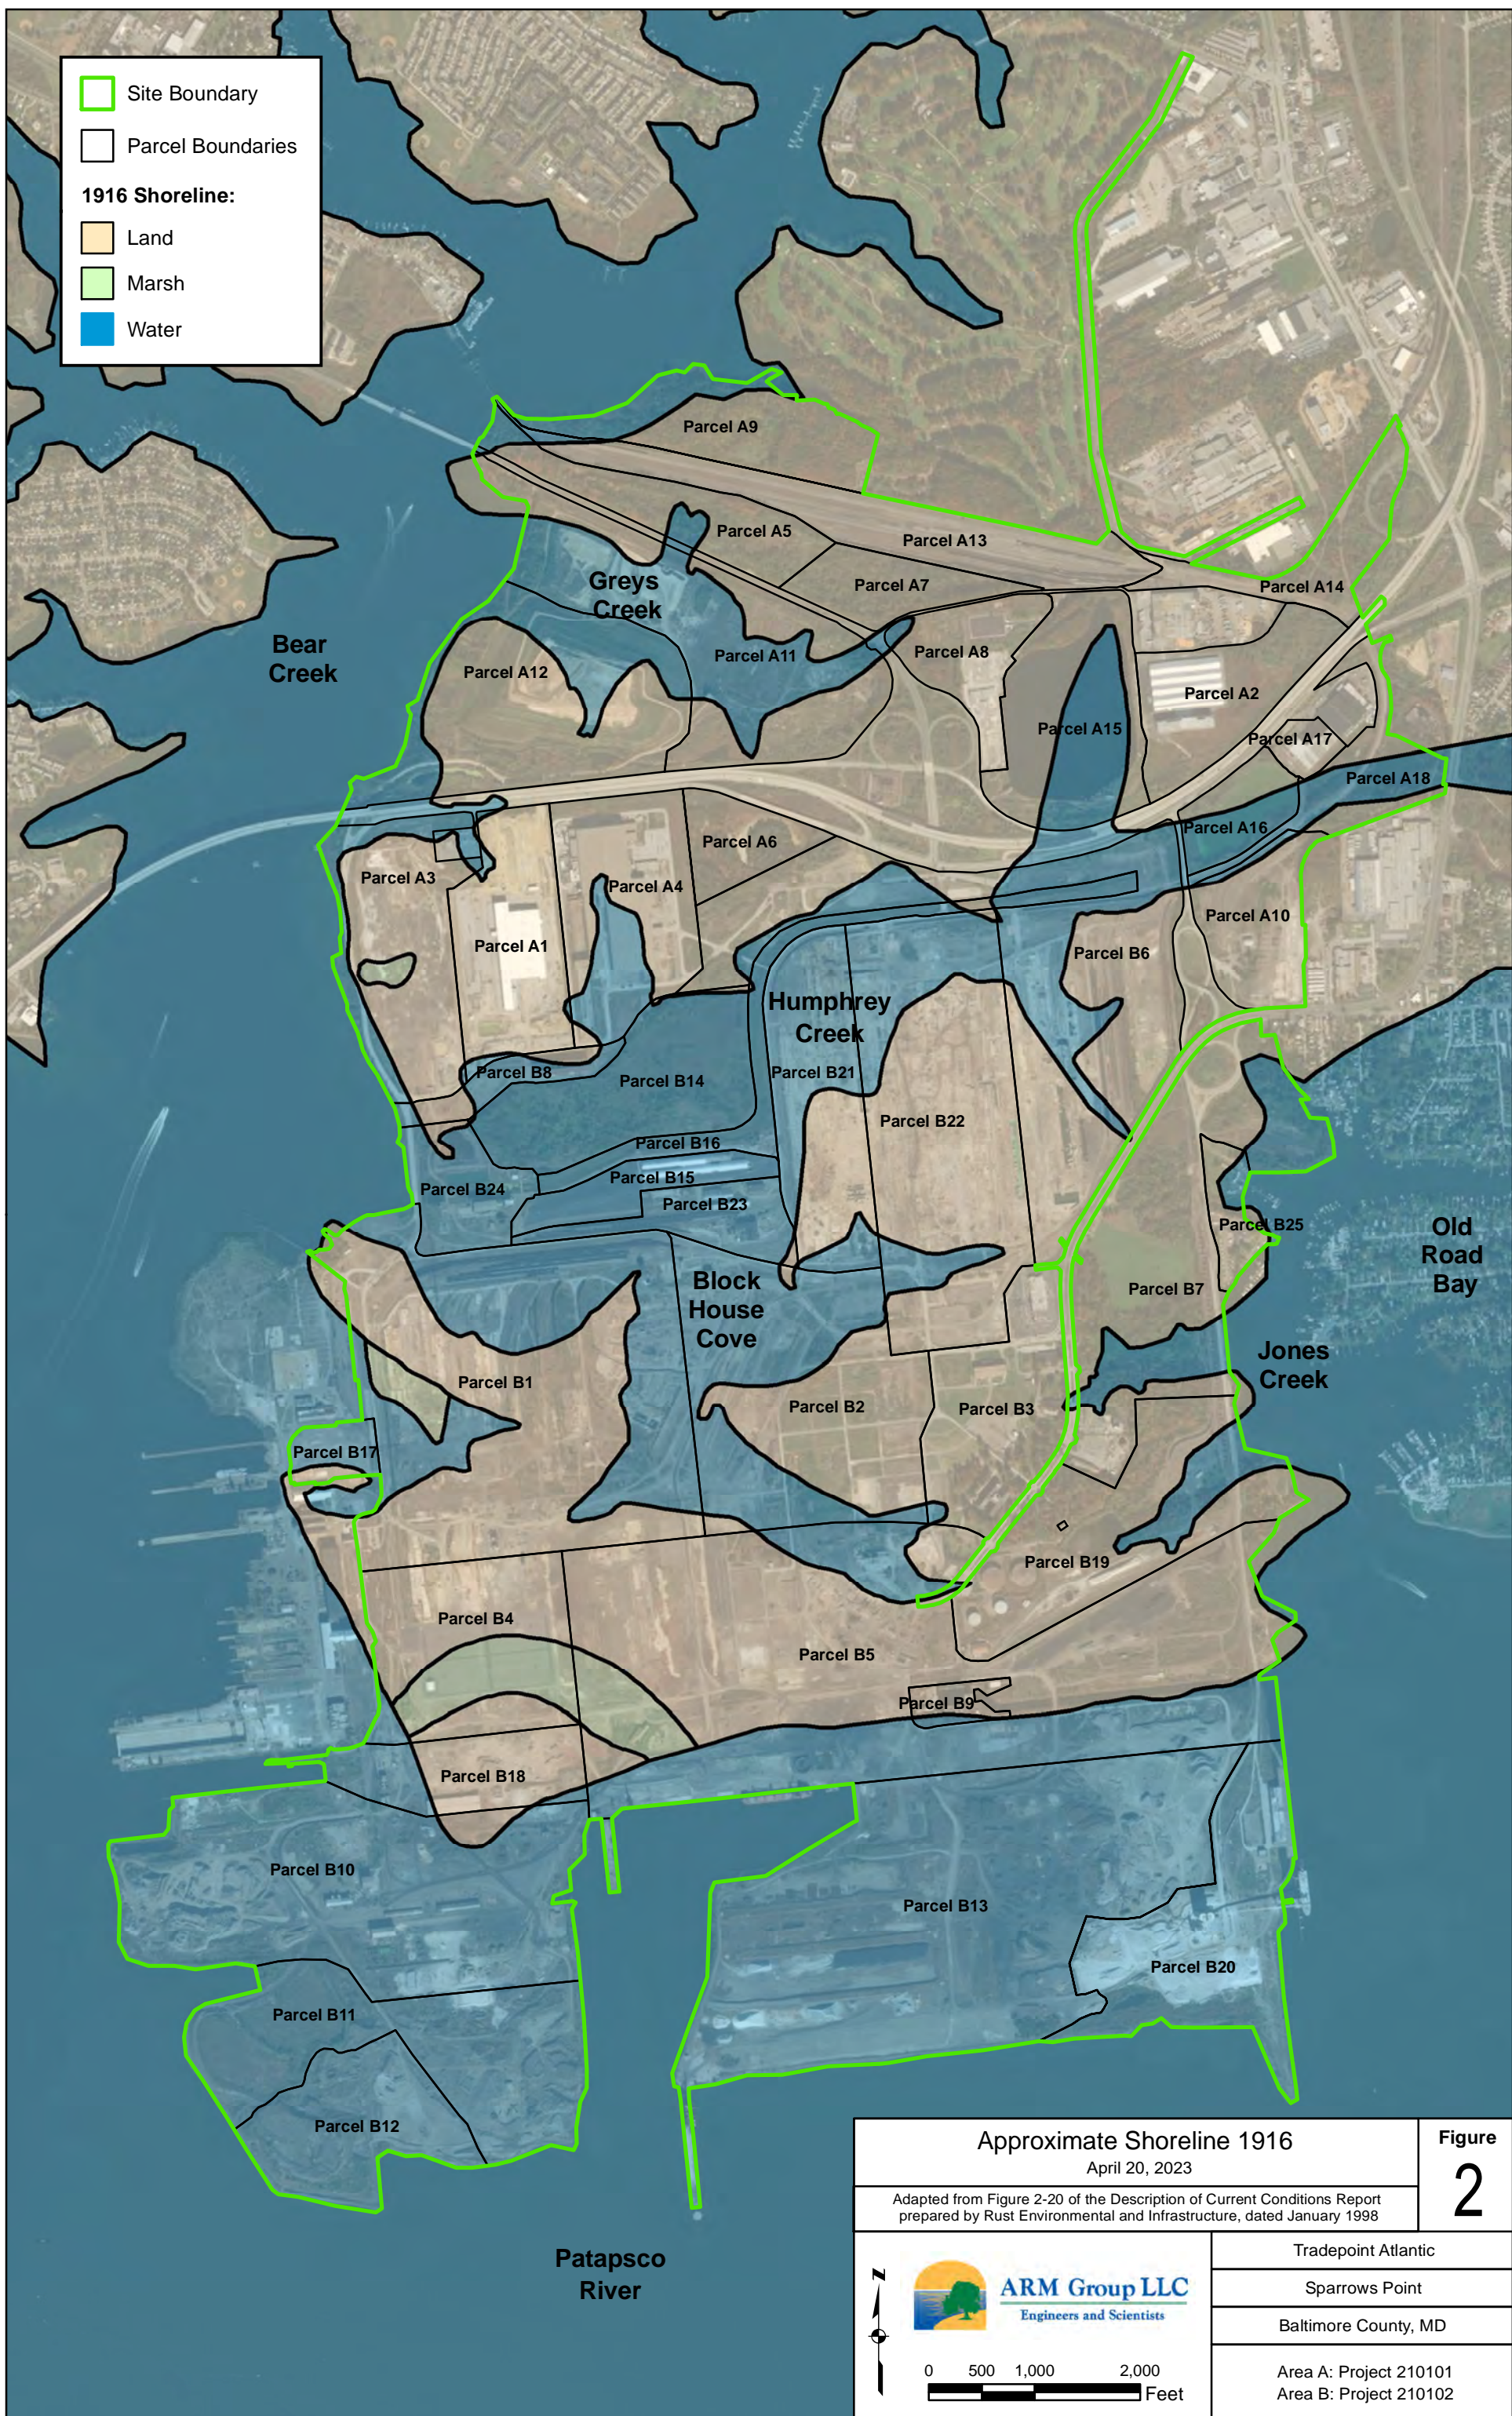
Site Boundary
 Parcel Boundaries
1916 Shoreline:
 Land
 Marsh
 Water

In 1916, groundcover in Parcel A15 was comprised of approximately 60% natural soils based on the approximate shoreline of the Sparrows Point Peninsula, as shown on **Figure 2** (adapted from Figure 2-20 on the Description of Current Conditions (DCC) Report prepared by Rust Environment and Infrastructure, dated January 1998).

The approximate shoreline of the Sparrows Point Peninsula in 1916 is shown in **Figure 2** (adapted from Figure 2-20 in the DCC Report prepared by Rust Environment and Infrastructure dated January 1998). In general, the encountered subsurface geology was comprised of non-native fill materials including slag, sand, and gravel, as well as natural soils including fine-grained sediments (clays and silts) and coarse-grained sediments (sands). Shallow groundwater was observed in soil borings at varying depths ranging from approximately 0.5 to 9 feet below ground surface (bgs)

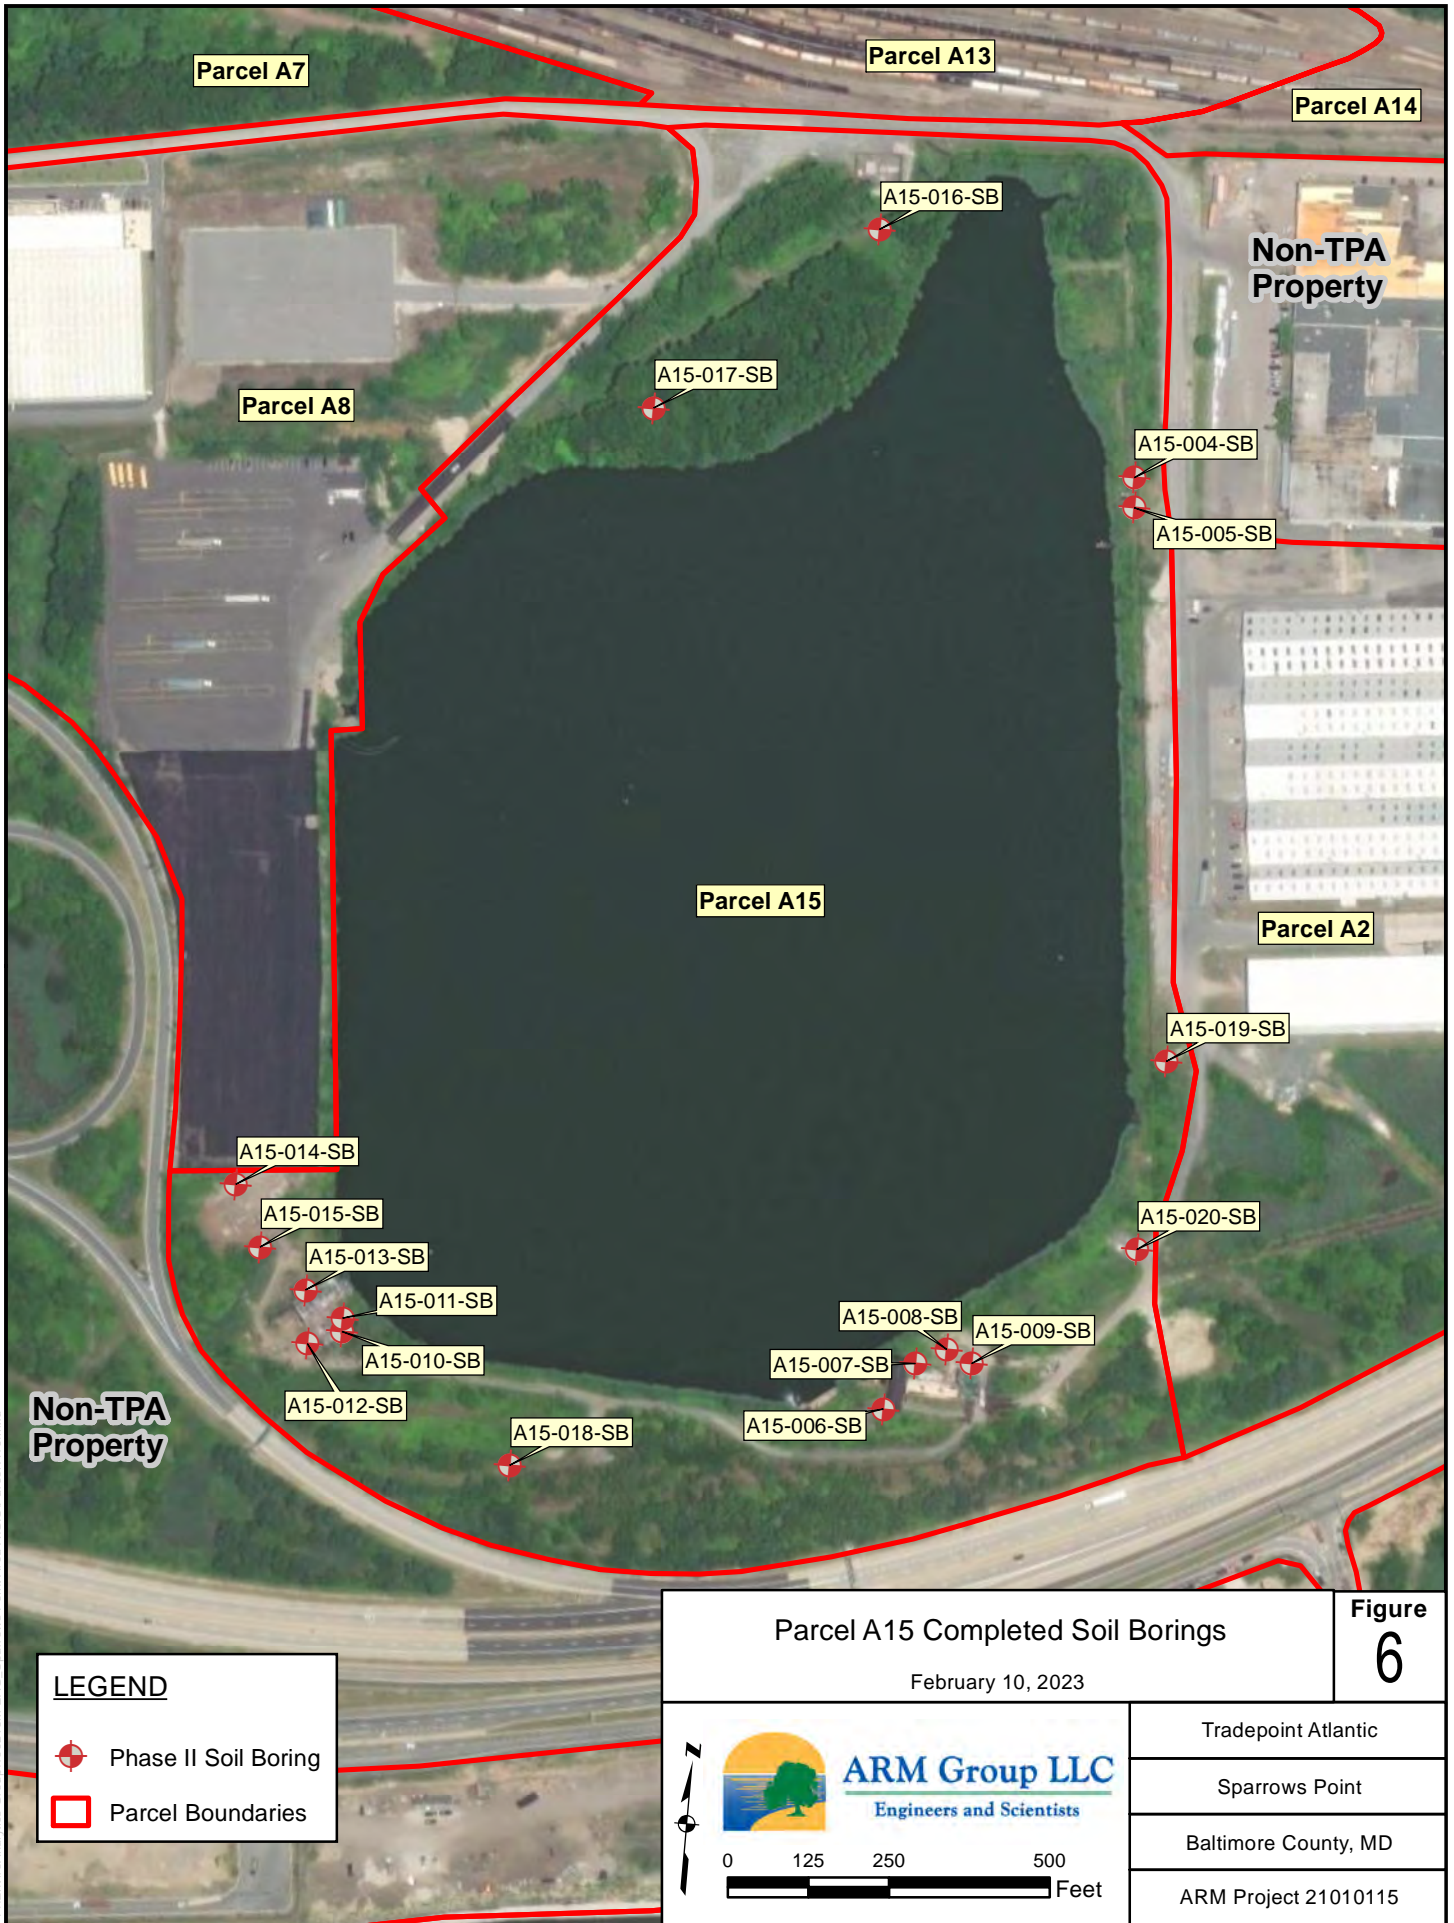
Figure 6

Parcel A15 Completed Soil Borings
February 10, 2023
