PHASE II INVESTIGATION REPORT

AREA A: PARCEL A16
TRADEPOINT ATLANTIC
SPARROWS POINT, MARYLAND

Revision 1 – August 11, 2023

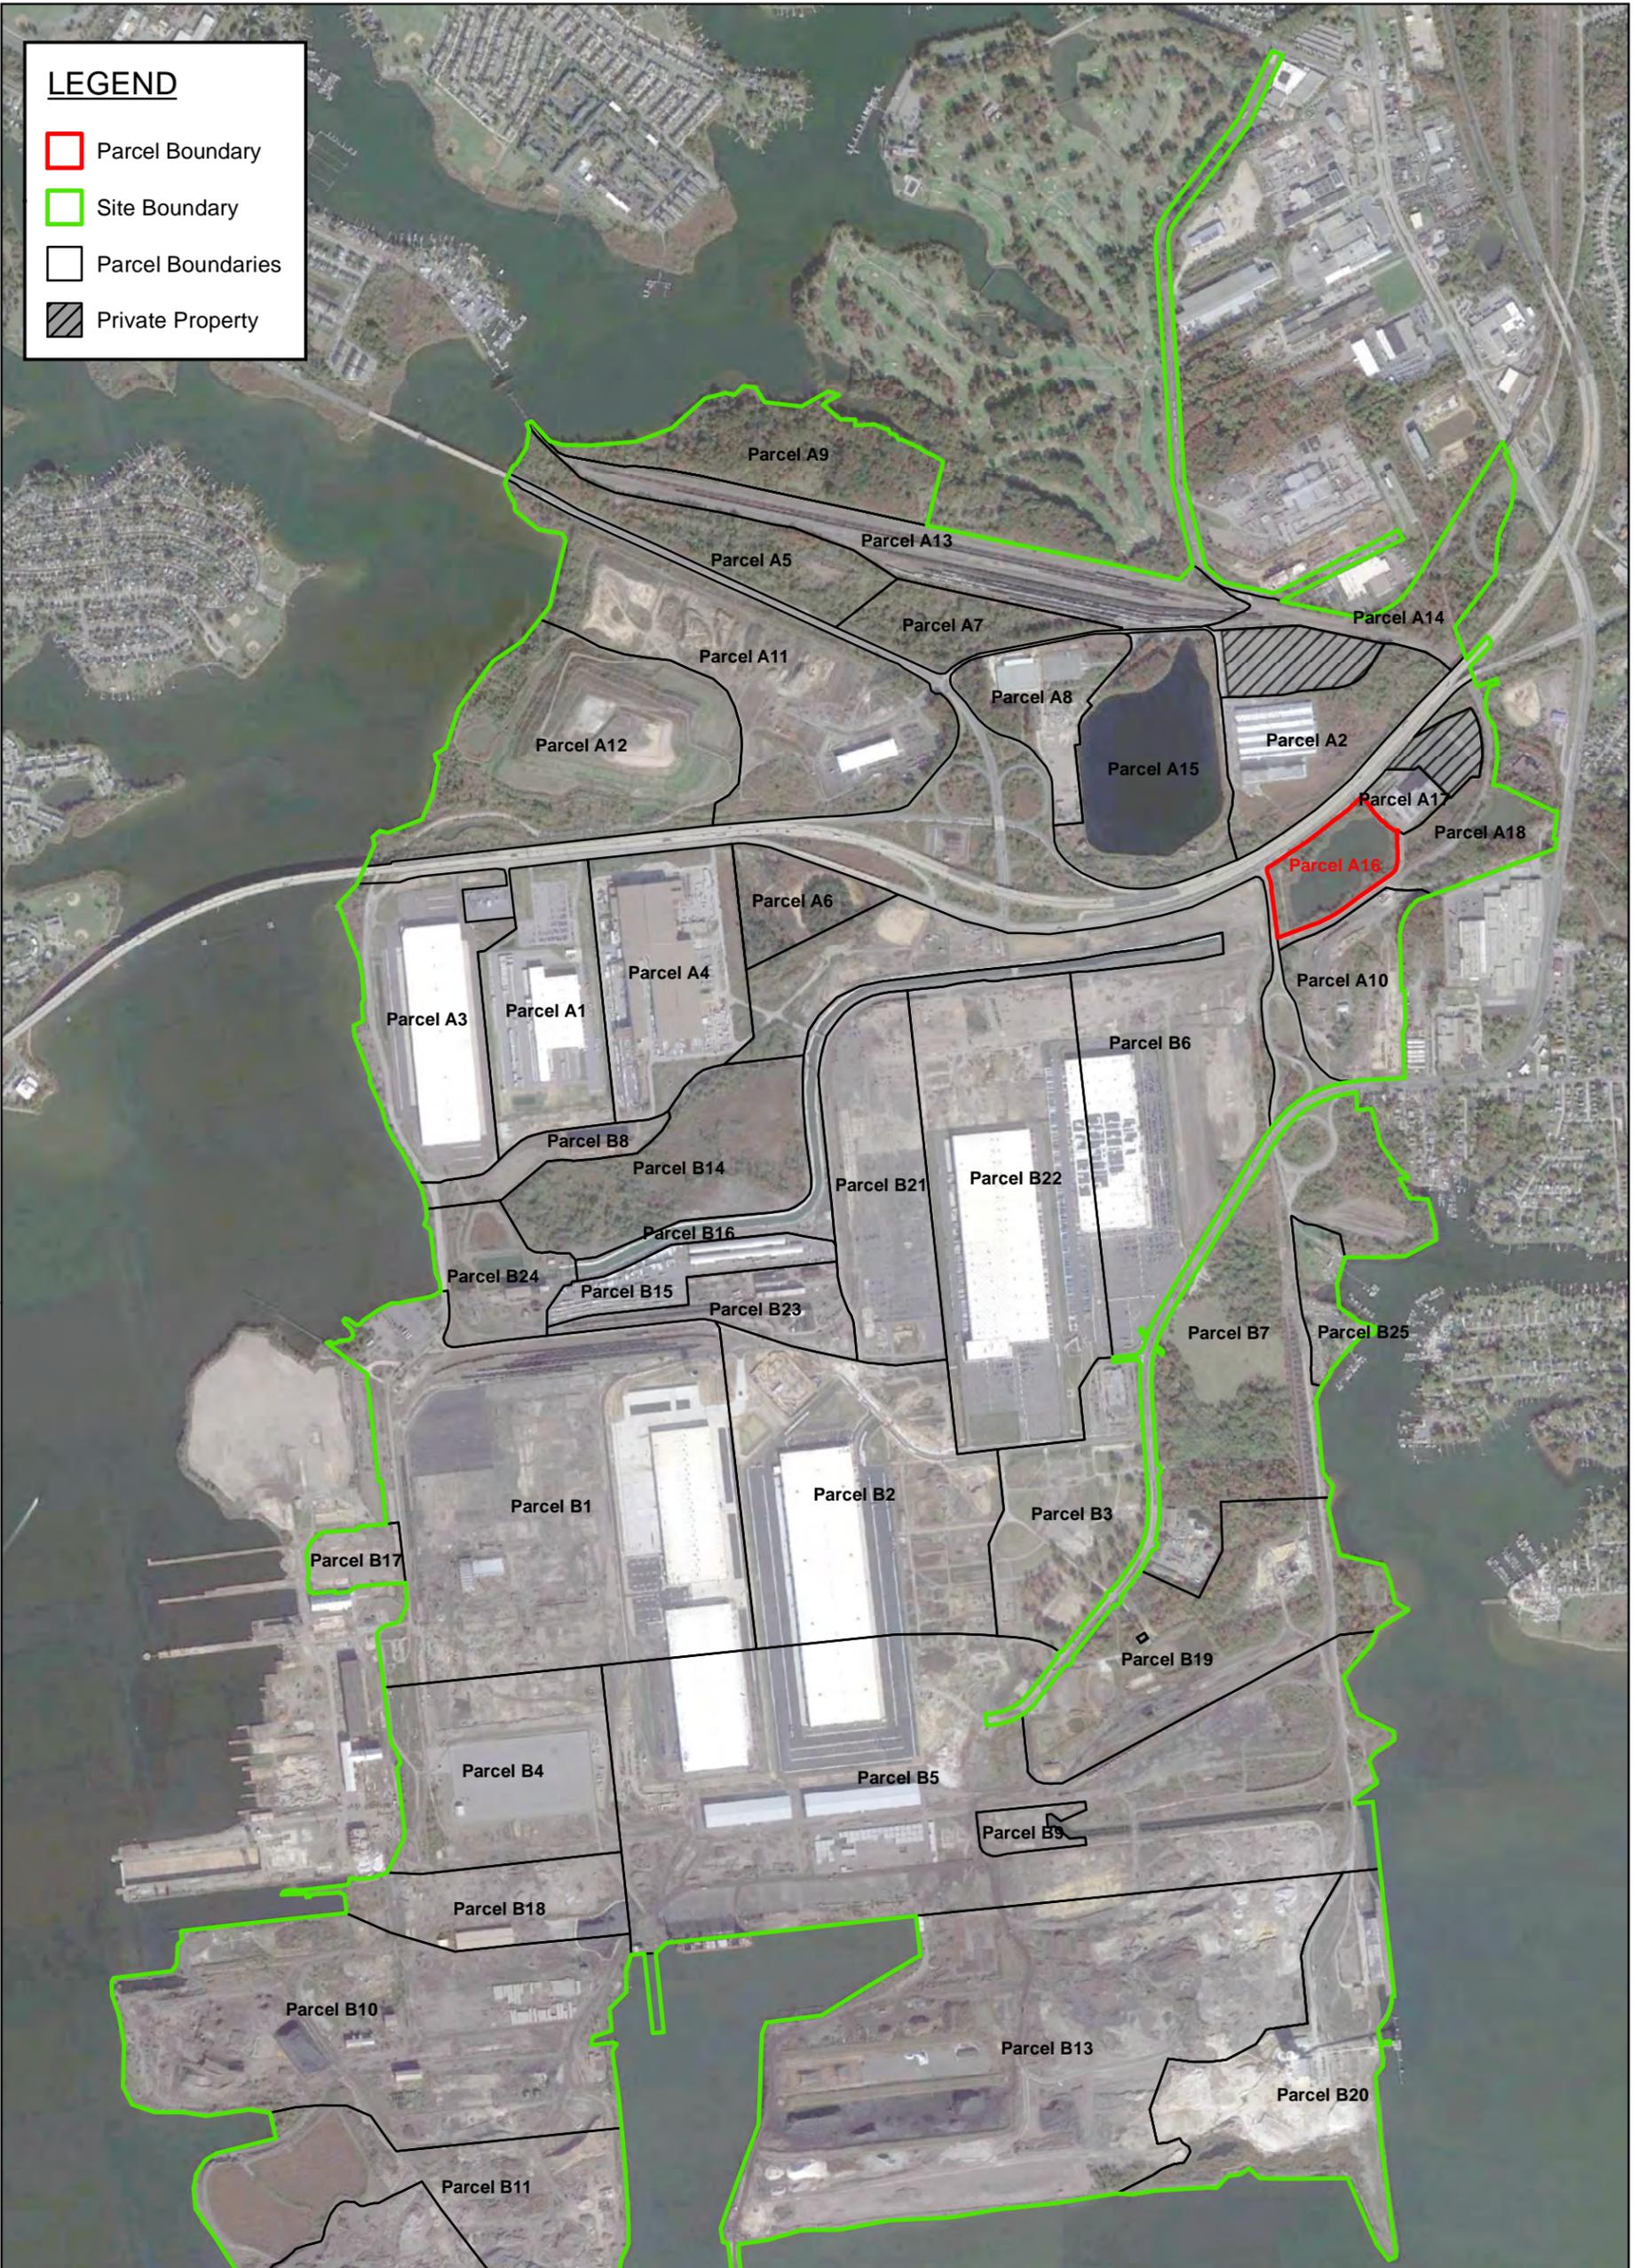
**Tradepoint Atlantic Property
Area A and Area B Parcel Boundaries**

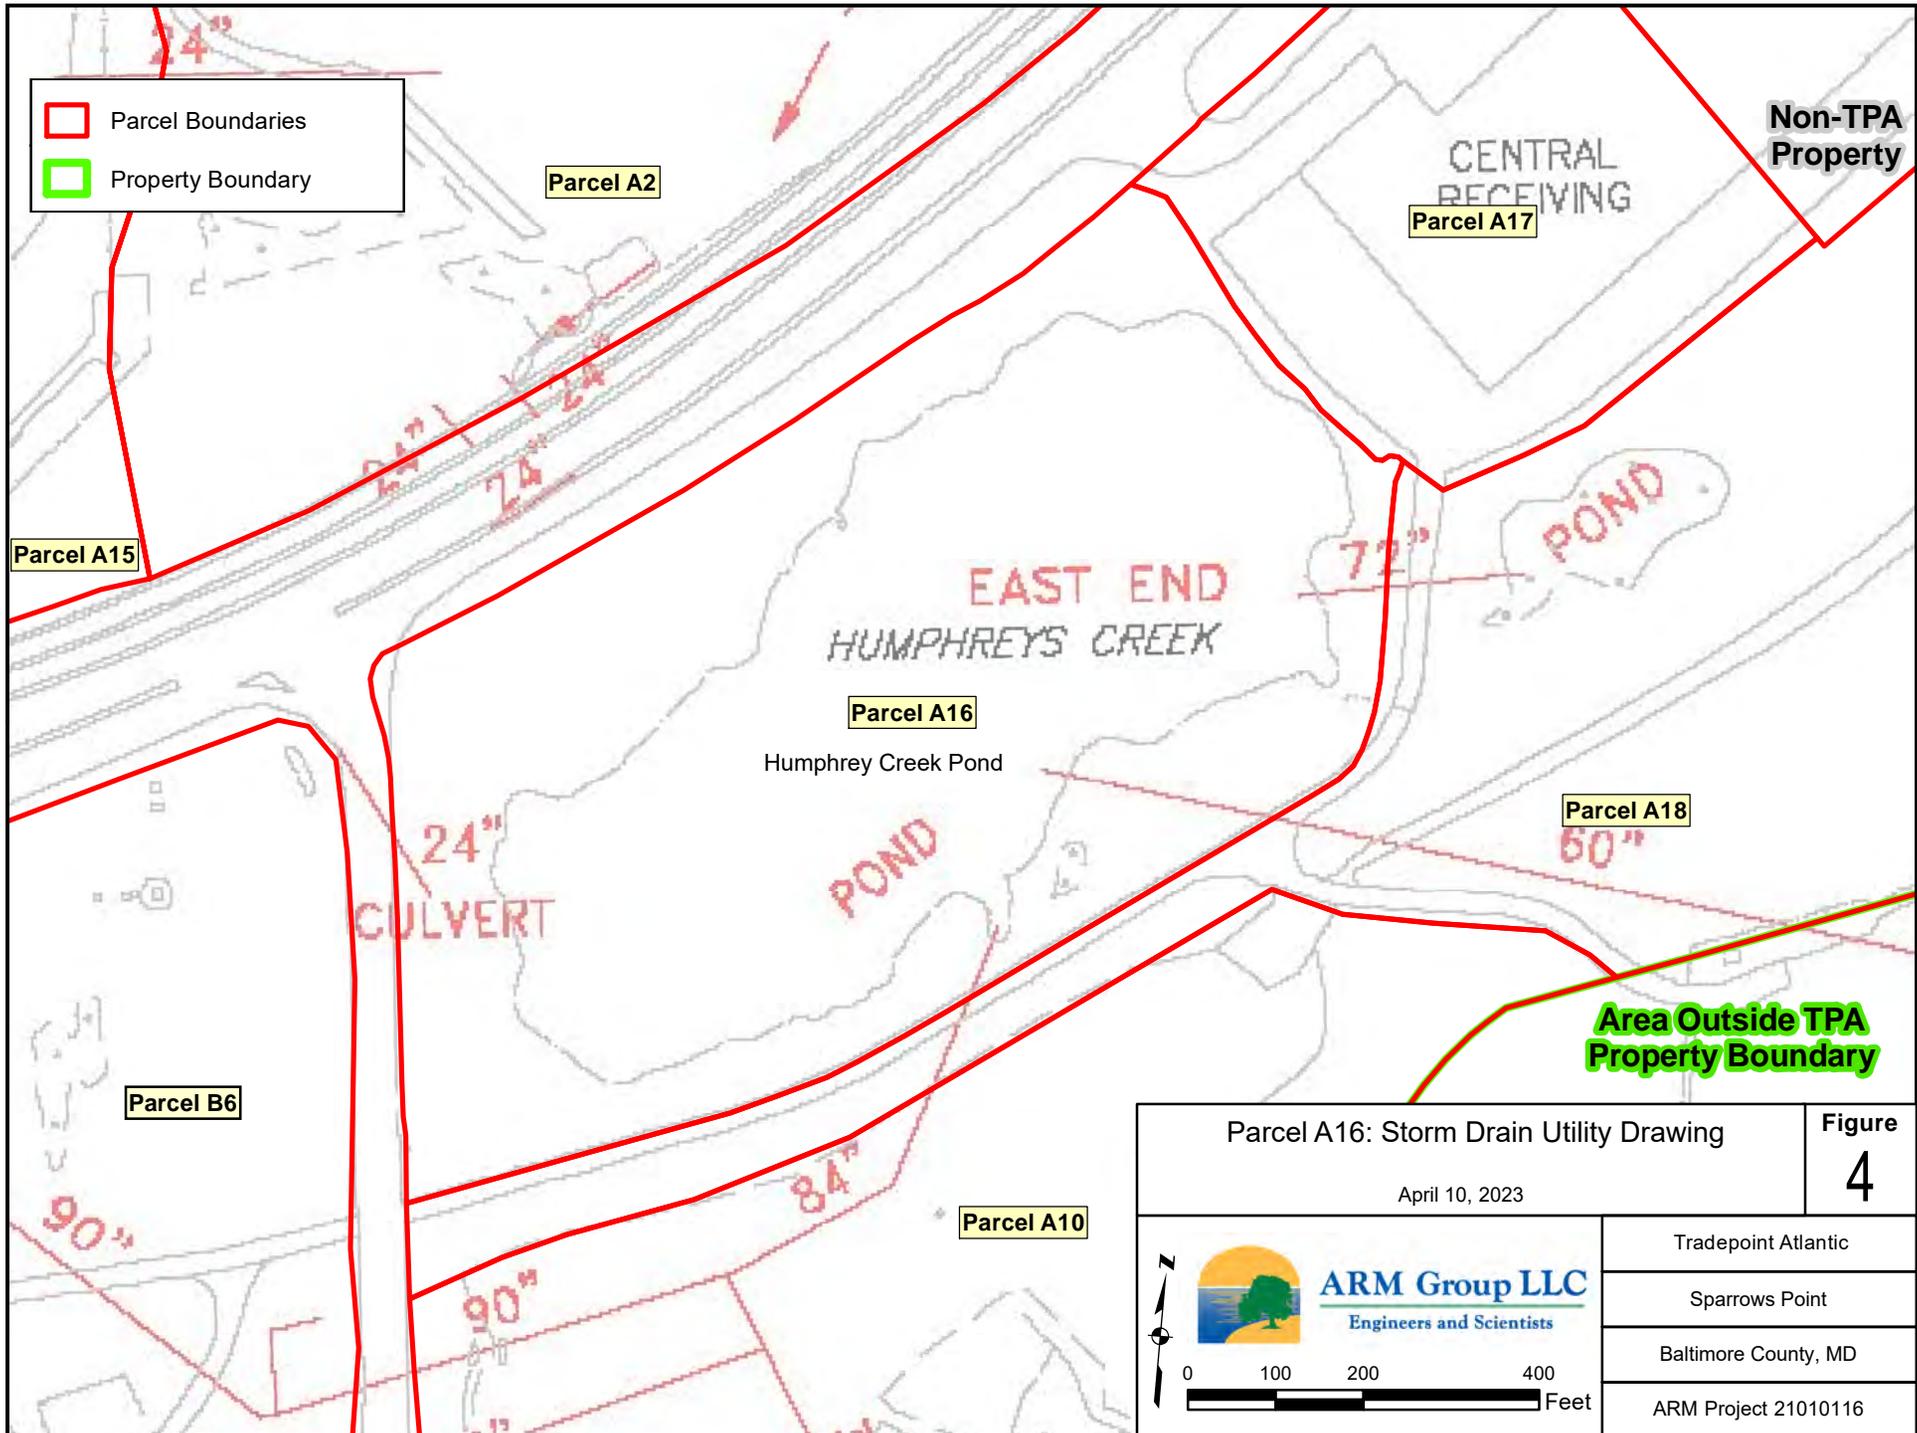
Figure 4

As shown on **Figure 4**, there are multiple pipes associated with the pond which include:

- a 24-inch influent culvert which receives storm water from Bethlehem Boulevard,
- a 60-inch influent pipe which receives storm water from the neighboring Edgemere Community,
- a 72-inch influent pipe connected to the pond on Parcel A18 and comes from the neighboring Edgemere Community, and
- an 84-inch discharge pipe located along the southcentral shore of the pond. The 84-inch pipe is routed to the southwest and discharges to the Tin Mill Canal.

Parcel A16: Storm Drain Utility Drawing
