RESPONSE AND DEVELOPMENT COMPLETION REPORT

AREA B: SUB-PARCEL B1-2 TRADEPOINT ATLANTIC SPARROWS POINT, MARYLAND

ARM Project No. 21010201

Revision 1 – June 20, 2023

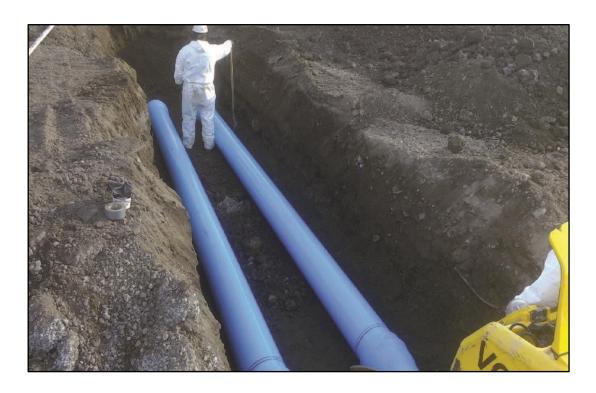
Photo 2: Utility excavation

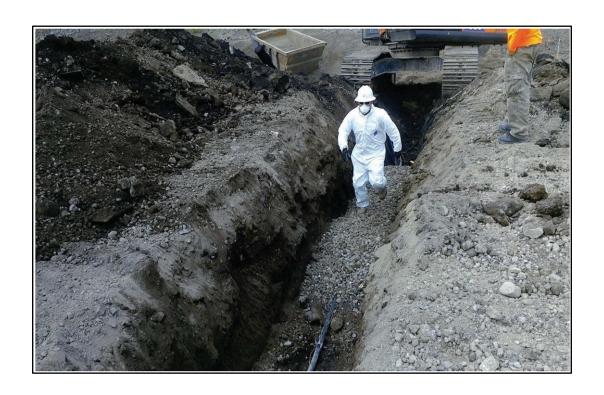
Photo 3: Utility excavation

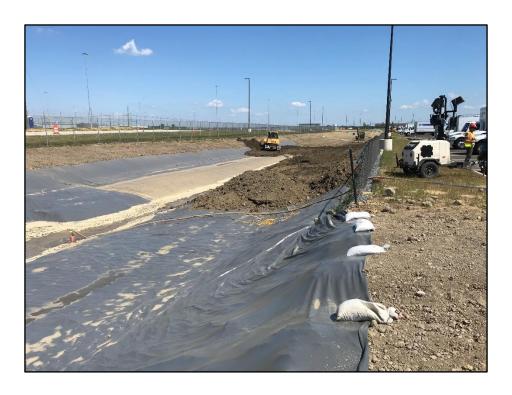
Photo 4: Utility placement

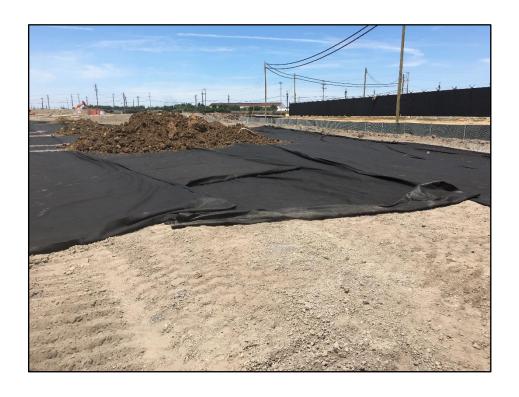
Photo 5: Placement of fabric and clean fill in basin

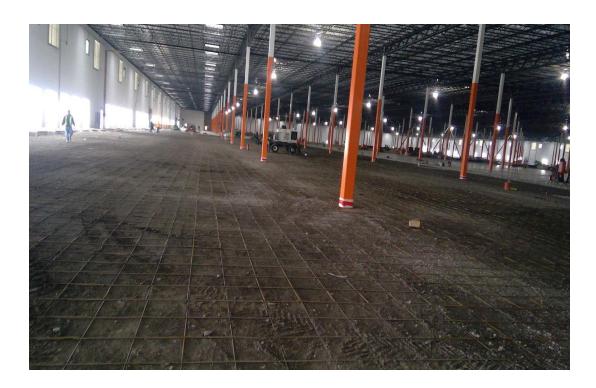
Photo 11: Interior concrete slab

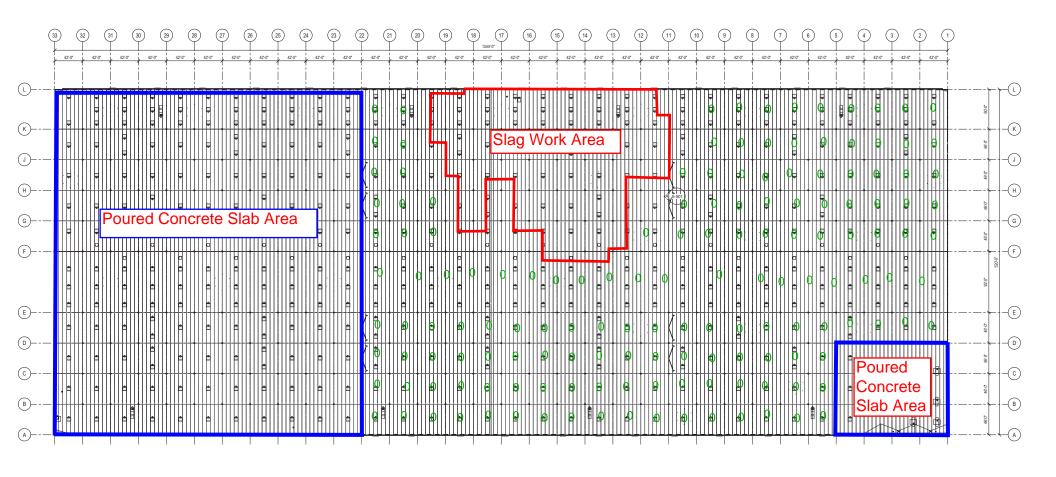
TIGER BUILDING PAD - PID SURVEY

^{*}Numbers in Green Represent Screened Soil Locations and Corresponding PID Readings (all zero)

^{*}Background Ambient Conditions Were Also Zero at Each Location
