NONPOINT SOURCE PROGRAM SUCCESS STORY

Maryland

Restoring Stream Improves Water Quality and Fish Community Health

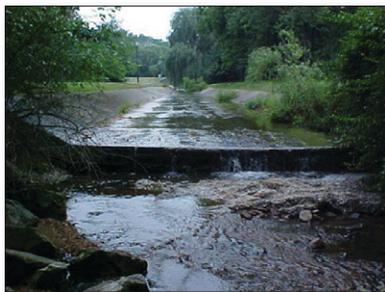
Figure 2. At this site (looking toward Pot Spring Road) before restoration efforts, Spring Branch flowed through a concrete channel. The concrete step seen here obstructed fish passage.

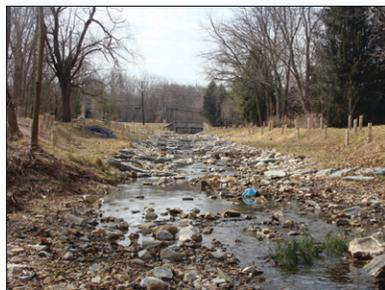
Figure 3. After restoration, the concrete channel seen in Figure 2 has been removed. Sewer lines running along both sides of the stream prevented partners from restoring a natural meandering pattern.

In phase I, DEPRM created a new channel of Spring Branch and added step pools, meander patterns and flood plains. That and other parts of the stream channel were stabilized using natural materials such as boulders, tree root wads, brush mattresses and live branch layers. In addition, DEPRM removed 1,740 feet of concrete channel (Figure 2), stabilized or removed sanitary sewer lines, added rock-lined step pools below storm drain pipes to dissipate energy from the flow, and constructed a stormwater wet pond to treat runoff from the headwaters. Replanting 12 acres with native trees and shrubs restored 10,000 linear feet of stream (Figure 3).
