NONPOINT SOURCE SUCCESS STORY

Baltimore County Stream Restoration Project Helps Restore Scotts Level Branch to its Natural State

EPA 841-F-22-001P
August 2022

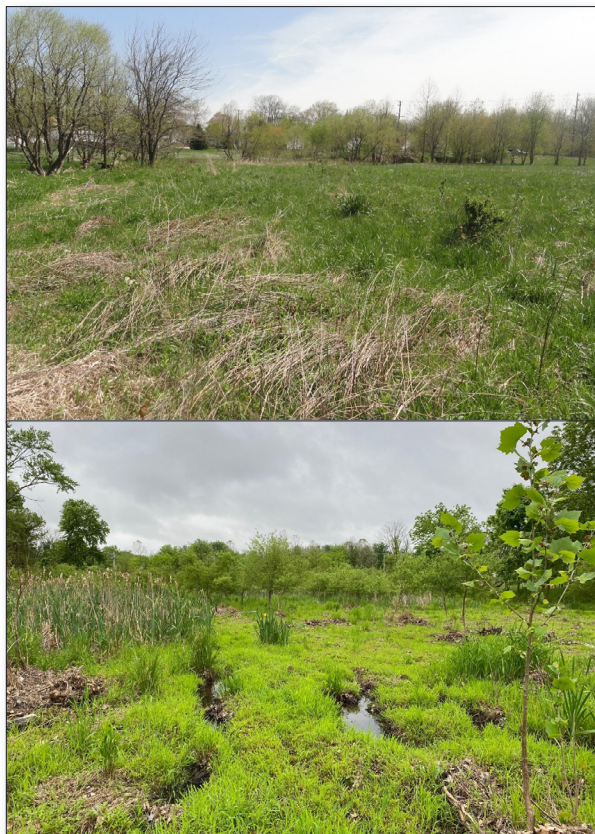
Figure 2. Typical floodplain conditions before (top, 2011) and after (bottom, 2020) restoration.

The area treated by best management practice (BMP) implementation included 1,973 linear feet of stream restoration, 1.51 acres of floodplain plantings, and 3.2 acres of wetland establishment and restoration (Figures 2 and 3). The Scotts Level Branch floodplain was excavated to re-establish floodplain connection and reduce erosive flows. Bank heights were reduced to approximately bank-full elevation to promote frequent inundation of the floodplain. An aggressive canopy, shrub, and herbaceous layer planting was installed after construction. Specific BMPs installed include imbricated stone walls (i.e., layers of stacked angular rock built into stream banks); log and stone cross vanes; J-hooks and J-hooks with logs; cascades; constructed runs; riffle grade controls; and landscaping with grasses, forbes, and trees.

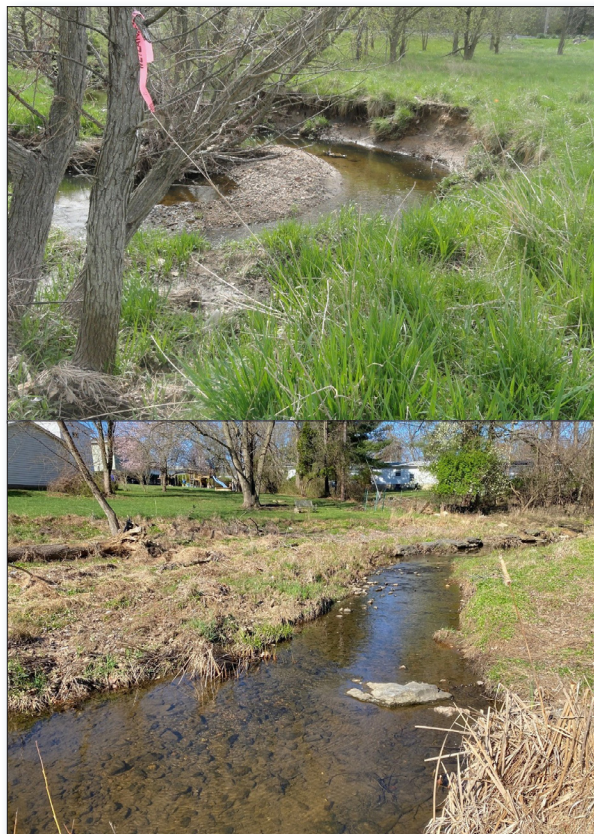
Figure 3. Example of streambank conditions before (top, 2011) and after (bottom, 2020) restoration.
