Upper Back River Small Watershed Action Plan

Volume 1

November 2008

Prepared by:
Baltimore County Department of Environmental Protection
and Resource Management

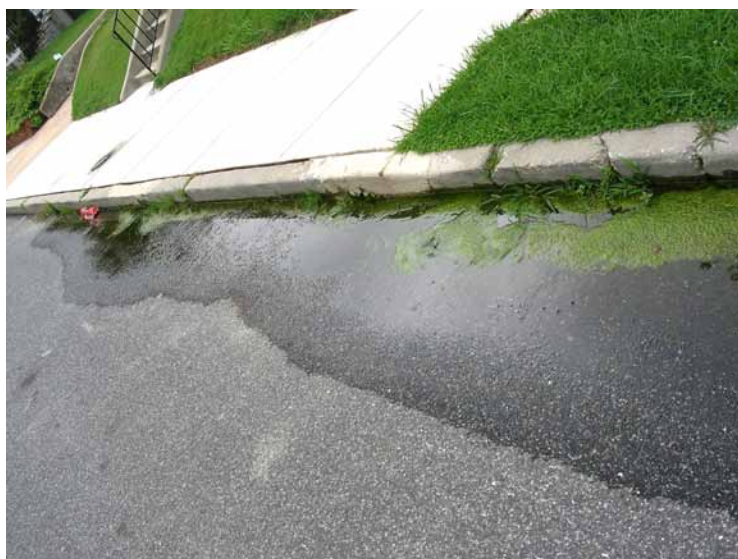
Dry weather discharge and algae in NSA-L-85

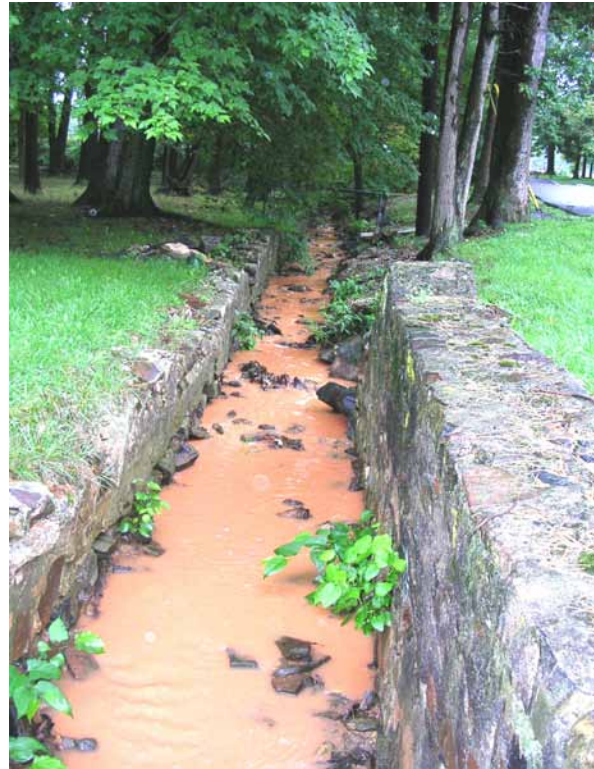
sediment laden stream in NSA-L-18

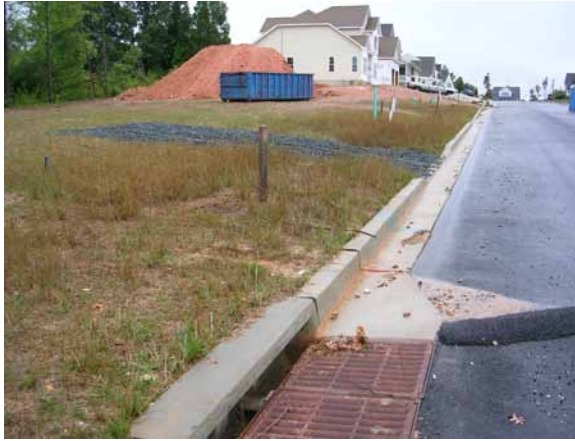
poor sediment control in NSA-L-177

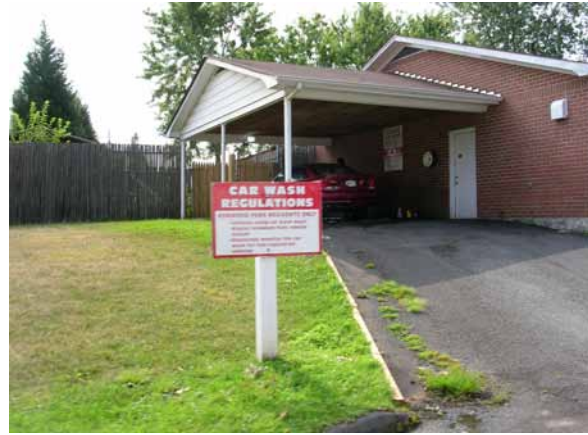
car wash where runoff goes to stormdrain in NSA-L-19

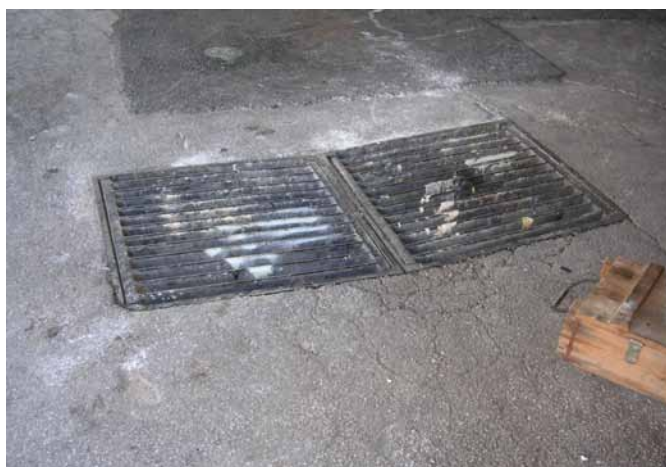
evidence of paint dumping at ISI-L-154

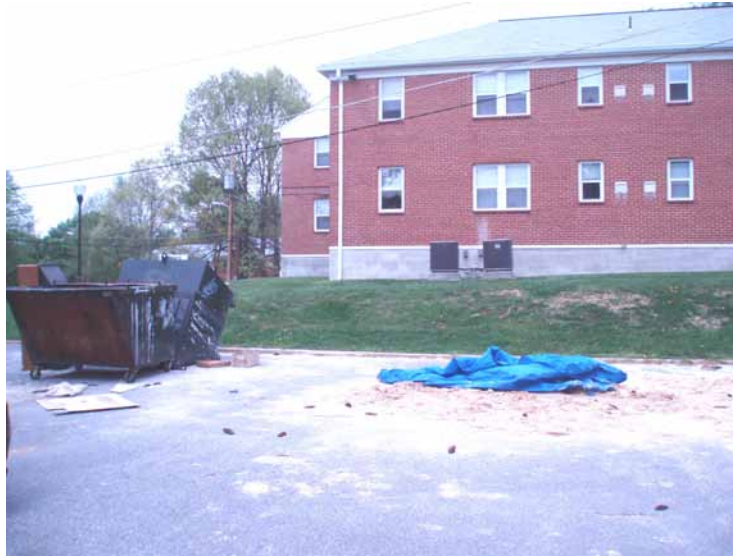
poor sediment control in NSA-L-89

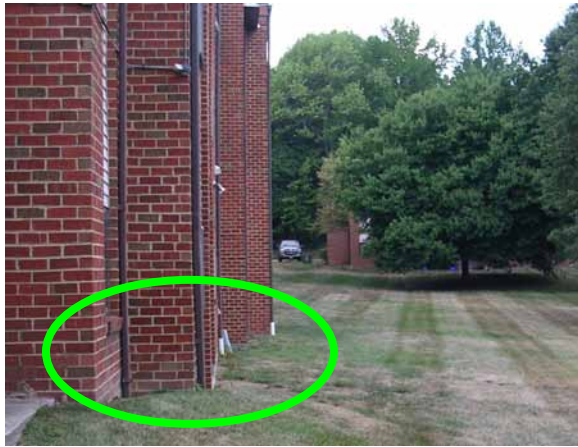
Directly connected downspouts in NSA L-155B that are suitable for redirection onto lawn

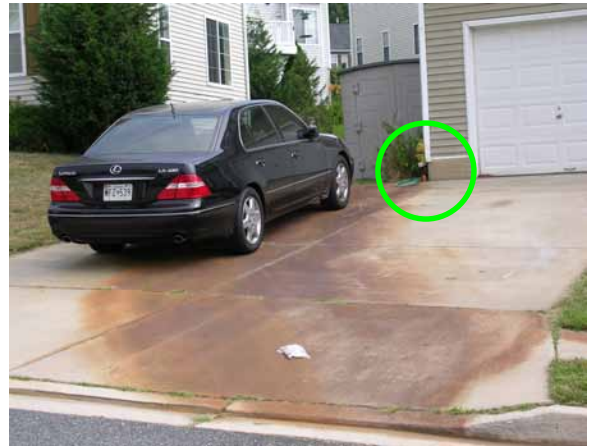
Impervious downspout drainage & staining in NSA-L-197

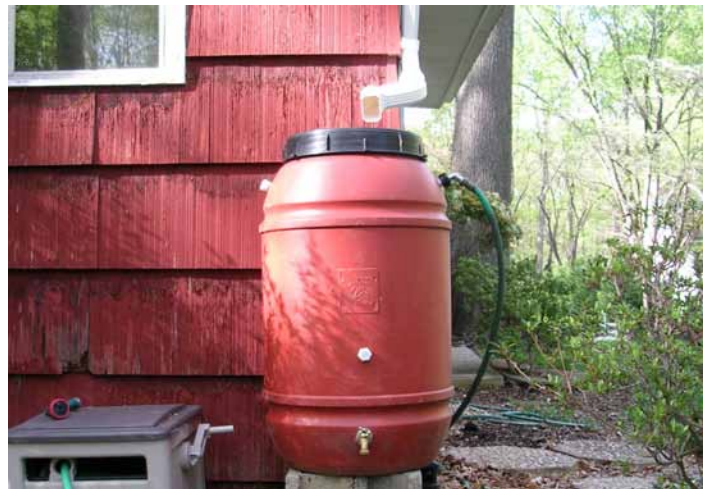
A typical rain barrel installation with overflow hose

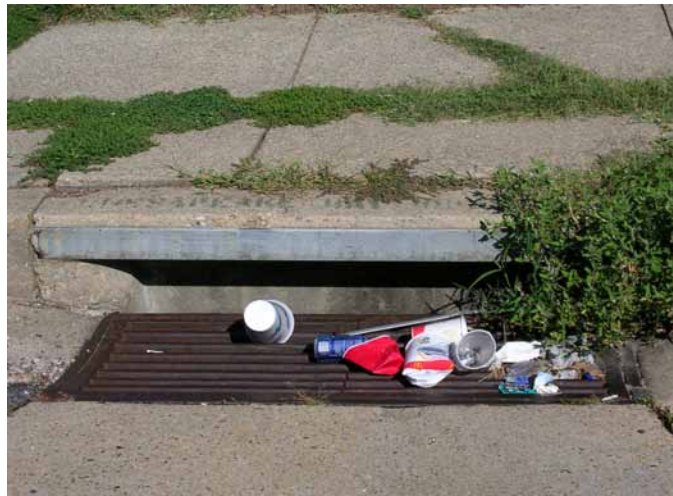
Trash on its way to a nearby stream in NSA-L-83

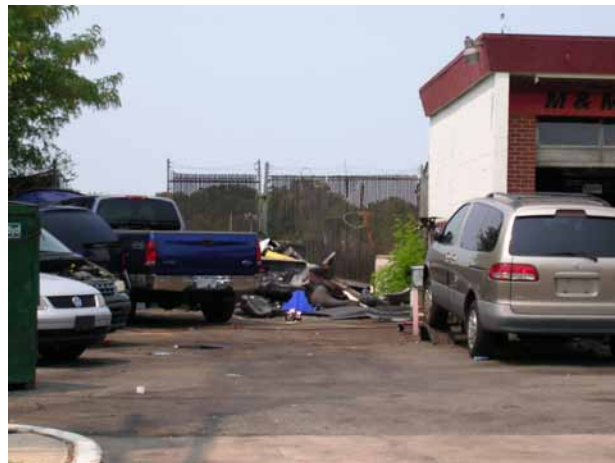
HSI site L-502, an auto shop where vehicles are stored and repaired outside

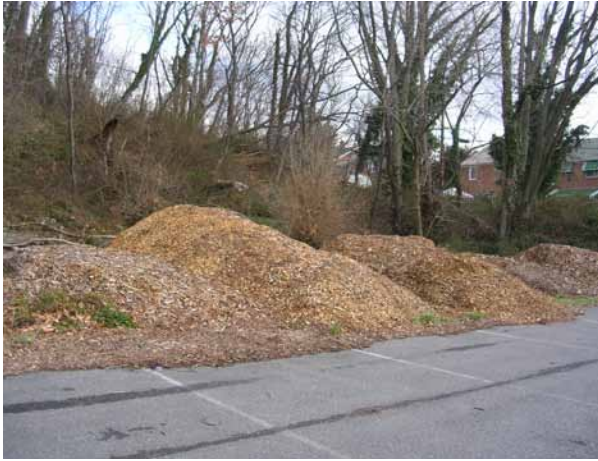
Improperly stored outdoor materials at ISI site L-104

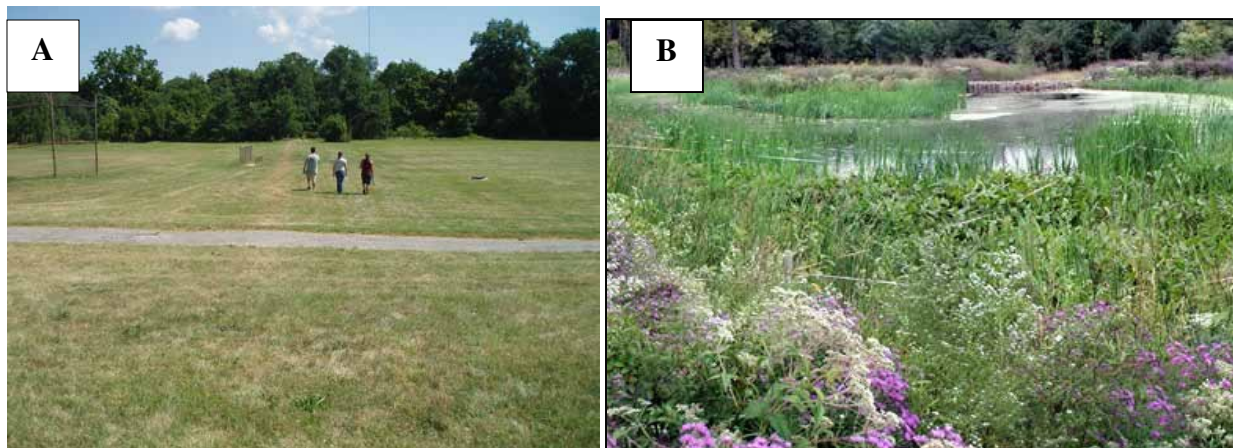
Figure 5-1. Available space for a stormwater retrofit (A) and an example of a stormwater wetland on Staten Island (B).

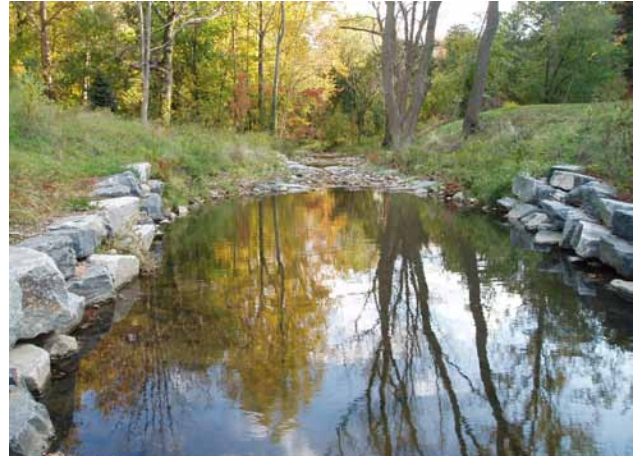
Figure 5-3. Stream restoration along Stony Run in the Jones Falls Watershed.

Stream restoration can often be combined with sanitary sewer capital repair projects to leverage additional money and water quality benefits for less cost. Examples include the Stony Run stream restoration project in the Jones Falls watershed completed by Baltimore City and the Minebank Run stream restoration project in the Lower Gunpowder Falls watershed completed by Baltimore County.

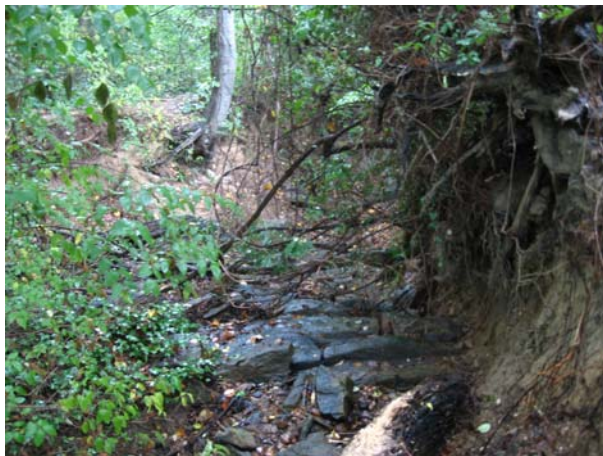
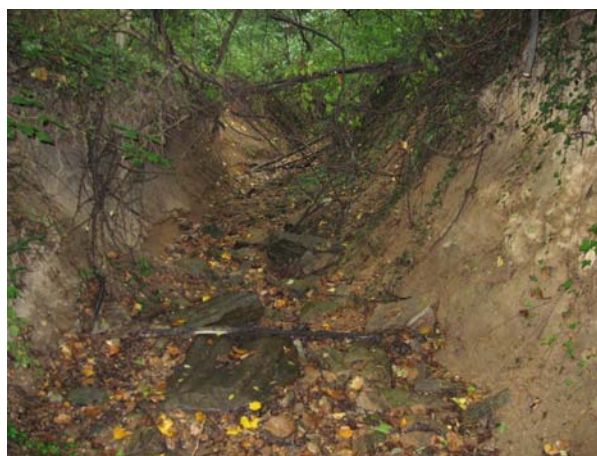
Figures 12A & B: Erosion and debris in HW-03-01-01

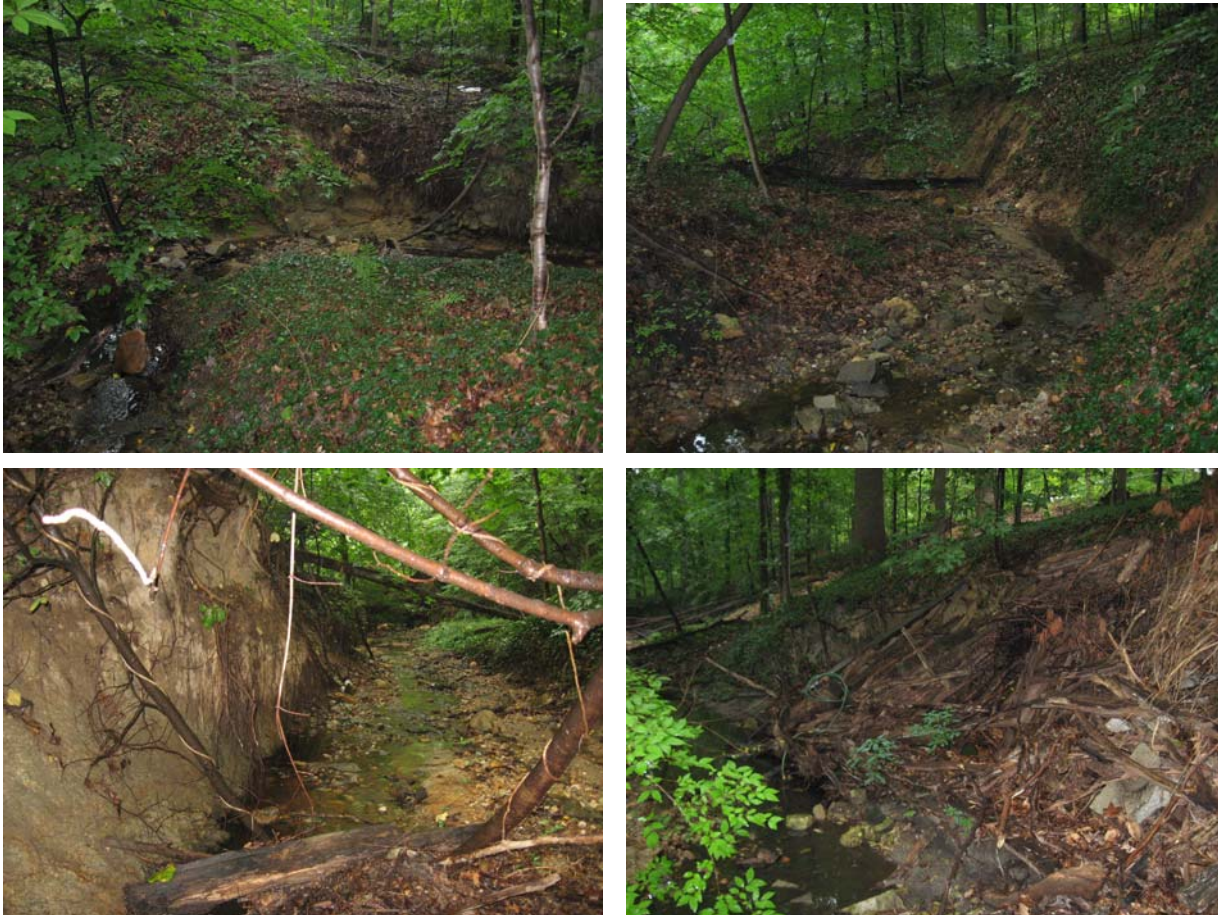
Figures 13A, B, C & D: Erosion at meander bends and fallen trees debris in HW-02-00-01

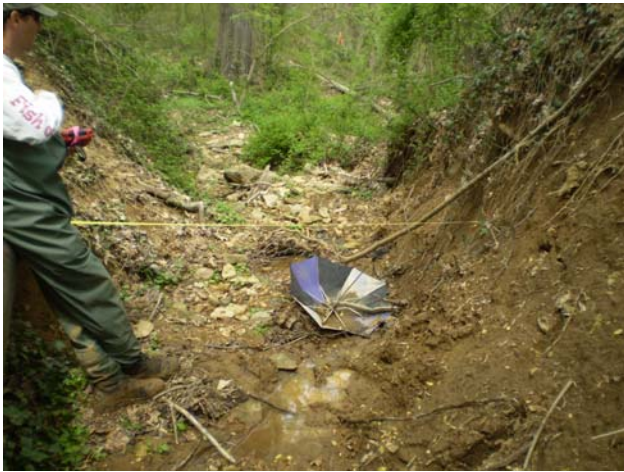
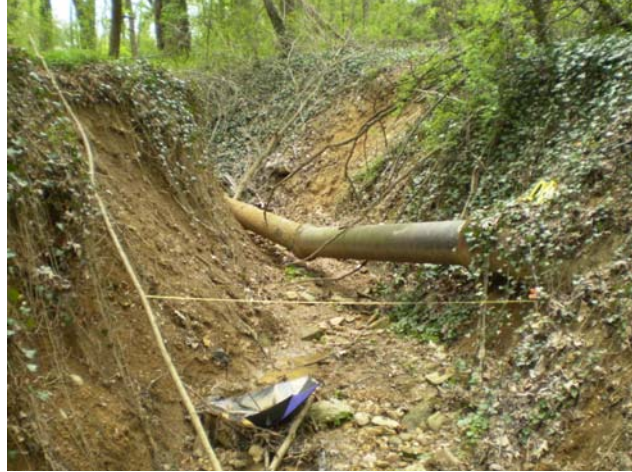
Figures 14A & B: Eroded areas in upstream reach of HW-08-00-01

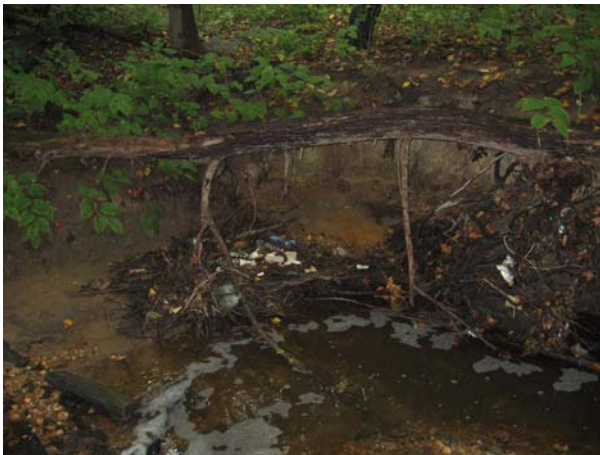
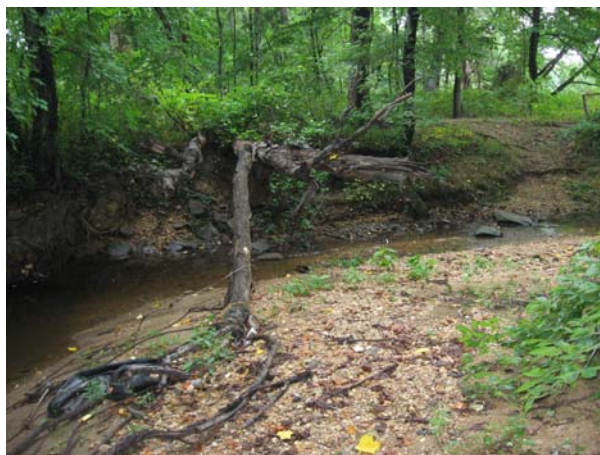
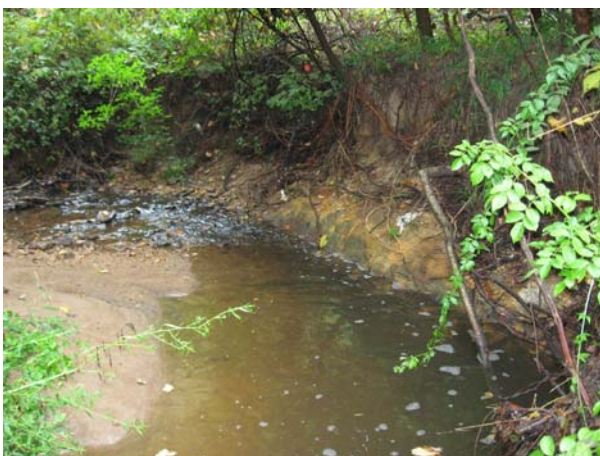
Figures 16A, B & C: Erosion and debris in SR-12-00-03

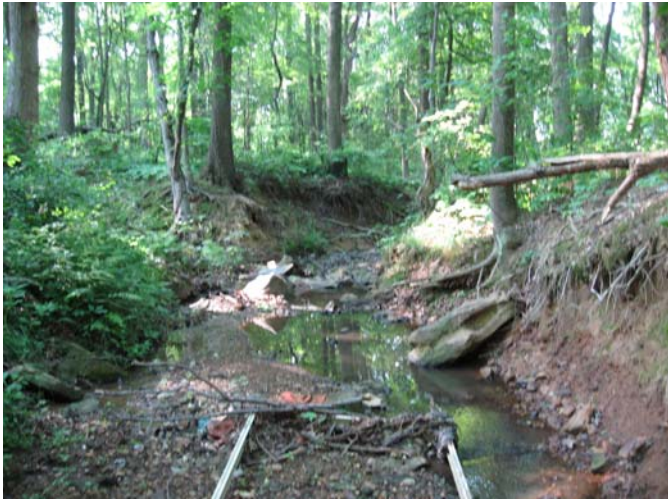
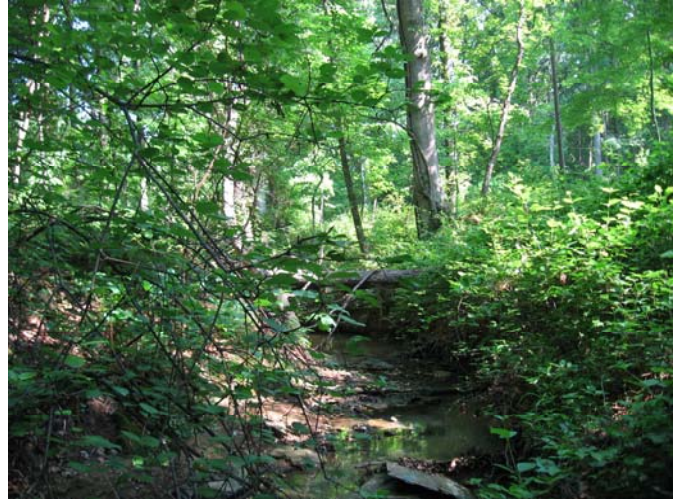
Figures 17A & B: Erosion at downstream and debris at upstream in SR-19-00-01

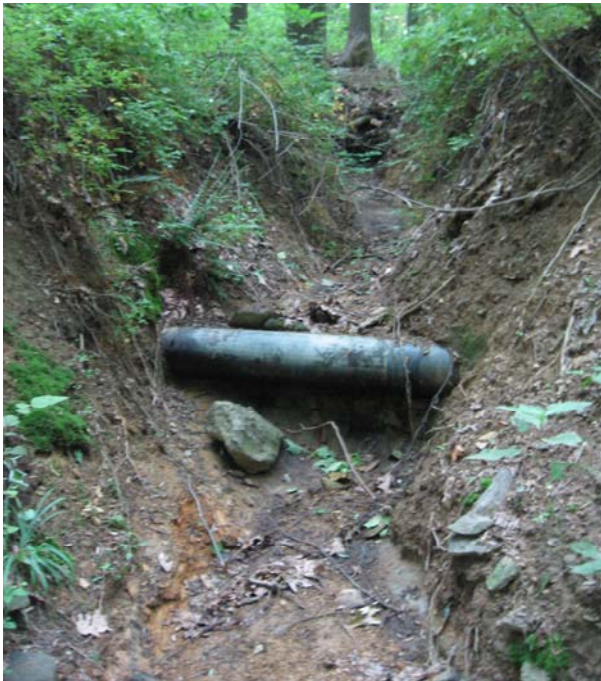
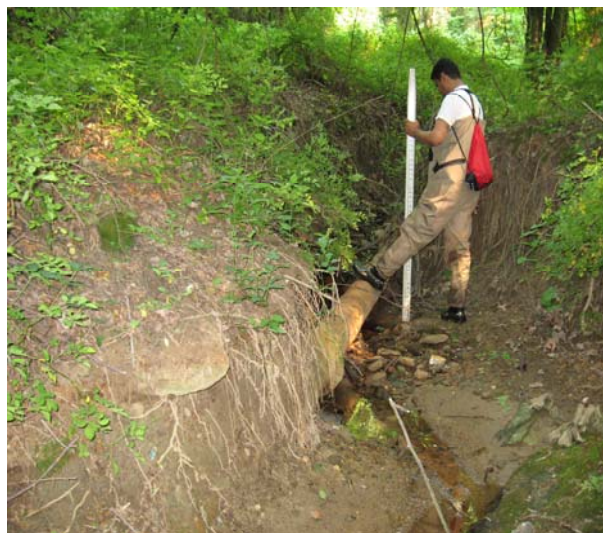
Figures 18A & B: Exposed utility and erosion in SR-08-02-01
