**Maryland Department of Environment**  
**Water and Science Administration**  
**Compliance Program**  
**1800 Washington Blvd, Suite 420**  
**Baltimore, MD 21230-1719**  
**410- 537-3510, 1-800-633-6101**

**Site Name:** Patapsco WWTP  
**Facility Address:** 3501 Asiatic Ave, Curtis Bay, MD 21226  
**County:** Baltimore City County

**Permit / Approval Numbers:** 15DP0580  
**NPDES Numbers:** MD0021601  
**Inspection Reason:** Follow-up (Non-Compliance)  
**Site Status:** Active  
**Compliance Status:** Noncompliance  
**Site Condition:** Noncompliance  
**Recommended Action:** Additional Investigation Required  
**Evidence Collected:** Photos or Videos Taken, Record Review, Samples Taken, Visual Observation  
**Delivery Method:** Email  
**Weather:** Clear Average

Today a Performance Audit Inspection (PAI) was conducted for compliance with the individual NPDES Discharge Permit MD0021601 and State number 15-DP-0580 for the Patapsco WWTP. The permit effective date is 10/1/2017, expiration date 09/30/2022 and a reapplication date of 03/31/2021. The renewal application has been received. The facility's activity code or standard industrial classification (SIC) is 4952 and the North

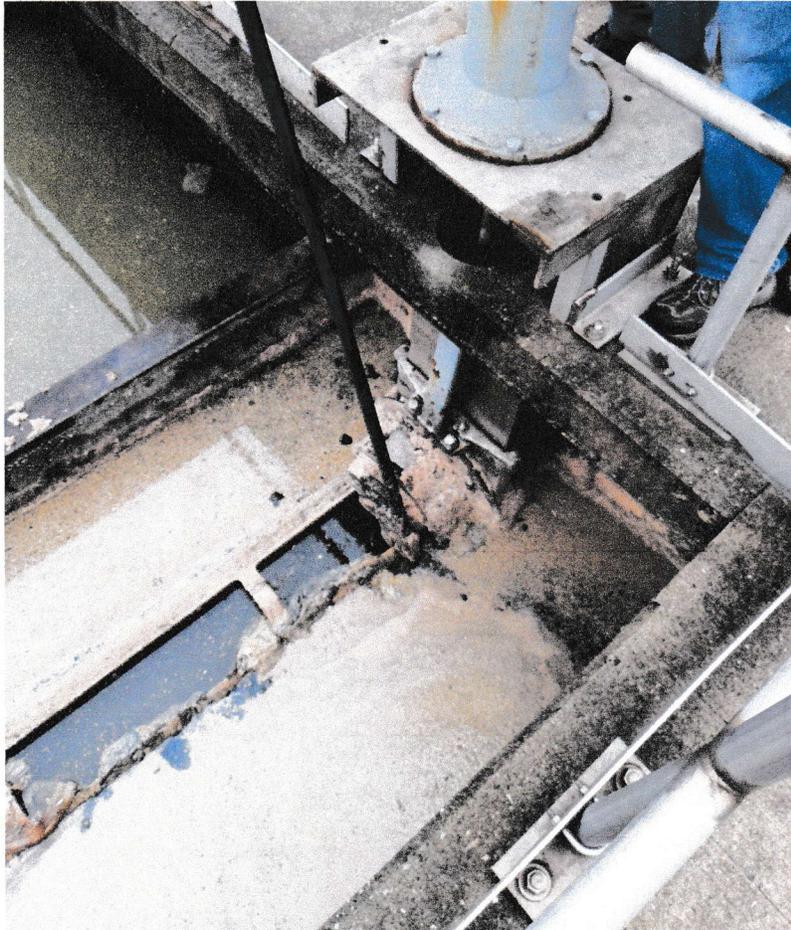
After the meeting, I conducted a site review accompanied by Mr. Jackson, Mr. Thomas, Ms. Grace, and Mr. Williams. The first stop was at the PSTs. There were five of the six PSTs online at this time. I observed a considerable amount of floating scum and FOG. According to Mr. Jackson, the increase in flow due to rainfall and ongoing maintenance at the grit building caused the FOG from the grit chambers to wash down to the PSTs. I observed that all of the PSTs were overwhelmed with floating scum and FOG. Three of the PSTs can now be manually rotated to keep the scum troughs open using a tool designed by Mr. Eric Johnson. According to Mr. Jackson, the troughs are rotated twice a day and manually skimming with a net is being conducted as well. I noticed that a trash can has been placed in the skimming area as I requested during the 10/6/21 inspection to place the skimmed materials. However, I observed that the skimmed material is still being placed on the walkway deck and gratings. This practice defeats the purpose of skimming because the skimmed materials can get back into the system.

During periods of high flows or hydraulic overloads, as experienced today more frequent rotations are required. I observed the final effluent from the scum troughs and observed no floating scum going over the weir. Next, I traveled to the channel where the incoming effluent from the GSTs is returned to the channel that mixes with the PST effluent. The GST effluent was a dark grey color due to high solids content. During the preliminary meeting, I asked what was the TSS concentration of the effluent from the GSTs. According to Mr. Williams the TSS concentration of

4/6/2022 PST scum trough requires turning. Mr. Thomas, from Hazen and Sawyer turns the scum trough with tool designed to rotate the trough.

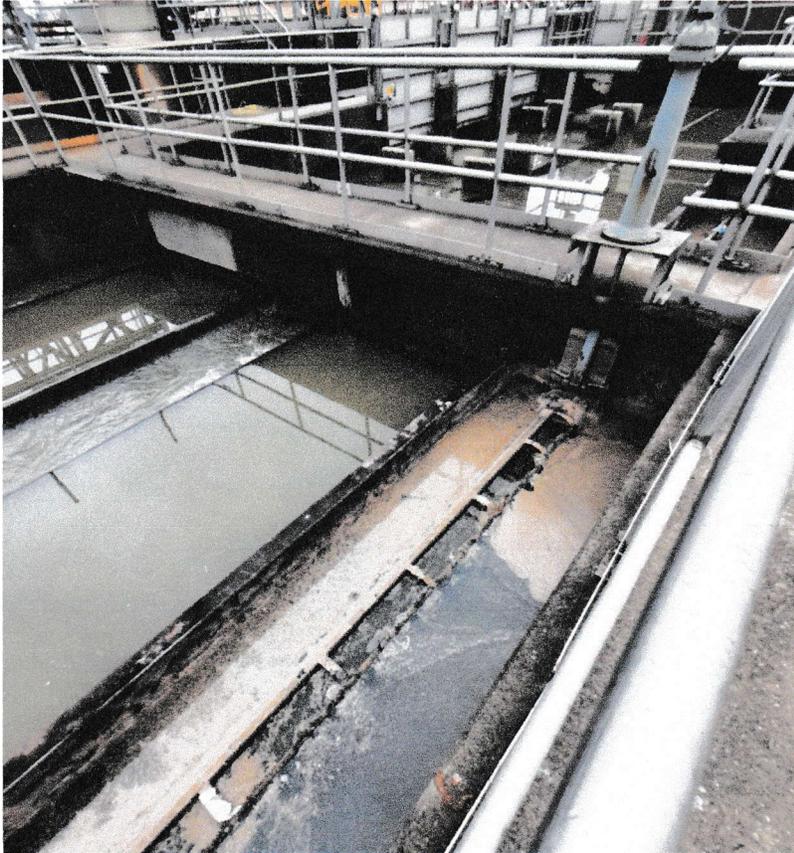
4/6/22 another of the 18 scum troughs requiring attention

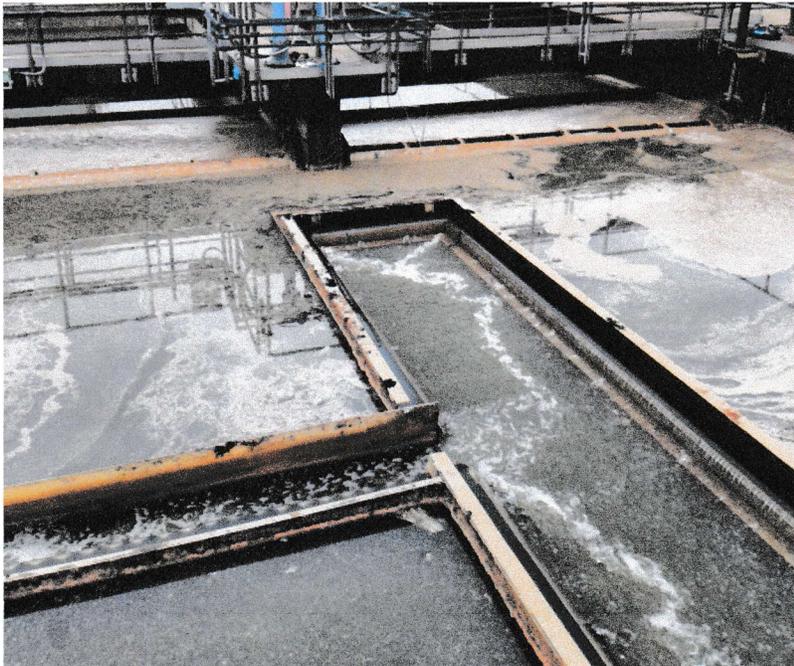
4/6/22 FOG and scum on PST

- E. With respect to item 5 above, within 30 days of the receipt of this report, the permittee should submit to the Department a report detailing all specific measures and actions taken to ensure compliance with the FOG Mitigation Plan for the year 2021 as required by Special Condition. Then, the permittee shall begin submitting on an annual basis at the end of each calendar year all measures taken during the year to comply with the FOG Mitigation Plan.

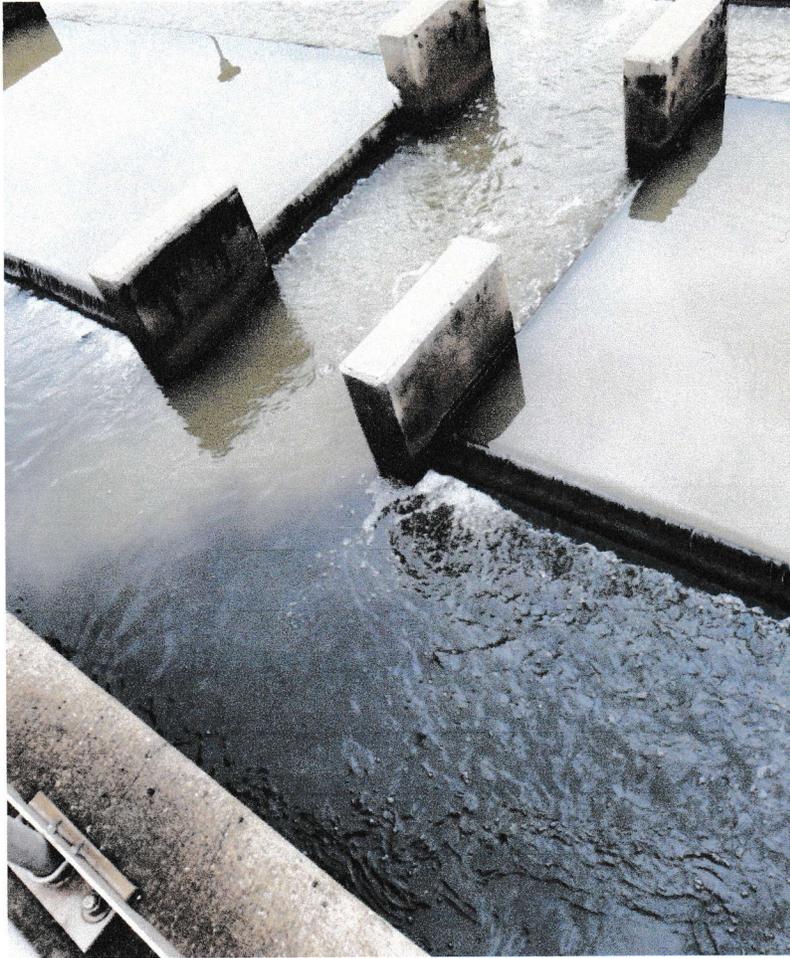
the GST effluent is 4, 000 mg/L. If functioning properly, the final effluent should be between 200 – 500 mg/L.

4/6/22 Dark grey effluent on the right is effluent from GSTs mixing with PST effluent. Color caused by 4,000 mg/L or higher TSS. This water is going to the biological reactors for secondary treatment.

- A. With respect to item 1 above, the Patapsco WWTP should devise a permanent solution for the management of solids produced by the treatment process. Within 30 days of the receipt of the report the Patapsco WWTP must submit a plan addressing a permanent solution for the proper management, treatment and disposal of solids produced by the treatment process. The Patapsco WWTP shall keep the Department informed of the progress made to find a solution on the proper management and handling of solids at the treatment plant. The facility should consider the use of Frac tanks for the holding of sludge.
- B. With respect to item 2 above, The Patapsco WWTP must comply with the condition of the permit and operate the plant in a manner necessary to eliminate effluent violations and bypasses of necessary treatment processes.

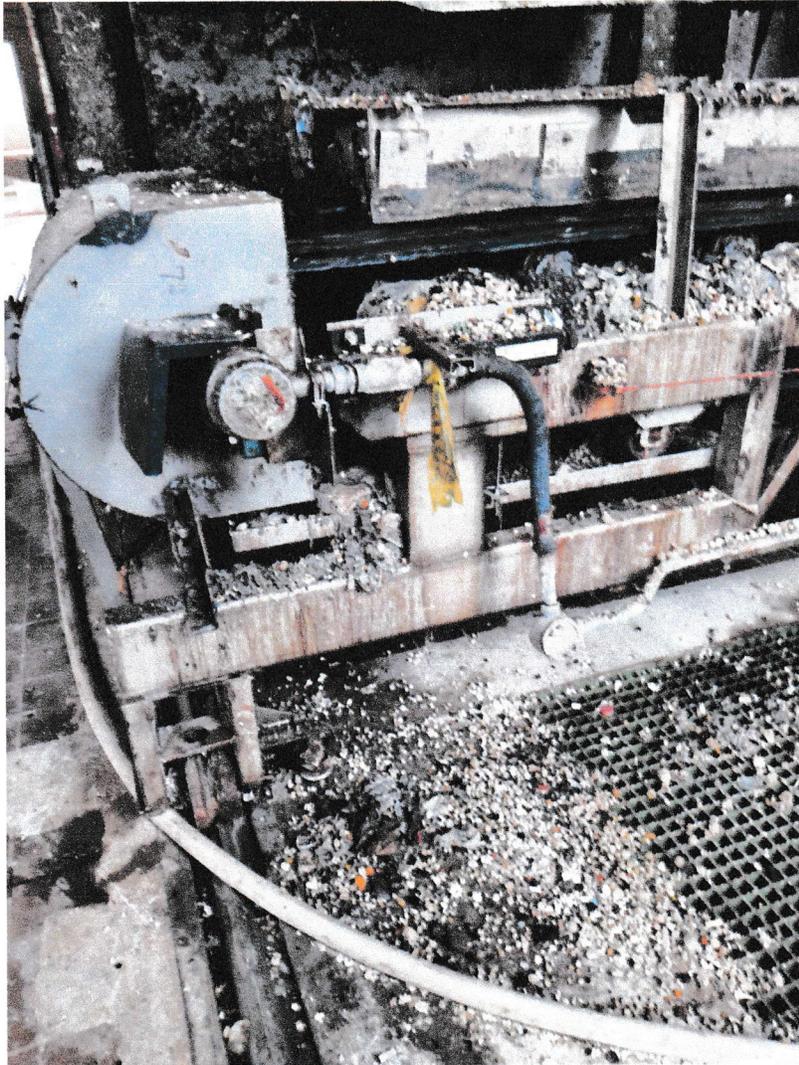
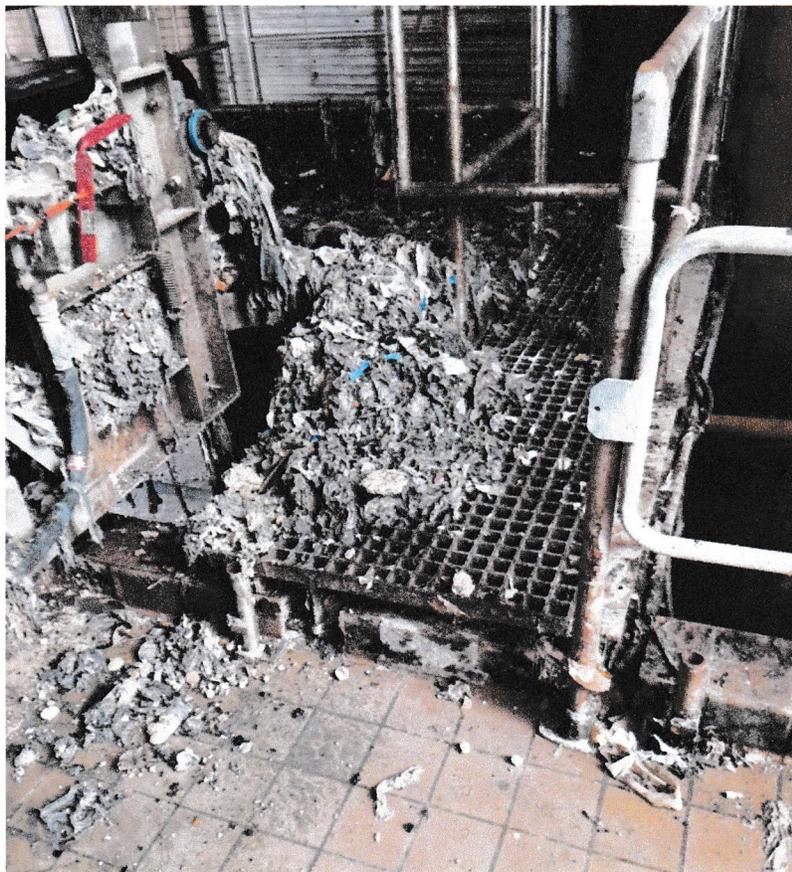
The next stop is at the fine screening building. The City has appropriated the funds to upgrade the bar screens by replacing all the internal parts and installing a more effective wash system. Two of the bar screens have been overhauled and reinstalled. I noticed that the refurbished units were not online. According to Mr. Jackson, the screens needed to be cleaned because rags are preventing them from functioning so the operator took them offline until they can be serviced. Three bar screens were online at this time. I observed that there is still a problem with trash accumulation on the conveyor belts. The transport system does not appear to be functioning possibly due to the buildup of trash on the belts.

4/6/22 Trash overflowing the belt transport system

- G. With respect to item 7 above, the intake tubing on the automatic samplers should be thoroughly cleaned or replaced
- H. With respect to item 8 above, the permittee should ensure that all process equipment is maintained appropriately at all times, and routine service and preventative maintenance is performed to ensure satisfactory operation of the treatment works.

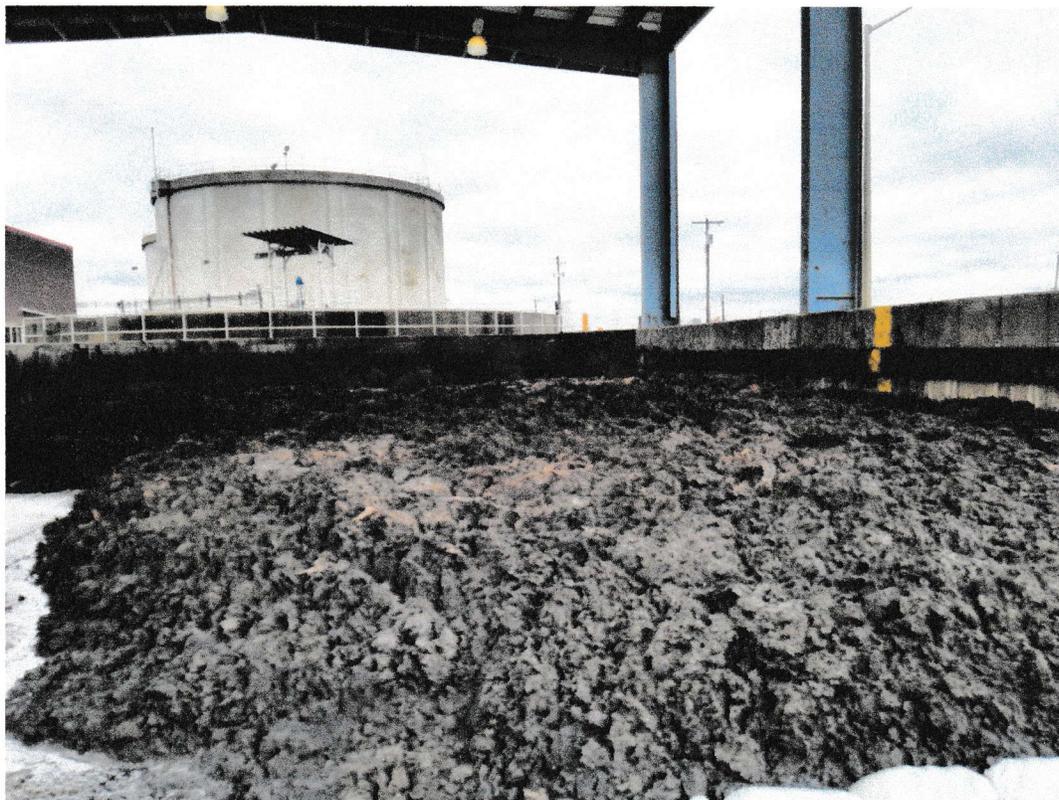
Next, we traveled to the Tailings Transfer Station to evaluate the utilization of this area for untreated sludge storage. I found that the area is already being used to store sludge. The storage area is partially covered, and the concrete pad of the transfer station is sloped slightly to the rear. When I first inspected this area there were open grated drains covering the length of the front of the pad that are connected back to the WWTP. The grated drains were designed to collect drainage from the pad and prevent pad drainage from going into the roadway where there are storm drains that flow to waters of the State. On the date of this inspection, I found that the open grates on the drains were replaced with solid plates and along the inside perimeter of the plates is a small berm constructed of sandbags. Therefore, any drainage from the sludge will flow into the roadway instead of going back to the treatment plant. This configuration is not acceptable. The solid plates must be immediately removed and replaced with open grates that allow drainage from the pad to go to the WWTP. During the initial discussion with Mr. Jackson on 1/31/22, we agreed the sludge would be placed towards the back of the transfer station beyond the yellow line marking on the side

walls and keep the front open. Today, I found sludge has been place at the front of the transfer station, and the sludge has breached the sandbag berm overflowing onto the roadway.

4/6/22 stored untreated sewage sludge. Sludge should have been placed to the rear of the yellow marking on the right side of the picture.

- C. With respect to item 3 above, The Patapsco WWTP must remove the unprocessed sludge from the front of the Tailings Transfer Station and moved to it the back of the pad to the rear of the yellow lines on the wall. The solid plates should be removed from the front drains and replace with the open grated drains so that pad drainage can be collected and sent to the WWTP for processing.

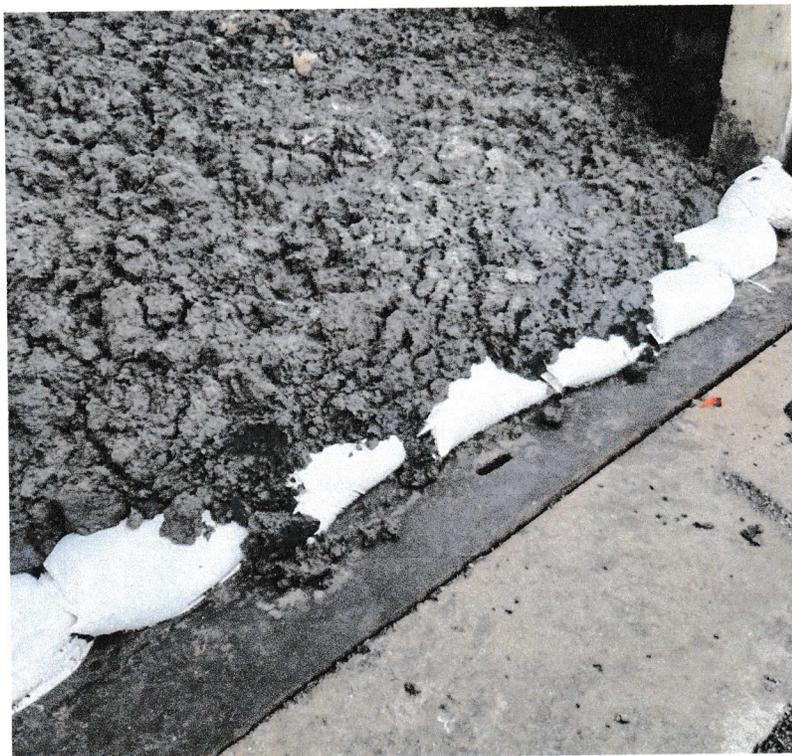
4/6/22 Sewage sludge overflowing the berm.

3. The Patapsco WWTP is storing unprocessed sludge in a position that could cause pathogens and bacteria to enter waters of the State.
4. The BAF system is still losing media and discharging filter media to the surface water of the State.

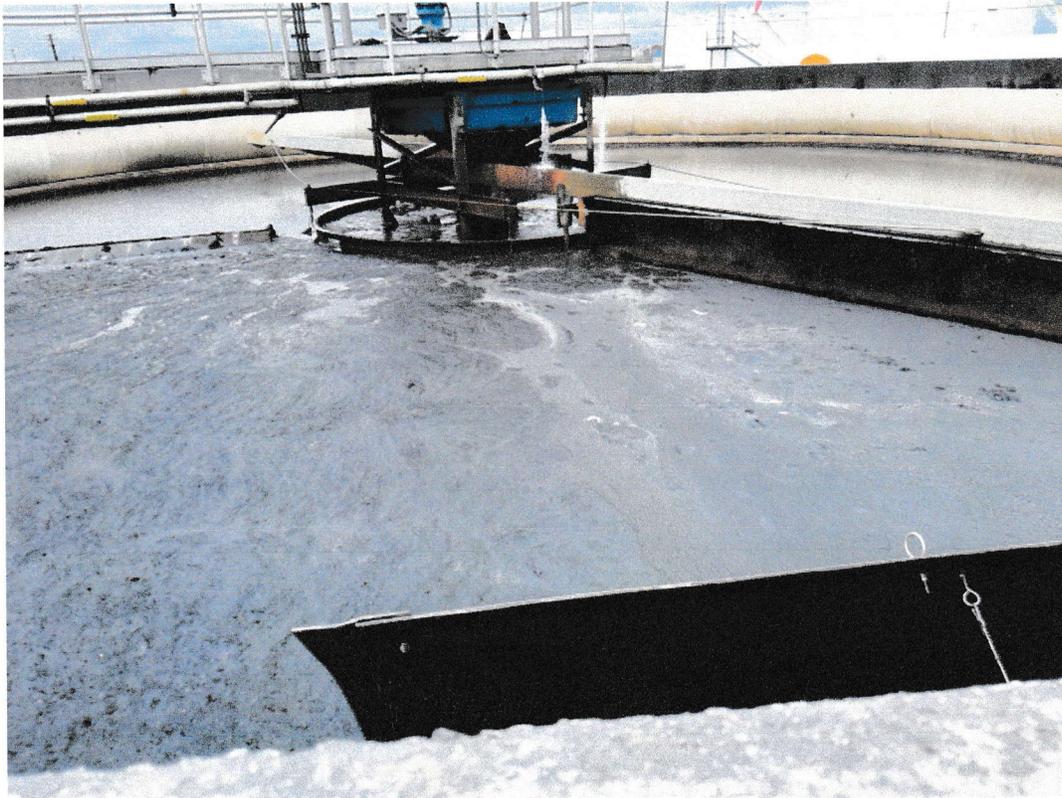
4/6/22 GST #1

The next area of evaluation were the GSTs discussed earlier. The facility has 3 GSTs (#1, #2 and #4) and two are online. The #4 GST is down for repairs. The scrapers, drive and pumps need to be replaced and according to Mr. Thomas it will be back online sometime between 8/22 and 9/22. During an inspection of the # 1 GST, I observed that the sludge blanket is too high blocking the weirs flow. The weirs are cleaned daily. The # 2 GST skimmer was not in complete alignment with the surface of the water. The sludge blanket on GST#2 is also high causing the top layer of supernatant to be dark grey. The GSTs are designed to thicken biosolids to produce a concentrated solids product and a relatively solids-free supernatant. It is evident that the GSTs at the Patapsco WWTP are not producing a relatively solids-free supernatant. This problem has led to monthly effluent violations for BOD, TP and TSS and process control issues. There is almost a threefold increase in the monthly average TSS concentration from 12/31/21 to 2/28/22, which in turn has caused a higher monthly average BOD concentration for the same period. The biological reactors are not nitrifying because the BOD of the influent is too high because of the solids concentration. This in turn has led to issues with controlling ammonia. The monthly average ammonia concentration has doubled from 12/31/21 to 2/28/22 because nitrifying bacteria are not oxidizing ammonia to nitrite due to the higher BOD concentration. If corrections are not made the facility is poised to exceed the seasonal ammonia limits for 2022 as well.

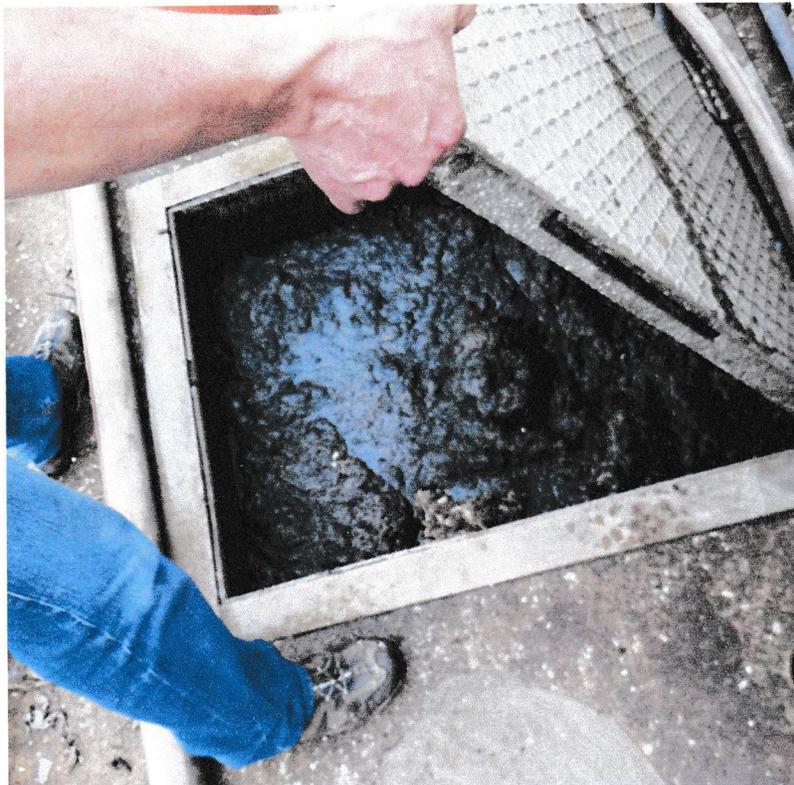
4/6/22 Sludge pit at GST was completely filled. The pit collects the sludge from the GST.

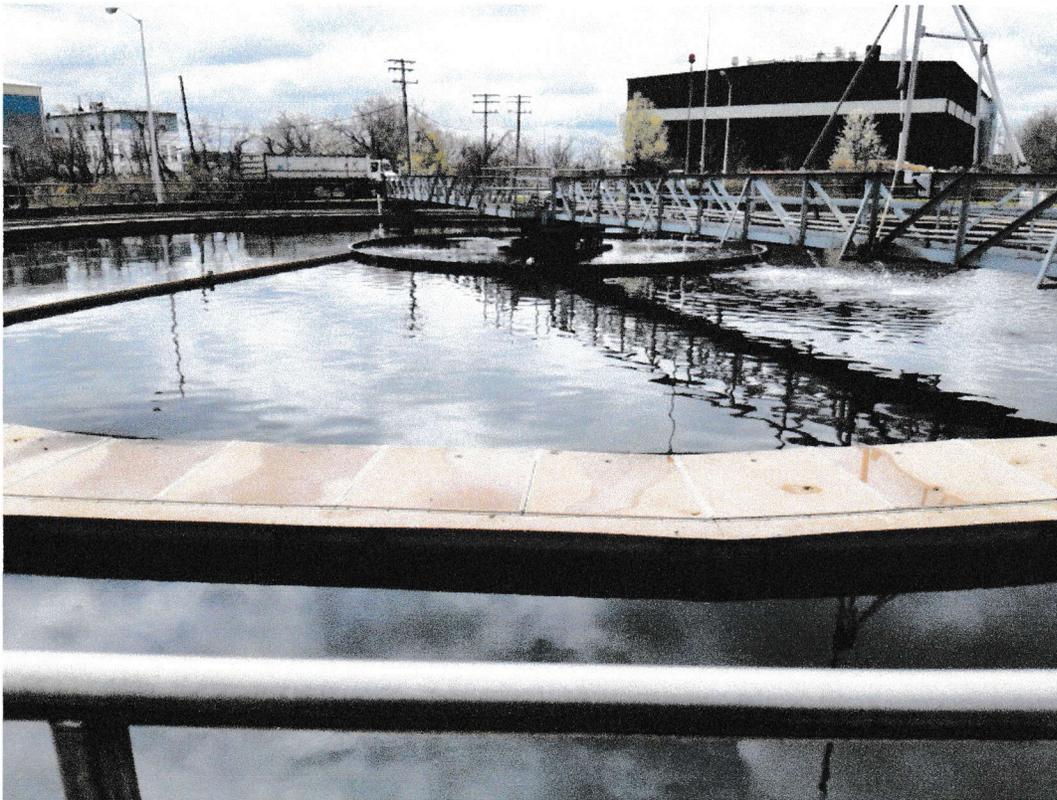
4/6/22 Secondary clarifier

The next I conducted an evaluation of the secondary clarifiers. The water in the clarifiers was grey due to the TSS concentration. There were also media pellets observed in the water of secondary clarifier #1. According to M. Jackson, the media is coming from backwash from the BAF system.

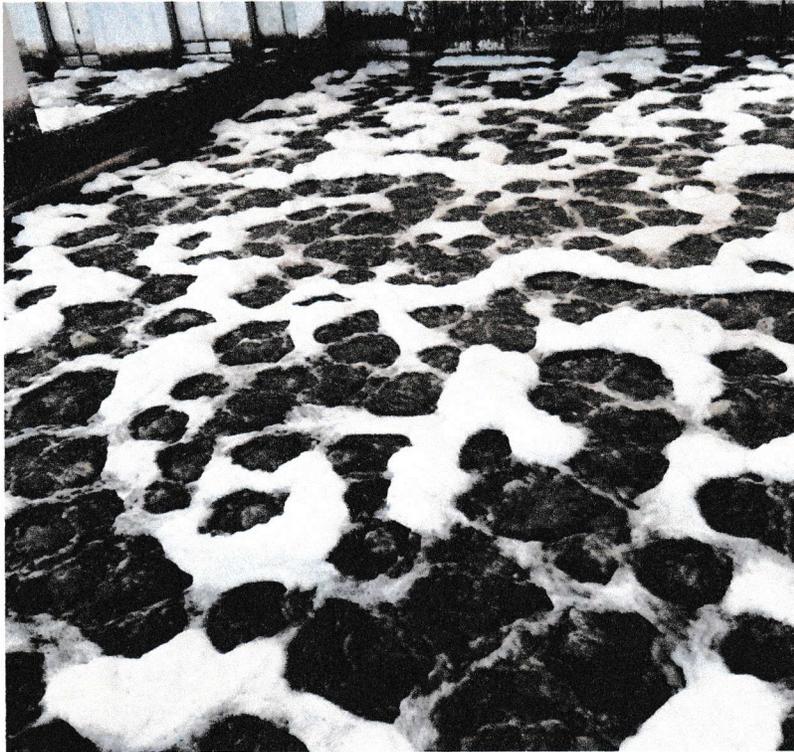
The ENR filter building was the next stop during the site review. The facility has 22 biological aerated filters for nitrification and currently BAF cell #21 is out of service. BAF filter cell #5 has been identified as the malfunctioning cell that is leaking media. There are 34 denitrification filters (DNF) and currently all are online. Earlier today during the preliminary meeting, I received email notice that the facility reported a bypass of the BAF system. During my discussion with Mr. Jackson regarding the incident, he informed me that the bypass was necessary to prevent damage to the system due to the high solids concentration in the wastewater going into the BAF system. The BAF system was now back online. Next, I inspected the filter backwash chamber. There was no filter backwashing occurring at this time, however, residual media can be seen on the horizontal beam in the backwash chamber (See picture below)

4/6/22 BAF system back online after the bypass

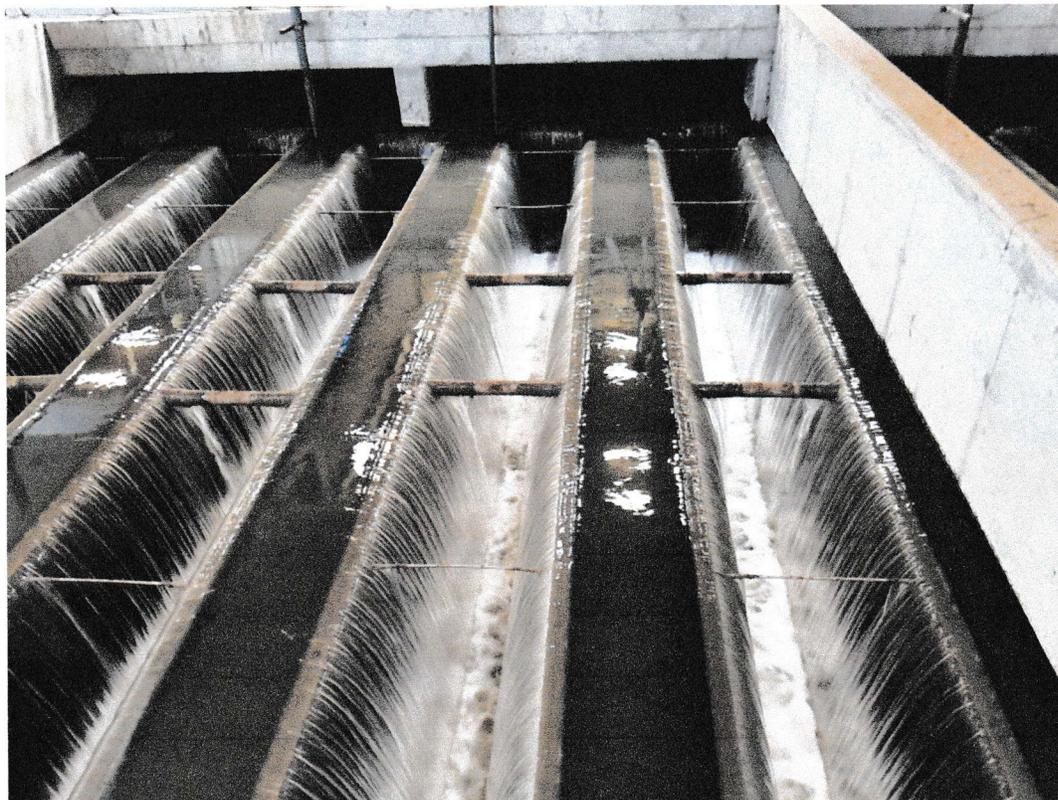
4/6/22 Overflow from BAF to DNF

- D. With respect to item 4 above, the discharge of the filter media to the surface waters of the State is not acceptable, and the Patapsco WWTP must address and resolve this violation. Within 30 days of the receipt of this report the Patapsco WWTP, shall submit a corrective measures plan to mitigate media loss and an engineered plan to collect and prevent the media from entering the Patapsco River.

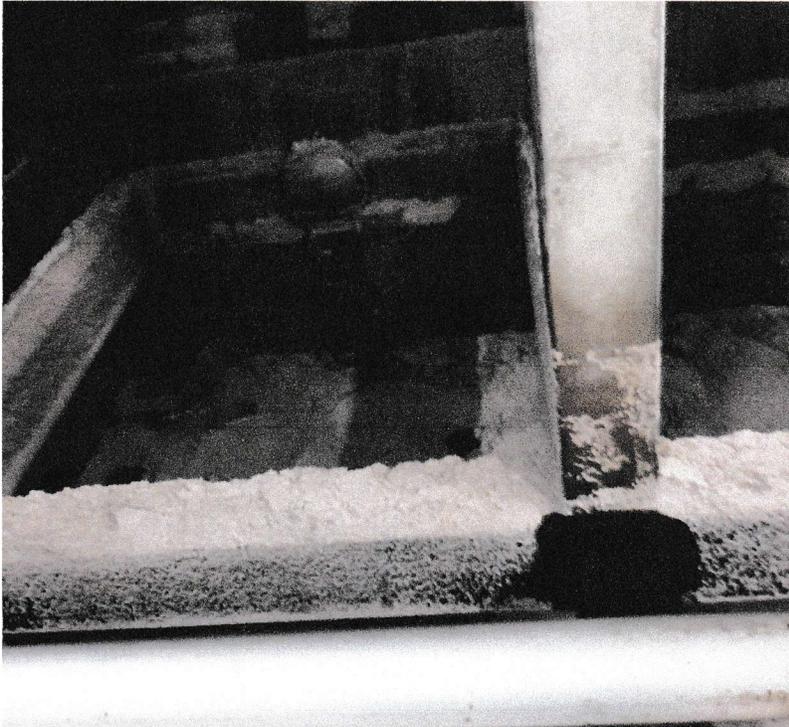
4/6/22 Residual media in backwash chamber from backwash system

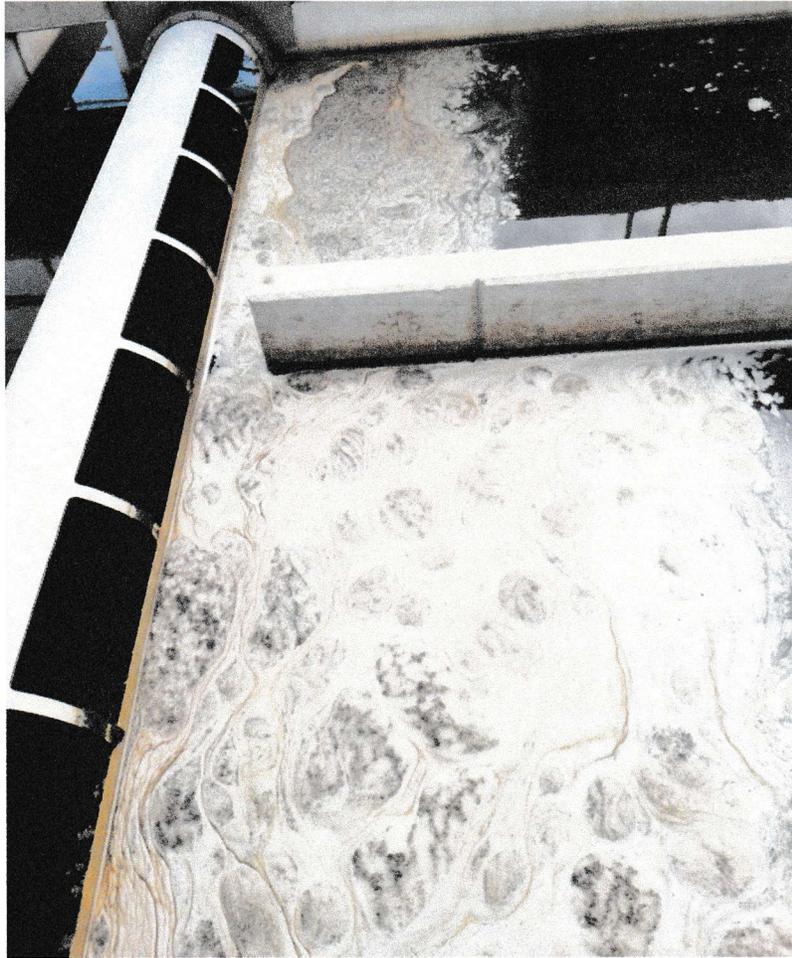
Next, I inspected the chlorine contact basins prior to the final discharge. There are 4 contact chambers and 3 of the 4 are currently online. Each contact chamber has 3 scum logs or troughs to remove floating scum. I observed the final effluent prior to discharge, which was an opaque grey color indicating higher-than-normal solids concentration in the effluent. I also notice a heavy scum layer on the surface of the water in the chlorine contact basins. According to Mr. Jackson, the scum was due to the bypassing of the BAF system earlier today.

4/6/22 Heavy layer of scum at the chlorine contact chamber

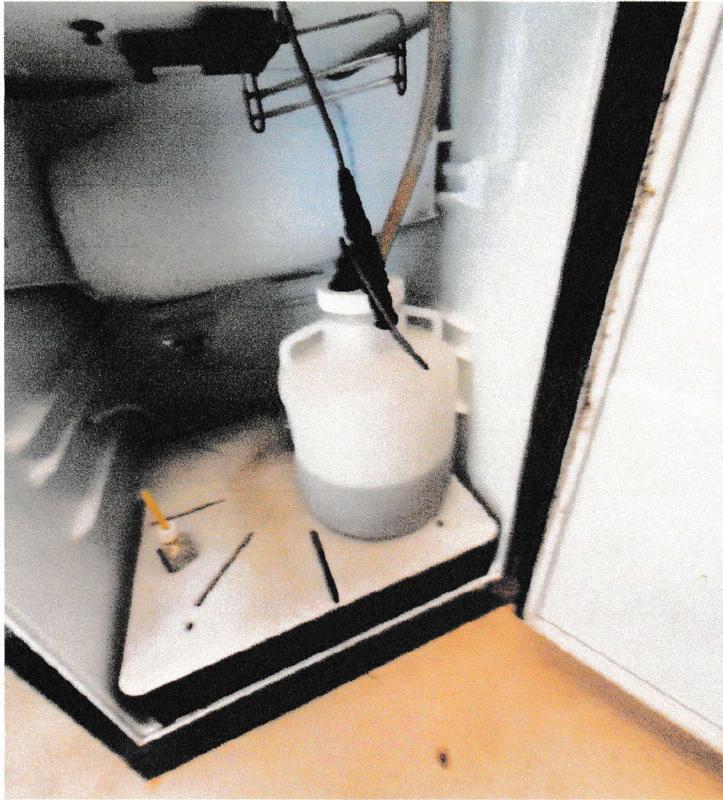
4/6/22 Automatic sampler

The facility is collecting a 24-hr, flow-proportioned composite samples at Outfall 001 in accordance with the requirements of the permit. The primary refrigerated, automatic composite sampler was inspected, and I found that the temperature of the compartment was satisfactory, and the sampling container was also clean. However, the intake tubing had an accumulation of solids on the inside wall, and it should be replaced or thoroughly cleaned. The temperature of the refrigerated compartment was 4.4 degrees C, which meets 40 CFR Part 136 requirements. The facility also has an identical back-up refrigerated, automatic composite sampler, which I also checked and found to be in the same condition and requiring replacement or cleaning of the intake tubing. I inspected the final effluent in the sampling container and observed that the composite sample was an opaque dark grey with visible particulates (see pictures). This condition is not acceptable, and measures must be taken to correct the problem of high solids in the final effluent and throughout the treatment system. According to Mr. Jackson the high solids are due to the earlier bypassing of the BAF.

6. The colorimeter is checked before use with secondary standards but not quarterly using a series of primary standards.
7. The intake tubing on the automatic samplers had an accumulation of solids that could compromise sample results.

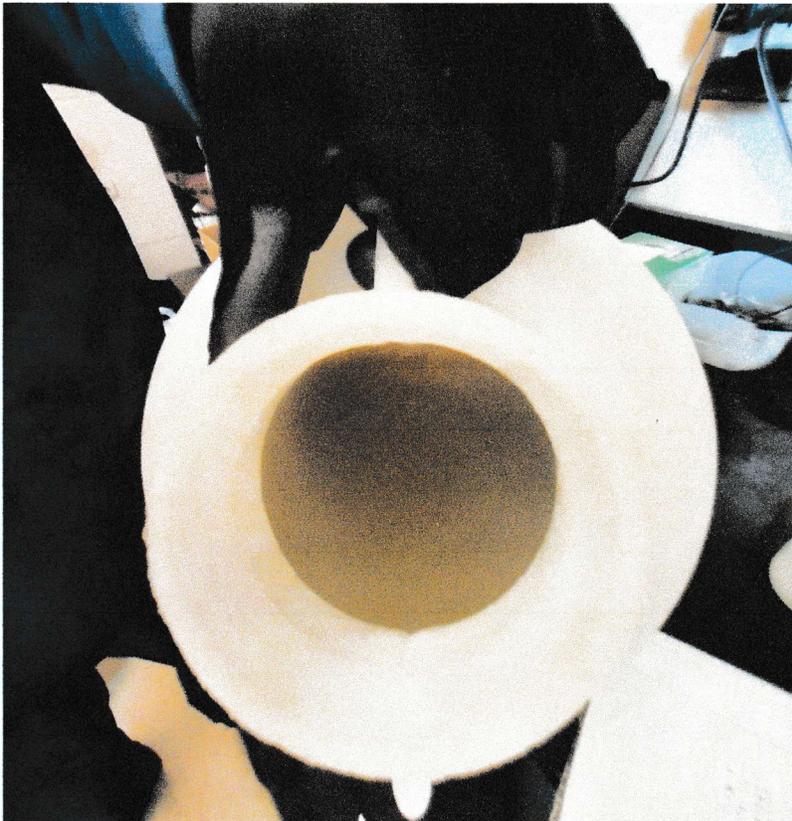
4/6/22 Final effluent composite sample dark opaque grey with particulates

1. The final effluent was an opaque dark grey color with particulates indicating high solids concentration and turbidity. This problem is because the solids processing facility, Synagro Inc. has not been able to successfully keep up with the processing of the solids that are being generated by the treatment system. This has caused an increase of solids in the final effluent. To address this problem, Patapsco WWTP is now storing the excess solids at an on-site transfer station for disposal or treatment at a later date.
2. Although the Patapsco WWTP is having problems dealing with dewatering and disposal of sewage sludge, the facility has an obligation to comply with the conditions of the permit. There were eight reported effluent violations for the period January 1, 2022 – February 28, 2022, see Table 1 below.
