Maryland Department of Environment
Water and Science Administration
Compliance Program
1800 Washington Blvd, Suite 420
Baltimore, MD 21230-1719
410- 537-3510, 1-800-633-6101

Site Name: Patapsco WWTP
Facility Address: 3501 Asiatic Ave, Curtis Bay, MD 21226
County: Baltimore City County

Permit / Approval Numbers: 15DP0580
NPDES Numbers: MD0021601
Inspection Reason: Complaint
Site Status: Active
Compliance Status: Noncompliance
Site Condition: Noncompliance
Recommended Action: Additional Investigation Required
Evidence Collected: Photos or Videos Taken, Record Review, Visual Observation
Delivery Method: Email
Weather: ClearAverage

Today I performed a follow up inspection at the Patapsco WWTP for complaint of a black discharge at the final Outfall 001A. The facility's NPDES Discharge Permit number is MD0021601 and State number 15-DP-0580, the Patapsco WWTP. The permit effective date is

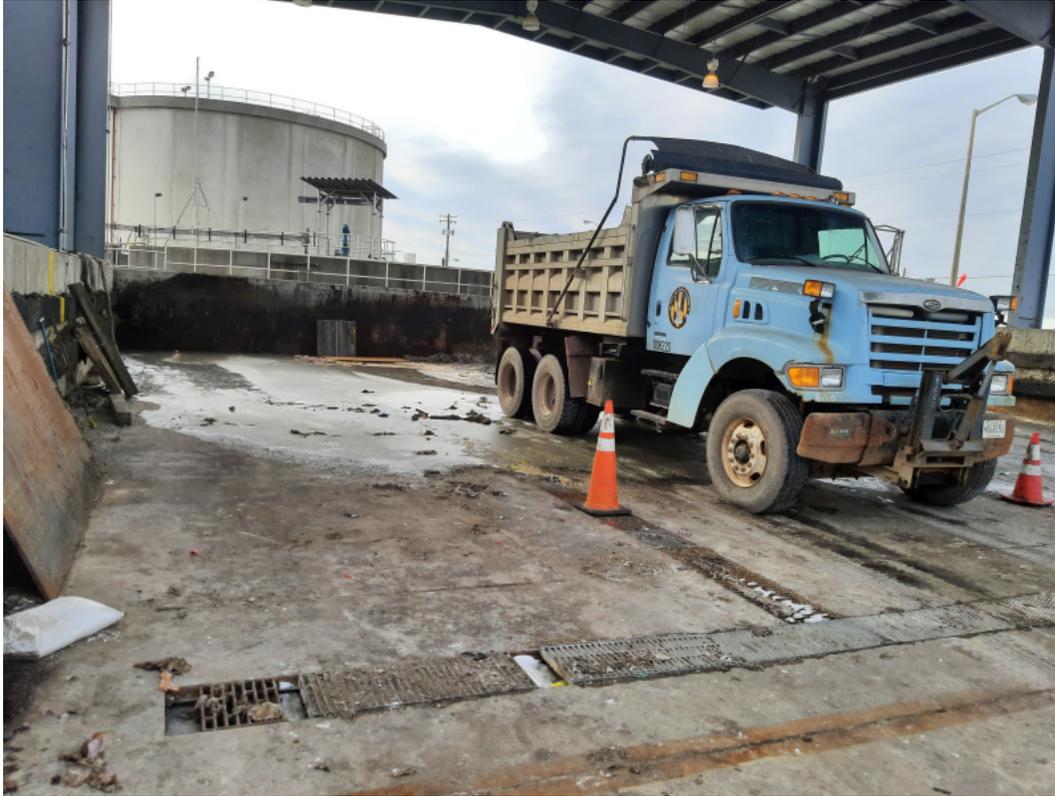
Transfer station 1/31/22 note clogged grates at the front of the entrance

The area is partially covered, and the concrete pad of the transfer station is sloped slightly to the rear. There are drains at the front of the pad that are connected back to the WWTP. The pad drains were designed to collect any drainage from the pad and preventing drainage from going into the roadway. The grates of the drains were clogged with solid material and therefore not able to function as designed. Therefore, any drainage from the pad can flow over these grates into the roadway where there are two storm drains approximately 25 feet from the transfer station. Drainage from the area has the potential to reach the storm drains and ultimately waters of the State. Before this area is used for temporary sludge storage, the necessary provision should be made to ensure that the drainage from the site does not enter the paved roadway adjacent to the transfer station. Note: I was informed by Mr. Jackson that on 2/9/2022, the transfer station is being used to store the unprocessed sludge. Mr. Jackson does not know at this time how long the transfer station will be used for the storage of the sludge. Sludge storage at the Transfer Station should be a temporary solution. After speaking with Mr. Jackson, as it stands as of 2/10/2022, the permittee does not appear to have a long-term solution to the solids processing problem.

1. The grated drains at the front of the Transfer Station were clogged with solid material, trash and other debris preventing the drains from functioning as designed. Because of the clogged drains, there is reasonable potential that drainage or runoff from the storage area will travel over the drains enter the nearby storm drains and ultimately enter waters of the State.

- A. With respect to item 1 above. the grated drains at the front of the Transfer Station should be cleaned of solids, trash and other debris so that the drains are capable of collecting any drainage from the Transfer Station pad.

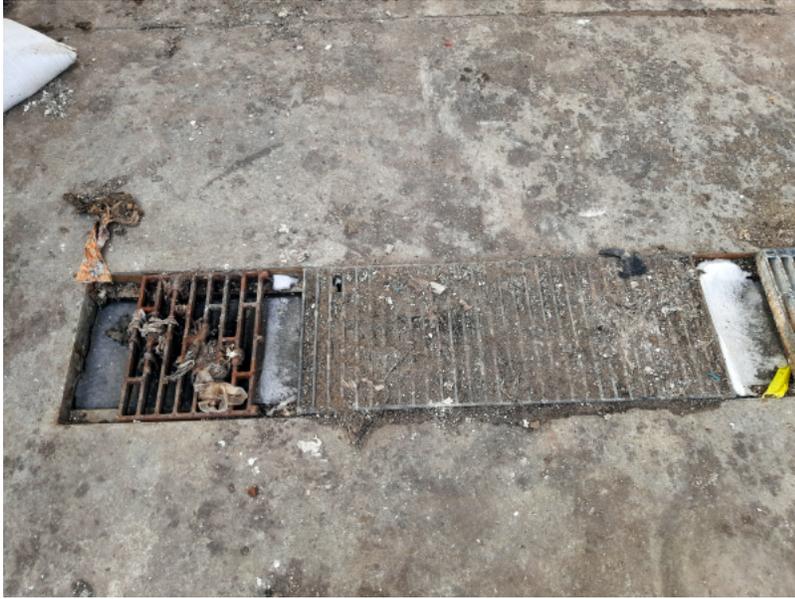
Close up of clogged drain 1/31/22

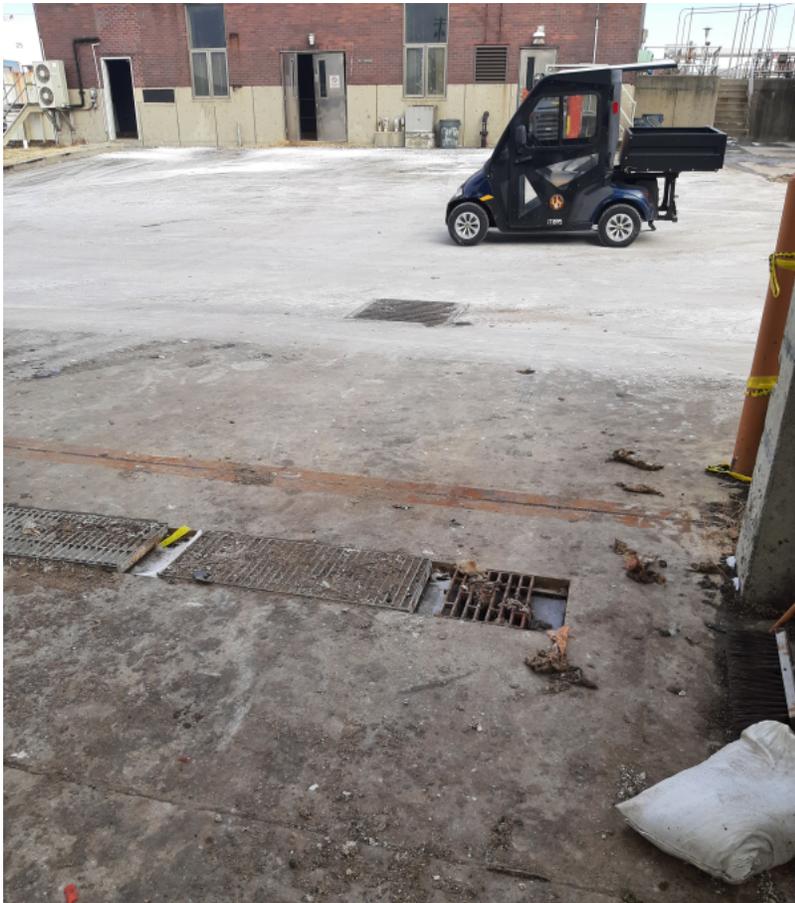
View from inside the pad. Note one of the storm drains in the roadway 25' from clogged drain.
1/31/22

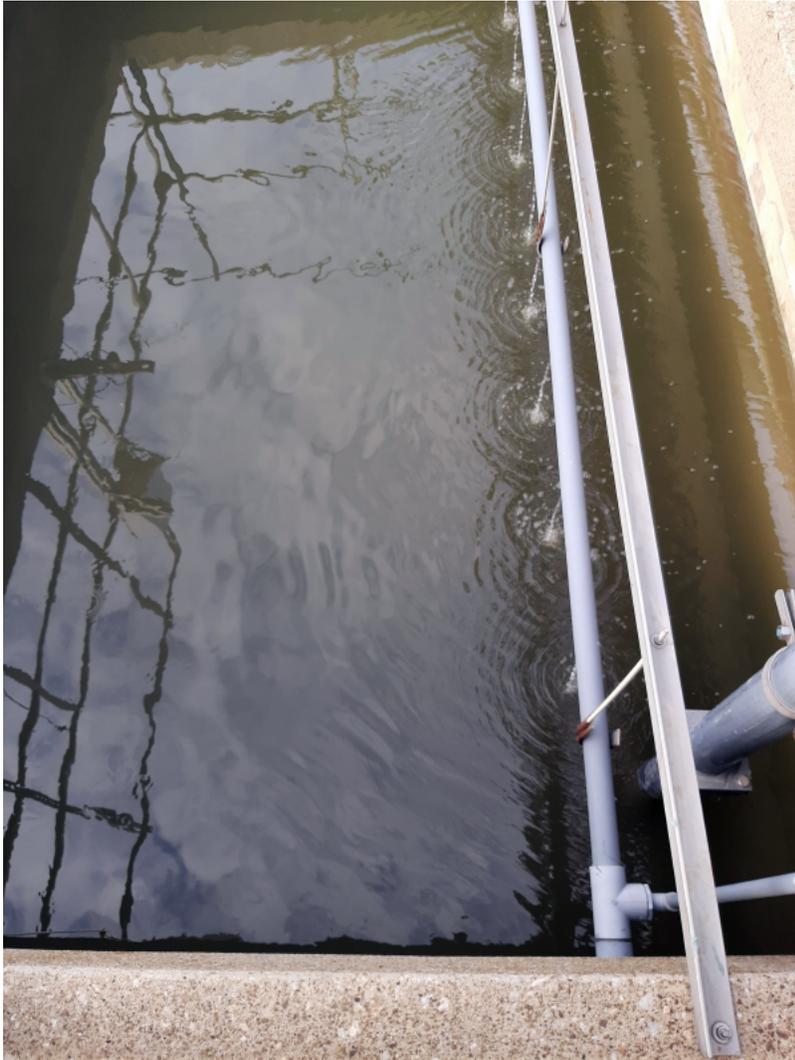
Next, we traveled to the chlorine contact chambers (CCC). There I observed the final effluent, which was an opaque grey color indicating higher-than-normal solids concentration in the effluent.

The effluent in the CCC was an opaque dark grey color 1/31/2022

5. The final effluent was an opaque dark grey color indicating high solids concentration and turbidity. This problem is because the solids processing facility, Synagro Inc. has not been able to successfully keep up with the processing of the solids that are being generated by the treatment system. This has caused an increase of solids in the final effluent. To correct this problem, Patapsco WWTP is now storing the excess solids at an on-site transfer station for disposal or treatment at a later date.

- E. With respect to item 5 above, the Patapsco WWTP should devise a permanent solution for the management of solids produced by the treatment process. Within 30 days of the receipt of the report the Patapsco WWTP must submit a plan addressing a permanent solution for the proper management, treatment and disposal of solids produced by the treatment process.

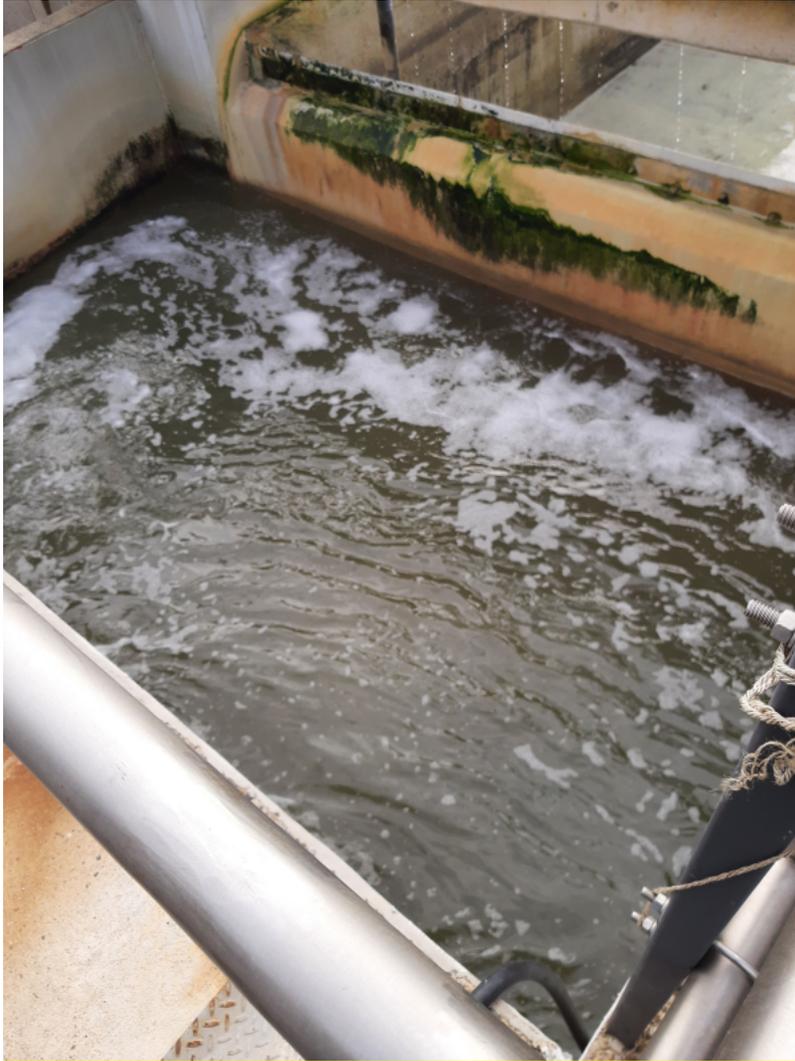
Final effluent overflow point- grey effluent with slight foaming due to turbulence. 1/31/22

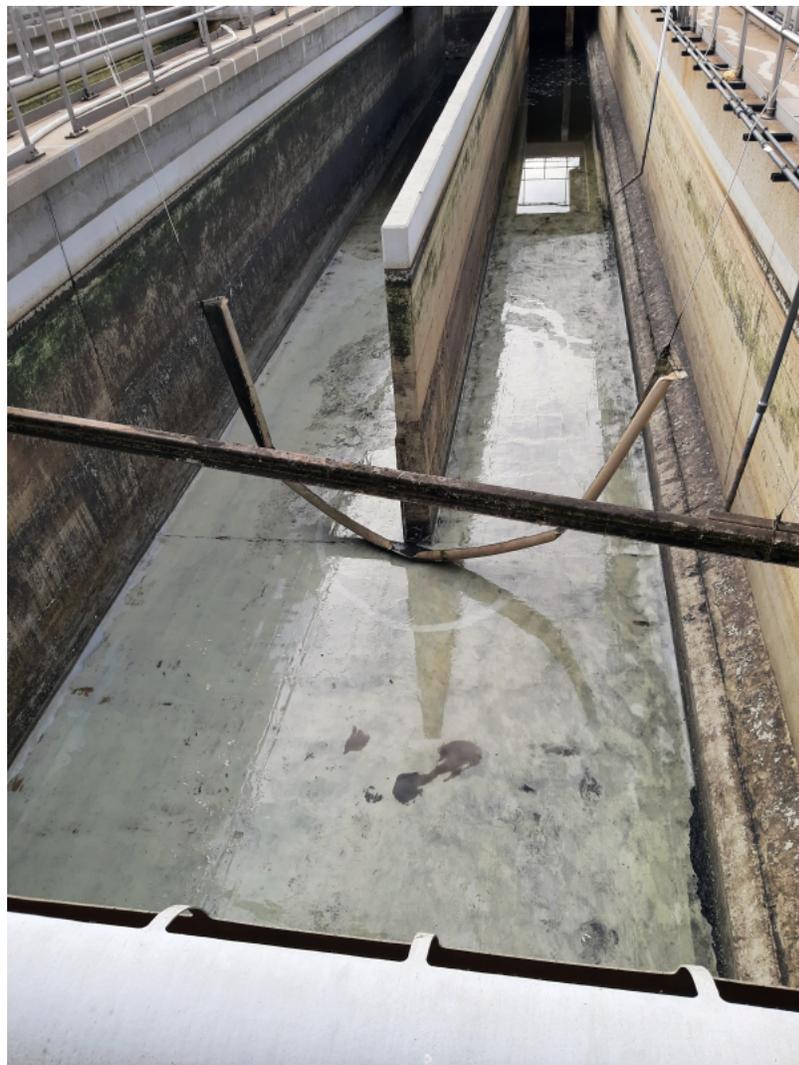
CCC #4 drained and taken out of service for cleaning 1/31/2022

I observed that the #4 CCC had been drained. According to Mr. Johnson, they are in the process of cleaning the #4 CCC. He further stated that they plan to clean all CCC regularly.

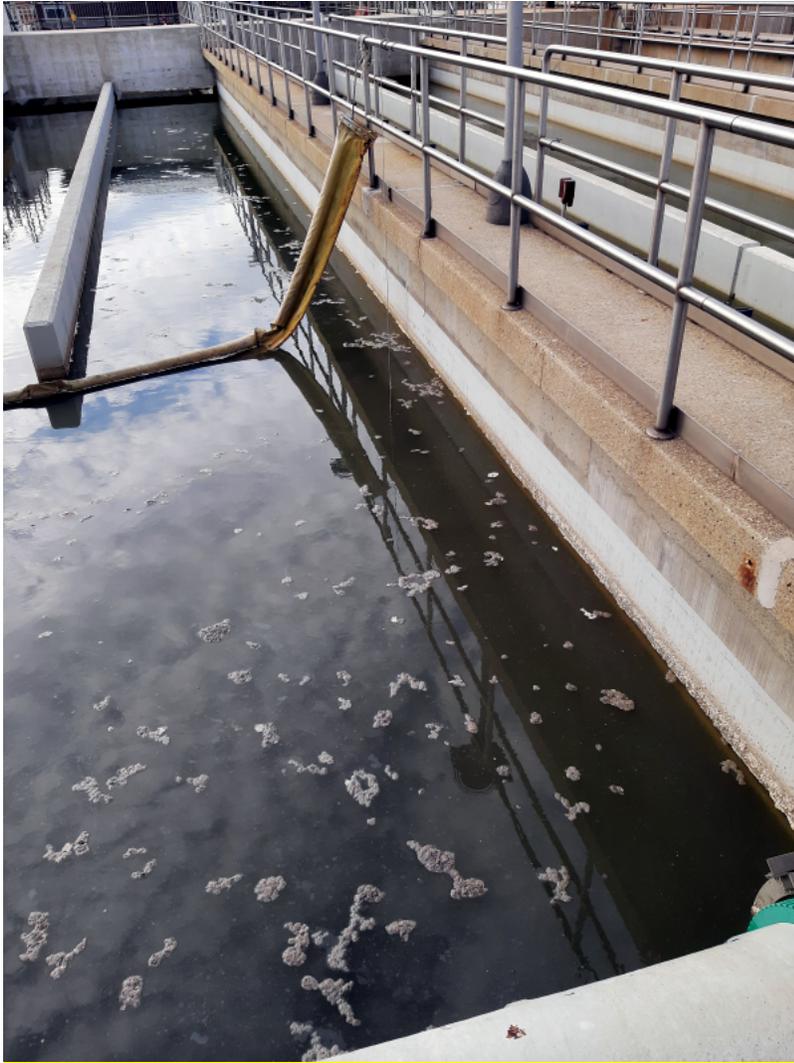
During my assessment of the area, I noticed that there was no one skimming the floating solids at the CCC before the overflow channel. According to Mr. Johnson, the shift just changed, and someone would be at the CCC skimming soon. I was in the area for approximately 20 minutes, so I am not sure how long it took for someone from the next shift to arrive and begin skimming.

CCC – Dark grey turbid effluent with floating solids/ FOG traveling to scum log 1/31/22

2. Along with the management of the scum logs, Patapsco WWTP staff perform manually skimming at the CCC. My evaluation of the CCC area occurred during a shift change, and no one was at any of the skimming stations. All manual skimming and management of the scum log cease for a period of time during shift changes.

- B. With respect to item 2 above, the Patapsco WWTP must conduct FOG mitigation activities and make every effort to comply with Special Condition A2 footnote 2 of the permit which states, "There shall be no discharge of floating solids...". The Patapsco WWTP should comply with Special Condition M. should be available to raise or lower the scum logs as necessary for optimum FOG removal to prevent floating FOG from entering the Patapsco River.

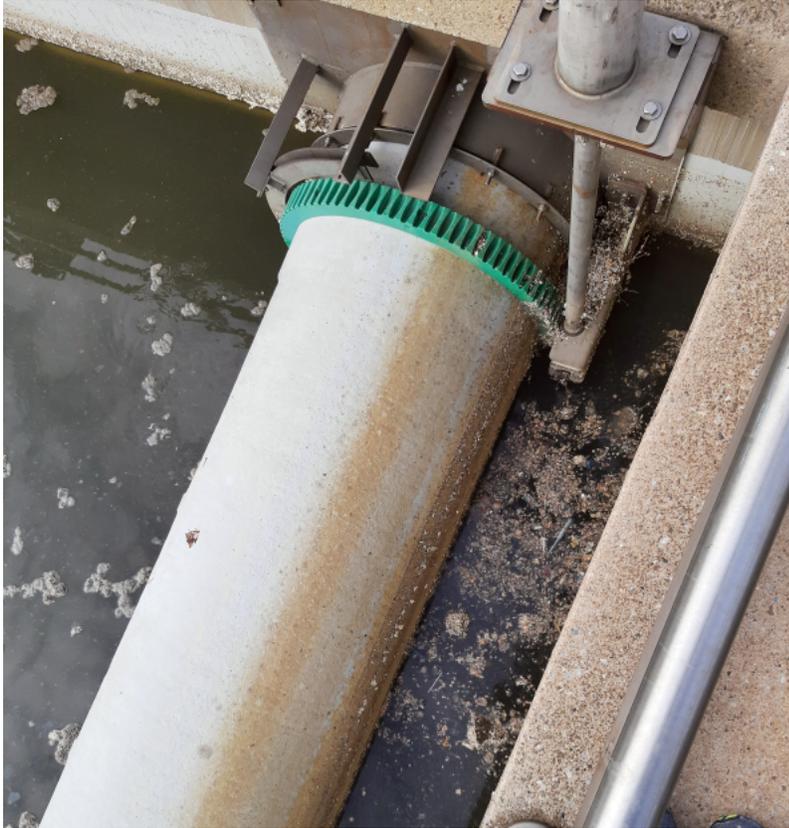
During this inspection, I found that the active scum log was in the correct alignment to collect the floating scum. However, I observed that some of the scum was able to pass through the scum log. This scum should be manually skimmed to remove the floating material.

Scum was able to pass through the scum log 1/31/22
