**Maryland Department of Environment**  
**Water and Science Administration**  
**Compliance Program**  
**1800 Washington Blvd, Suite 420**  
**Baltimore, MD 21230-1719**  
**410- 537-3510, 1-800-633-6101**

**Site Name:** Patapsco WWTP  
**Facility Address:** 3501 Asiatic Ave, Curtis Bay, MD 21226  
**County:** Baltimore City County

**Permit / Approval Numbers:** 15DP0580  
**NPDES Numbers:** MD0021601  
**Inspection Reason:** Follow-up (Non-Compliance)  
**Site Status:** Active  
**Compliance Status:** Noncompliance  
**Recommended Action:** Continue Routine Inspection  
**Evidence Collected:** Photos or Videos Taken, Record Review, Visual Observation  
**Delivery Method:** Email  
**Weather:** Clear Average

### **Inspection Findings:**

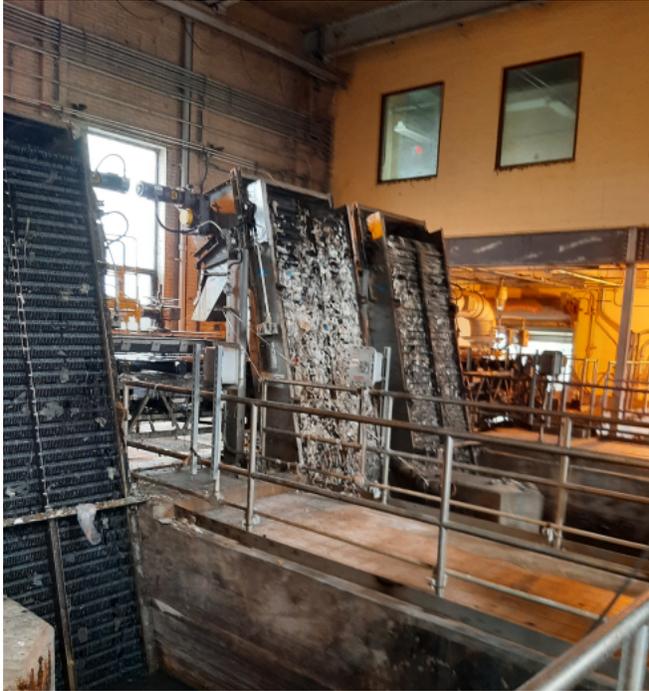
The facility has eight screening units, four for each of the two trains. During my inspection of the fine screening units, I found that there were no changes from the May 6, 2021, inspection. However, the system was overwhelmed with collected trash on this occasion. The trash conveyors and collection hoppers were being overfilled with trash. The debris from the screens was falling off the conveyor belts and the trash collection hoppers were being overfilled. The current screening system alone at this point is not able to manage the incoming trash. The permittee should manually assist with maintaining the trash to prevent backups in the system. According to Mr. Johnson, the City has appropriated the funds to upgrade the bar screens by replacing all the internal parts and installing a more effective wash system. In addition, the conveyor belts will be replaced, and a new skirting system will be installed.

10/6/2021 Bar Screen units.

- E. With respect to item #5 above, the trash and debris in the fine screening building should be evaluated and addressed as necessary to ensure that the area is managed properly.

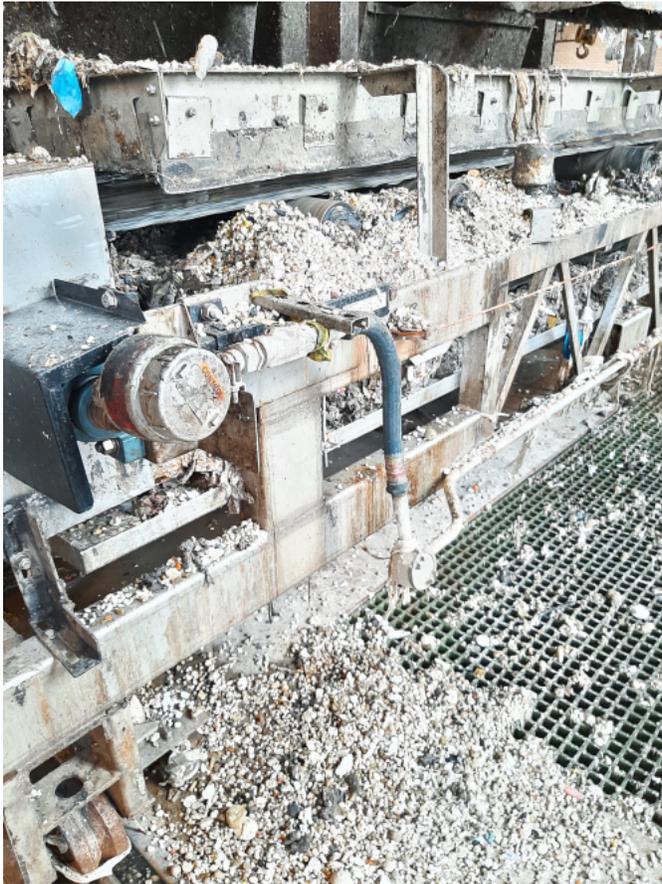
10/6/2021 Conveyor belt overwhelmed by trash

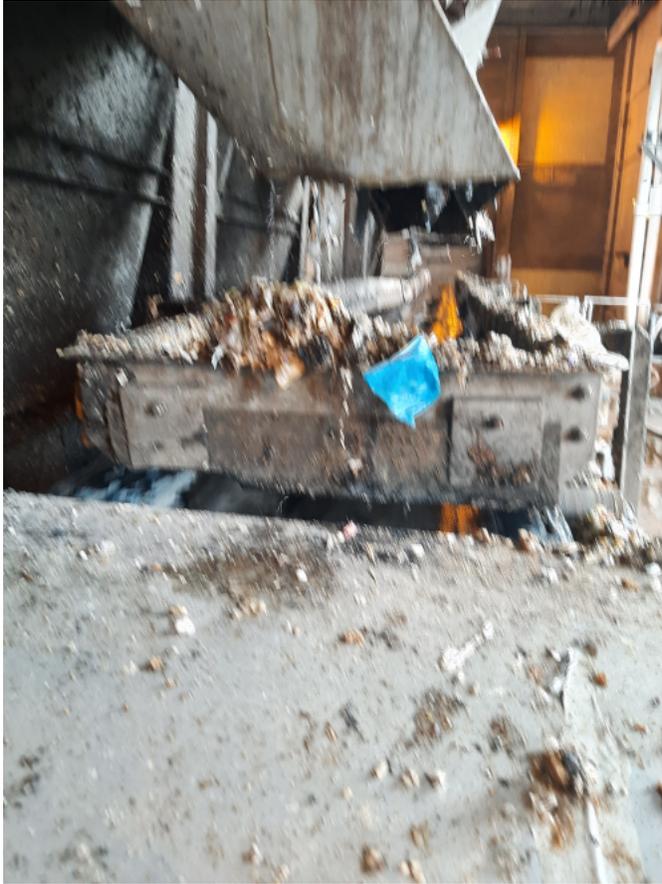
10/2/2021 Trash collection hopper in fine screen building

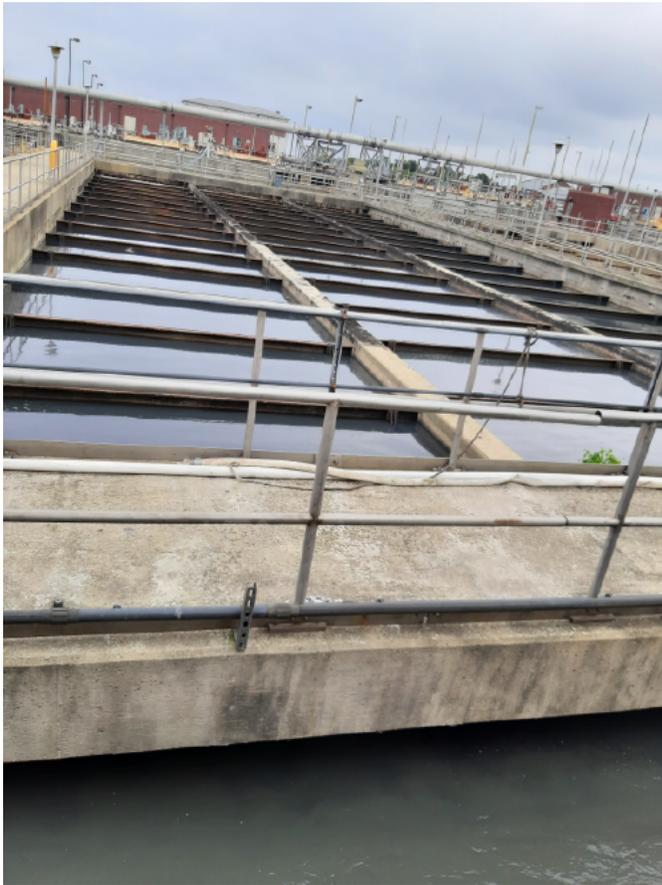
The wastewater travels from the fine screening to the primary settling tanks (PST) for initial settling of the solids. The plant has six primary settling tanks with 3 passes. The bottom sludge from the tanks is gathered by screw collectors at the bottom of the tanks and collected in hoppers and then sent to gravity thickeners. During an inspection of the PSTs, I found that there was a significant improvement from my observations during the May 6, 2021, inspection. Today, all the PSTs were in operation. The scum and FOG solids that had clogged the system have been vacuumed out of the PSTs allowing the wastewater to freely flow through all the PSTs. Now that the scum and FOGs have been removed the skimmers can be manually turned on four of the PSTs. The permittee is using nets to skim the remaining PSTs. When I asked how often the skimmers are checked and turned, I was told every day, however the operator who turns the skimmer stated that he checks every other day. Mr. Jackson stated that there may be an operator on another shift that also checks and turns the skimmers. The satisfactory collection and elimination of FOG from the wastewater is an important process at the primary treatment stage. There should be a schedule designating when the skimmer should be checked and skimmed. The permittee should maintain a log showing date, time, name of the person who checks and turns the skimmers and skims with net each of the skimming units. The plant manager should determine how often the units should be checked and turned, however at minimum it should be at least once per day. During the inspection of the PSTs, I observed one skimmer that needed attention due to the floating scum that needed to be cleared from the trough. Mr. Jackson asked one of the operators to take care of the problem. Some of the skimming is done using nets. I observed that during the net skimming the scum/FOG

10/6/2021 PST now cleared of FOG and other solids

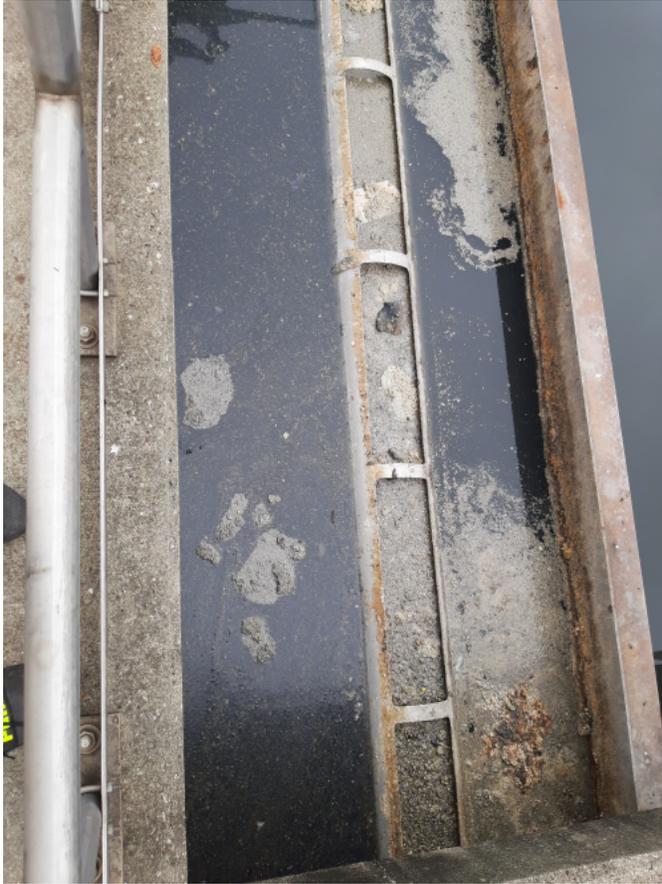
10/5/2021 PST requiring attention.

- F. With respect to item #6 above, there should be a schedule designating when the skimmers should be checked and manually skimmed. The permittee should maintain a log showing date, time, name of the person who checks and turns the skimmers and skims with a net at each of the skimming units.

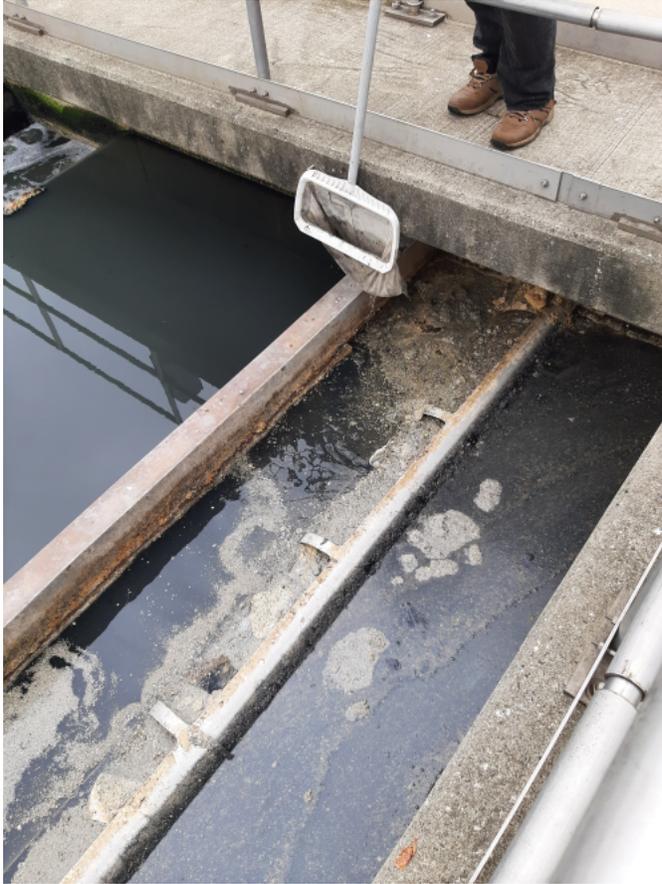
10/4/2021 Skimming the FOG/scum

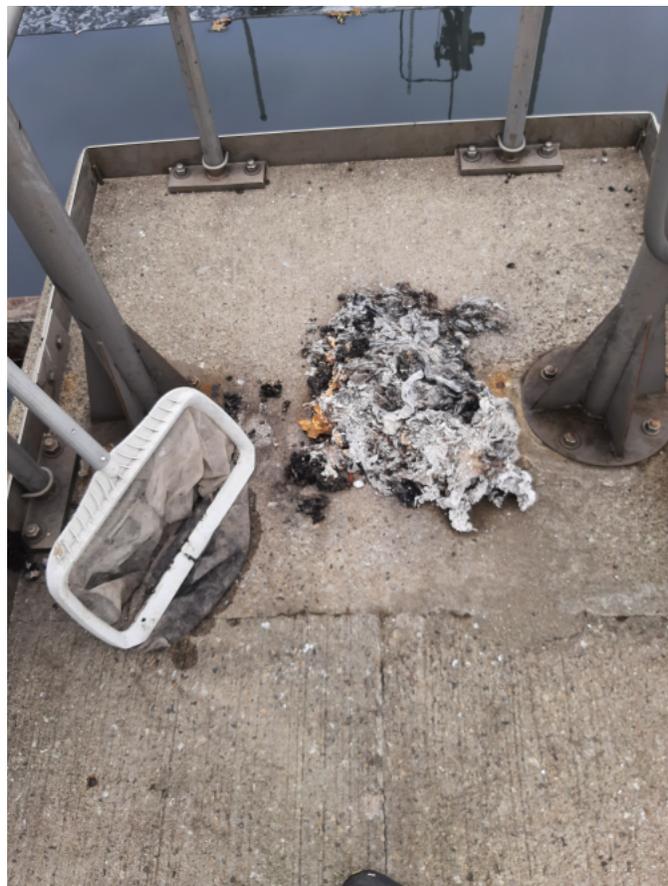
that is collected is dumped on the walkway deck. This waste should be placed in a collection container or trash can for proper disposal to prevent reentry back into the system.

10/6/2021 Skimmed waste being dumped on the deck of the PST

- G. With respect to item #7 above, skimmed material should be placed in collection containers and disposed of properly.
- H. With respect to item #8 above, FOG in the Patapsco River is a continuing problem, the permittee should find a way to address this problem as soon as possible considering the options mentioned above.

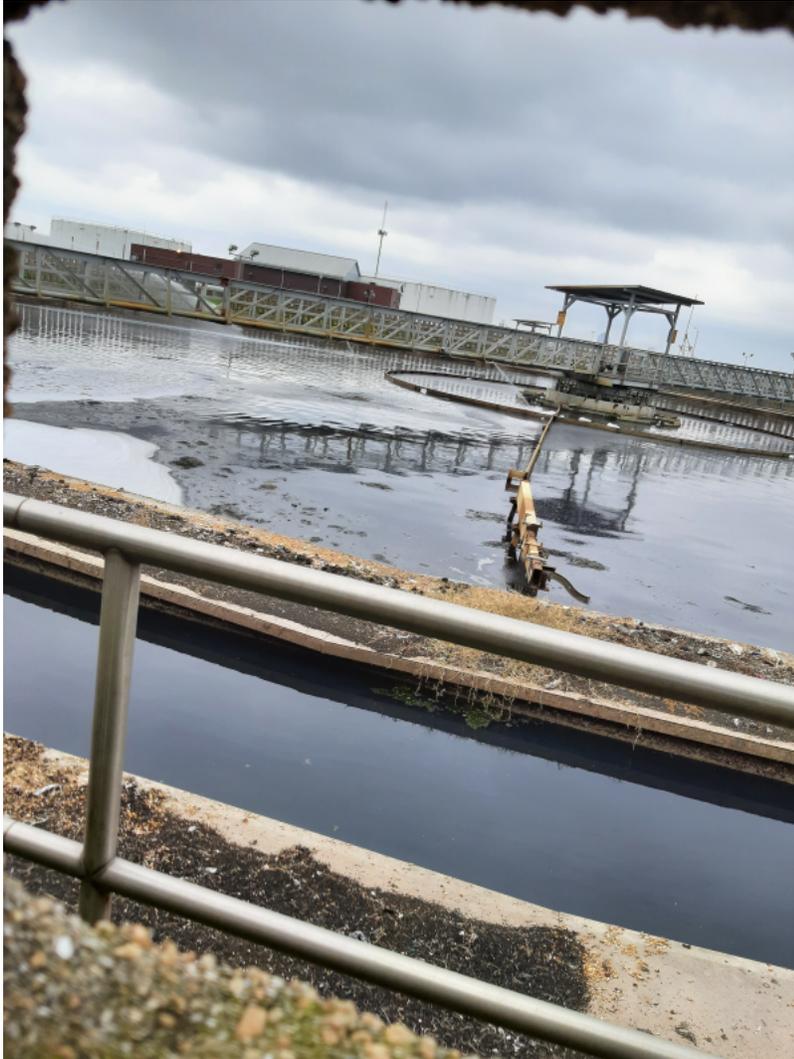
The wastewater leaves the primary settling tanks and flows to high-pressure oxygen reactors. Each of the six settling tanks has an associated reactor. In the oxygen activated sludge reactor process, the first stage receives no oxygen and oxygen is added to the second stage to maintain a dissolved oxygen concentration of at minimum 6.0 mg/l up to 12.0 mg/L. As previously mentioned above, the on-site liquid oxygen plant is operating at a reduced capacity due to equipment problems and failures. The facility is not able to inject the purchased liquid oxygen with the same pressure as can be done using the onsite oxygen plant and because of this the second stage dissolved oxygen can only reach 5.0 mg/L, which is under the minimum 6.0 mg/L required for second stage nitrification in the biological treatment. Under normal operation with the oxygen plant in operation, the second stage DO is monitored by the operators and adjusted as necessary. The waste streams from reactors are split between eight secondary clarifiers. During this inspection, clarifiers #3 and #6A were out of service. Two of the RAS pumps on #6A were out of service. According to Mr. Johnson, there are no replacement parts for the 4 large clarifiers, however contract SC457 was approved to refurbish the large clarifiers. I observed that the skimming arm on clarifier #5A was broken and required repairs and clarifier # 4 had dried media with vegetation growing on the weir cover. The skimmer arm on clarifier #5A should be repaired and the media and vegetative growth should be removed from clarifier #4.

10/6/2021 Clarifier #4

- B. With respect to item # 2 above, the Patapsco WWTP should keep the Department informed on the status of the repairs and corrective actions taken to address the major problems with plant performance due to equipment failures, maintenance and process problems.

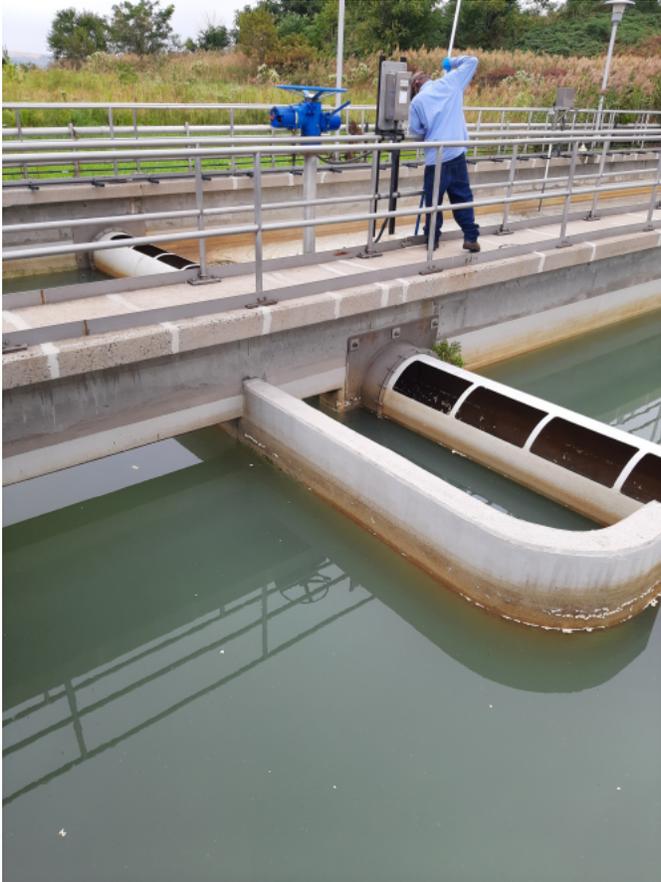
Next, I inspected the chlorine contact basins prior to the final discharge. There are 4 contact chambers and 3 of the 4 are currently online. Each contact chamber has 3 scum logs to remove floating scum. Moreover, because of fluctuations in flow, the scum logs must be manually raised and lowered according to the water level. I observed that an operator was at the contact basins collecting the floating scum using a net and monitoring the active scum log. The scum logs can only be used at one chlorine contact chamber at a time because the amount of collected scum overwhelms the system when the scum logs for two or more chambers are used simultaneously. The scum pit fills faster than it can be pumped off causing additional problems. The facility should find a way to ensure that all scum logs can be used concurrently. The facility should either invest in a larger scum pit or find a way to effectively pump out the scum from the scum pit using additional pumps or a pump that can keep up with the incoming scum going to the scum pit.

10/6/2021 operator manually skimming at the contact chamber

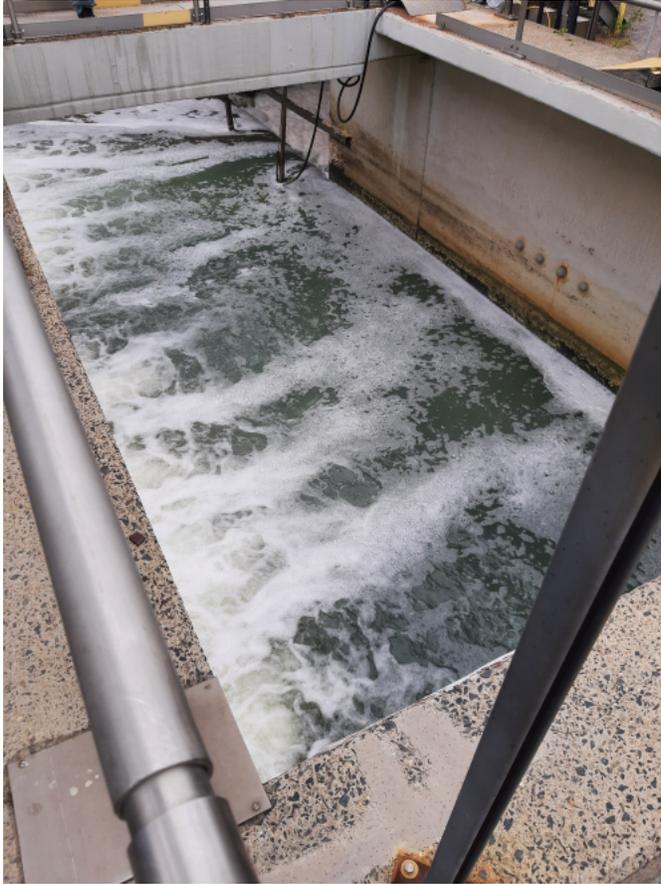
10/6/2021 Final effluent.

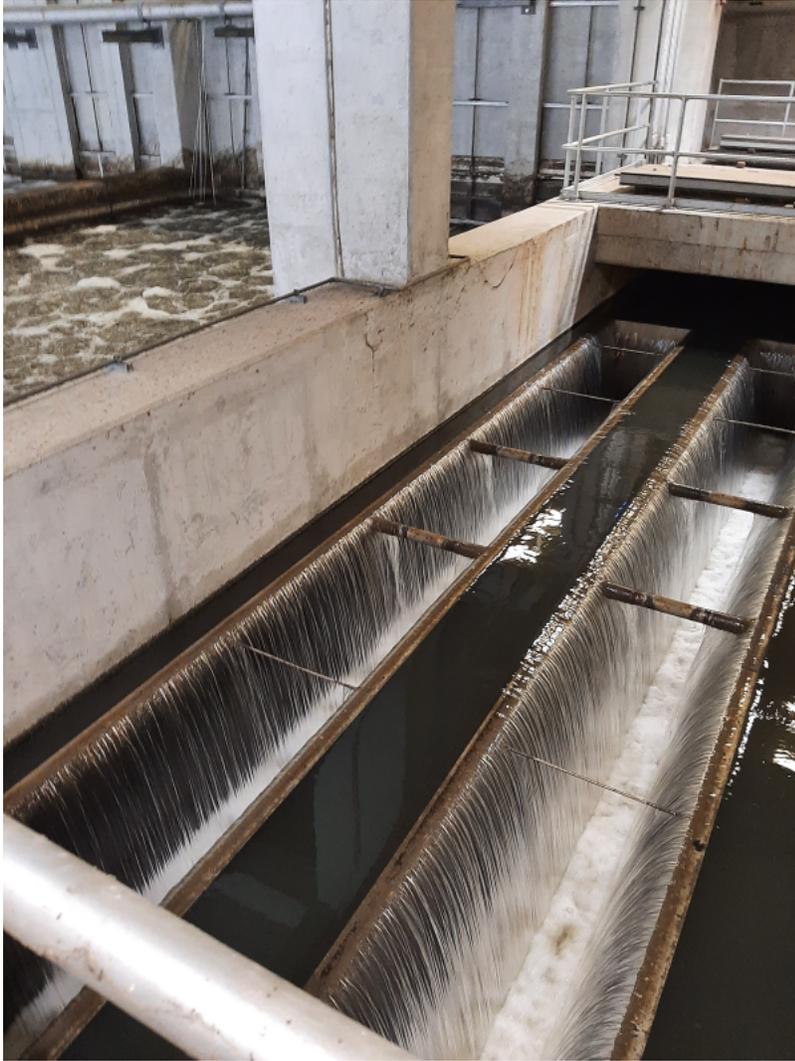
The ENR filter building was the last stop during the site review. The facility has 22 biological aerated filters (nitrification and de-nitrification filters). As mentioned above, filter cell #5 has been identified as the malfunctioning cell that is leaking media. During the backwash procedure, I observed what appeared to be media going over the weir. Residual media can be seen on the horizontal beam in the backwash chamber.

10/6/2021 ENR Biological Aerated filter system

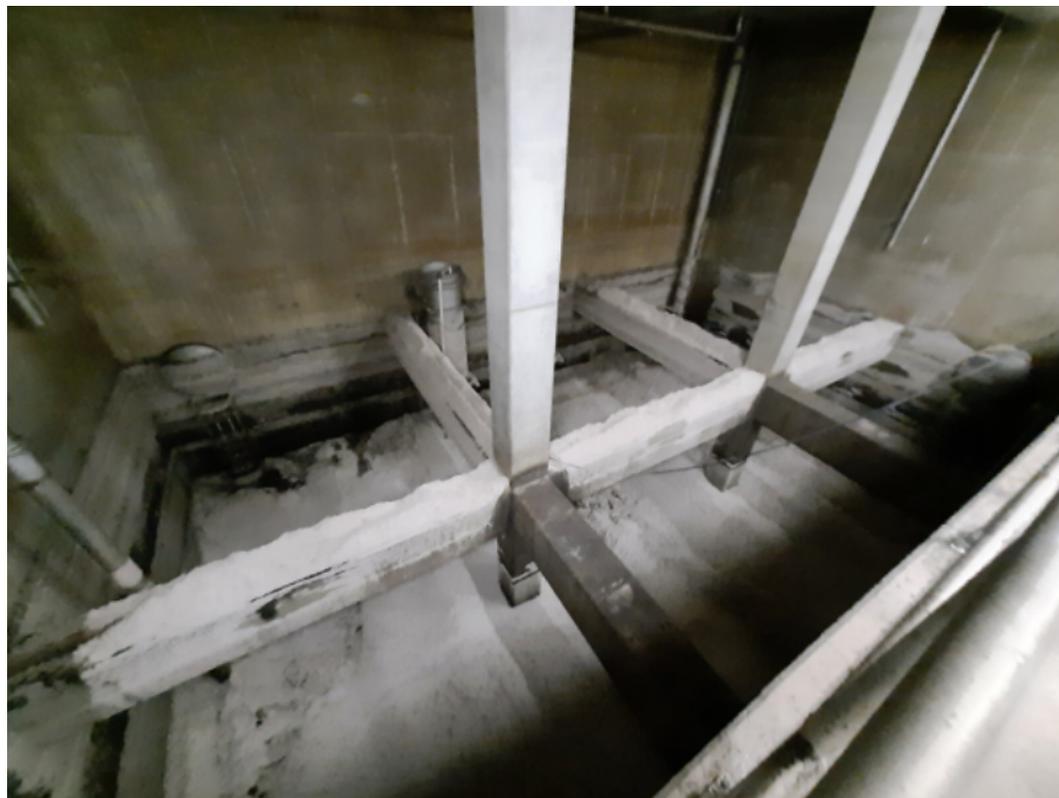
10/6/2021 In the backwash chamber- filter media on center horizontal beam
