# **Overtopping Protection 101**

Scott Bass, P.E.

MDE Dam Safety

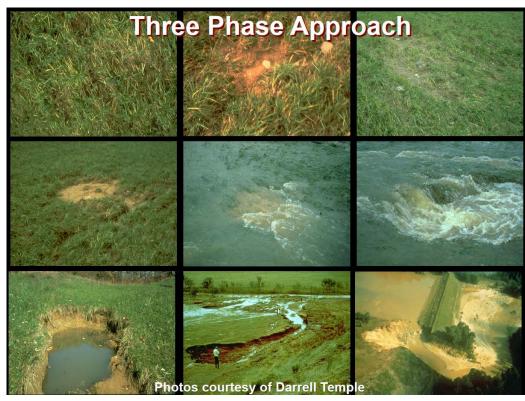
Breach Process. USDA – ARS Research

- 1. Failure of Vegetal protection development of concentrated flow
- 2. Concentrated flow surface erosion leading to the formation of a vertical, or near-vertical headcut
- 3. Downward and headward advance of headcut

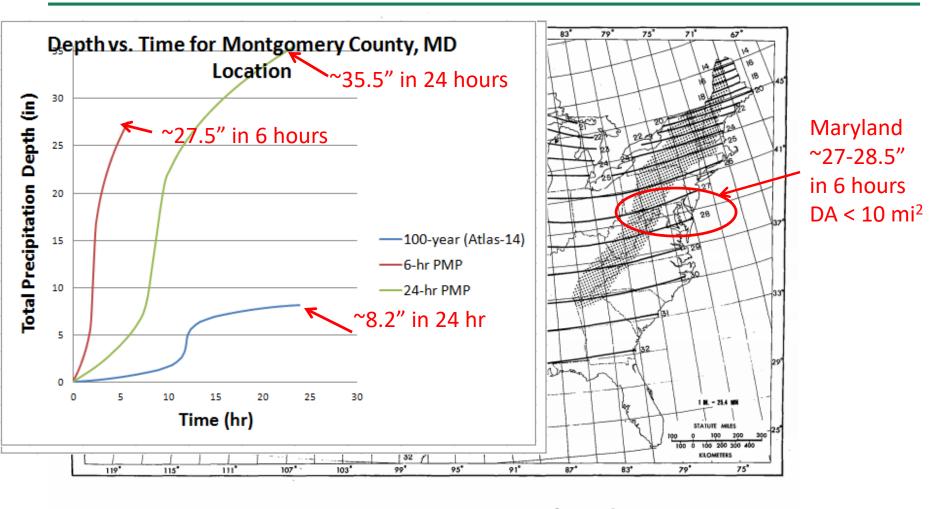
Figure 18.--All-season PMP (in.) for 6 hr 10 mi<sup>2</sup> (26 km<sup>2</sup>).

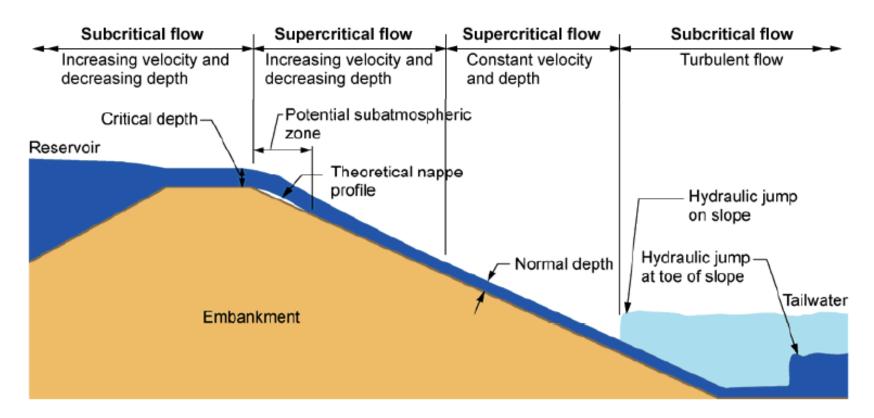
Figure 1-1.—Typical hydraulic conditions during embankment overtopping (Reclamation).

## Important Flow Characteristics to Determine

- Flow Depth
- Flow Velocity
- Shear Stress
- Flow Type
- EGL
- Hydraulic jump location

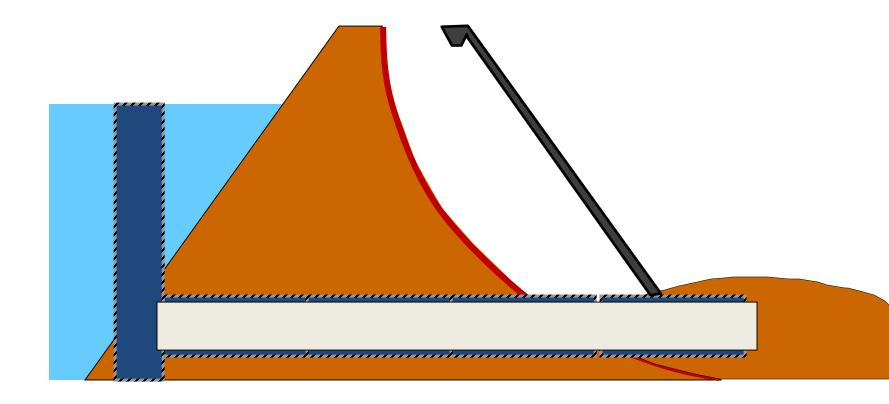
# **Slope Stability**

Stability during construction, during normal loading, during max loading conditions.

Slope stability analyses for an embankment dam consist of five primary steps (PCA, 2002):

- 1. Characterizing the geometry of the slope and material boundaries
- Evaluating the material properties for each type of material in the embankment and foundation
- Evaluating internal and external water pressure and loading or seepage conditions
- Inputting geometry, material properties, and water pressures in a model for analysis of slope stability
- 5. Solving for the minimum theoretical factor of safety

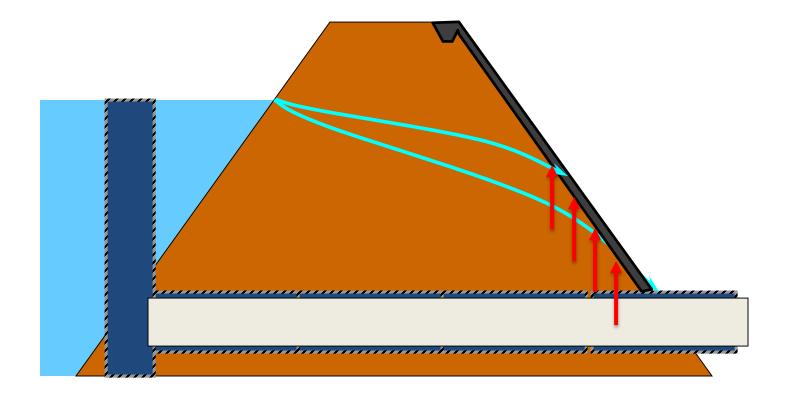
The overtopping protection design must be compatible with the seepage conditions resulting from a modification of the embankment dam. Seepage collection and control features are often required in the design of overtopping protection to:

- Collect and control seepage through the embankment or foundation under normal reservoir conditions
- Limit uplift pressures that could develop beneath the overtopping protection as a result of flood releases
- Collect and control infiltration of water through cracks and joints in the overtopping protection

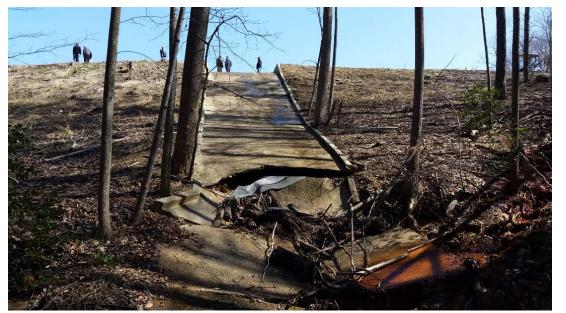
Figure 3-2.—Concrete delamination due to thermal expansion (Reclamation, 1997).

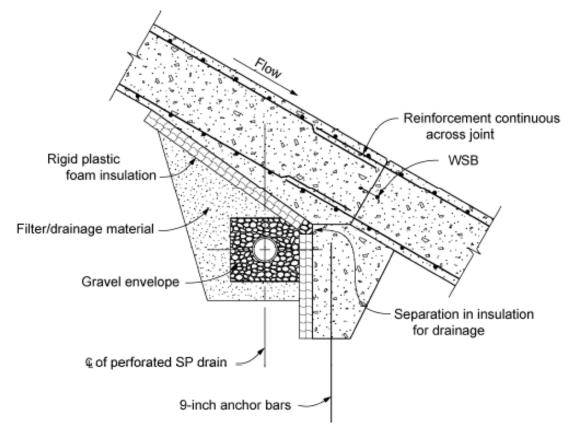
Figure 3-8.—Defensive design measures for concrete chutes to prevent uplift failure (Reclamation, courtesy of Bill Fiedler).

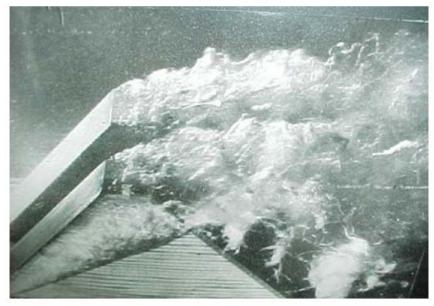
Figure 3-9.—Cavitation created in low ambient pressure chamber (Reclamation, 1990a).

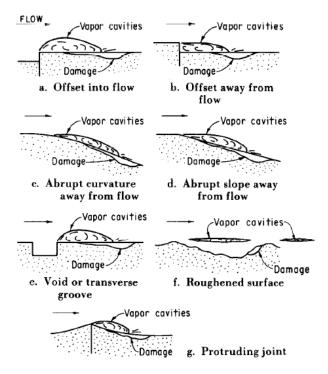
FIGURE 2-1.—Typical isolated roughness elements found in hydraulic structures.

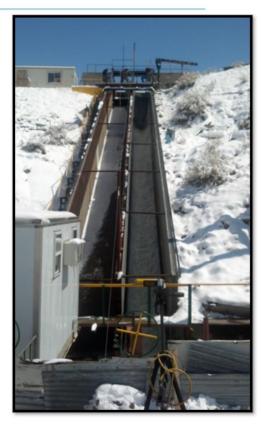
### CSU Steady State Overtop Flume

- ASTM D 7277 / 7276 -Performance Testing of Articulating Concrete Block (ACB) Revetment Systems for Hydraulic Stability in Open Channel Flow
  - 1.5-ft, 3.0-ft, 5.0-ft and 5.5ft Overtopping Depths
  - Hydraulic Jump
  - Impact & Abrasion from Large Debris
  - · Intentional Damage Hole
- · 32 hours of Testing
- Tested to Maximum Capacity of the Flume
- Tested to a Velocity of 40.5 ft/sec
- · No Erosion or Instability
