# The Corsica River *Targeted Watershed Project*

Maryland Department of the Environment

Chemical & Biological Monitoring Division

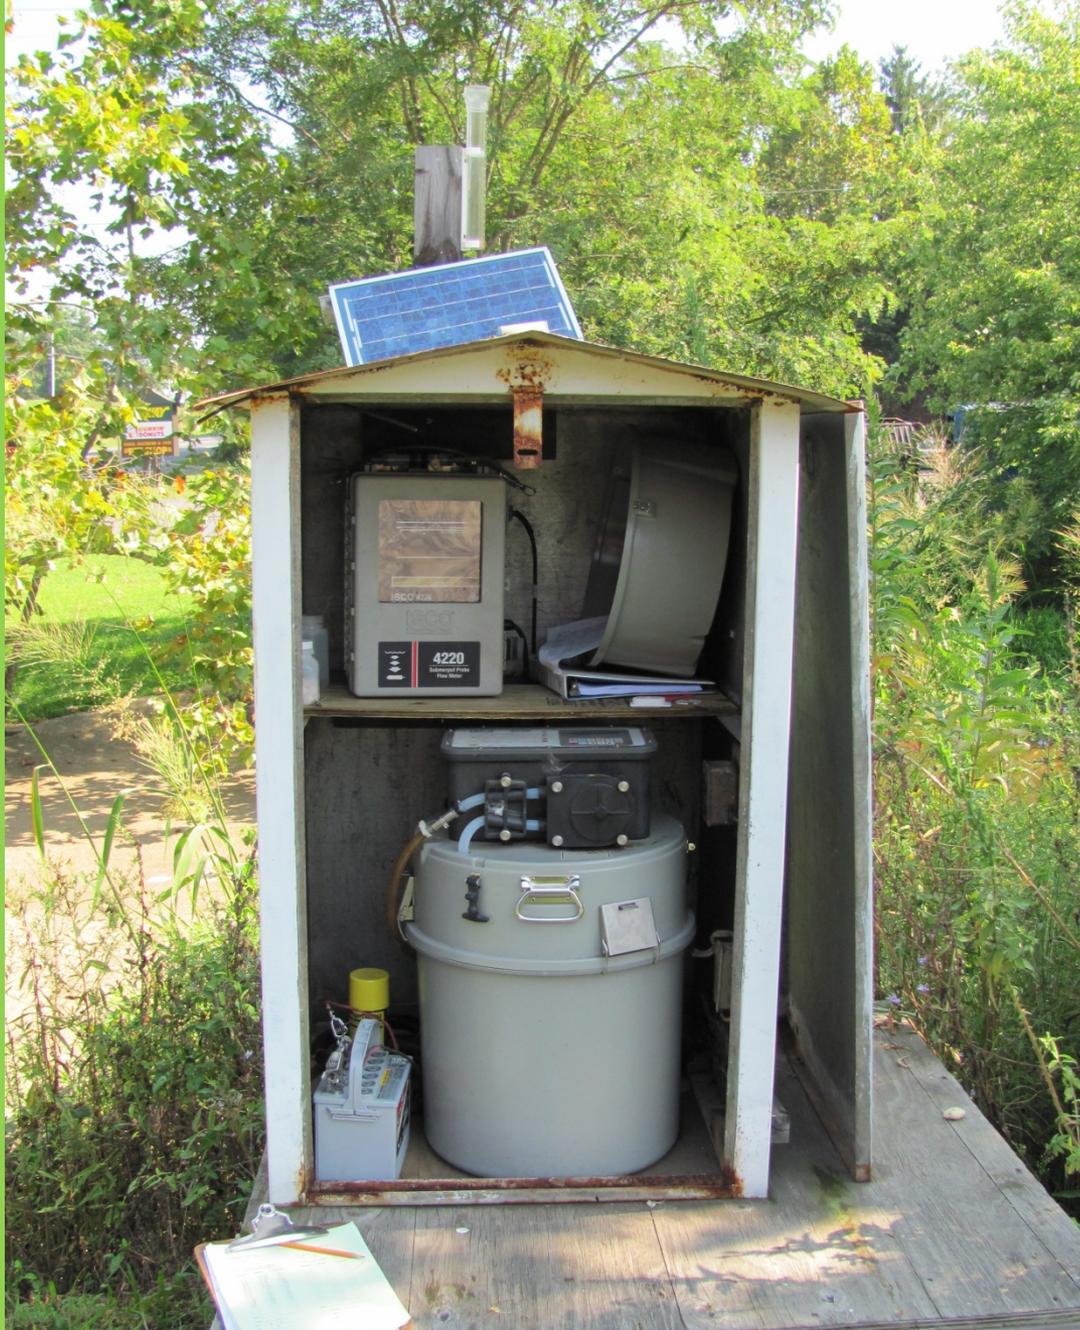
**Gravel Branch (GVL) Monitoring Site** 5-7-2013

- Weekly surface water *grab* samples
- Continuous flow weighted *composite* samples to capture storm events
- Automated stage height recording to estimate cumulative stream discharge (*to establish loadings*)
- Water samples analyzed for TN, TP, NO<sub>2</sub>, NO<sub>2</sub>+NO<sub>3</sub>, NH<sub>4</sub> & PO<sub>4</sub>
- Monitoring Timeline: August, 2005 to Present

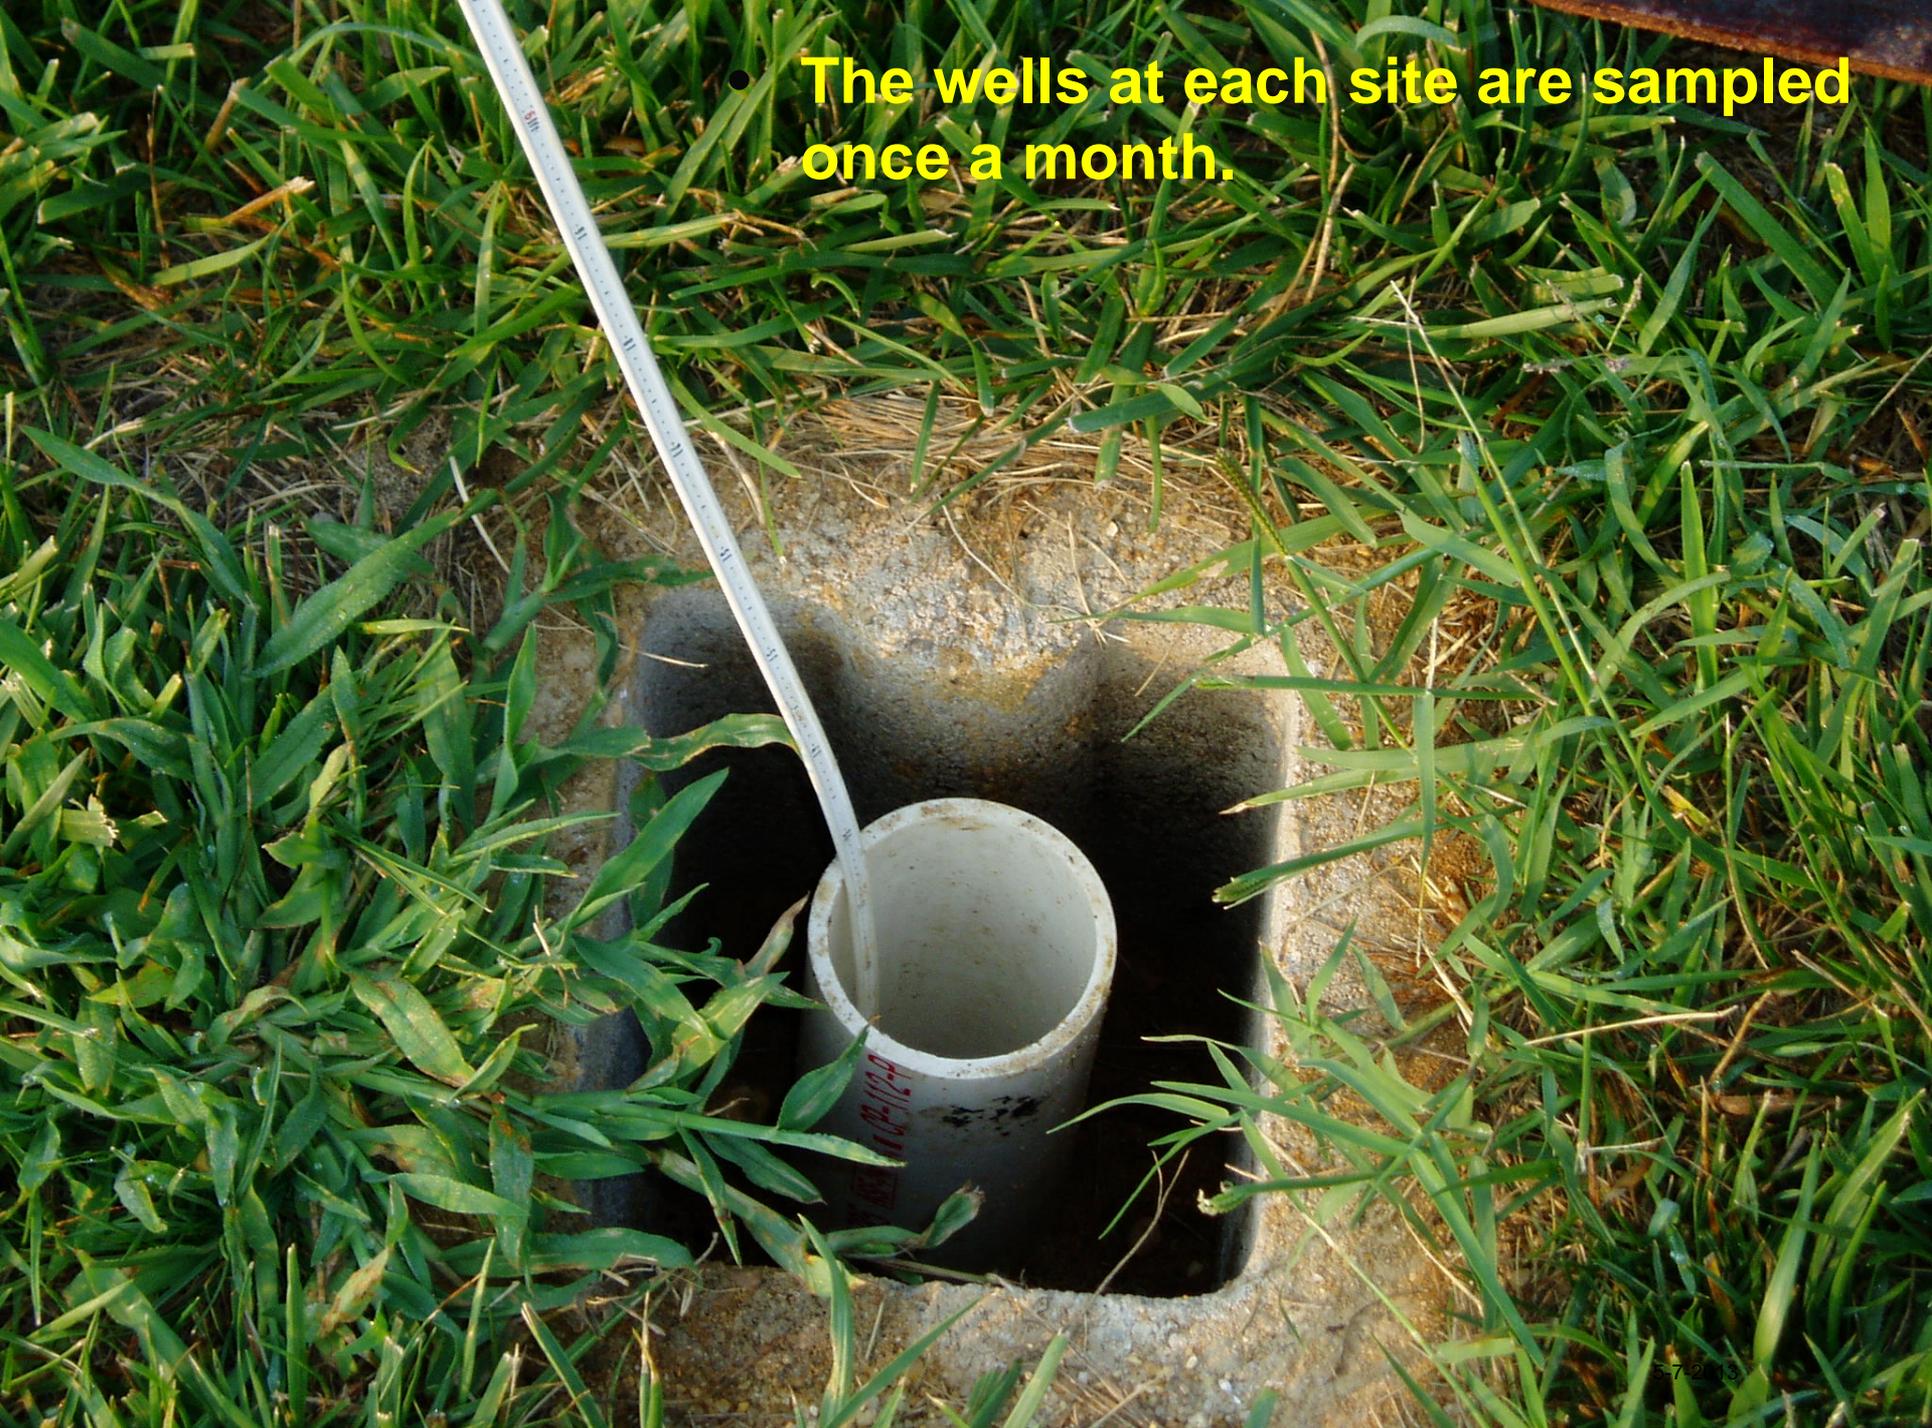
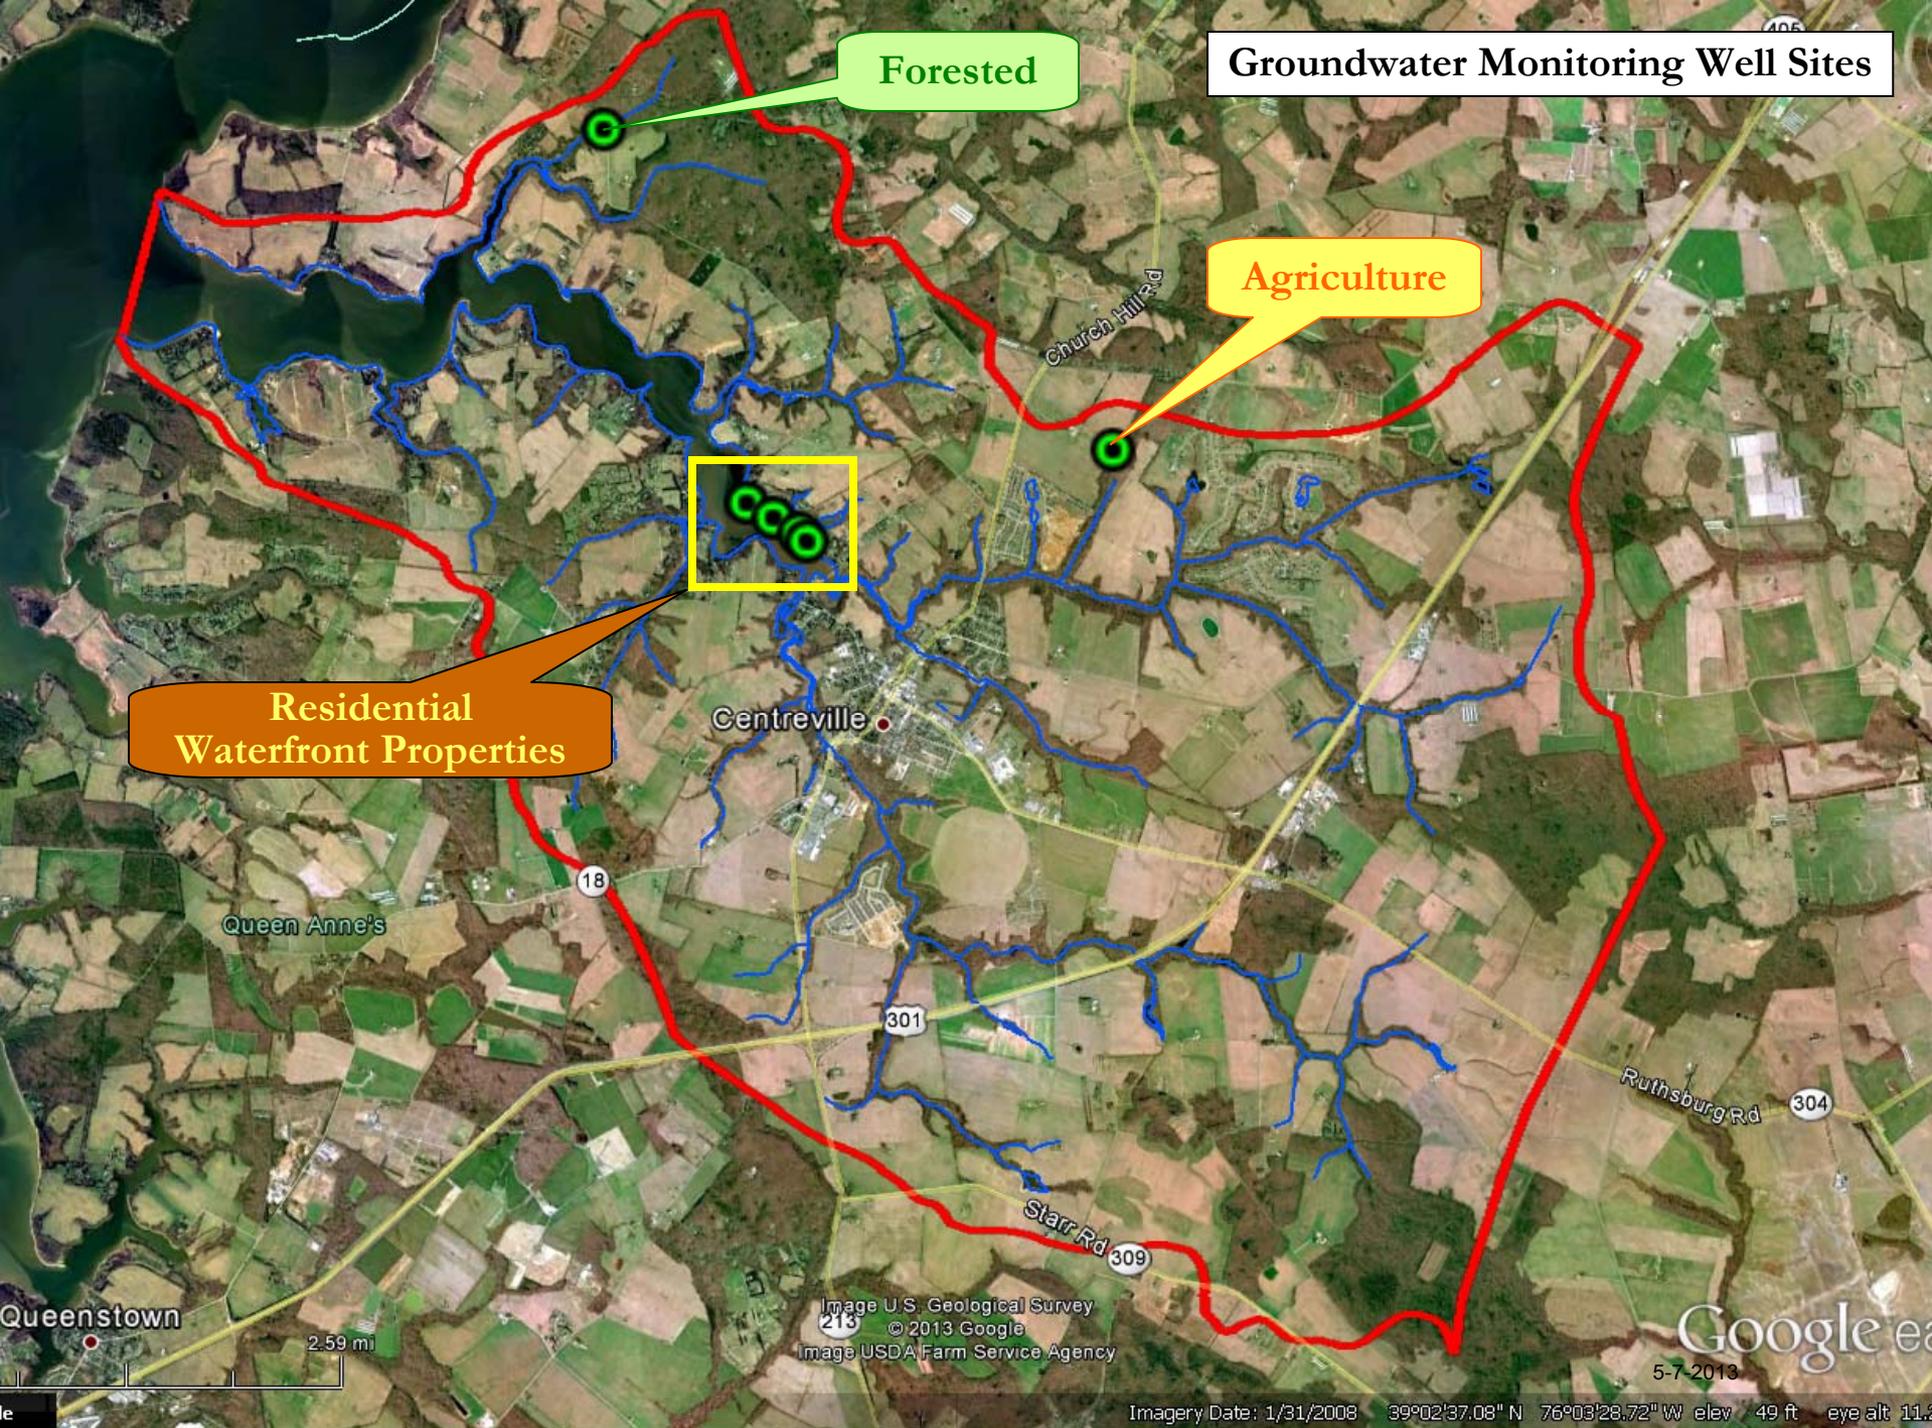
# Groundwater Monitoring Well Sites

- To quantify reductions in dissolved nitrogen loads delivered to the surface aquifer from septic systems retrofitted with nitrogen reduction technology

- The wells at each site are sampled once a month.

Forested

Agriculture

Residential Waterfront Properties

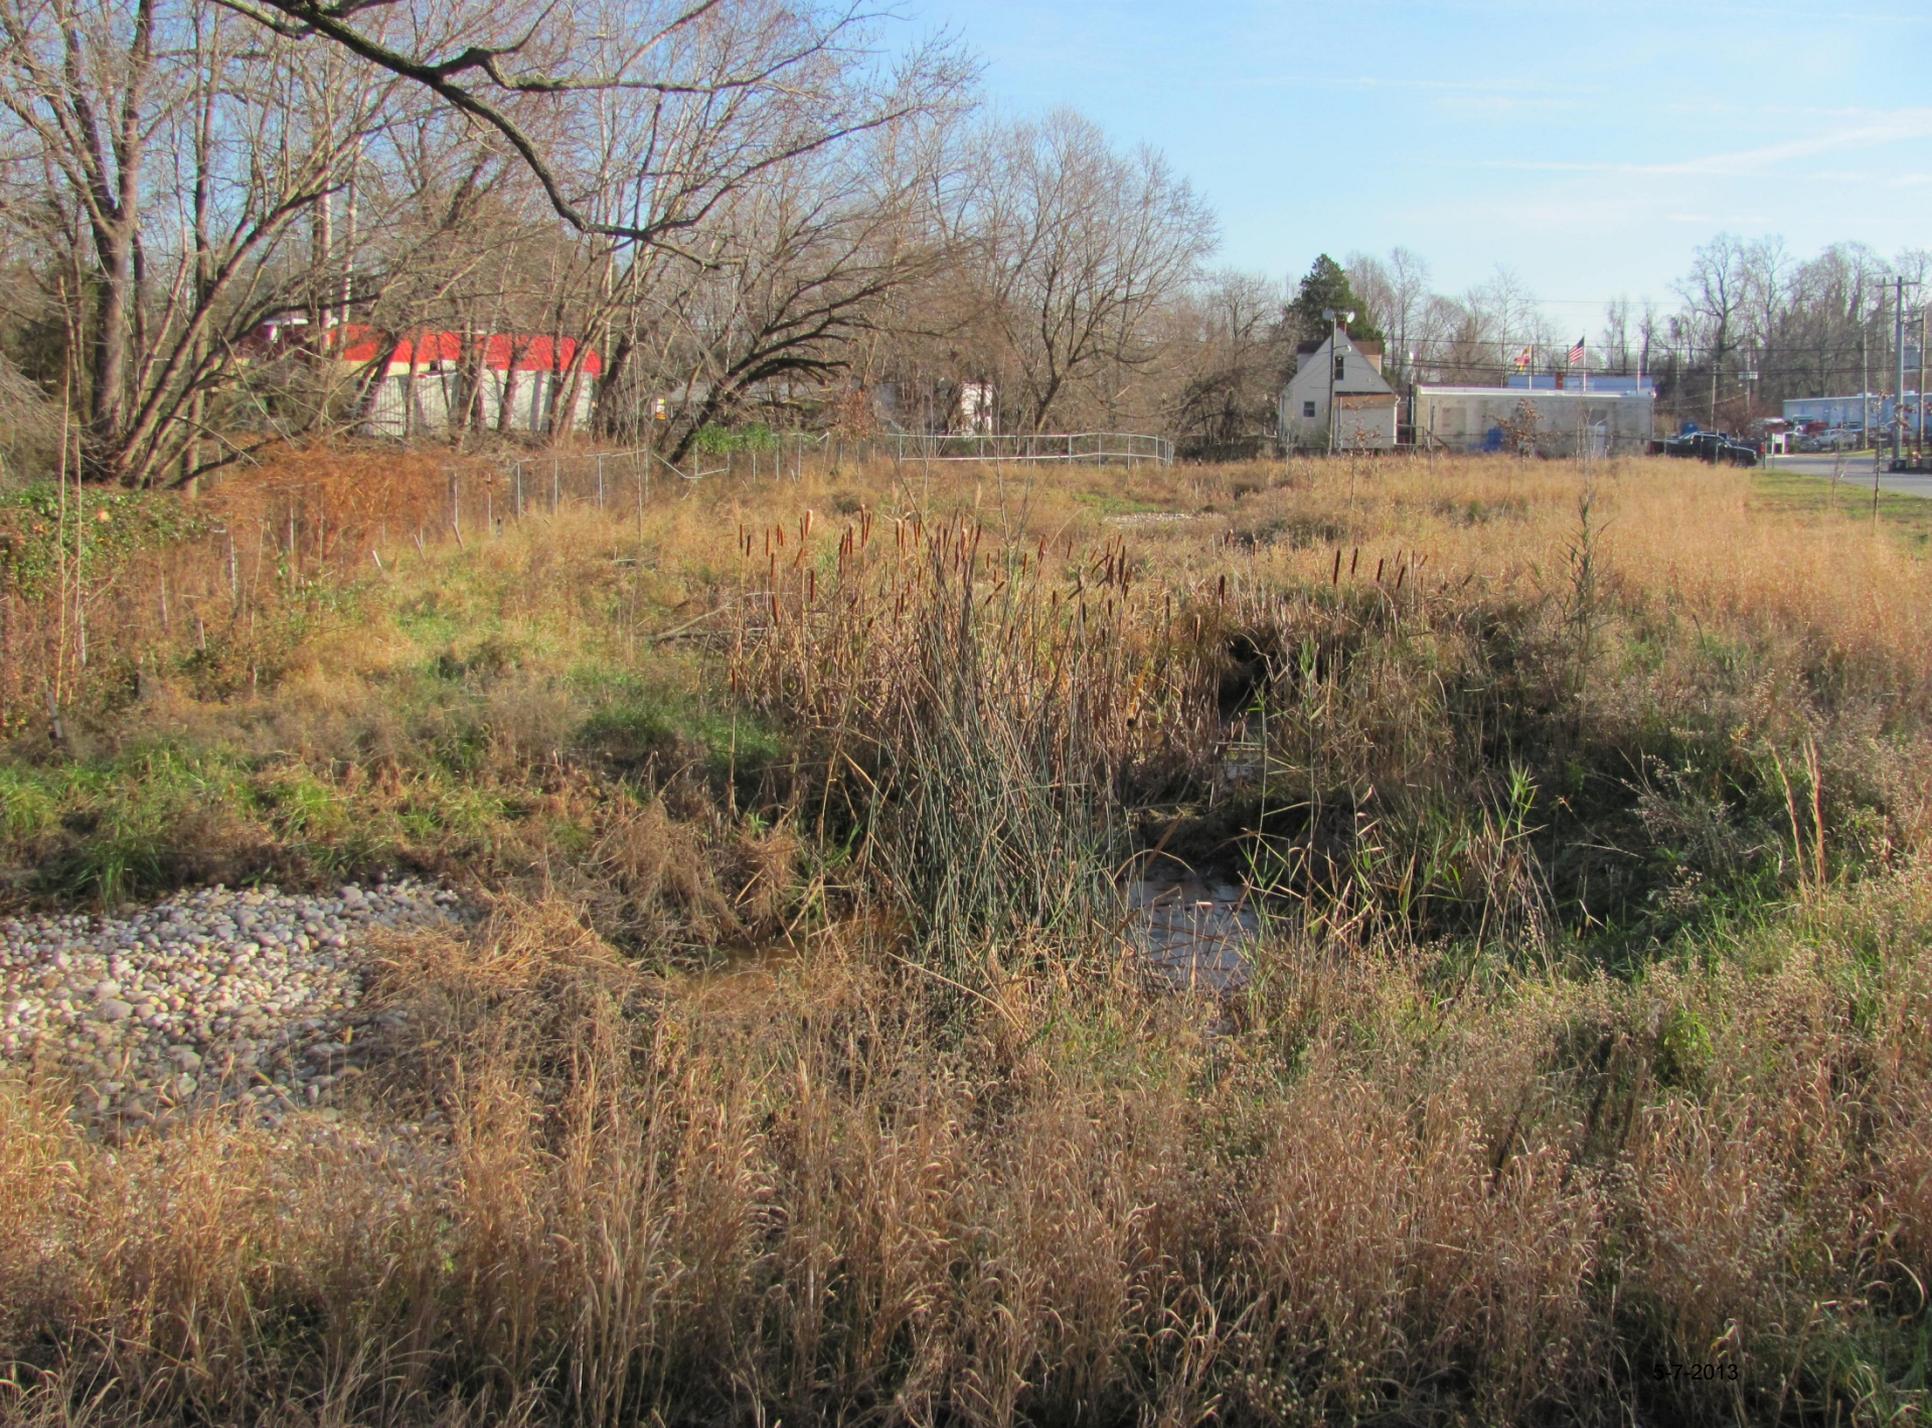
**Stormwater  
Wetland  
Inlet Pond  
(Forebay)**

*After 1 Year  
of Operation*

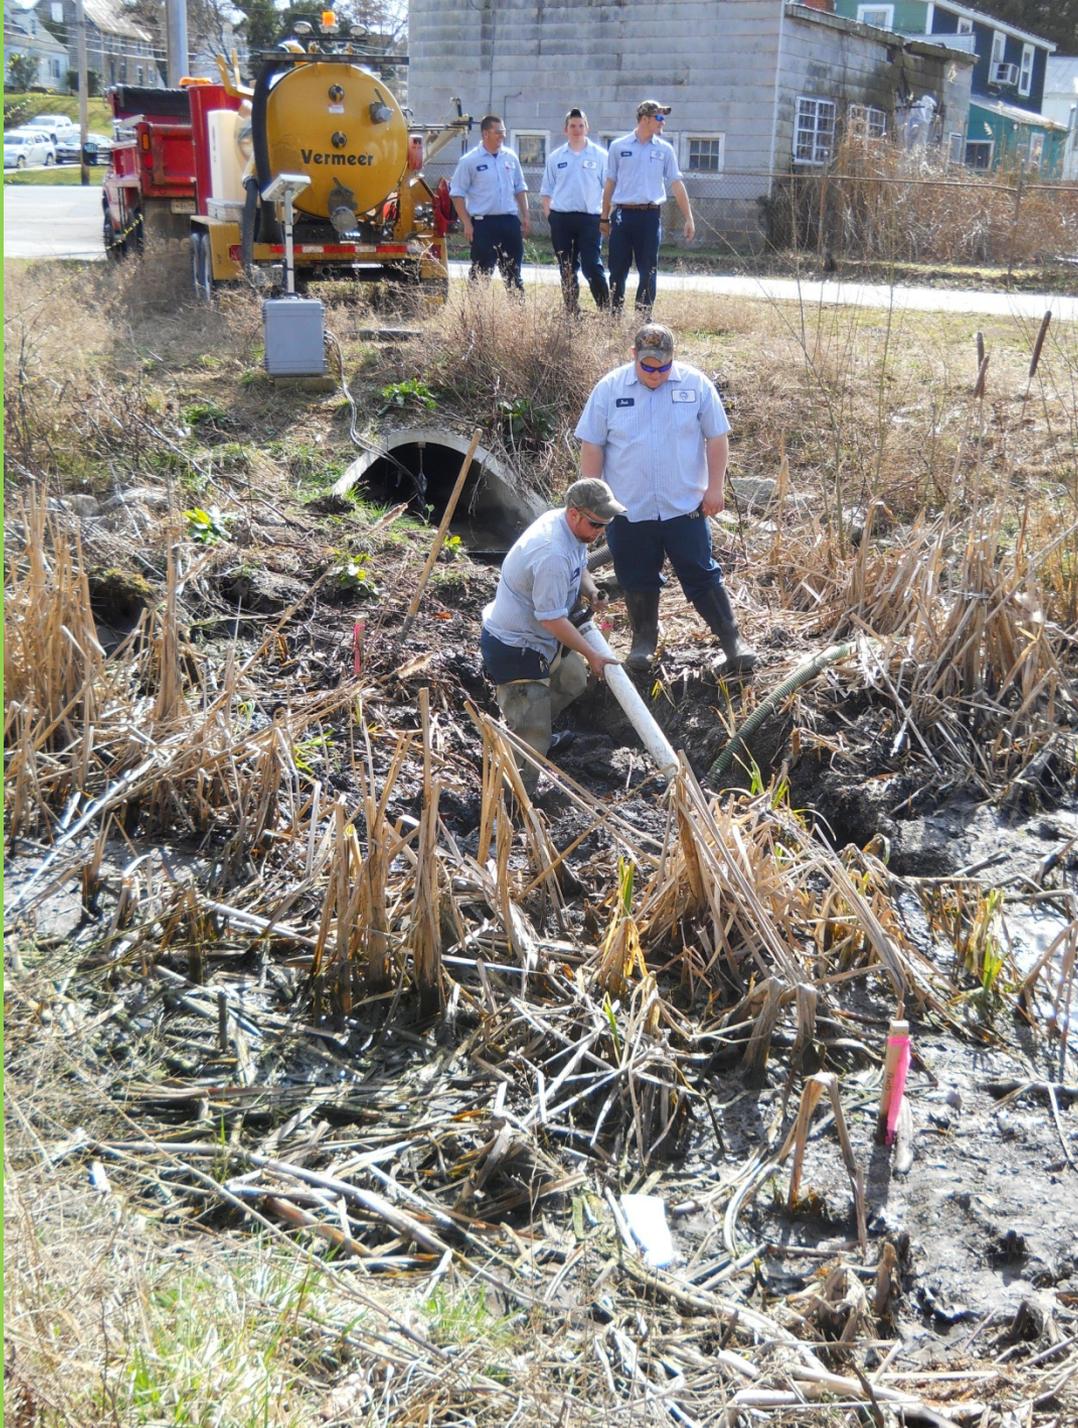
**Wetland  
Forebay is  
full of  
sediment**

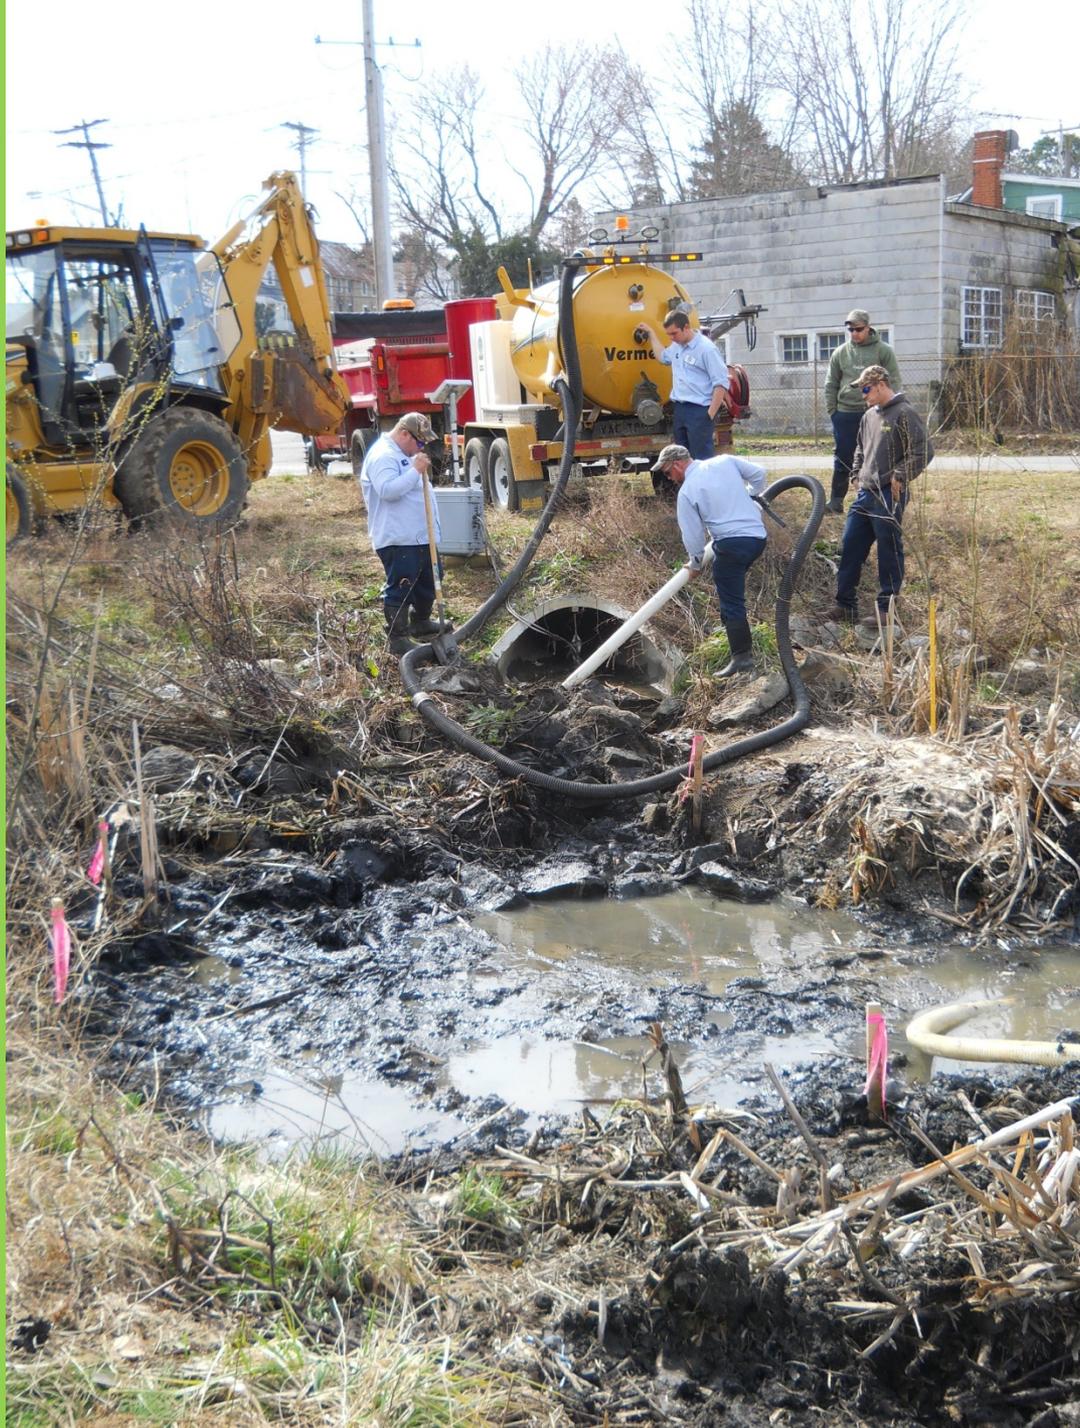
# Stormwater Wetland Inlet Pond (Forebay)

**4 Cubic  
yards of  
sediment  
were  
removed!**
