FINAL COMPENSATORY MITIGATION PLAN

KEY BRIDGE REBUILD PROJECT

BALTIMORE CITY, ANNE ARUNDEL COUNTY, AND BALTIMORE
COUNTY, MD

JUNE 2025

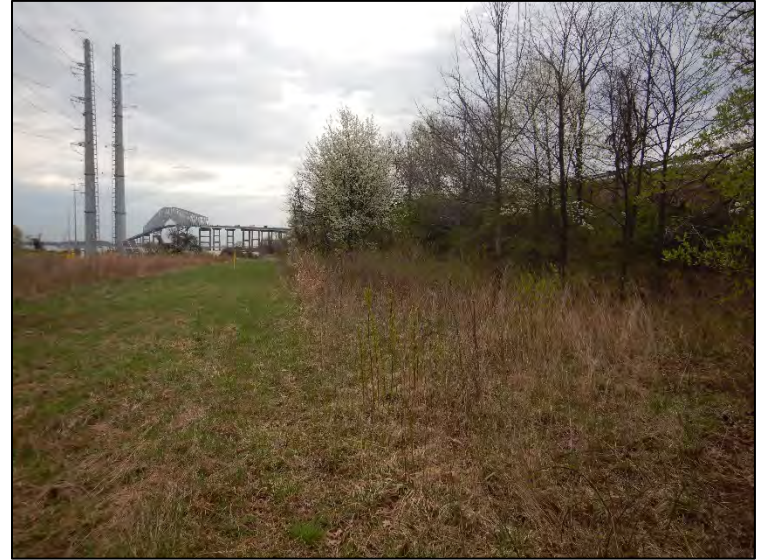
Photo 3: Looking northeast at 1FS3

Stand 1FS3 is a disturbed early successional black locust forest. Canopy closure is approximately 40 percent with a dominant size class of 2-6" DBH. The canopy is dominated by Callery pear and black locust. There is also one 18" DBH pin oak (*Quercus palustris*) within the stand. Dominant species in the understory include amur honeysuckle and rambler rose (*Rosa multiflora*). Smooth sumac is also present on the edge of the forest stand. Dominant species in the herbaceous layer include Japanese honeysuckle and common reed. Overall, the forest stand is in poor condition with high invasive species cover, low downed woody debris, and moderate vine cover.
