Maryland Transportation Authority

June 7, 2024

The Maryland Transportation Authority (MDTA) is submitting an Abbreviated Joint Federal/State Permit Application for the alteration of any tidal wetland and/or tidal waters in Maryland (JPA) and supporting documentation for the I-695 Francis Scott Key Bridge Demolition project, located in Baltimore/Dundalk, Maryland. The project is within the Baltimore Harbor Maryland 8-digit Watershed (02130903). This application is submitted pursuant to the requirements of the Code of Maryland Regulations, Sections 26.17 and 26.23, and Section 404 of the Clean Water Act via MDE's E-collaboration tool. The application and supporting documentation include the following:

Francis Scott Key Bridge Rebuild Project

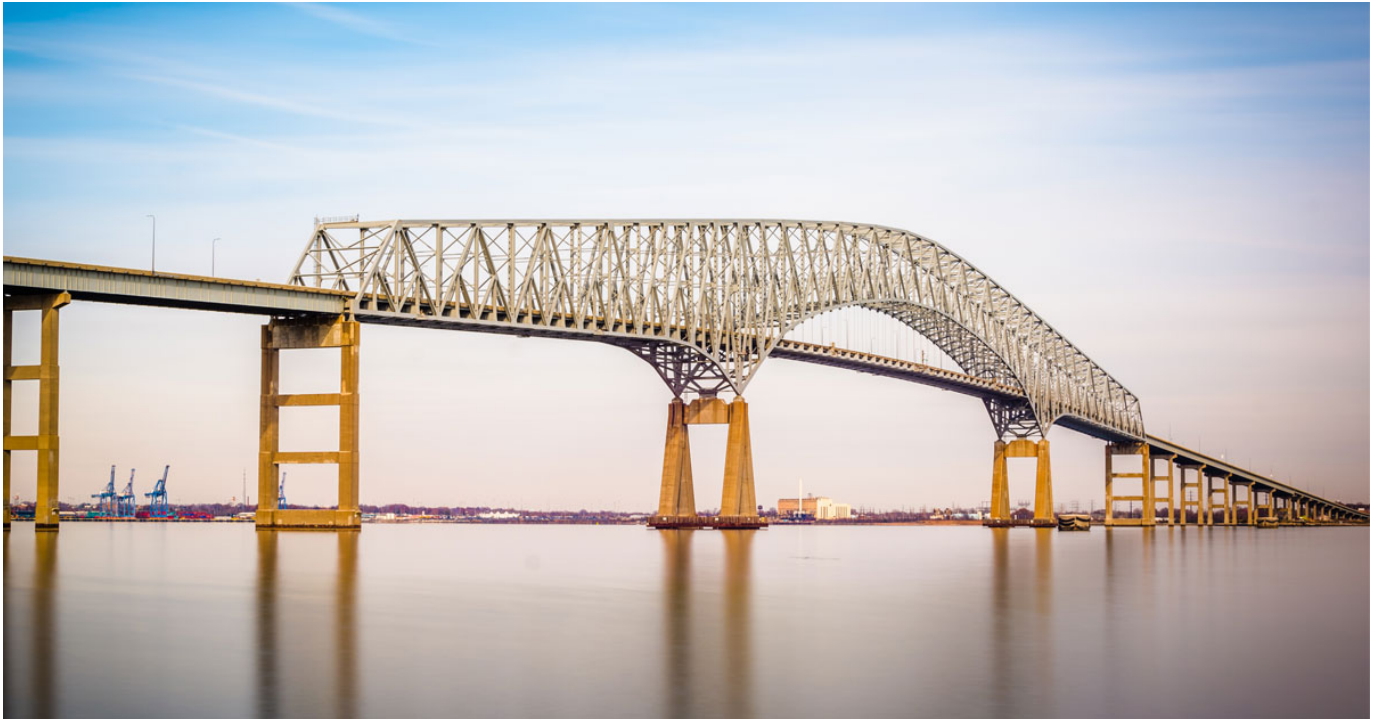
Piers 19-21 Conceptual Blast Plan

As part of the recovery of the collapsed Francis Scott Bridge and the opening of the navigable waterway piers 19, 20 and 21 will need to be removed. One option is to remove the piers to the top of the tremie concrete. The second option would be to remove the pier columns to the top of footing (foundation concrete) only. The drilling and blasting methodology for option 1, complete removal, is outlined in this conceptual plan. The piers will be drilled vertically from the top using a hydraulic drill rig with an onboard dust collection system and electronic hole alignment. The drill will be staged on a barge. A template will be constructed for each pier that will facilitate the use of casing pipes as guides for the drilling of the holes in the footings and foundations. Holes will be drilled to the required depths and will be spaced to miss the vertical steel piles.

As an alternative method the columns of each pier could be removed conventionally to the top of the footings and each pier could have a coffer dam constructed around it. Once constructed and de-watered the footing and foundation could be drilled in the “dry” by placing the drill rig on top of the footing inside the coffer cell. The loading of explosives could also be conducted inside the cell in the dry. Once the structure is loaded the cell could be flooded to allow the water to act as confinement for the blast debris.
