Re: Mount Ephraim Road Property
Frederick County, MD
Tax ID 07-193874

Subject: Flooding Soils Evaluation and Wetland Delineation

HOLDER PROPERTY
WETLAND DELINEATION
 SITUATED ON MT. EPHRAIM ROAD
 FREDERICK COUNTY, MARYLAND
 TAX ID: 07-193874

**WETLAND DELINEATION
HOLDER PROPERTY**

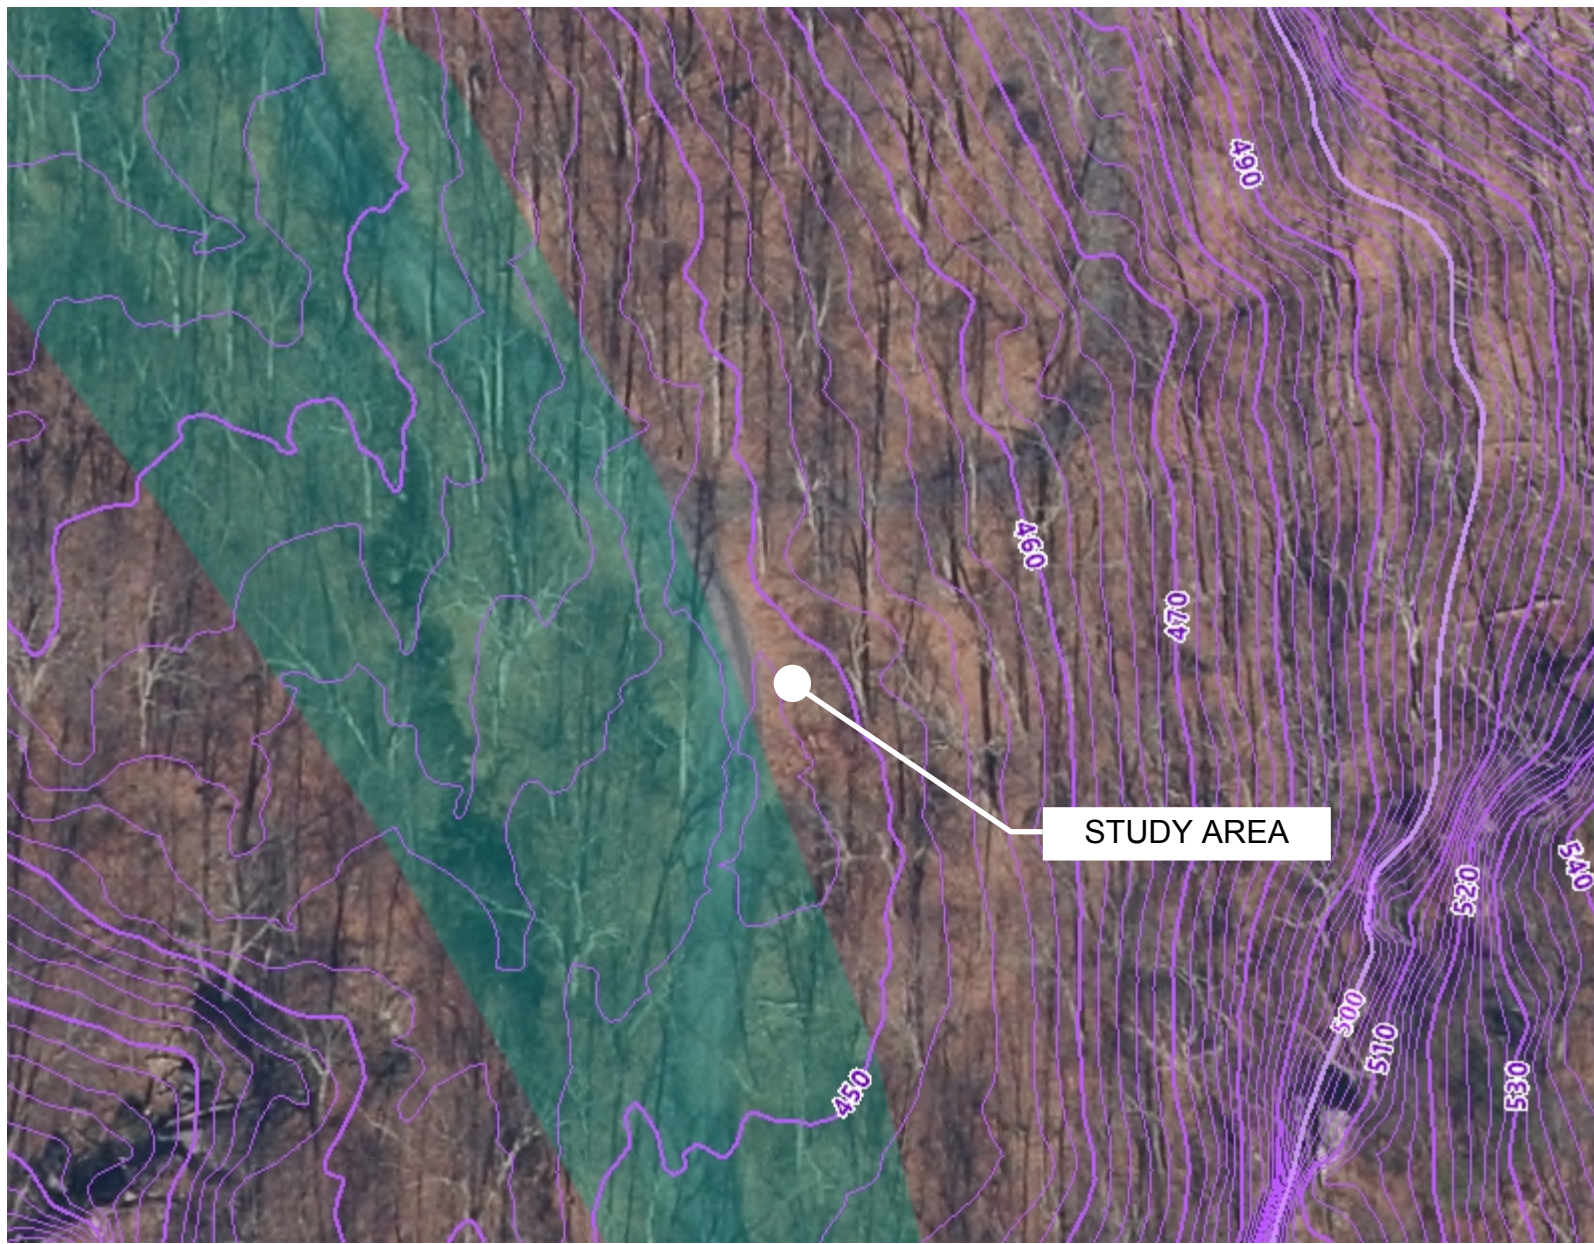
The project area is located within the Lower Monocacy River watershed (HUC 02140302) and is drained by Bear Branch. The watershed for Bear Branch is designated as Class III-P, which includes Native Trout Waters and Public Water Supply. Forested wetlands are mapped in the riparian area of Bear Branch (Exhibit 1). A groundwater seep emerges from a rock outcrop on the adjacent property and drains to Bear Creek through a culvert under Mt. Ephraim Road. The groundwater seep is the hydrologic source for the forested wetlands on the property. Photographs of the property are attached.

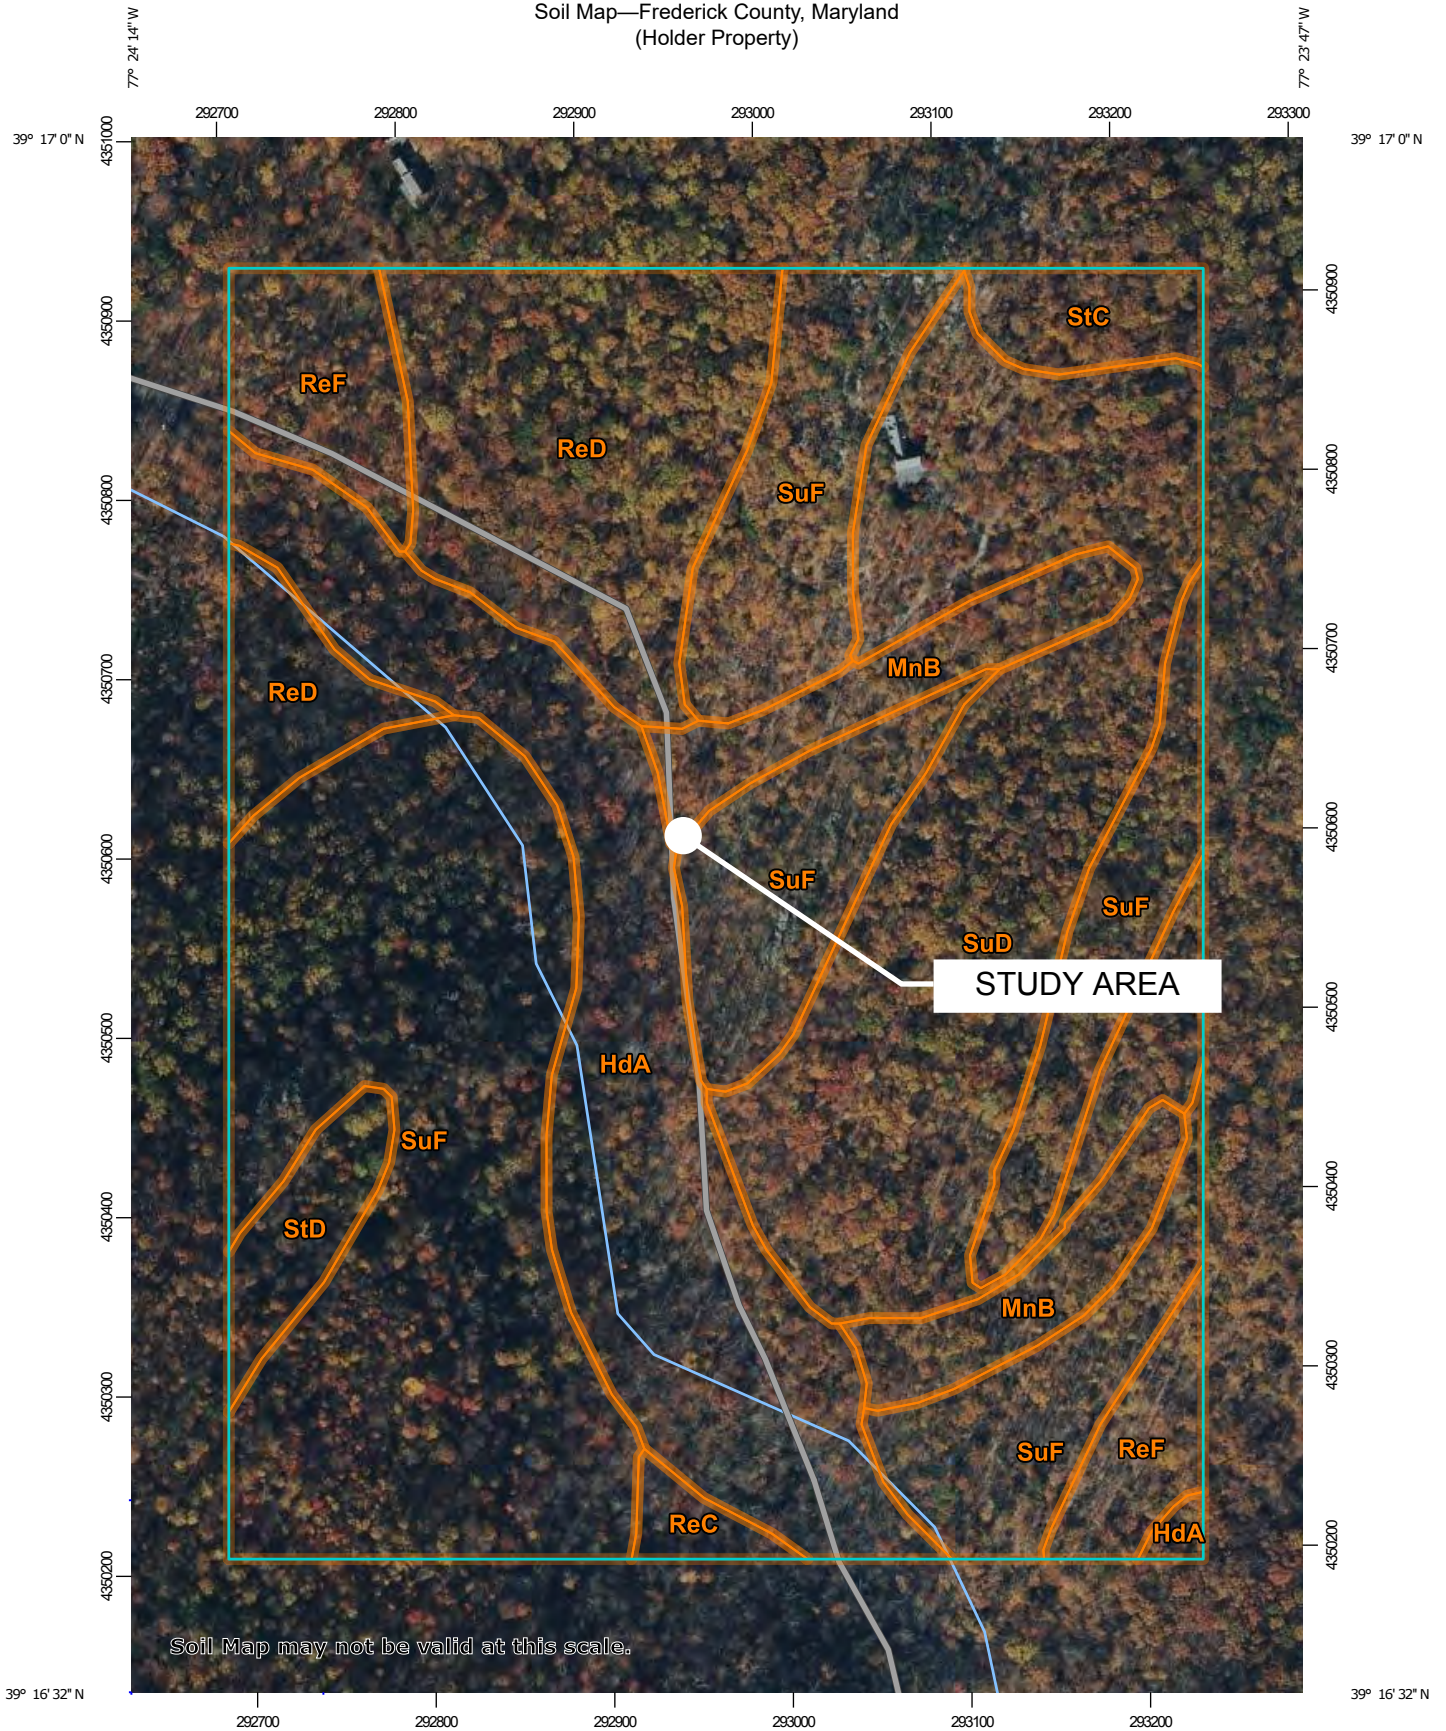
Soil Map—Frederick County, Maryland
(Holder Property)

Soils in the project area include the following mapping units (Exhibit 2):

- HdA – Hatboro-Codorus silt loams, 0 to 3 percent slopes
- MnB – Mt. Zion-Rohrersville complex, 3to 8 percent slopes
- SuF – Stumptown-Bagtown-Rock outcrop complex, 25 to 65 percent slopes

Hatboro and Codorus soils are associated with floodplains, and Hatboro is classified as a hydric (wetland) soil. The observed soils more closely resemble Lantz silt loam, a hydric soil that is subject to ponding. Lantz soils are very poorly drained and have a water table within 6 inches of the surface for long duration. The soils meet Hydric Soil Field Indicator F3 (depleted matrix), as described on the attached wetland data form.

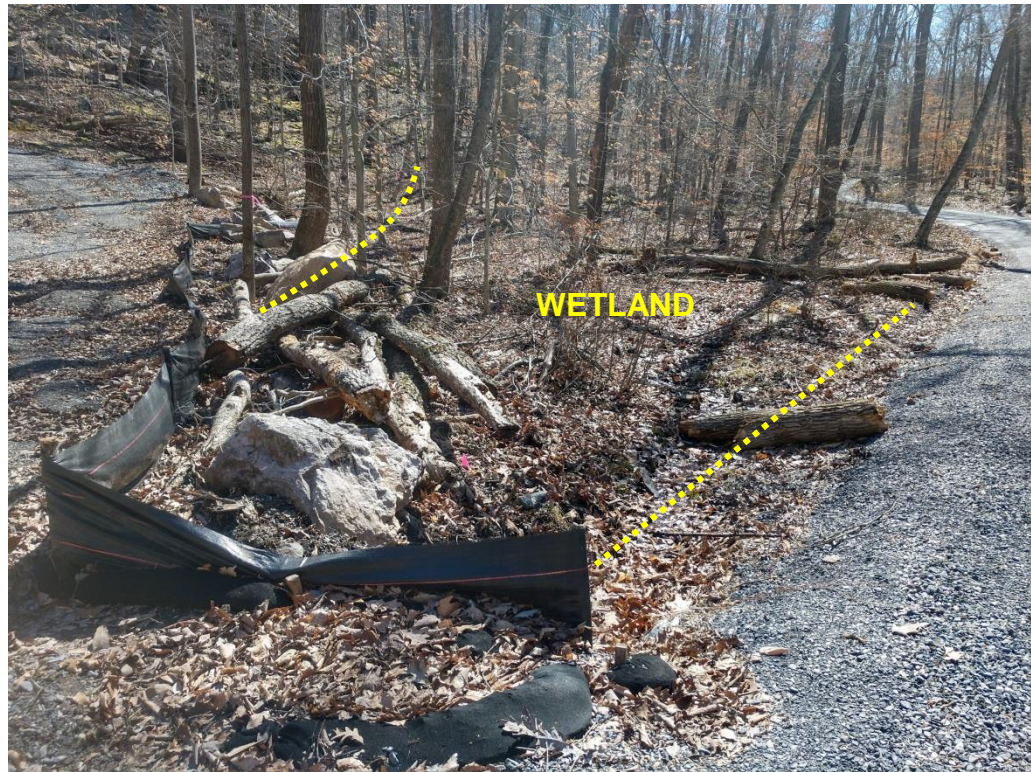
South View

Potential wetland areas were evaluated in accordance with the Regional Supplement to the Corps of Engineers Wetland Delineation Manual: Eastern Mountains and Piedmont Region (Version 2.0). A forested wetland was identified on the property in the area where the gravel driveway meets Mt. Ephraim Road. The limit of disturbance (silt fence) for the driveway stops at a culvert that provides drainage under Mt. Ephraim Road.

It is likely that a small section of the driveway was built in wetlands; however, a soil test pit was not excavated in the driveway to confirm if the soils under the gravel were hydric (i.e., wetland). The boundary of the wetland was delineated with pink flagging for future survey by others. See attached map for approximate location of the wetland and the regulated area that was disturbed.

We estimate that approximately 250 square feet of wetlands have been filled and 696 square feet of the 25-buffer have been cleared, subject to a survey of the wetland boundary flags. An "after the fact" permit will be needed from the Maryland Department of the Environment and the Frederick County Department of Permits and Inspections.
