August 23, 2018

RE: Raphel Road Bridge Replacement
Kingsville, Baltimore County, Maryland

SUB: Wetland Assessment & Delineation Letter Report

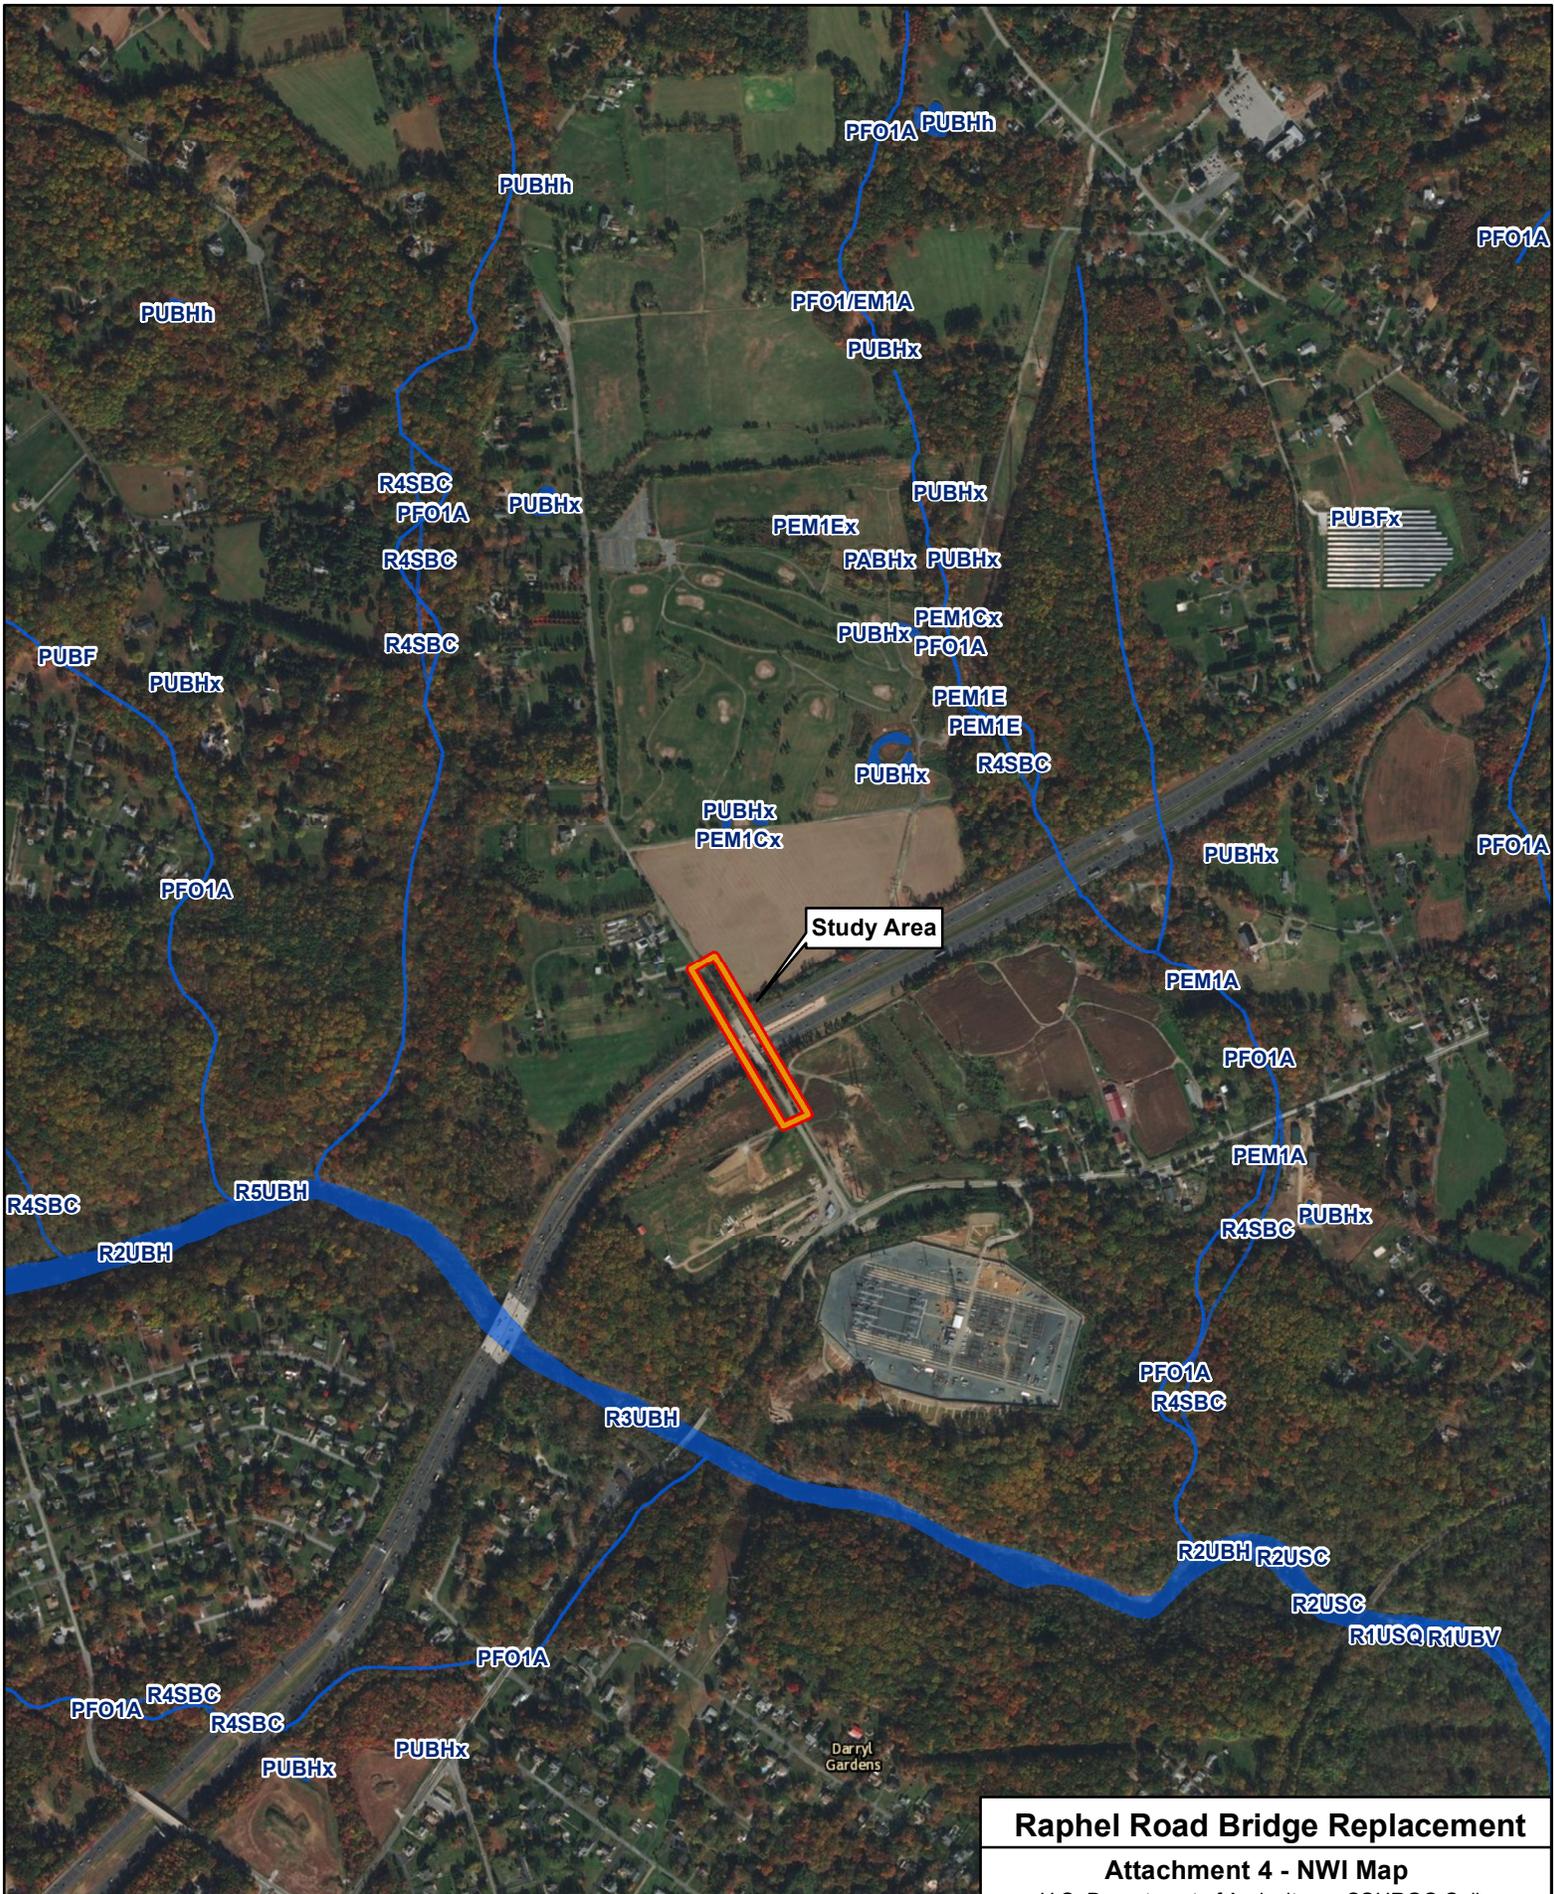
Attachment 4 - NWI Map

The *National Wetlands Inventory (NWI) Map for White Marsh, Maryland* (U.S. Fish and Wildlife Service [USFWS], 1981-2002) does not identify any wetlands within the study area. Attachment 4 shows the locations of NWI-classified wetlands in the vicinity of the study area.

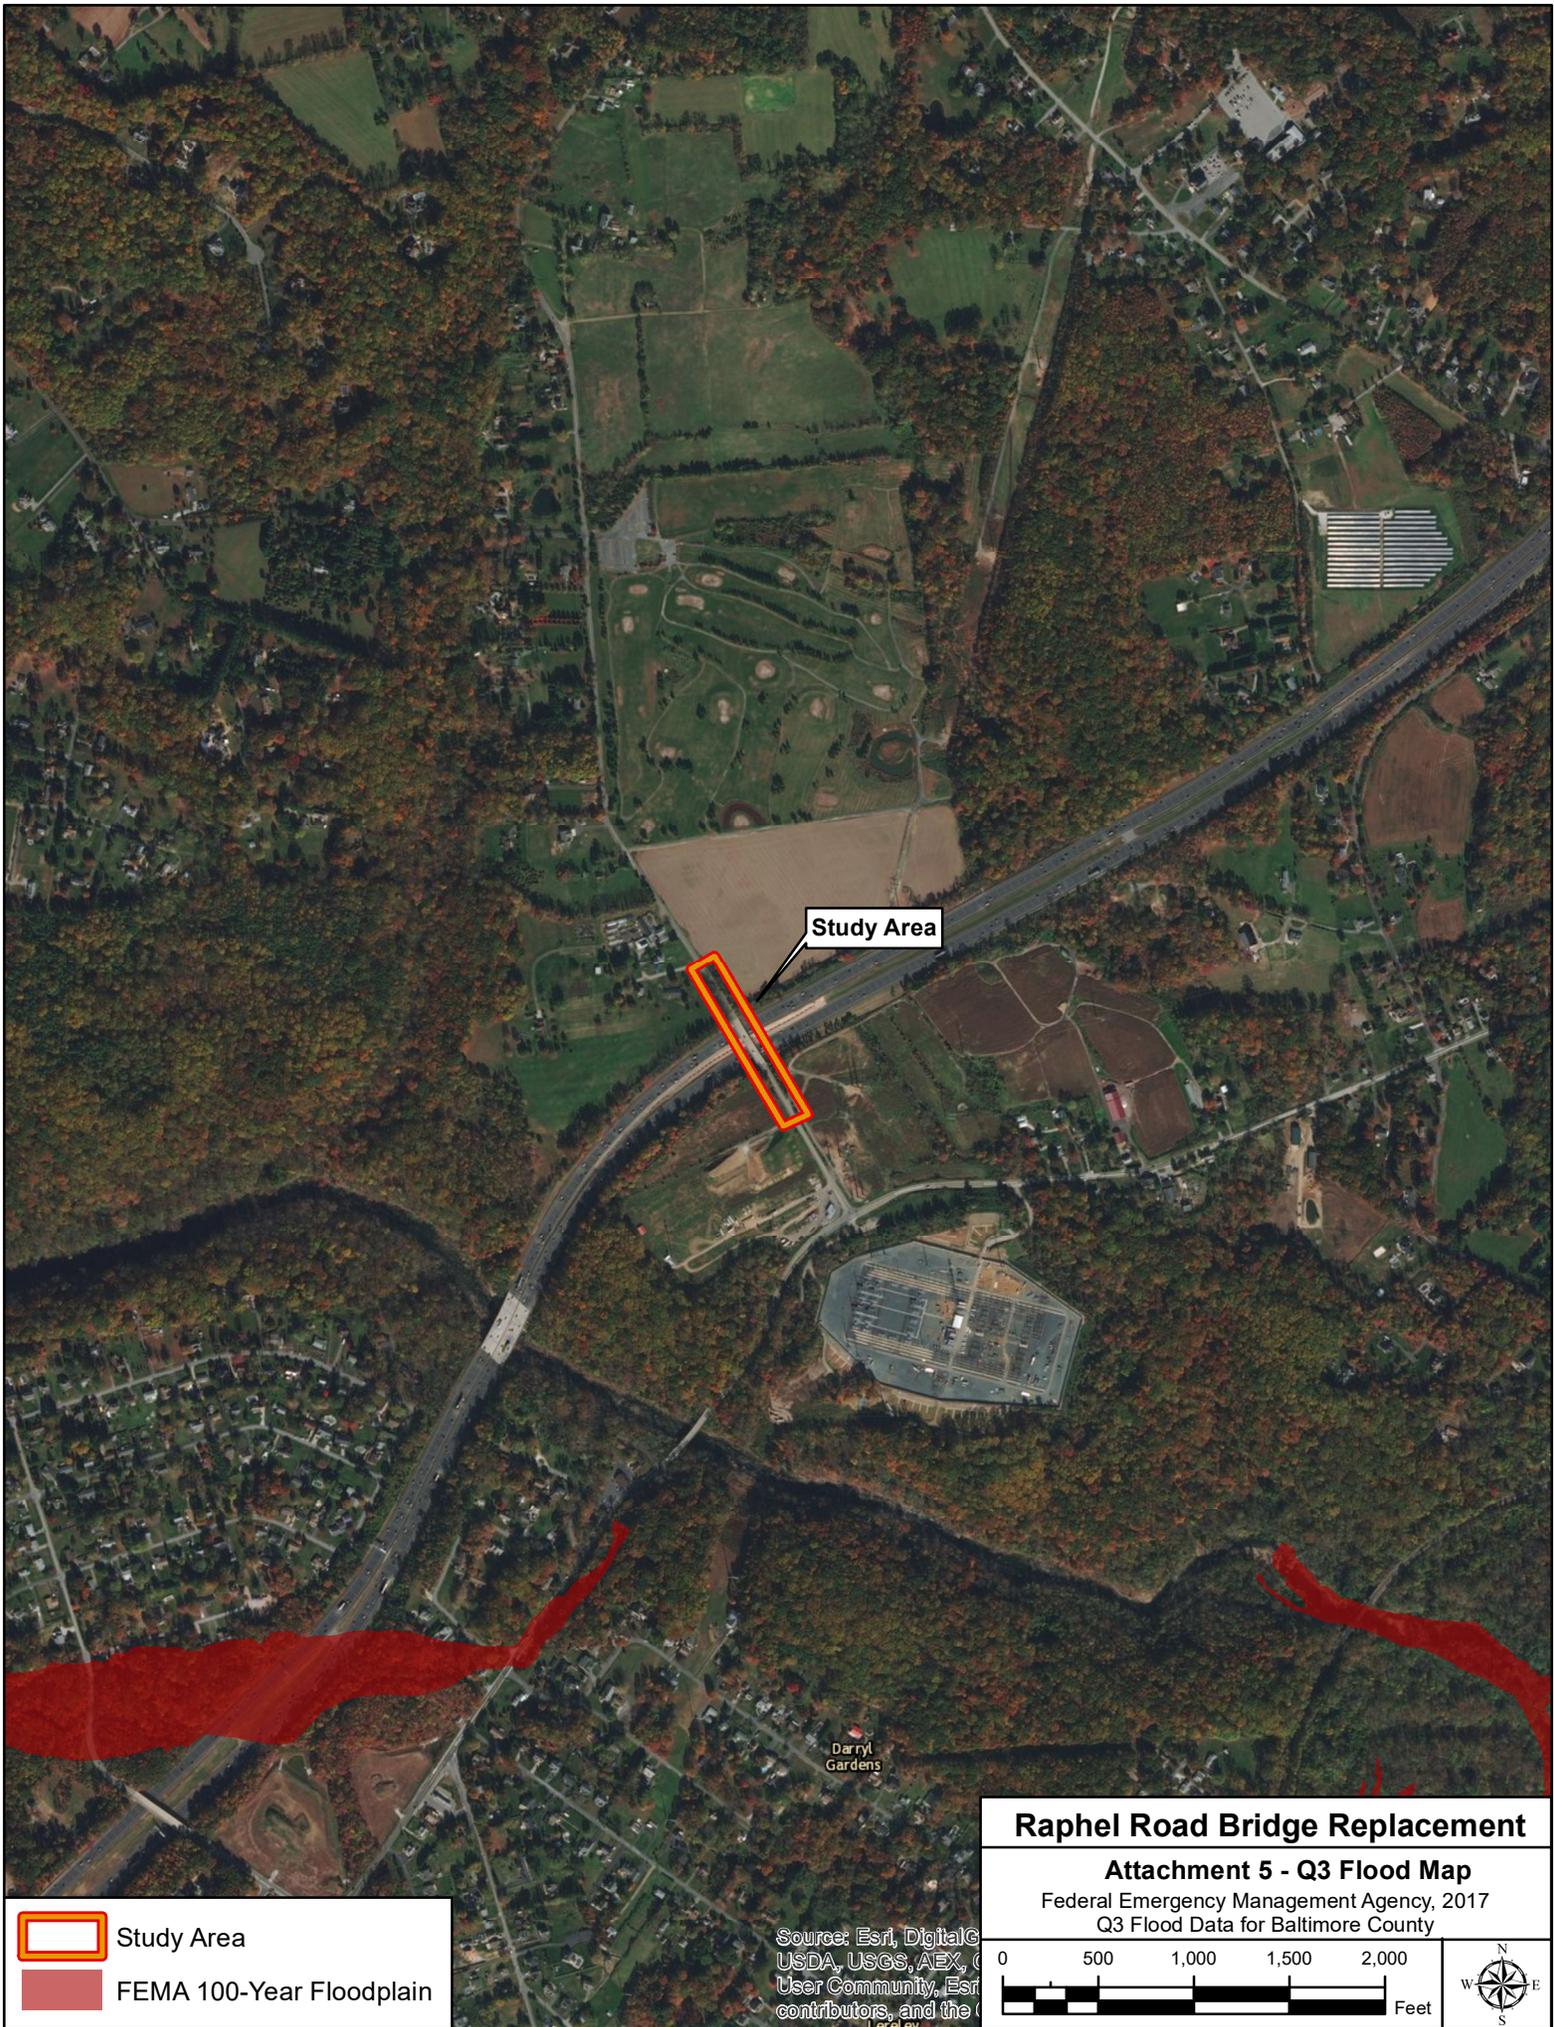
Attachment 5 - Q3 Flood Map

According to a review of Federal Emergency Management Agency (FEMA) Q3 flood data, no designated 100-year floodplains are present within the study area (*FEMA Panel No.2400100295G*). Attachment 5 shows the locations of FEMA-designated floodplains in the vicinity of the study area.

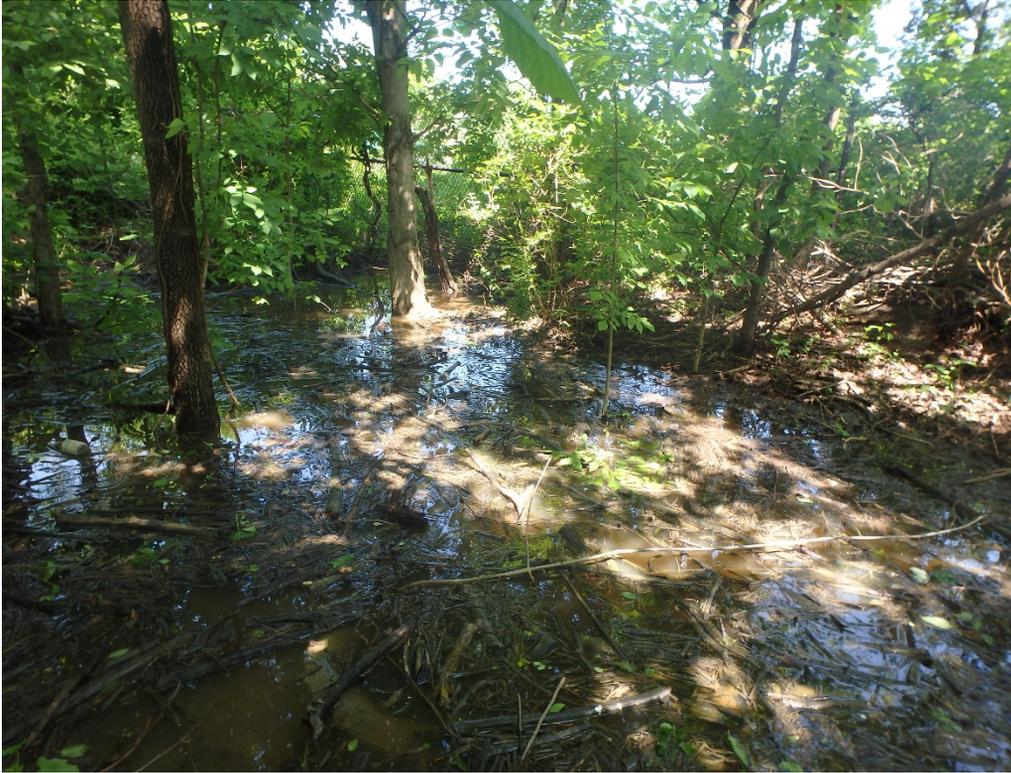
Wetland WP001 is a palustrine, forested, broad-leaved deciduous, temporarily flooded (PFO1A) wetland within the southeastern portion of the study area. This wetland occupies approximately 0.01 acre and is entirely within the study area. Wetland WP001 receives hydrology from groundwater and overland flow and is isolated in its location. This wetland was not identified on the *National Wetland Inventory Map for White Marsh, Maryland* (USFWS, 1981-2002).

KCI collected information from a sample plot within Wetland WP001 (Plot WP001-WET) in order to properly classify the predominant vegetation, soil characteristics, and hydrologic indicators. Vegetative cover in close proximity to the sample plot is dominated by persimmon (*Diospyros virginiana*), sweet gum (*Liquidambar styraciflua*), red maple (*Acer rubrum*), Virginia creeper (*Parthenocissus quinquefolia*), fox grape (*Vitis labrusca*), poison ivy (*Toxicodendron radicans*), and euonymus species. Sassafras (*Sassafras albidum*), black cherry (*Prunus serotina*), Bradford pear (*Pyrus calleryana*), Japanese honeysuckle (*Lonicera japonica*), and garlic mustard (*Alliaria petiolata*), were also noted within the sample plot. Based on species composition, sample plot WP001-WET satisfies the hydrophytic vegetation criterion. Hydrologic indicators in the wetland include surface water, high water table, saturation, oxidized rhizospheres on living roots, sparsely vegetated concave surface, and geomorphic position.

Photographer: K. Myers
Date: 5/21/18
Frame No. 1
Direction: West
Comments: View of Wetland
Sample Plot WP001-WET

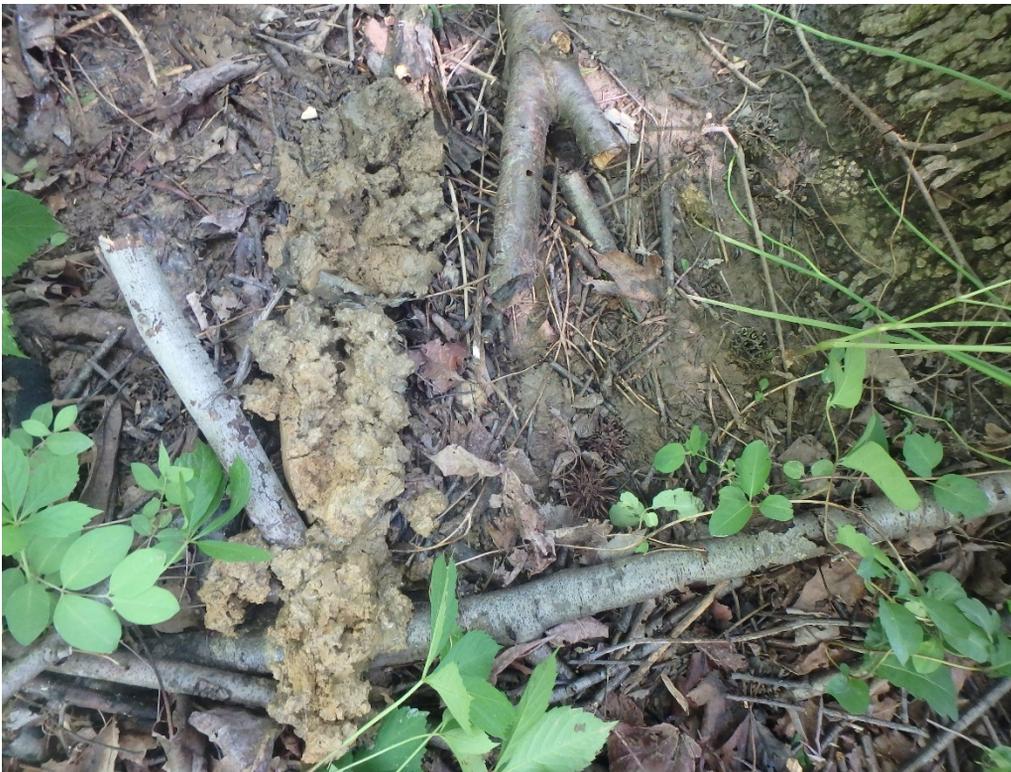
Depth (inches)	Texture	Matrix	Redox Features
0-8	Silt clay loam	10YR 4/2	10YR 2/1, depletions in the matrix 7.5YR 4/6, concentrations in the matrix
8-20	Silt clay loam	5YR 5/2	5YR 5/8, concentrations in the matrix 7.5YR 4/1, depletions in the pore linings 10YR 2/1, depletions in the matrix

Hydric soil indicators were identified within the soil profile; therefore, sample plot WP001-WET satisfies the hydric soils criterion.

Photographer: K. Myers
Date: 5/21/18
Frame No. 2
Direction: N/A
Comments: View of Wetland
Sample Plot WP001-WET soils

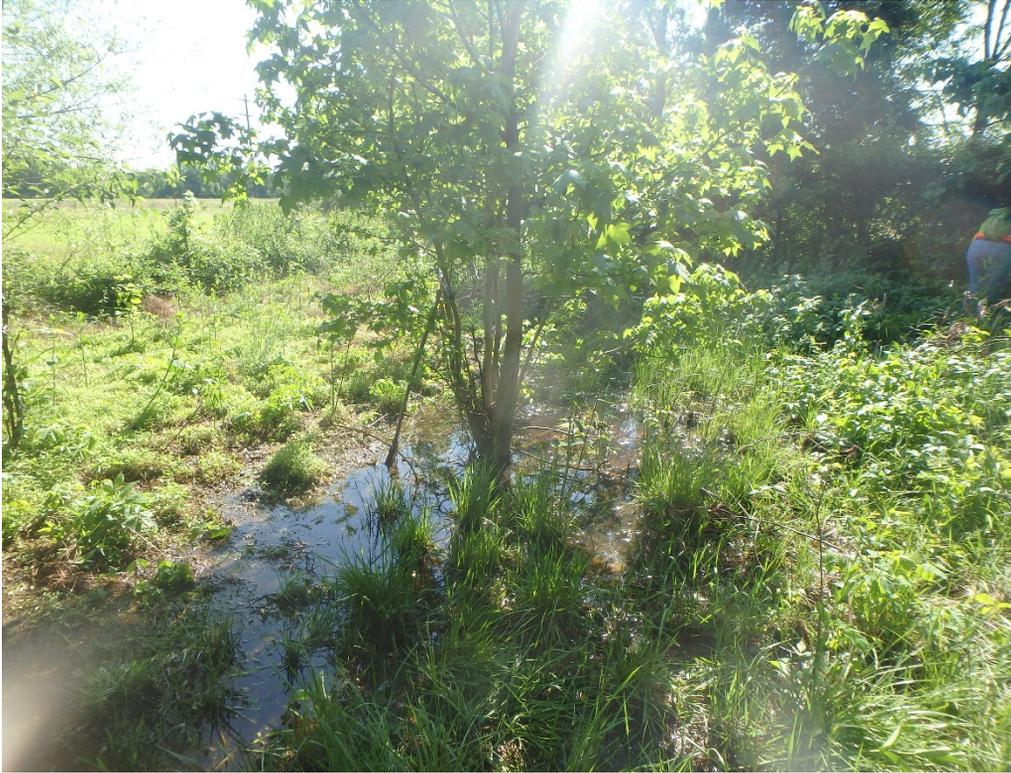
A second upland data point (UPL-1) was taken on the northwest side of I-95 in an area suspected to be wetland. Vegetation at UPL-1 is dominated by sweet gum, black willow (*Salix nigra*), Virginia creeper, Japanese stiltgrass (*Microstegium vimineum*), and poison ivy. Bradford pear, multiflora rose (*Rosa multiflora*), common reed (*Phragmites australis*), milkweed (*Asclepias*

syriaca), soft rush (*Juncus effusus*), and carex species were also noted within the sample plot. Based on the species composition, sample plot UPL-1 satisfies the hydrophytic vegetation criterion. Hydrologic indicators within the sample plot included surface water, saturation, and geomorphic position.

Photographer: K. Myers
Date: 5/21/18
Frame No. 3
Direction: East
Comments: View of Upland
Sample Plot UPL-1

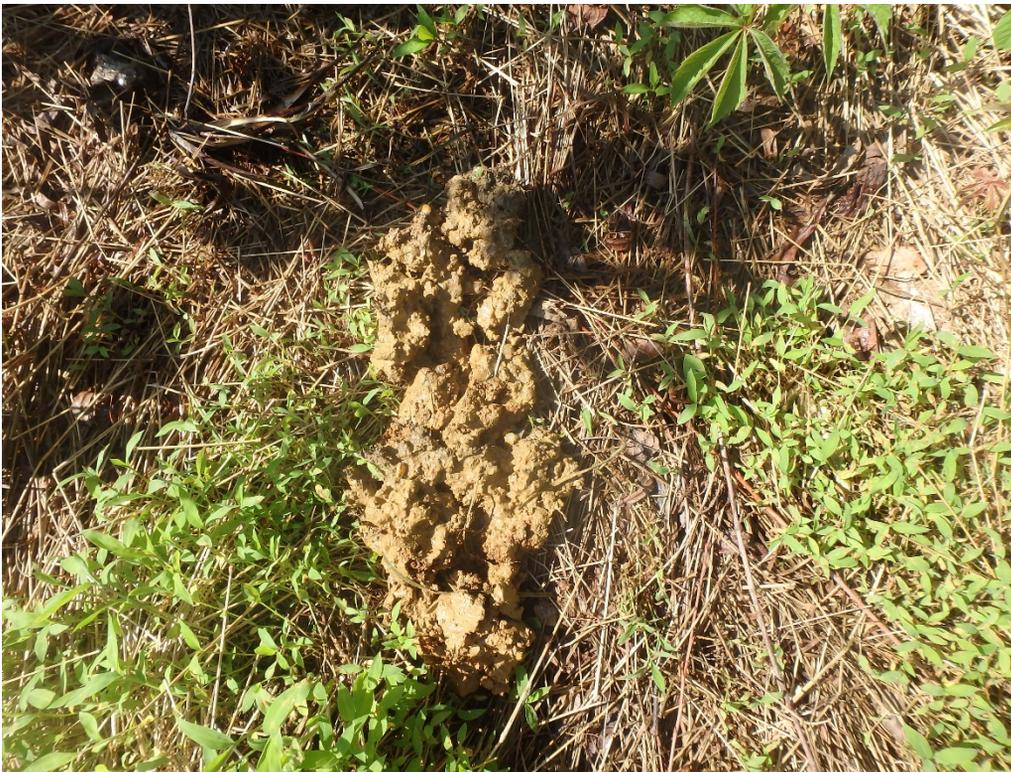
Depth (inches)	Texture	Matrix	Redox Features
0-12	Silt clay loam	7.5YR 4/4	10YR 2/1, depletions in the matrix 7.5YR 5/8, concentrations in the matrix 10YR 4/2, depletions in the matrix
12+	Fill material	Refusal	N/A

Hydric soil indicators were not identified within the soil profile; therefore, sample plot UPL-1 does not satisfy the hydric soils criterion. Sample plot UPL-1 satisfies only two of the three mandatory wetland criteria; therefore, this area is classified as upland.

Photographer: K. Myers
Date: 5/21/18
Frame No. 4
Direction: N/A
Comments: View of Upland
Sample Plot UPL-1 soils

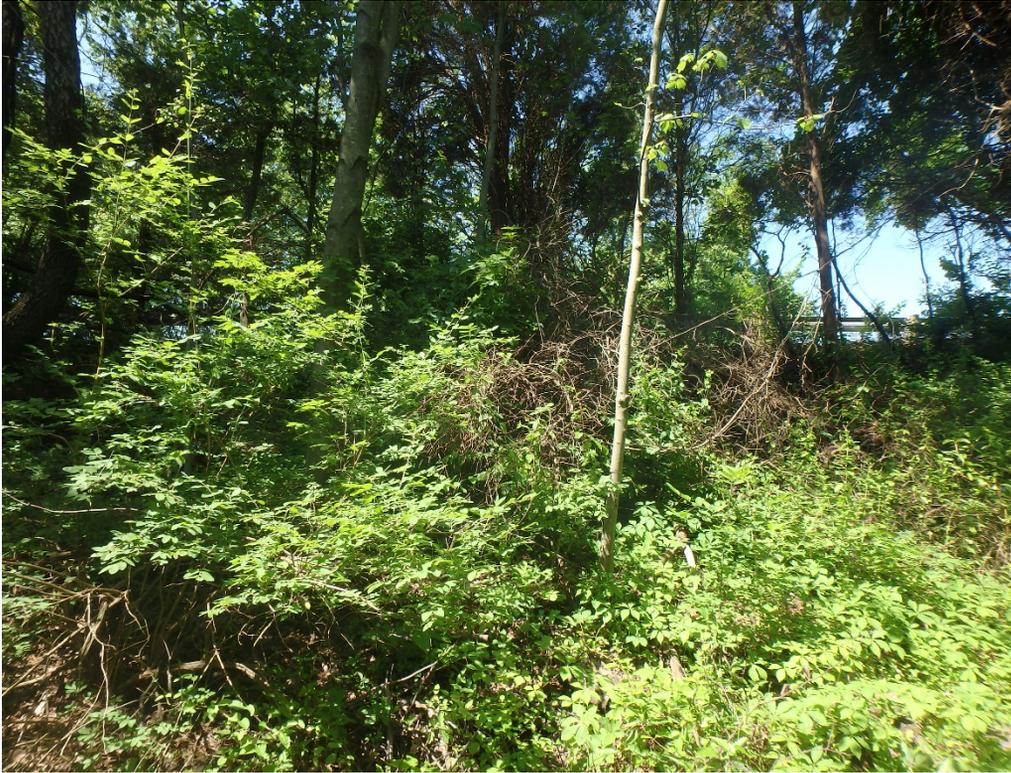
In addition to a sample plot within the wetland, an upland data point (UPL-2) was taken in close proximity to Wetland WP001 to classify the surrounding upland area. Vegetation at UPL-1 is dominated by eastern red cedar (*Juniperus virginiana*), black cherry (*Prunus serotina*), red maple, euonymus species, and Virginia creeper. Bradford pear, sweet gum, Japanese honeysuckle (*Lonicera japonica*), garlic mustard (*Alliaria petiolata*), and oriental bittersweet (*Celastrus orbiculatus*) were also noted within the sample plot. Based on the species composition, sample plot UPL-1 does not satisfy the hydrophytic vegetation criterion.

Photographer: K. Myers
Date: 5/21/18
Frame No. 5
Direction: East
Comments: View of Upland
Sample Plot UPL-2

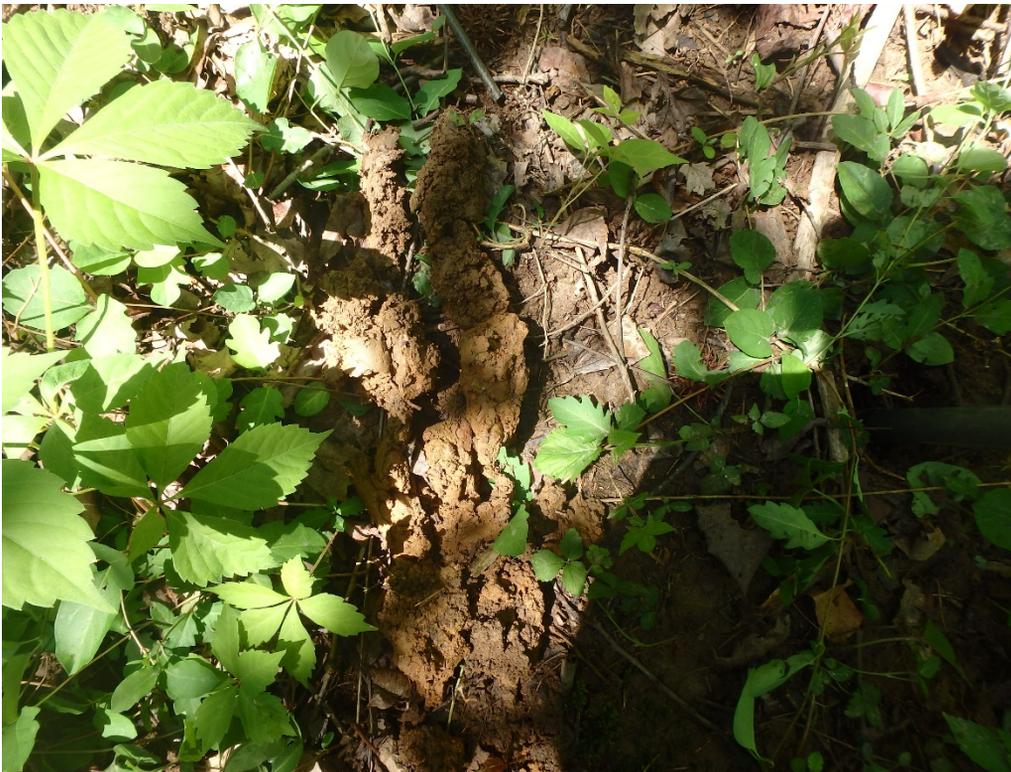
Depth (inches)	Texture	Matrix	Redox Features
0-3	Silt clay loam	7.5YR 4/3	N/A
3-10	Silt clay loam	5YR 4/6	7.5YR 4/3, depletions in the matrix 2.5YR 5/8, concentrations in the pore linings
10+	Fill material/gravel	Refusal	N/A

Hydric soil indicators were not identified within the soil profile; therefore, sample plot UPL-2 does not satisfy the hydric soils criterion. Wetland hydrologic indicators were not present in close proximity to upland sample plot UPL-2. Sample plot UPL-2 does not satisfy any of the three mandatory wetland criteria; therefore, this area is classified as upland.

Photographer: K. Myers
Date: 5/21/18
Frame No. 6
Direction: N/A
Comments: View of Upland
Sample Plot UPL-2 soils
