WETLAND AND WATERS DELINEATION REPORT

I-95 ETL NORTHBOUND EXTENSION

COWENTON AVENUE TO NEW FORGE ROAD

JMT Project Number 13-0770-054

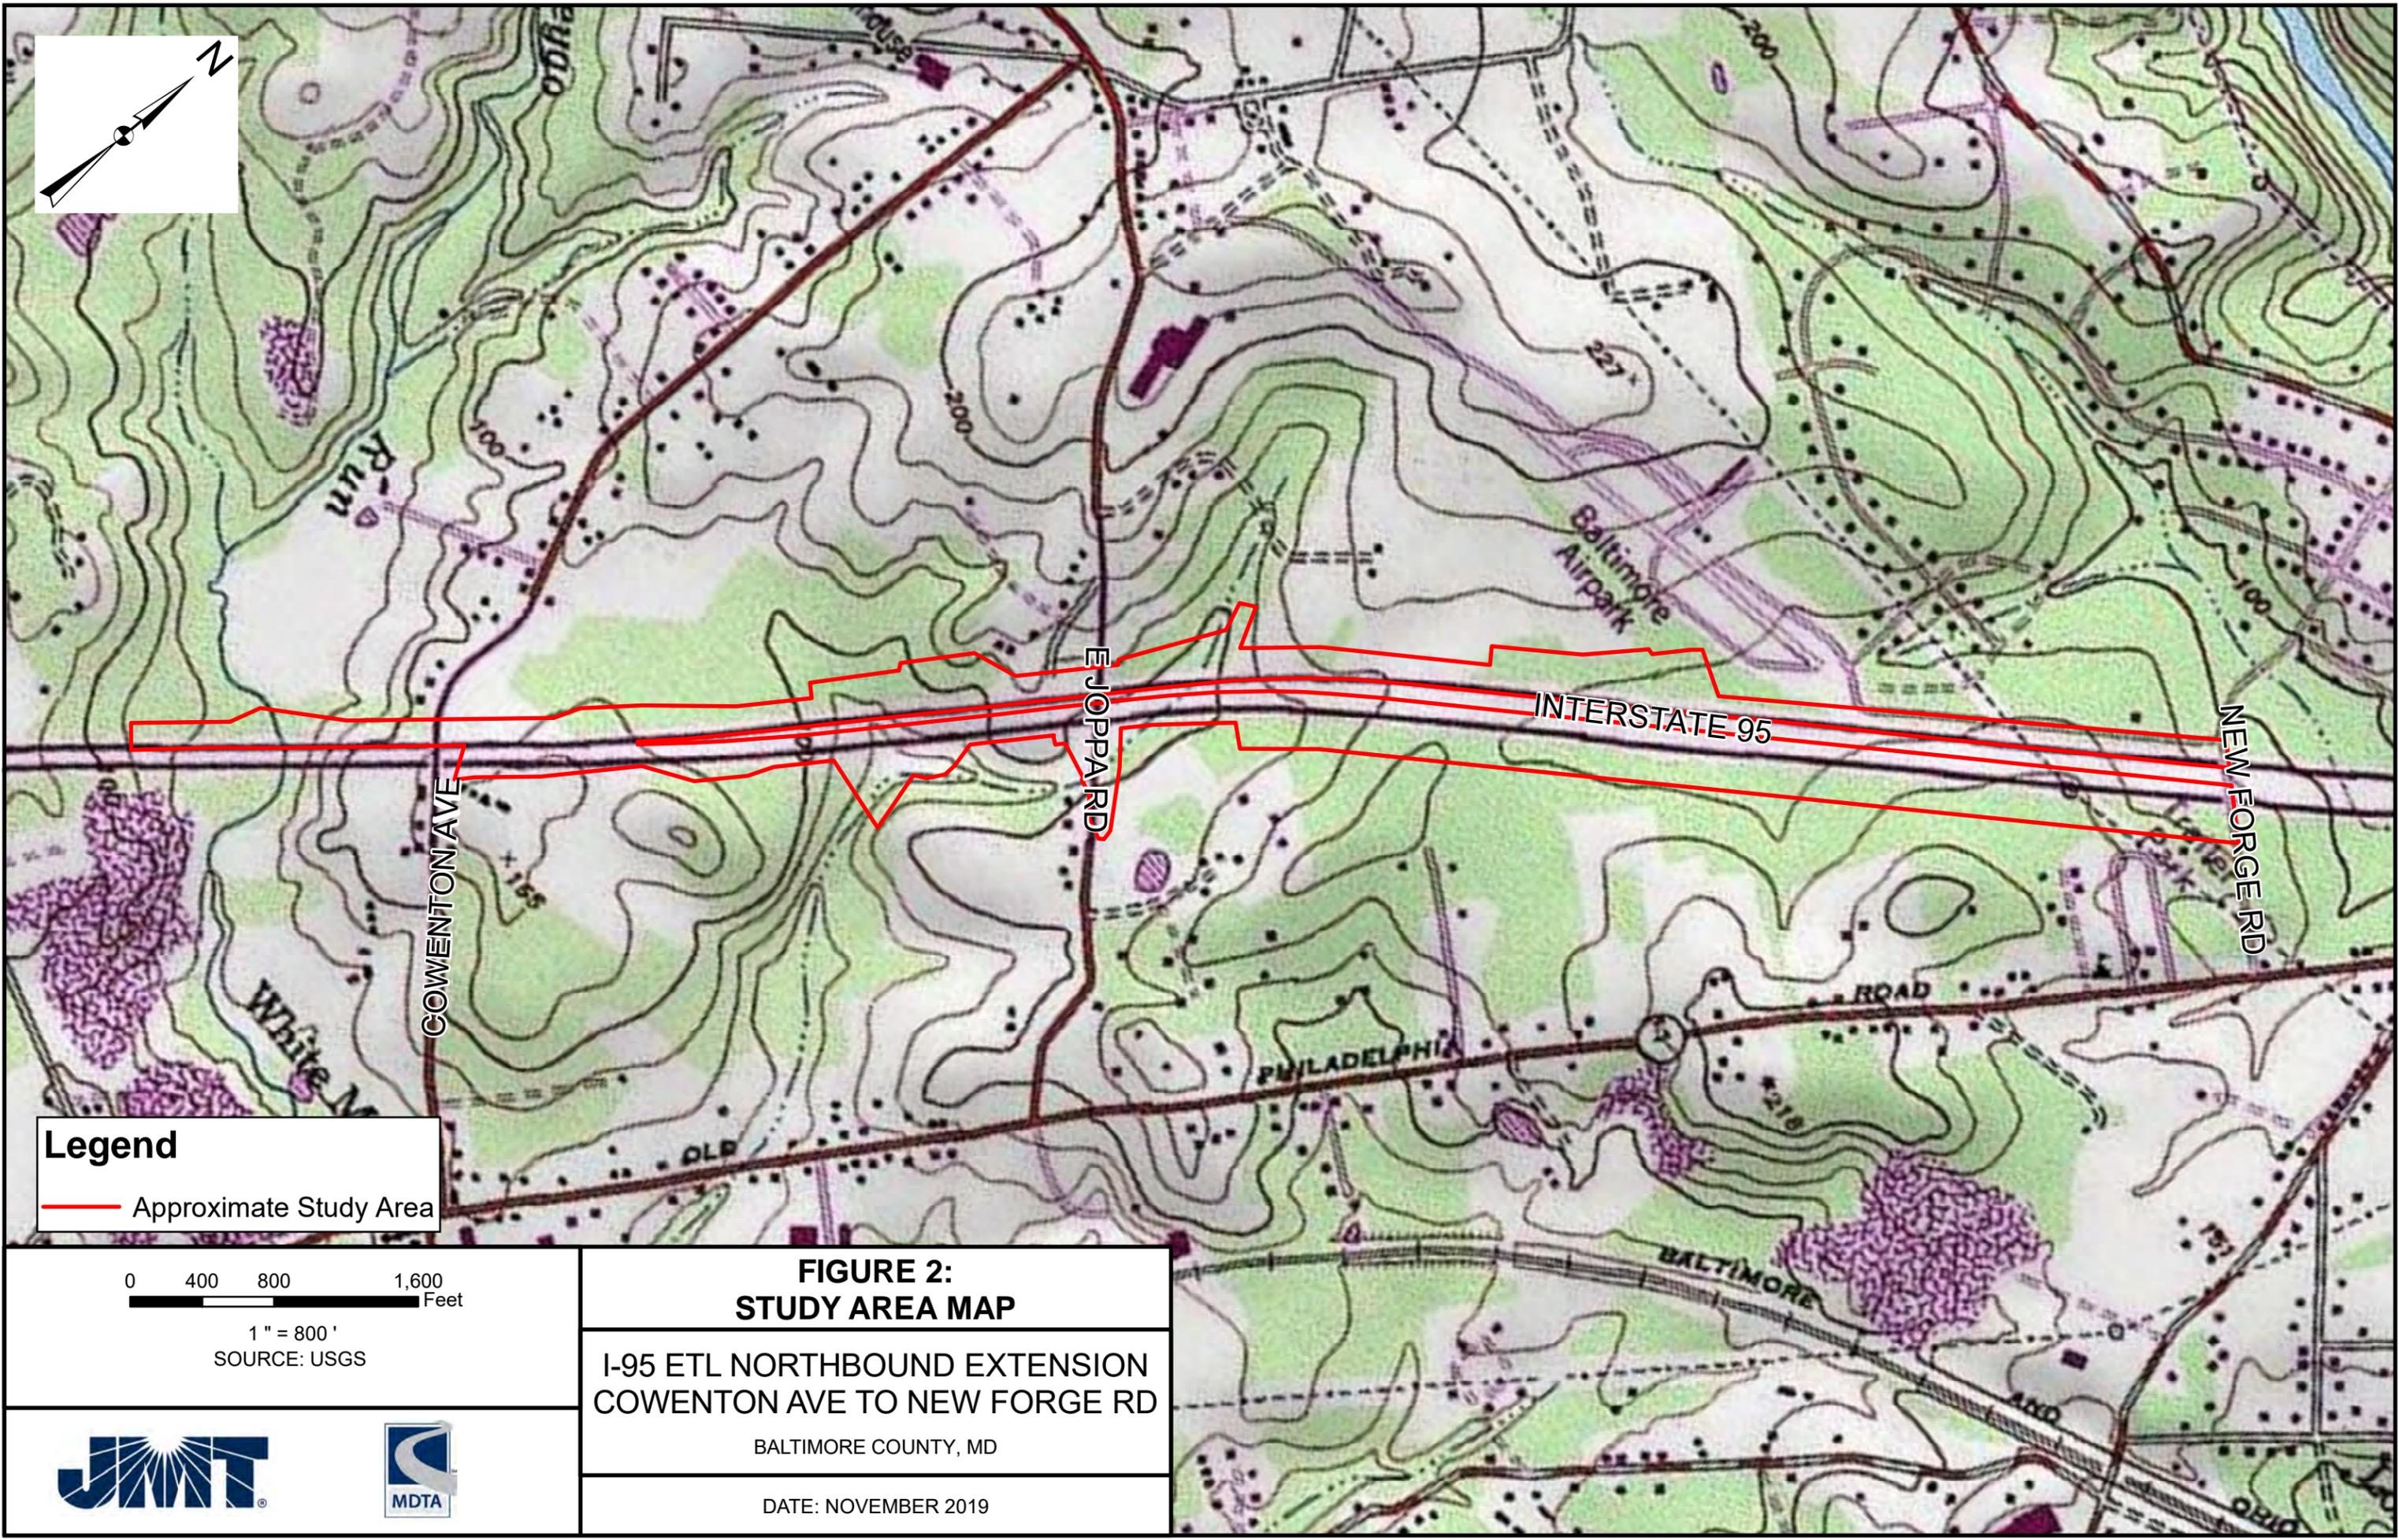
The Study Area is located along the northbound and southbound sides of I-95, within the MDTA right of way, in Baltimore County (**Figure 2**). The Study Area extends from the Cowenton Avenue overpass to the New Forge Road overpass and is mostly forested, exempting areas of existing roadways and shoulders. The southern portion of the Study Area lies within the Northern Atlantic Slope Diversified Farming Region of the Northern Coastal Plain Land Resource Area (MLRA 148). The northern portion of the Study Area lies within the Northern Atlantic Slope Diversified Farming Region of the Northern Piedmont (MLRA 149A). The Study Area is divided between two Maryland Department of Environment (MDE) 8-Digit Watersheds, Bird River (02130803) and Lower Gunpowder Falls (02130802).

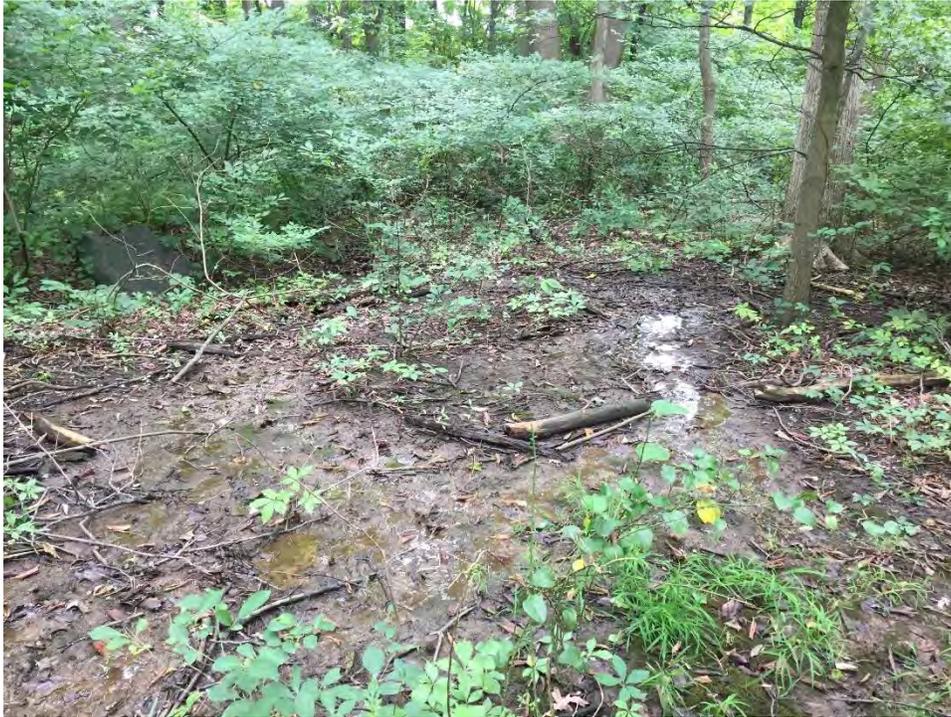
Photo 3: WET D

WET D is a palustrine forested wetland (PFO) located in the southeastern portion of the Study Area on the northbound side of I-95 (**Appendix B, Map 2**). The wetland is approximately 2,760 square feet (0.063 acres) in size. Primary hydrologic indicators included surface water, high water table, saturation, algal mat or crust, and water-stained leaves. The vegetation within the wetland is hydrophytic. The dominant vegetation within the sample plot included green ash, sweetgum (*Liquidambar styraciflua*, FAC), red maple (*Acer rubrum*, FAC), red oak (*Quercus rubra*, FACU), spicebush, multiflora rose (*Rosa multiflora*, FACU), lurid sedge (*Carex lurida*, OBL), whitegrass, poison ivy (*Toxicodendron radicans*, FAC), and Virginia creeper (*Parthenocissus quinquefolia*, FACU). Soils in the sample plot are hydric, meeting the criteria for the Depleted Matrix and Redox Dark Surface Soil Indicators. This wetland feature is not shown on NWI or DNR GIS mapping.

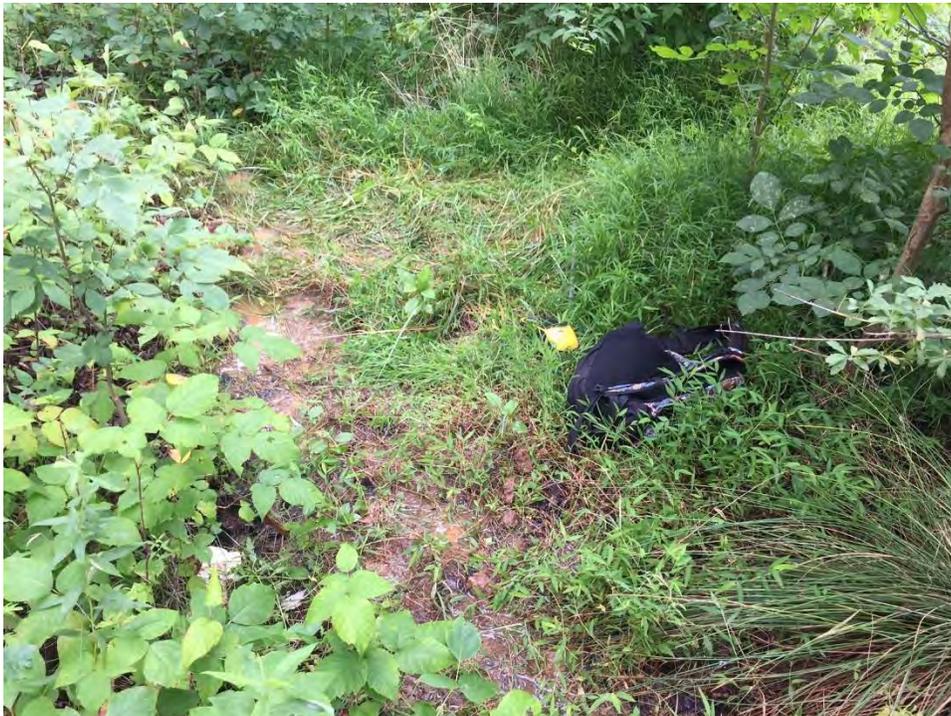
Photo 6: WET F

WET F is a PEM wetland located to the south of East Joppa Road on the northbound side of I-95 (**Appendix B, Map 3**). The wetland is approximately 364 square feet (0.008 acres) in size. Primary hydrologic indicators included surface water, high water table, and saturation. The vegetation within the wetland is hydrophytic. The dominant vegetation within the sample plot included green ash, sweetgum, rice cutgrass (*Leersia oryzoides*, OBL), Japanese stilt grass (*Microstegium vimineum*, FAC), and Japanese honeysuckle (*Lonicera japonica*, FACU). Soils in the sample plot are hydric, meeting the Depleted Matrix Soil Indicator. This wetland feature is not shown on NWI or DNR GIS mapping.

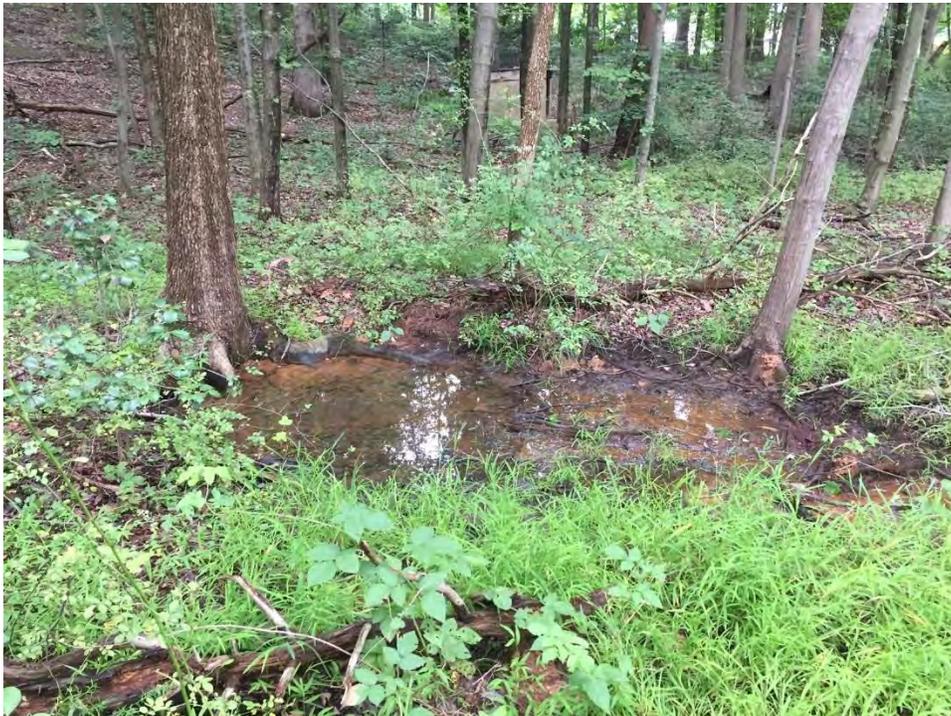
Photo 8: WET G

WET G is a PFO wetland located in the middle of the Study Area along the northbound side of I-95 (**Appendix B, Maps 3 & 4**). The wetland is approximately 5,621 square feet (0.129 acres) in size. Primary hydrologic indicators included surface water, high water table, saturation, water marks, and water-stained leaves. The vegetation within the wetland is hydrophytic. The dominant vegetation within the sample plot included red maple, sweetgum, whitegrass, and poison ivy. Soils in the sample plot are hydric, meeting the Depleted Matrix Soil Indicator. This wetland feature is not shown on NWI or DNR GIS mapping.

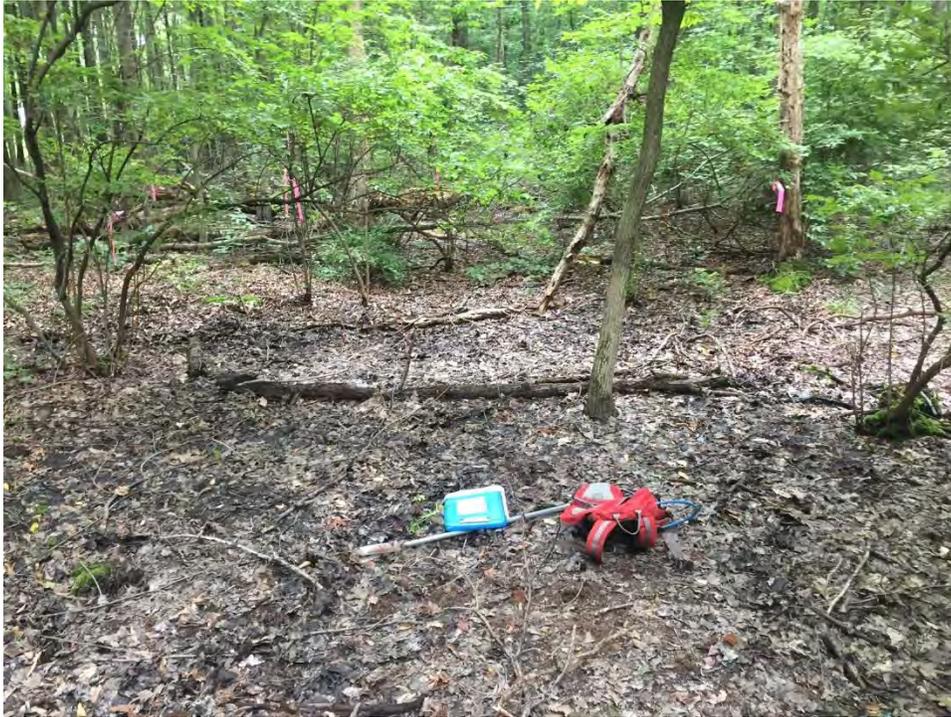
Photo 11: WET I

WET I is a PFO wetland located on the northbound side of I-95 at the southwestern end of BRBR-WET1 (**Appendix B, Map 4**). The wetland is approximately 292 square feet (0.006 acres) in size. Primary hydrologic indicators included water-stained leaves. The vegetation within the wetland is hydrophytic. The dominant vegetation within the sample plot included black gum (*Nyssa sylvatica*, FAC), highbush blueberry (*Vaccinium corymbosum*, FACW), and soft rush. Soils within the sample plot are hydric, meeting the Redox Dark Surface Soil Indicator. WET I is an expansion of BRBR-WET1, which was previously delineated under the I-95 ETL Section 100 project. This wetland feature is shown on NWI and DNR GIS mapping.

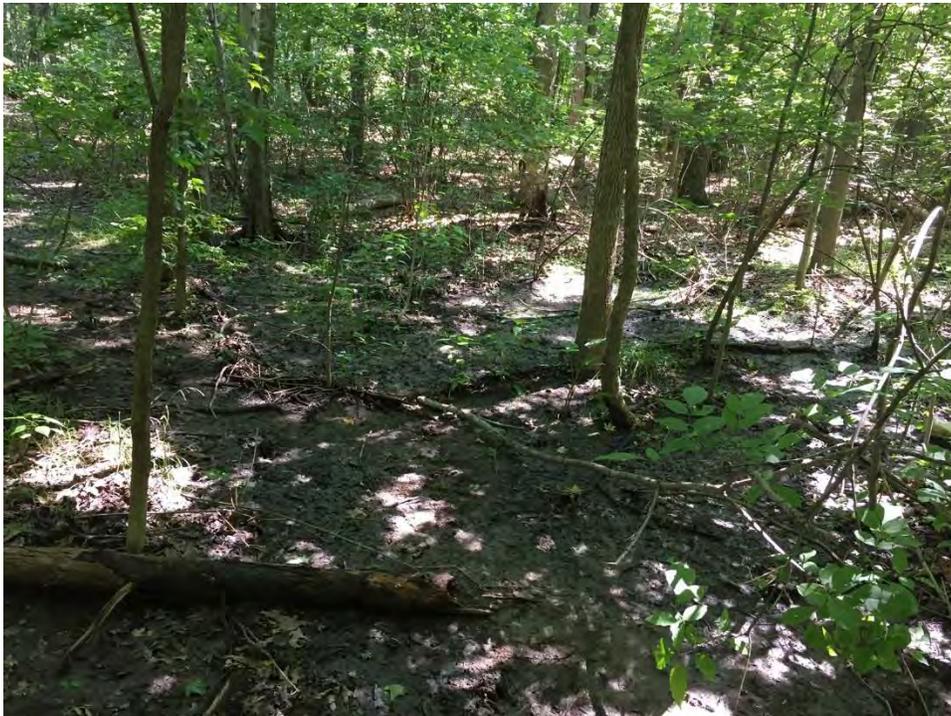
Photo 12: WET J

WET J was a PFO wetland located in the northeastern portion of the Study Area on the northbound side of I-95 that has since been impacted by construction (**Appendix B, Map 5**). The wetland was approximately 3,716 square feet (0.085 acres) in size. Primary hydrologic indicators observed included surface water, saturation, and water-stained leaves. The

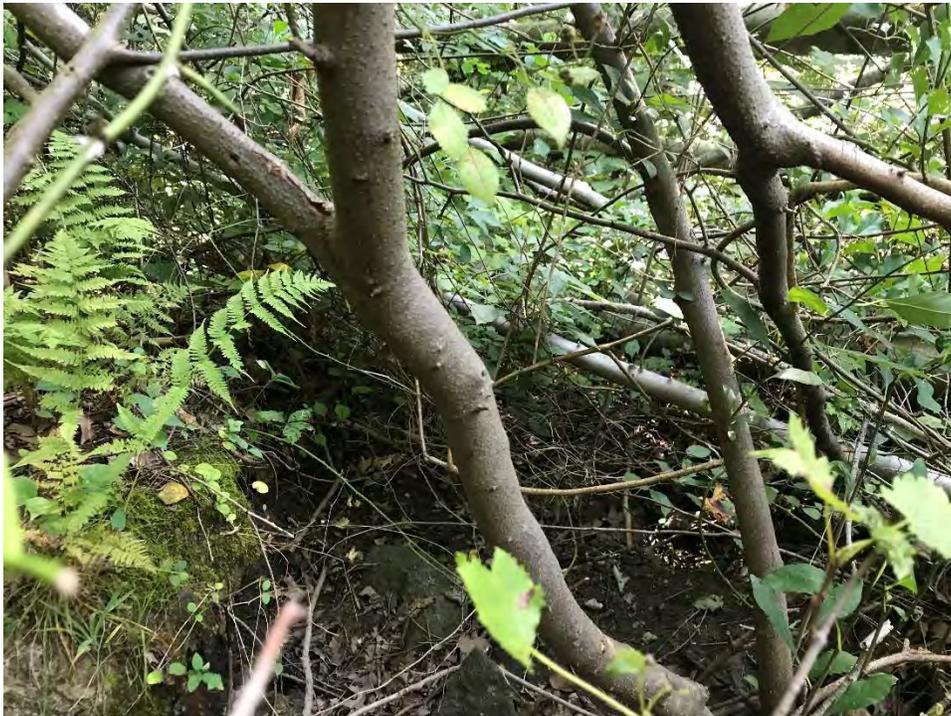
Photo 16: WUS Q – DOWNSTREAM

WUS Q is an ephemeral channel located on the northbound side of I-95, south of East Joppa Road (**Appendix B, Map 2**). The channel originates at the boundary of BRBR-WET21 and flows into BRBR-WUS1, a tributary to the Bird River, a TNW. Bank slopes are 2:1 and range between 1 and 3 feet in height; at the time of delineation no flow was observed within the channel. The substrate consists of cobble, gravel, sand, silt, and vegetation.

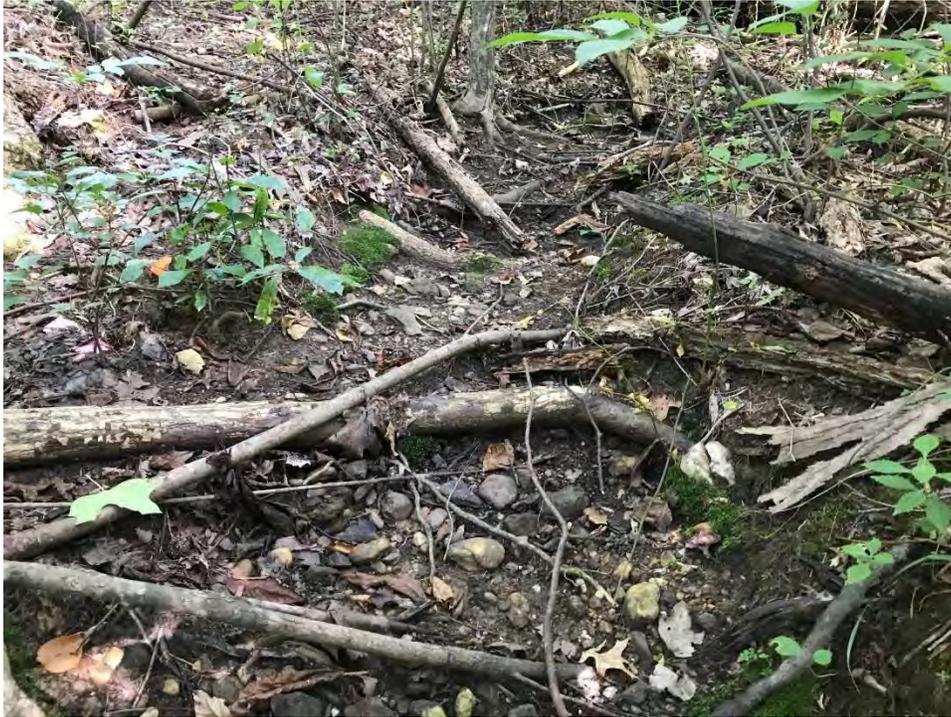
Photo 17: WUS R – UPSTREAM

WUS R is an ephemeral channel located on the northbound side of I-95, south of East Joppa Road (**Appendix B, Map 2**). The channel originates to the north of WUS Q and flows southeast into BRBR-WUS1, a tributary to the Bird River, a TNW. Bank slopes are 2:1 and 1 foot in height; at the time of delineation no flow was observed within the channel. The substrate consists of gravel and sand.

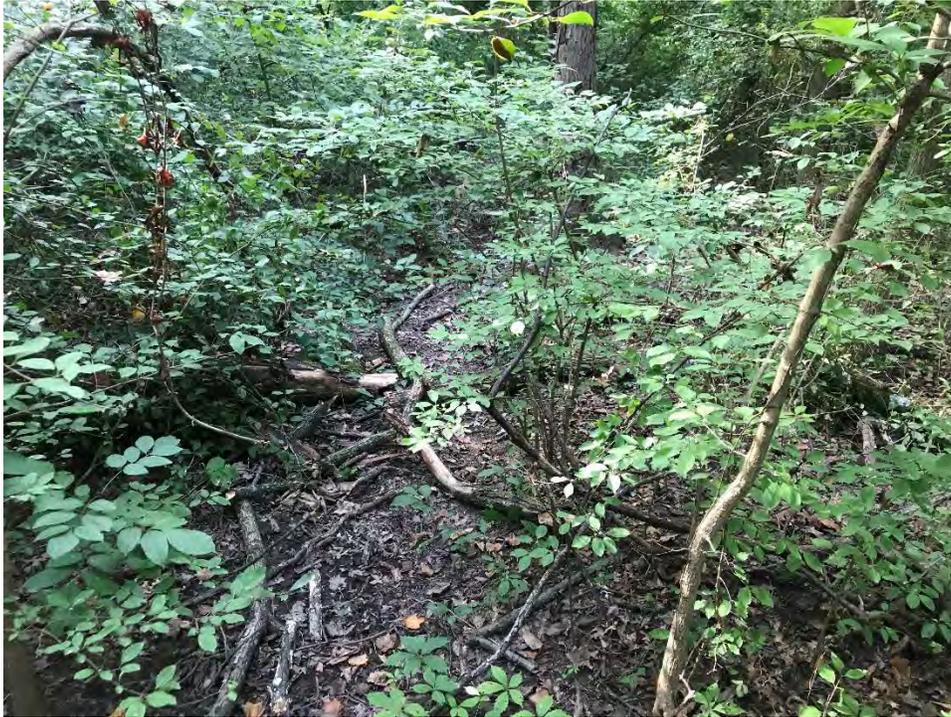
Photo 21: WUS G – DOWNSTREAM

WUS G is an ephemeral channel located on the northbound side of I-95, south of East Joppa Road (**Appendix B, Map 2**). The stream originates at the boundary of WET D and flows south outside of the Study Area into BRBR-WUS7, a tributary to the Bird River, a TNW. Bank slopes are 2:1 and range between 3 and 12 inches in height; at the time of delineation there was no flow observed within the channel. The substrate consists of sand, silt, and vegetation.

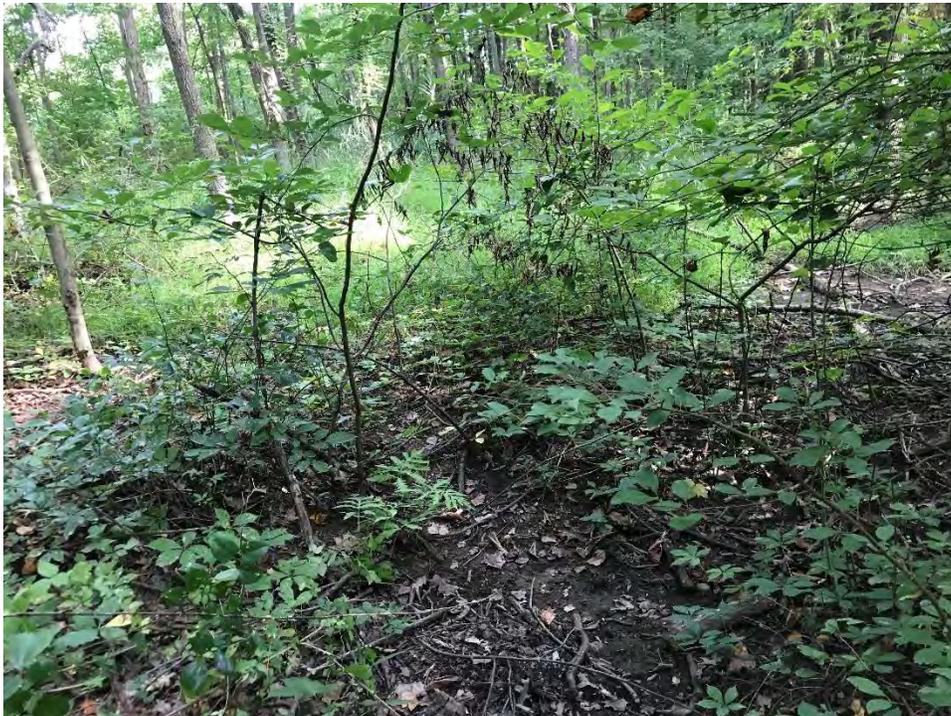
Photo 22: WUS H - UPSTREAM

WUS H is an ephemeral channel located on the northbound side of I-95, south of East Joppa Road (**Appendix B, Map 2**). The stream originates at the boundary of WET D and flows south outside of the Study Area, eventually draining into BRBR-WUS7, a tributary to the Bird River, a TNW. Bank slopes are 2:1 and 6 inches in height; at the time of delineation there was no flow observed within the channel. The substrate consists of gravel, sand, and silt.

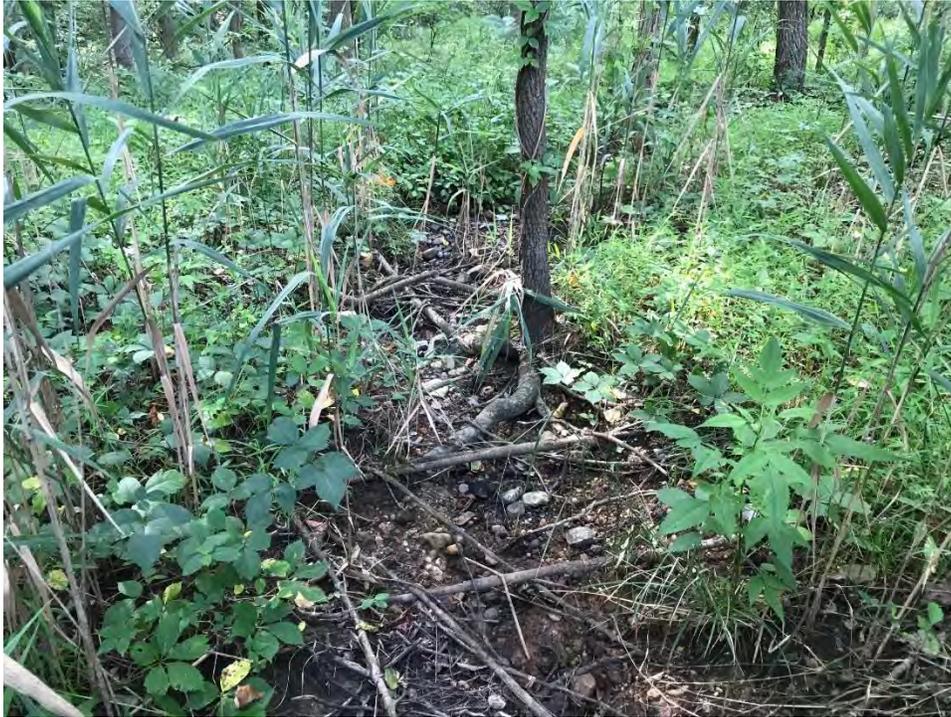
Photo 23: WUS F – DOWNSTREAM

WUS F is an ephemeral channel located on the northbound side of I-95, south of East Joppa Road (**Appendix B, Map 2**). The stream originates at the boundary of BRBR-WET22-PEM and drains into WET D. Bank slopes are 2:1 and range between 12 and 16 inches in height; at the time of delineation there was no flow observed within the channel. The substrate consists of cobble, sand, silt, and muck.

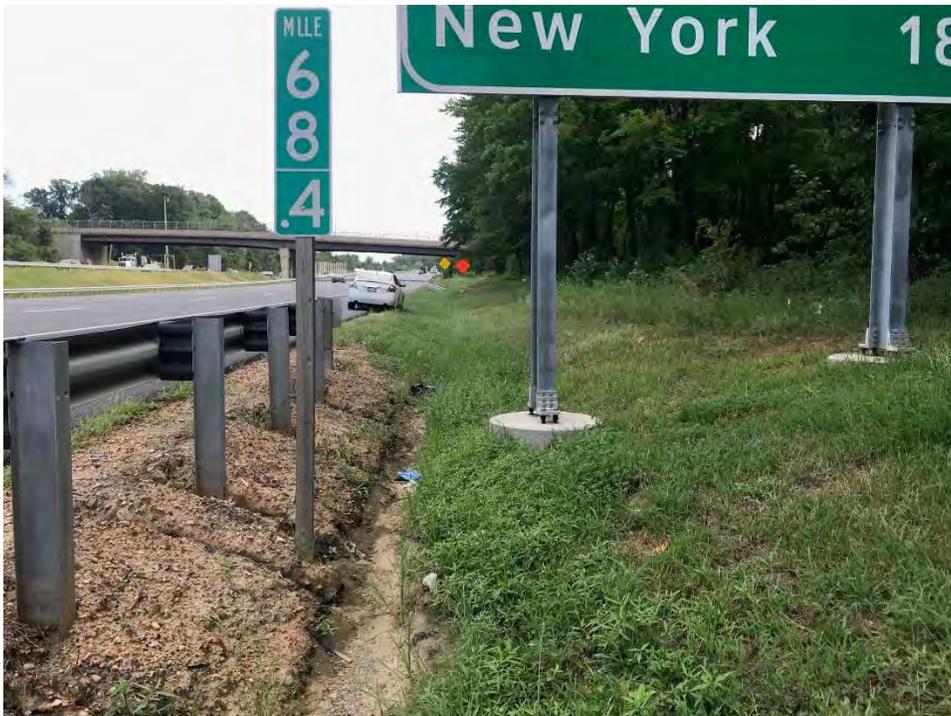
Photo 24: WUS I – UPSTREAM

On May 29, 2020, USACE determined that this resource is a non-jurisdictional roadside ditch. WUS I was previously delineated as an ephemeral channel located on the northbound side of I-95, south of East Joppa Road (**Appendix B, Map 3**). The ditch originates to the southwest of WET F and flows into BRIS-WET3. Bank slopes are 2:1 and range between 12 and 18 inches in height; at the time of delineation there was no flow observed within the channel. The substrate consists of gravel, sand, silt, muck, and vegetation.

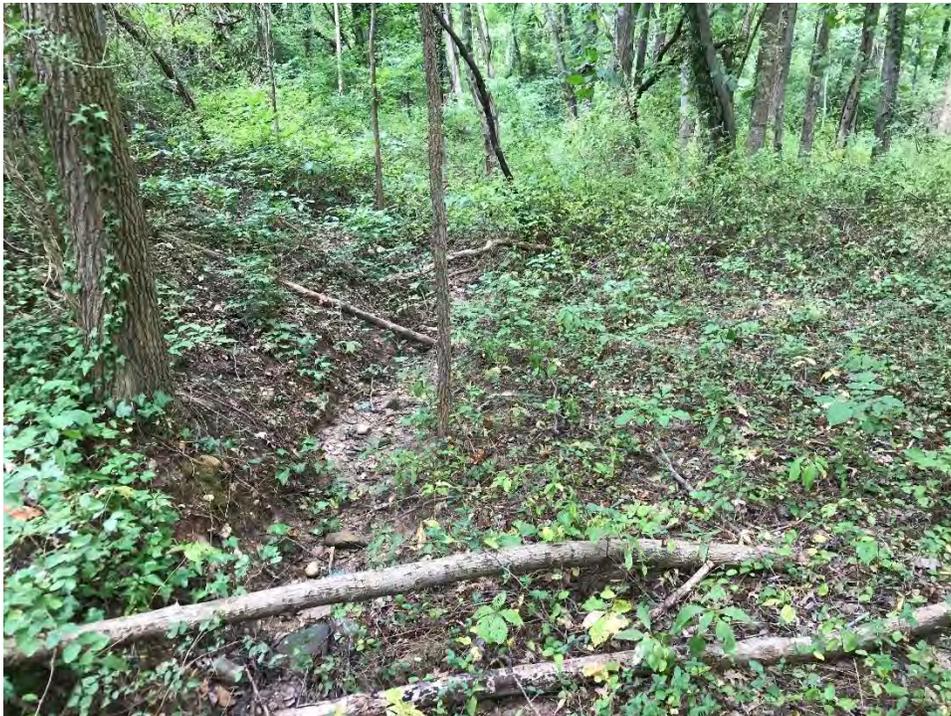
Photo 26: WUS T – DOWNSTREAM

WUS T is an ephemeral channel located on the northbound side of I-95, north of East Joppa Road (**Appendix B, Map 3**). The stream originates to the northeast of East Joppa Road and flows northeast, parallel to East Joppa Road, into BRBR-WUS1, a tributary to the Bird River, a TNW. Bank slopes are 2:1 and range between 2 and 4 feet in height; at the time of delineation there was no flow observed within the channel. The substrate consists of cobble, gravel, sand, and silt.

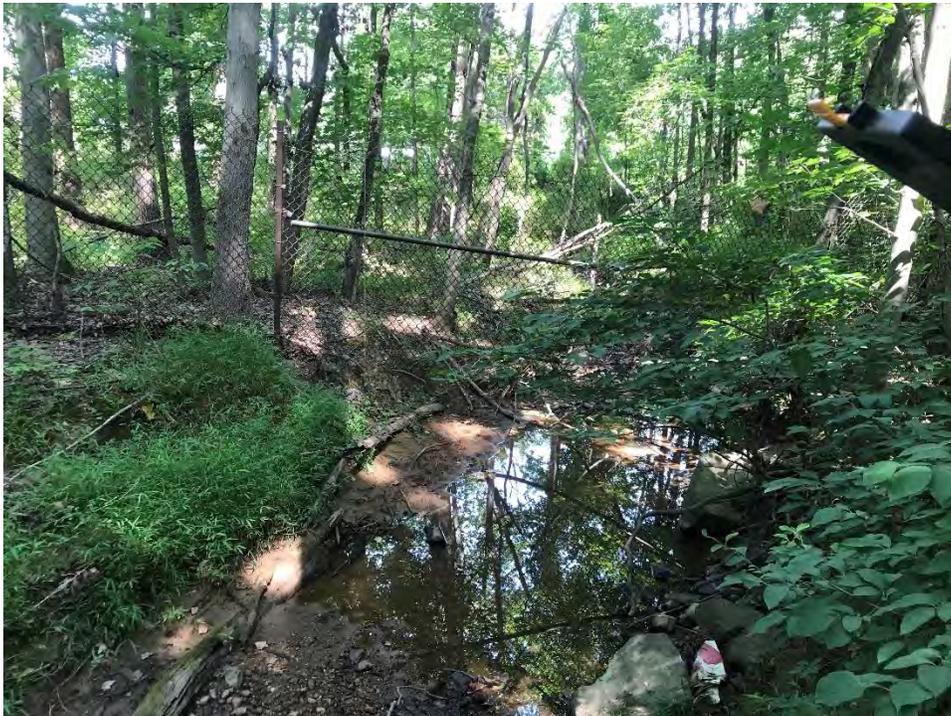
Photo 28: BRBR-WUS2 – UPSTREAM

BRBR-WUS2 is an intermittent stream located on the northbound side of I-95 north of East Joppa Road (**Appendix B, Map 3**). The stream originates outside of the Study Area and flows southwest into BRBR-WUS1, a tributary to the Bird River, a TNW. Bank slopes are 2:1 and 6 inches in height; at the time of delineation there was no flow observed within the channel. The substrate consists of gravel, sand, and silt. BRBR-WUS2 was previously delineated as BRBR-WUS2 under the I-95 ETL Section 100 project.

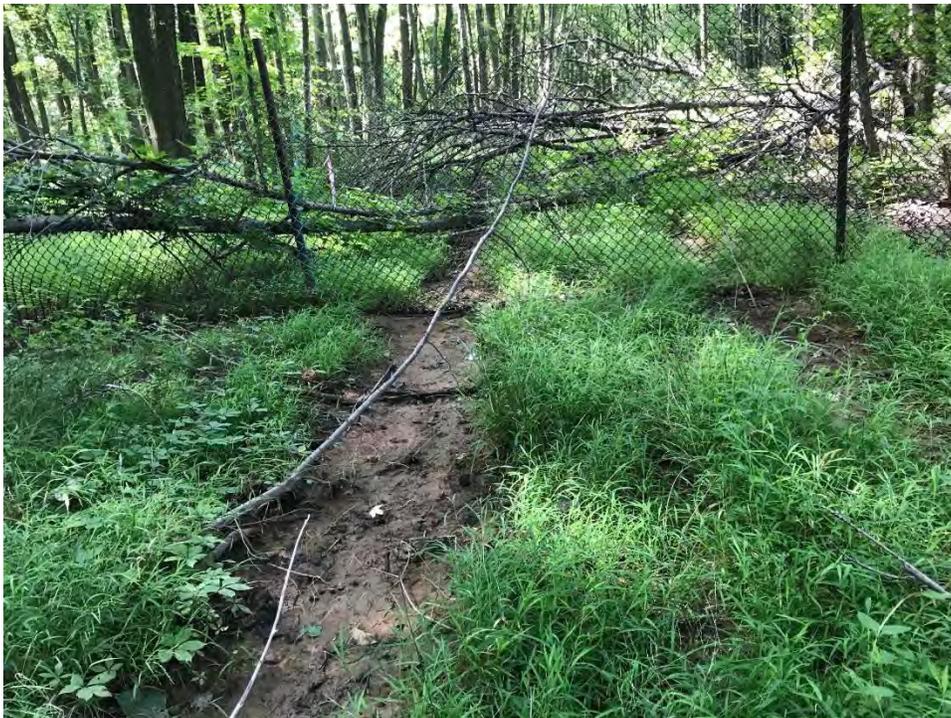
Photo 30: WUS L - DOWNSTREAM

WUS L is an intermittent stream located on the northbound side of I-95, north of East Joppa Road (**Appendix B, Map 3-4**). The stream originates from the boundary of WET G and flows southwest outside of the Study Area. Bank slopes are 4:1 and 4 inches in height; at the time of delineation no flow was observed within the channel. The substrate consists of sand, silt, and muck.

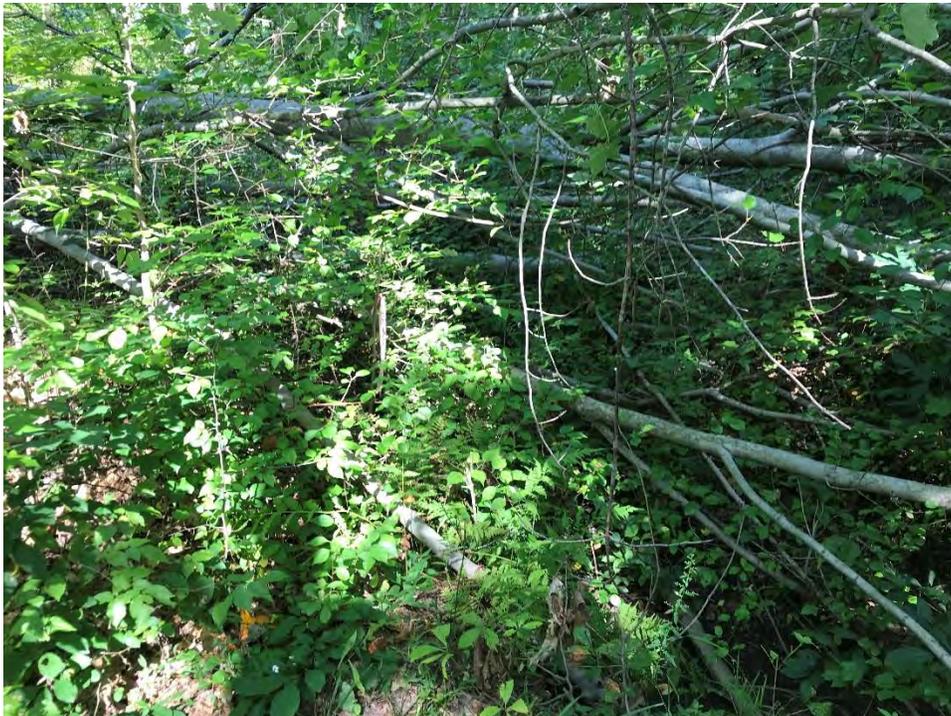
Photo 32: WUS M – DOWNSTREAM

WUS M is an ephemeral channel located on the northbound side of I-95, north of East Joppa Road (**Appendix B, Map 4-5**). The stream originates at WET H and flows to the northeast into GPJR-WUS2A, which is a tributary to the Gunpowder River, a TNW. Bank slopes are 3:1 and range between 1 and 3 feet in height; at the time of delineation no flow was observed within the channel. The substrate consists of sand, silt, and muck.

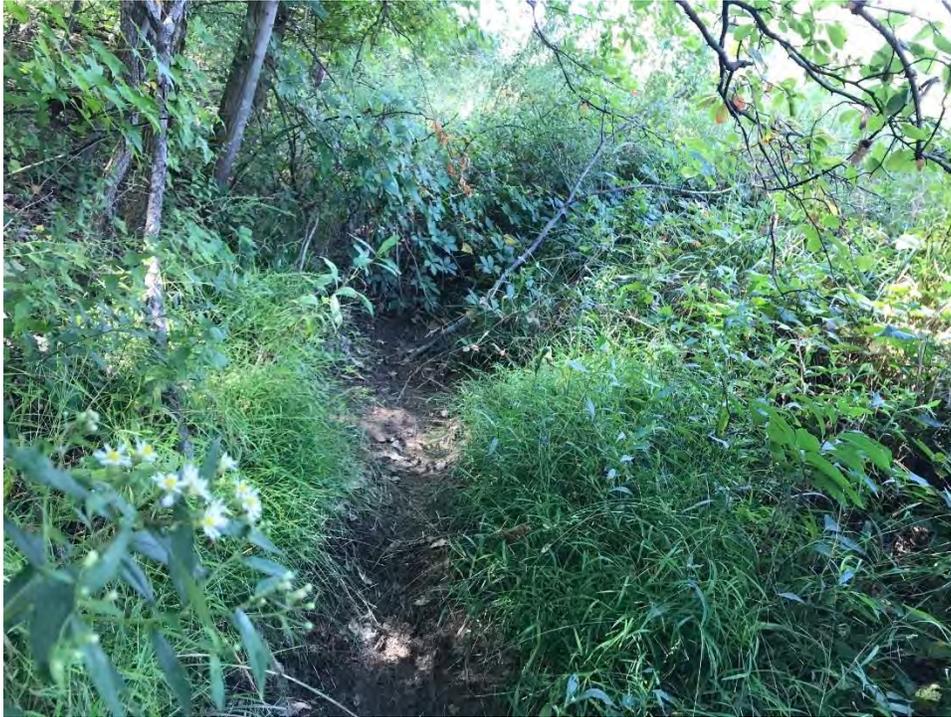
Photo 33: GPJR-WUS2A – UPSTREAM

GPJR-WUS2A is an ephemeral channel located on the northbound side of I-95, north of East Joppa Road (**Appendix B, Map 5**). The stream is a continuation of WUS M and flows north into GPJR-WUS1 (a tributary to the Gunpowder River, a TNW), which flows into a culvert under I-95. Bank slopes are 2:1 and 3 feet in height; at the time of delineation there was no flow observed within the channel. The substrate consists of gravel, sand, and silt. GPJR-WUS2A was previously delineated under the I-95 ETL Section 100 project as one of two streams named GPJR-WUS2; its name was changed to disambiguate the two streams.

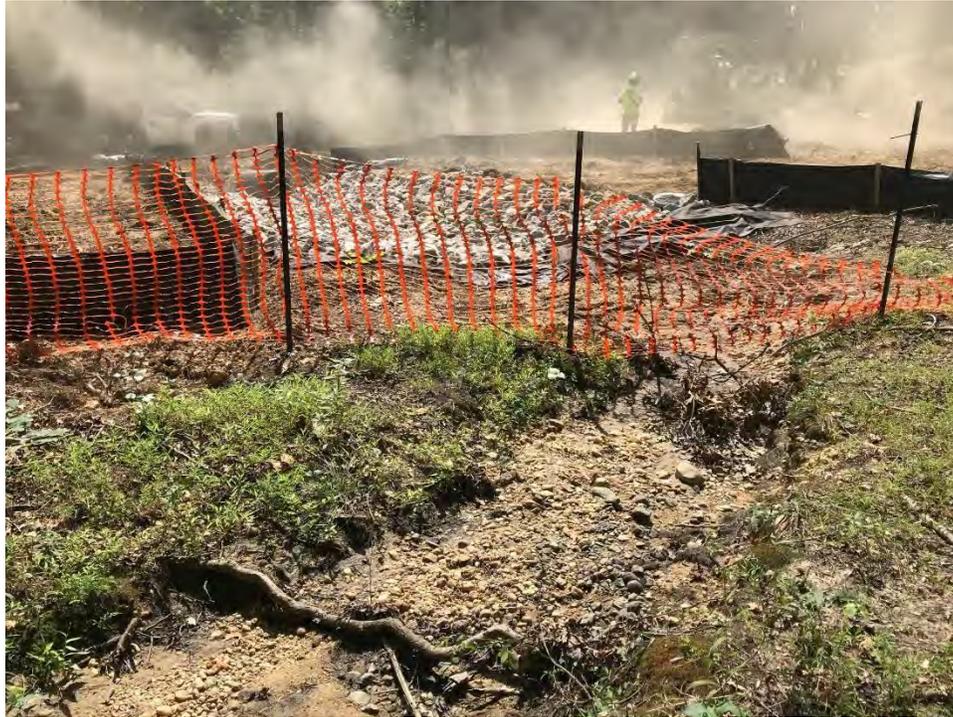
Photo 37: GPJR-WUS10B UPSTREAM

GPJR-WUS10B is an intermittent stream located on the northbound side of I-95, north of East Joppa Road (**Appendix B, Map 5**). The stream originates outside of the Study Area from a stormwater outfall and flows west into GPJR-WUS3, a tributary to the Gunpowder River, a TNW. Bank slopes are vertical and 4 inches in height; at the time of delineation, no flow was observed within the channel. The substrate consists of gravel and sand. GPJR-WUS10B was previously delineated under the I-95 ETL Section 100 project.

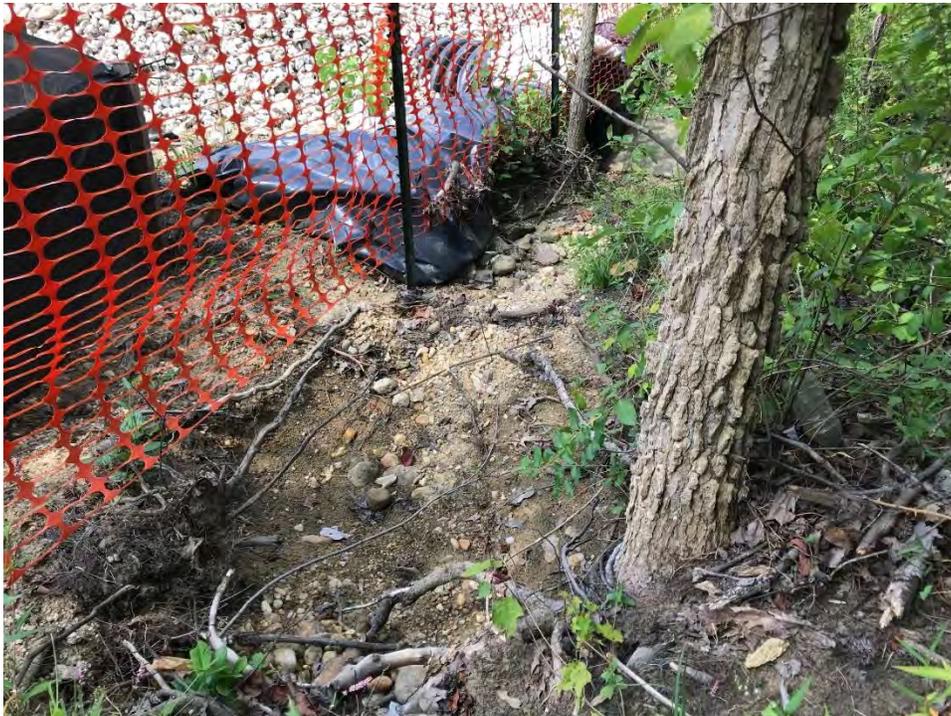
Photo 40: WUS O – DOWNSTREAM

WUS O is an intermittent channel located on the northbound side of I-95, north of East Joppa Road (**Appendix B, Map 5**). Prior to recent construction, the stream originated from WET J; however, WET J no longer exists, and WUS O is now fed only by upland runoff. It flows west into WUS P, a tributary to the Gunpowder River, a TNW. Bank slopes vary between vertical and 2:1 with banks 6 inches in height; at the time of delineation, no flow was observed within the channel. The substrate consists of gravel and sand. WUS O has been partially impacted by construction activities.

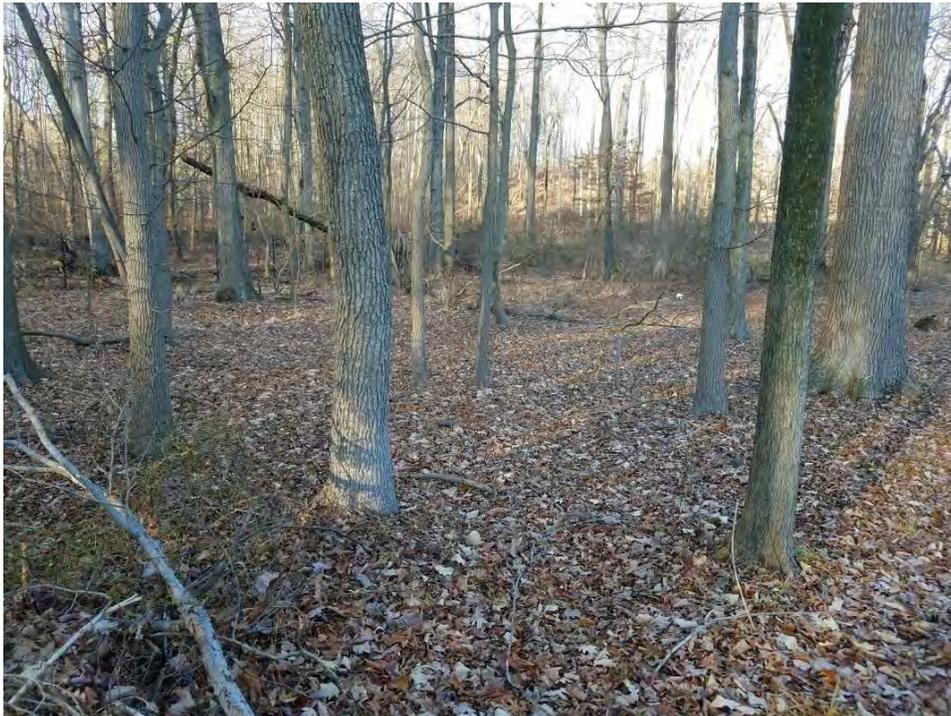
Photo 42: BRBR-WET 5

BRBR-WET5-PFO is a PFO wetland located along the southbound side of I-95, north of Cowenton Avenue (**Appendix B, Map 2**). The wetland is approximately 56,961 square feet (1.308 acres) in size. The wetland originates outside of the Study Area and drains to BRBR-WUS11 and BRBR-WUS13A. Primary hydrologic indicators included the presence of water-stained leaves and oxidized rhizospheres on living roots. Dominant species included red maple, pin oak (*Quercus palustris*, FACW), spice bush, southern arrowwood, bladder sedge (*Carex intumescens*, FACW), soft rush, Japanese stiltgrass, poison ivy, and roundleaf greenbriar. The soils in the sample plot are hydric, meeting the Depleted Matrix Soil Indicator. This wetland feature is shown on NWI GIS mapping. BRBR-WET5 was delineated within the previously delineated boundaries of BRBR-WET9 and BRBR-WET5 under the I-95 ETL Section 100 project.

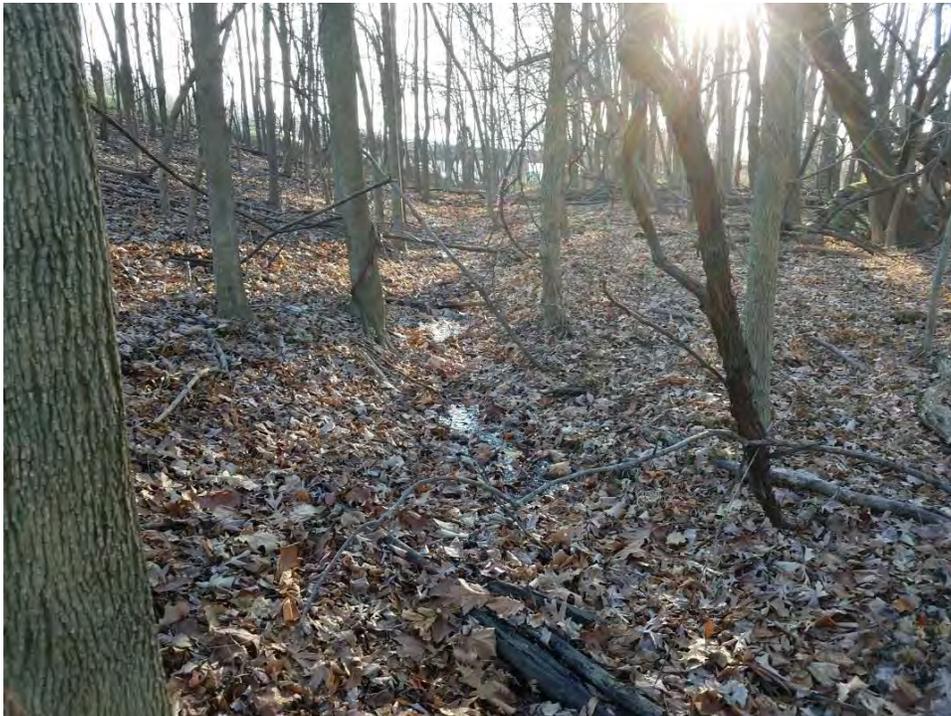
Photo 44: BRBR-WET98

BRBR-WET98-PFO is a PFO wetland located on the southbound side of I-95, immediately north of East Joppa Road (**Appendix B, Map 3**). The wetland is approximately 20,533 square feet (0.432 acres) in size. The wetland originates outside of the Study Area and drains to BRBR-WUS9. Primary hydrologic indicators included the presence of water-stained leaves and oxidized rhizospheres on living roots. Dominant species included red maple, pin oak, black gum, spice bush, southern arrowwood, Japanese stiltgrass, soft rush, bladder sedge, poison ivy, and roundleaf greenbriar. The soils in the sample plot are hydric, meeting the Depleted Matrix Soil Indicator. This wetland feature is not shown on NWI or DNR GIS mapping.

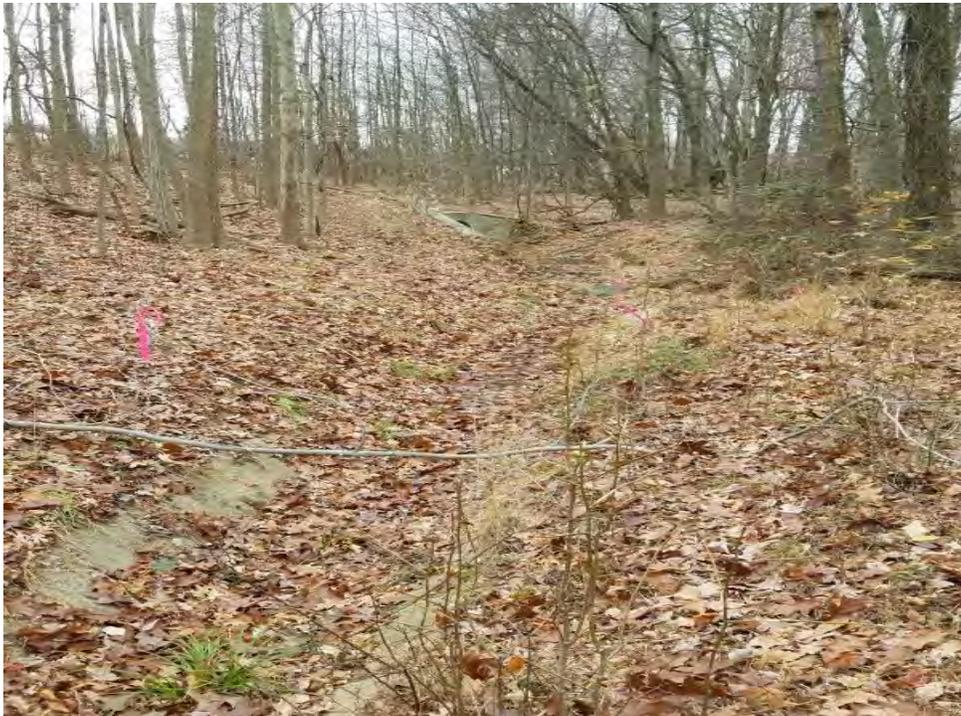
Photo 54: BRBR-WUS99 - DOWNSTREAM

BRBR-WUS99 is an intermittent and perennial stream located on the southbound side of I-95, immediately north of East Joppa Road (**Appendix B, Maps 3-4**). The channel consists of a concrete flume that flows southwest and parallels I-95 before reaching a confluence with BRBR-WUS9, where the stream becomes perennial, a tributary to the Bird River, a TNW. BRBR-WUS99 begins to capture groundwater approximately 250 feet upstream from its confluence with BRBR-WUS9. A coating of brown and green algae was observed, beginning at the upstream end of the channel. The concrete flume has numerous areas of damaged concrete for groundwater to infiltrate. The channel averages 9 feet wide, with an average water depth below 1 inch.
