**SOURCE WATER ASSESSMENT**  
for  
**BAIS YAAKOV SCHOOL AND VILLA JULIE COLLEGE**  
**BALTIMORE COUNTY, MD**

**Prepared By**  
**Water Management Administration**  
**Water Supply Program**  
**March 2006**

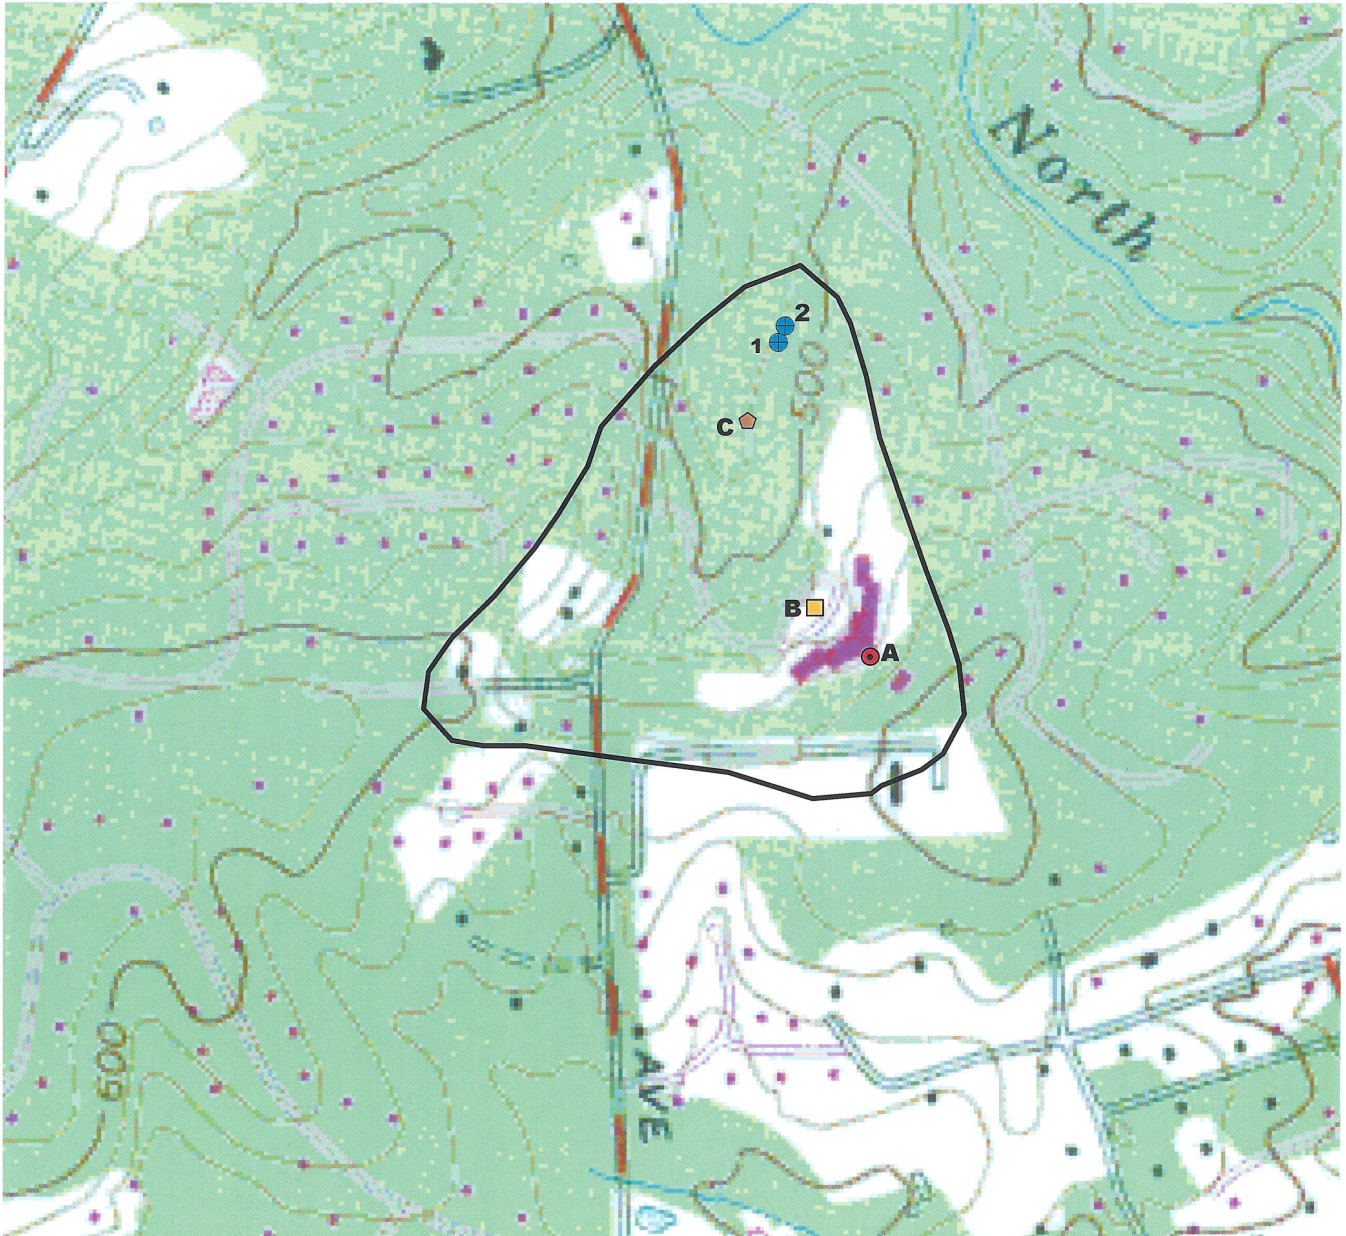
Figure 2. Wellhead Protection Area for Bais Yaakov School with Potential Contaminant Sites

A review of MDE contaminant databases as well as a field survey revealed two point sources of contamination in the Bais Yaakov WHPA (fig 2) and one in the Villa Julie WHPA (fig. 5). A 10,000-gallon underground storage tank (UST) for heating oil, and an old dump site (DUMP) were identified in the Bais Yaakov WHPA. A science laboratory (LAB) was identified in the Villa Julie WHPA. Table 2 lists the facilities identified and their potential types of contaminants. Potential contaminants are grouped as Volatile Organic Compounds (VOC), Nitrate (NN), Metals (M) and Microbiological Pathogens (MP)

ID	Type	Site Name	Address	Potential Contaminant	Comments
A	UST	Bais Yaakov School	11111 Park Heights Ave	VOC	10,000 gallon –heating oil
B	DUMP	Bais Yaakov School	11111 Park Heights Ave	VOC, M	Former dump site for appliances and equipment
C	SEPT	Bais Yaakov School	11111 Park Heights Ave	MP, N	7 Onsite Septic Fields
D	LAB	Villa Julie College	1525 Greenspring Ave.	M	Located in Science Bldg

A review of the Maryland Department of Planning's 2002 Baltimore County Sewer Map indicates that there is no planned sewer service for either of the two WHPAs. Bais Yaakov School has seven on-site septic fields located in front of the school upgradient of the supply wells (figure 2). Residential properties surrounding the school also have on-site septic systems for waste disposal. Onsite septic systems may be potential sources of the nitrates to the supply wells. Villa Julie College has a wastewater treatment plant that discharges treated wastewater to a stream located outside the WHPA. Residential and farms surrounding the College use on-site septic systems for waste disposal.

No VOCs above 50% of an MCL have been detected in either Bais Yaakov School or Villa Julie College water supplies since 1993. There are two potential sources of VOC contamination in the WHPA for Bais Yaakov School (figure 2), and one for the Villa Julie WHPA. A review of the water quality data indicates that these sources have not had an impact on the water supply.

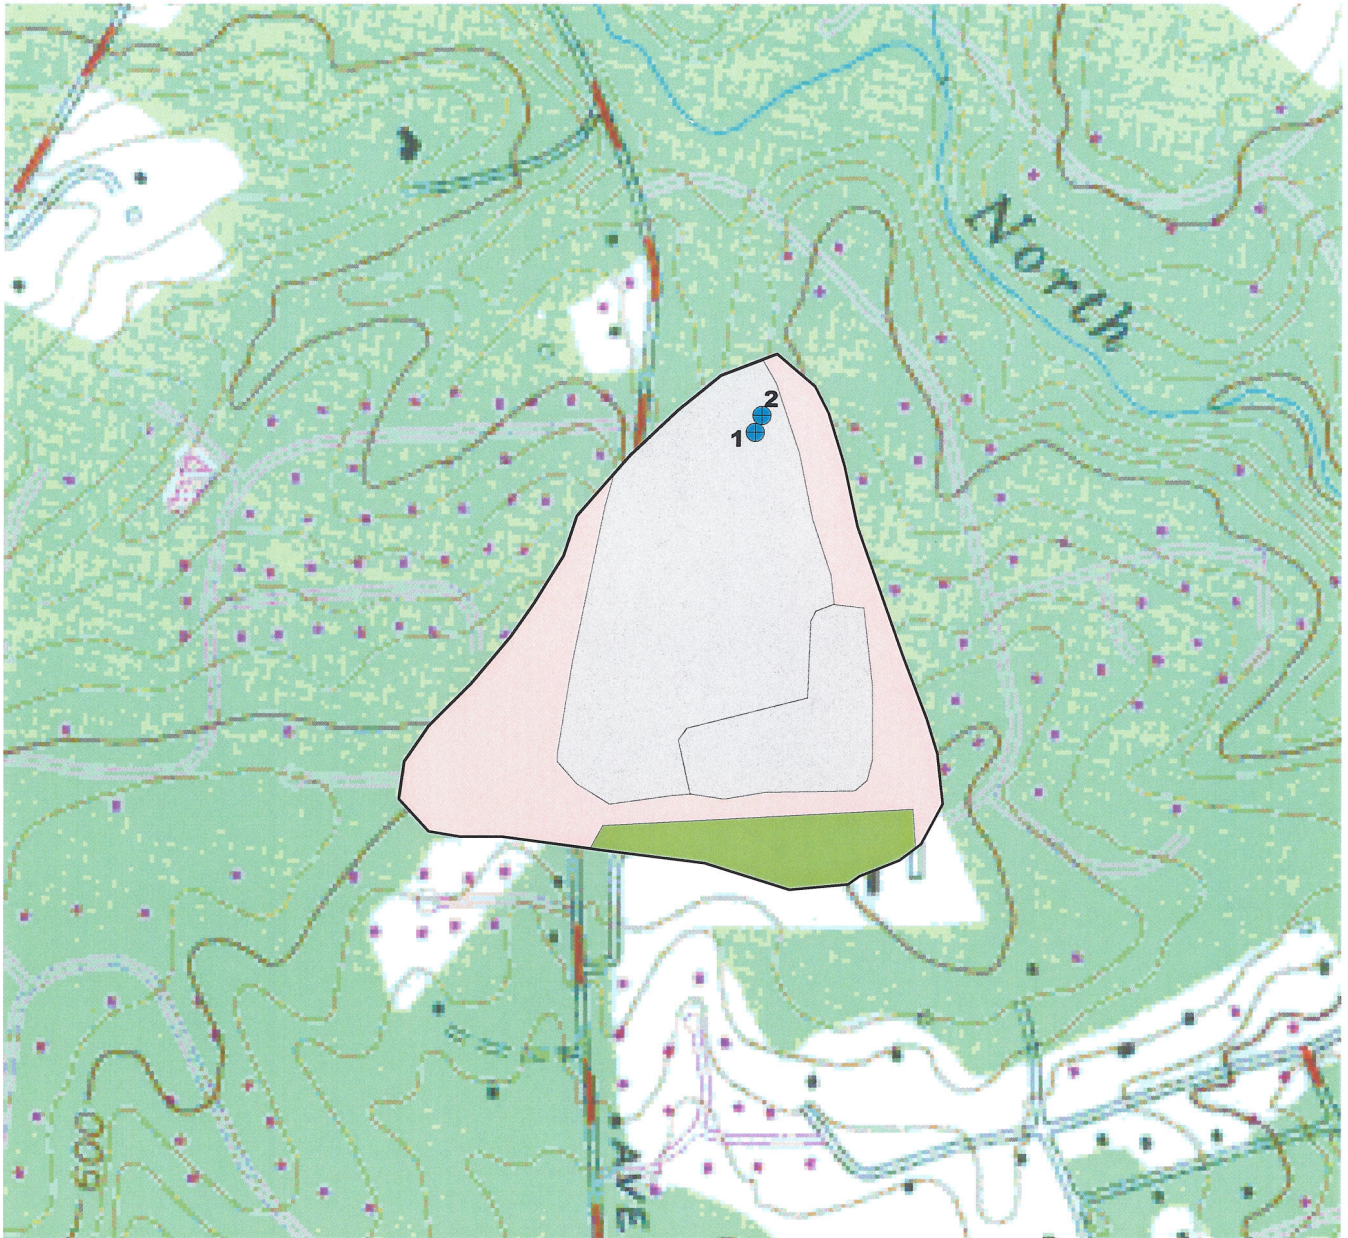
Figure 3. Land Use within the Bais Yaakov School Wellhead Protection Area

The Maryland Department of Planning's 2002 digital land use map for Baltimore County was used to determine the predominant types of land use in the WHPAs (figures 3 and 6). Table 3a and 3b show the land use categories within the WHPAs for Bais Yaakov School and Villa Julie College, respectively. The

largest portion of the Bais Yaakov WHPA is institutional land (school property) followed by residential properties. The major portion of the Villa Jullie College WHPA is cropland.

LAND USE CATEGORIES	TOTAL AREA (Acres)	PERCENTAGE OF WHPA
Low Density Residential	21.02	34.0
Institutional	35.12	56.7
Pasture	5.76	9.3
Total	61.90	100.00

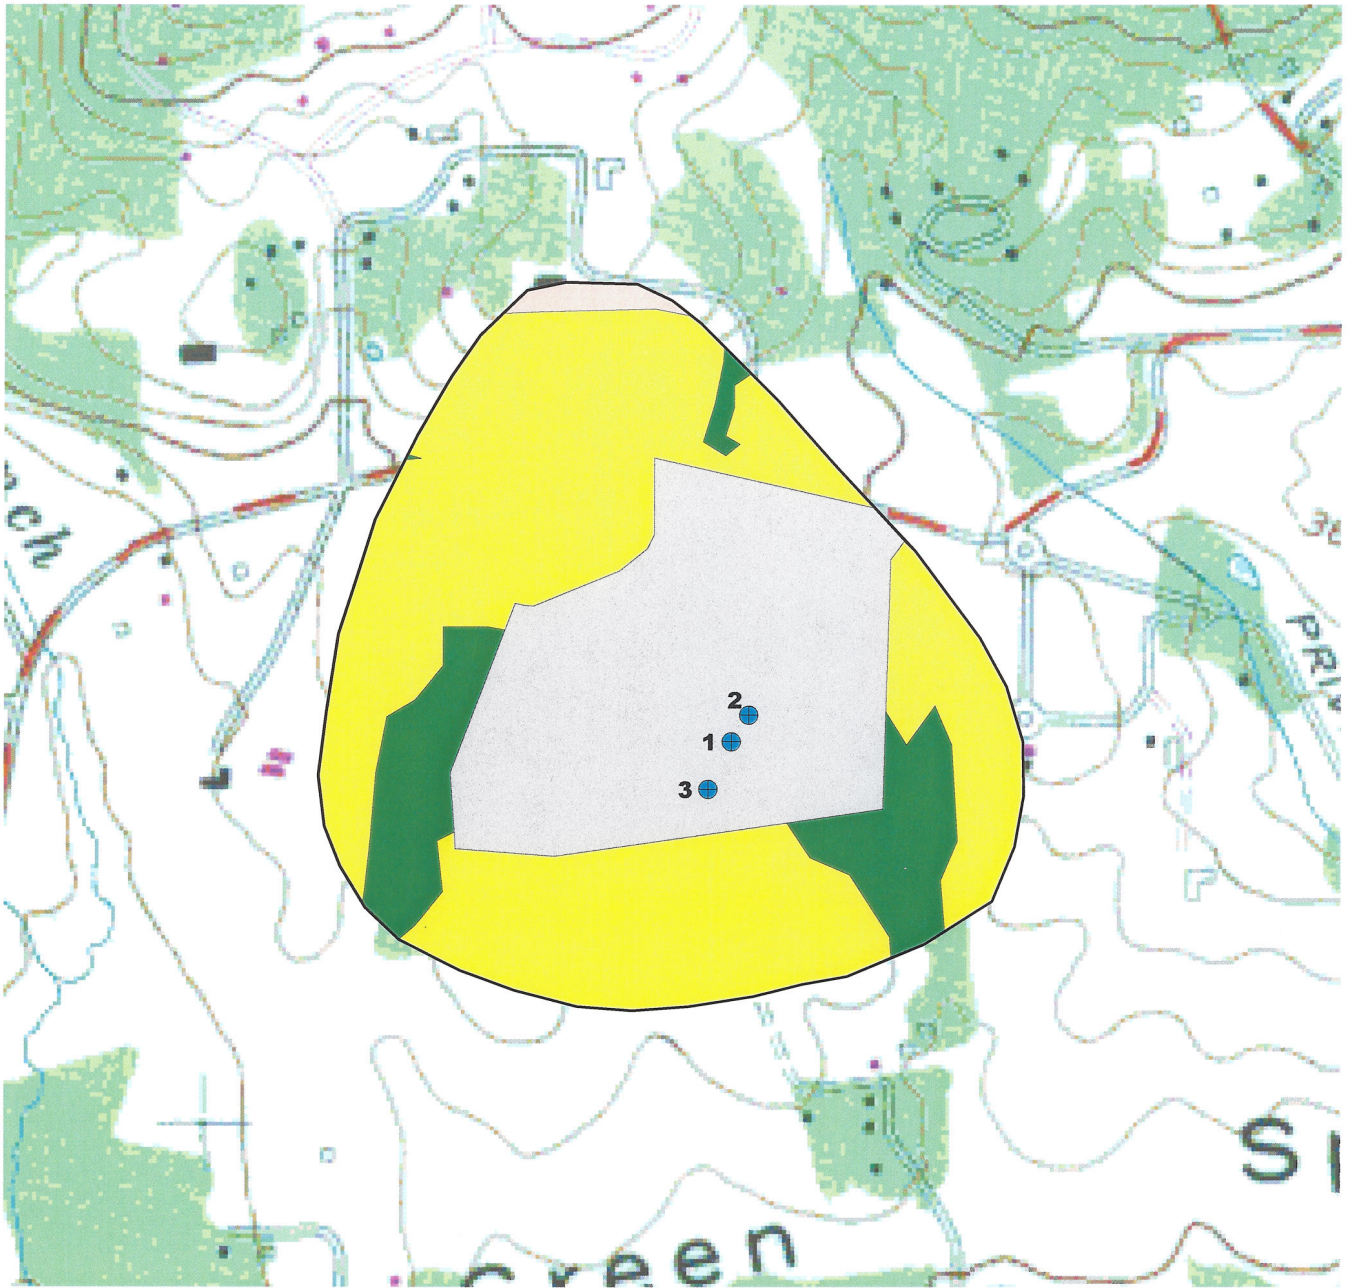
Figure 6. Land Use within the Villa Julie College Wellhead Protection Area

LAND USE CATEGORIES	TOTAL AREA (acres)	PERCENTAGE OF WHPA
Low Density Residential	1.29	0.9
Institutional	45.35	34.4
Cropland	70.07	53.1
Forest	15.26	11.6
Total	131.97	100.00
