SOURCE WATER ASSESSMENT

**Town of Emmitsburg
Frederick County, Maryland**

Prepared by
Maryland Department of the Environment
Water Management Administration
Water Supply Program
February 2001

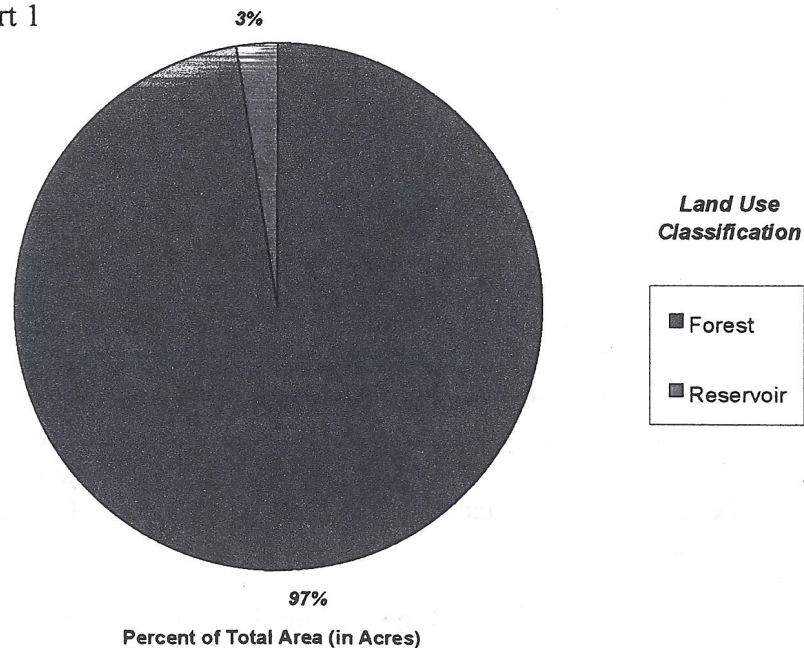
Based on the Maryland Department of Planning's 1997 land use data, the land use distribution in the Rainbow Lake watershed is summarized in Table 5 and Chart 1 below:

Land Use	Total Area in Acres	Percent of Total Watershed
Forest	508.8	97%
Open Water/Lake	13.4	3%

Rainbow Lake Watershed Land Use Summary
