**SOURCE WATER ASSESSMENT**  
for  
**DEER CREEK at**  
**the CHAPEL HILL WATER TREATMENT PLANT**  
**Harford County, Maryland**

Prepared by  
Maryland Department of the Environment  
Water Management Administration  
Water Supply Program  
July, 2005

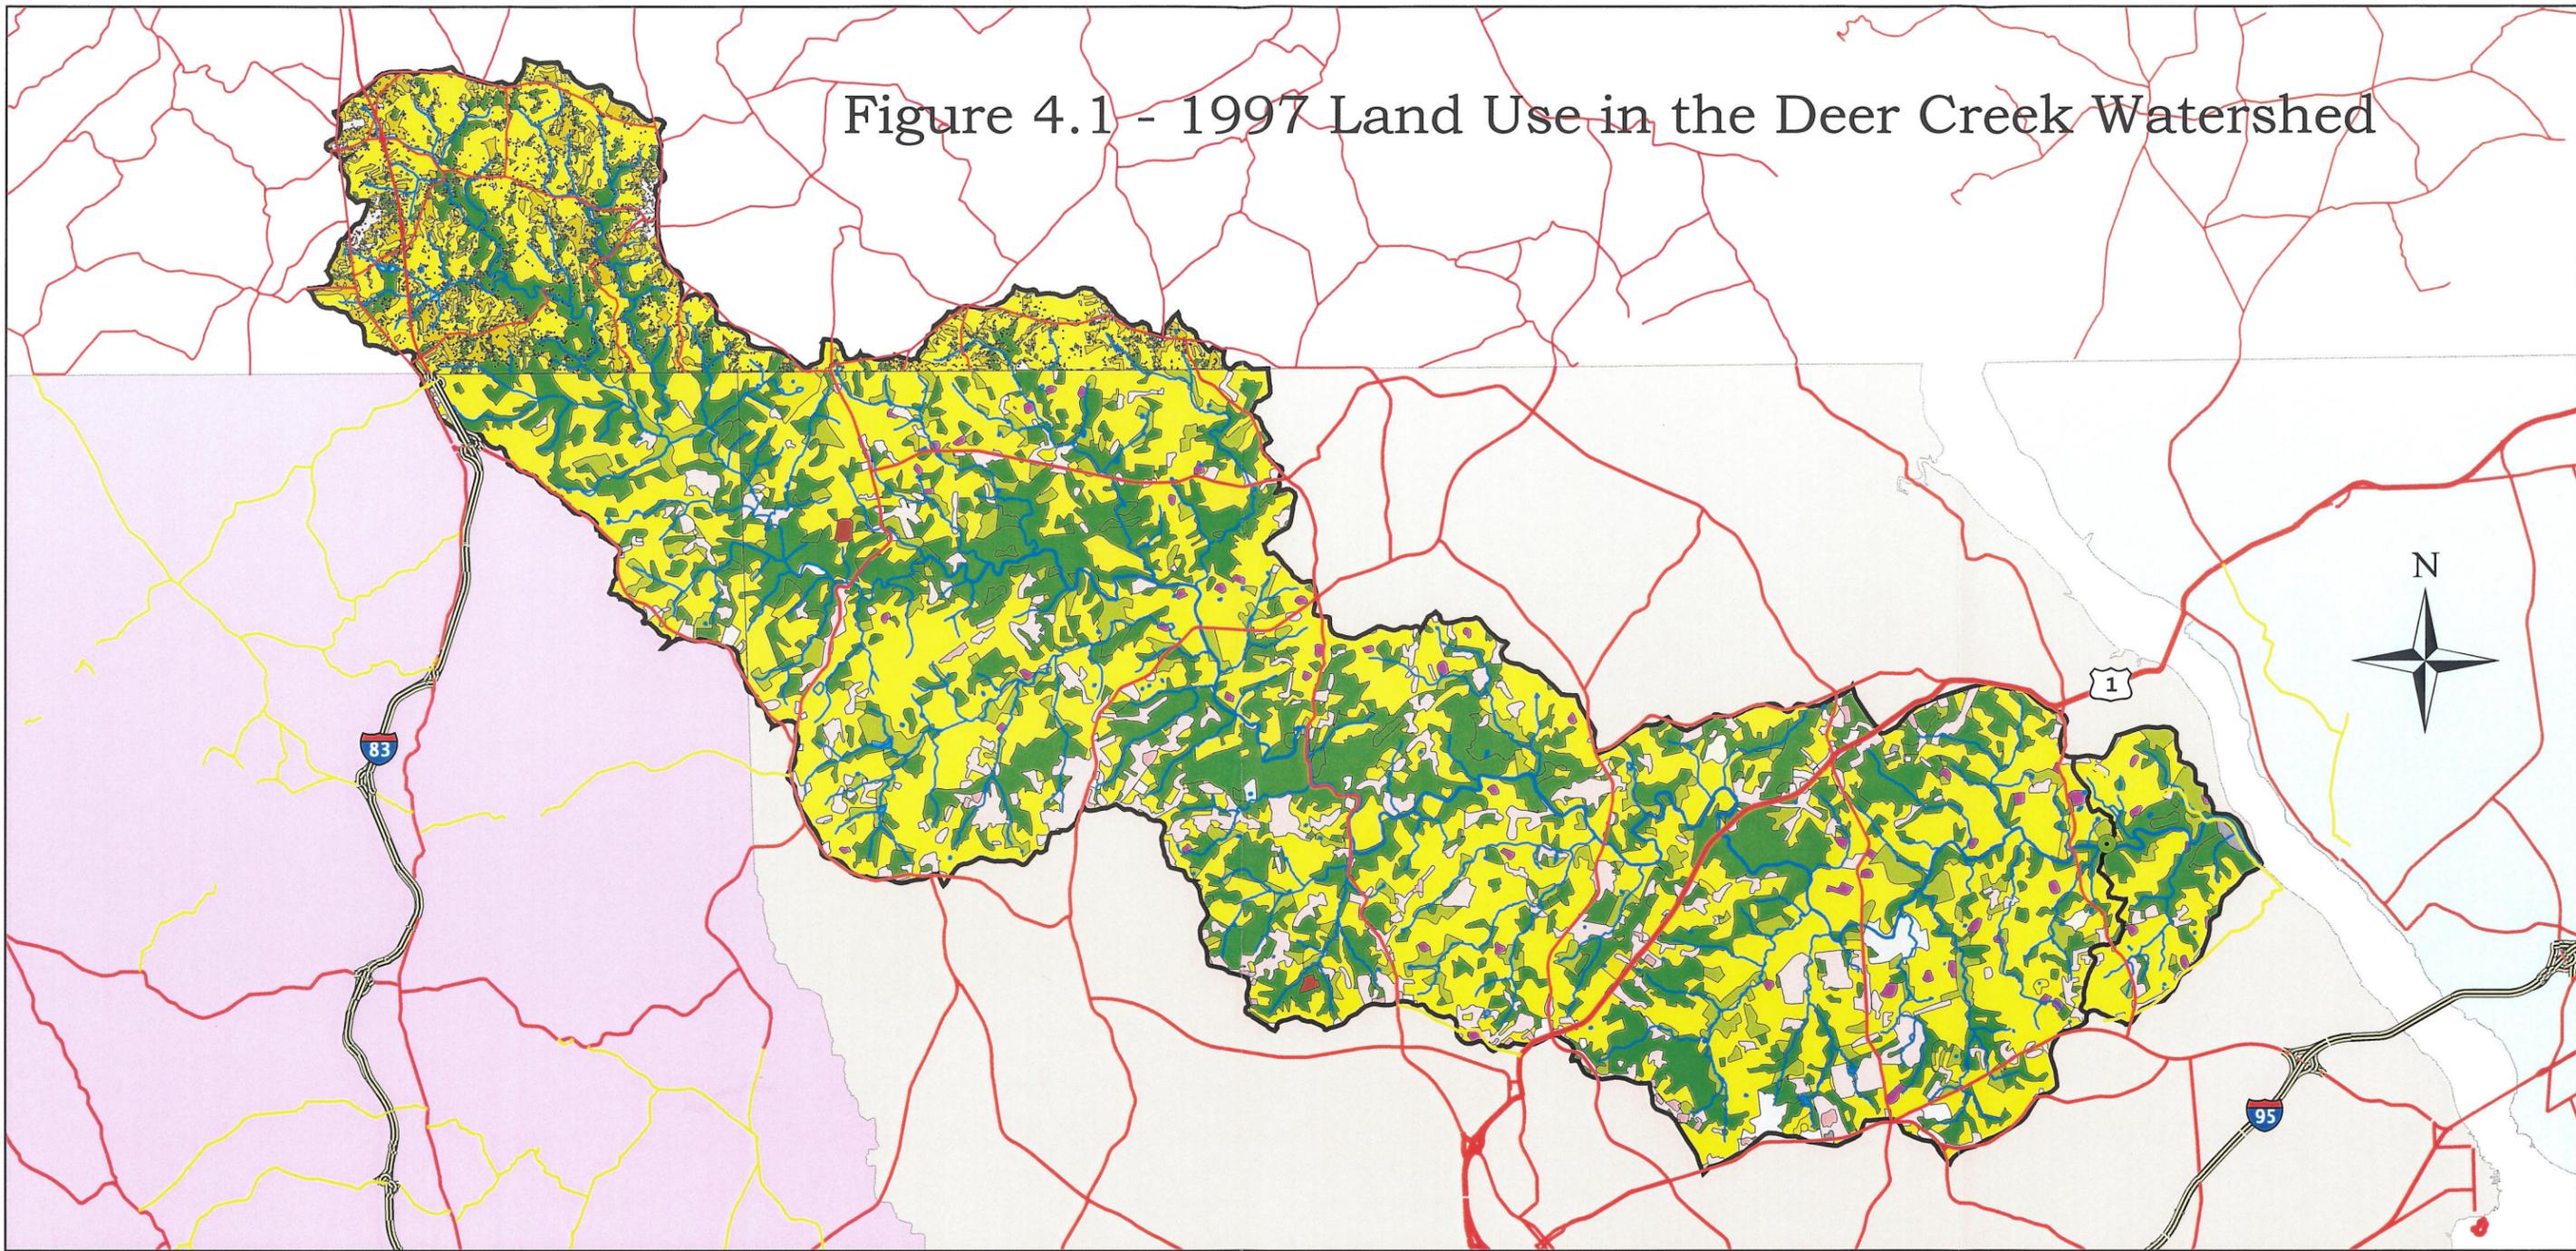
Figure 4.1 - 1997 Land Use in the Deer Creek Watershed

Based on the Maryland Department of Planning 1997 land use data and the MRLC data for Pennsylvania, the land use distribution in the Deer Creek Watershed above its confluence with the Susquehanna River is summarized in Table 4.1. Approximately 4,263 acres (6.66 square miles) of land area below the intake are included in Table 4.1.

According to the data presented in Table 4.1 (1997 land use), 64,647 acres (about 60% of the watershed) are used for agricultural purposes. Almost half of the watershed (49.4%) is in cropland with 8.7% of the watershed used for pasture. Land used to grow crops can be a source of nutrients (from fertilizer) synthetic organic compounds (herbicides) and sediment load. Pastureland is often a recipient of animal waste and therefore a potential source of nutrients and pathogenic protozoa (giardia and cryptosporidium), viruses and bacteria. Feeding operations (about 700 acres) are also a potential concentrated source of contaminants associated with animal wastes. Developed land (residential, commercial, industrial) accounted for 9,909 acres (9%) of the Deer Creek Watershed in 1997. Sediment, nutrients, pathogens (giardia and cryptosporidium), deicing compounds, and heavy metals are the most significant concerns from runoff in developed areas. Lawn and pavement in residential areas result in increased storm water velocity which leads to streambank and streambed erosion. Forested lands use makes up about 30% of the watershed. In the upper portion of the watershed, forested land is largely restricted to the stream valley. Forested lands provide the most protection from erosion and sediment loss and contribute much less nutrients and pathogens to the streams than the other land uses. Due to the preponderance of agricultural land in the watershed, this land use has the most significant impact on the water quality of Deer Creek.

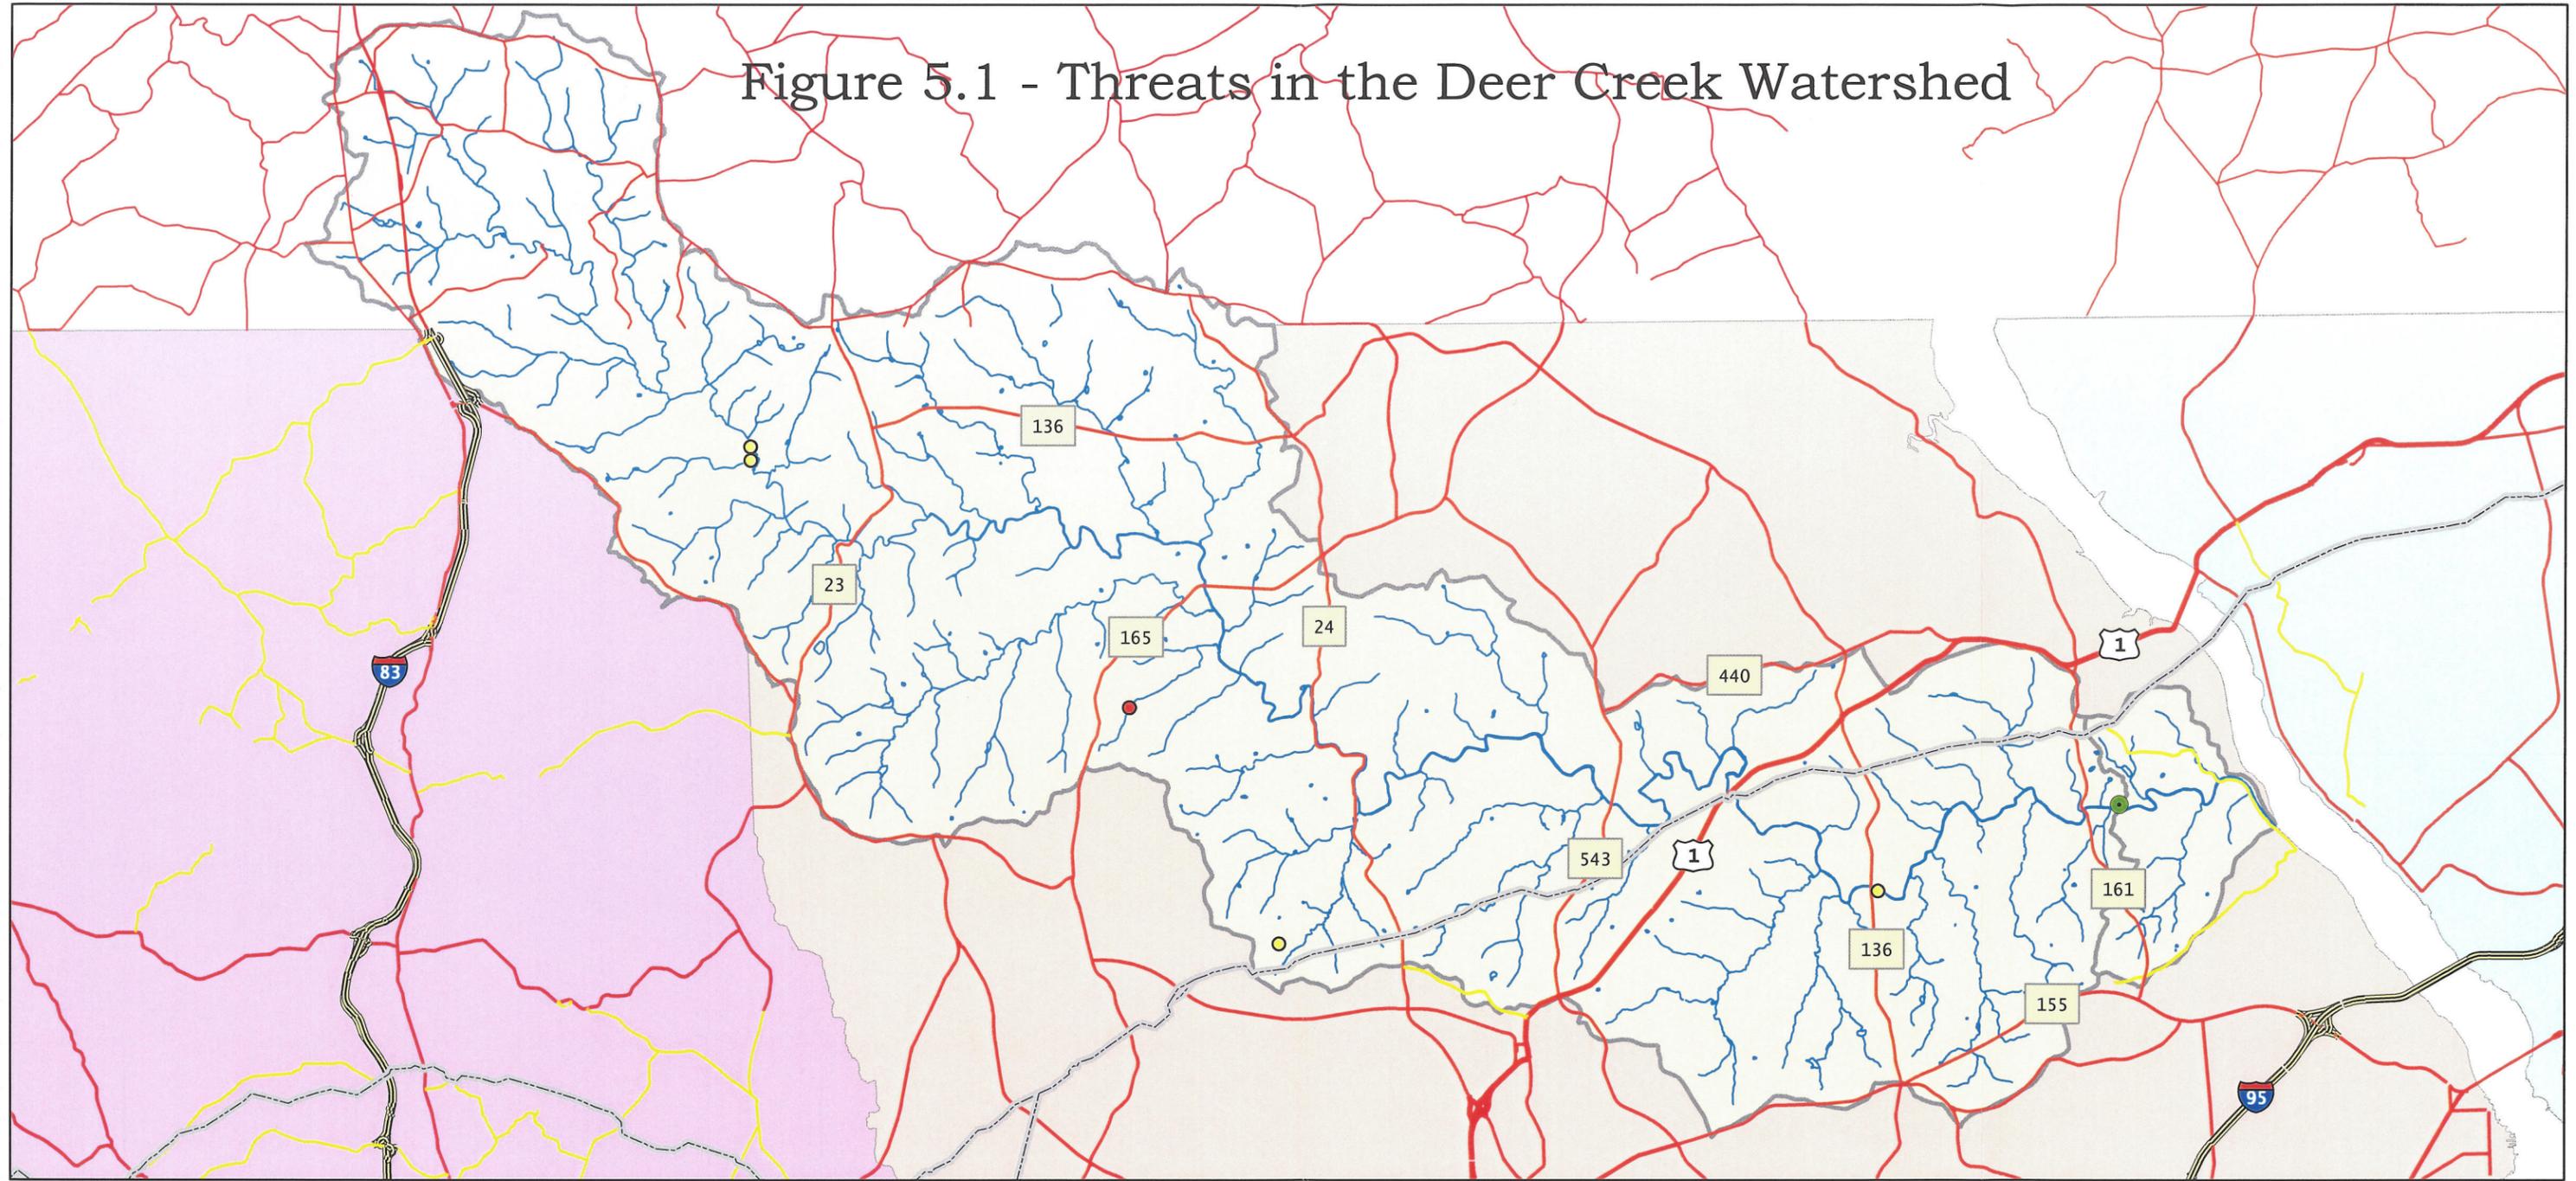
Figure 5.1 - Threats in the Deer Creek Watershed

A review of MDE's municipal and industrial discharge permit programs indicates there are one active and two inactive industrial, and one active municipal discharge located within the source water assessment area (Figure 5.1).

A significant potential source of contamination to the Deer Creek intake is created by the network of transportation infrastructure including State primary and secondary highways and major county roads. US Route 1, MD Routes 543, 161, 165, 136, 24 and 23 cross the main stem of Deer Creek. I-83 also crosses the furthest upstream portion of the watershed in Maryland and Pennsylvania. In addition to concerns related to the affect of the application of deicing compounds on water quality, the roads provide for the bulk movement of hazardous materials. At the locations where each of these routes cross Deer Creek or a tributary feeding Deer Creek, there is the potential for a spill of hazardous materials to cause significant damage. U.S. Route 1 and MD Routes 136 and 161 are the closest to the intake and therefore of greatest concern.

Colonial Pipeline, an interstate carrier of petroleum products, crosses the entire width of the lower part of Deer Creek Watershed above the intake of Chapel Hill Water Treatment Plant. Pipeline accidents and leaking of petroleum products can cause contamination of raw water with petroleum and associated volatile organic compounds.

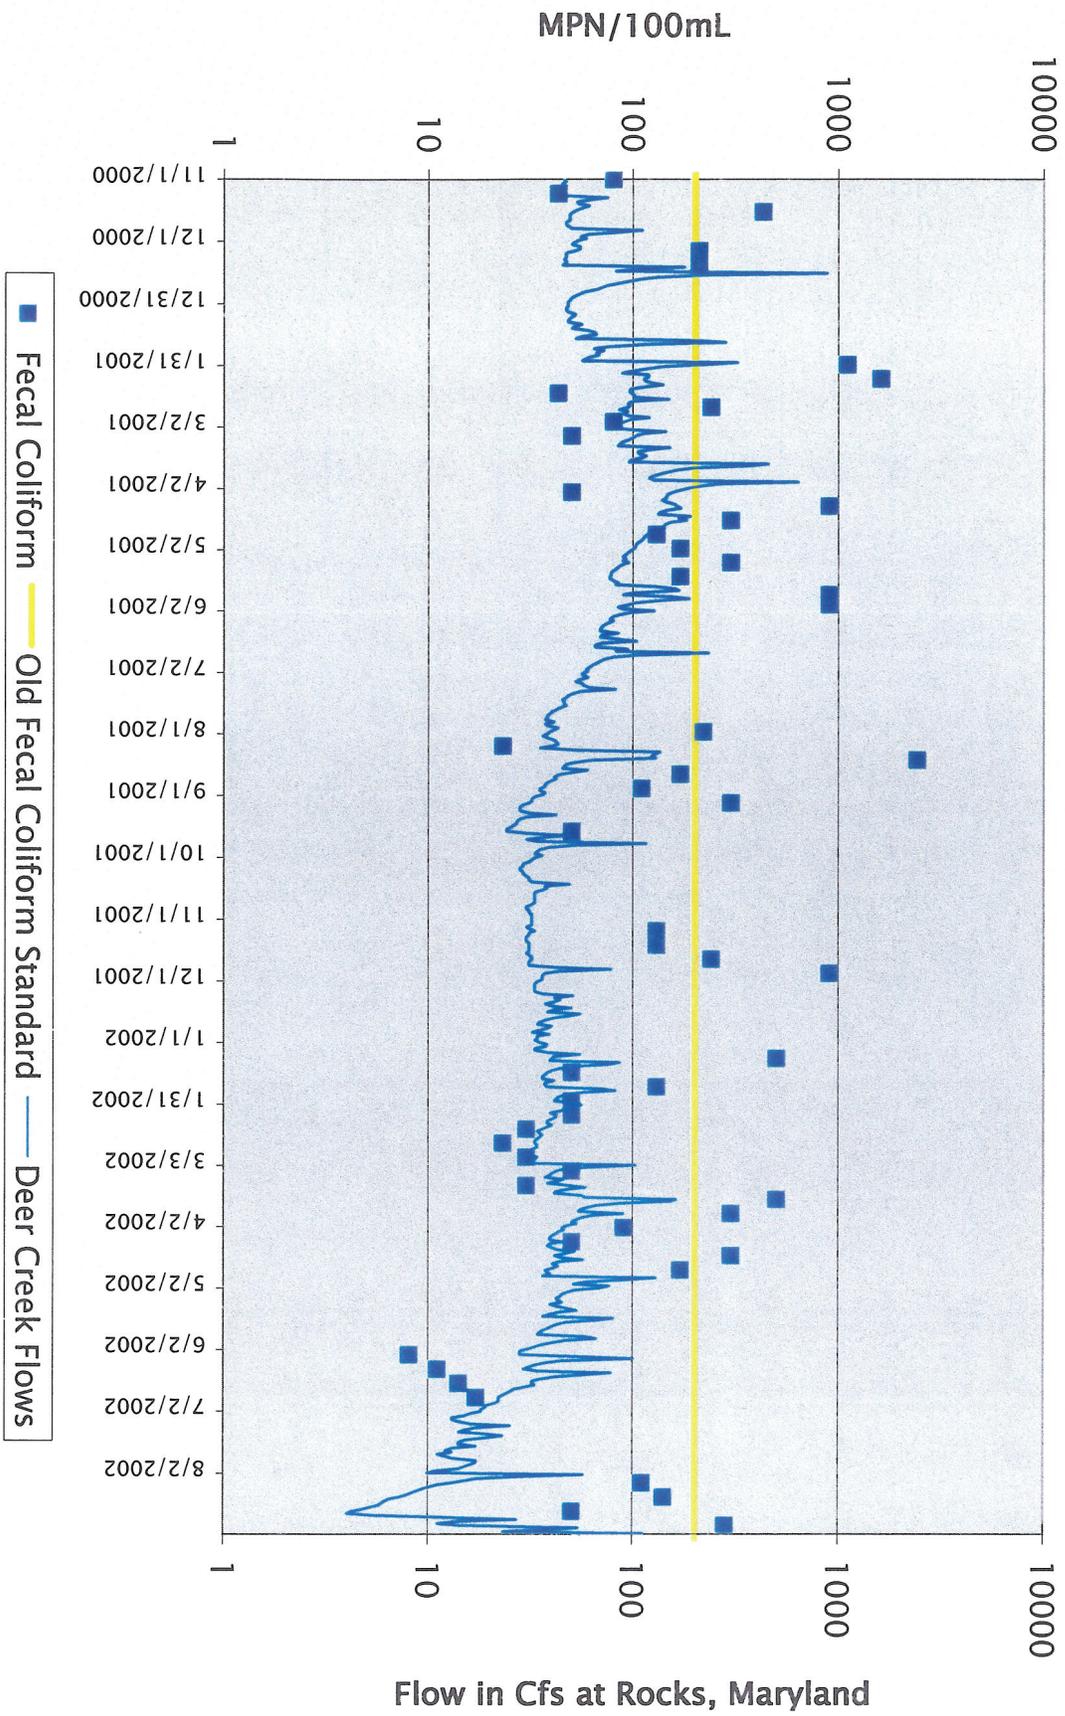
Figure 6-1 Fecal Coliform Assay for Chapel Hill (APC-Deer Creek)

At the request of MDE, the Chapel Hill Water Treatment Plant operators began a raw water monitoring program starting in October 2000. The raw water samples were collected weekly and tested for fecal and E. Coli until September 2002. Figures 6-1, 6-2 shows the results in most probable number/100 ml from November 2000 through August 2002 for fecal coliform and E. coli. The flow in Deer Creek as measured at Rocks, Maryland is also plotted with the microbiological results. About forty percent (40%) of the samples were greater than the former fecal coliform water quality standard of 200 MPN/100 ml that was in effect at the time of sampling. A similar percentage exceeds the current standard for E. coli of 126 MPN/100 ml. We did not evaluate the data, however, to determine compliance with the water quality standard, as compliance is based on the geometric mean of five samples collected over a 30-day period. A comparison of the flow data with the water quality results show that each of the values of 500 MPN and higher can be linked to a storm event, as evidenced by the peaks in the stream hydrograph.

The consistent presence of fecal coliform and E.coli bacteria in Deer Creek indicates susceptibility to pathogenic microorganisms. All of the higher measurements of fecal coliform were associated with higher flows. Deer Creek, like most surface water sources in Maryland, is potentially susceptible to these contaminants. The potential non-point sources of pathogenic protozoa, viruses, and bacteria in the source water of Deer Creek include livestock, pets, failing residential septic system and wildlife. Further study is needed to determine the most significant sources of pathogens in the Deer Creek Watershed.
