WELLHEAD AREA SURVEY
MOUNT SAVAGE COMMUNITY CENTER
ACHD SITE NO. 34
Mount Savage, Allegany County, Maryland

ALWI Project No. AL7N001

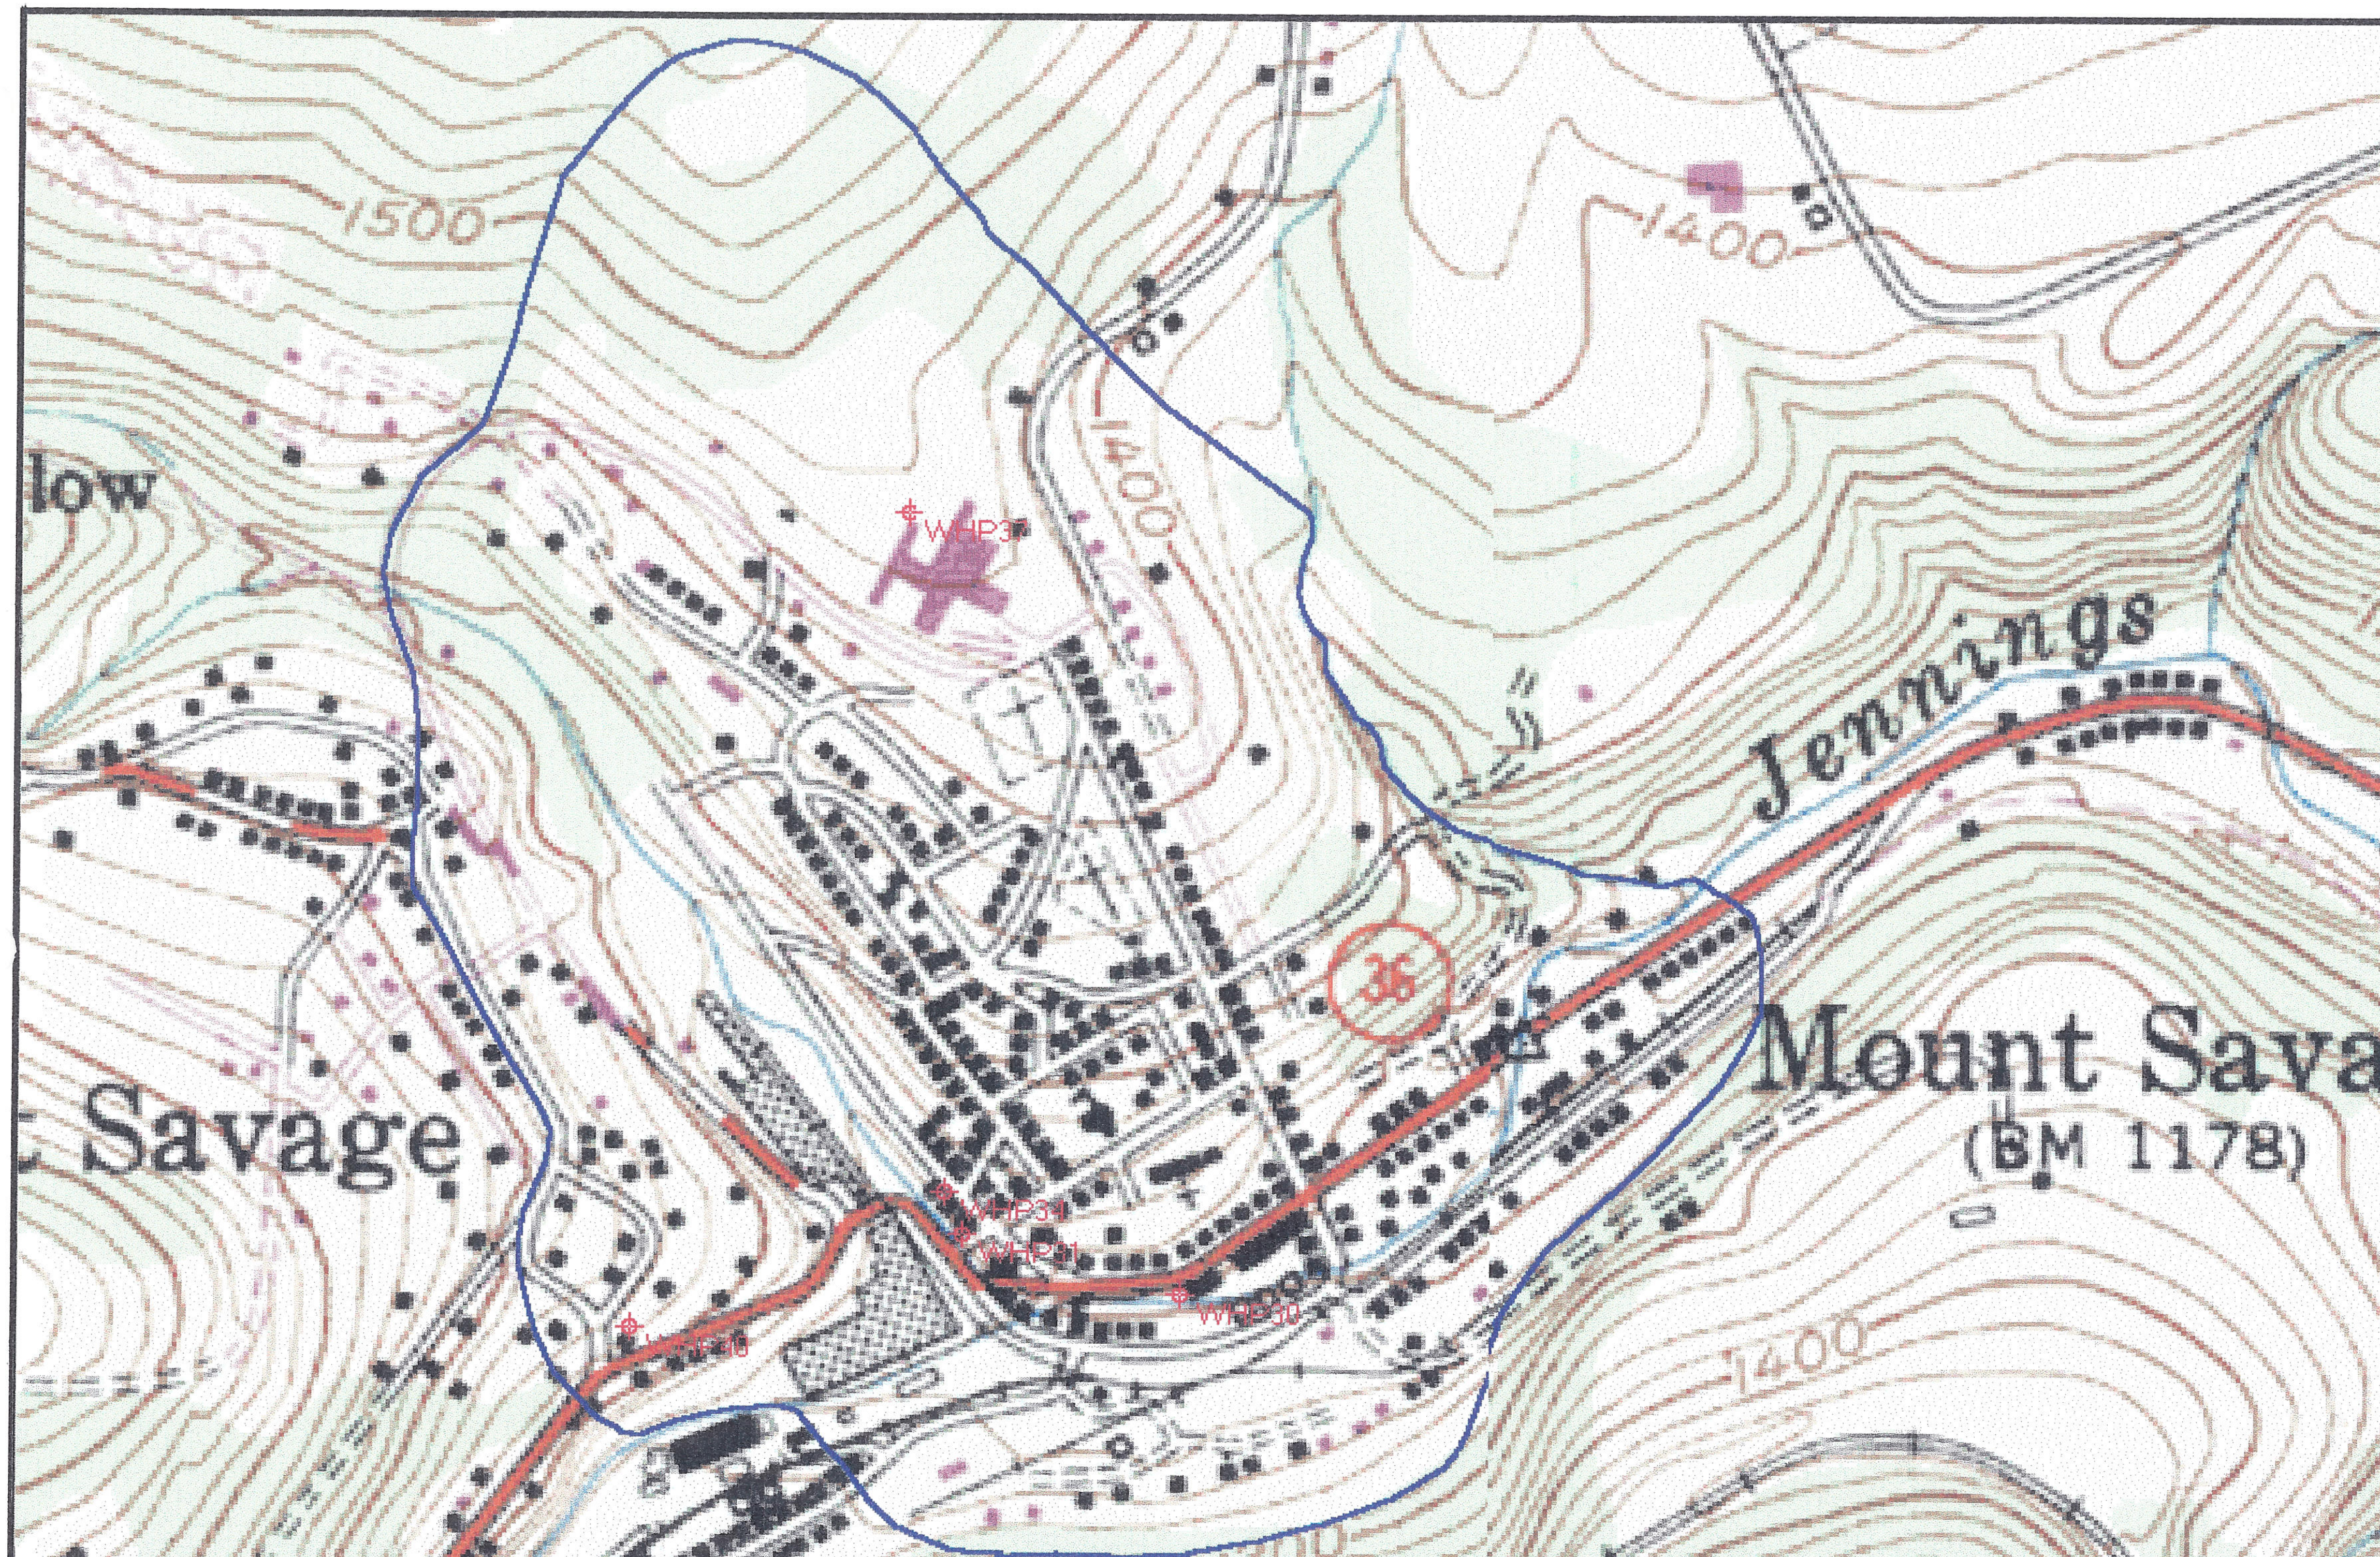
Figure 2. Composite Source Water Protection Area for Mount Savage

topographically-constrained sourced water protection area [includes areas within 1,000 feet of each surveyed well unless clear hydrogoelogic evidence suggested a need for a site-specific modificaiton of this MDE criterion.
