Source Water Assessment

Misty Meadows II Mobile Home Park Water System

Cecil County, Maryland

May 2003

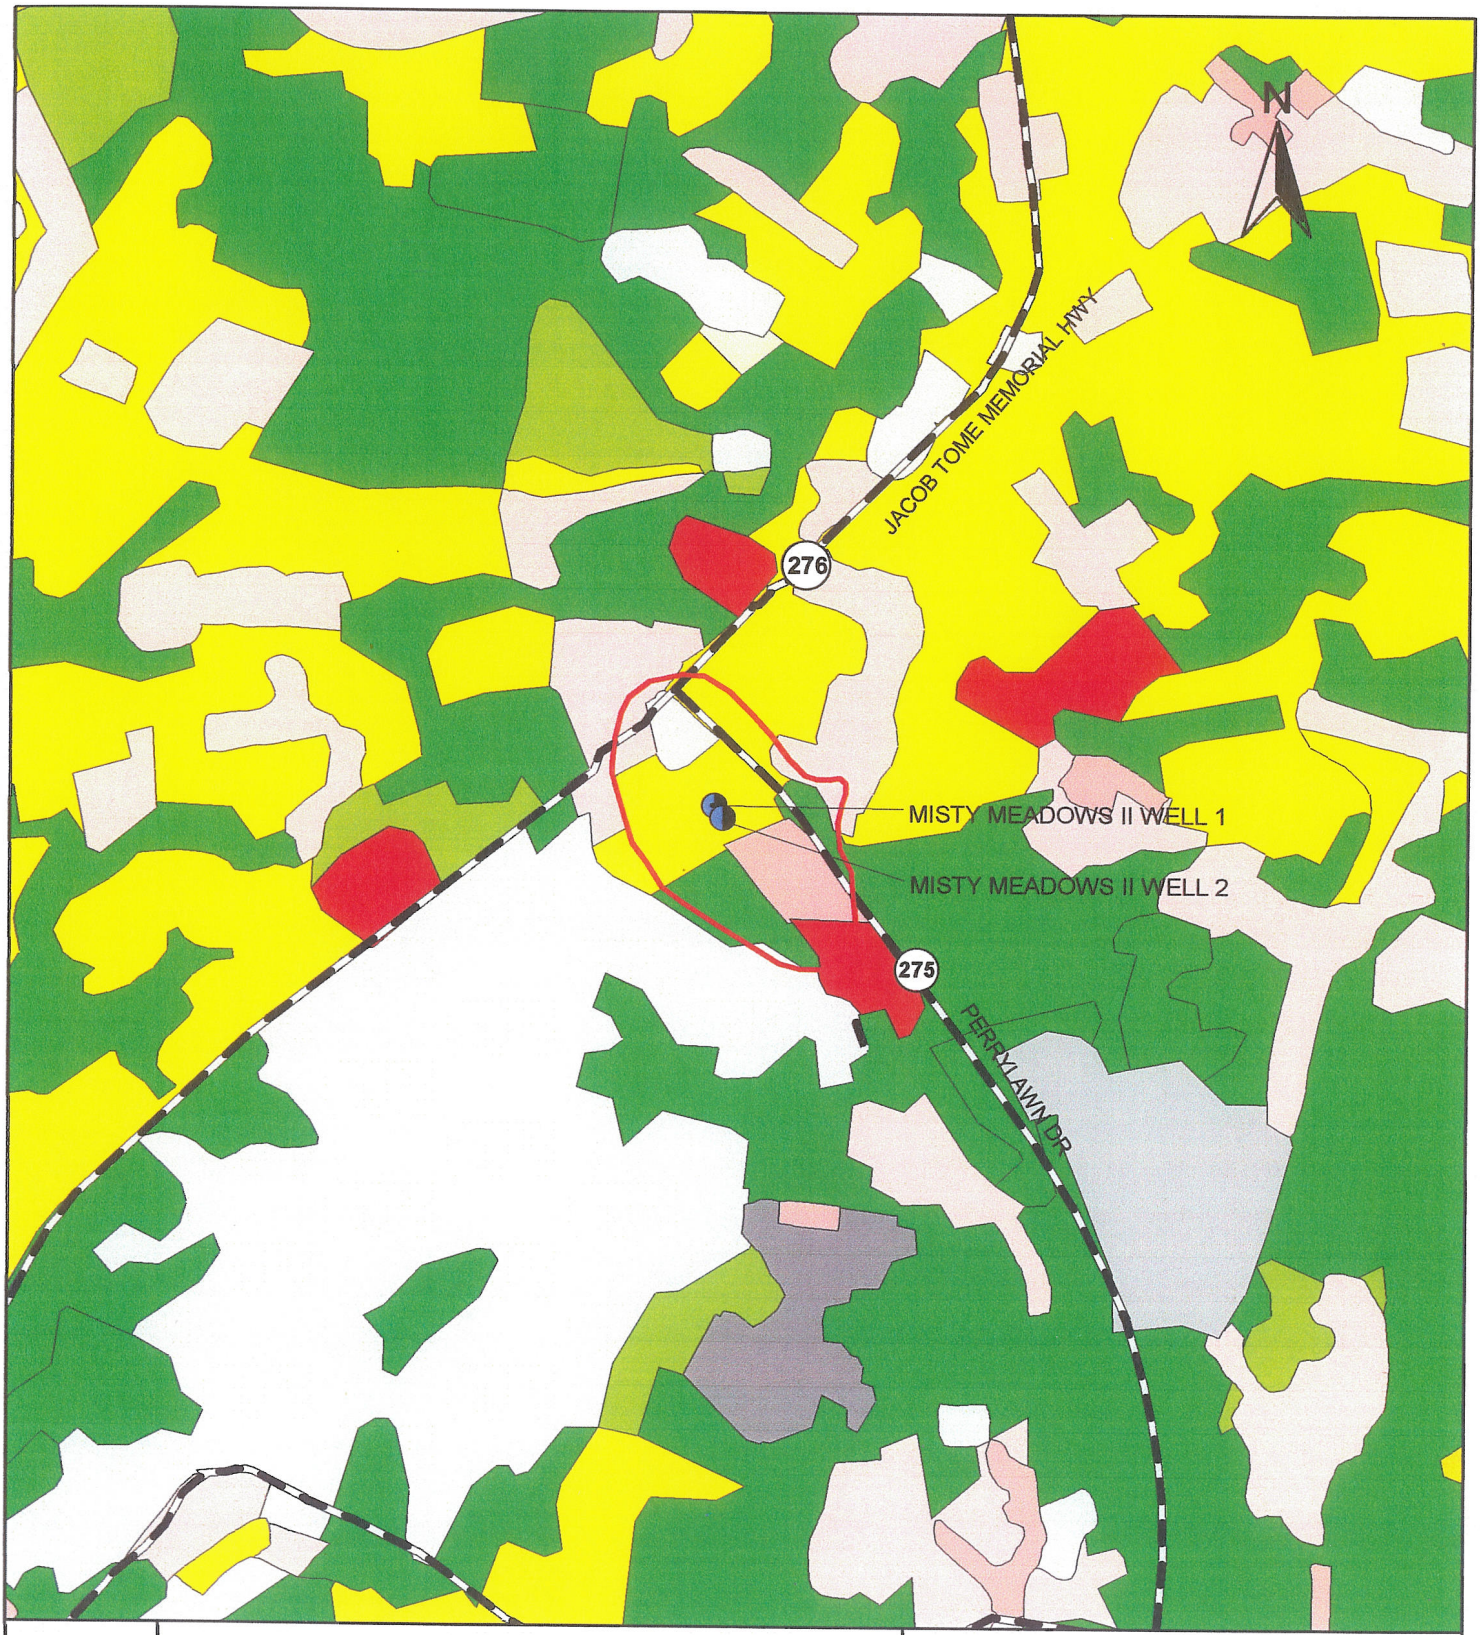
Figure 3. Misty Meadows II MHP
Land Use Map of the
Source Water Protection Area

From an interpretation of the graphs above, cropland (49 acres) and residential areas (37 acres) accounts for over one-half of the SWPA (121 acres). The use of fertilizers and pesticides in croplands and residential areas are common. Therefore, there is potential for the migration of potential contaminants into the ground water.

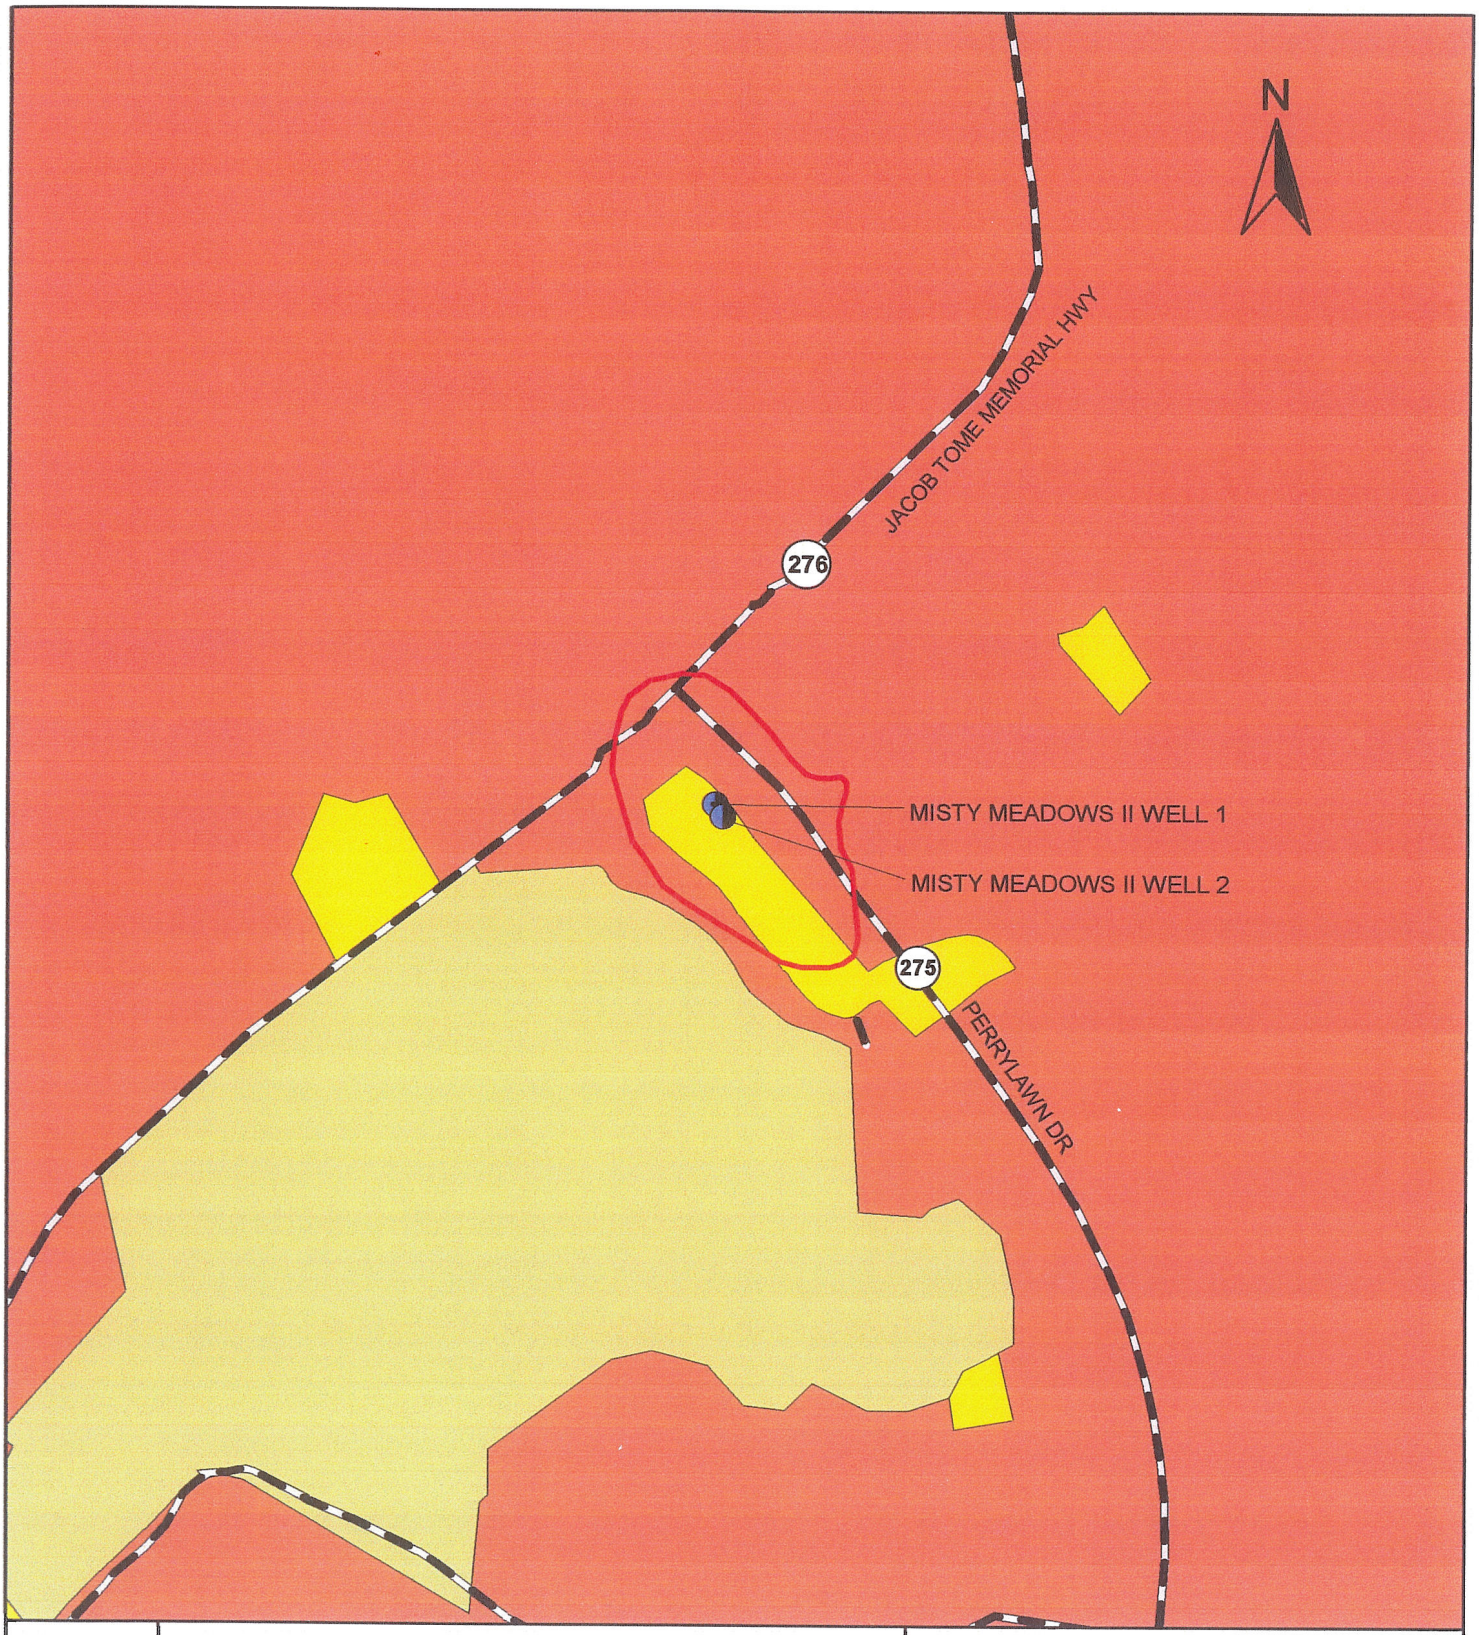
Figure 4. Misty Meadows II MHP Sewer Service Map of the Source Water Protection Area

Using the 1993 Maryland Office of Planning's Cecil County sewerage coverage, potential non-point sources from other septic system users in the SWPA were assessed (Figure 4). By overlaying the SWPA on the sewerage coverage layer in ArcView GIS, it was determined that approximately 68 percent of the SWPA does not have public sewer service and 32 percent is either on public sewer service or is under construction.

Approximately 68 percent of the SWPA is not served by public sanitary sewer systems and most likely uses septic systems, which can cause nitrate pollution in ground water. However, no concentrations of nitrate have been reported above 1 mg/L. No trends in the reported nitrate concentrations in the water samples have been observed over time.
