Supplemental Groundwater Monitoring and UST System Evaluation Report

Urbana Pike BP
1904 Urbana Pike
Clarksburg, MD
Facility # 87

August 8, 2025

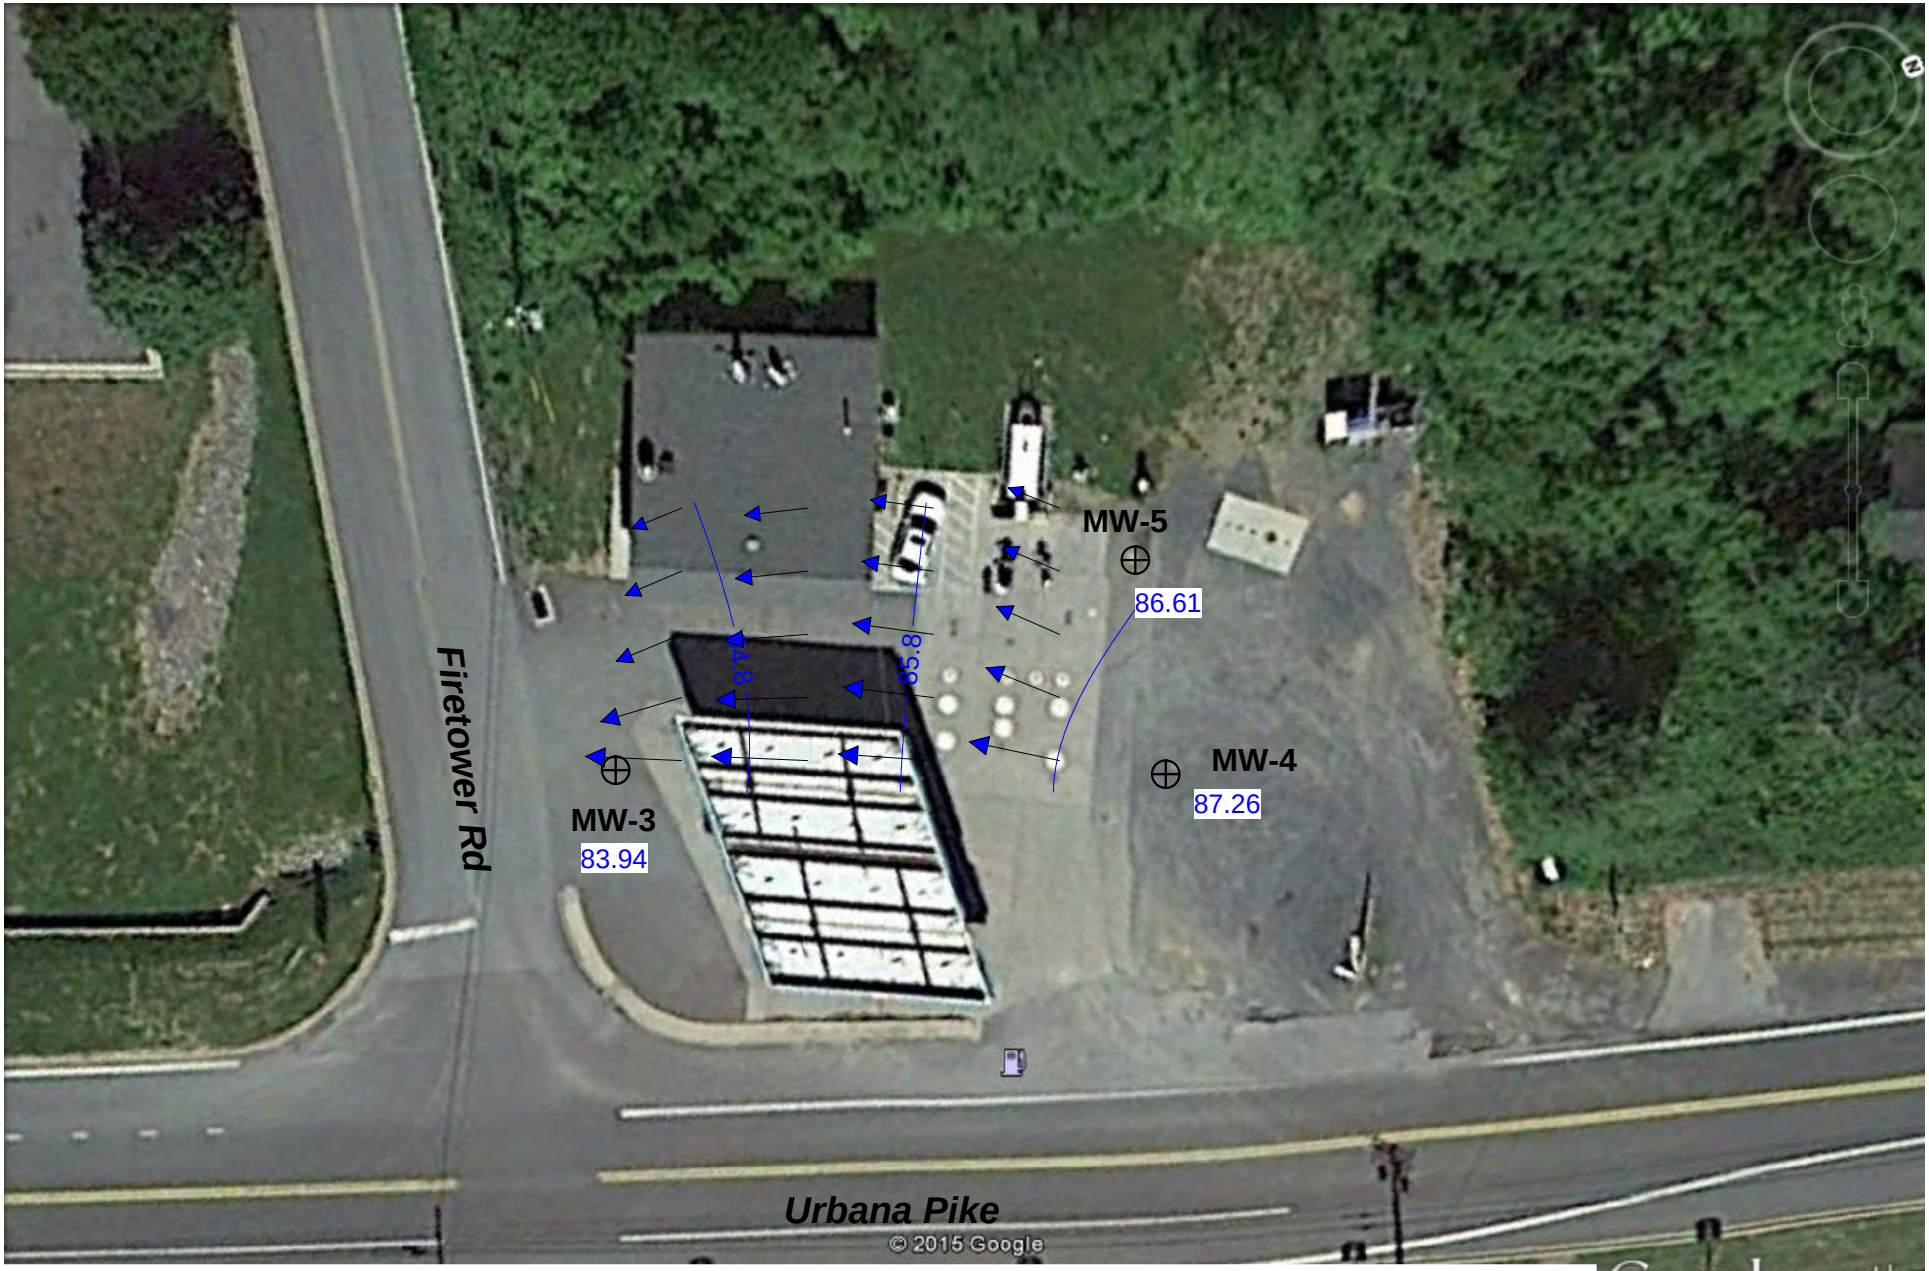
Groundwater Elevation Contour Drawing 07/25/2025

Groundwater elevation observed during the 07/25/2025 sampling event ranged from 87.26 feet in MW-4 (highest) to 83.94 in MW-3 (lowest). AEC has constructed groundwater elevation contours based upon the depth to groundwater measurements collected on 07/25/2025 and previously established top of casing elevations which depict groundwater flow on site to be to the south. A groundwater elevation contour map can be found in Appendix A.
