Dodging the Bullet: Lessons Learned From Recent Dam Emergencies

by
Hal Van Aller, P.E.
Maryland Dam Safety

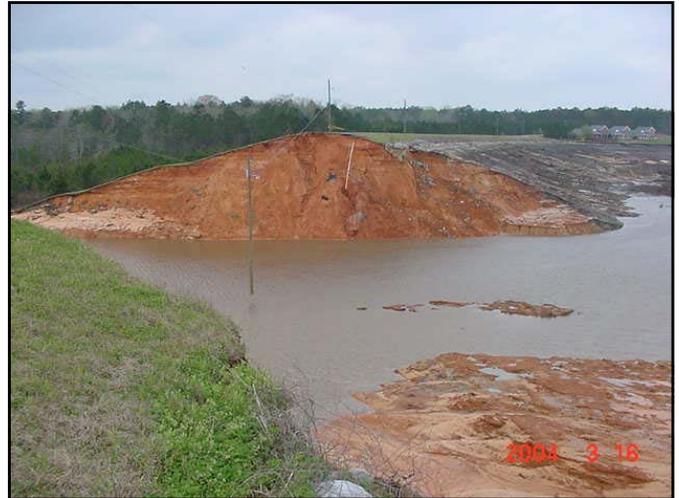
2004 3 16

- 15 years old (constructed 1999)
- 55 feet high. Lake 42 feet deep
- Well maintained, although 'minor' seepage along and into spillway conduit joints
- Inspected periodically by engineer
- Observed daily by maintenance staff

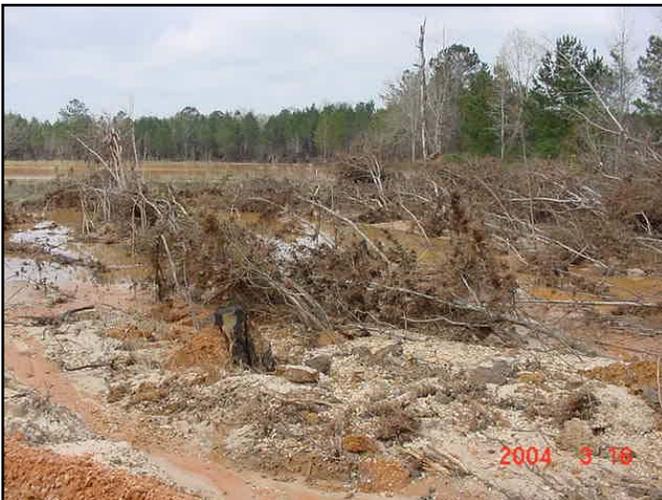
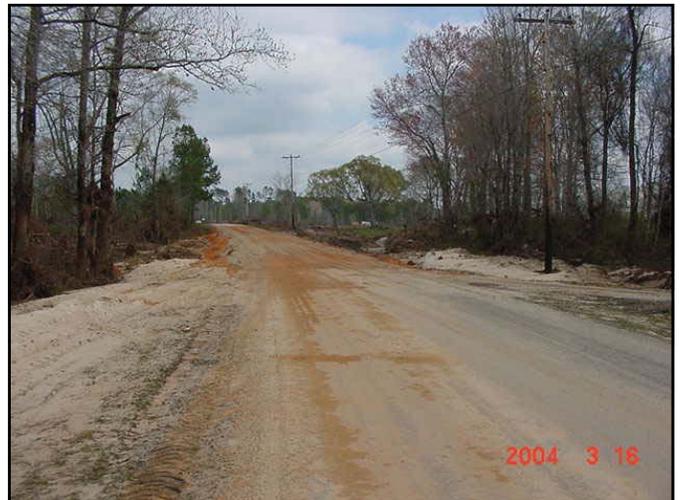
- Around 1240 NWS issued a flash flood warning for two downstream counties
- State Dam Safety was notified of complete breach of dam at 1240

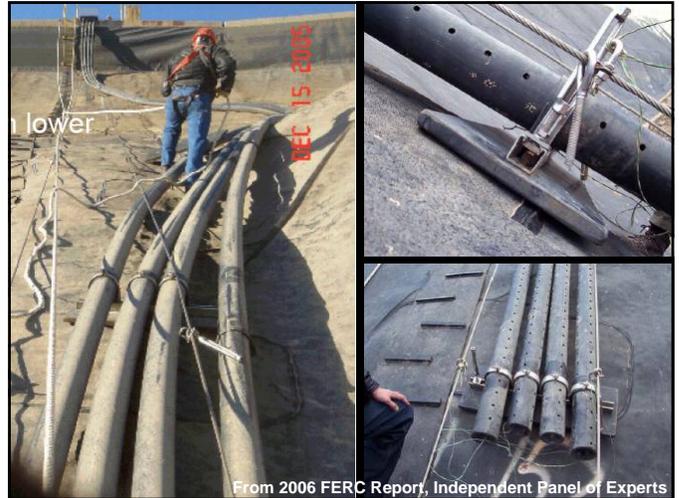
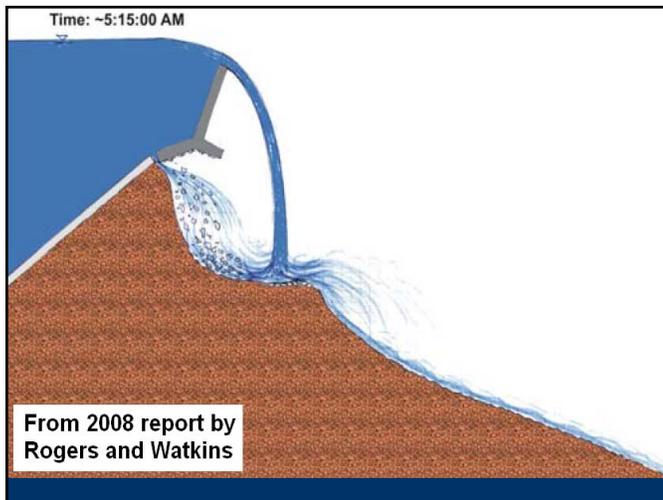
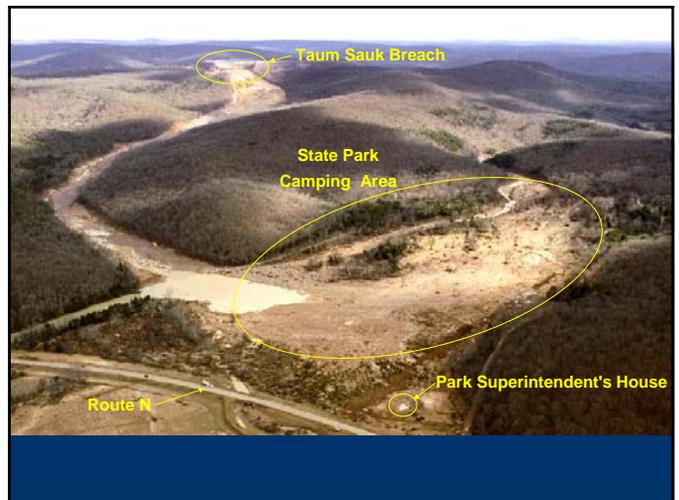
Taum Sauk Upper Dam, MO

- 85 foot high earth/rockfill embankment, 1 mile long
- Concrete slab facing with membrane liner
- 10 foot high retaining wall at top
- 50+ acre reservoir
- Overtopped and failed in December 2005 when newly installed water level sensor detached from wall causing pumps to keep running (inflow of 5,000+ cfs)
- Reservoir emptied (4,350 ac-ft) in 25 minutes
- No loss of life, but three residents nearly drowned when home was swept downstream

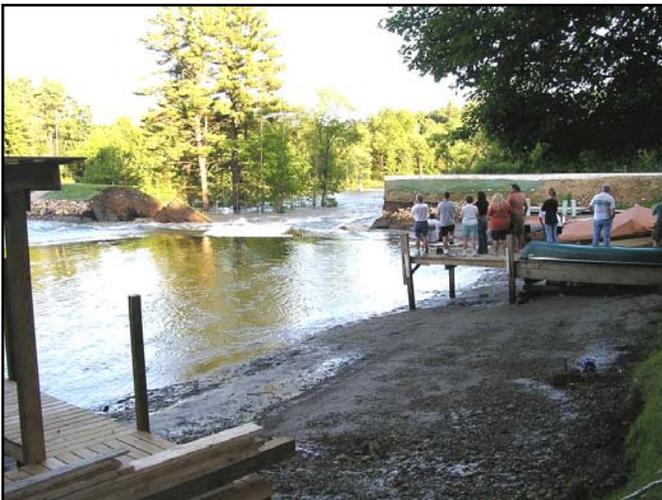
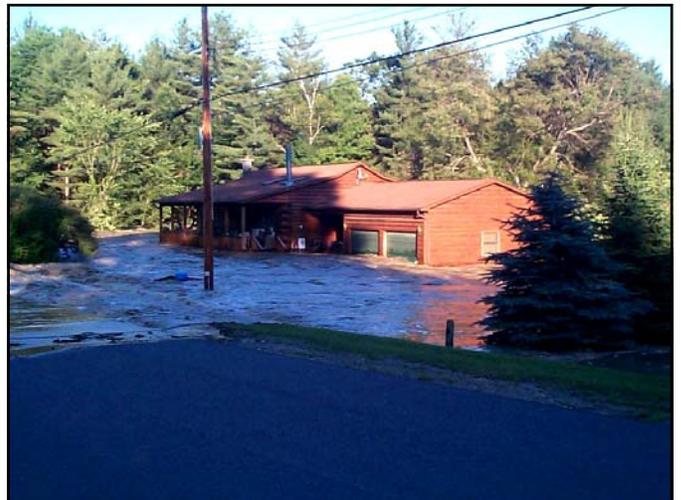
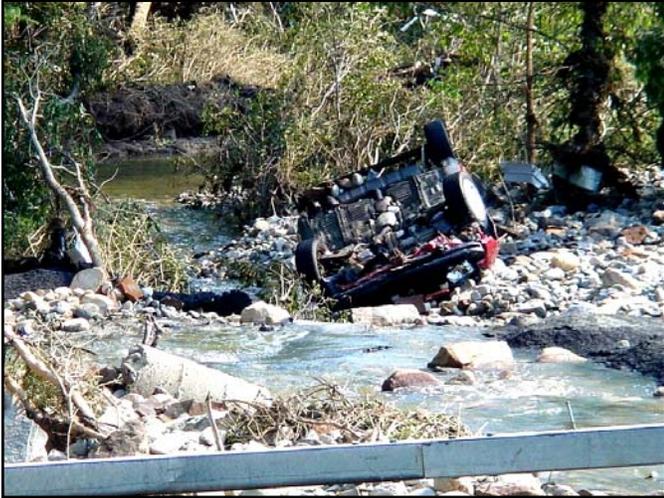
Hadlock Pond Dam Failure, NY

- 100 year old earth and timber crib/rockfill dam
- New spillway constructed in 2004-2005
- 30 foot high dam about 900 feet long
- Lake was about 200 acres
- Failed on first filling in June 2005

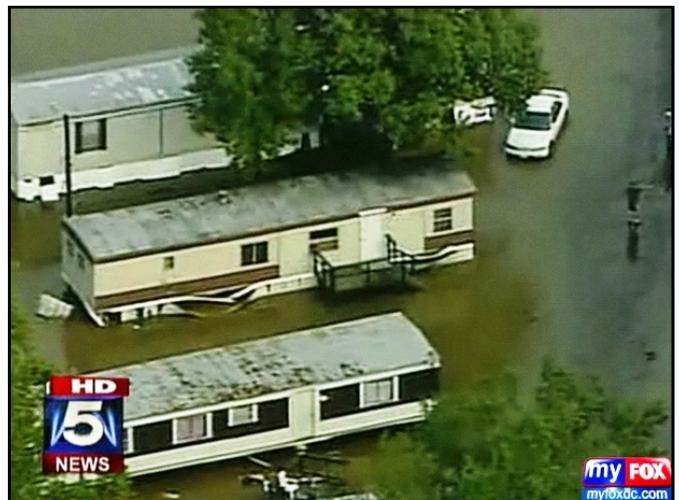
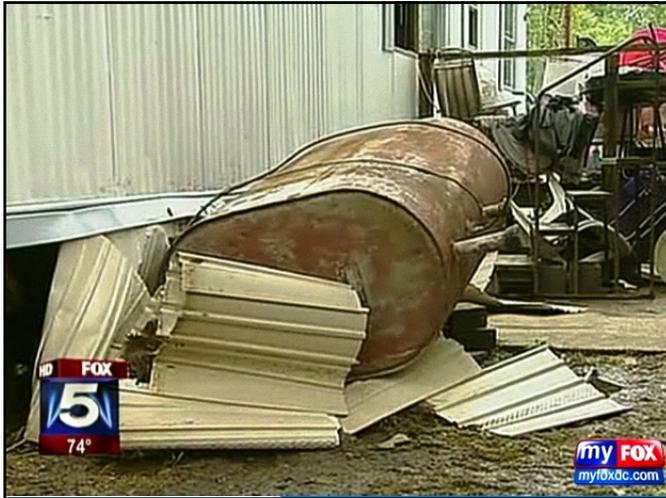
St Mary's Lake Dam

- In 2010 a storm caused flooding of a downstream community, although not because of the dam
- Subsequent review of the EAP for the dam noted that the trigger elevation for dam failure notification was after flow through emergency spillway occurred
- There was concern that evacuation could then not occur as many roads would be inundation
- So, the EAP trigger elevation was lowered to below the emergency spillway, but unfortunately the text of the notice was not changed, which stated that "dam failure is imminent"

- When lake elevation reached the Level III trigger during Hurricane Irene, the public notice incorrectly advised that dam failure was imminent
- However, no flow occurred through the emergency spillway and the dam was never in danger of failure
- 2012 EAP update adds a new warning level to evacuate residents before flow through the emergency spillway

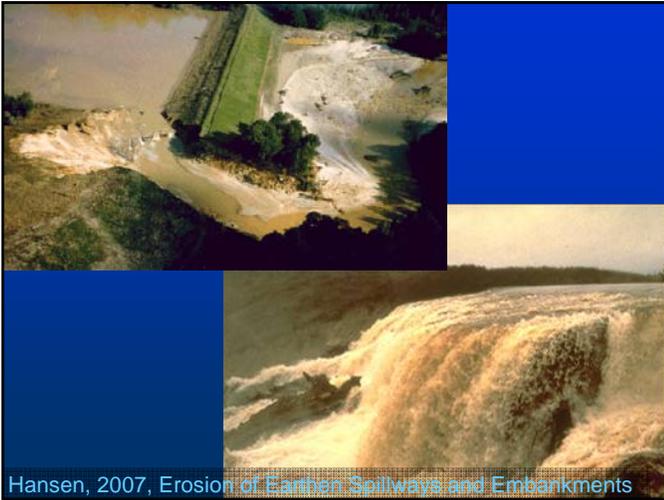
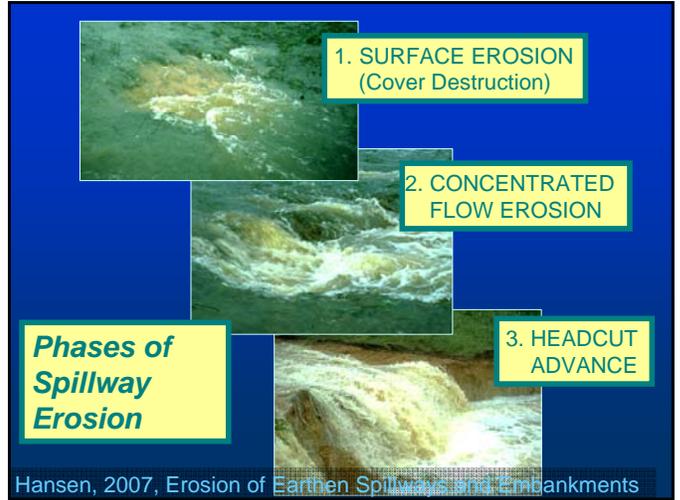
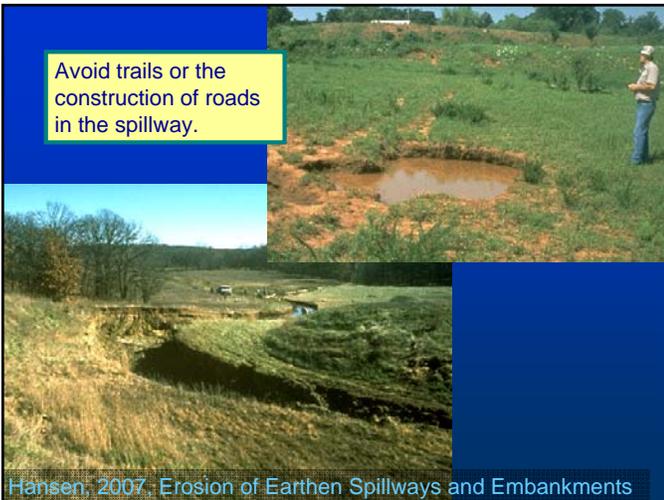
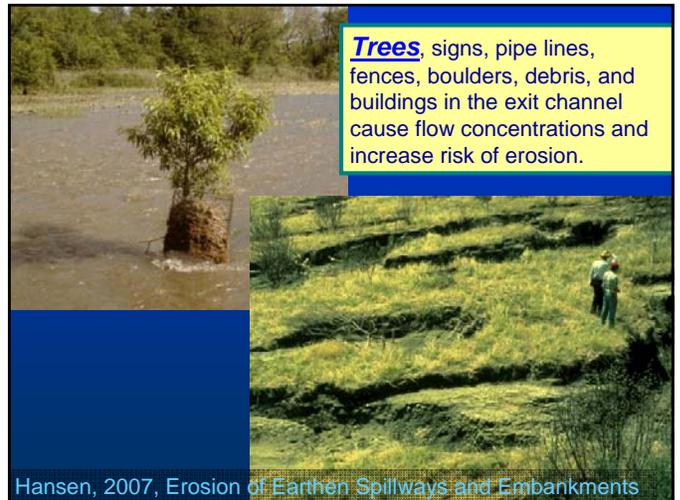
Trees, signs, pipelines, fences, boulders, debris, and buildings in the exit channel cause flow concentrations and increase risk of erosion.
